Project D Update, Part II:
Using Historic Photographs to Monitor
Geomorphic Changes
to the Colorado River corridor in
Grand Canyon National Park, AZ

H.C. Fairley, M.L. Scott and A.H. Fairley
USGS Southwest Biological Science Center
Grand Canyon Monitoring and Research Center

Annual Reporting Meeting
April 9, 2025

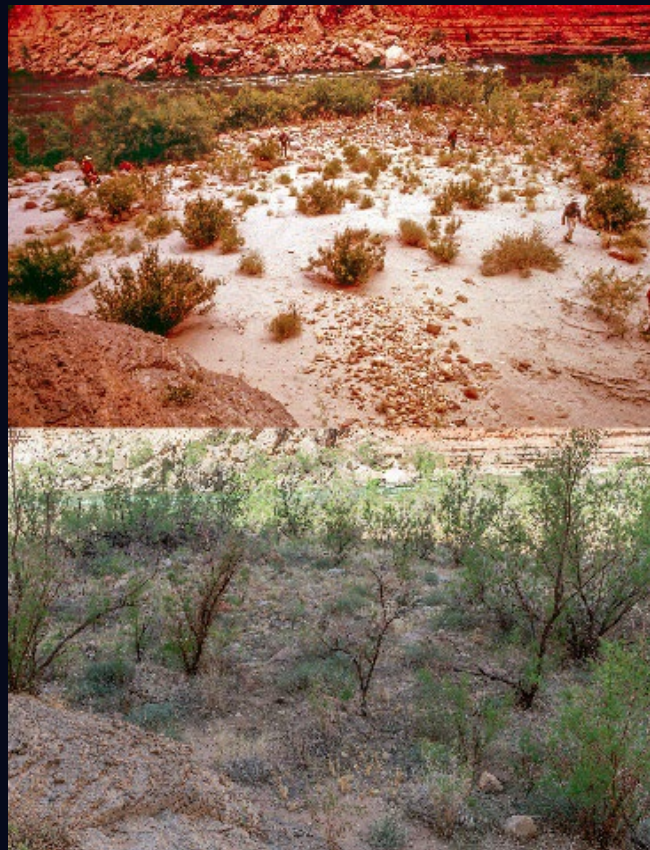
River Mile 37.7L, Example of conditions in July 1973 (top photo) matched with identical view of 2022 conditions. 1973 photos by unknown photographer; matched by A.H. Fairley. 5/1/22

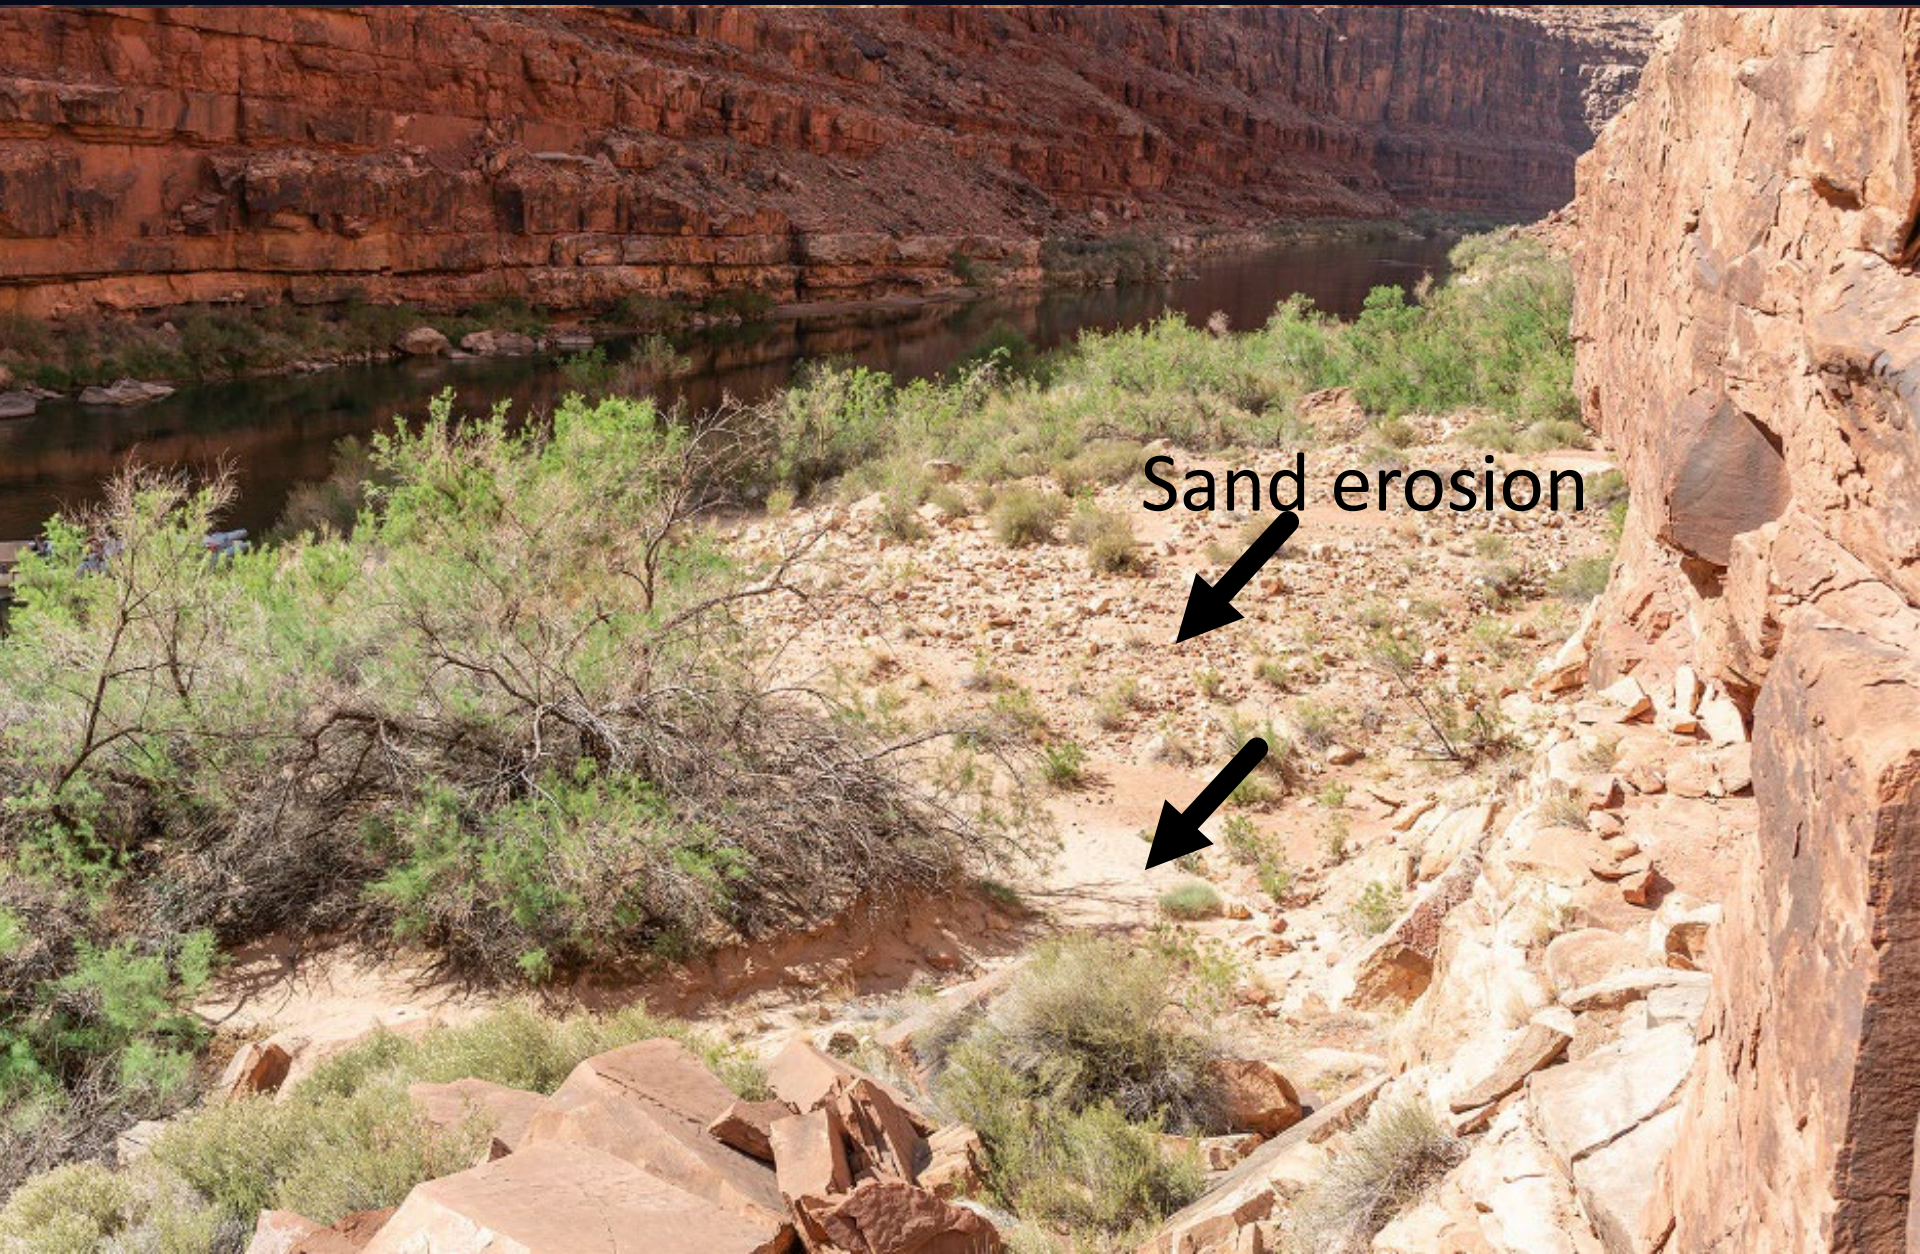
Sand erosion

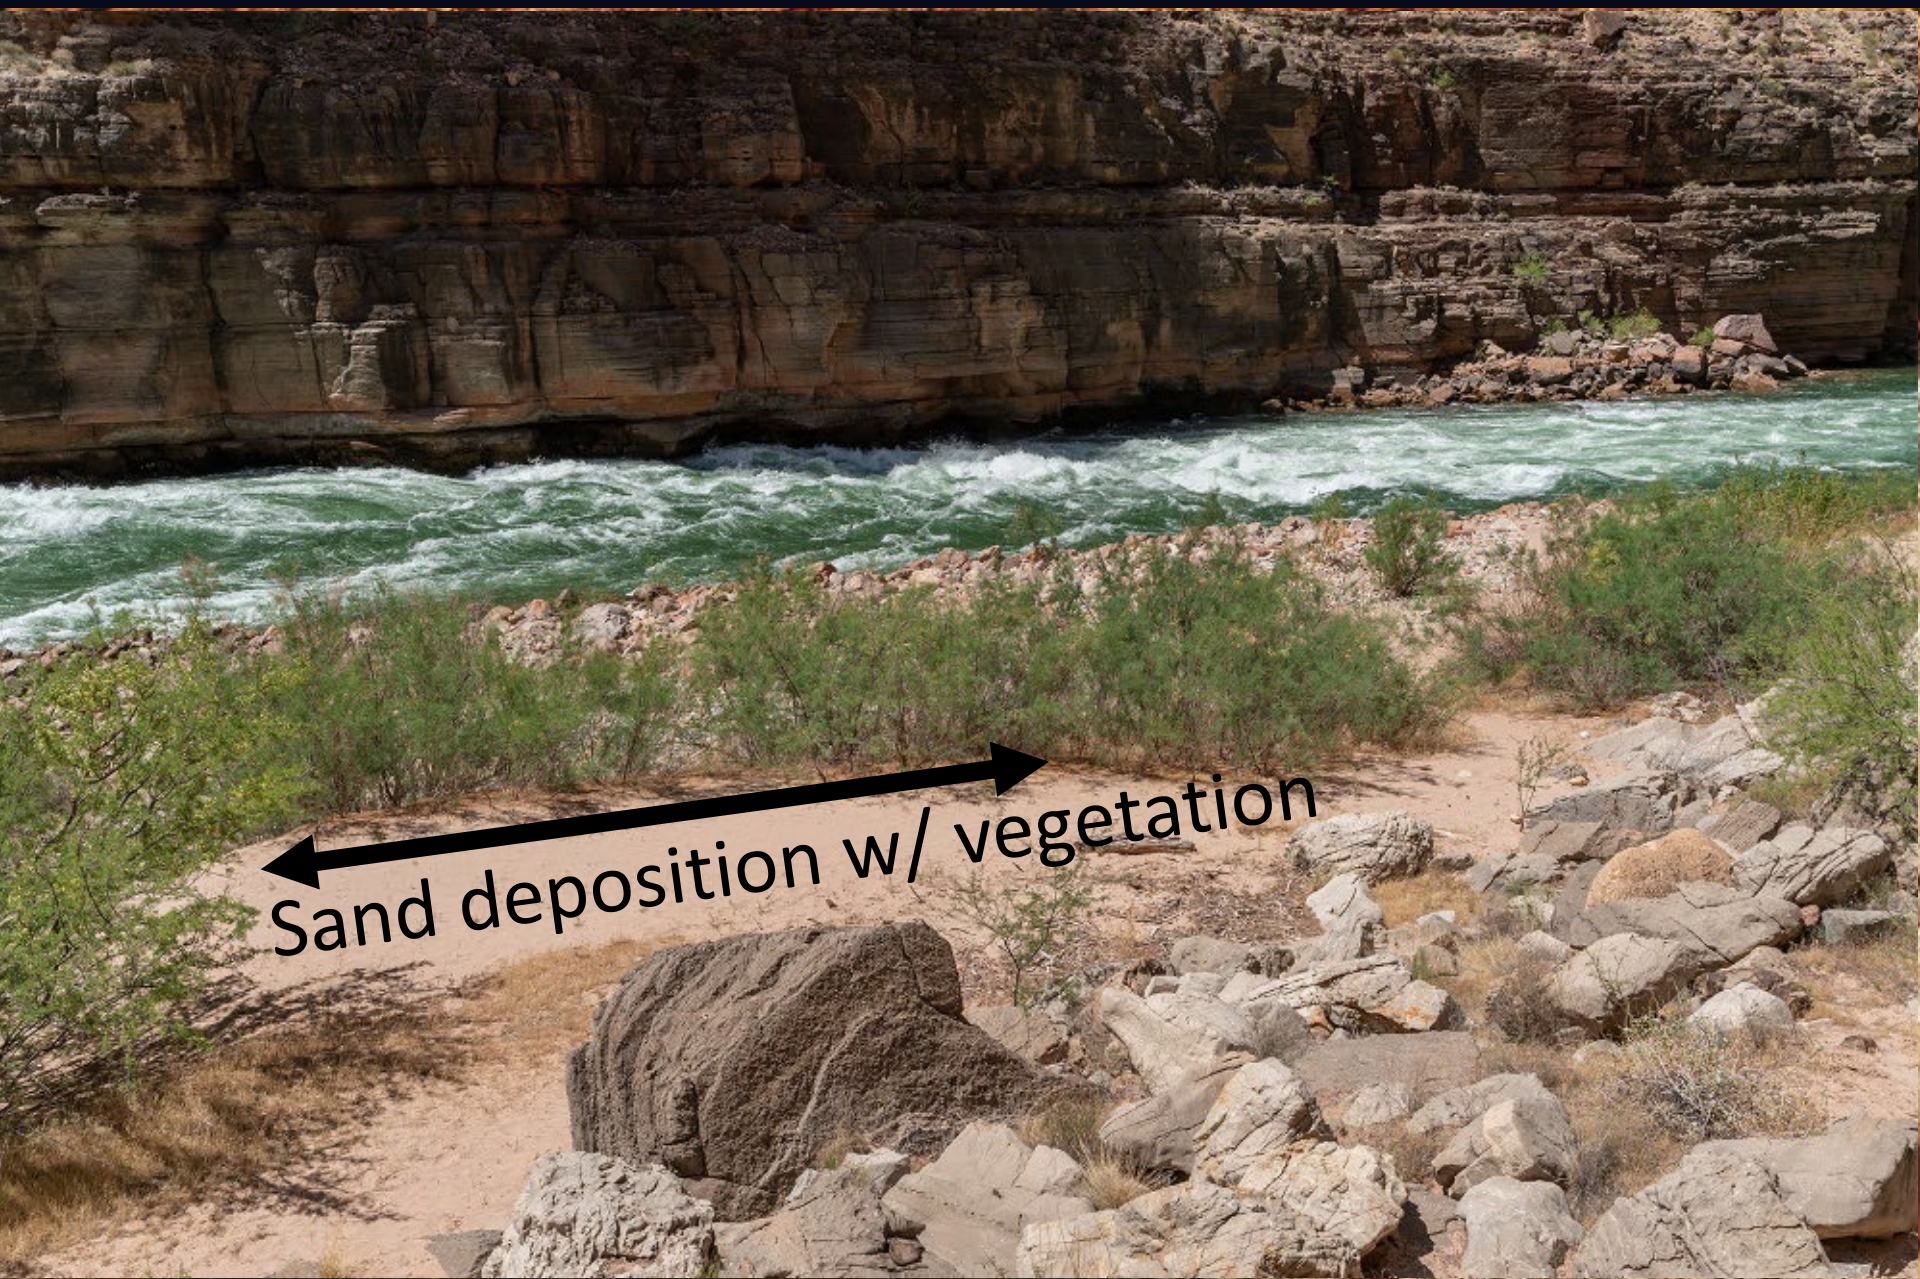
Sand deposition w/ vegetation

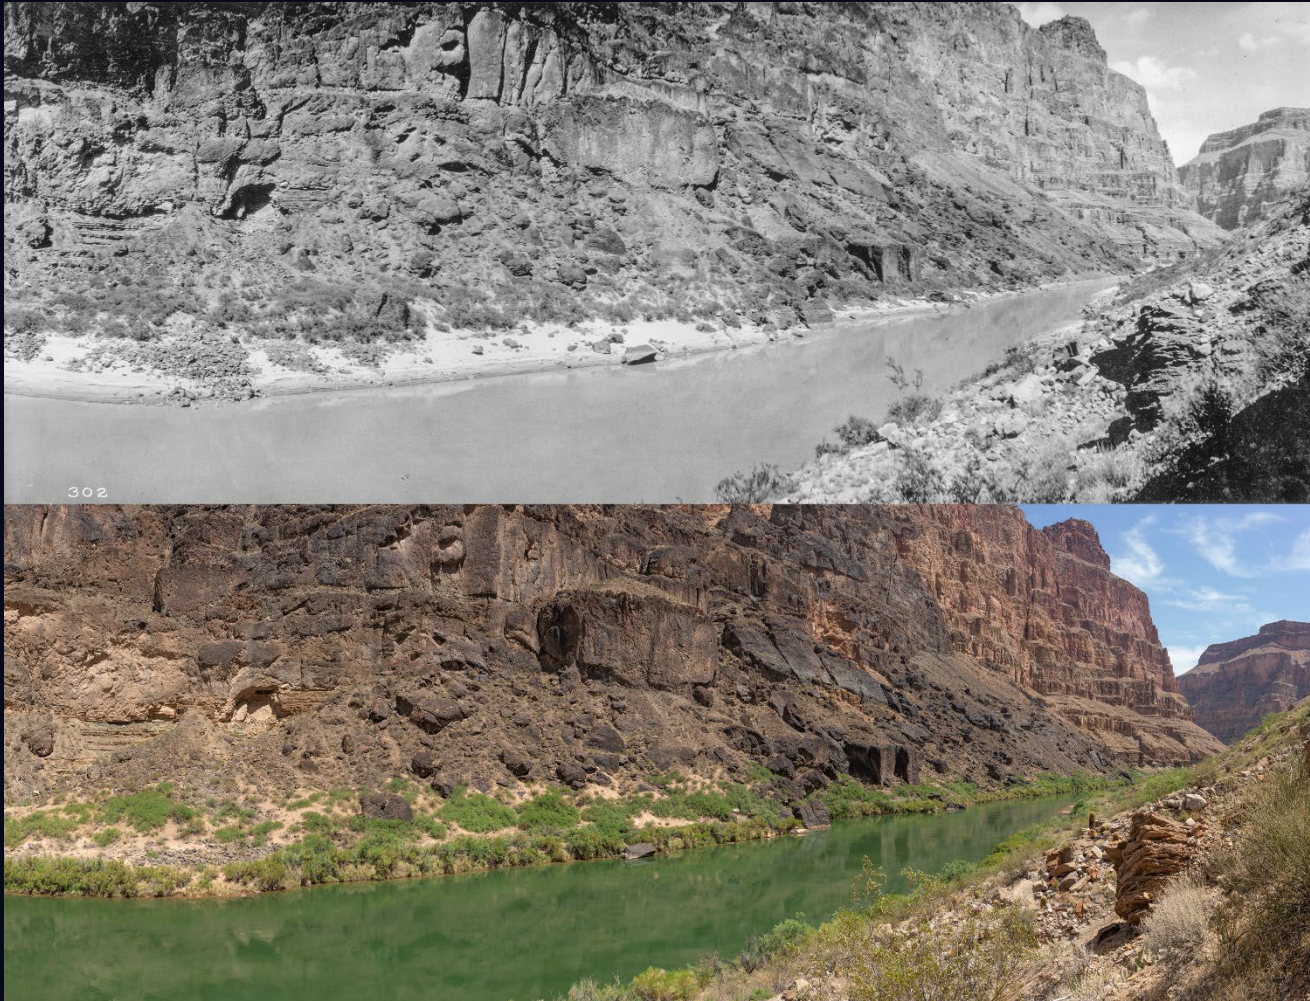
Zone 1 Vegetation Encroachment is Leading to Widespread Shoreline Steepening

River mile 179.2 L (Stake No. 697ab). Top photo E.C. LaRue, 9/19/1923;
Bottom photo A.H. Fairley, 5/19/2021

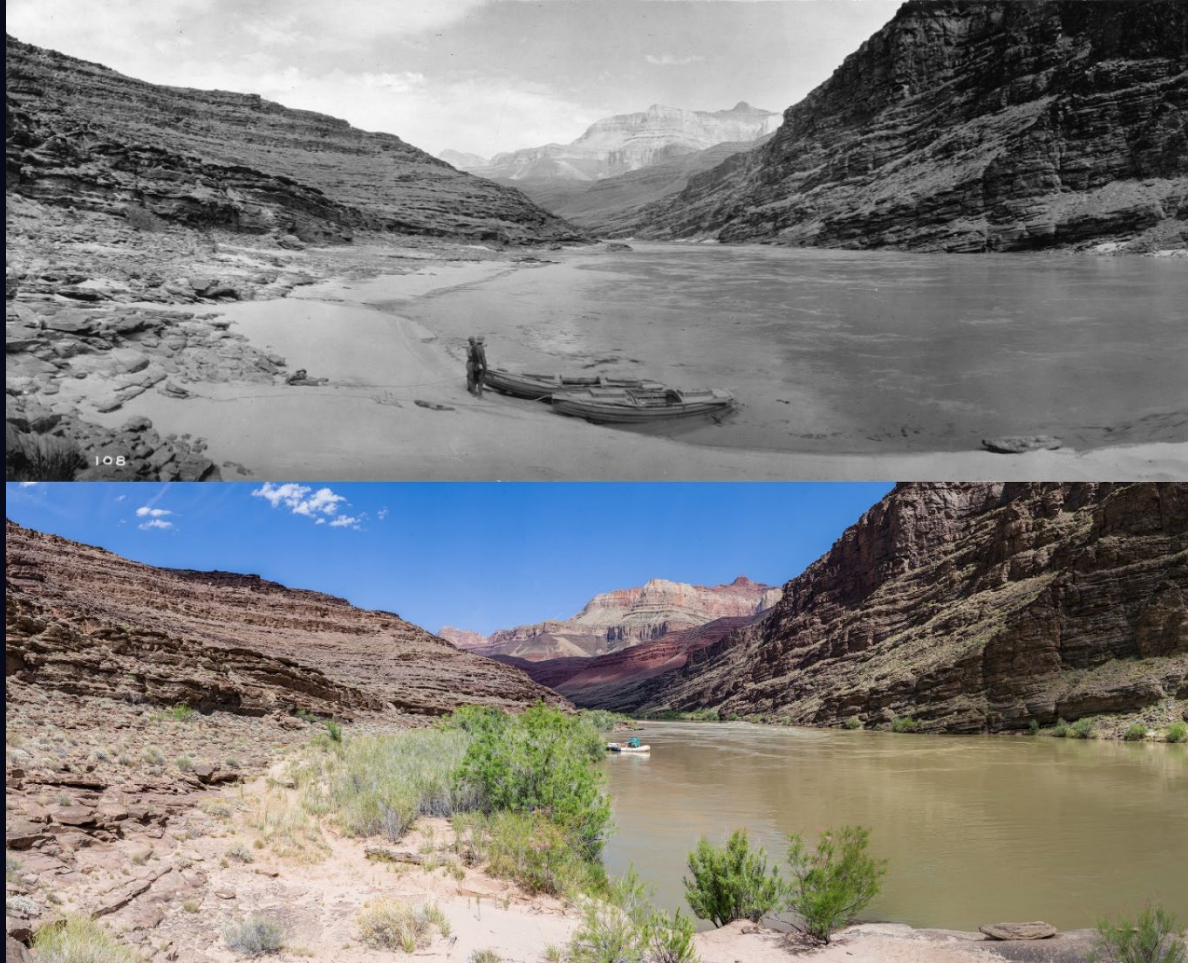
Zone 1 Vegetation Encroachment is Leading to Widespread Shoreline Steepening, cont.

River mile 74. 6 (Stake No. 2505): Top photo E.C. LaRue, 8/15/1923; Bottom photo A.H. Fairley, 5/4/2016

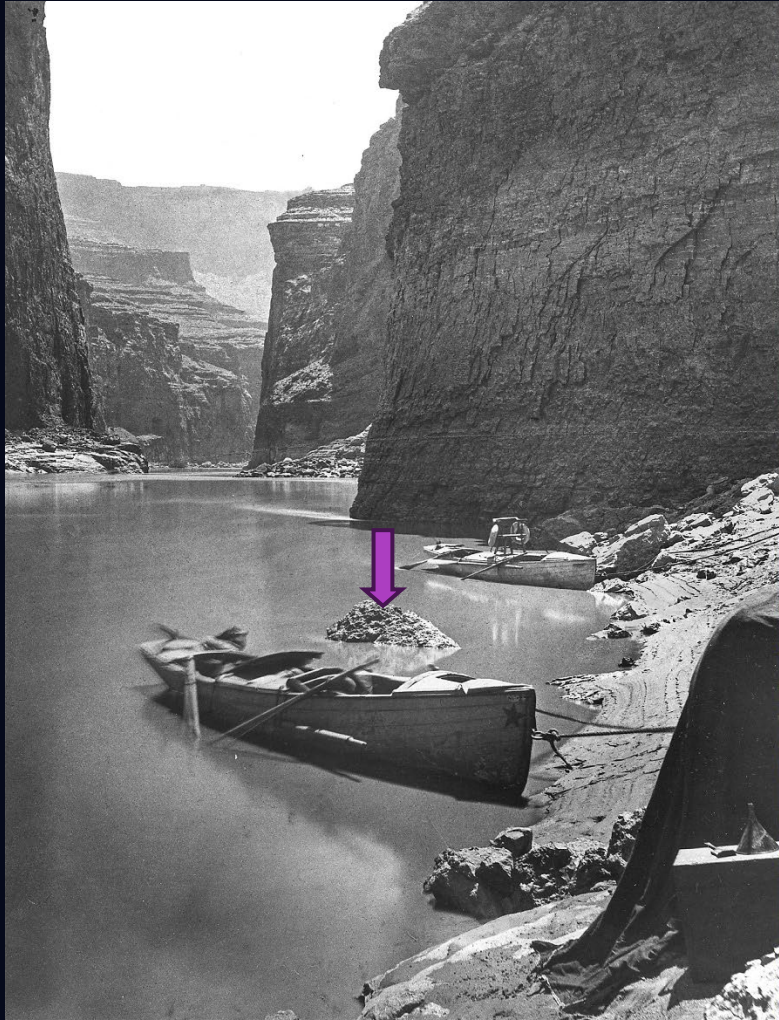
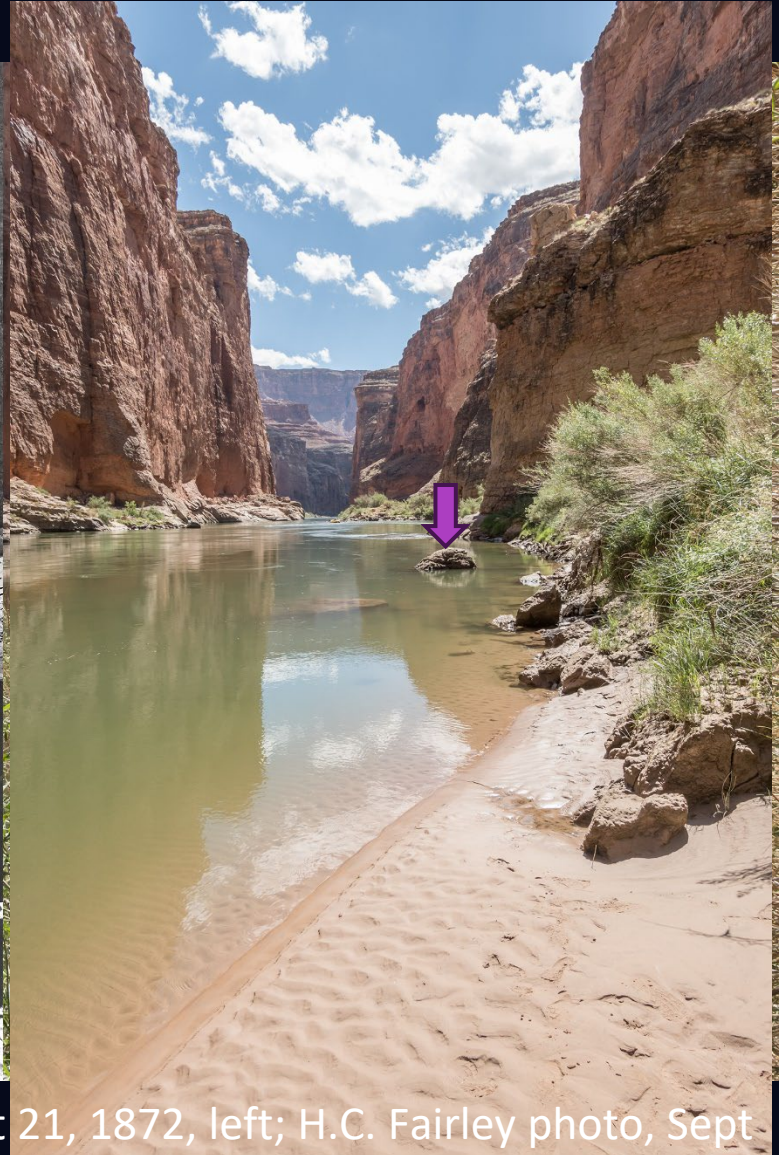
Another example of shoreline steepening

John K. Hillers photo, August 21, 1872, left; H.C. Fairley photo, Sept 15, 2024 right. River mile 34.2, right bank.

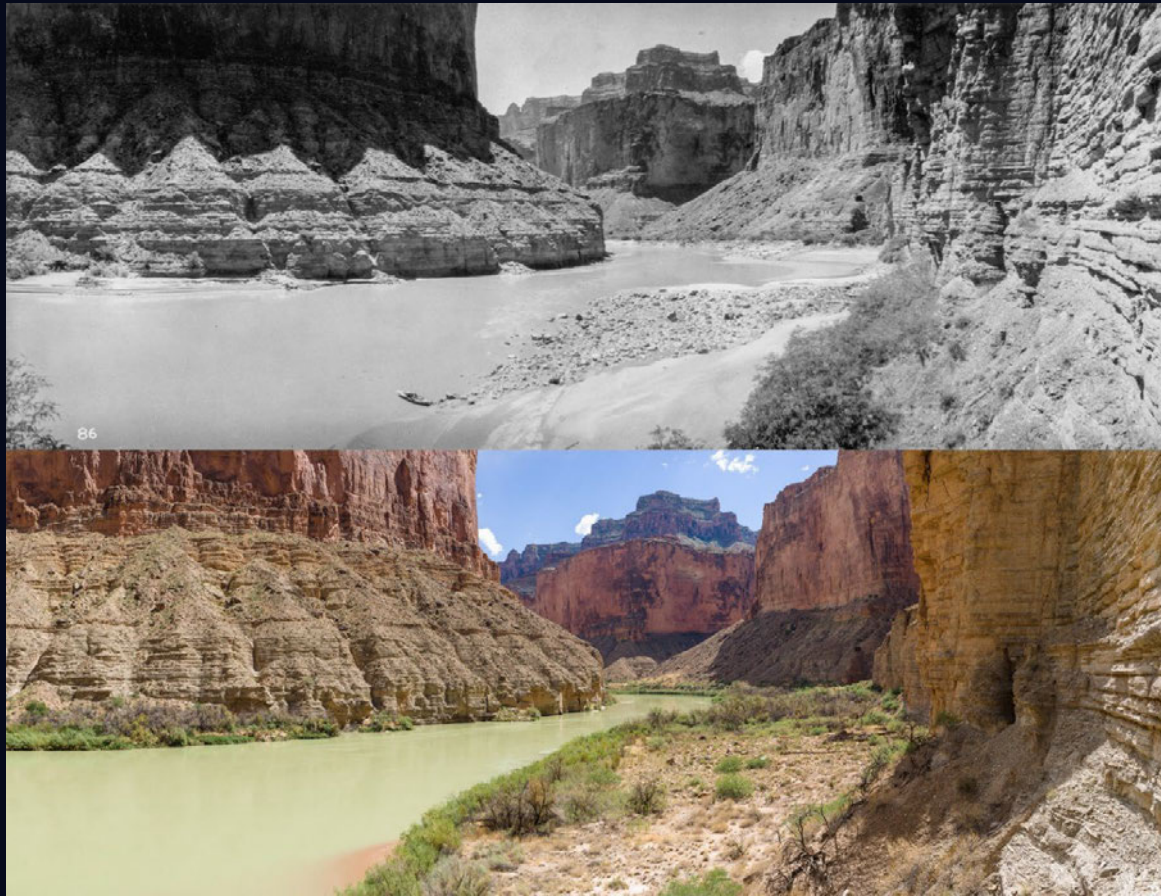
Steeper shorelines, vegetation barriers limit sand deposition at elevations >25k cfs, except during high flow experiments (HFEs)

River mile 46.8 (Stake No. 798): Top photo E.C. LaRue, 8/11/1923; Bottom photo A.H. Fairley, 8/26/2017

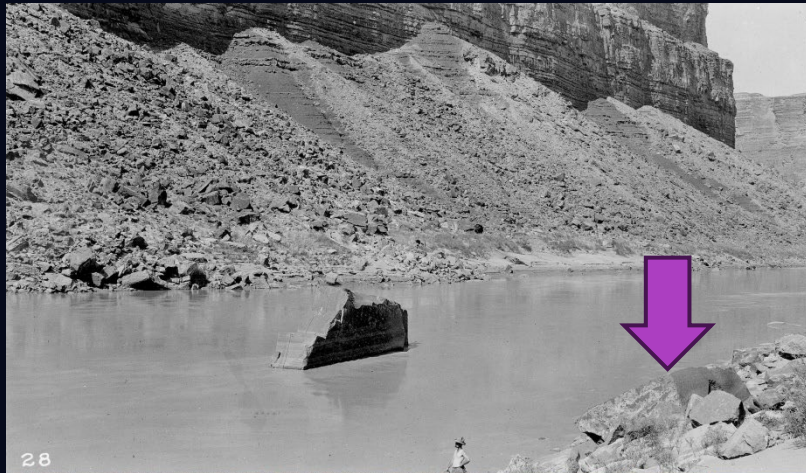
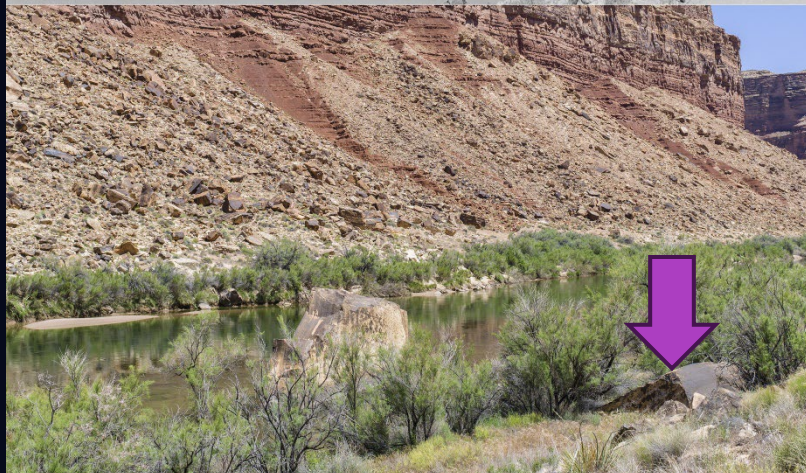
RM 10.2, Left
(Stake 2758)

During HFEs, sand is deposited in and adjacent to Zone 1 vegetation

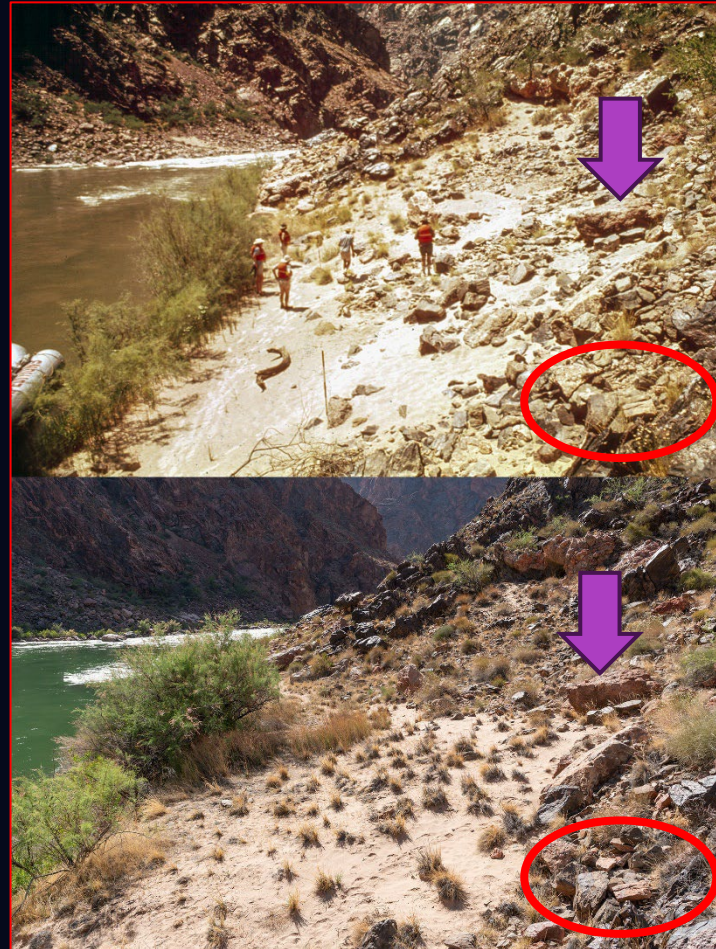
River mile 99.6, right
Stake No. 5509

Another example of sediment build-up next to Zone 1 vegetation

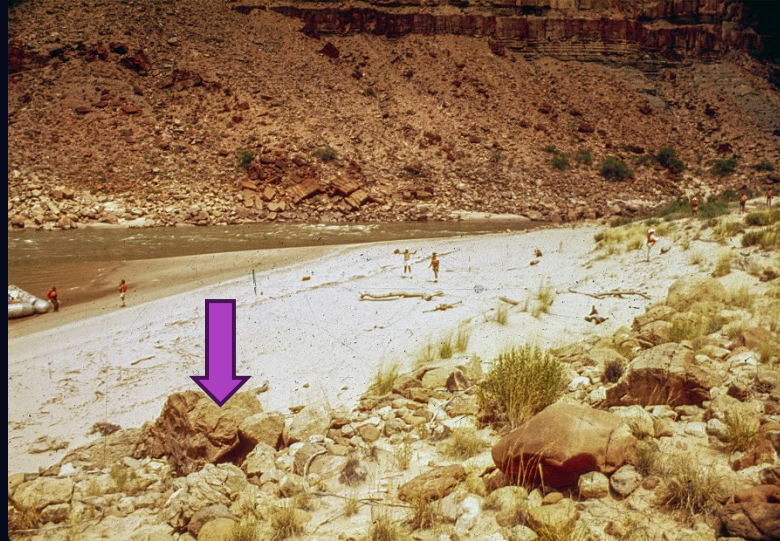
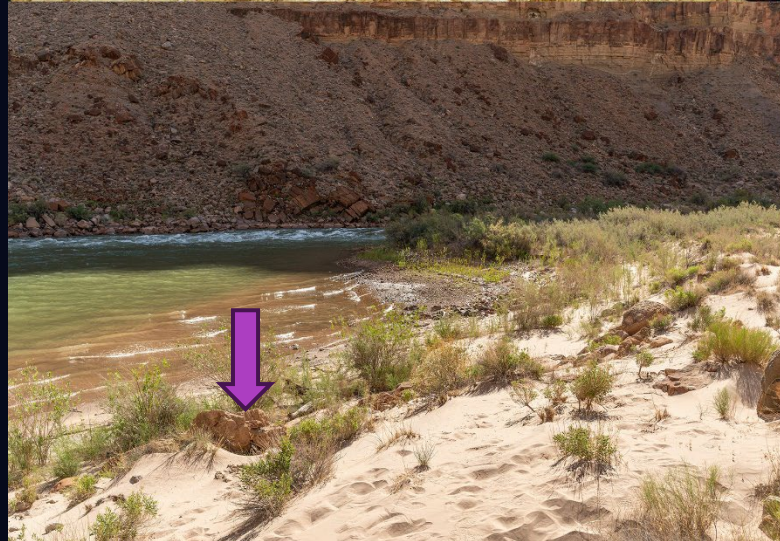
River mile 124.2, left
Stake No. 5561

Beach Erosion At Lower Elevation with Sediment Accumulation At Higher Elevation

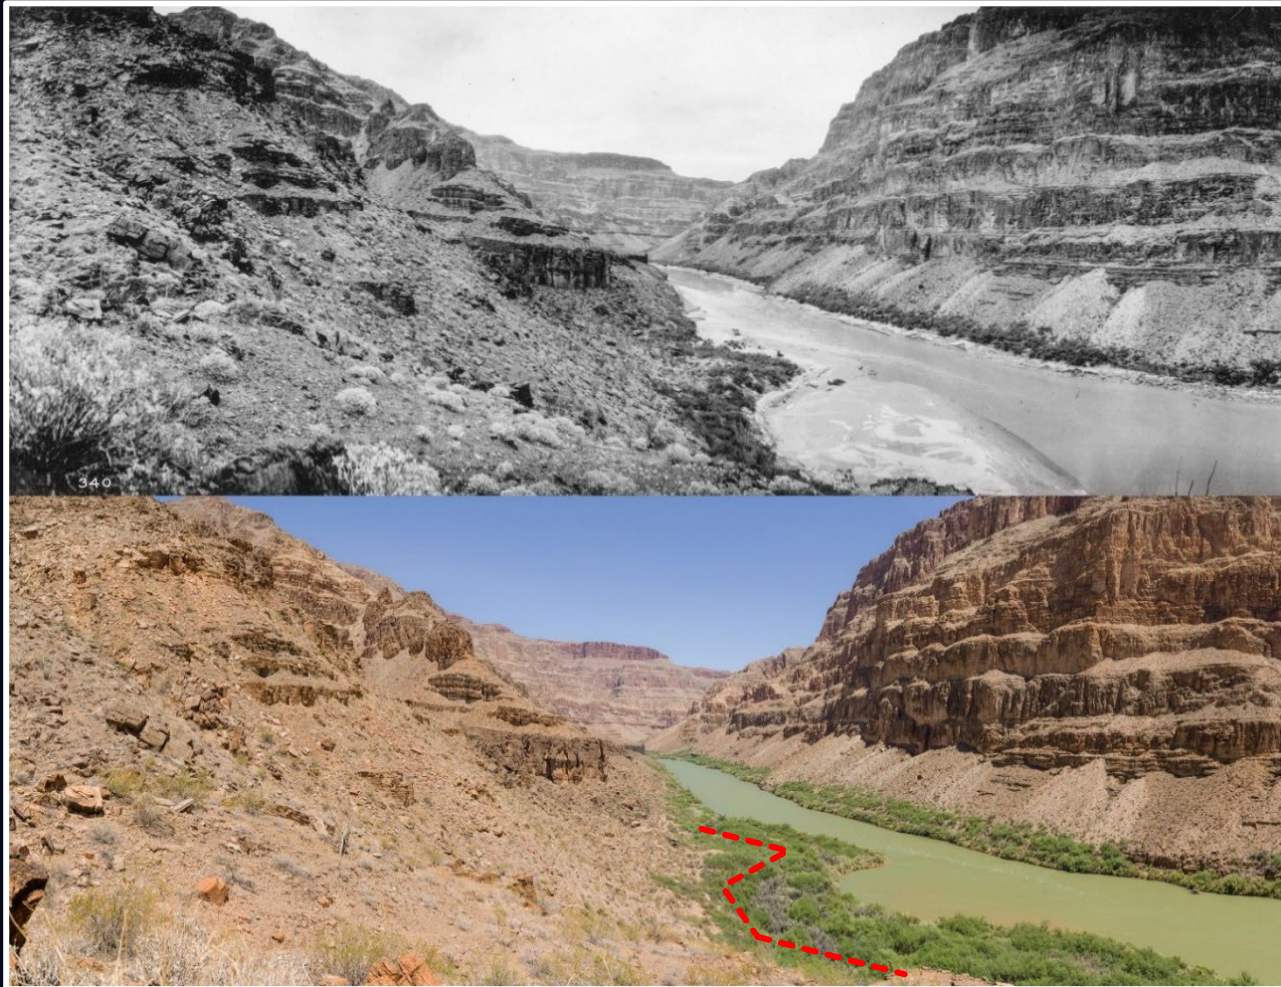
Infrequent HFEs and vegetation encroachment is also leading to channel narrowing, with implications for future sediment deposition and habitat quality

River mile 204.8, right, looking upstream (Stake No. 1802):
Top photo E.C. LaRue, 9/27/1923; Bottom photo A.H. Fairley, 5/11/2018

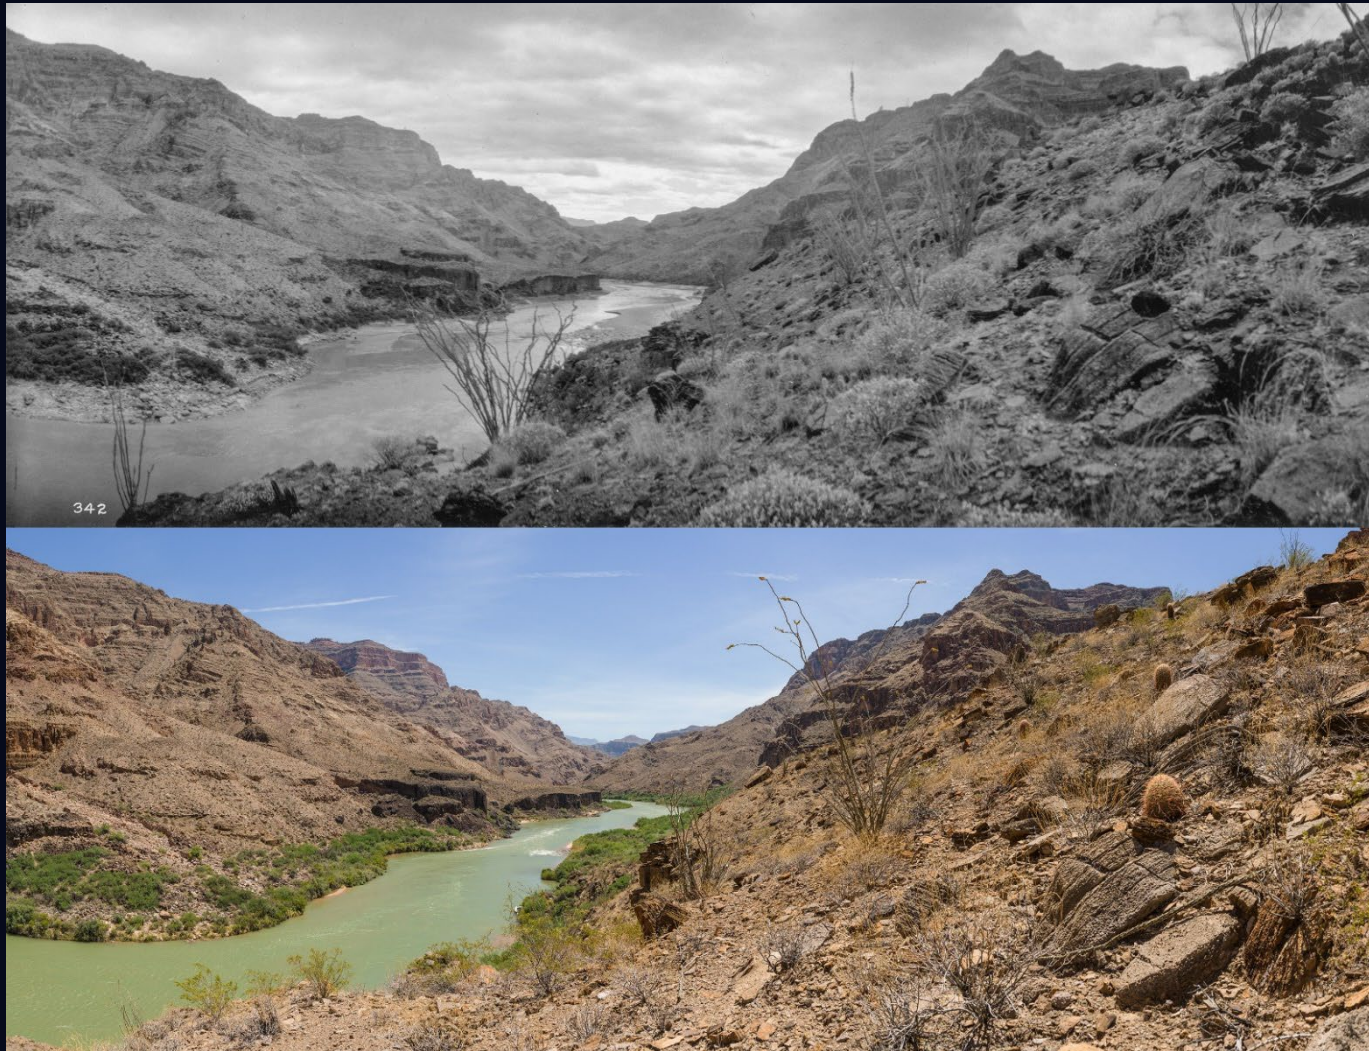
Another Example of Channel Narrowing

River mile 204.8, right, looking downstream (Stake No. 1796):
Top photo E.C. LaRue, 9/27/1923; Bottom photo A.H. Fairley, 5/11/2018

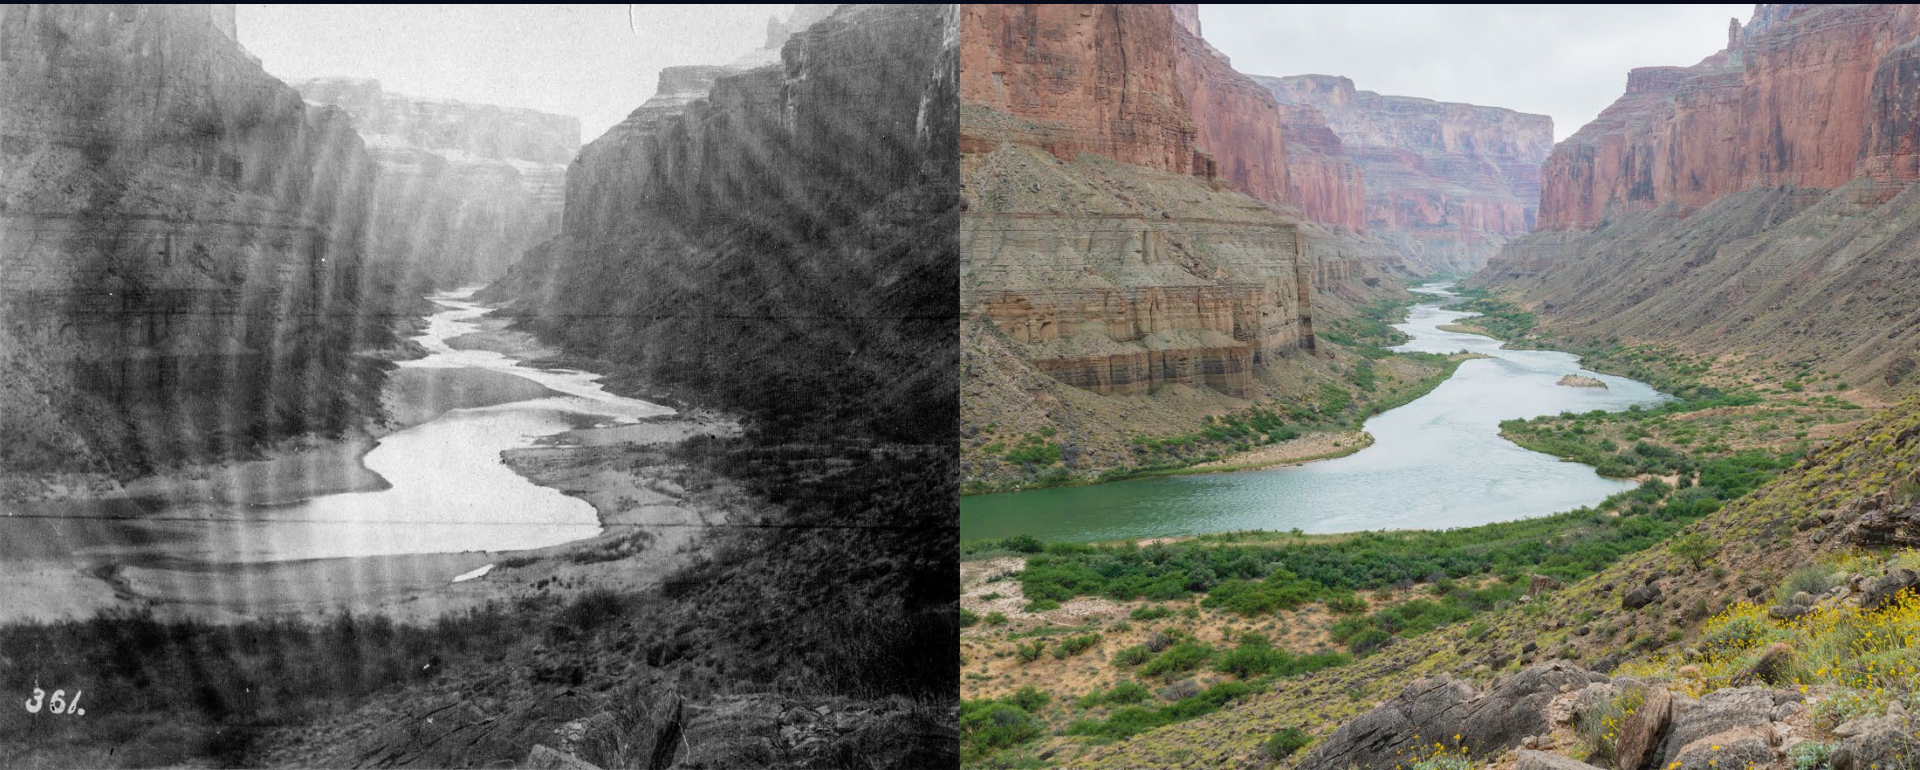
Another Example of Channel Narrowing

Nankoweap, River mile 53.2, right, looking downstream (Stake No. 1424a):
Left photo R.B. Stantion, 1/18/1890; Bottom photo A.H. Fairley, 5/7/2019

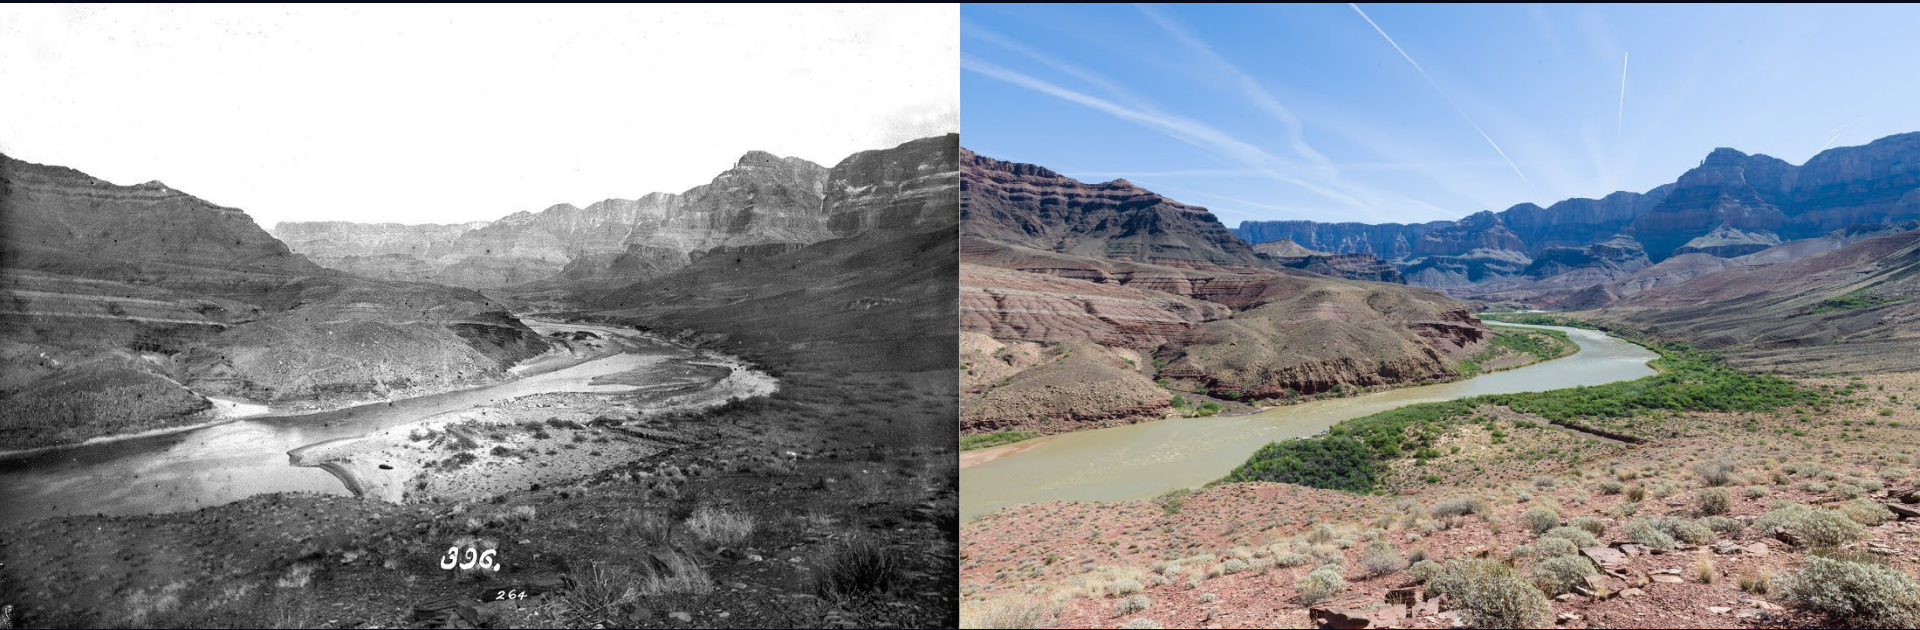
Another Example of Channel Narrowing

Cardenas, River mile 70.2, left, looking upstream (Stake No. 1440):
Left photo R.B. Stantion, 1/23/1890; Bottom photo A.H. Fairley, 5/4/2016
