MEMORANDUM FOR RECORD

SUBJECT: Interbasin Flow, Browns Valley Dike, Browns Valley, Minnesota, 2001 Flood and Historical Information

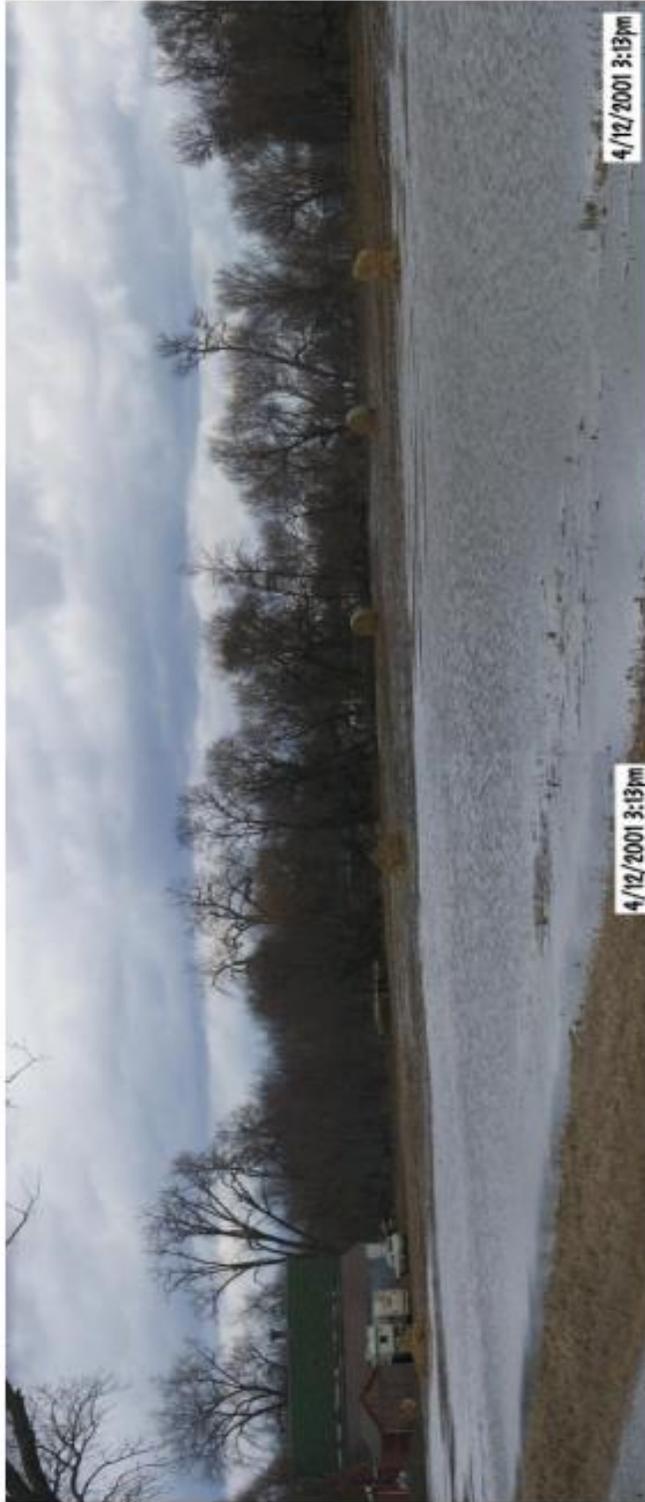
Enclosure 2

Browns Valley, MN, Continental Divide, Breakout Flow April 12, 2001

The above view is south-southeast from Point A on Enclosure No. 1. The tree line is the left bank of the Little Minnesota River. River flow is right-to-left. The breakout water in the foreground is flowing directly at the viewer to the right of the farmstead. The round bales of hay are sitting in the path of the breakout flow.

The farmstead on the left is between points A and B on Enclosure No. 1.

Mr. Jutila took some pictures of the breakout flow area during his visit. These are attached to this memorandum as Enclosures 2, 3 and 4. Enclosure No. 2 is a view south-southeast from [Point A](#) on Enclosure No. 1. Enclosure No. 3 is a view southwest from [Point B](#). Enclosure No. 4 is a view southeast from [Point C](#). Detailed explanations of each photograph are included on each enclosure. For additional reference, Points A, B, C, D and E can also be seen on some of the other enclosures to this memorandum. Point F is an additional breakout flow area, which is discussed below.

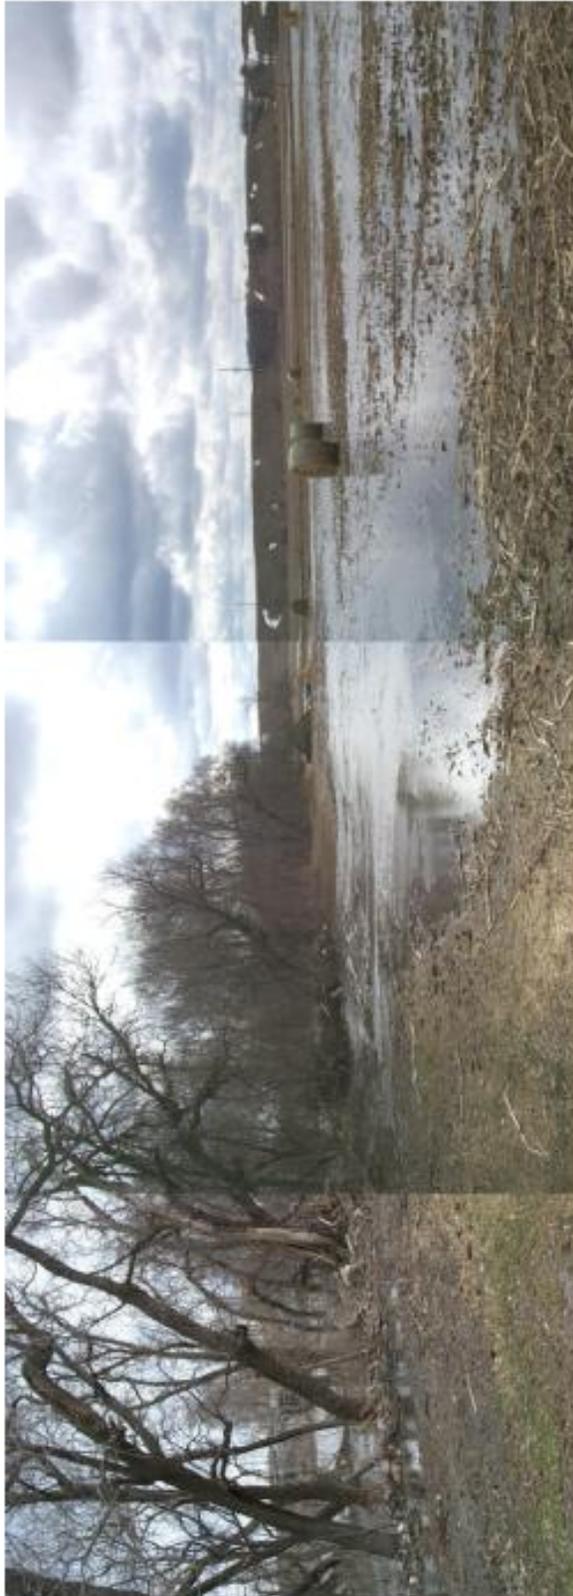
Enclosure 3

Browns Valley, MN, Continental Divide, Breakout Flow April 12, 2001

The above view is southwest from Point B on Enclosure No. 1. The photographer is behind the barn shown on Enclosure No. 2. The tree line is the left bank of the Little Minnesota River. The breakout flow can clearly be seen in the foreground of the picture flowing left-to-right. Breakout flow is also occurring further southwest of here along the toe of the escarpment seen in the background (see Point F on Enclosure Nos. 1, 5, 6, 7, 10, and 11). The discharge at the Peever gage is approximately 3,000 cfs at this time.

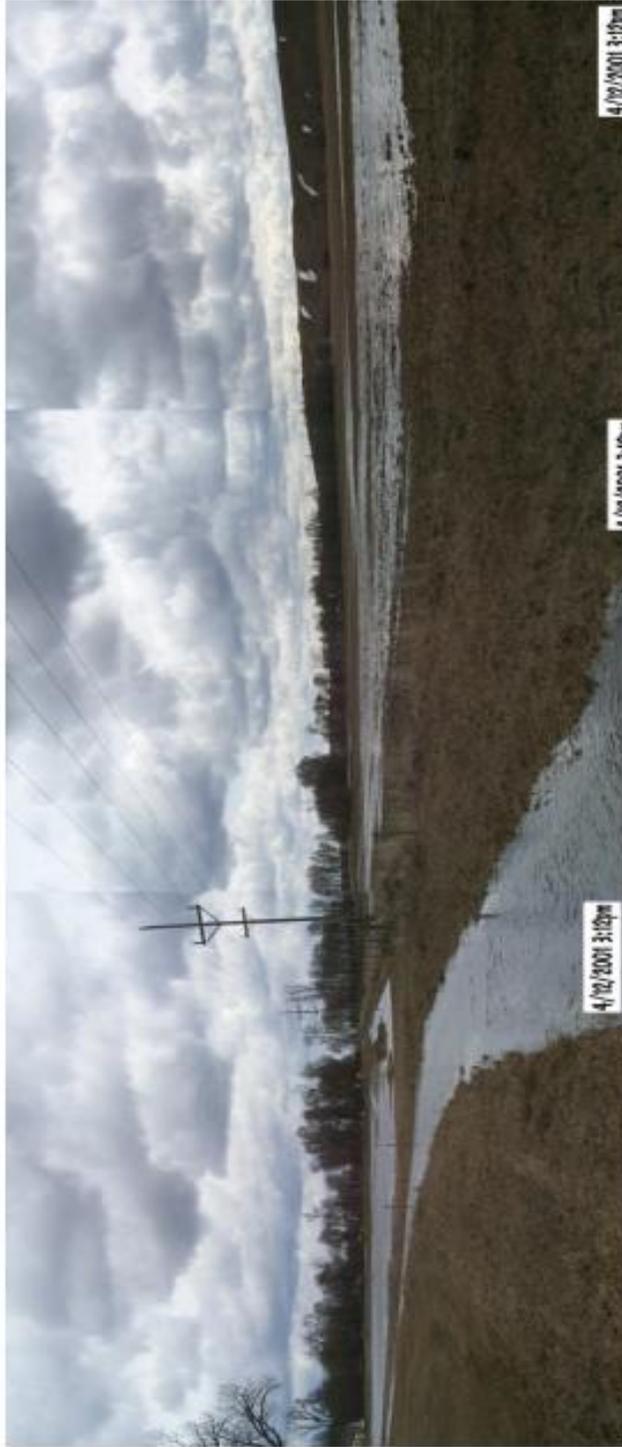
Enclosure 4

Continental Divide, Breakout Flow April 12, 2001

The above view is southeast from Point C on Enclosure No. 1 along the Roberts/Traverse County Line. The telephone line follows the county line (see Enclosure Nos. 5 and 6). The tree line in the background is the left bank of the Little Minnesota River. This water (from Point B) follows the Highway 7/28 ditch to the small culvert at Point E on Enclosure No. 1 and on into Lake Traverse. The ditch in the foreground can be seen on Enclosure Nos. 10 and 11. **Enclosure 4**

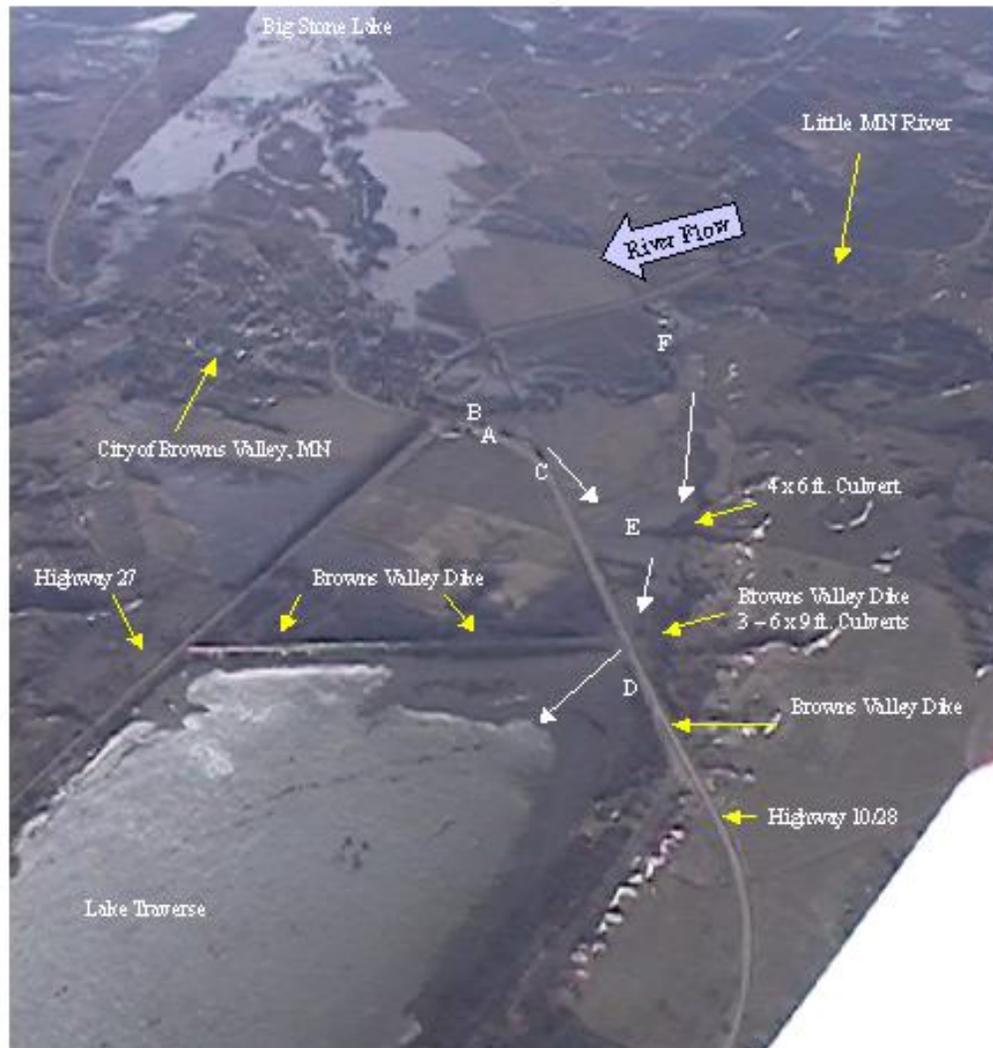
Enclosure 5

Continental Divide, Breakout Flow Area, April 14, 2001

The above view is southeast from **Point G** on Enclosure No. 1. The Little Minnesota River enters the picture on the right side of the photograph. The water in the background is backwater from Big Stone Lake. The water in the foreground is Lake Traverse. The white arrows illustrate breakout flow paths.

5. On 14 April 2001, Jon Boese of Holloway, Minnesota, took some oblique aerial photographs of the Browns Valley breakout flow area at approximately 1000 hours. David Craigmile of Boyd, Minnesota, provided the photographs to this office. They are attached as Enclosures 5 through 9. Enclosure No. 5 is an overall view of the area. Enclosure No. 6 is a view of the reach of the Little Minnesota River along which breakout flow occurs. Enclosure No. 7 is a view of the breakout flow area at Point F on Enclosure No. 1 (near the escarpment). Enclosure No. 8 is a close-up of Enclosure No. 7. Enclosure No. 9 is a close-up of the Browns Valley dike culverts under Highway 10/28 (see Point D on the enclosures). No field observations of breakout flow were made on the ground on 14 April. However, Enclosure No. 8 indicates that breakout flow is occurring. The discharge at the Little Minnesota River at the Peever gage was approximately 2,500 cfs at this time. Detailed explanations of each photograph are included on each enclosure.

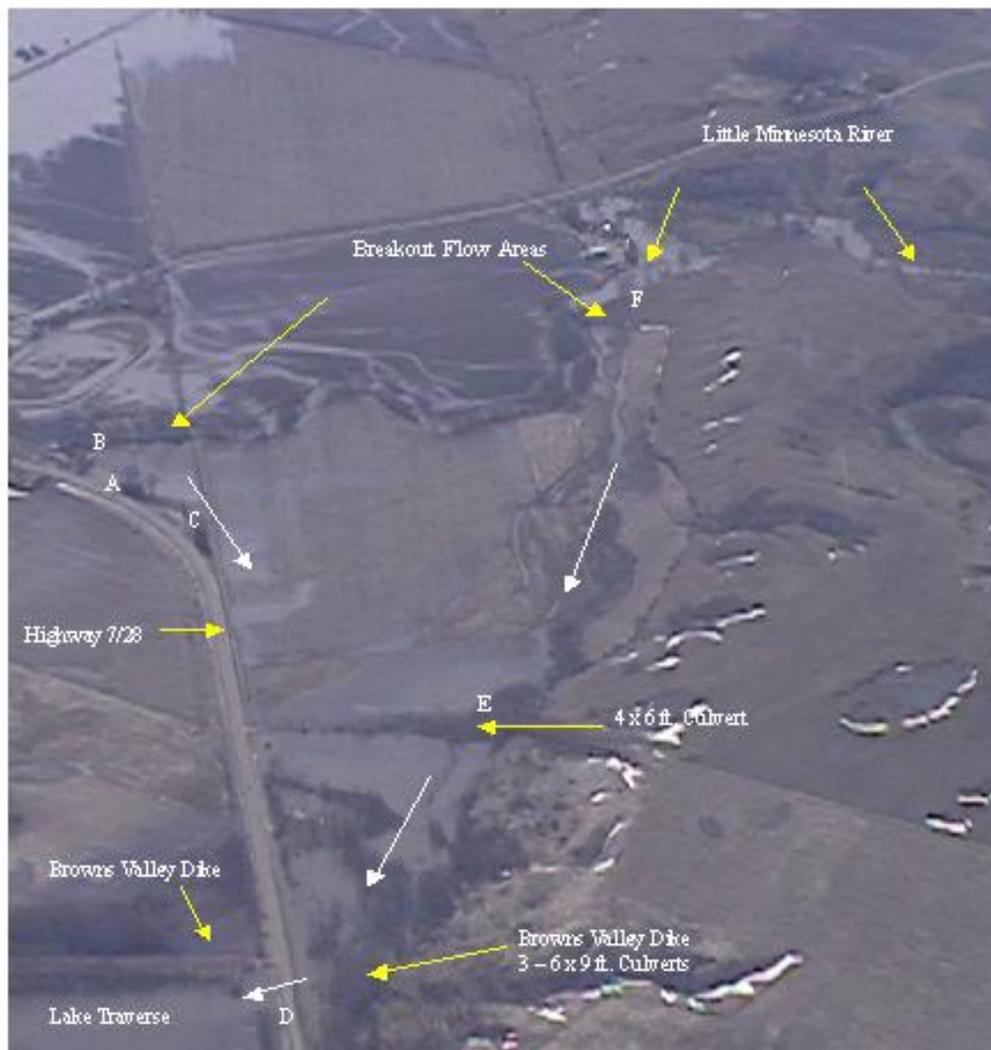
Continental Divide, Breakout Flow Area, April 14, 2001

The above view is southeast from **Point H** on Enclosure No. 1. The Little Minnesota River enters the picture in the upper-right corner of the photograph. The Little Minnesota River flow is from right-to-left. The white lines represent breakout flow paths. **Enclosure 6**

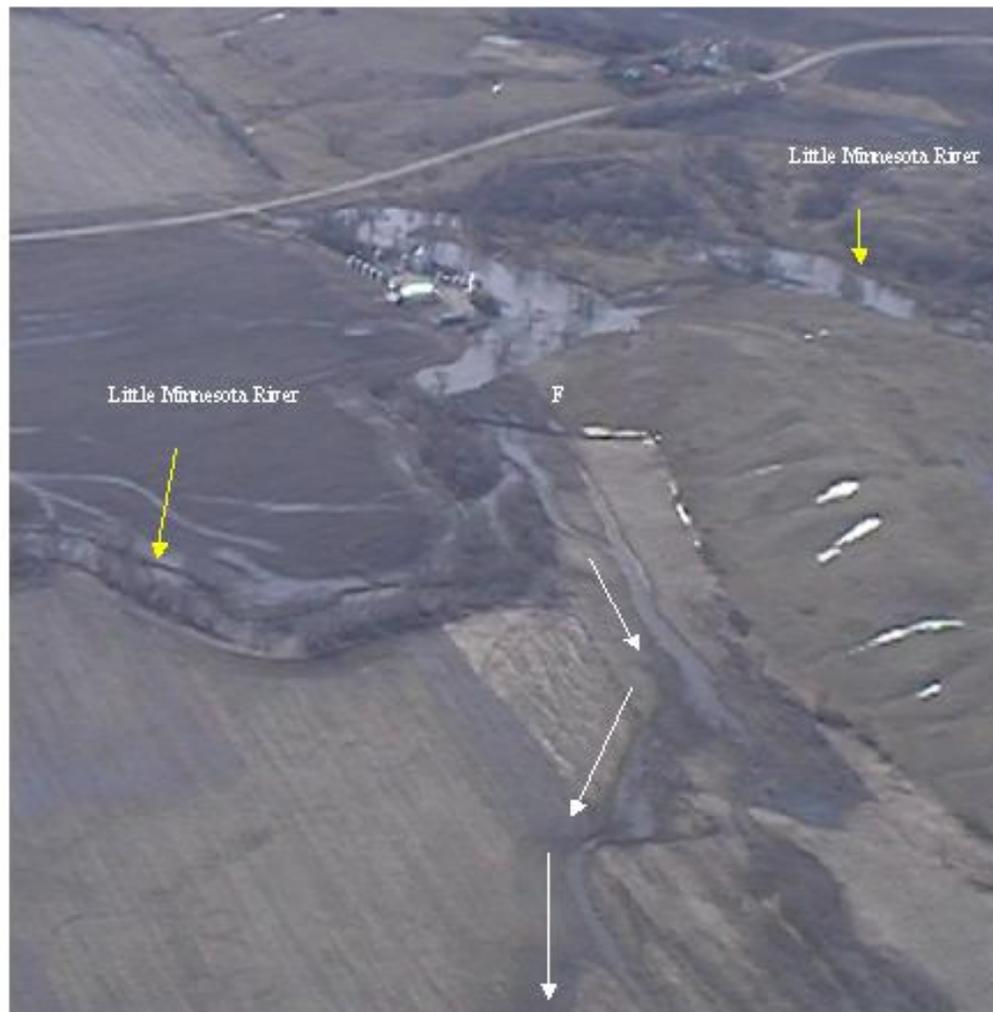
Enclosure 7

Continental Divide, Breakout Flow Area, April 14, 2001, approx. 1000 hrs.

The above view is southeast from [Point I](#) on Enclosure No. 1 toward [Point F](#). The

Little Minnesota River enters the picture in the upper-right corner of the photograph. The Little Minnesota River flow is from right-to-left. The white lines represent breakout flow paths. The discharge at the Peever gage is approximately 2,500 cfs at this time.

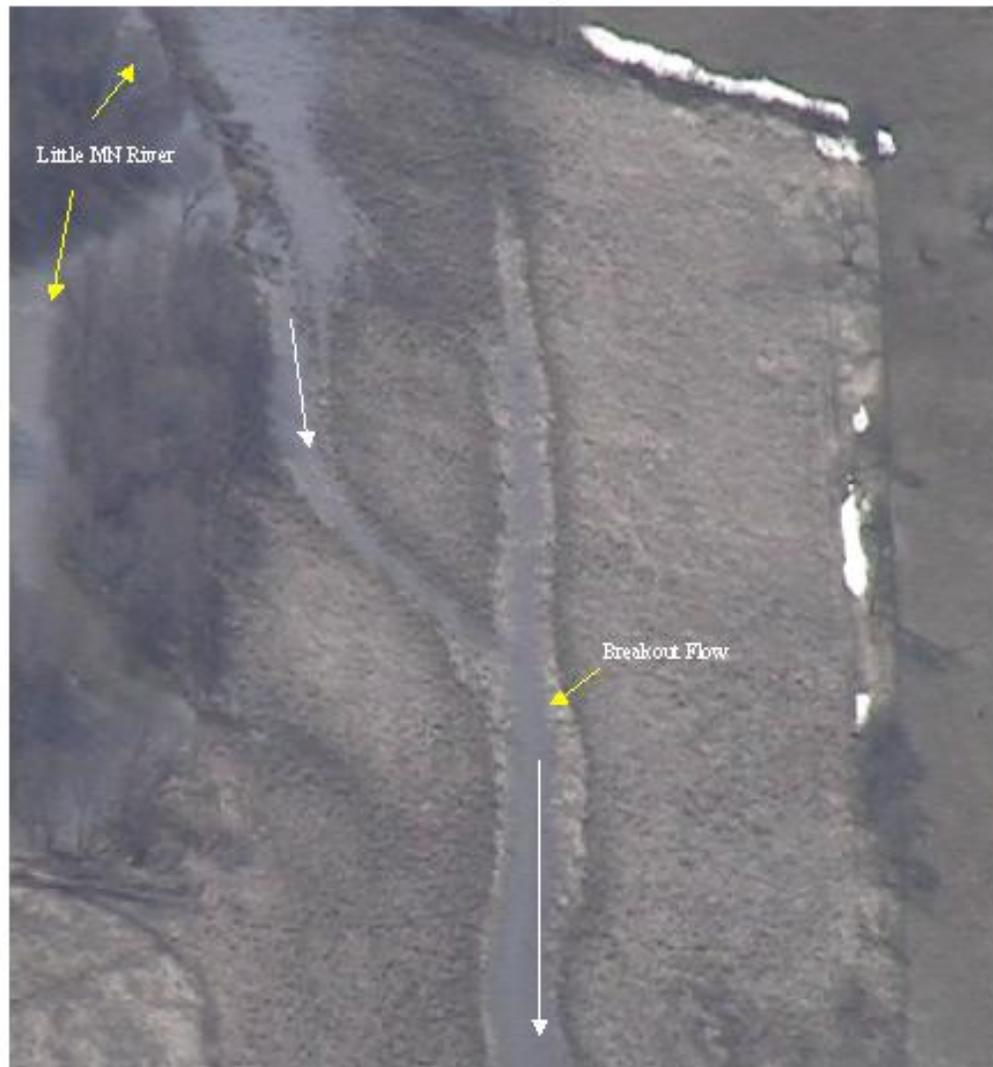
Continental Divide, Breakout Flow Area, April 14, 2001

The above view is southeast and is a close-up of the Point F area on Enclosure No. 7 (also see Pt. F on Enclosure No. 1). The Little Minnesota River is in the upper left corner of the photograph. Breakout flow can be seen escaping from the left bank of the Little Minnesota River and flowing into a ditch along the toe of the adjoining ridge. The white lines represent breakout flow paths. **Enclosure 8**

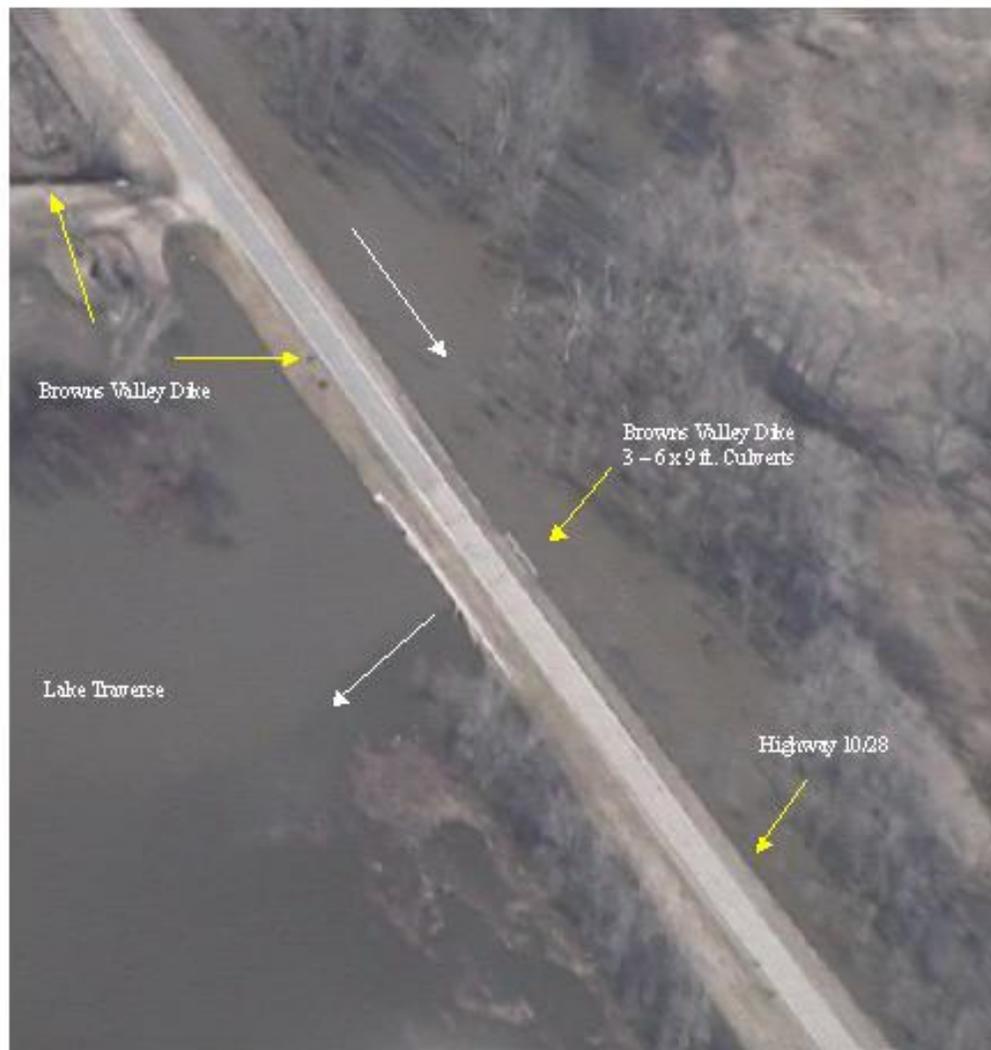
Continental Divide, Breakout Flow Area, April 14, 2001

The above view is south-southeast and is a close-up of the Point D area on Enclosure No. 1 (also see pt. D on the other Enclosures). The main portion of the Browns Valley Dike can be seen in the upper left corner of the picture. The road also forms a portion of the dike in a northwest direction. The triple box culvert/bridge can be seen in the center of the picture. The white lines represent breakout flow paths. **Enclosure 9**

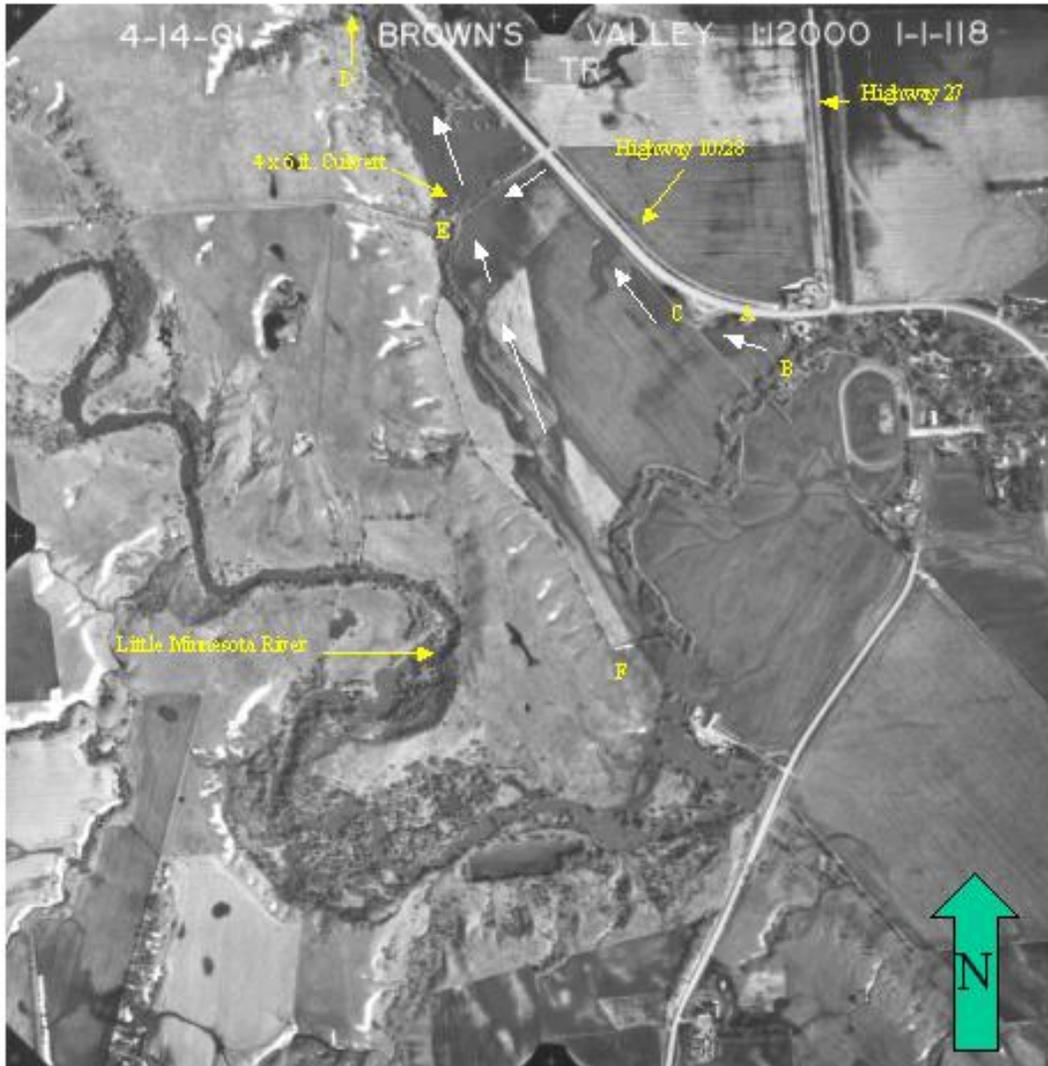
Continental Divide, Breakout Flow Area, April 14, 2001

The Browns Valley Dike culverts are just off the top edge of this photograph. The white lines represent breakout flow paths. **Enclosure 10**

6. On 14 April 2001, a Corps of Engineers contractor took some 1:12000 high altitude aerial photographs of the Browns Valley area. This information is attached as Enclosures 10 and 11. Enclosure No. 11 is a close-up view of Enclosure No. 10. Breakout flow from the Point F area can be seen on these photographs. Evidence of breakout flow from near Point B can also be seen on Enclosure No. 11. Details of each photograph are included on each enclosure.

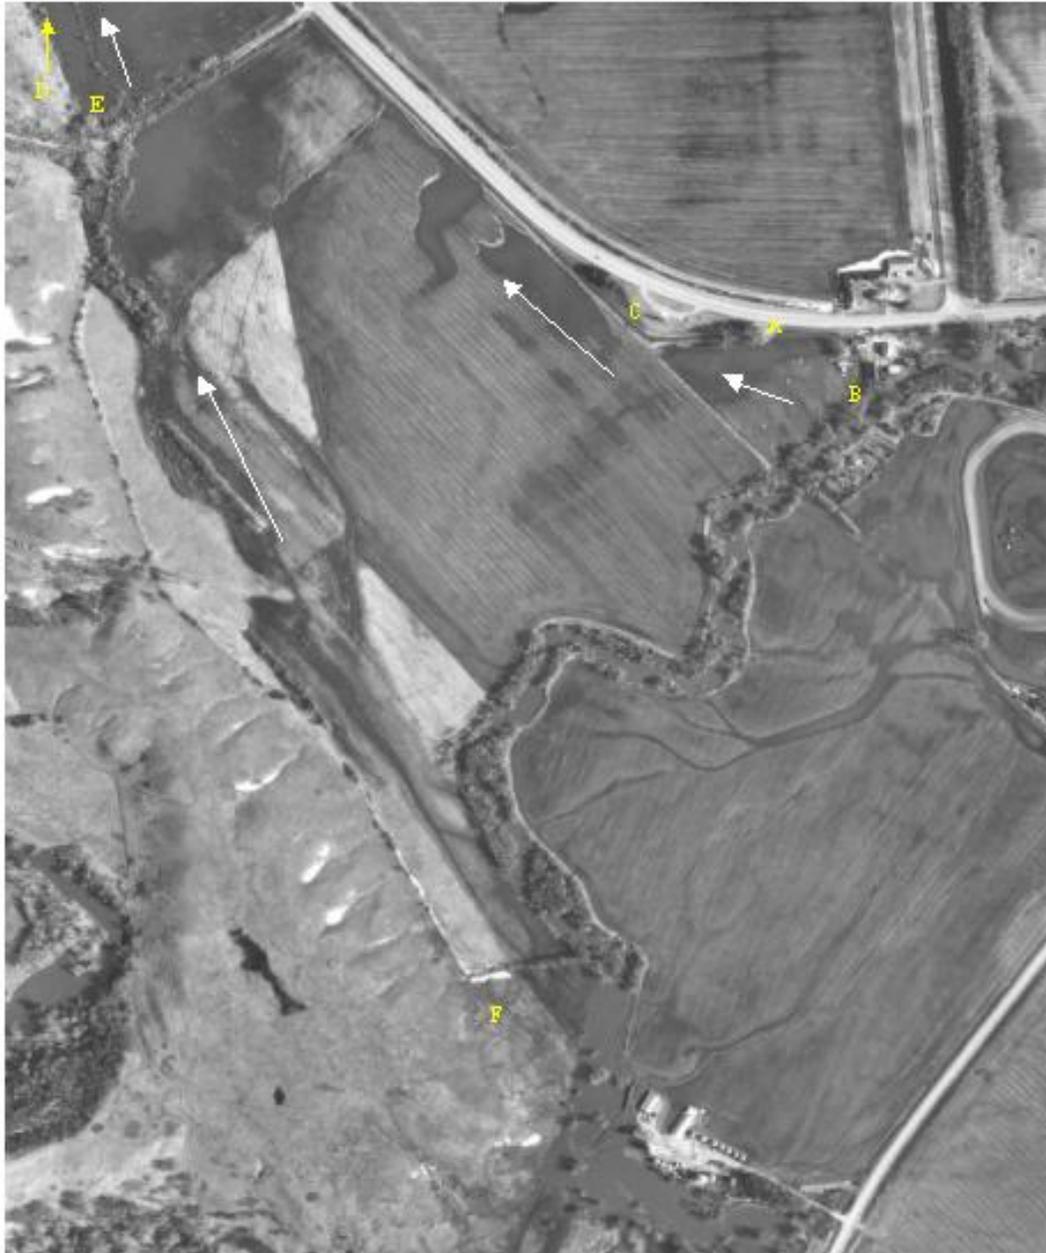
Enclosure 11

Continental Divide, Breakout Flow Area, April 14, 2001

This is a close-up of Enclosure No. 10. The breakout flow paths can be seen in the Point A-B-C and F areas. The white lines represent breakout flow paths.

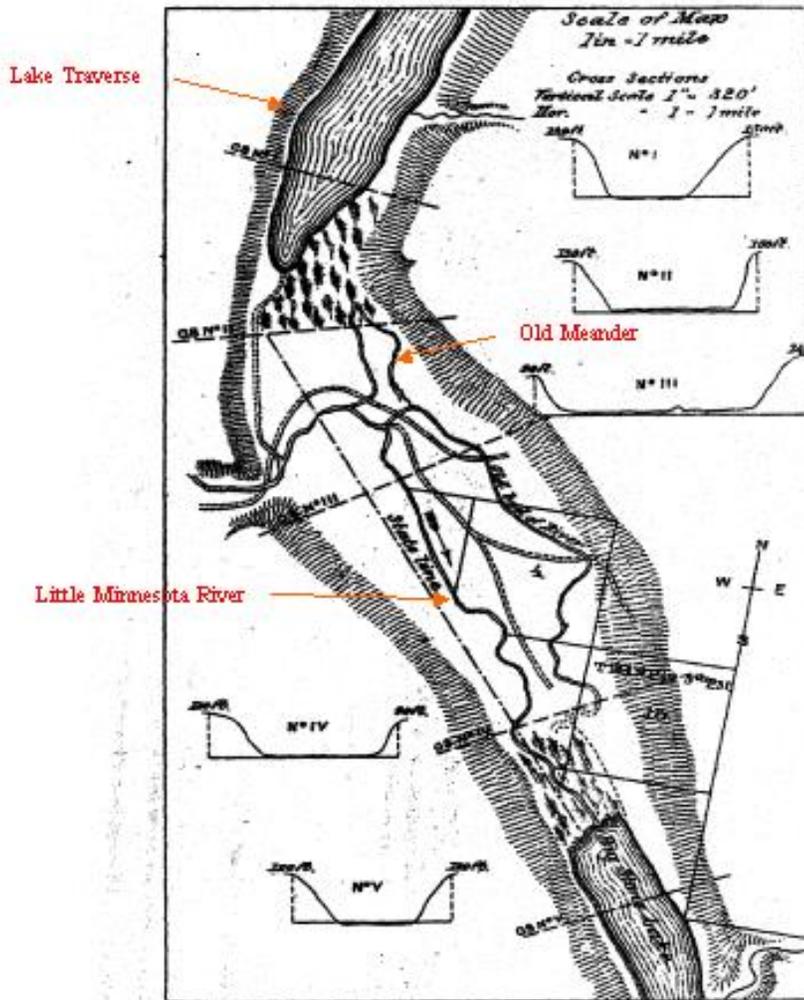
The body of water at the top of the map is Lake Traverse. The river flowing into Big Stone Lake is the Little Minnesota River.

Note the meander of the river that enters the wetland that is directly adjacent to Lake Traverse. **Enclosure 12**

A map (circa 1872) obtained from Reference 1.d. (see Enclosure No. 12) indicates that the meanders of the Little Minnesota River would, at times, enter the marshy wetland area that was directly linked to Lake Traverse.
