August 2011 Construction Photos

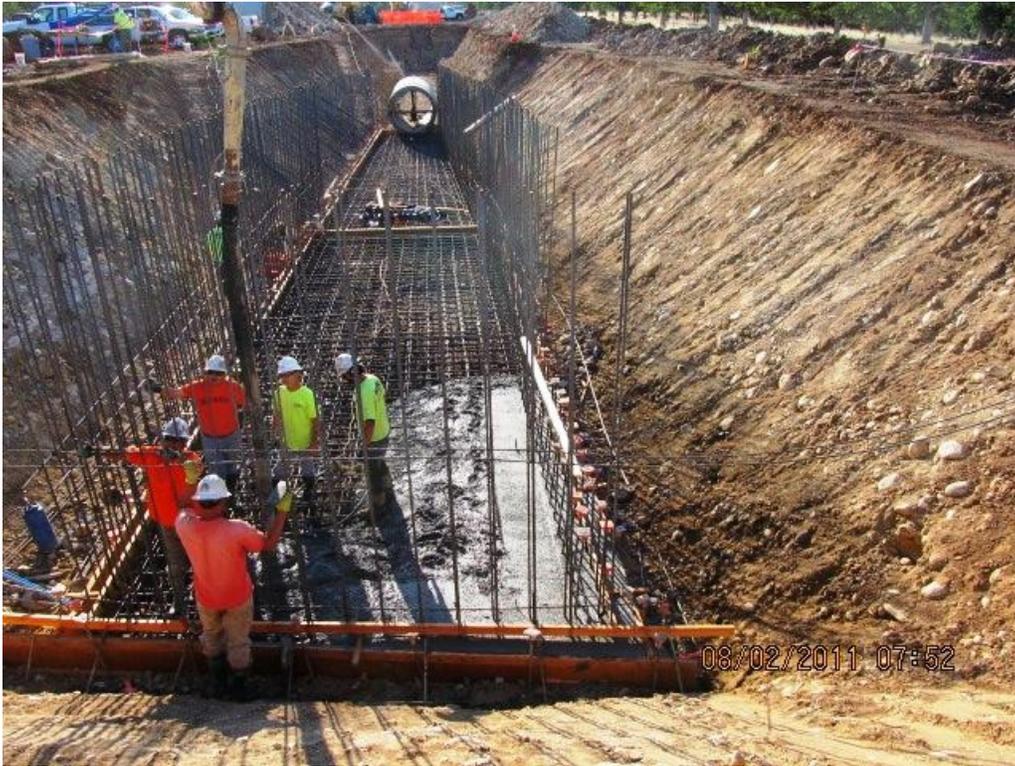
Coleman Diversion Dam/Inskip Powerhouse: Subcontractor Camblin Steel completed placing rebars and subcontractor Muse Concrete began pouring concrete for the Upper Jump Basin slab footing.

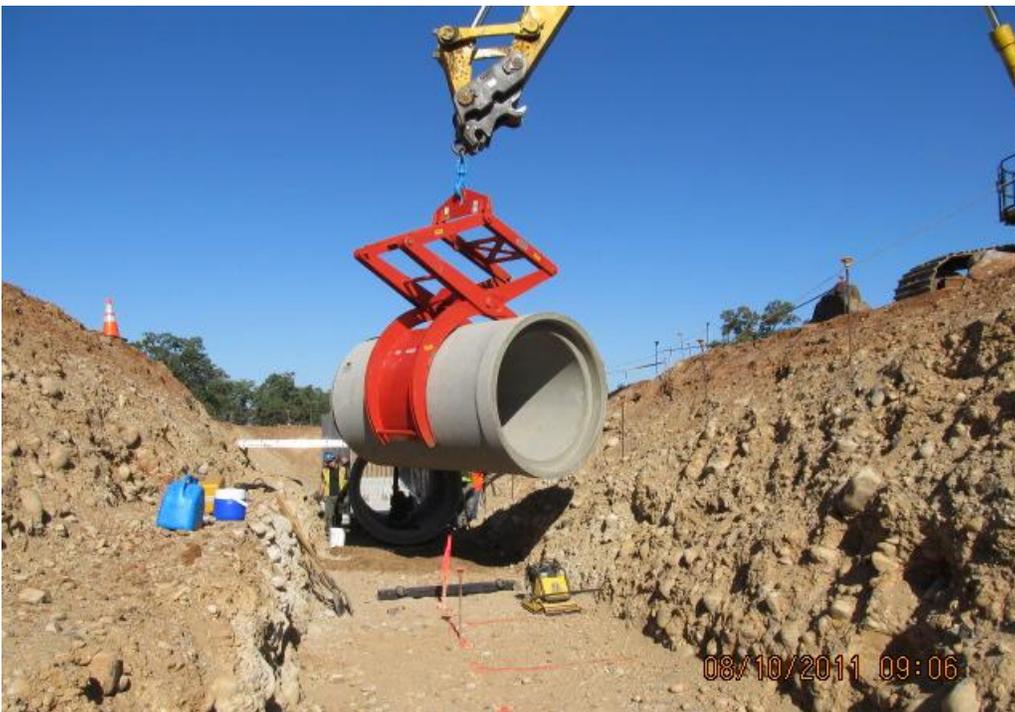
Coleman Diversion Dam/Inskip Powerhouse: General contractor RTA Construction Inc. installing the 66-inch Reinforced Concrete Pipe (RCP) penstock bypass using a custom made hoisting clamp.

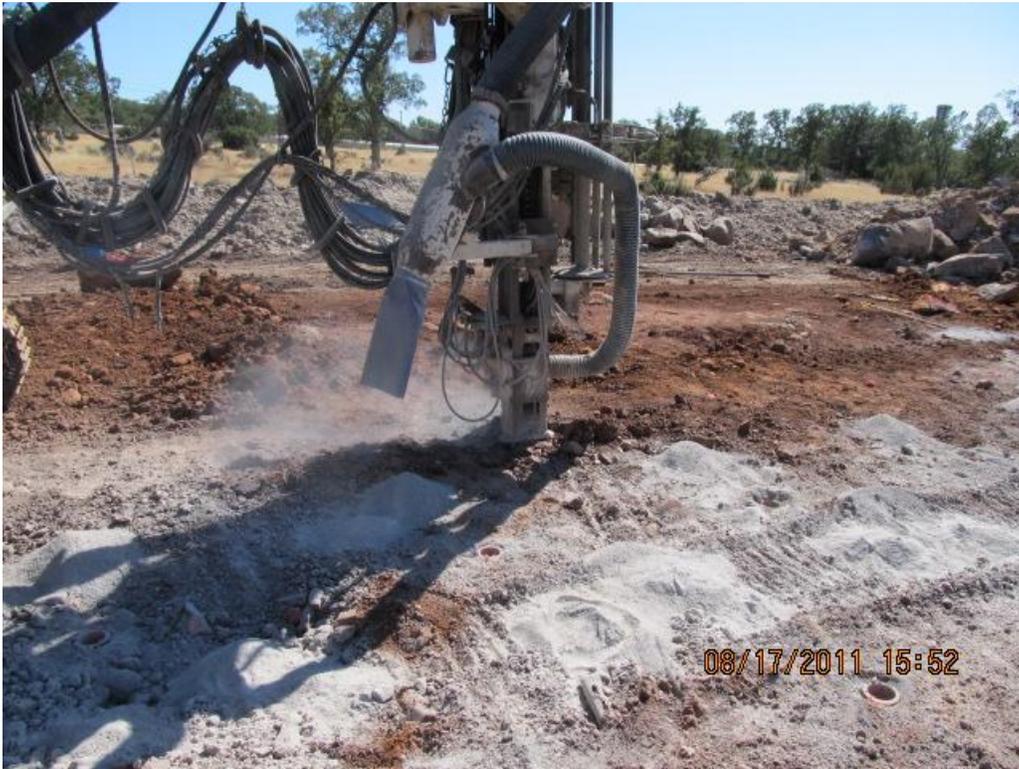
Coleman Diversion Dam/Inskip Powerhouse: Subcontractor E&M Rock Drilling performed drilling and blasting along the 66-inch RCP penstock bypass alignment.

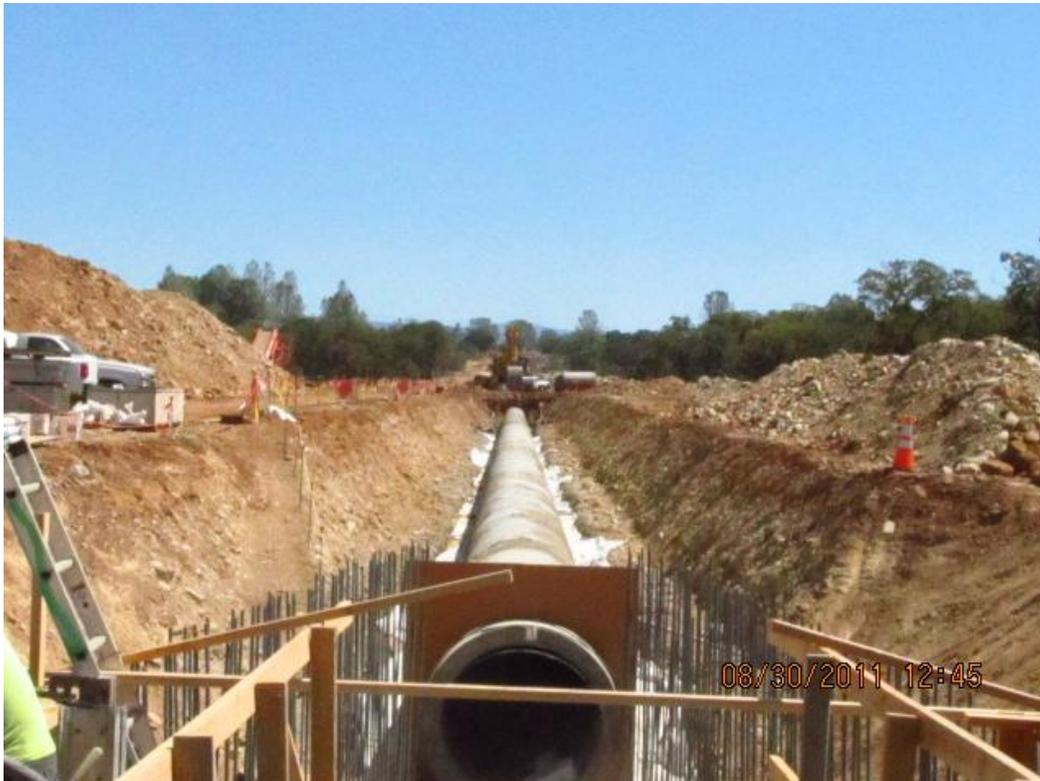
Coleman Diversion Dam/Inskip Powerhouse: Photo of 66-inch RCP penstock bypass looking upstream from the Upper Jump Basin.

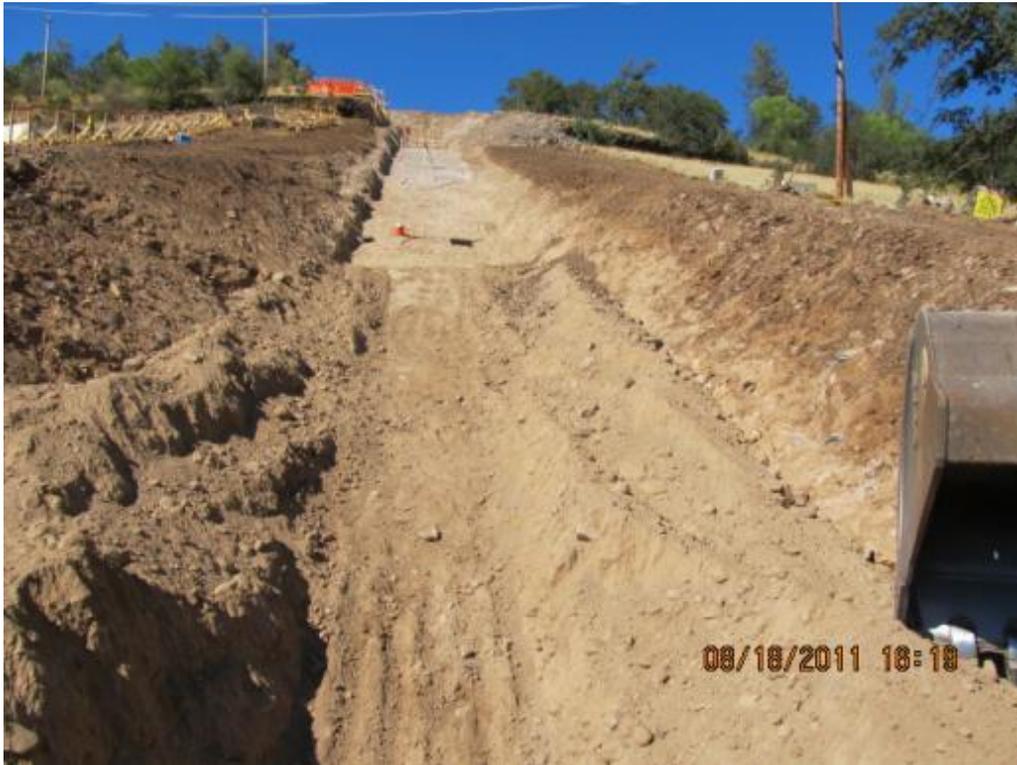
Coleman Diversion Dam/Inskip Powerhouse: RTA continued excavation of the penstock bypass chute until final sub-grade was reached.

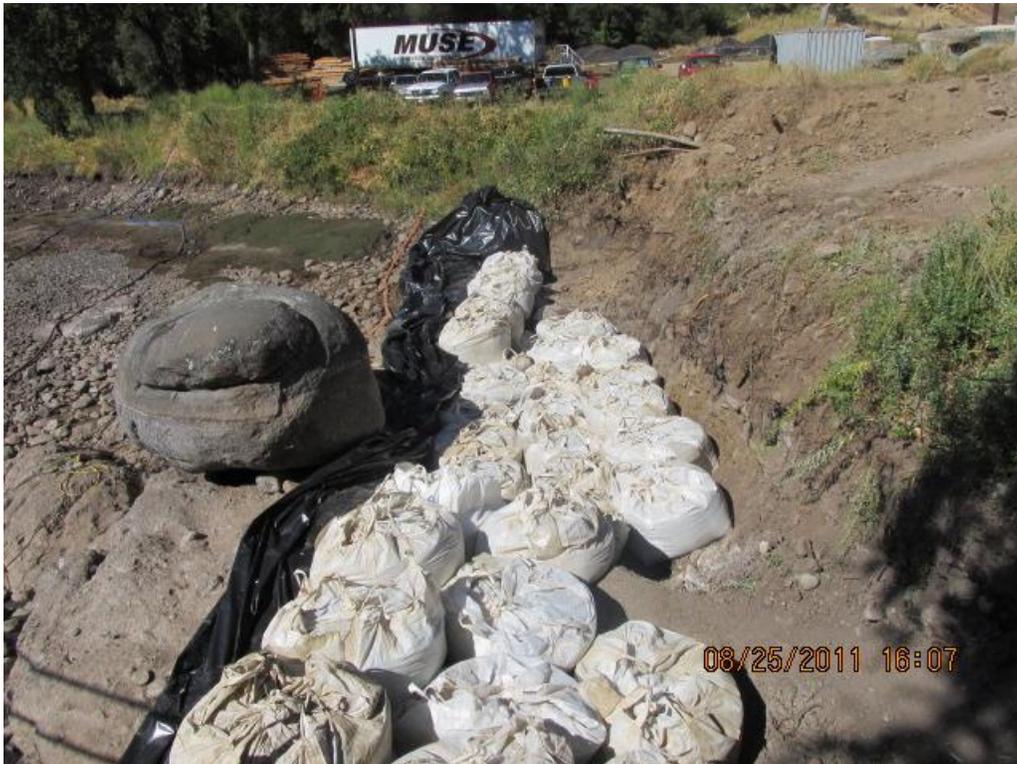
Coleman Diversion Dam/Inskip Powerhouse: During a 7-day outage contractor RTA unwatered and installed a cofferdam in Coleman Canal for upcoming tailrace and bypass outlet works.

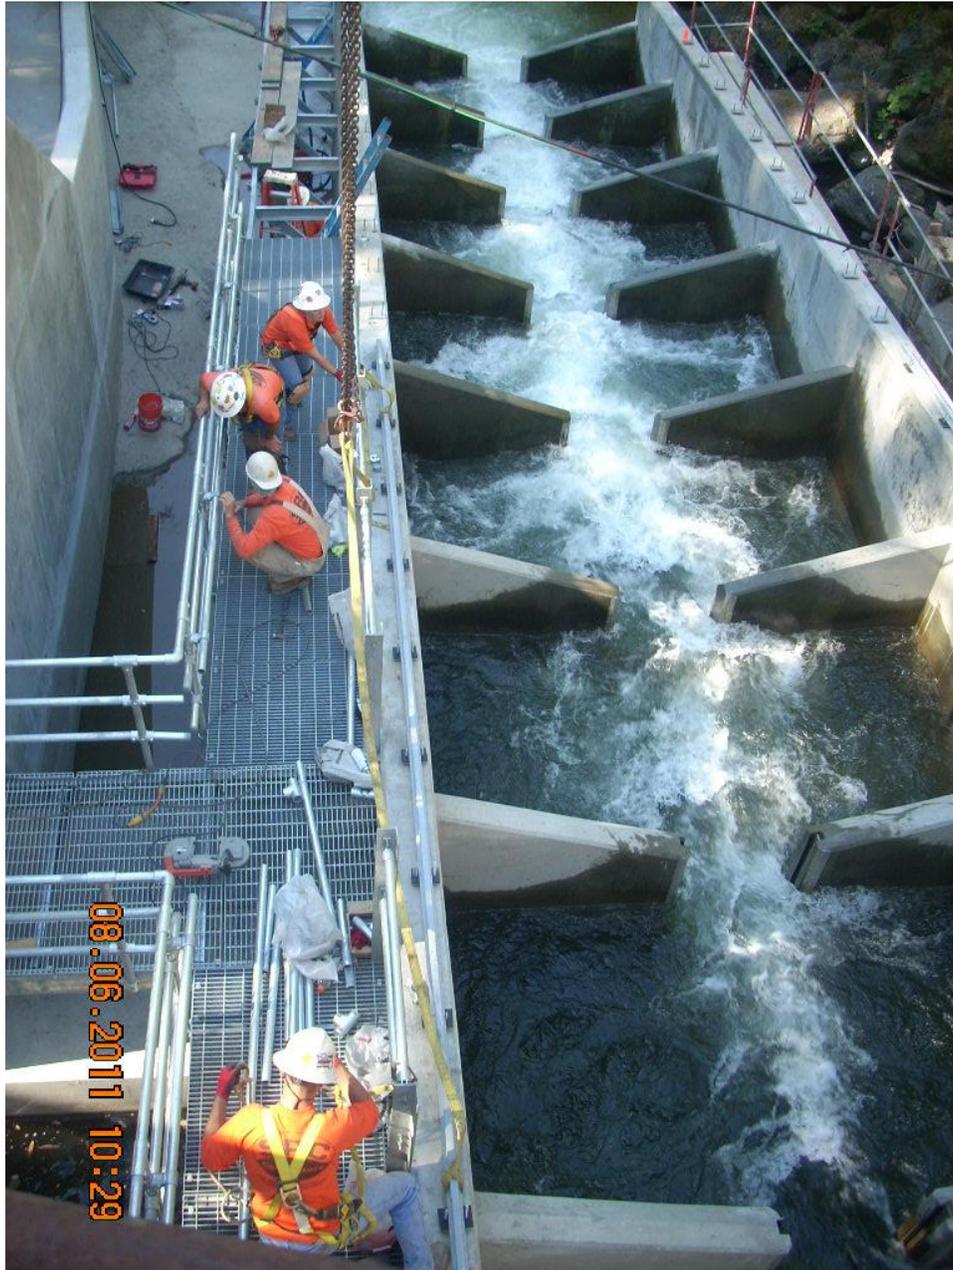
North Battle Creek Feeder: Contractor Syblon Reid Construction (SRC) completed installation of a walkway along the left outside face of the fish ladder structure and began assembling the movable walkway in the lower center of the photo.

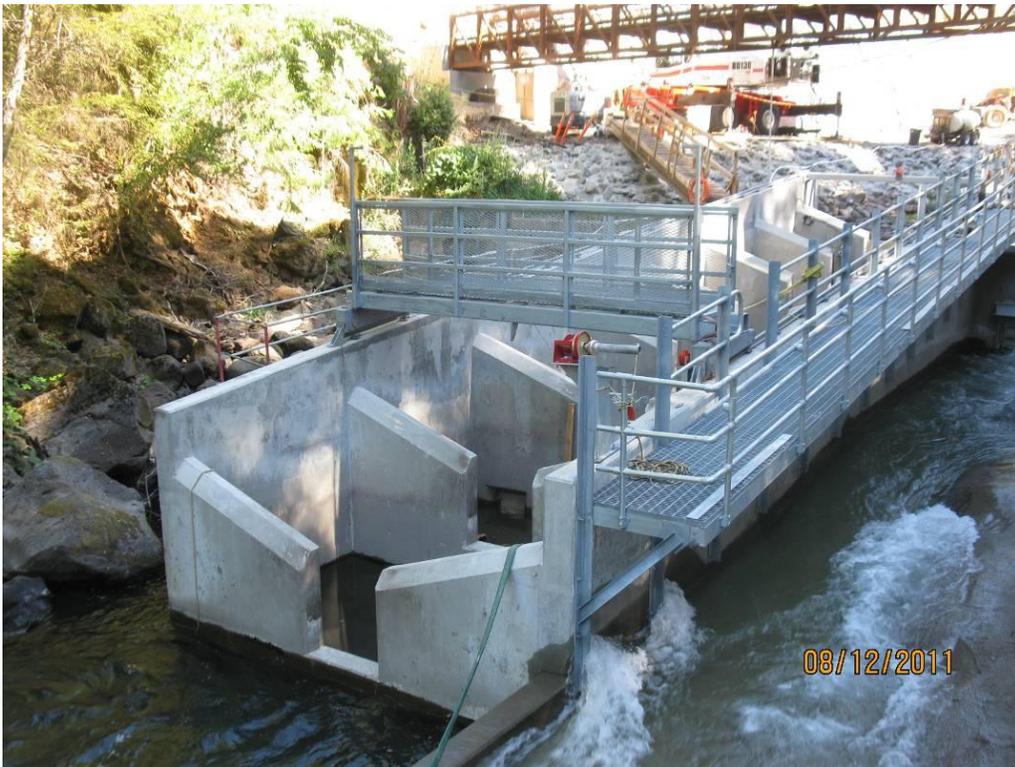
North Battle Creek Feeder: SCR completed installation of the moveable walkway (center) including its railing and winch systems, walkway and handrails, and permanent metal ladders into the fish ladder pools.

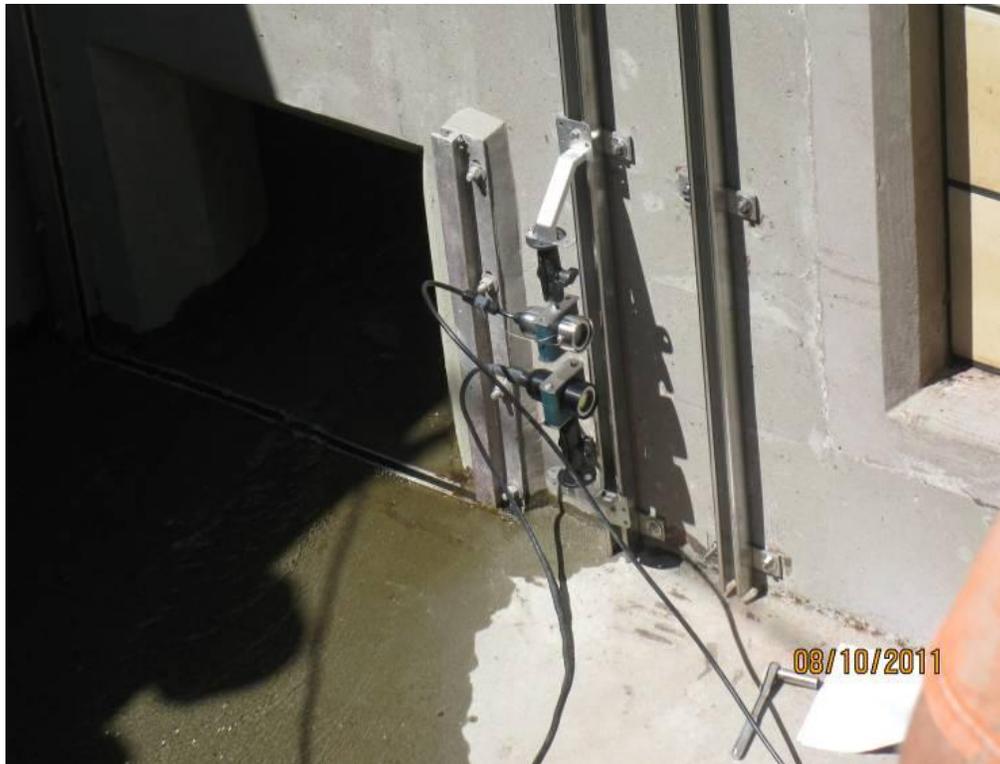
North Battle Creek Feeder: Subcontractor Tesco completed installation of two new underwater video cameras on the downstream side of the fish ladder baffle wall #1.

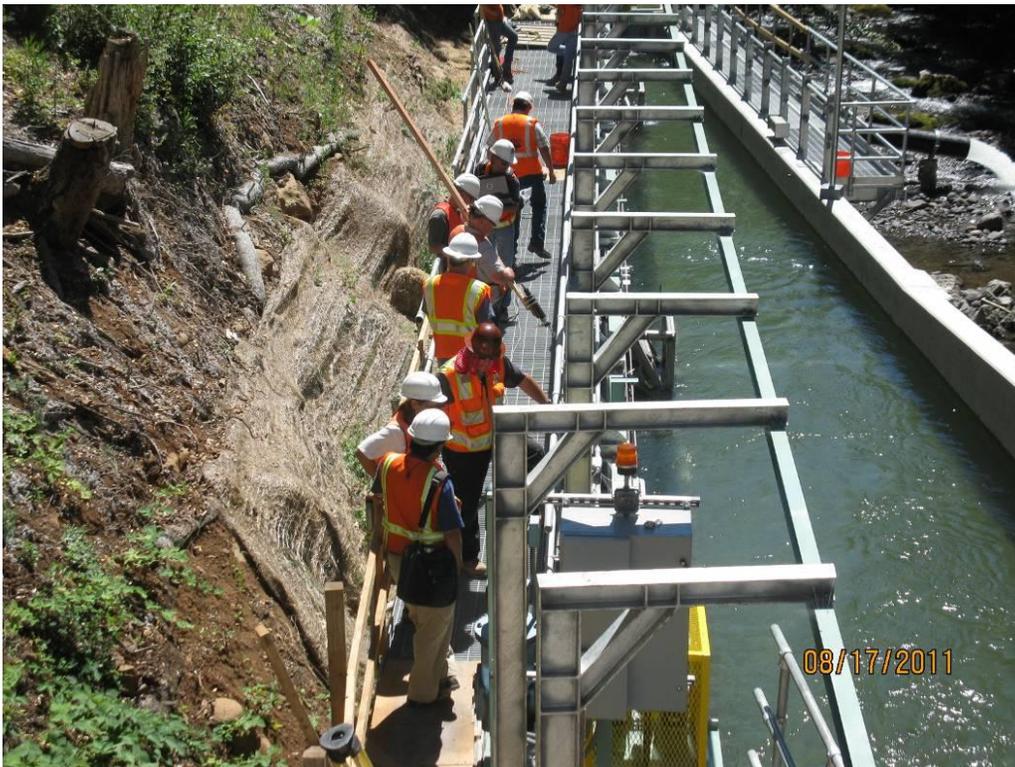
North Battle Creek Feeder: Team members from NOAA-NMFS, DFG, DWR, PG&E, and USBR conducting a fishscreen hydraulic evaluation.

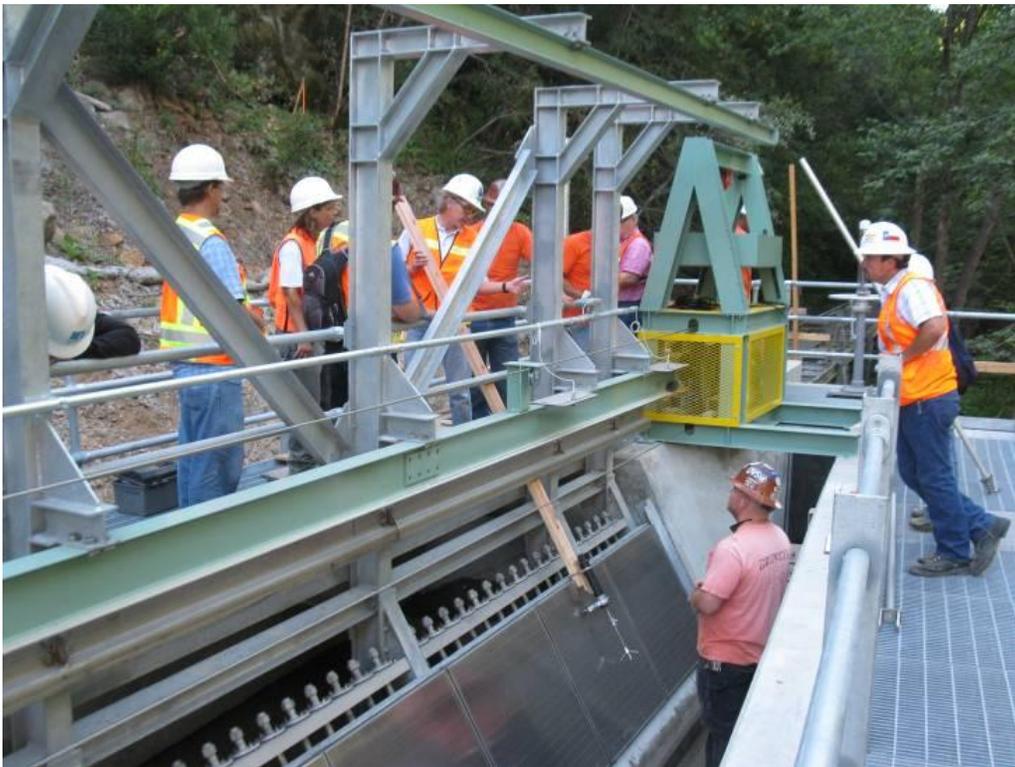
North Battle Creek Feeder: Using a 3-Dimensional Acoustic Doppler Velocity meter (ADV) the team measured the approach and sweeping velocities across the fishscreen panels and adjusted the flow control louvers to achieve uniform flows across the entire fishscreen.

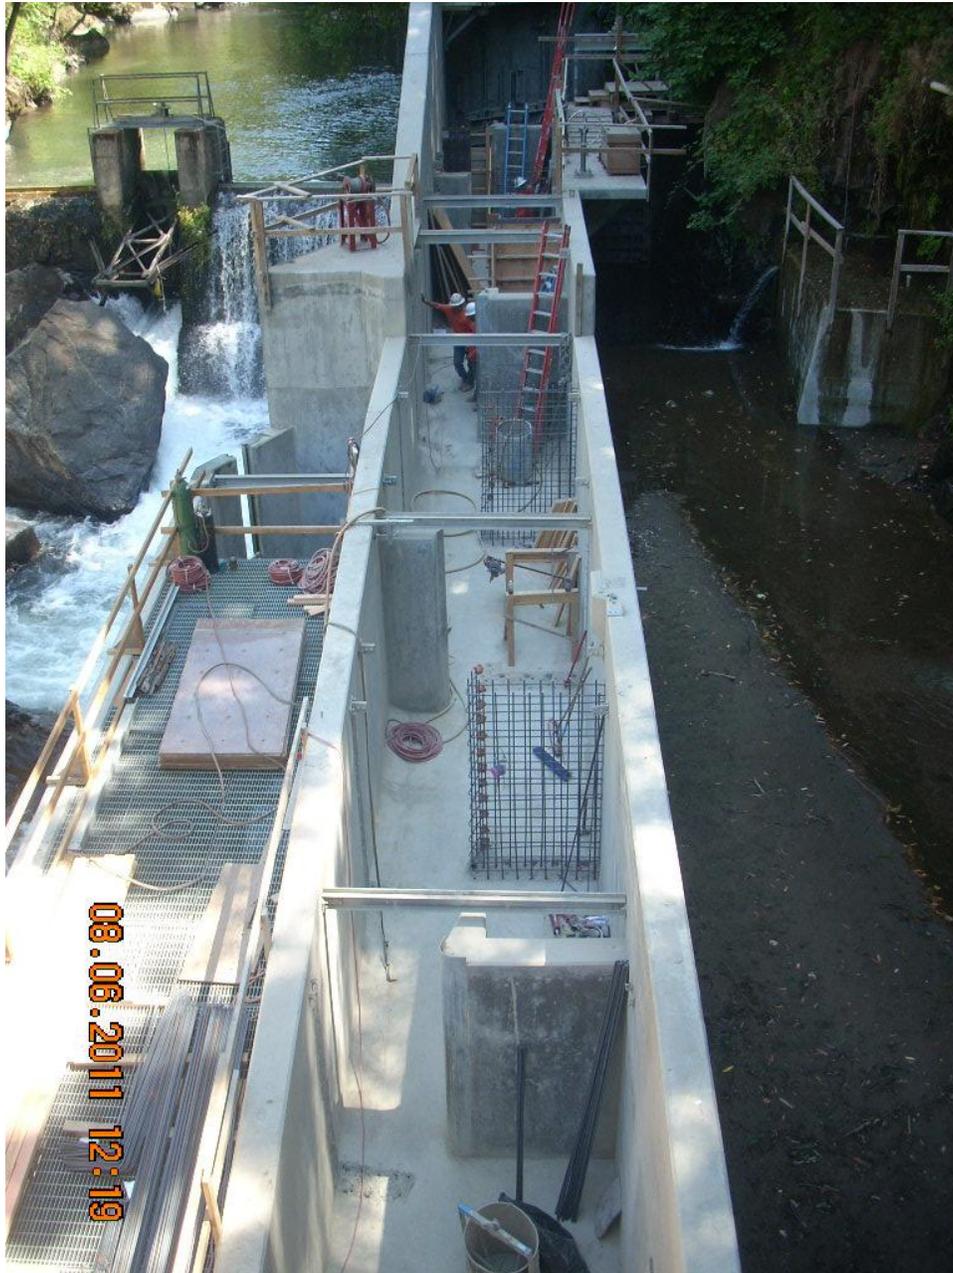
Eagle Canyon Diversion Dam: Contractor SRC completed drilling for rebar embedment and began placing rebar and setting up forms for the baffle wall remediation.

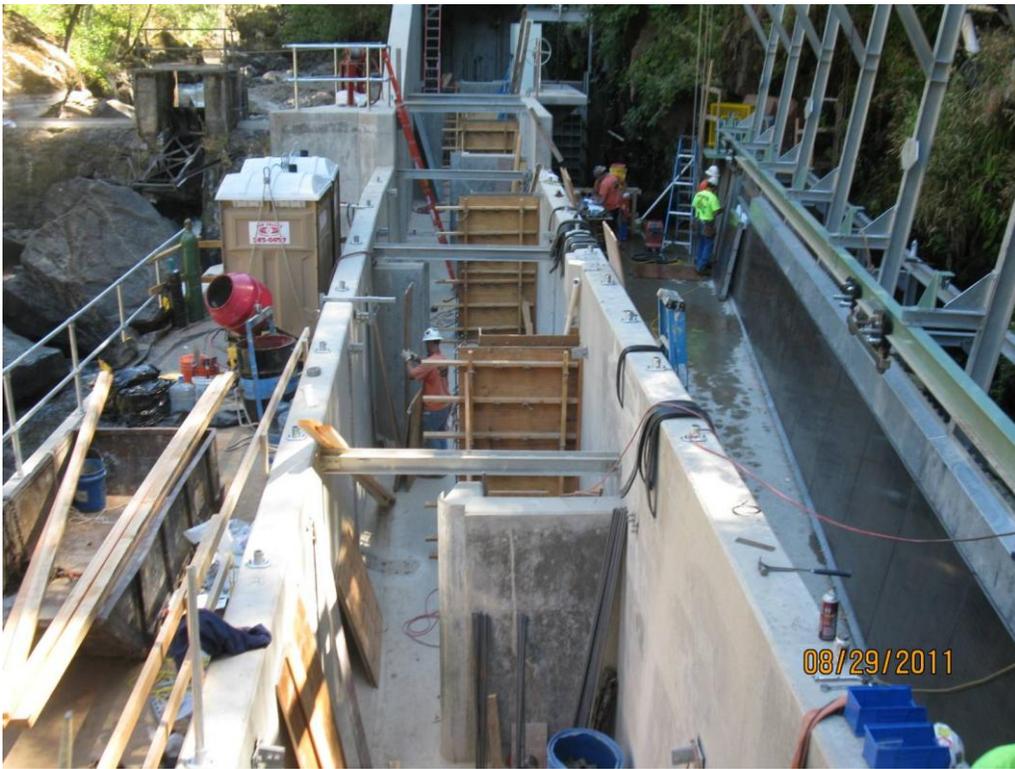
Eagle Canyon Diversion Dam: Contractor SRC setting up concrete forms for fish ladder baffle walls (center) and working on installation of the fish screen panels (right).

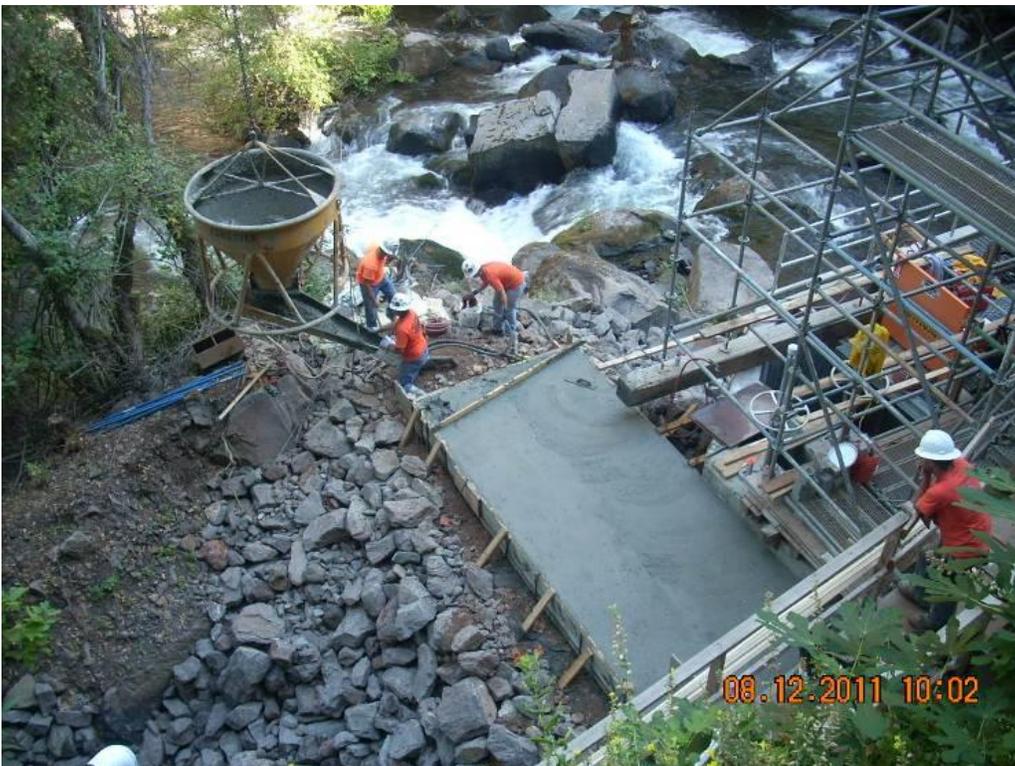
Eagle Canyon Diversion Dam: SRC crew placing concrete for the new stair pad for access to the dam and fish facilities.

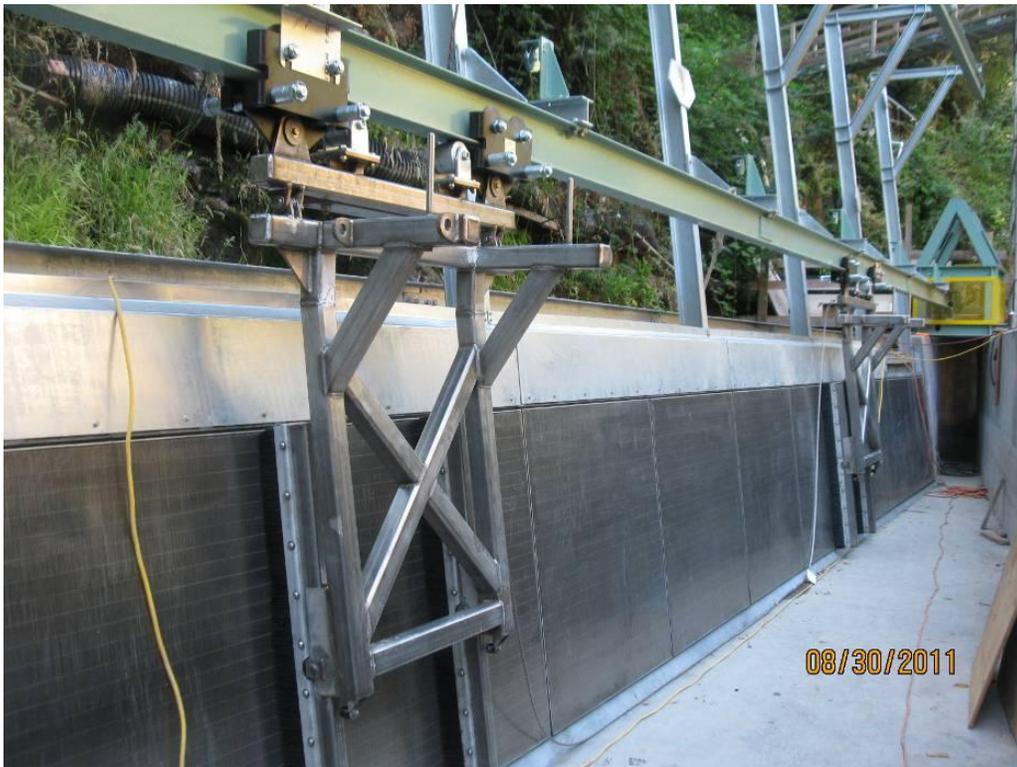
Eagle Canyon Diversion Dam: Contractor SRC completed installation of the flow control louvers, fish screen panels (center) and began installation of the two brush arm trolley for the fishscreen brush cleaning system.
