Revised Draft Environmental Impact Statement/
Environmental Impact Report

Truckee River Operating Agreement

Sedimentation and Erosion Appendix

Shorezone Erosion at Lake Tahoe: Historical Aspects, Processes, and Stochastic Modeling

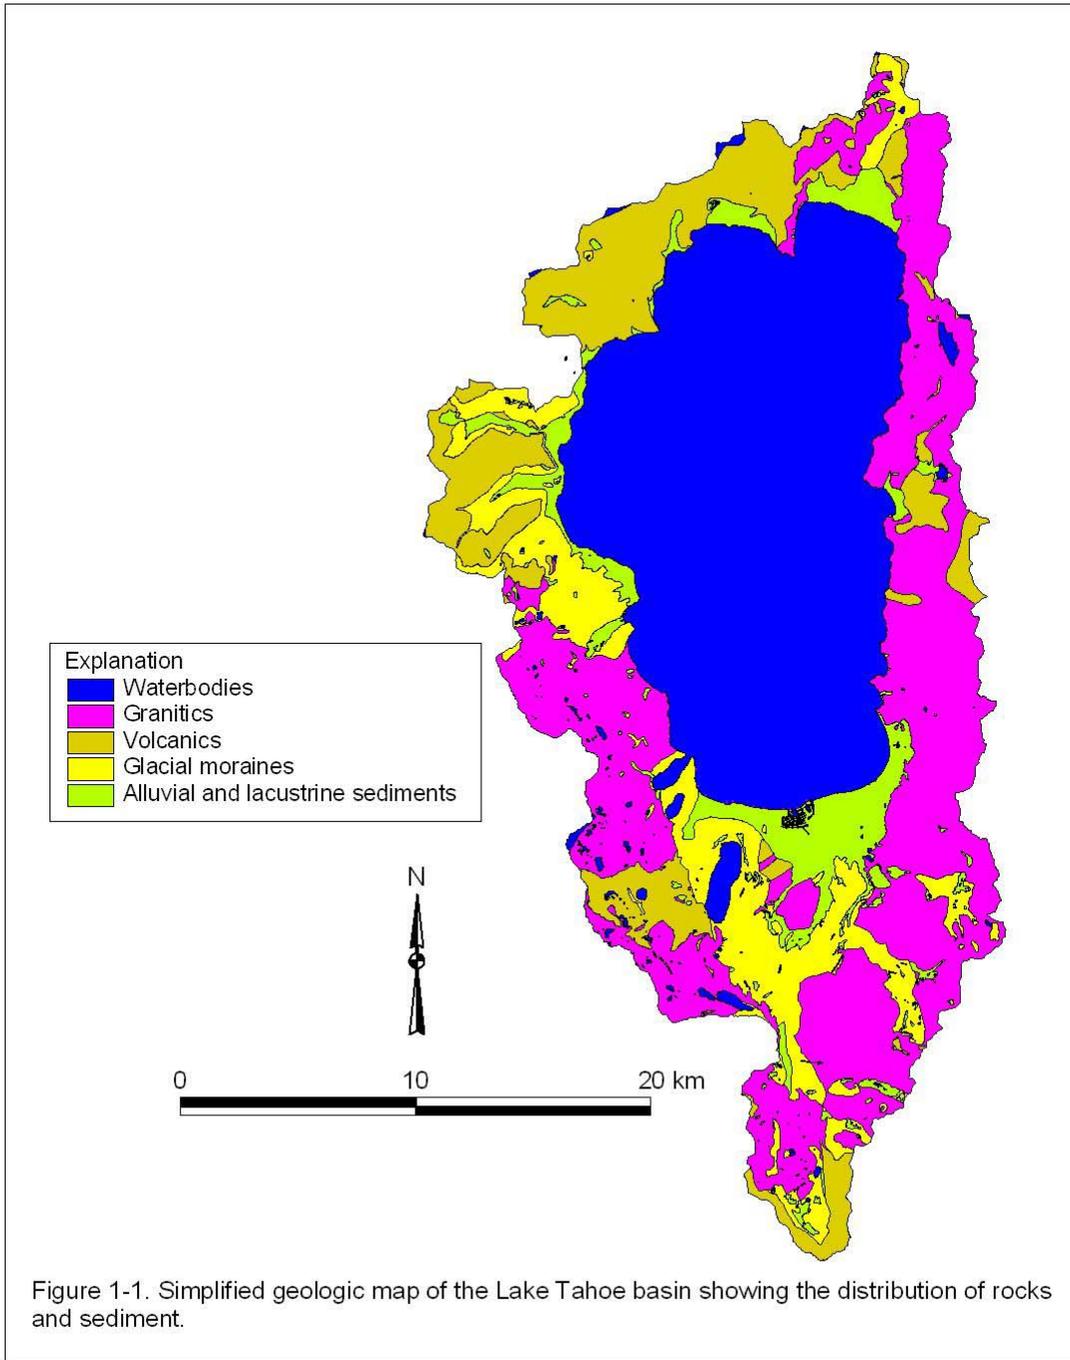
Figure 1-1 shows the distribution of rocks and sediments in the basin. This geologic map reveals a variety of different geologic units near lake level, each of which probably responds to wave action in different ways. Along the eastern shore of the lake, granitic bedrock dominates except for a few small pocket beaches including Sand Harbor, Glenbrook Bay, and Zephyr Cove. The southern shore is largely composed of glacial outwash deposits into which young lake deposits are inset (Fig. 1-1). At the shore, the outwash appears to be graded to levels higher than the current lake level of about 1899 m, which means that either there has been significant shorezone erosion since the outwash was deposited or that the outwash was deposited when lake levels were higher. The western shore of the lake is dominated by glacial moraines, outwash, and lake deposits, although granitic bedrock does crop out near Rubicon Point. The northern shore of the lake is largely comprised of Tertiary volcanic rocks with some granitics around Stateline Point and abundant areas of alluvial and lake deposits near the shore (Fig. 1-1).

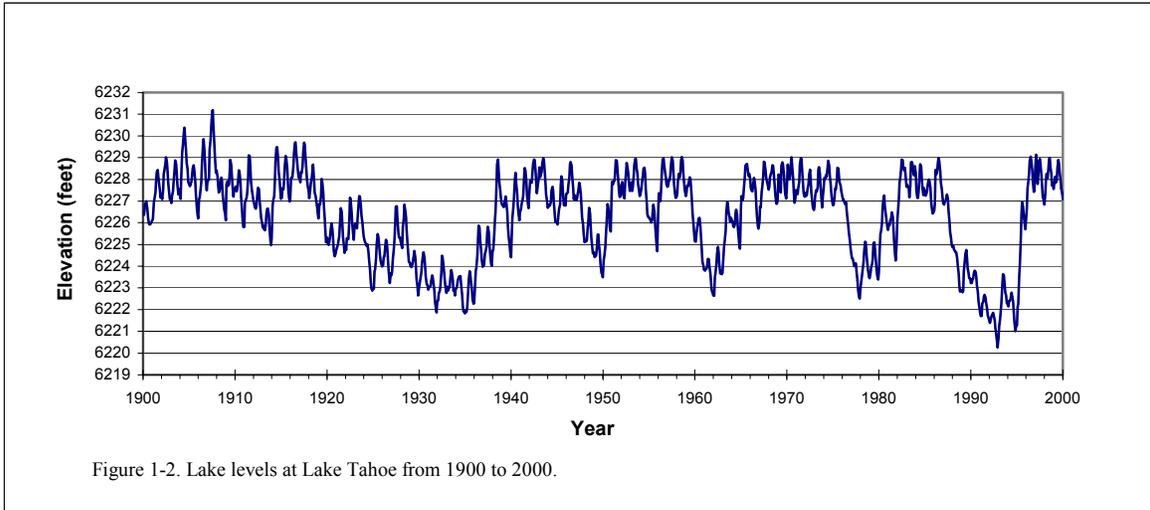
In the early part of the 20th century, lake levels commonly exceeded the now legally mandated maximum elevation of 1896.65 m (6229.1 ft) (Fig. 1-2). The highest historic level was in 1907 when the lake rose above 1899.29 m (6231.19 ft). Shoreline erosion undoubtedly occurred during these high water periods, but the aerial photography used in our study (Chapter 3) does not extend far enough back in time to capture the effects of these periods.

After the dam was installed, the lake rose several times to levels above 1898.65 m (6229.1 ft) in the early part of the 20th century (Fig. 1-2). On five separate occasions, lake level exceeded the current maximum for periods of up to several months at a time. In terms of shorezone erosion, the two most important high water periods probably occurred in 1904 and again in 1907 when lake level was above the current maximum beginning in March and lasting through the summer months. The effect of these early high lake periods is not exactly known, but it is likely that they caused widespread erosion around the lake. Evidence of these early high water periods may be found at Baldwin Beach (Fig. 2-1) and Nevada Beach (Fig. 2-2) where young beach features are found about 1 m above the modern shore.

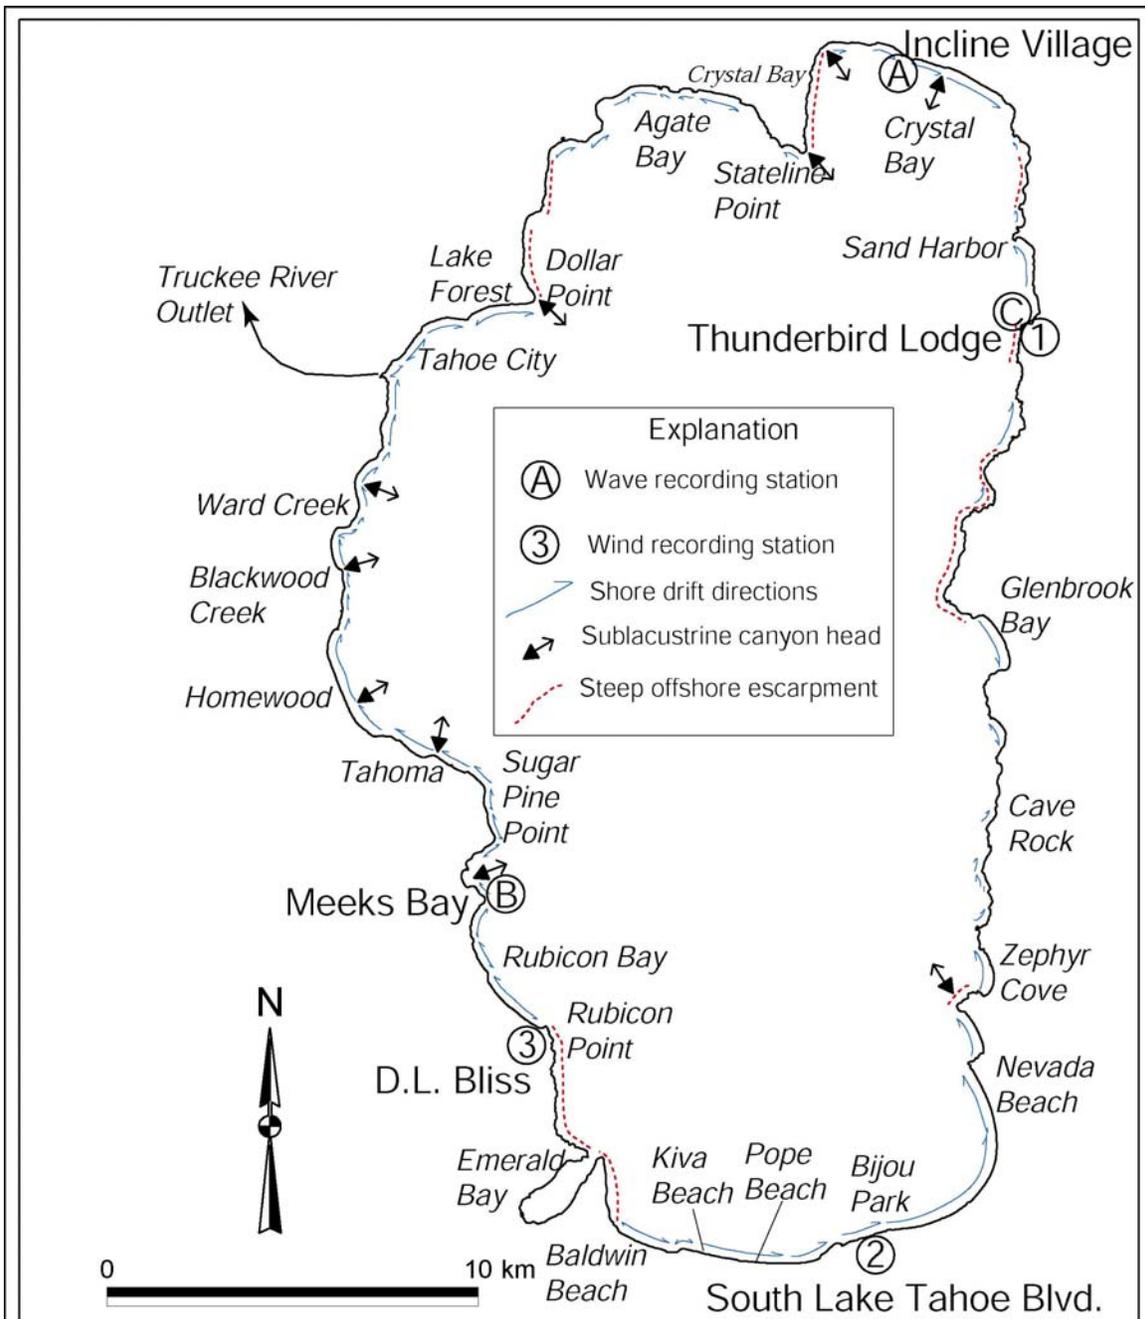
Figure 1-3. Map of Lake Tahoe showing dominant shore drift directions, locations of sublacustrine canyon heads, steep offshore escarpments, wave recording stations, wind recording stations, and locations mentioned in the report. Both the sublacustrine canyon heads and steep offshore escarpments are probably barriers to littoral drift. Data used to construct this figure are from Orme (1971), Osborne et al. (1985), and observations made during the course of this study.

Osborne et al. (1985) provide a comprehensive review of the lithologies, grain shapes and size distributions, sediment sources and sinks, and shore drift patterns of the littoral zone of Lake Tahoe. This study represents the synthesis of three master theses that include the studies of Waldron (1982), Edelman (1984), and Gaynor (1984). The major conclusions of Osborne et al. (1985), with respect to shorezone erosion, are that 1) the principal sediment source for the major sand beaches at Lake Tahoe is the backshore erosion of young lacustrine and fluvio-glacial outwash; 2) the major sediment source for the gravel and cobble beaches is also erosion of backshore areas and possibly nearshore erosion of older lakebed deposits, moraines, and volcanic rocks; 3) sand is primarily delivered to the smaller pocket beaches by weathering of local granodiorite bedrock and boulders; 4) the maximum depth of fair-weather sand transport is about 3 m and about 9 to 10 m under storm conditions; and 5) littoral sand transport is restricted to many small, well-defined drift cells separated by closely spaced topographic barriers (Fig. 1-3).

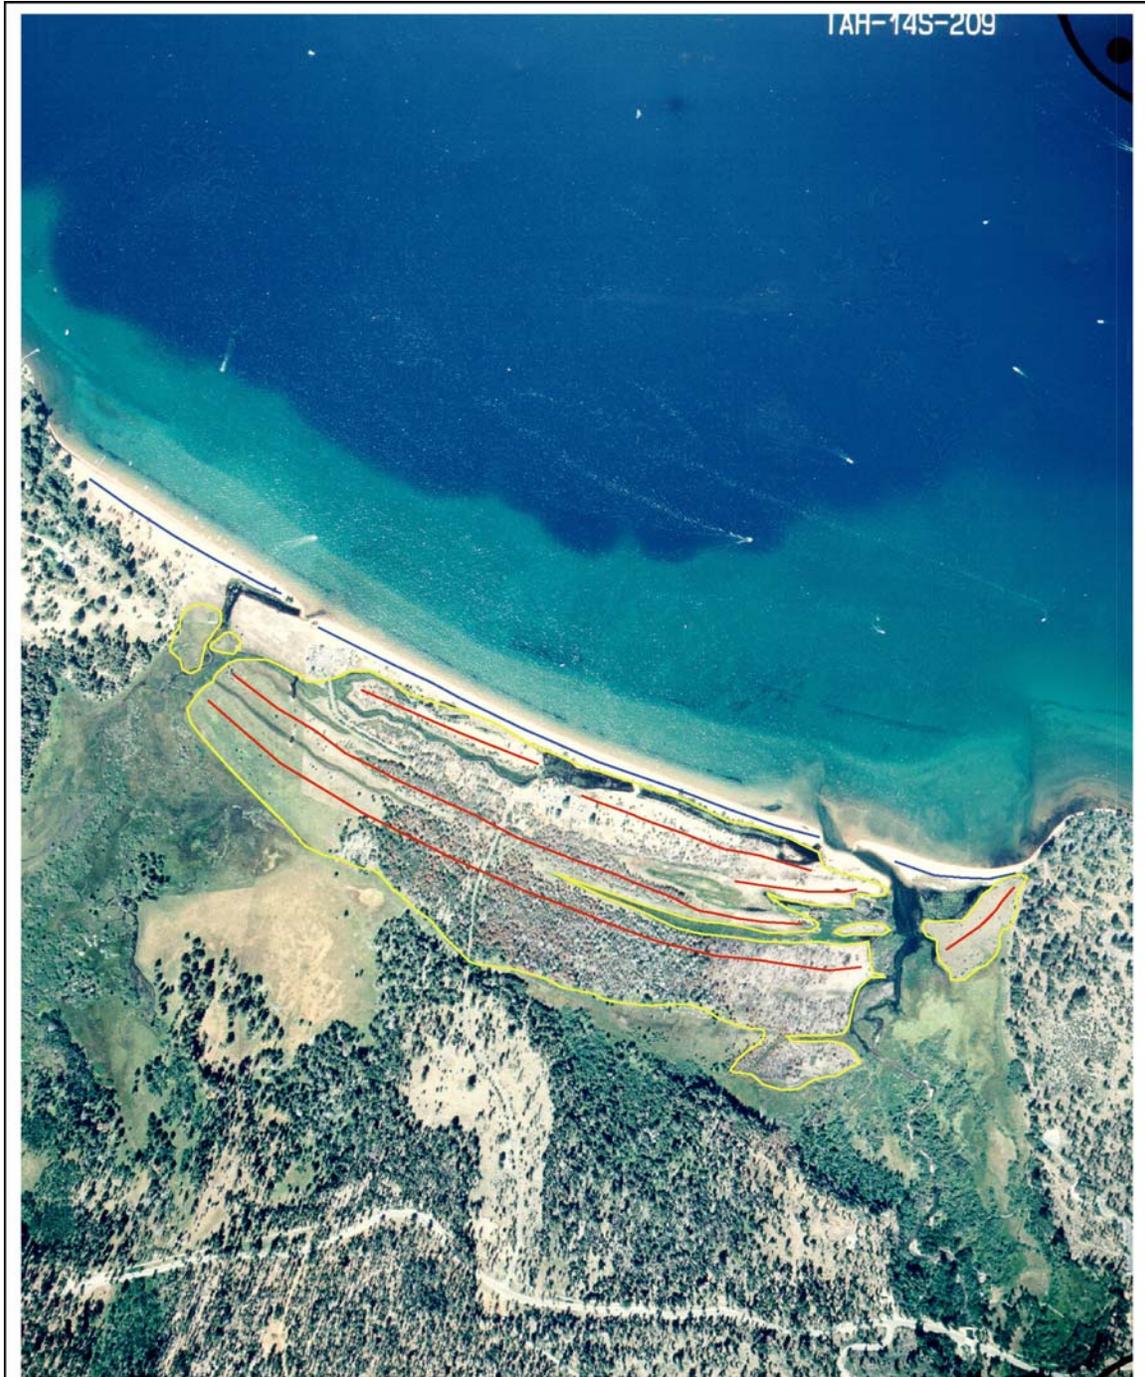
Figure 2-1. Vertical aerial photograph of Baldwin Beach (August 19, 1995) showing a series of beach ridges inland from the modern beach ridge. The older, slightly higher beach ridge crests are marked by red lines, and the extent of these older beach deposits are outlined in yellow. The modern ridge is marked by a blue line. The older beach ridges may have formed in the early 20th century when lake levels reached above 1899.23 m (6231 ft). See Fig. 1-2.

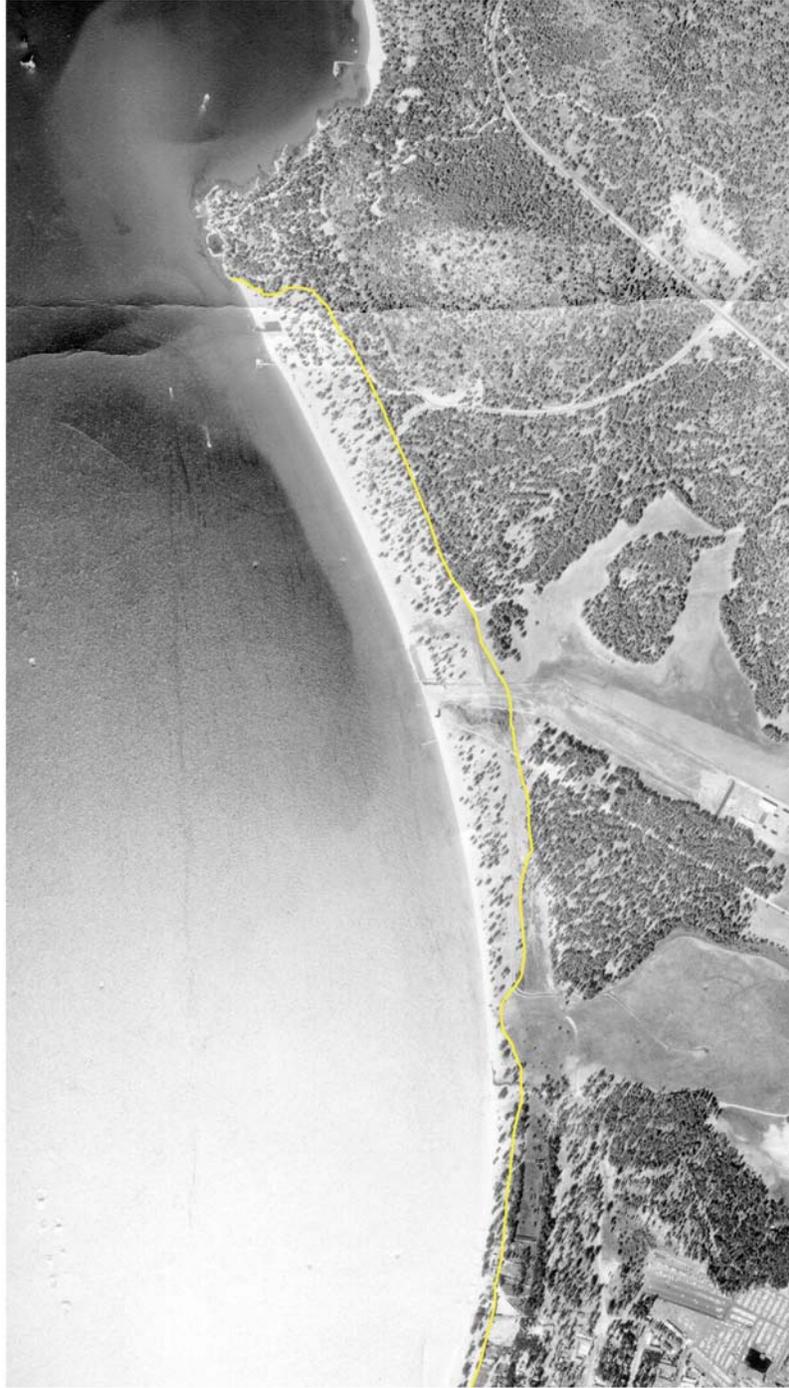
Figure 2-2. Aerial photograph of Nevada Beach (August 25, 1963) showing large beach platform that may have formed in early part of the 20th century when lake levels exceeded 1898.65 m (6229.1 ft). The yellow line marks marks the landward limit of this feature. Note the change in vegetation.

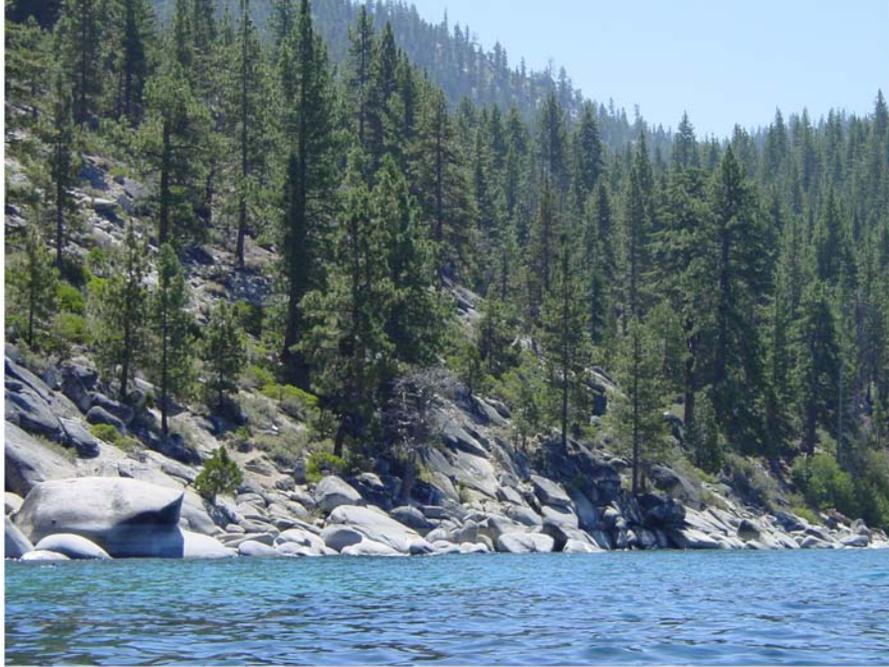
Figure 2-3. Armored shore along the east side of Lake Tahoe. This type of shorezone is relatively resistant to erosion from waves.

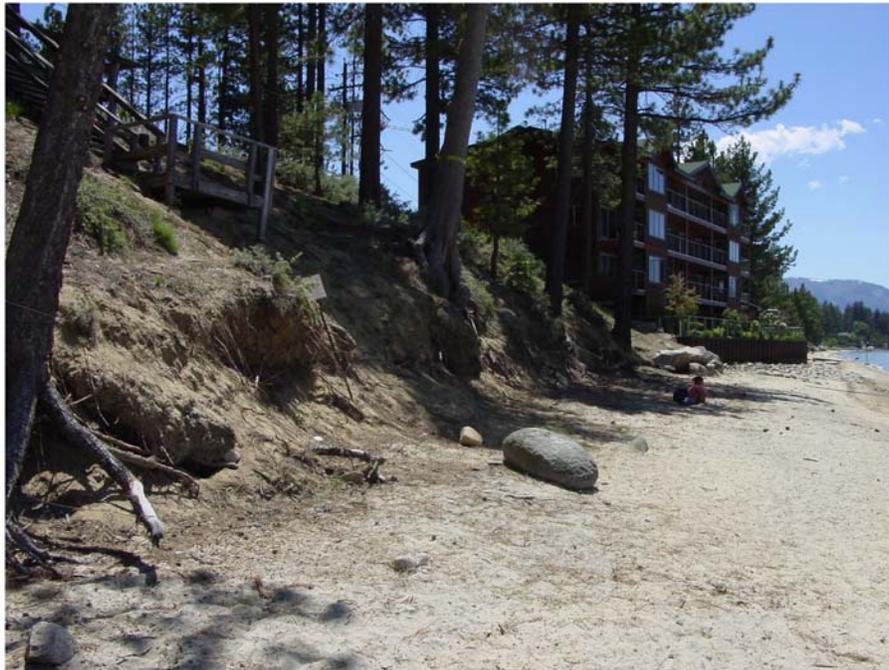
Figure 2-4. Fresh wave-cut escarpment in unconsolidated sediments. The shoreline angle is the abrupt break in slope at the top of the beach and at the base of the escarpment.

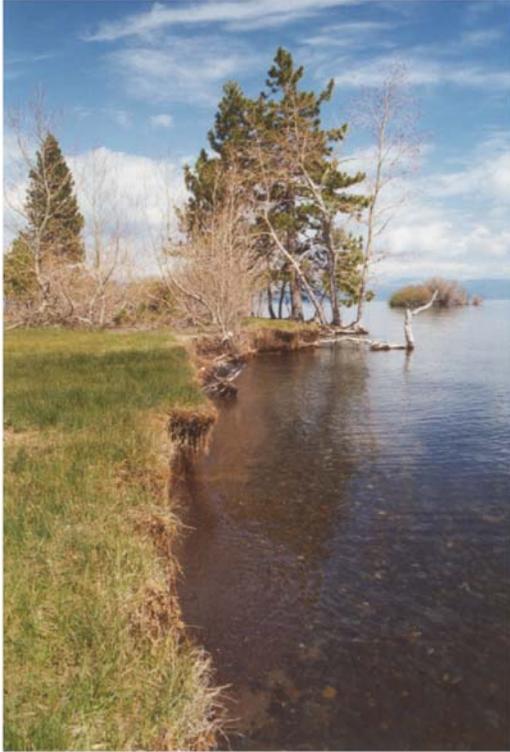
Figure 2-5. Two views of a wave-cut escarpment at Lake Forest on the northern shore of Lake Tahoe. In the photograph to the left, taken on May 17, 2000, lake level is near maximum and wave activity can directly impact the backshore area. In the photograph below, taken at the same place on August 28, 2003, lake level is much lower. The shore has undergone erosion here since May, 2000, as evidenced by the blocks of sediment at the base of the small escarpment. This erosion probably occurred from undercutting by wave activity when water level was high.

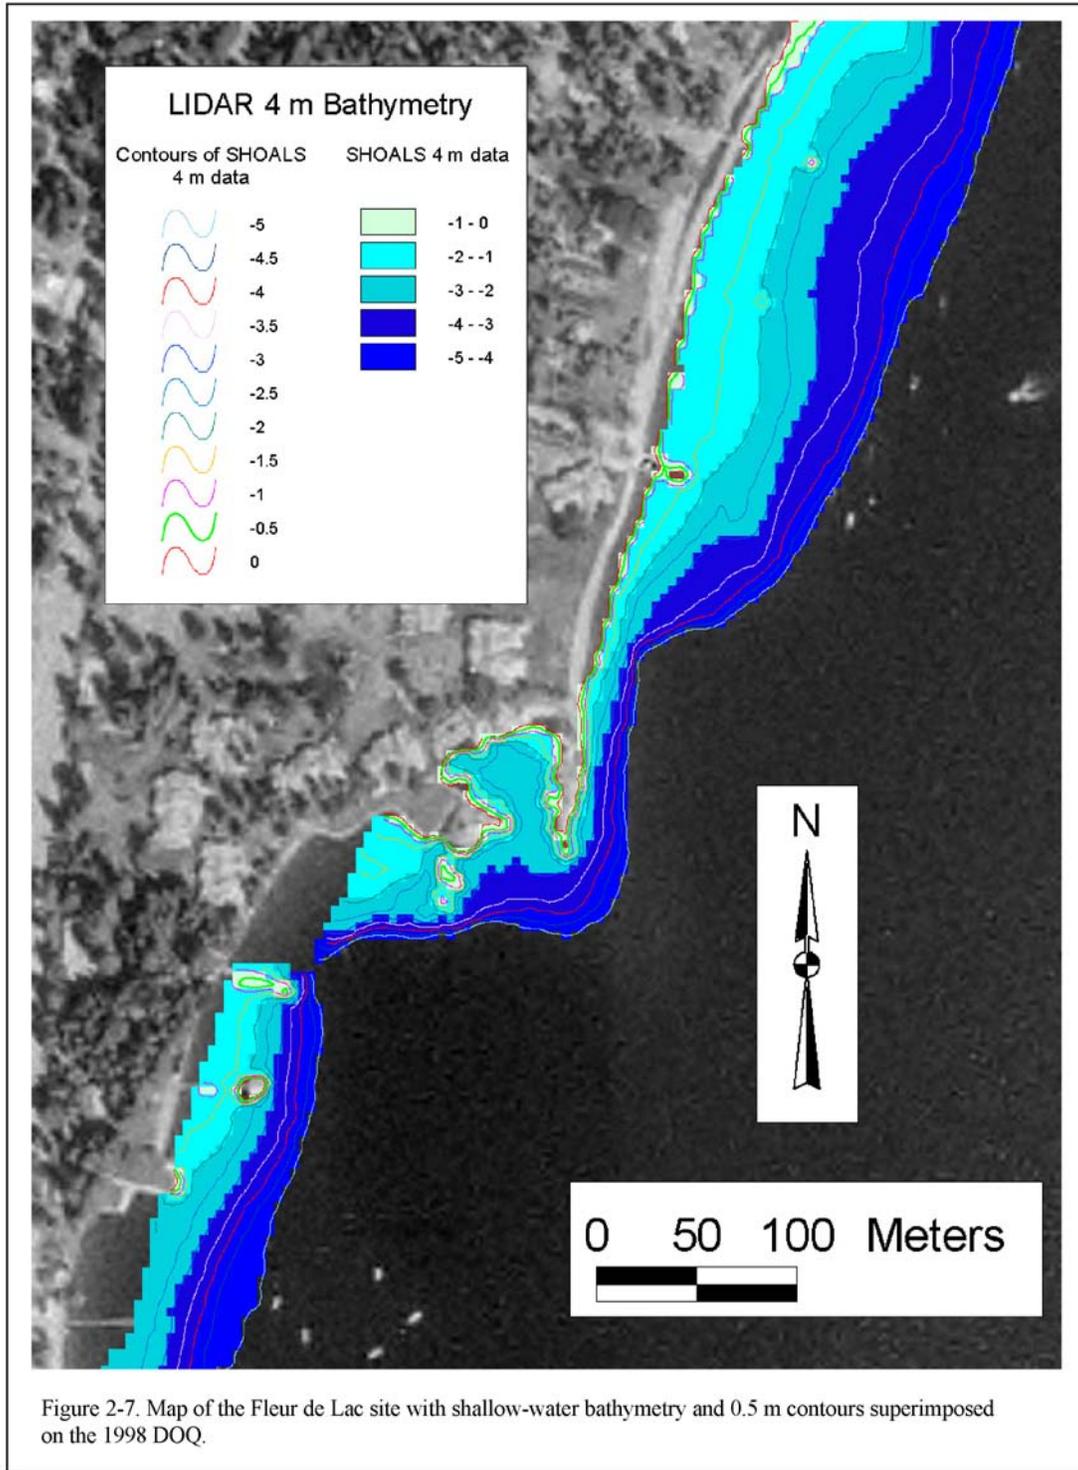
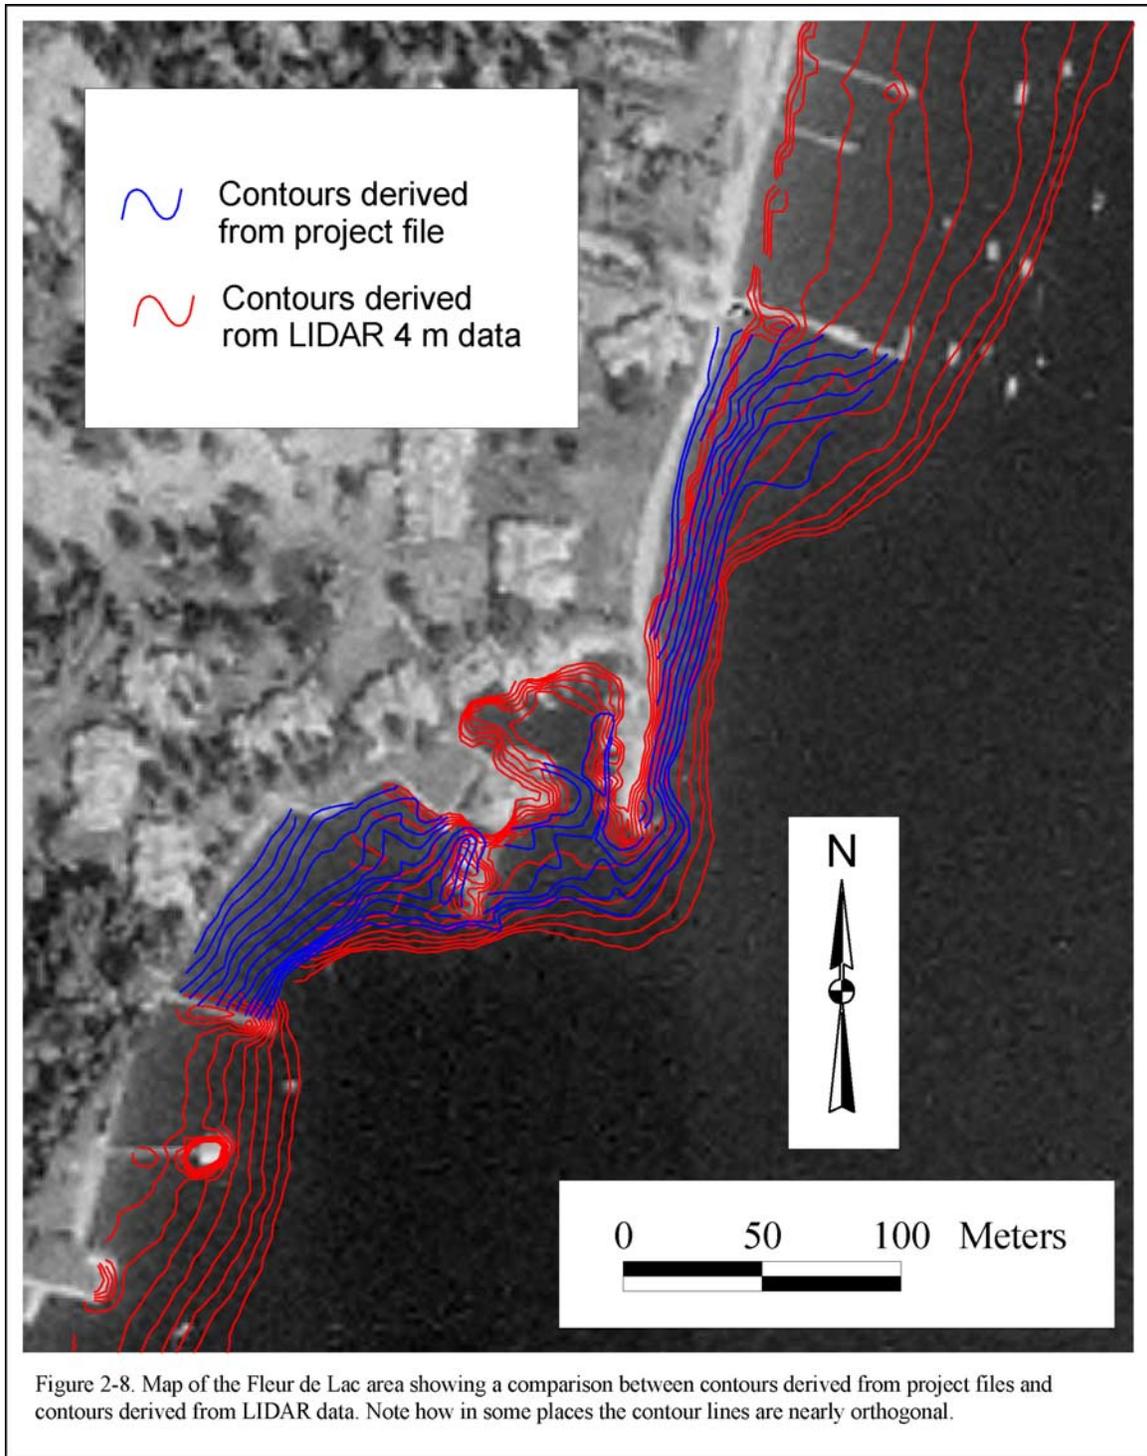
As can be seen from Fig. 2-8, project-file and LIDAR contours are not at all coincident. In places, the two sets of contour lines are nearly orthogonal to one another. This situation can mean one of two things. Either there has been a large amount of change in near-shore bathymetry or one or the other data sets is inaccurate or too coarse to make the comparison. Because the project contours appear sufficiently detailed and fit the shore geometry very well, we conclude that this data is reasonably accurate. In contrast, contour lines generated from the LIDAR data do not perfectly follow the shoreline and many are not continuous. The discontinuous nature of many of the contour lines appears largely due to edge effects, where the contours are inadvertently controlled by the edge of the grid. Edge effects are particularly prominent around some of the piers where contours close around data gaps (Figs. 2-7 and 2-8). The LIDAR data is accurate, but does not appear to be able to provide high enough resolution to make these types of comparisons at the parcel level.

To evaluate these limitations, a comparison was made between a project contour map from Fleur De Lac Estates at Tahoe Pines (1 foot contours; September, 1997) and contours derived from the fine bathymetric data (Figs. 2-7 and 2-8). This part of the shore consists of two breakwaters that nearly enclose a marina or lagoon and have been in place since at least 1939. From site drawings and other information gleaned from the project file and various aerial photographs, vertical shorezone protective structures are also located to the north and south of the breakwaters. Contours derived from the LIDAR 4 x 4 x 0.15 m bathymetry data are shown in Fig. 2-7. Although the higher-resolution data offers a significant improvement over the lower-resolution data, the high-resolution data still does not appear to be appropriate for comparison to project contour maps. Note how resolution of the data affects the creation of the contour lines and the mismatch between the “0” contour line and the shore (Fig. 2-7) Data gaps are also clearly evident where the data grid does not coincide with the shoreline.

From this exercise, we conclude that assessing bathymetric change by comparing project contour maps to high precision LIDAR bathymetry is not feasible. The hypotheses proposed in the DRI/TRPA Shorezone Erosion Study Phase II proposal dated November 1, 2000 are, therefore, not testable by this means. These hypotheses stated that vertical,
