## Bosque del Apache Sediment Plug Baseline Studies

Annual Report 2011

U.S. Department of the Interior  
Bureau of Reclamation  
Technical Service Center  
Fisheries and Wildlife Resources  
Denver, CO

March 2012

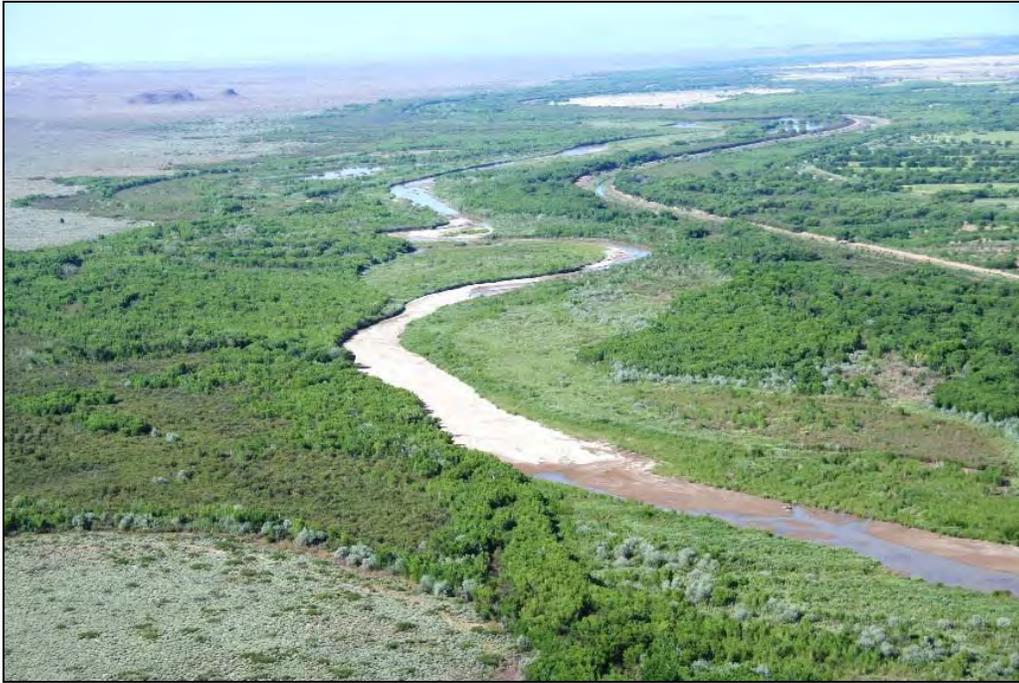
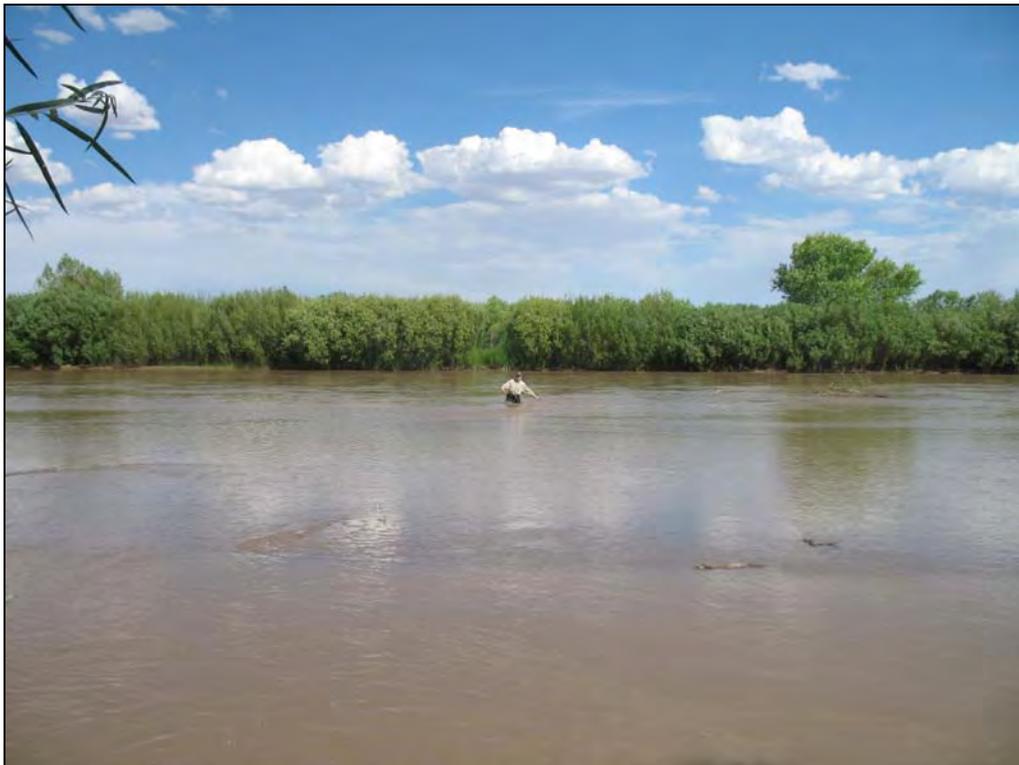
**Figure 1.**—Sediment plug formed in BDANWR looking downstream from above at minimal flows (top) and looking across the river at flows of approximately 1500 cfs (bottom). Top photo from Lai 2009.

A sediment plug formed in May 2008 within the Bosque del Apache National Wildlife Refuge (BDANWR) on the Middle Rio Grande near San Antonio in central New Mexico (Figure 1). This reach of the river is generally aggraded. Bureau of Reclamation (Reclamation) is using a two-dimensional model to study plug formation in the BDANWR area (Lai 2009). Model predictions were compared to cross section data measured in 2009. The study found that, as of July 2009, the portion upstream of the reach (i.e. North Boundary of the BDANWR to Range Line SO-1520.8) was degrading, the middle reach (from Range Lines SO-1525 to SO-1550, which includes the location of plug formation and where a pilot channel was excavated in October 2008) was also degrading, and the downstream reach (from Range Lines SO-1554 to 1562.9) was aggrading.
