Status and Monitoring of Southwestern Willow Flycatchers within Elephant Butte Reservoir, New Mexico

**U.S. Department of the Interior
Bureau of Reclamation
Ecological Planning and Assessment
Denver, Colorado**

December 2005

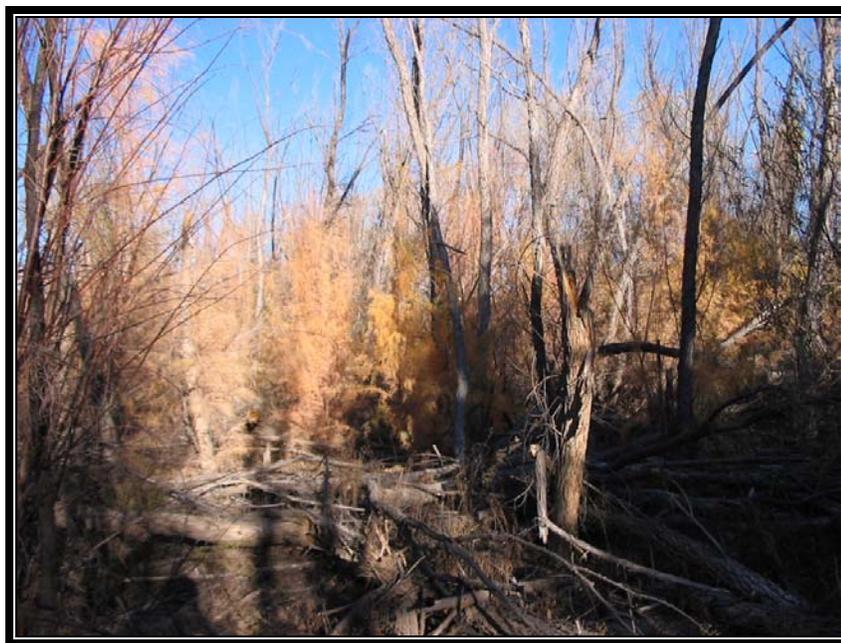
Figure 11. Native vegetation in the reservoir pool killed by salt accumulation and lack of “flushing” flows.

1998 prevented overbank flooding from flushing salts from the soil in this site. Between 1998 and 2002 suspected salt accumulation killed the native vegetation, rendering the site unsuitable for breeding SWFLs. Although no soil testing has been conducted, salt accumulation is a key factor in mortality of willows in areas with reduced flood frequency (J. Taylor, pers. comm. 2002) Figure 11 shows the result of salt accumulation on native willows in the headwaters of Elephant Butte Reservoir. Notice the dead and downed Goodding's willow (*Salix gooddingii*) and the encroaching saltcedar.

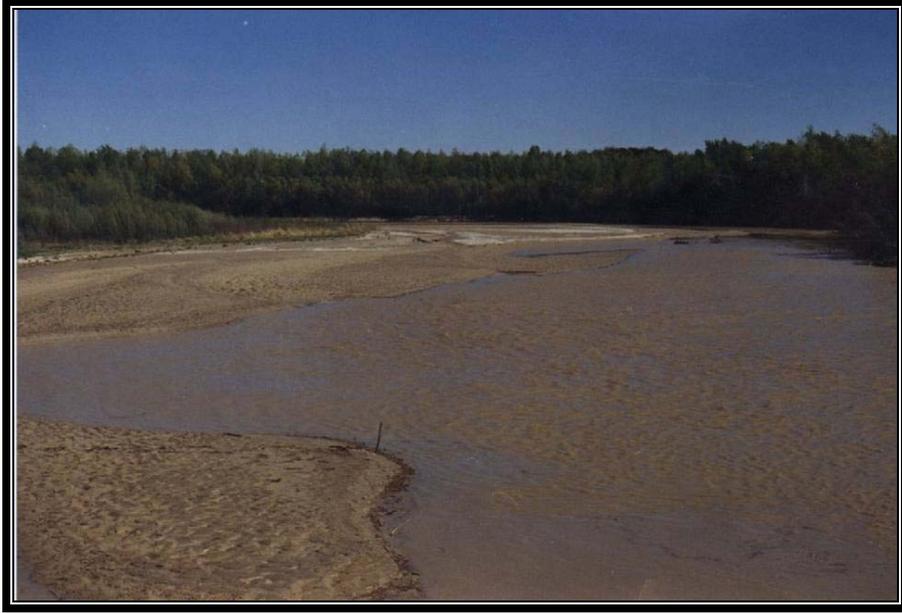
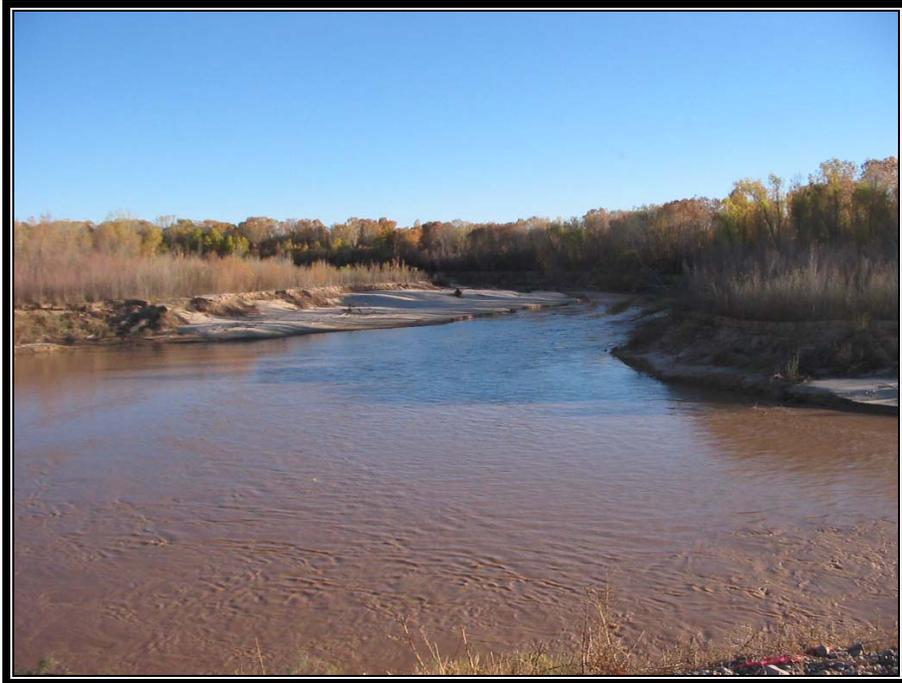
Figures 12.1 and 12.2. River channel below San Marcial before and after high flow degradation event of 2005.

patches. It is possible that these patches will suffer significant mortality, reducing their suitability to nesting SWFLs. Figures 12.1 and 12.2 show the Rio Grande channel at San Marcial before and after the degradation even in 2005. Although incision was rampant in 2005, and may continue for the next few years as other ‘headcuts’ migrate into the San Marcial area, this reach is still an aggrading reach and will likely begin aggrading again in the next 5 to 10 years (T. Massong, pers. comm. 2005).

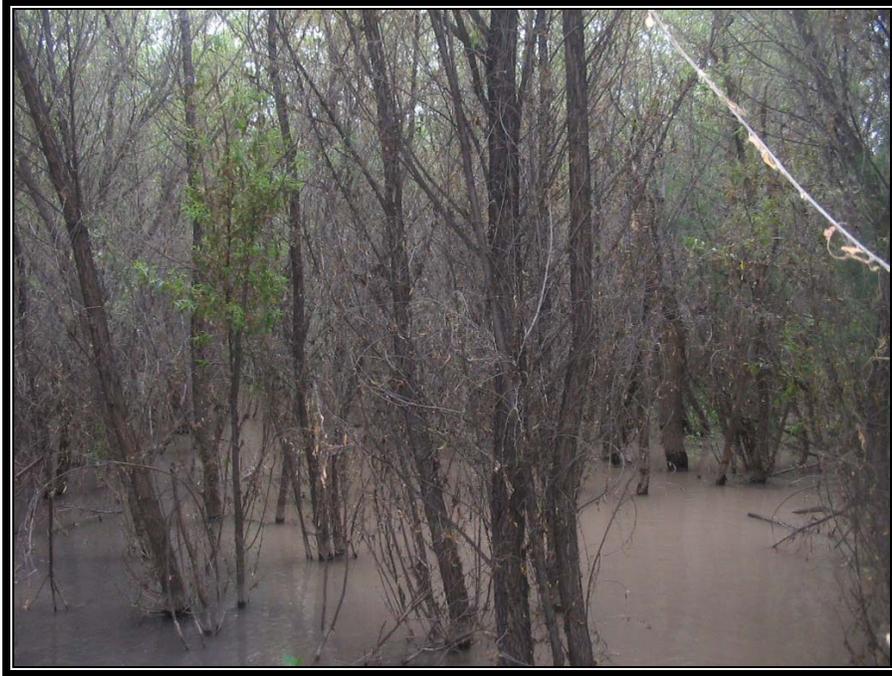
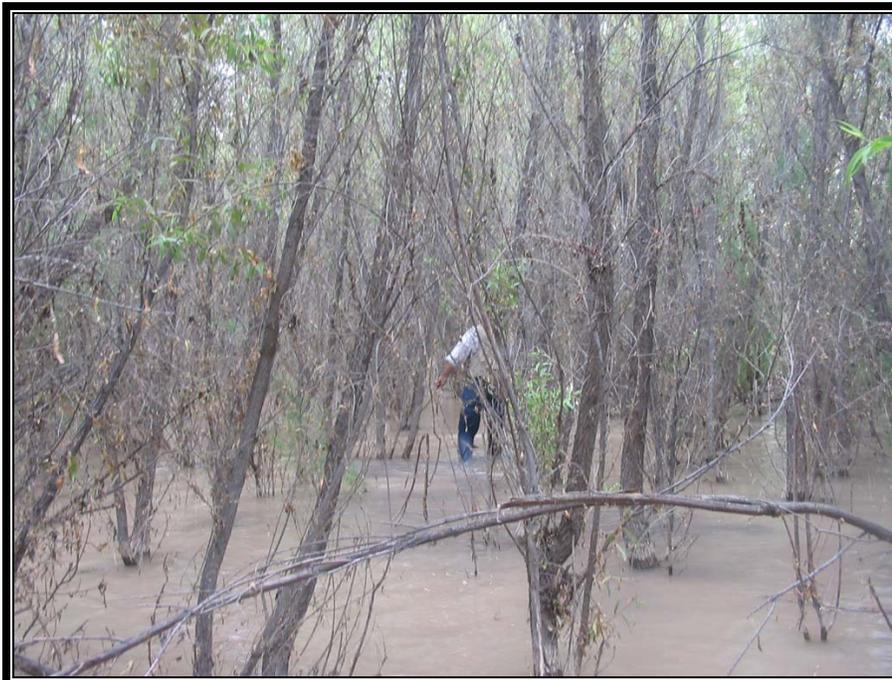
Figures 13.1 and 13.2. Photos of cottonwood leaf beetle defoliation in the headwaters of Elephant Butte Reservoir – spring 2005.

Lastly, in the spring of 2005, an outbreak of cottonwood leaf beetles (*Chrysomela scripta*) was noted in the headwaters of Elephant Butte Reservoir. It was the first time in 10 years of surveying in the San Marcial area that these beetles were documented by Reclamation personnel. The beetles’ population can be somewhat cyclical in nature, flourishing when conditions are right (M. Nelson, pers. comm. 2005). Their host plant is typically cottonwood (*Populus* spp.). However, in the spring of 2005, these beetles were prolific on the Goodding’s willow in certain areas of the reservoir headwaters. Defoliation occurred on a broad scale in several areas (Figures 13.1 and 13.2) and SWFL territories in one severely impacted area dropped from four in 2004 to two in 2005.
