Vegetation Response to Interim Flows in the San Joaquin River

Annual Report 2011

U.S. Department of the Interior
Bureau of Reclamation
Technical Service Center
Denver, Colorado

February 2012

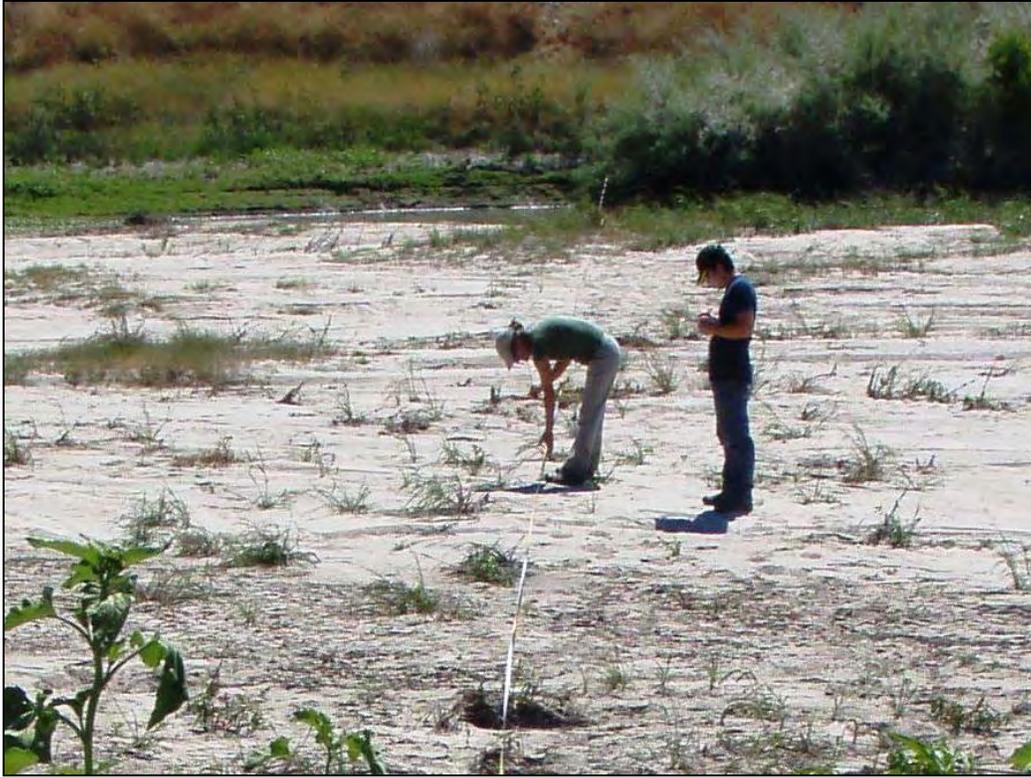
Figure 3—Measuring herbaceous cover along transect.

For herbaceous understory measurements, cover and species composition were measured either every 0.5 or 1 m along the transect depending on the length of the transect. The point-intercept method was used, which entailed recording the first “hit” for herbaceous plants by species and for woody species under 1 m tall (Figure 3). If a plant was not intercepted, then bare soil, litter, rock, or water were recorded. The location and extent of invasive weed species were documented when encountered.
