GR-78-8

# HYDRAULIC MODEL STUDIES FOR PALMETTO BEND DAM SPILLWAY

*Hydraulics Branch  
Division of Research  
Engineering and Research Center  
Bureau of Reclamation*

*November 1978*

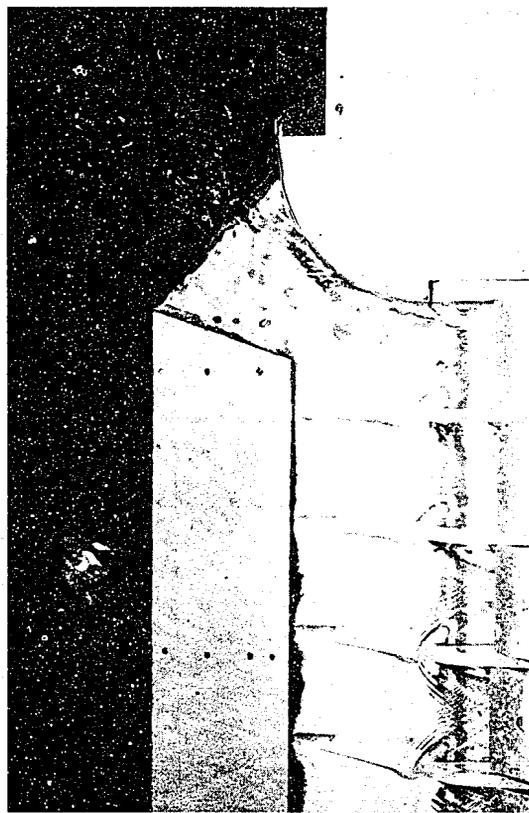
a. Flow at spillway entrance without a spur dike.

b. First trial spur dike.

c. Flow at spillway entrance with recommended dike.

d. The recommended dike.

Figure 5.—Flow conditions of the approach channel. Photo P801-D-79034

Flow conditions at the left side of the spillway were poor (fig. 5a). Water flowed along the dam and perpendicular to the approach channel at the spillway, disturbing flow through the two side bays and influencing flow as far as the fifth bay.

To prevent undesirable perpendicular flow, a spur dike was placed normal to the dam 61 m (200 ft) left of the spillway (fig. 5b). The spur dike extended 107 m (350 ft) into the reservoir, with the upstream edge near the inner bank of the curve. Flow conditions at the spillway entrance were greatly improved. However, at the reservoir end of the dike, there was an acceleration of flow around the dike into the approach channel. Sand eroded from the end of the dike and moved into the spillway entrance. This configuration of the dike, without adequate riprap protection, appeared potentially susceptible to erosion.

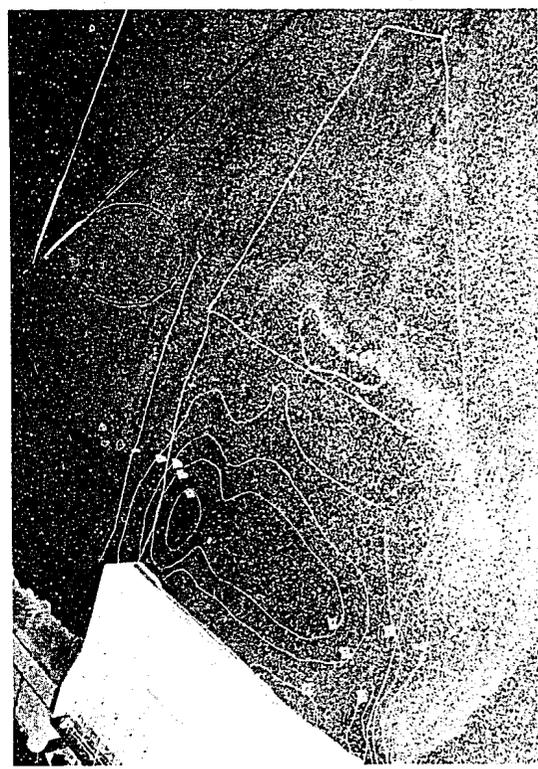
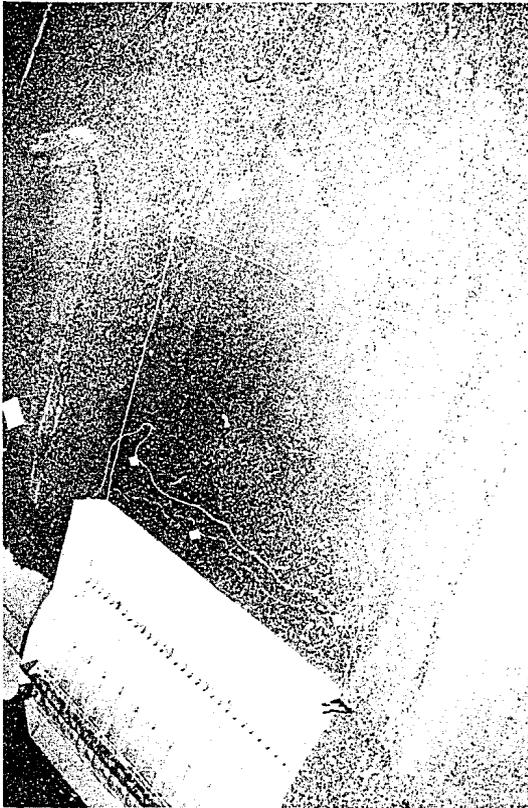
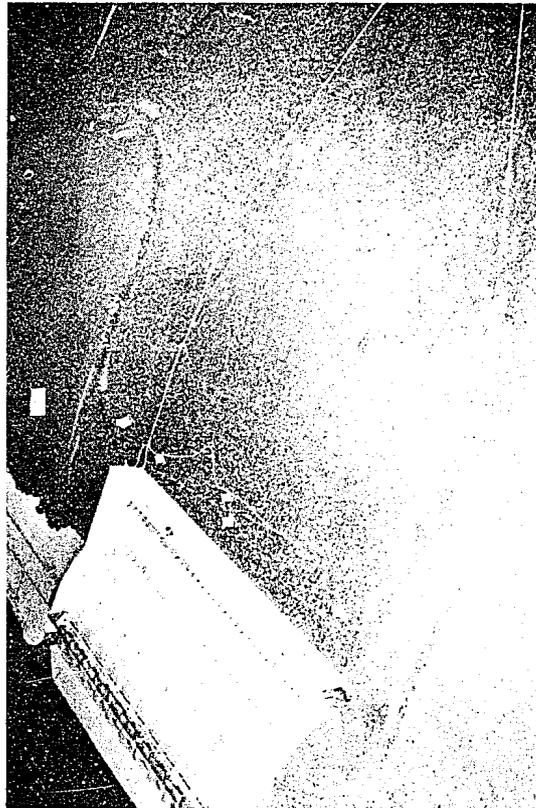
a. Plain floor with no appurtenances (1T).

c. Triangular end sill and 172-m (564-ft) bottom width approach channel (4T).

b. Triangular end sill and 141-m (464-ft) bottom width approach channel (3T).

d. Triangular end sill and floor blocks (8T).

Figure 8.-Erosion tests of 1:100 scale model. Photo P801-D-79036

e. Floor blocks only and floor EL -4.3 m (-14 ft) [11T].

g. Floor blocks only, floor EL -3.0 m (-10 ft), and stilling basin length reduced by 11.6 m (38 ft) [18T].

f. Floor blocks and dentated end sill, floor EL -4.3 m (-14 ft) [12T].

h. Recommended stilling basin [26T].

Figure 8.—Erosion tests of 1:100 scale model.—Continued. Photo P801-D-79037

2. For this low Froude number stilling basin, floor blocks had the most significant effect in increasing the energy dissipation (fig. 8e).
3. A dentated end sill reduced the erosive force downstream from the stilling basin better than a solid triangular end sill.
4. Model tests showed that a stilling basin floor elevation 1.2 m (4 ft) higher than the initial design elevation still provided satisfactory energy dissipation.
5. Dikes 122 m (400 ft) long, one on each side of the spillway exit channel, improved flow conditions at the downstream corners of the stilling basin. The size of the eddy on the right and the strength of the lateral undercurrent at the corner side of the stilling basin were substantially reduced by the dikes (fig. 12).

stilling basin while the model was operating. Not much difference in basin flow conditions was detected, but the best operation appeared when the sill was located about 12 m (40 ft) upstream from the basin end. Erosion test 12T indicated that the dentated sill at this location was not an appreciable improvement (figs. 8e and 8f).

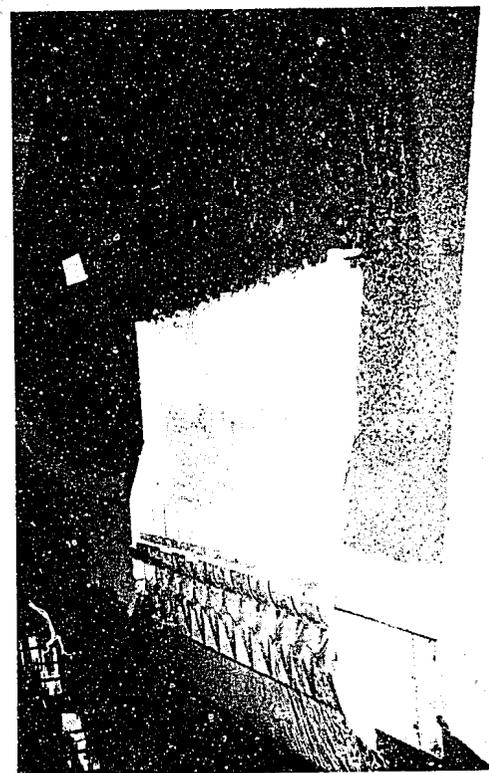
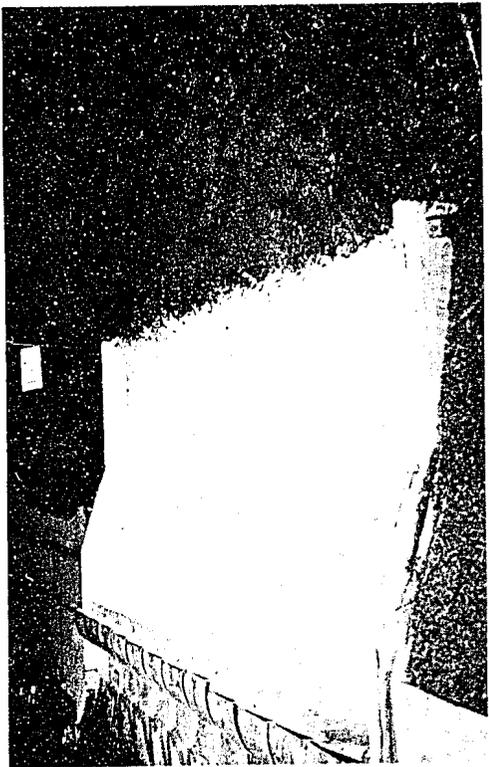
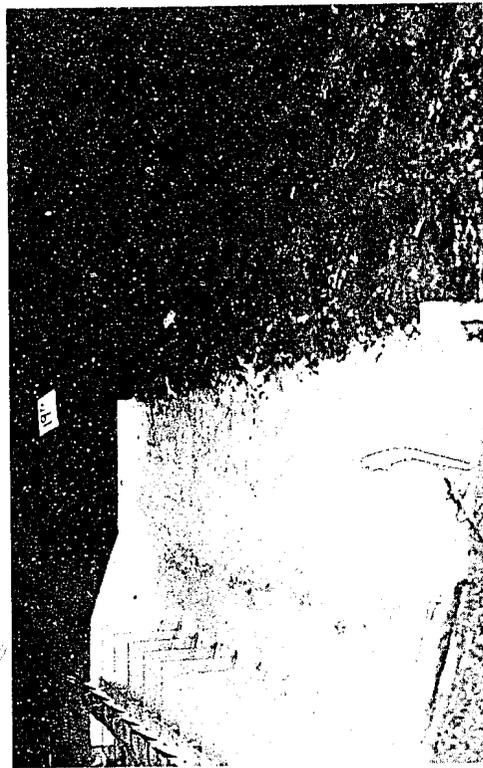
a. Floor EL -4.3 m (-14 ft) and tailwater EL 9.4 m (31 ft).

c. Floor EL -3.0 m (-10 ft) and tailwater EL 9.4 m (31 ft).

b. Floor EL -4.3 m (-14 ft) and tailwater EL 7.9 m (26 ft).

d. Floor EL -3.0 m (-10 ft) and tailwater EL 7.9 m (26 ft).

Figure 10.-Flow in stilling basin with floor blocks. Photo P801-D-79038

Up to this point in the test program, the floor block appurtenances made the most significant reduction in erosion. The triangular end sill had been in place since 2T. Thus, for 11T, the triangular end sill was removed to determine how effective the floor blocks alone were in dissipating the energy. There was less erosion without the sill than with the sill (figs. 8d and 8e). The solid triangular end sill did not appear to be a very effective appurtenance. Flow conditions at 9.4- and 7.9-m tailwater elevations for the stilling basin configuration are shown in figures 10a and 10b.

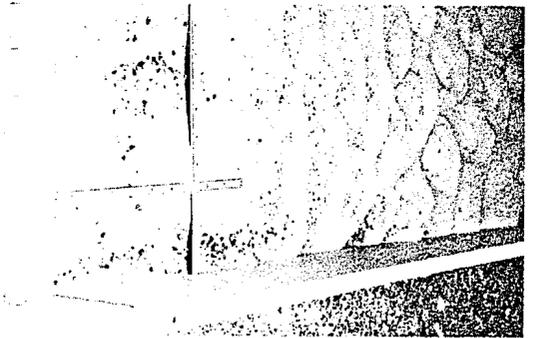
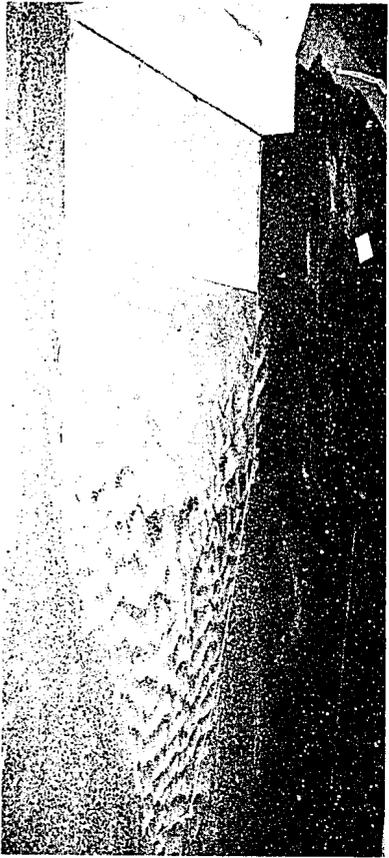
a. Stilling basin floor EL -3.0 m (-10 ft) with floor blocks.

c. Sidewalls with dented end sill.

d. Sidewalls without dented end sill.

b. Simulated 61-m (200-ft) length of soil-cement.

Figure 11.-Tests with fine sand. Photo P801-D-79039

e. Representation of the 1:30 scale sectional model in the 1:100 scale model.

Figures 11c through 11e show results of tests made to help interpret results from the 1:30 sectional model and are discussed in a subsequent section of the report.

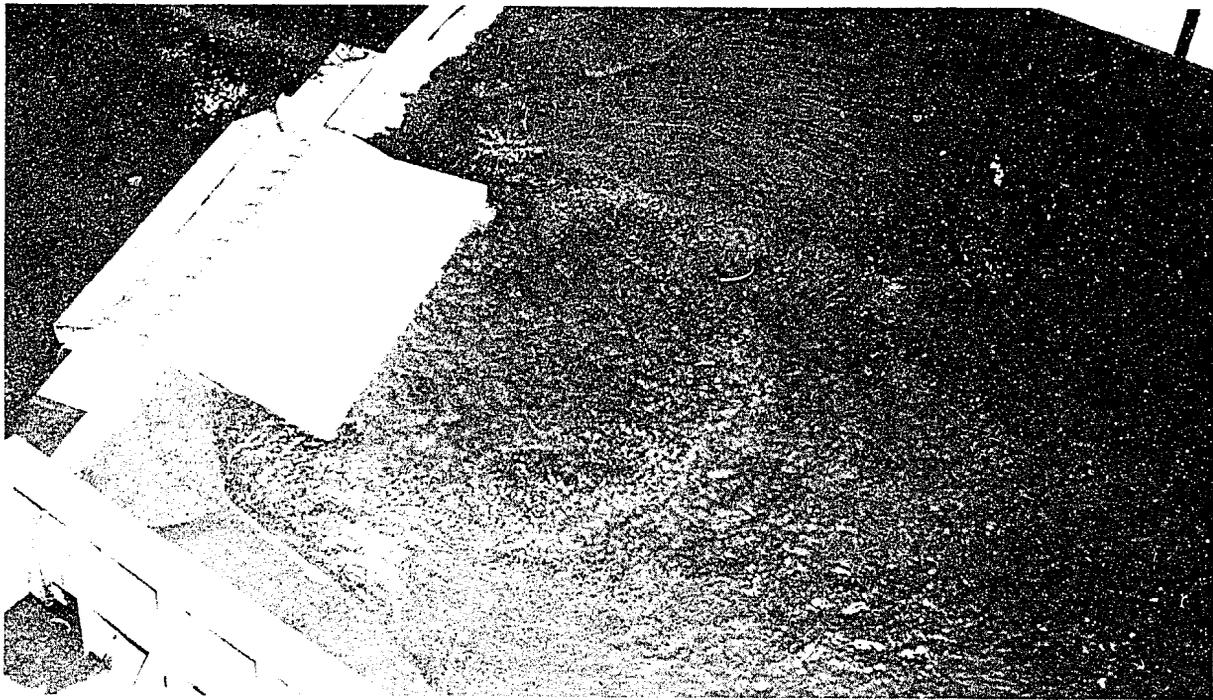
a. Exit channel flow before dikes.

b. Exit channel flow confined by dikes.

Figure 12.—Exit channel downstream from the stilling basin. Photo P801-D-79040

During initial tests, a large eddy was present at each corner of the basin outlet. To constrain the flow, dikes were placed along a 119-m (390-ft) downstream distance on each side of the exit channel. The bottom toe of the dikes was in line with the basin sidewalls, and extended 13.7 m (45 ft) upward at a 3:1 slope. The eddies were considerably reduced (fig. 12). Excavated material from the exit channel is a waste-type fill which could not be used for constructing the dam. This excess fill may be placed in back of the dikes and the dikes blended into the natural topography (fig. 12b).

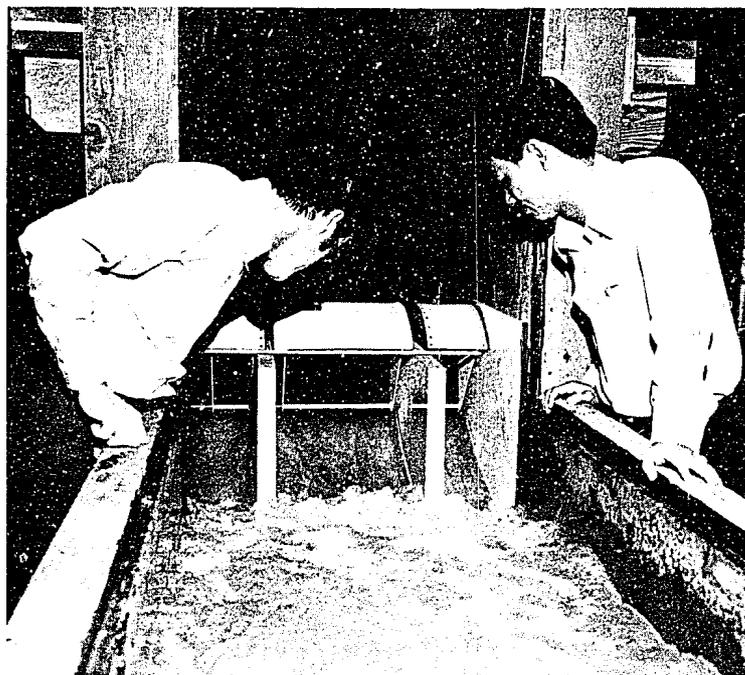
Figure 13.—The 1:30 scale sectional model, test R2 in progress.  
Photo P801-D-79041

(16 ft). The stilling basin portion of the model was located between the transparent sides of the flume to better observe the profiles of the flow action.

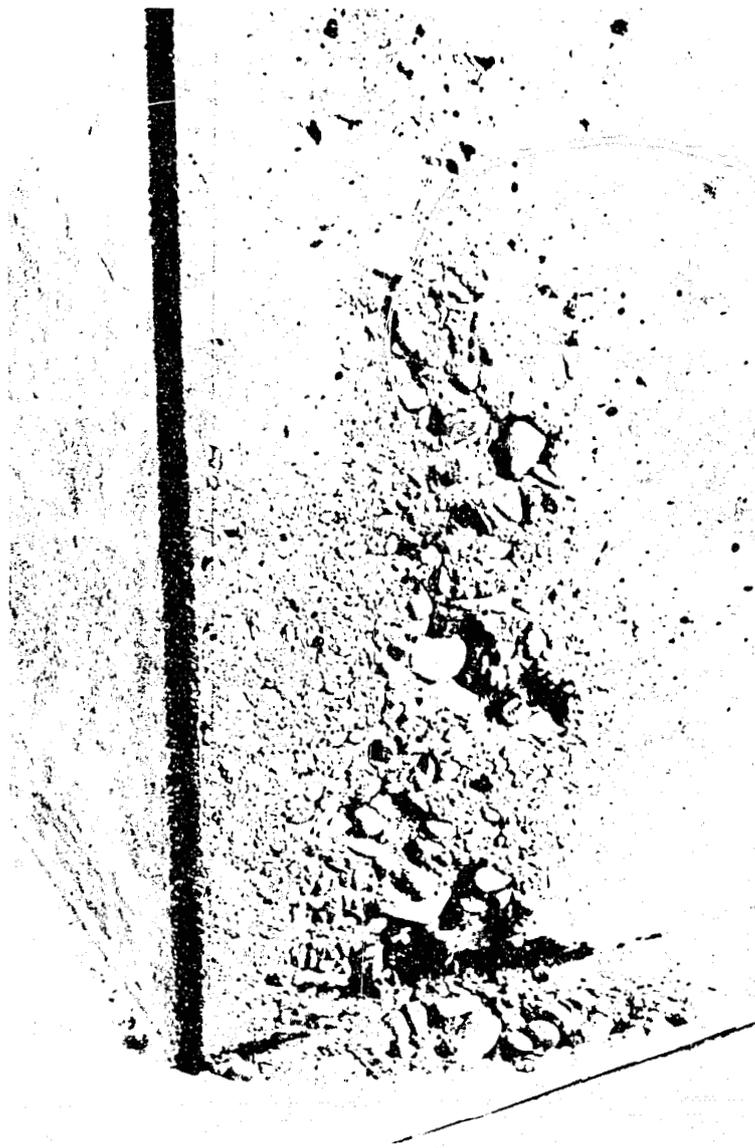
Figure 19.—Cavitation erosion of a floor block, in a prototype structure having a head and basin velocity approximately the same as Palmetto Bend at maximum design flow. View looking at the side of the floor block, flow from left to right. Photo P801-D-79046

Cavitation erosion can occur on floor blocks and on the stilling basin floor near the blocks (fig. 19). Therefore, measurements were made on a model floor block to check for cavitation pressures. The erosion locations shown in figure 19 were used as guides for locating piezometer taps in the model. Piezometer taps were placed within and upstream from the damaged areas and along the centerline of the floor block (figs. 20b and c). Also, piezometer taps were placed along the centerline upstream and downstream from the floor
