\*\*\*\*\*  
\*  
\* UNITED STATES \*  
\* DEPARTMENT OF THE INTERIOR \*  
\* BUREAU OF RECLAMATION \*  
\*  
\* --- \*  
\* REPORT ON VIBRATION STUDIES \*  
\* MADE AT BLACK CANYON DAM \*  
\* BOISE PROJECT \*  
\*  
\* --- \*  
\* MEMORANDUM TO MR. K. B. JENSEN \*  
\* by \*  
\* R. E. GLOVER, ENGINEER \*  
\* C. W. THOMAS, ASSISTANT ENGINEER \*  
\* T. R. HAMMETT, JUNIOR ENGINEER \*  
\*  
\* --- \*  
\* Denver, Colorado \*  
\* July 26, 1939 \*  
\*  
\*\*\*\*\*

**Subject:** Report on vibration studies made at Black Canyon Dam, Boise project, from March 20, 1939, through April 6, 1939.

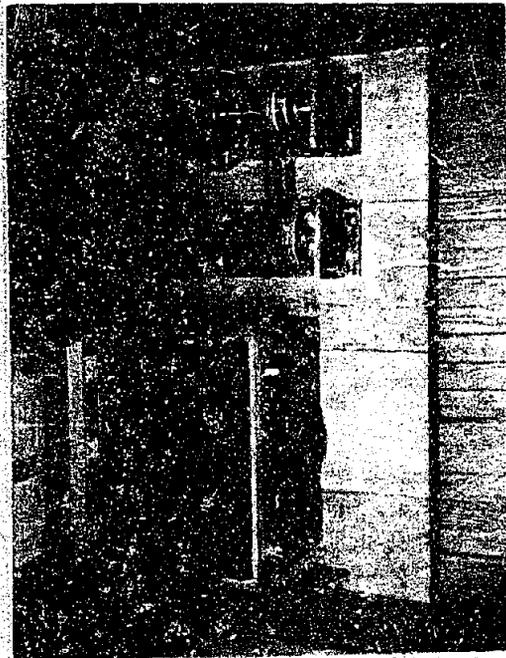
VIEWS OF SHAKING TABLE USED TO CALIBRATE  
ACCELEROMETER UNITS

celerometer box is placed on the table and a record of the movement of the accelerometer unit is obtained on the oscillograph. Then, knowing the deflection of the table, the value of the eccentric weight plus the weight of the entire apparatus (including accelerometer box) and the speed of the disk carrying the eccentric weight, the acceleration produced can easily be calculated. Hence the deflection of the oscillograph element which represents an acceleration of 0.1 gravity can be found. As the shaking table oscillates in but one direction at a time, each accelerometer unit has to be calibrated separately. To calibrate the vertical element, one end of the table was suspended by means of a spring and the casters on the table blocked so that the only motion was in the vertical direction. With this set-up the same procedure was followed as for calibrating the horizontal units.

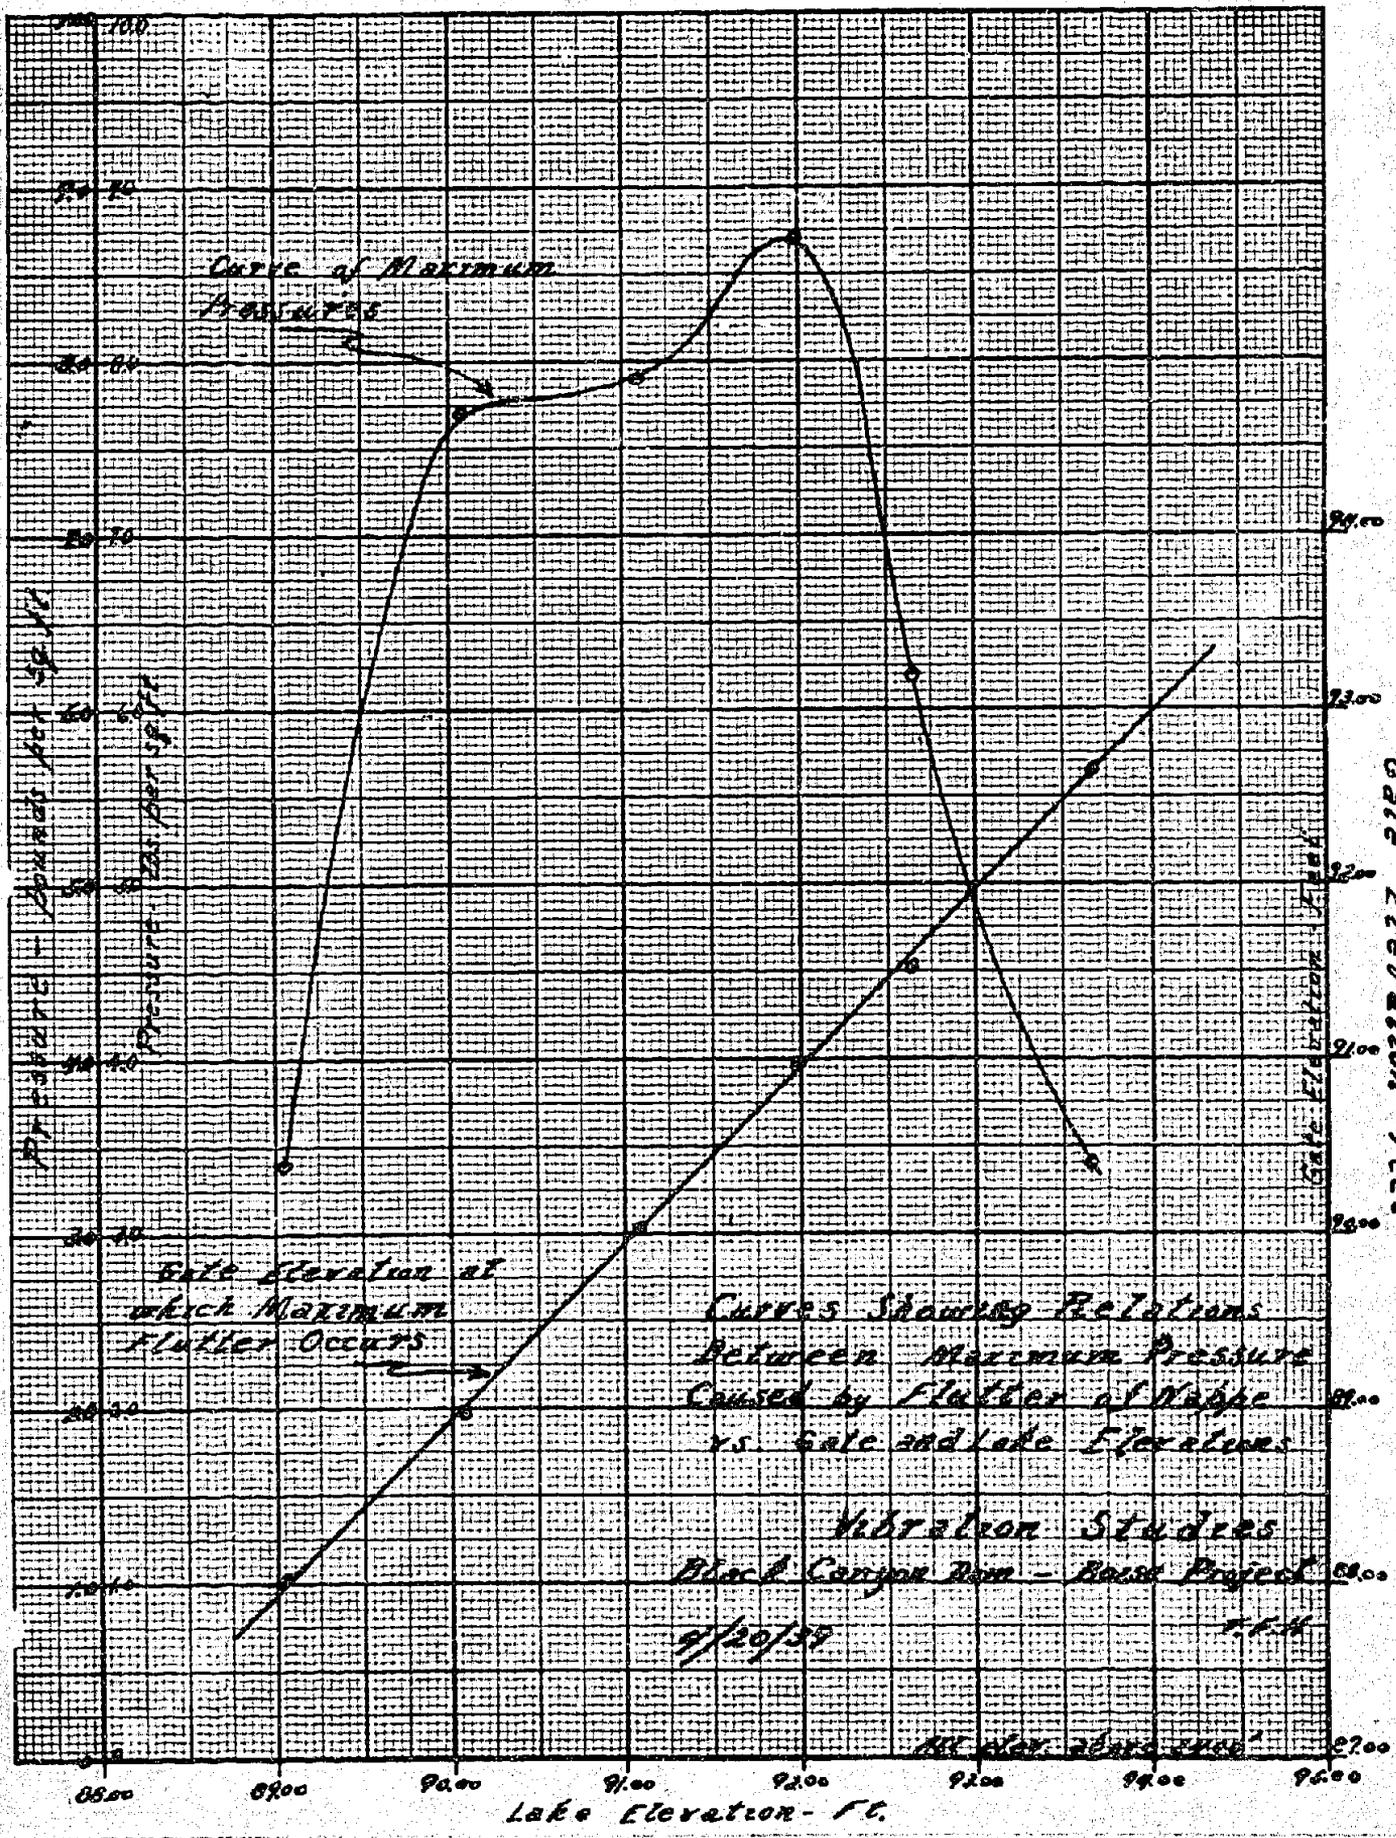
Curve of Maximum Pressures

Gate Elevation at which Maximum Flutter Occurs

Curves Showing Relations Between Maximum Pressure Caused by Flutter of Wabbe vs. Gate and Lake Elevations

E. The maximum pressure was found to occur at all elevations of the lake, where flutter was present, when the difference in elevation between the lake and the crest of the gate was about one foot.

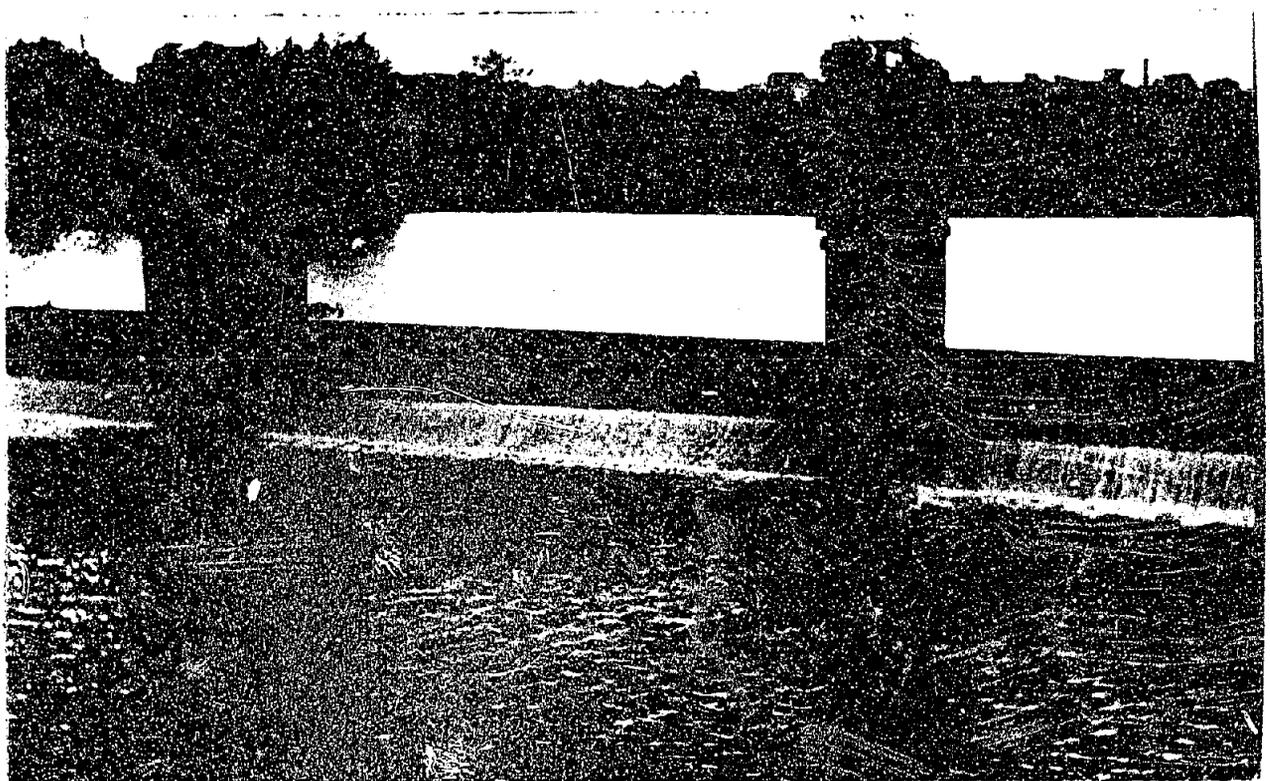
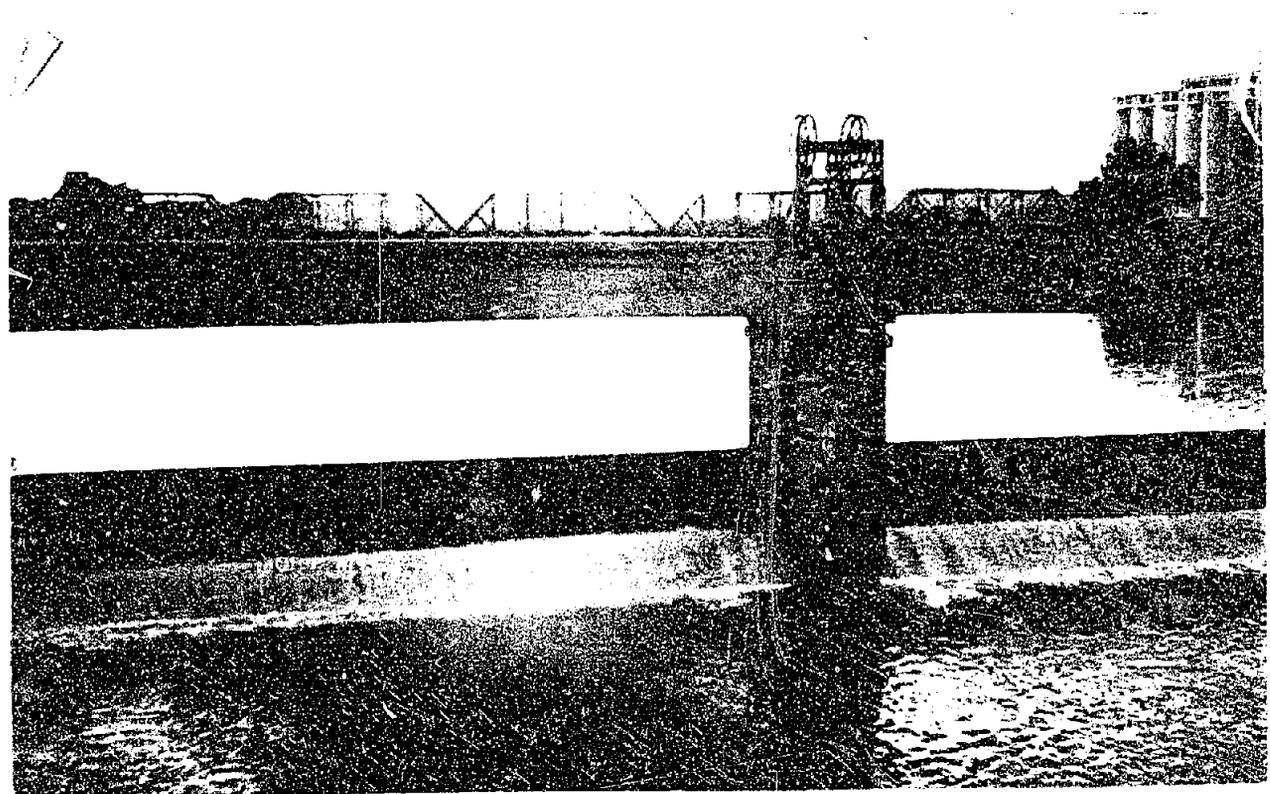
VIBRATION OF JET FROM WEIRS OF DAM IN CEDAR RIVER,  
CEDAR RAPIDS, IOWA

Engineer J. E. Warnock of this office reports observing vibration of the nappes from the movable weirs on the crest of a dam across Cedar River at Cedar Rapids, Iowa. The crests of these weirs were at different elevations. The frequency of the vibration was observed to be less for the weirs having the greater head. In some instances the jet over the weir was separated by debris lodged on the crest but vibration was present in some cases even with a very short length of free crest. Photographs of the vibration are shown on the following pages.

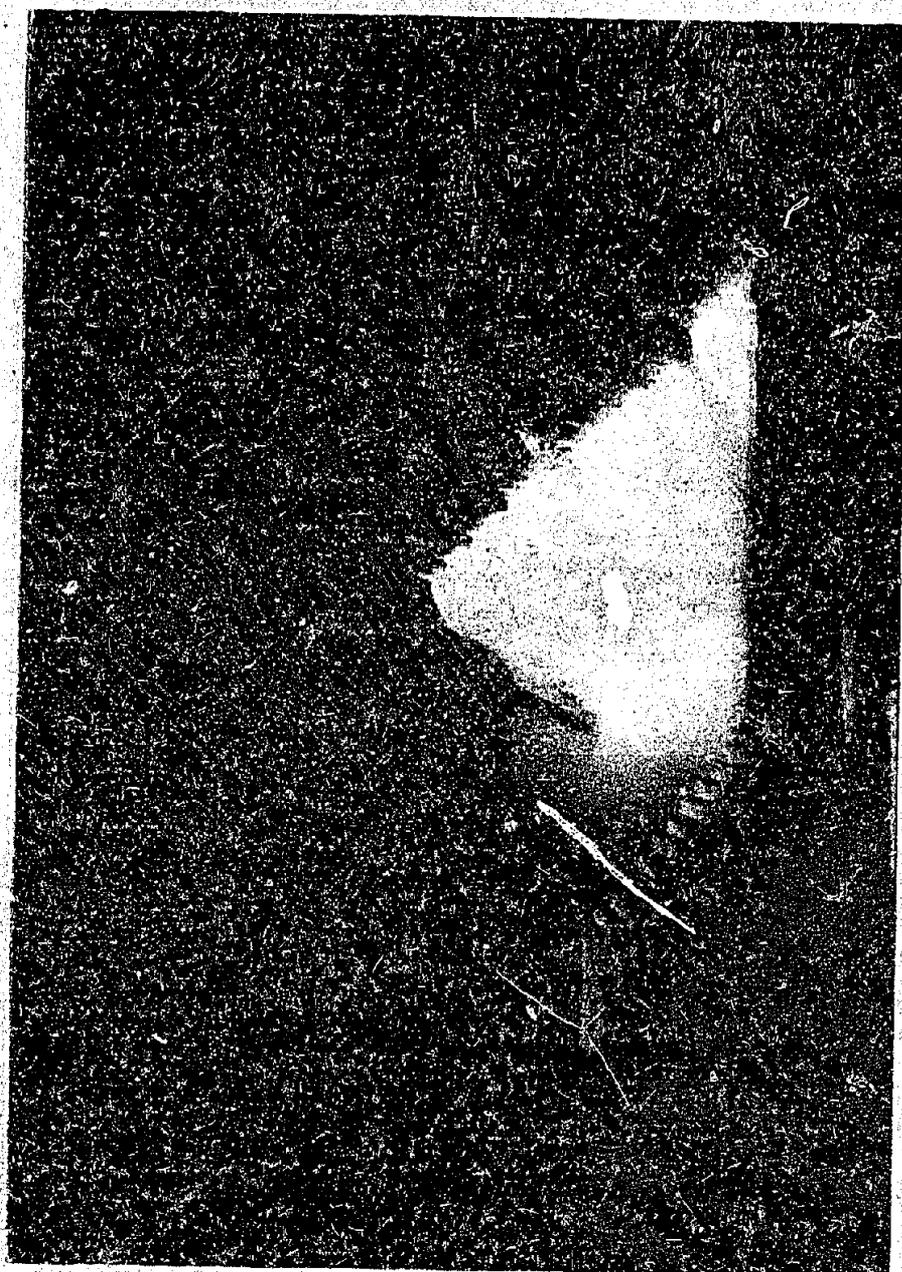
65- BY 8-FOOT DRUM GATES ON TIETON DAM SPILLWAY  
GATES COMPLETELY RAISED - SMALL HEAD OVER GATES

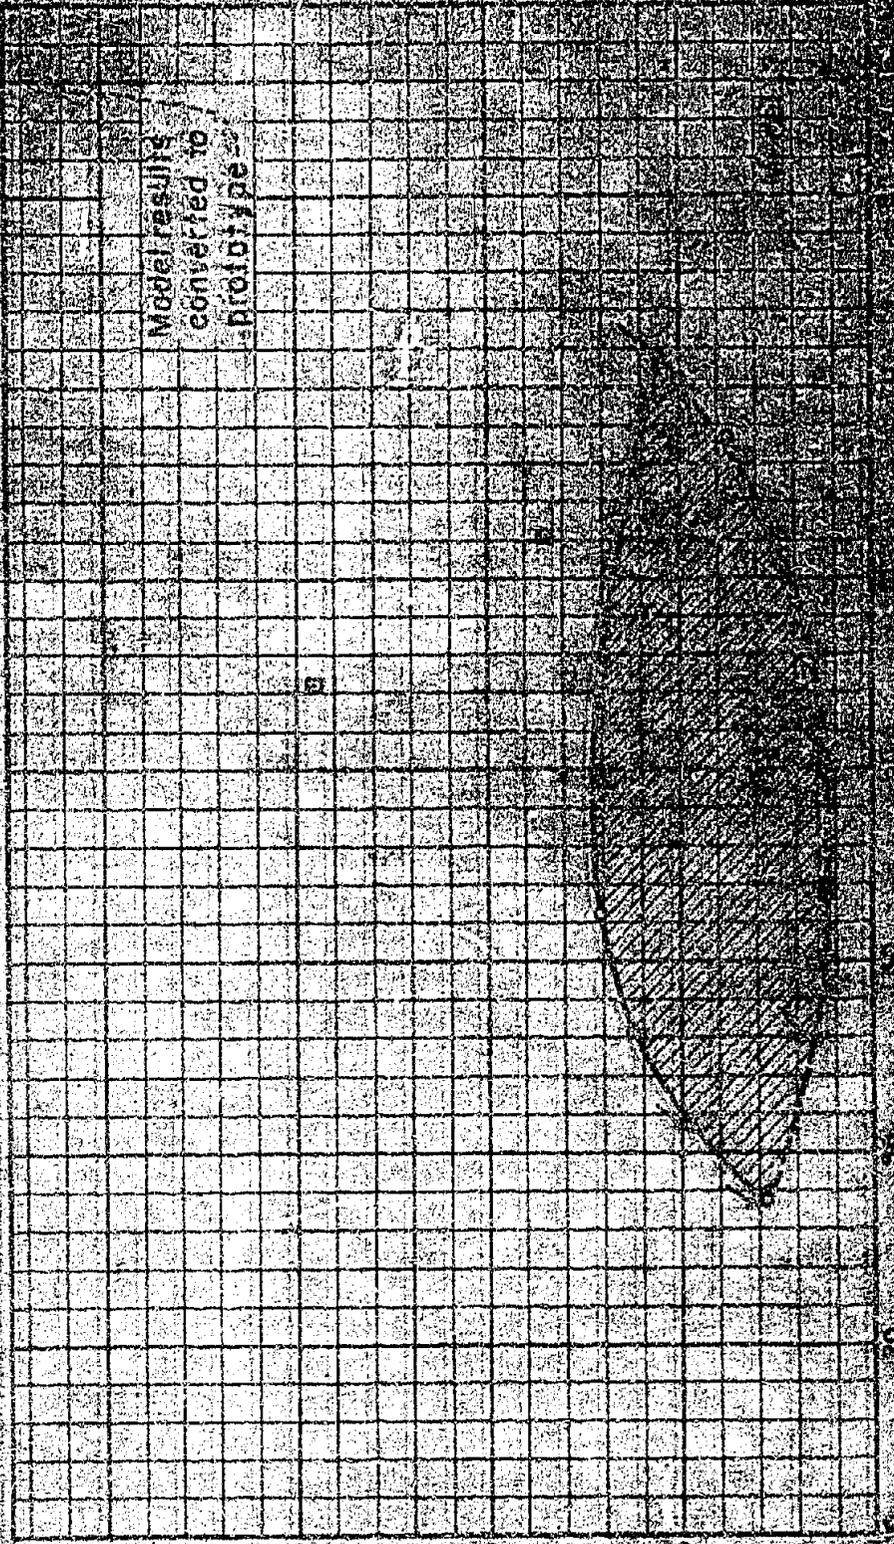
Model results  
converted to  
prototype

EXPLANATION  
 (1) Head on gate, 2.0 ft  
 (2) Prototype (100 ft) velocity, 10 ft/sec  
 (3) 1.5 ft  
 (4) 1.0 ft  
 (5) 0.5 ft  
 (6) 0.2 ft  
 (7) 0.1 ft  
 (8) 0.05 ft

Head over the drum gate plotted against the amount the gate was raised in percent of the total raise for Black Canyon Dam, Norris Dam, and the 1 to 40 model of Grand Coulee Dam is shown on the following page. The vibration of the jet at Black Canyon Dam occurred when the gates were raised from 25 percent to 75 percent of their total travel and the head was from 0.25 foot to 1.40 feet. There was no vibration of the jet when the gates were raised above 75 percent of their total lift. Extrapolation of the data shows that no vibration occurs when the gates are raised less than 25 percent of their total travel. Although the data from Norris Dam are few, the available points indicate that vibration occurs when the gates are raised from 50 percent to 70 percent of their total travel and the head is between 1.0 foot and 3.0 feet. The vibration of the jet on the Grand Coulee model occurred when the gate was raised 86 percent of its total travel and with a head over the gate of 0.1-foot model or 4.0-foot prototype. The prototype data indicate that the vibration of the jet occurs when the drum gates are within the middle one-half of their total travel, hence, vents provided to aerate the jet for the upper 30 percent of the gate travel as indicated by the model, would be only partially effective.
