# UPPER GILA RIVER FLUVIAL GEOMORPHOLOGY STUDY

STREAM CORRIDOR ASSESSMENT  
ARIZONA

US Department of the Interior  
Bureau of Reclamation

MARCH 5, 2004

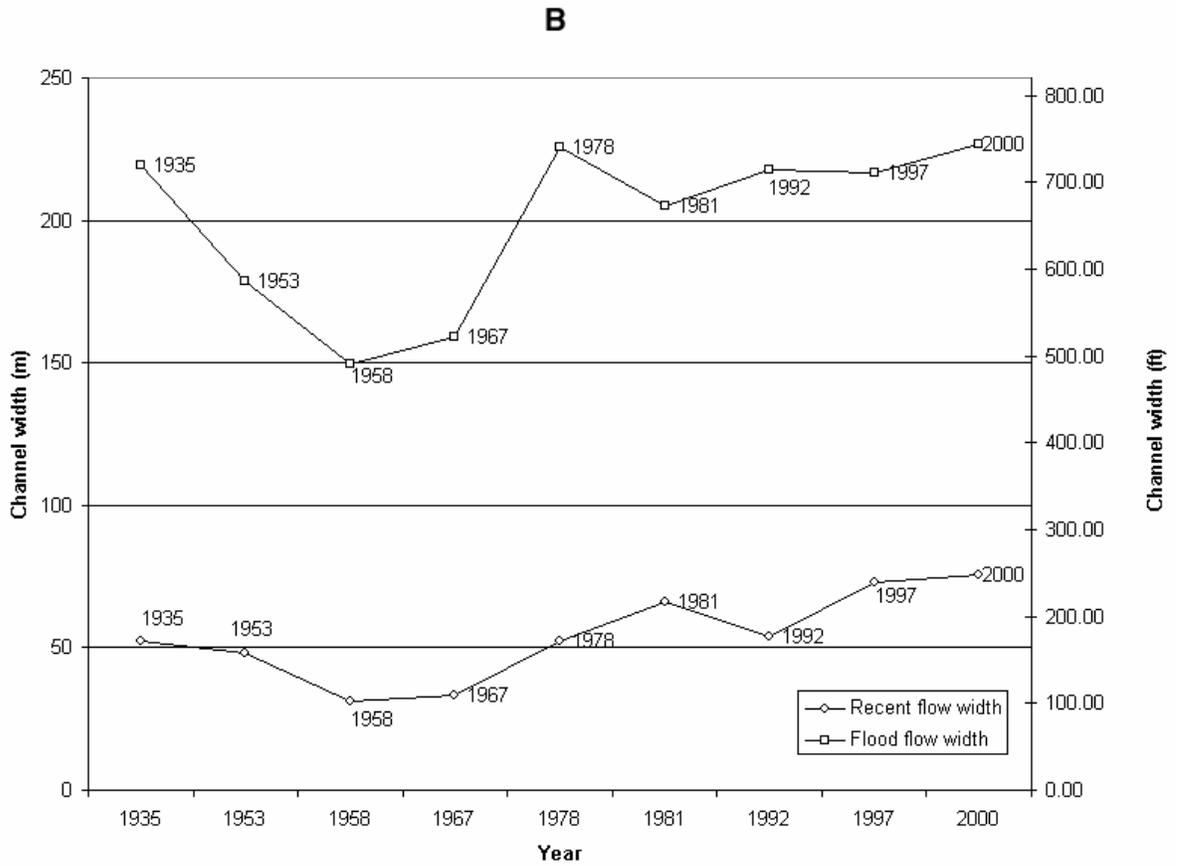
Figure 2. Average width by year in A. Safford Valley; B. Duncan Valley.

The average width data for Duncan Valley show similar trends to that of Safford Valley. From 1935 to 1958, there was a general decrease in both recent flow channel width and flood width, especially from 1953 to 1958. This decrease followed a period of fewer and smaller magnitude floods. From 1958 to 1981, channel width increased, most likely due to the 1965, 1972 and 1978 floods in Duncan Valley. From 1981 to 1992, widths decreased slightly for the recent flows and increased for the flood flows, the latter of which may be associated with the 1984 flood, which is the second largest peak in the record at the Gila River near Clifton gaging station. From 1992 to 1997, average flood width appears to have remained constant and reached the average flood width of 1935 measurements in 2000. Recent flow width increased from 1992 to 2000.

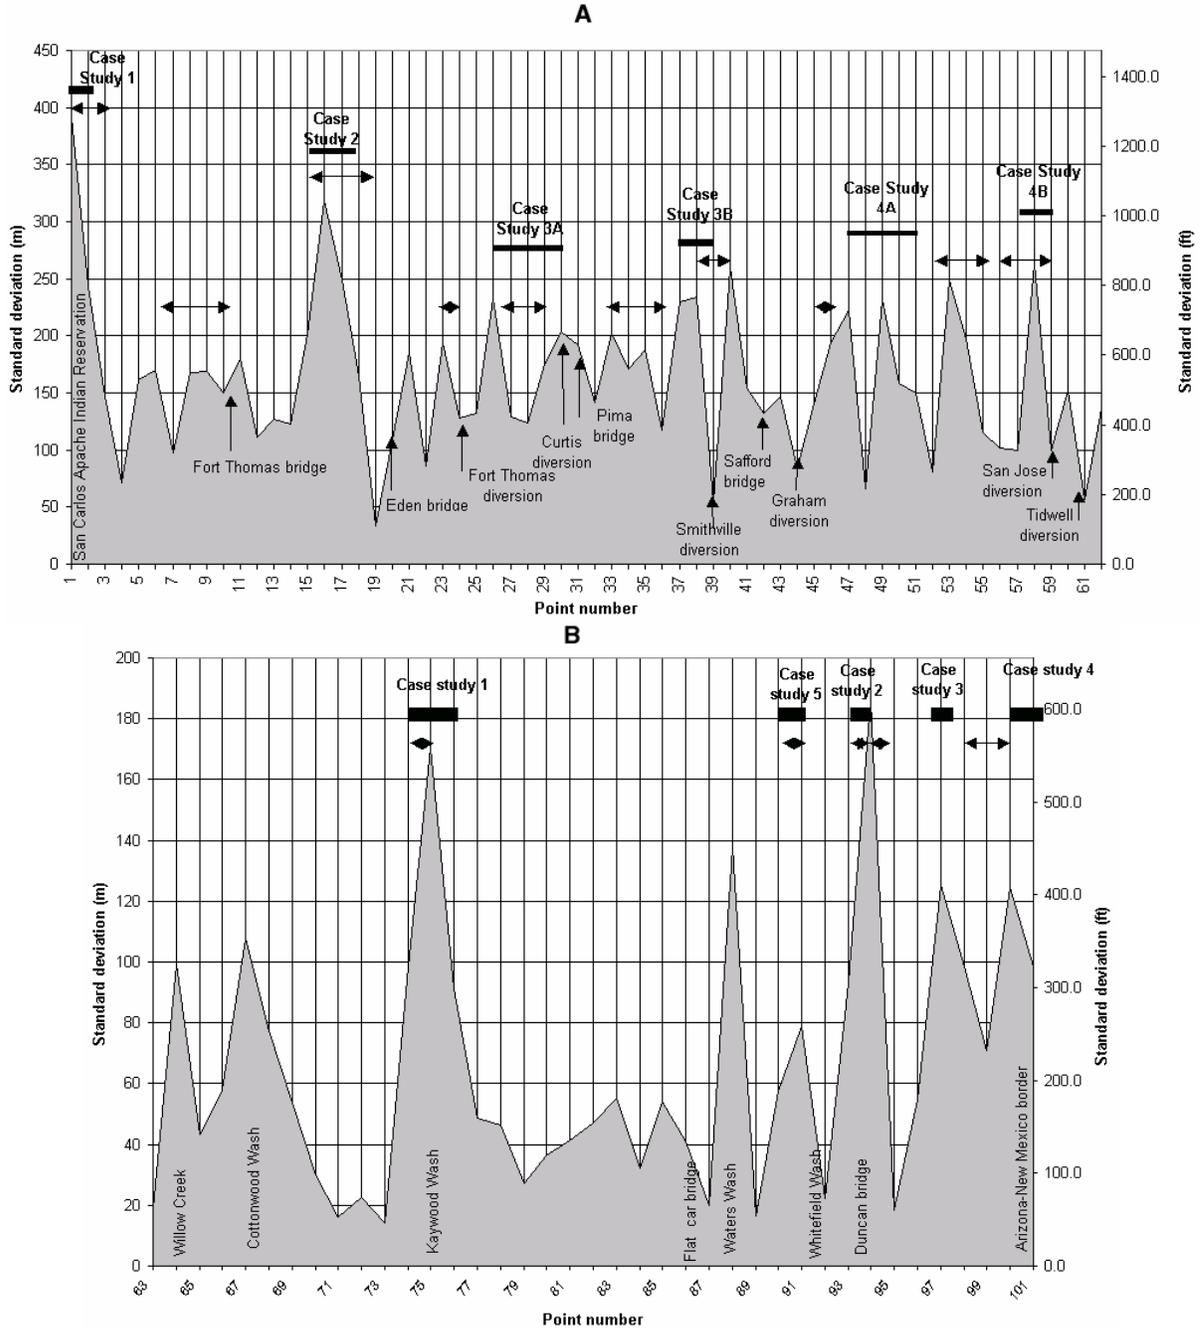
Figure 3. Standard deviation of channel widths measured at each point in A.) Safford Valley and, B.) Duncan Valley.

The statistical analysis of channel change identifies the reaches of greatest variability in flood channel width and also those of intermediate and small variability over the period measured (Figure 3). The standard deviation of the widths for all non-flood years at each measurement point was compared relative to other points so that reaches with high variability could be identified. This analysis only includes results for the flood width measurements, although the same could be performed for active channel width measurements. Flood width measurements appear to be the more important variable to analyze, as these are the measurements that reflect the greatest change in the river system.

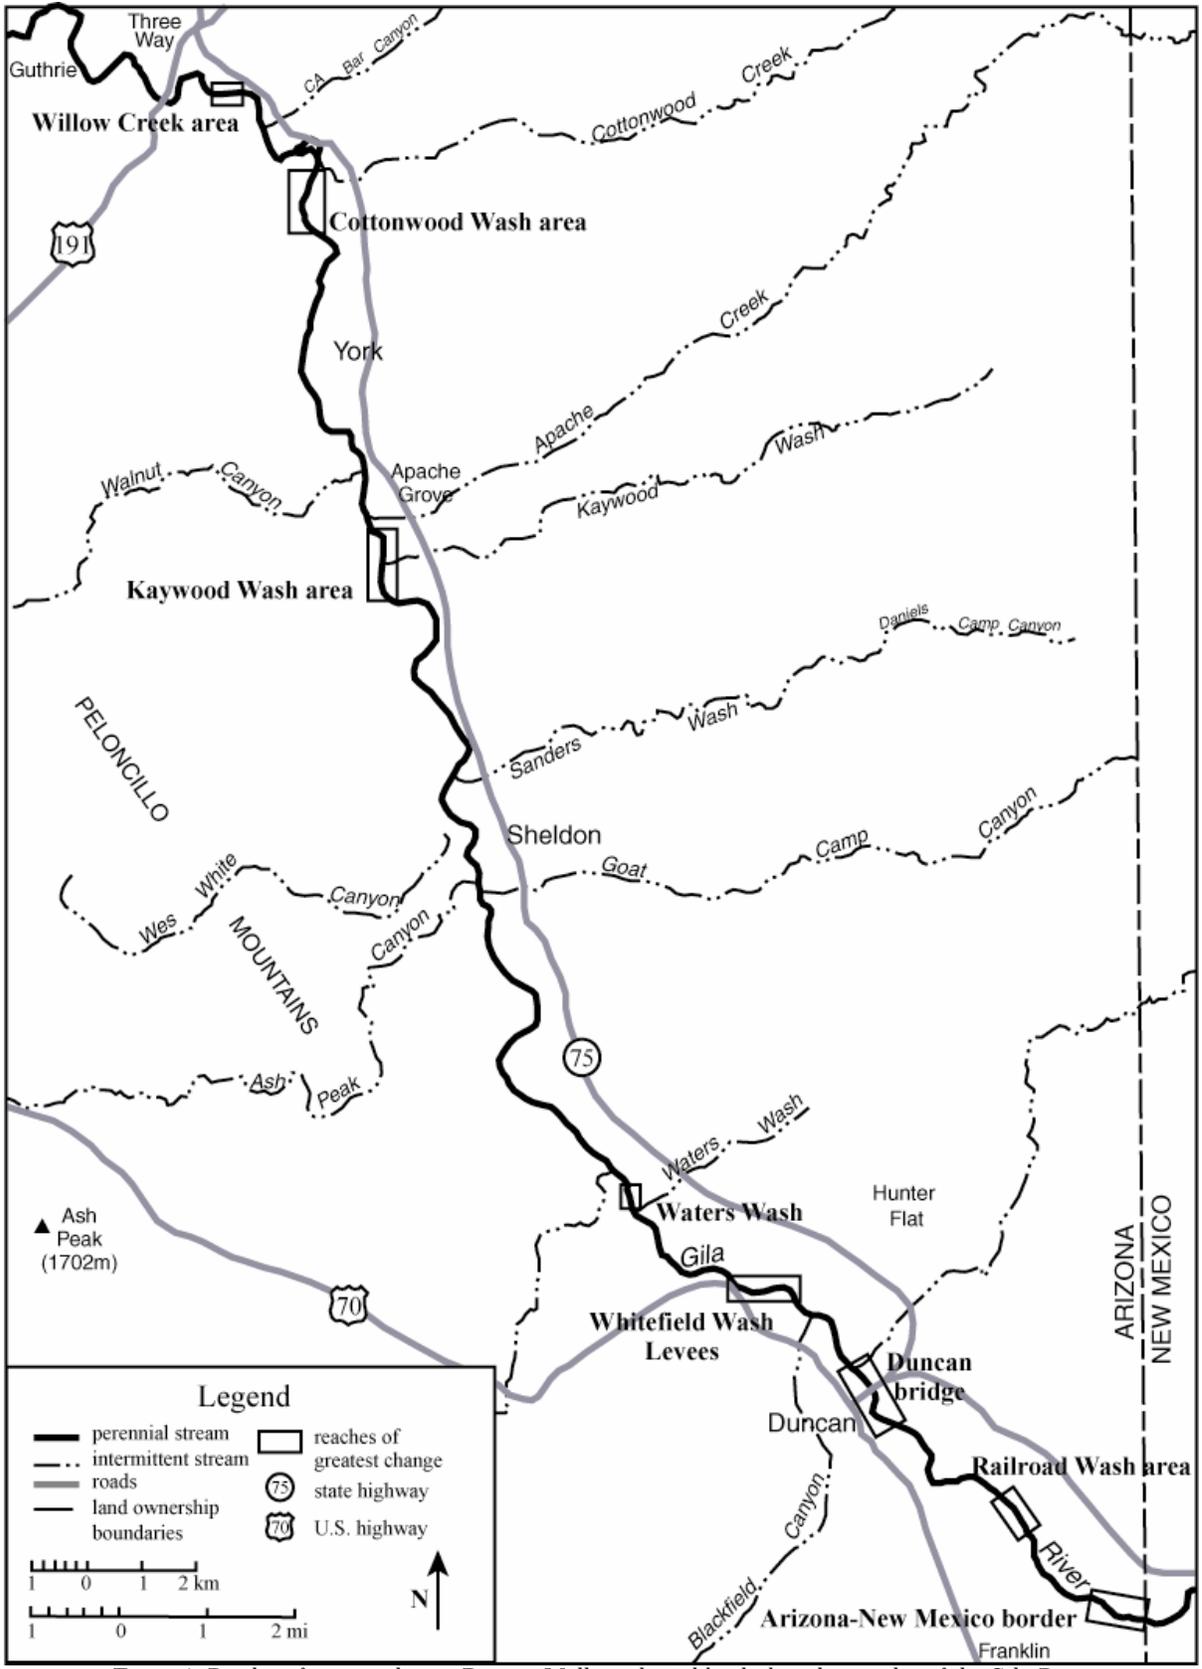
Figure 4. Reaches of greatest change: Duncan Valley indicated by the boxed in reaches of the Gila River.

This reach is generally similar throughout most of the period of record, but exhibits major channel changes between 1992 and 1997 (Figure 4 and Figure 5). The 1935 channel exhibited more sinuous channel morphology, but was generally similar to subsequent years. This difference is most likely due to the construction of levees in 1953, which forced the channel to conform to a particular pattern. This pattern persisted through 1981, where levees were constructed in a slightly different arrangement and with greater length. This was probably in response to the 1978 flood, in which inundation is apparent behind the levees on reoccupied farmland on the 1981 photograph set. The 1992 channel had a similar configuration, although some levees had been eroded in the intervening years. In 1997, the left bank levee had been eroded where it was built up after the 1978 flood, and a new right bank meander cut into the floodplain that was previously a part of the flood width in 1935. In sum, although a seemingly new channel was created, high flows between 1992 and 1997 cut into areas that were previously part of the inundation area.

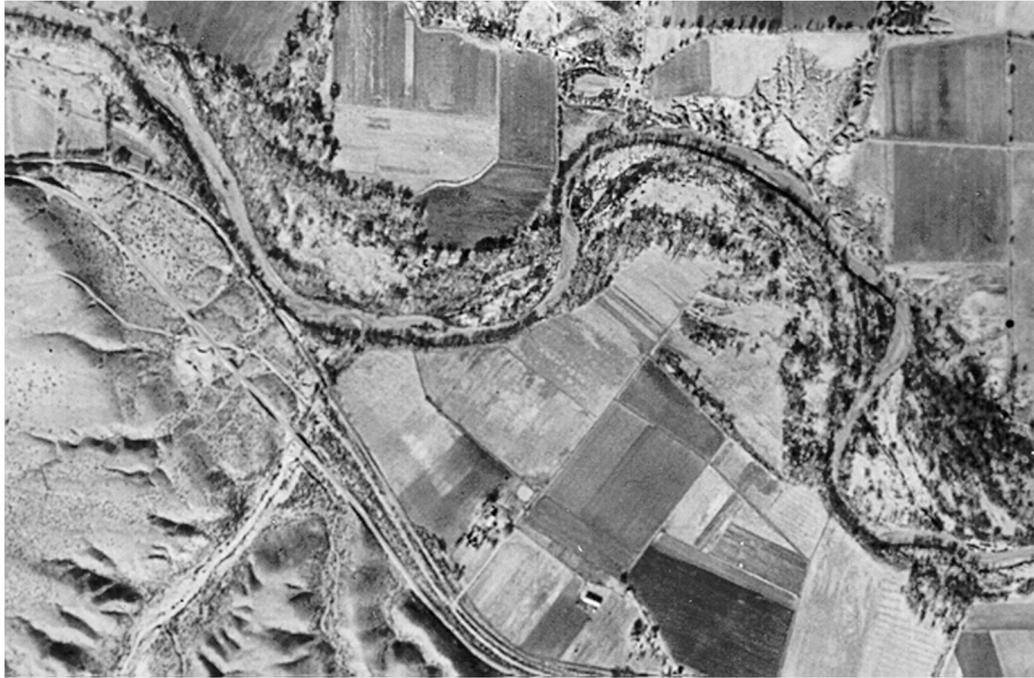
**(a) 1935**

*Figure 5. Case Study 5: Whitefield Wash levees. Levees imposed on the left bank caused changes in channel morphology from (a) 1935 to (b) 1953. Flow is from right to left.*

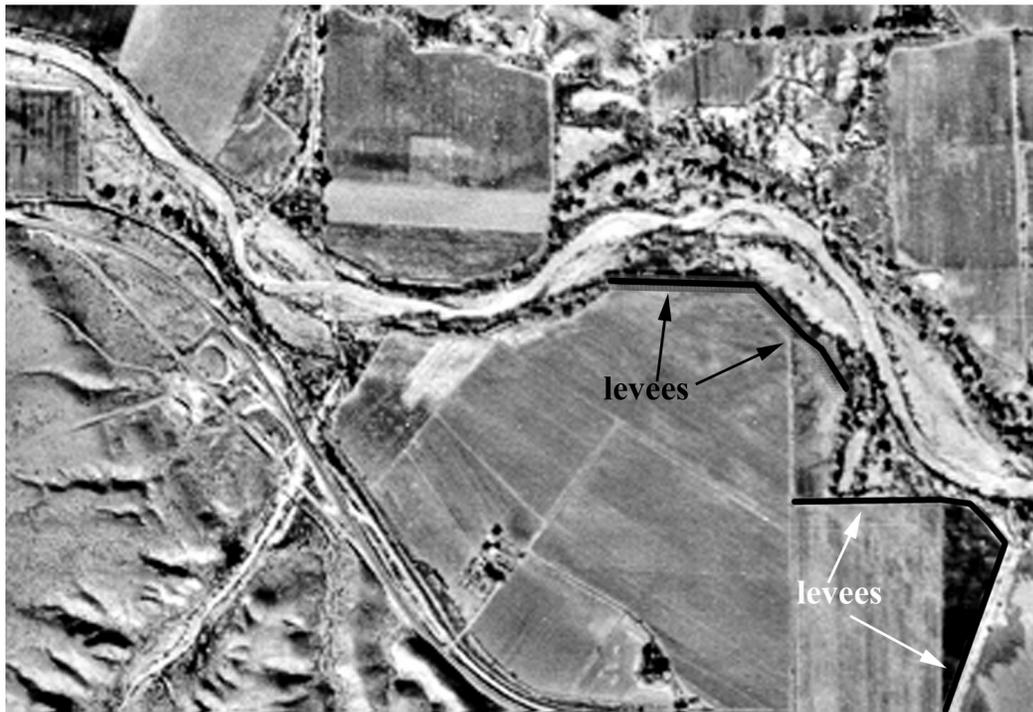
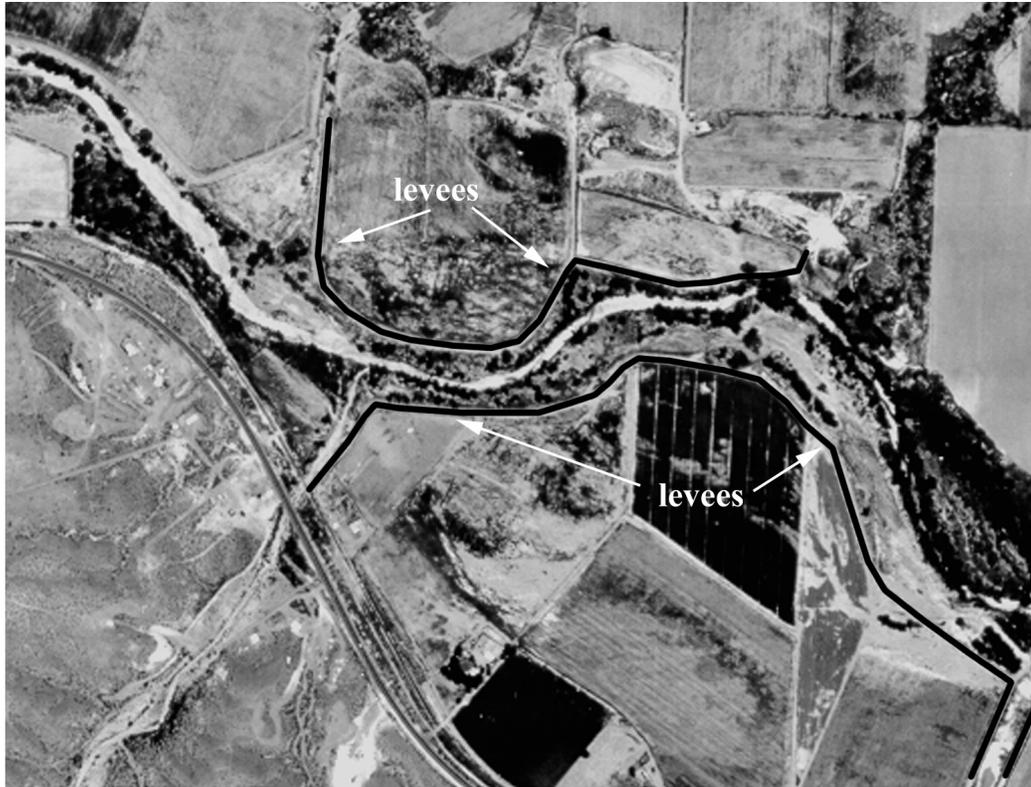
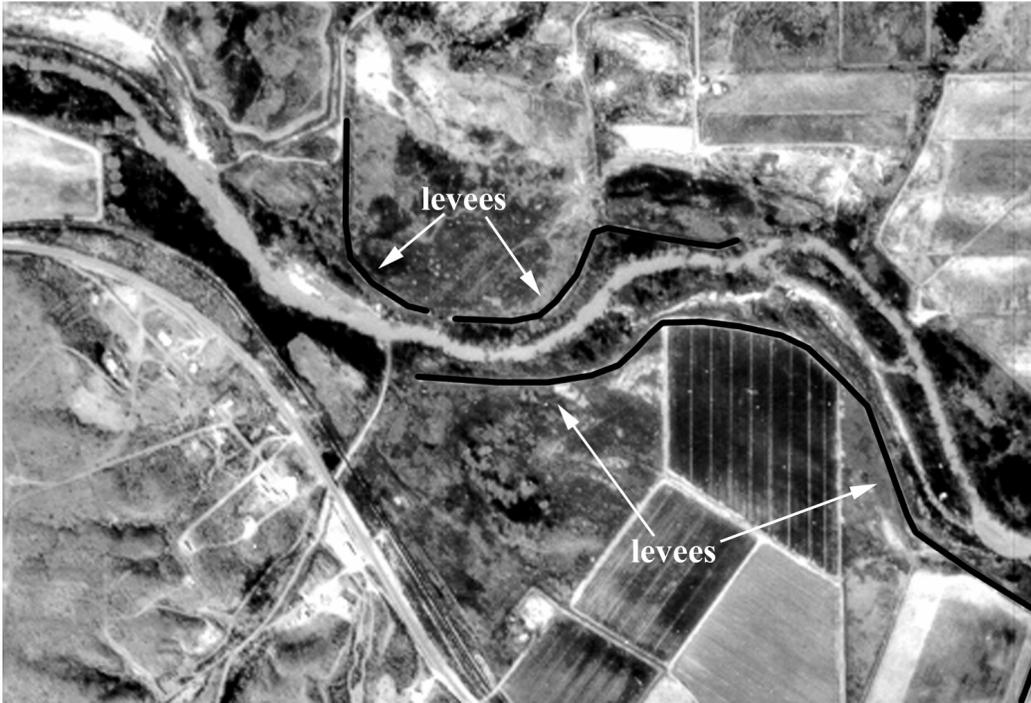
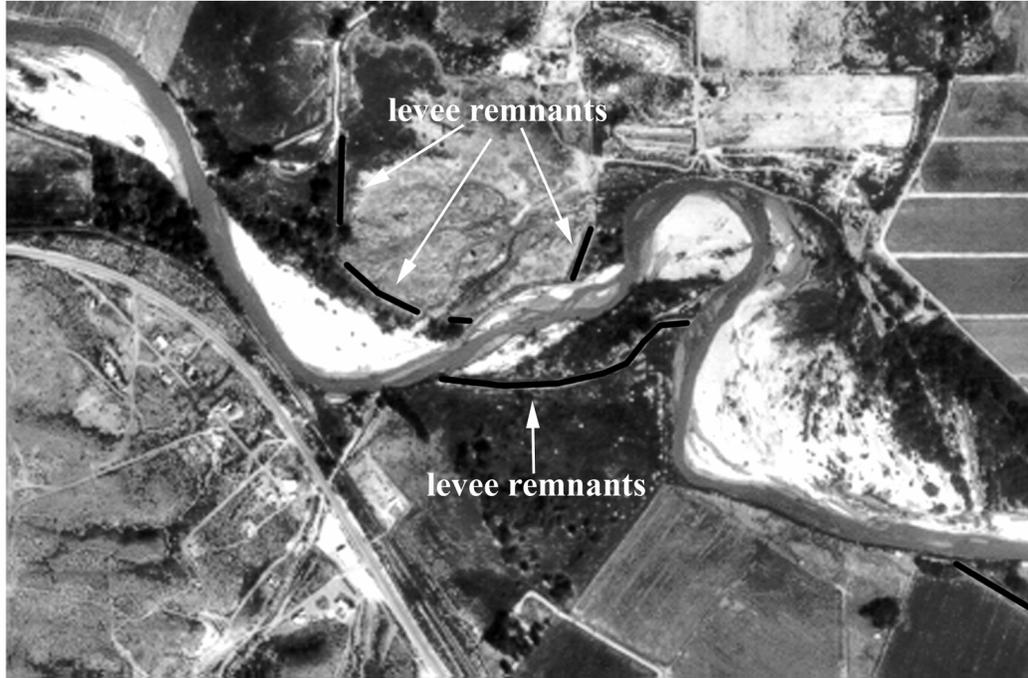
*Figure 5 (cont.) (c) Additional levees constructed by 1981 on the right and left banks imposed further restrictions on the channel and by (d) 1992, some of these levees had been eroded and not replaced. The majority of the erosion probably occurred during the 1984 flood. Flow is from right to left.*

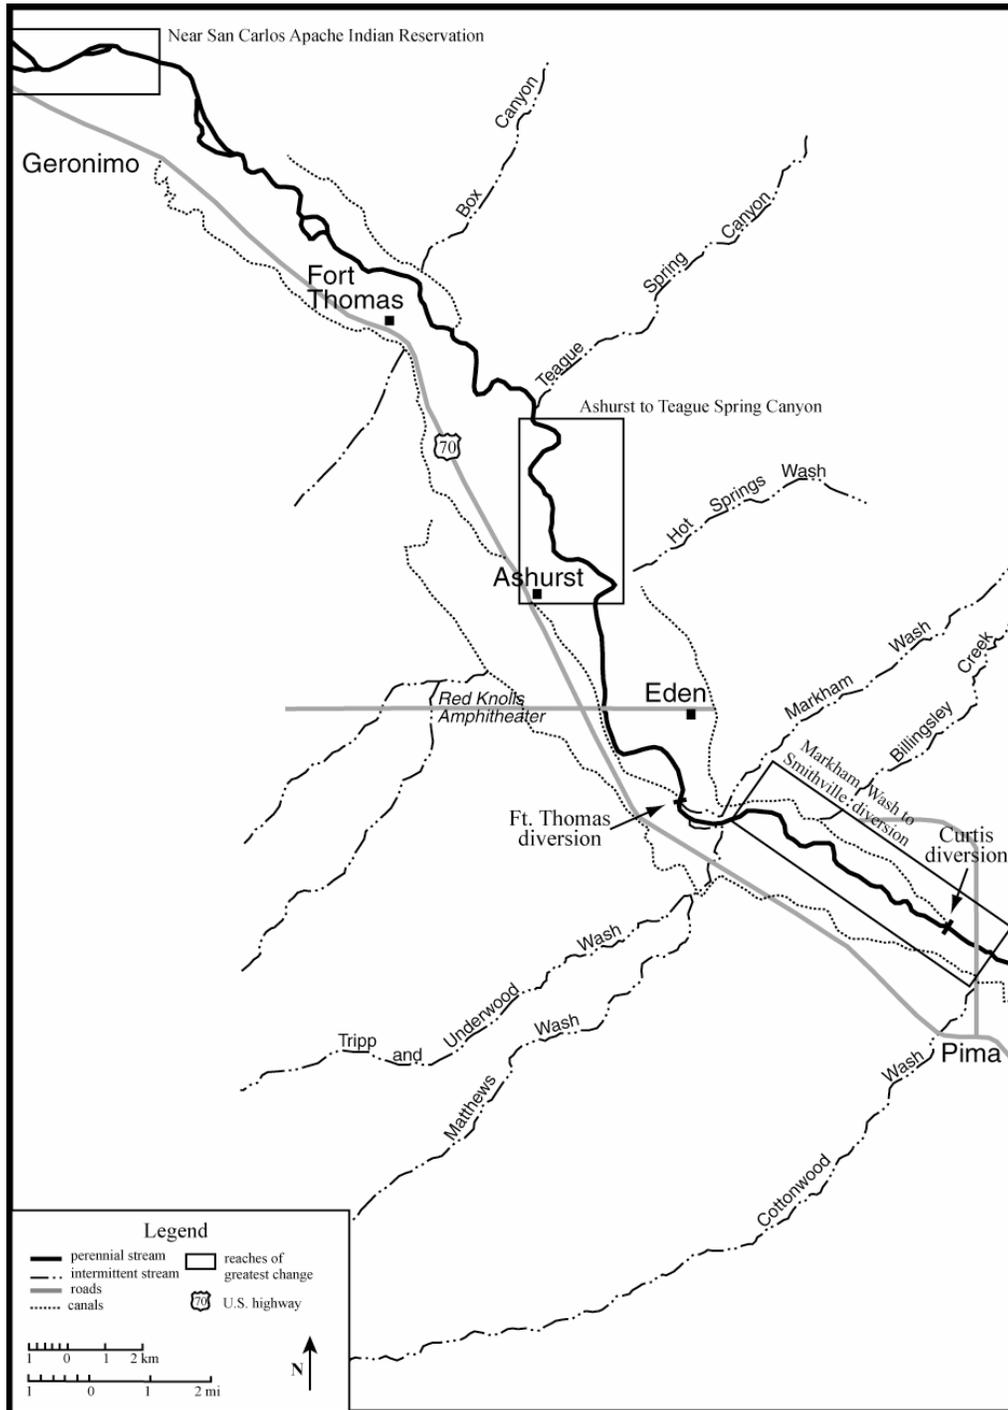
Figure 6. Location figure showing reaches of high variability, including the reach near the San Carlos Reservation.

The overall channel pattern in this reach over the period of study is similar; however, channel narrowing and widening appears to be related to levees in the study reach (Figure 6 and Figure 7). The 1935 channel was the widest channel recorded in the period of measurement. By 1953, the channel has narrowed by approximately 25%. By 1997, the channel pattern had changed dramatically to a more sinuous channel with nearly 90-degree bends from bank to bank. This pattern is associated with erosion into right and left bank levees and channel modification.

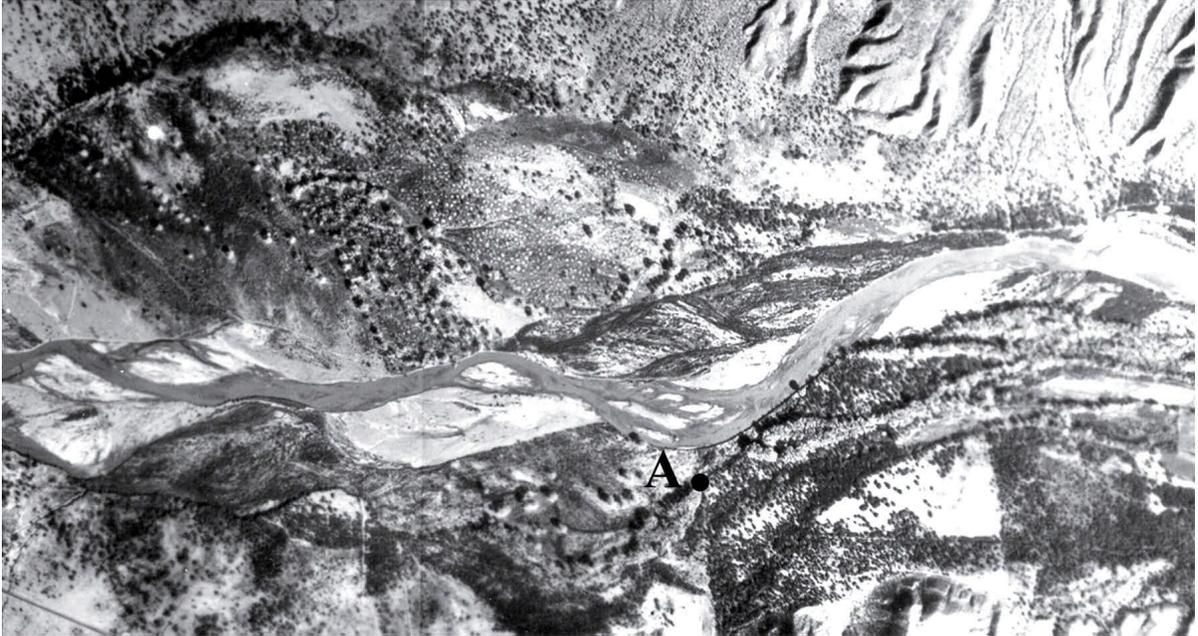
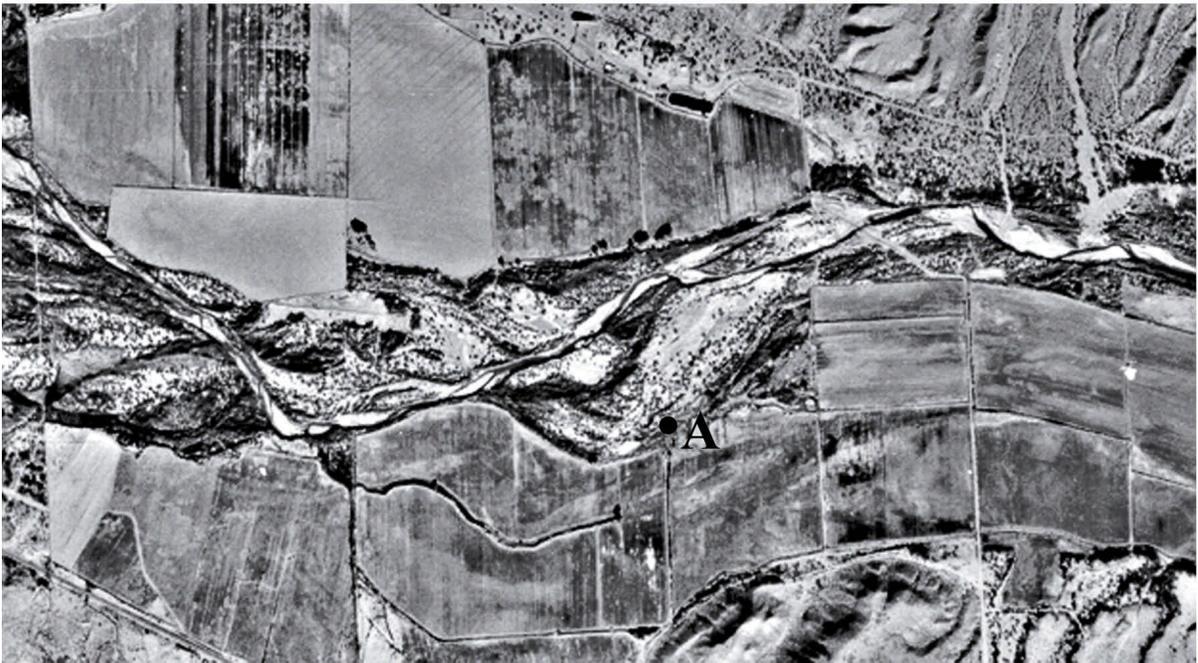
*Figure 7. Case Study 1: Near San Carlos Reservation. From (a) 1935 to (b) 1953, channel width had decreased significantly in the study reach. See point A for reference. Flow is right to left.*

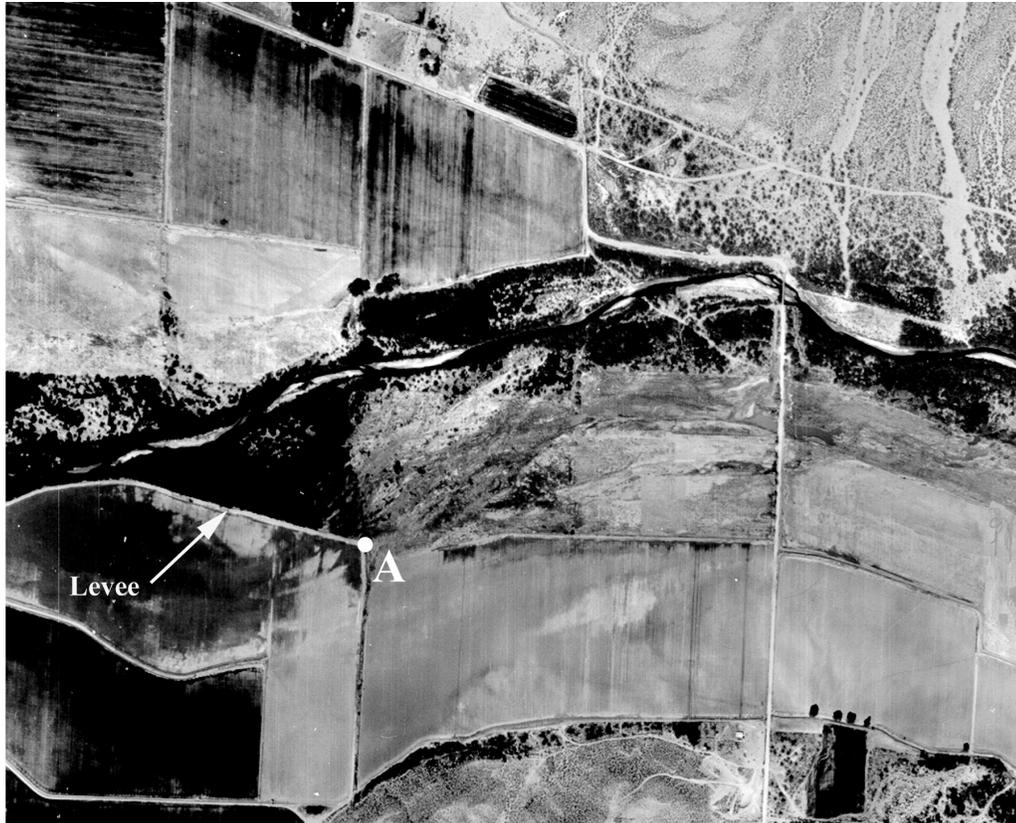
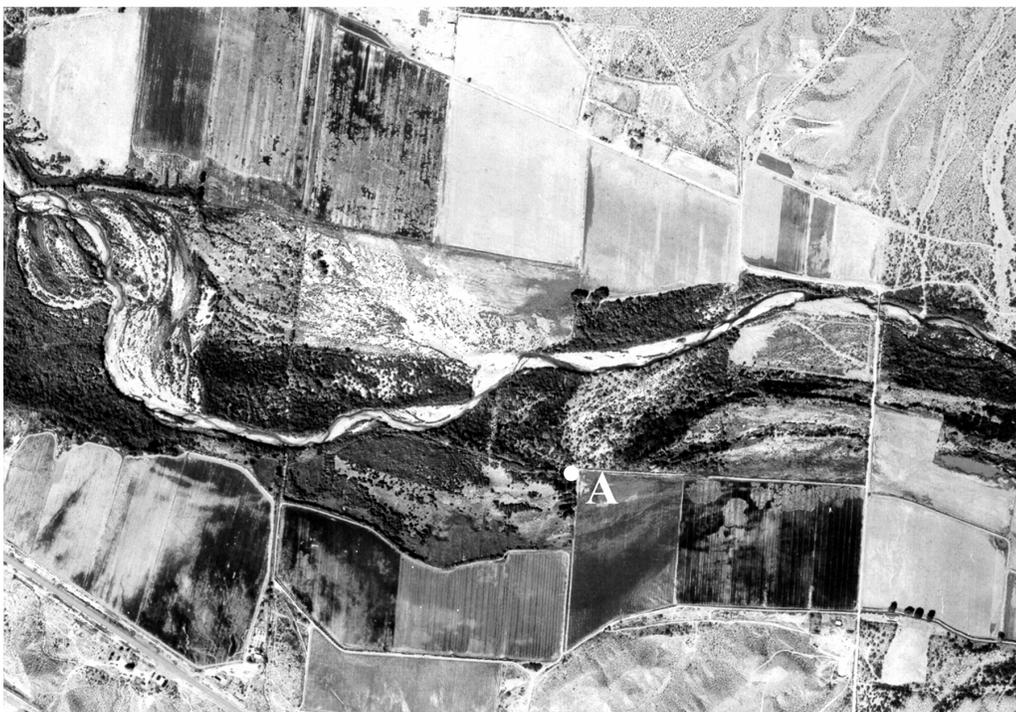
Figure 7 (cont.) Levees built at A in (c) 1967 further restrict the channel; by (d) 1978, these levees have disappeared.

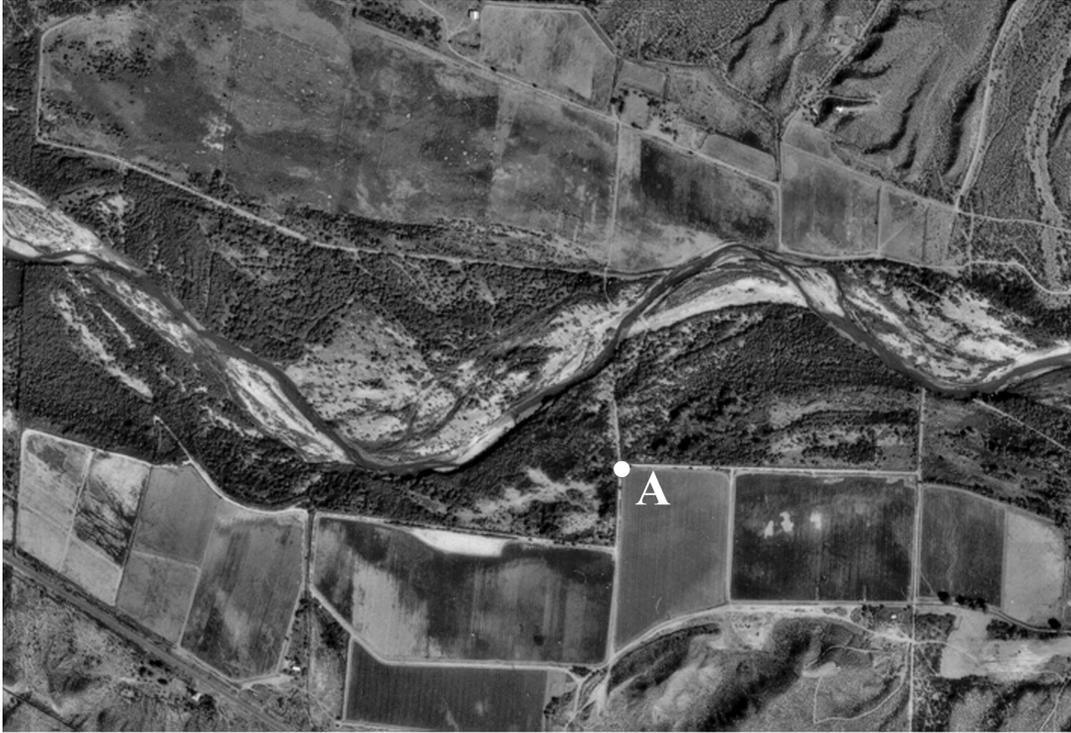
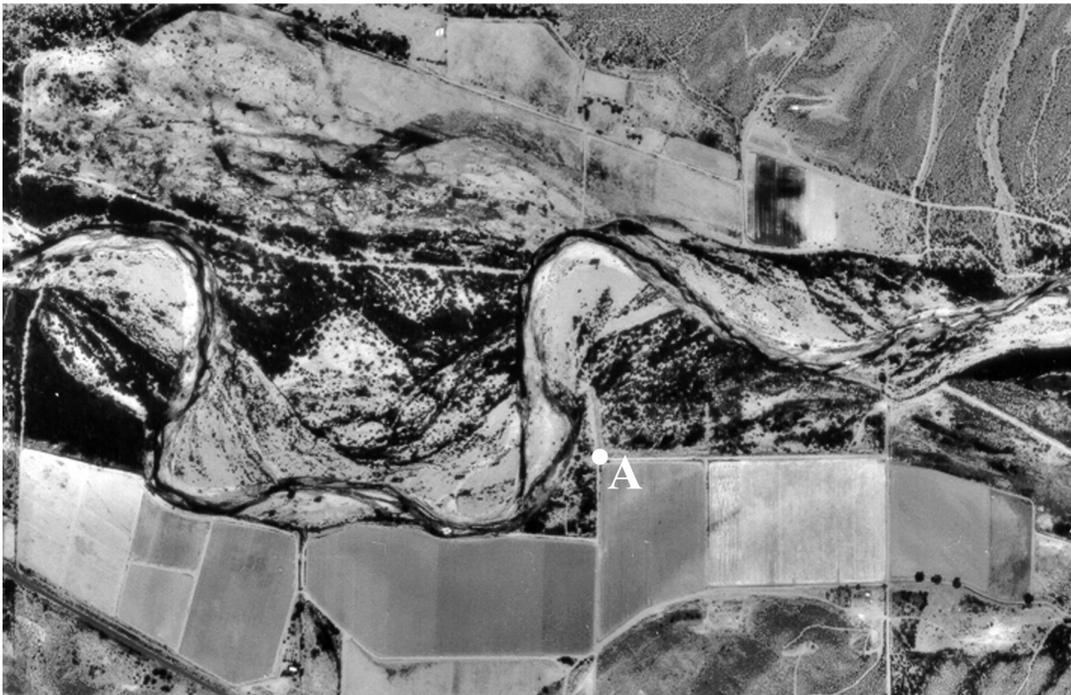
*Figure 7. (cont.) By (e) 1992, the Gila River channel had reoccupied the left bank channel downstream of point A. By (f) 1997, the channel pattern had changed dramatically to a more sinuous channel with nearly 90-degree bends from bank to bank. This pattern is associated with erosion into right and left bank levees and channel modification. Flow is from right to left.*

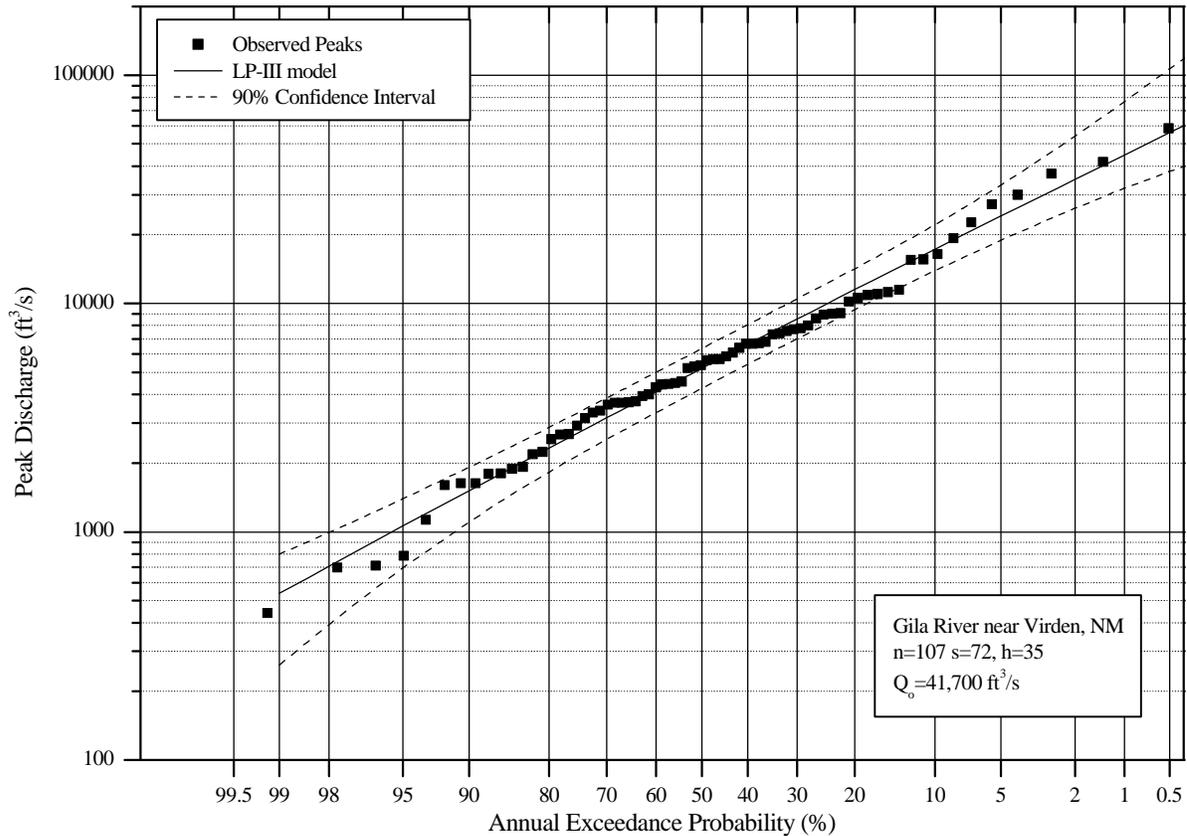
Figure 13. Annual peak discharge frequency curve for the Gila River near Virden, NM.

Because the records at all five sites are relatively long, the distributions are fairly well behaved over the magnitudes of interest. There is higher variability for the larger (50- and 100-year) return periods. For fluvial geomorphic analyses, the 2-year and 10-year flood estimates are well-defined at all five sites. The 2-year flood ranges from 5,210 to 9,650 ft<sup>3</sup>/s at the five locations. There is a noticeable decrease in flood frequency estimates between the head of Safford Valley and Calva for more frequent floods. The 100-year flood estimates increase from upstream to downstream locations, and ranged from 44,800 to 175,000 ft<sup>3</sup>/s.

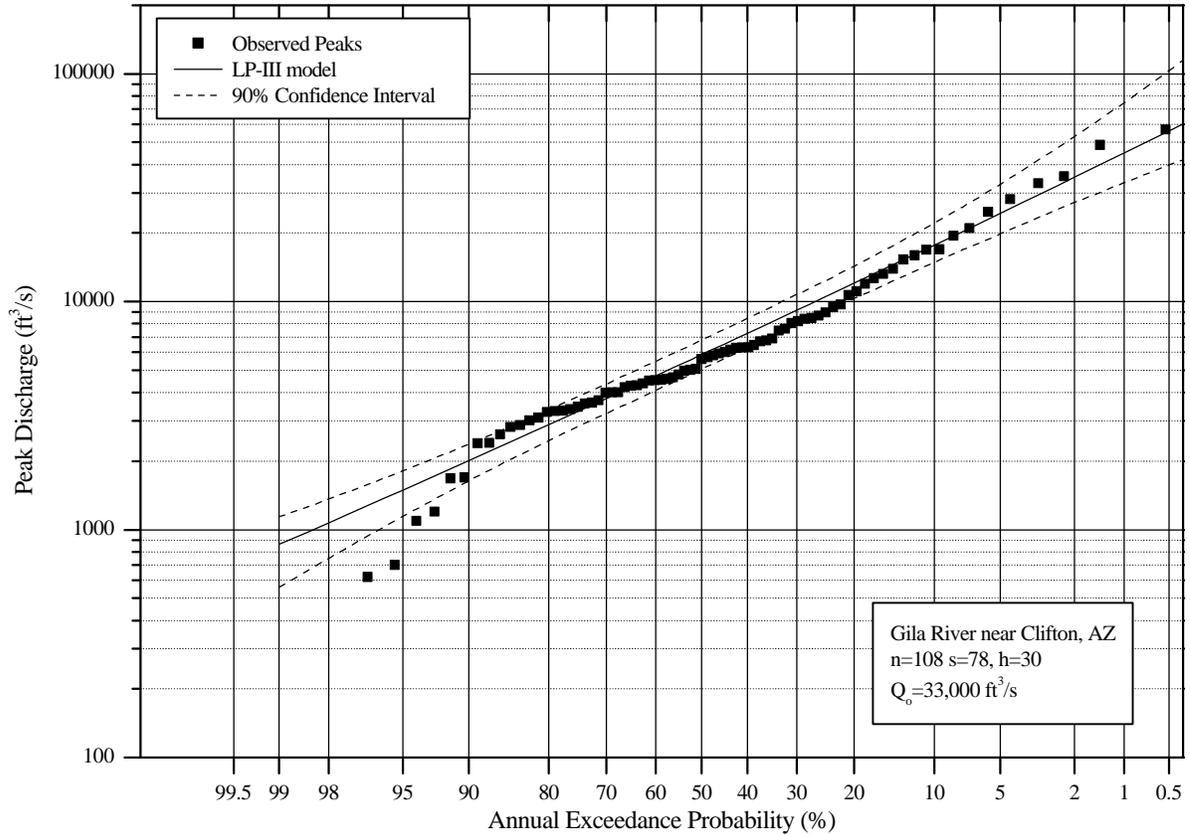
Figure 14. Annual peak discharge frequency curve for the Gila River near Clifton, AZ.

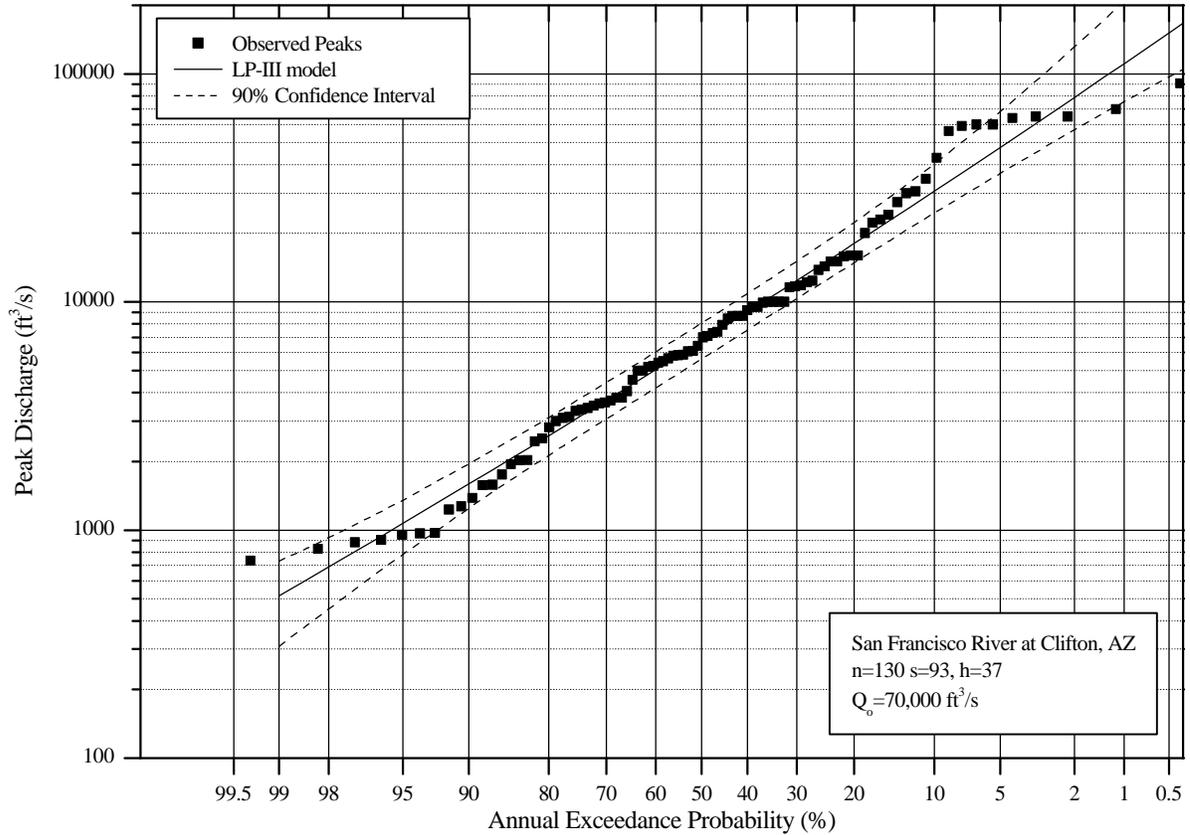
Figure 15. Annual peak discharge frequency curve for the San Francisco River at Clifton, AZ.

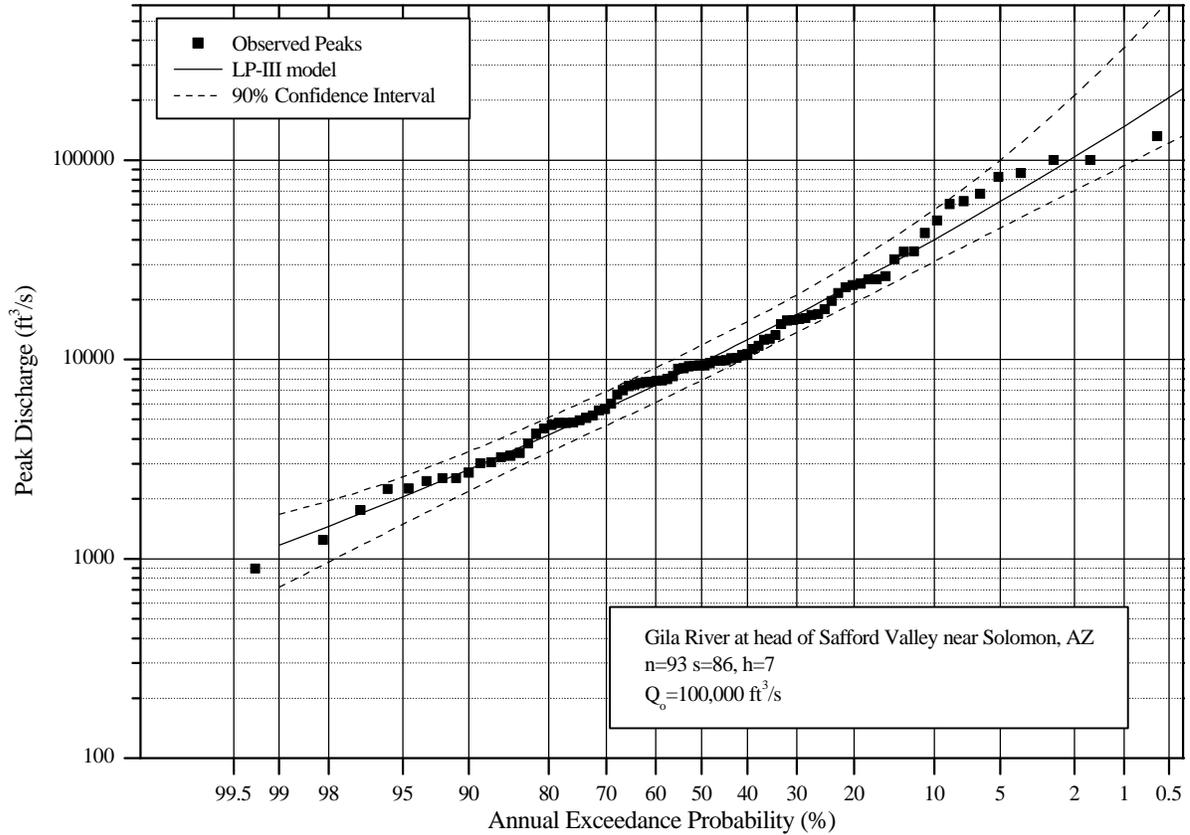
Figure 16. Annual peak discharge frequency curve for the Gila River at head of Safford Valley near Solomon, AZ.

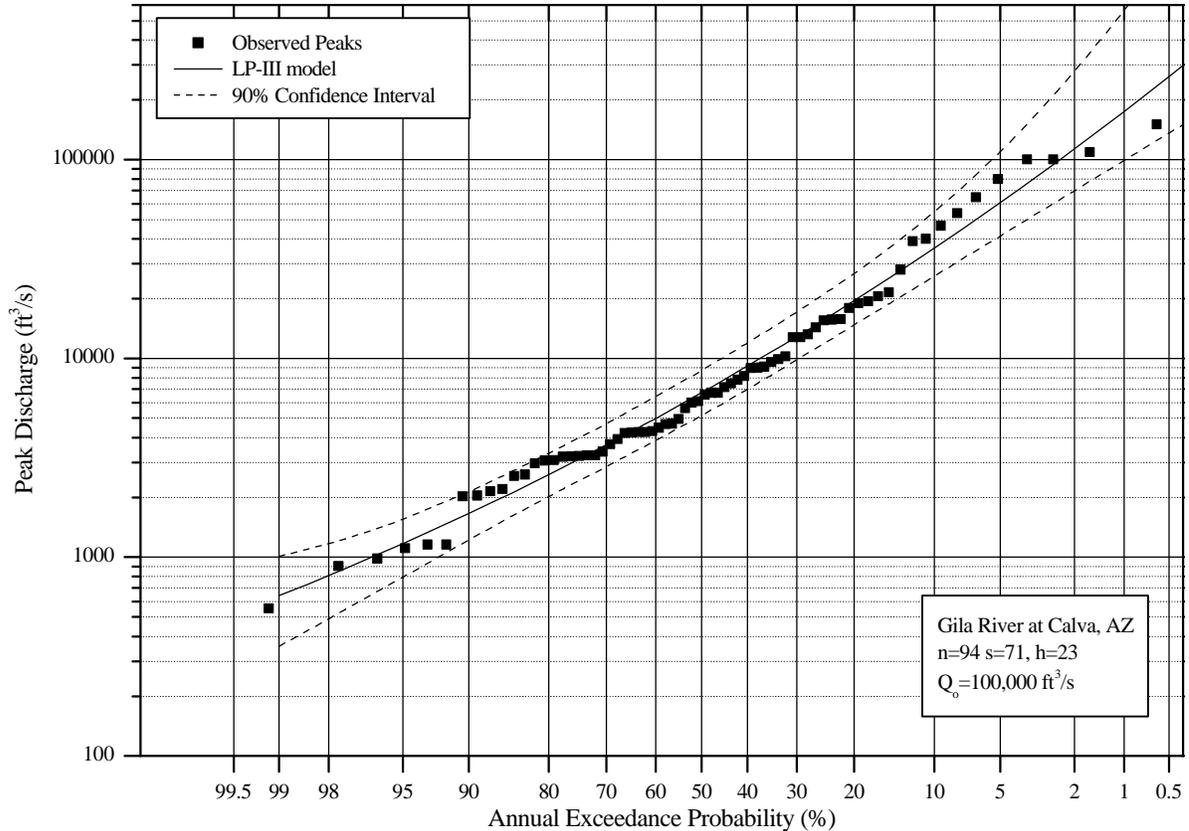
Figure 17. Annual peak discharge frequency curve for the Gila River at Calva, AZ.

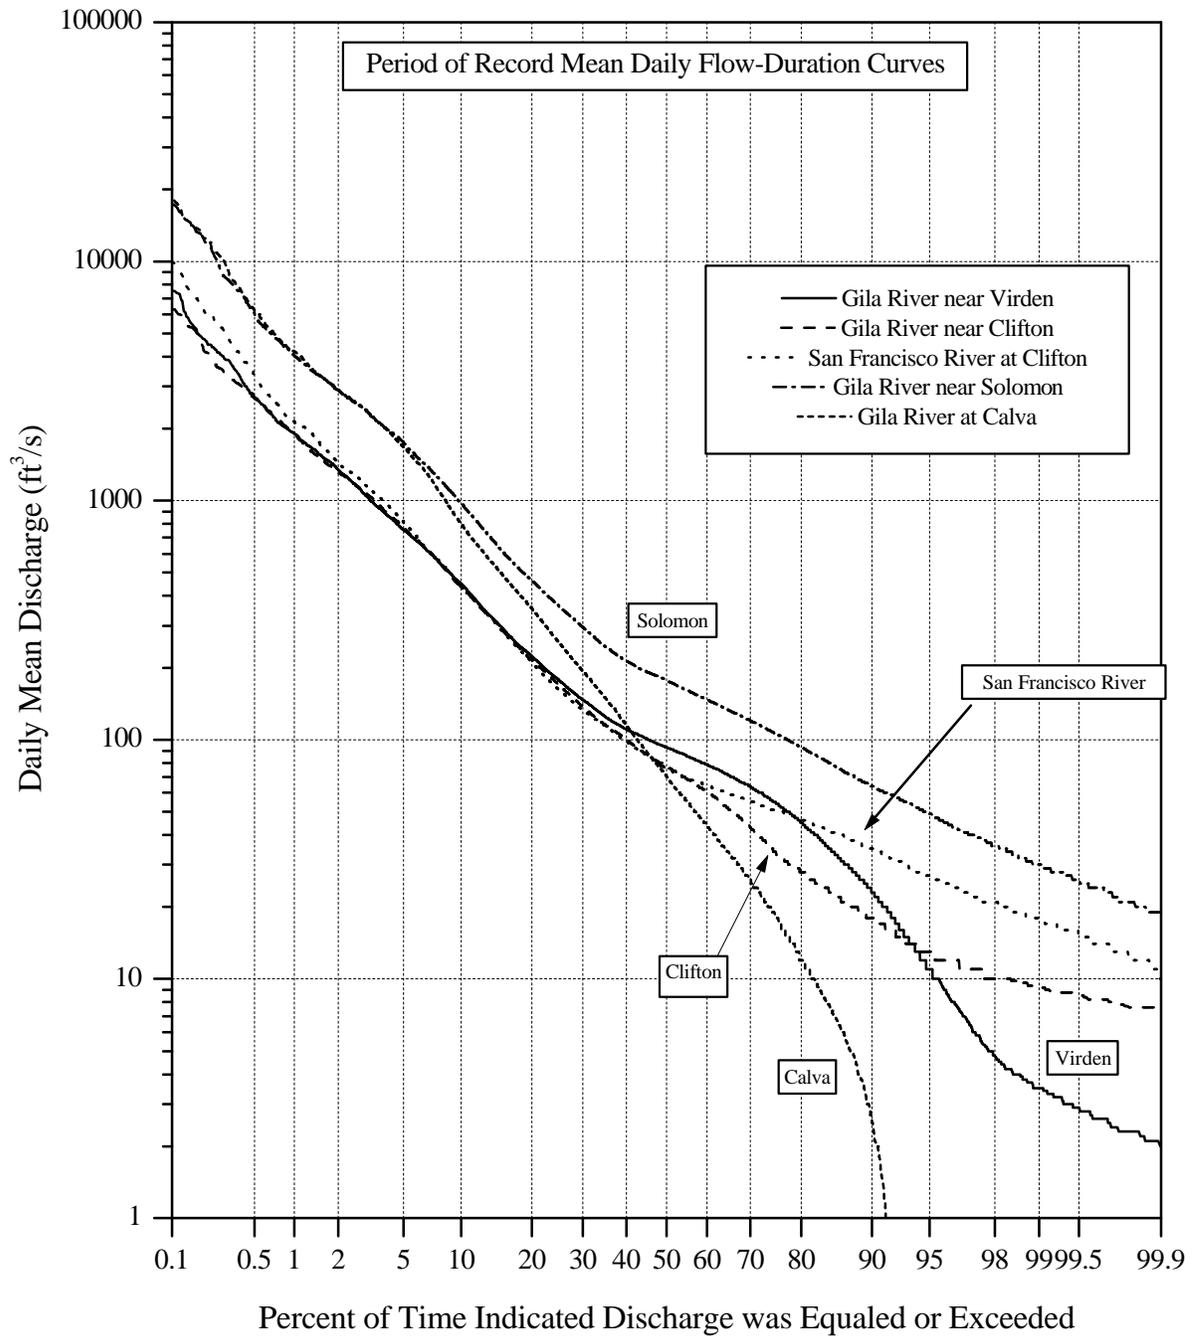
Figure 18. Period of record mean daily flow duration curves for five stations in the Upper Gila River basin.

Two sets of flow-duration curves were made: a period-of-record annual FDC, and seasonal FDCs for winter (November-April) and summer (July-October) flows at each site. The period-of-record annual FDC (Figure 18) shows that mean daily flows are less than about 10,000 ft<sup>3</sup>/s about 99.7 percent of the time, and less than 1,000 ft<sup>3</sup>/s 90 percent of the time for all sites. The median flows (50 percent) range from about 60 to 200 ft<sup>3</sup>/s for the water year. Because there are significant water diversions upstream of the Calva gage, mean daily flows are zero about 10 percent of the time (Figure 18, Table 10). Mean daily flows for the November-April winter season are nearly always greater than the summer season (Figure 19 and Figure 20). In some cases, the winter FDCs are higher than the annual FDCs for approximately 0.5 percent of time. Specific FDC percentiles of daily mean discharge for the period of record are summarized for each site in Table 10.
