# UPPER GILA RIVER FLUVIAL GEOMORPHOLOGY STUDY

STREAM CORRIDOR ASSESSMENT  
ARIZONA

US Department of the Interior  
Bureau of Reclamation

MARCH 5, 2004

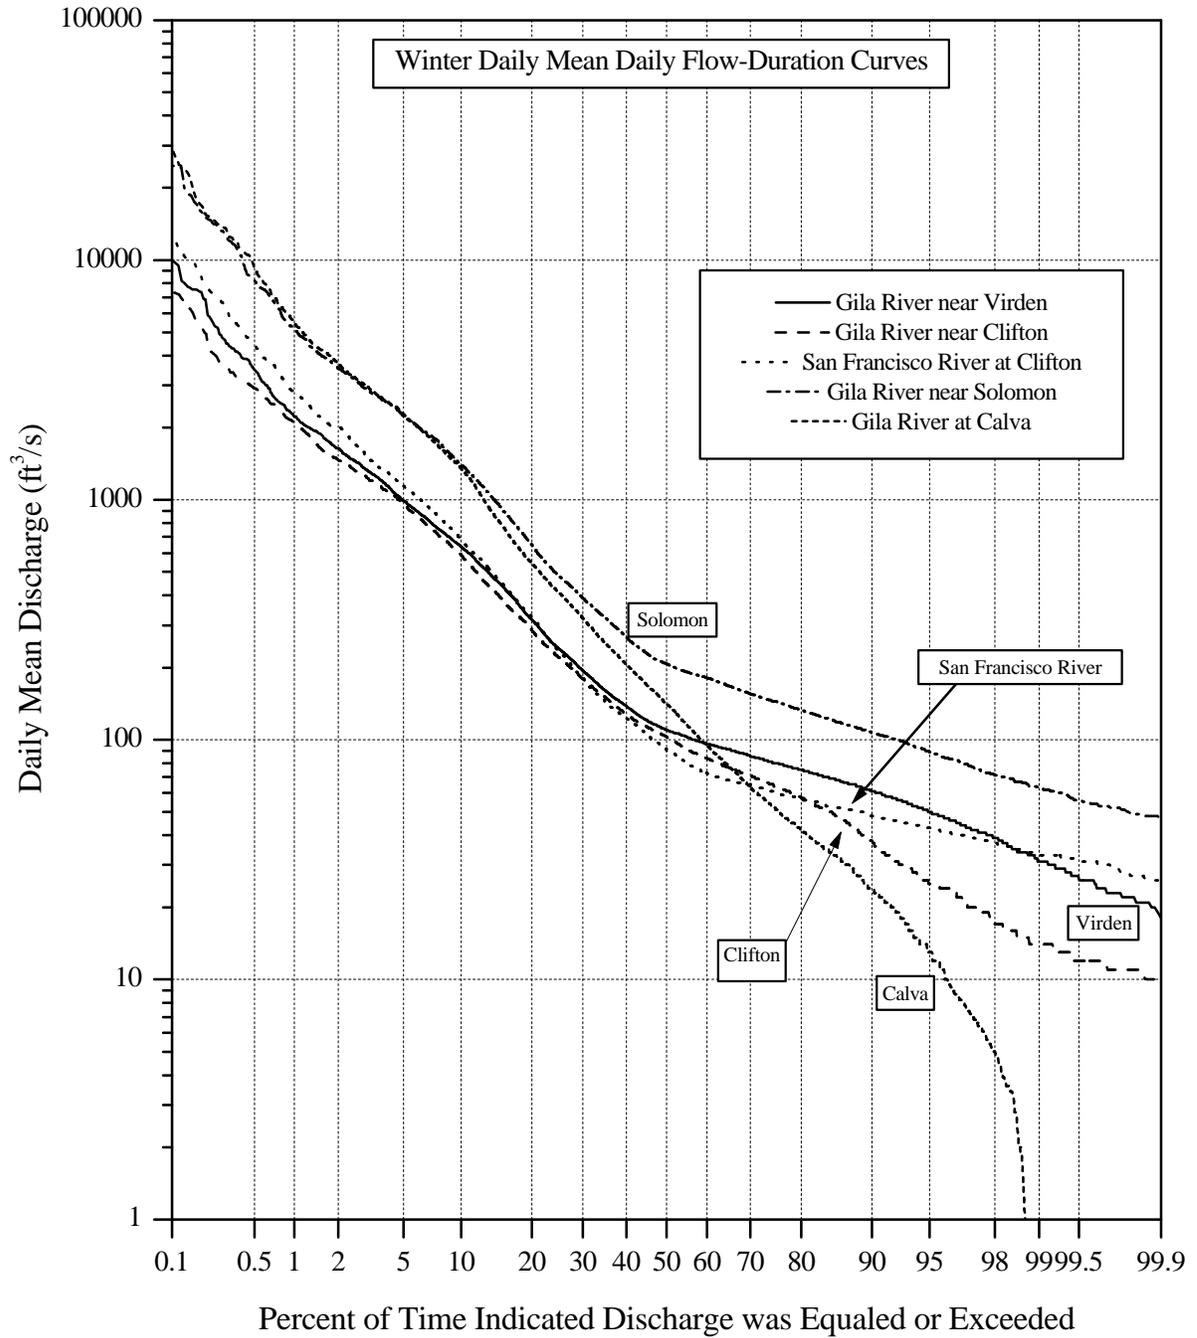
Figure 19. Winter season mean daily flow duration curves for five stations in the Upper Gila River basin.

Two sets of flow-duration curves were made: a period-of-record annual FDC, and seasonal FDCs for winter (November-April) and summer (July-October) flows at each site. The period-of-record annual FDC (Figure 18) shows that mean daily flows are less than about 10,000 ft<sup>3</sup>/s about 99.7 percent of the time, and less than 1,000 ft<sup>3</sup>/s 90 percent of the time for all sites. The median flows (50 percent) range from about 60 to 200 ft<sup>3</sup>/s for the water year. Because there are significant water diversions upstream of the Calva gage, mean daily flows are zero about 10 percent of the time (Figure 18, Table 10). Mean daily flows for the November-April winter season are nearly always greater than the summer season (Figure 19 and Figure 20). In some cases, the winter FDCs are higher than the annual FDCs for approximately 0.5 percent of time. Specific FDC percentiles of daily mean discharge for the period of record are summarized for each site in Table 10.

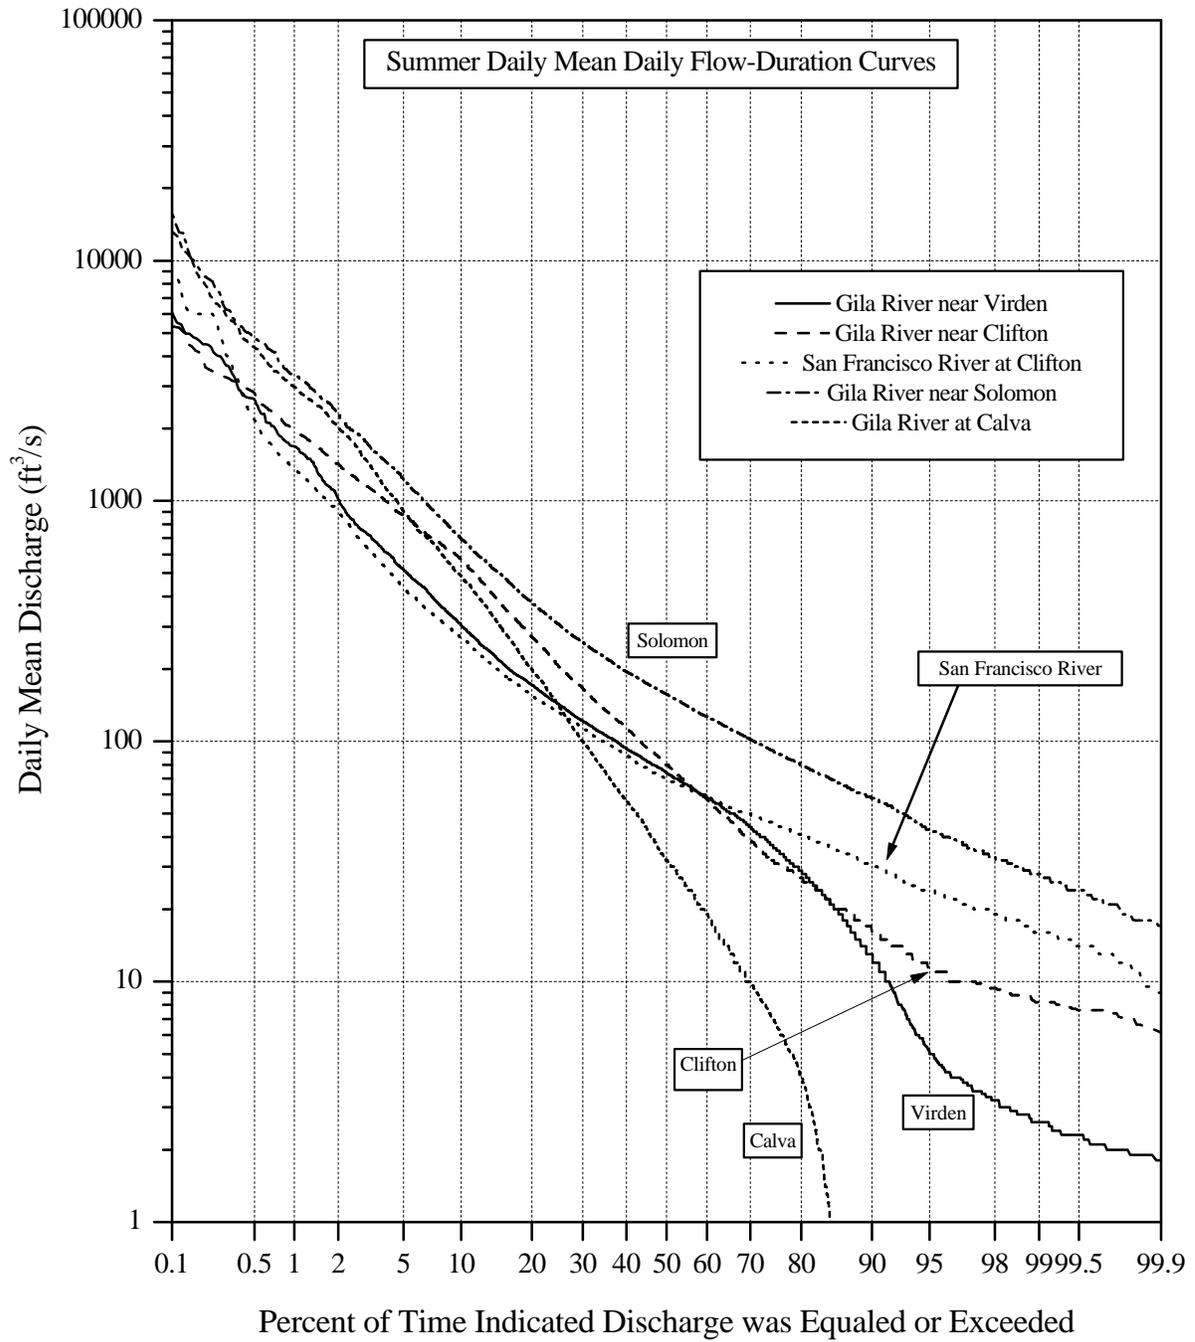
Figure 20. Summer season mean daily flow duration curves for five stations in the Upper Gila River basin.

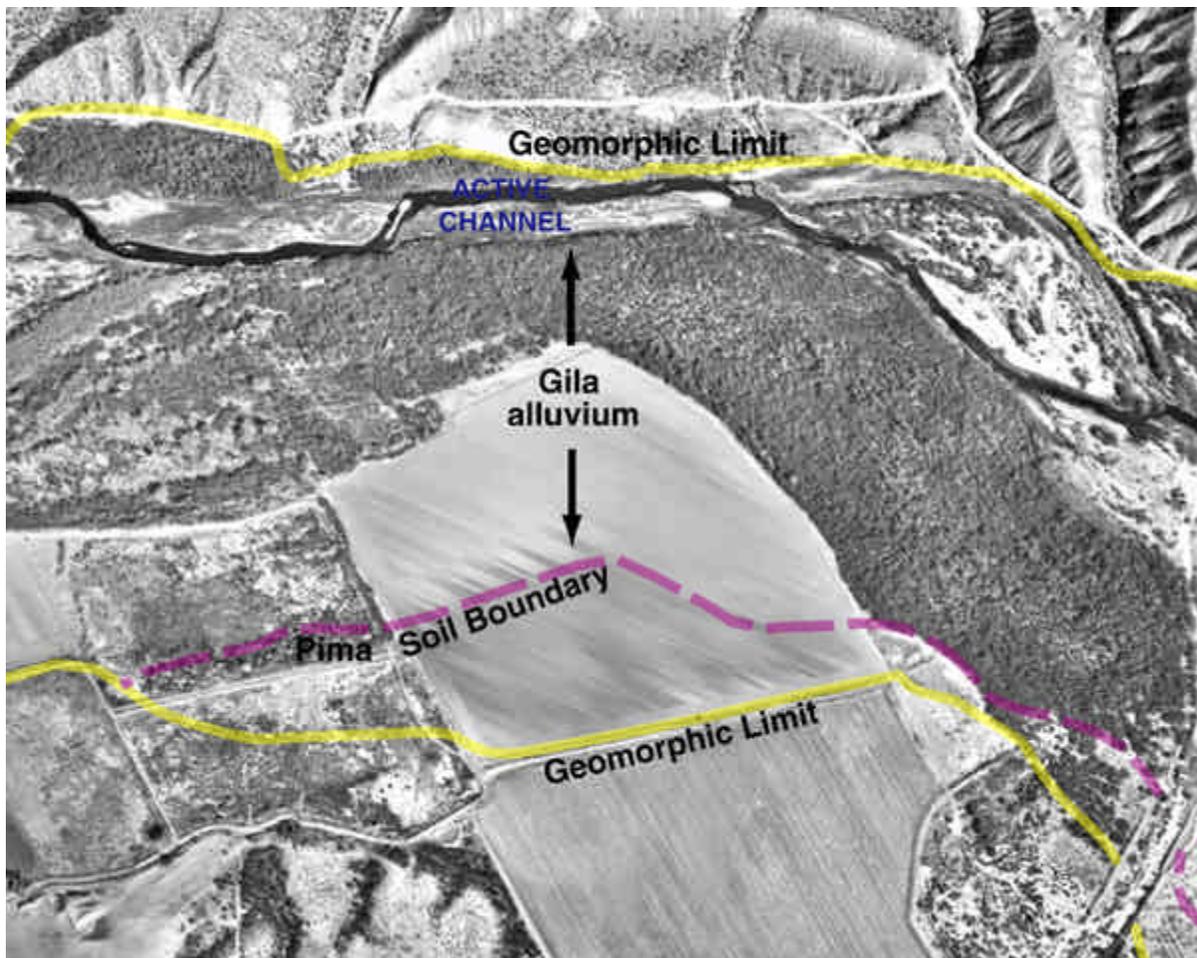
Figure 21. Sample map showing extent of the Gila alluvium and depiction of the Pima Soil and Geomorphic Limit.

The Gila alluvium is most commonly adjacent to the active channel and is part of the channel migration zone of the past several hundred years. The Gila alluvium is composed of weakly developed soils with a C-horizon commonly at the surface. Buried soils exist in many cases; some of these soils appear to be truncated with no A-horizon, while others consist of an A and C-horizon with no B-horizon development. The texture of the Gila alluvium is typically either a silt loam or sandy loam. The soils generally are formed on point bars, or on floodplain nearest to the river. The Gila Soil Series as described in Poulson and Stromberg (1950) is a clay loam and fine sandy loam formed on level to 2% slopes and is generally adjacent to the low flow channel and subject to frequent overflow. The surface is frequently channelized, or channelized scars are readily apparent on the surface. Radiocarbon dates obtained from charcoal samples range in age from 0 to 500 years old.

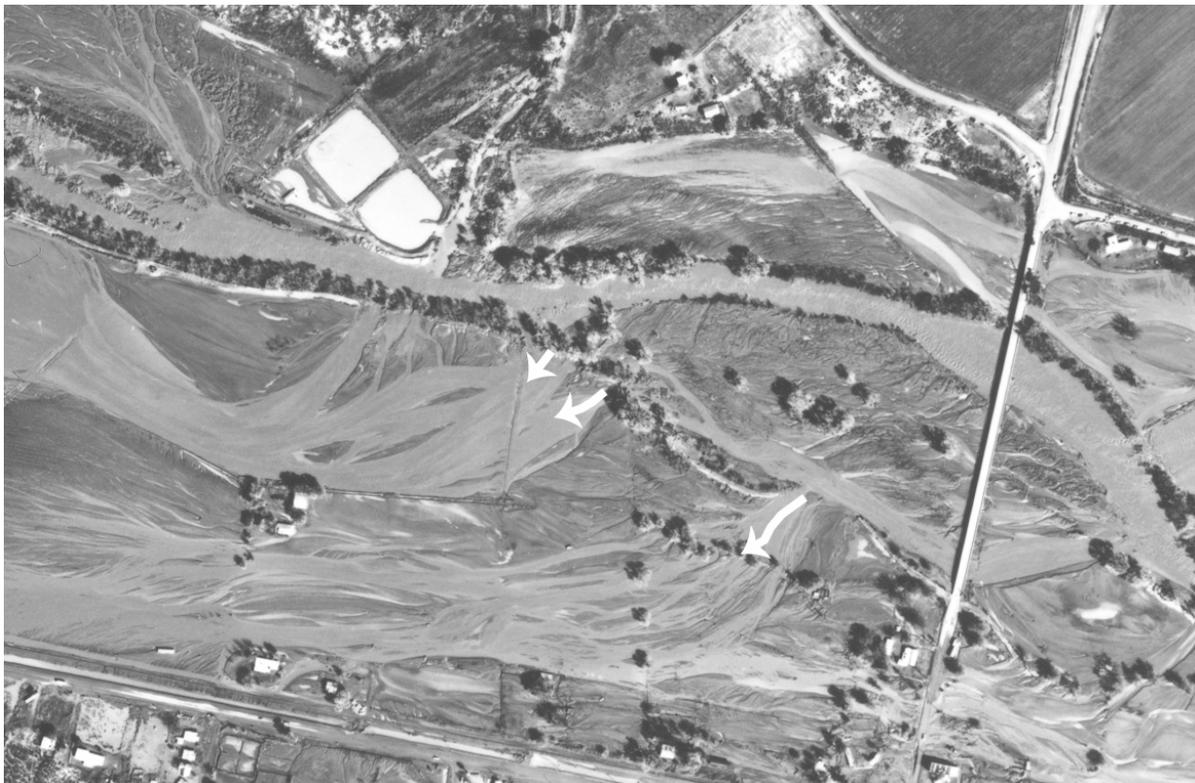
*Figure 22. Surface morphology following the flood of December, 1978 at Duncan Bridge. White arrows show levee breaches, inundating Gila and Pima alluvium on the left bank downstream of Duncan Bridge. Photography dated Dec. 21, 1978. Flow is right to left.*

downstream of Duncan Bridge and substantial sedimentation over the Pima Soil (Figure 22). The Geomorphic Limit of Flood Evidence is against bedrock and piedmont alluvium in some places, while in other areas the alluvium appears to be related to the Gila River. Soils found in these banks have been developing for at least 1,000 years. In comparing Safford Valley and Duncan Valley, the Geomorphic Limit is much closer to the active channel in Duncan Valley when compared to the Geomorphic Limit in Safford Valley. This seems logical since the size of the river is much smaller in Duncan Valley, whereas the San Francisco River greatly increases the size of peak discharges and therefore the width of the Gila River flood channel in Safford Valley. The Pima Soil is only preserved in wider reaches of Duncan Valley, where the flood channel does not frequently re-occupy the entire area within the Geomorphic Limit. In Safford Valley, the Pima Soil is more prevalent, paralleling the Gila River for the majority of its length in the study reach.

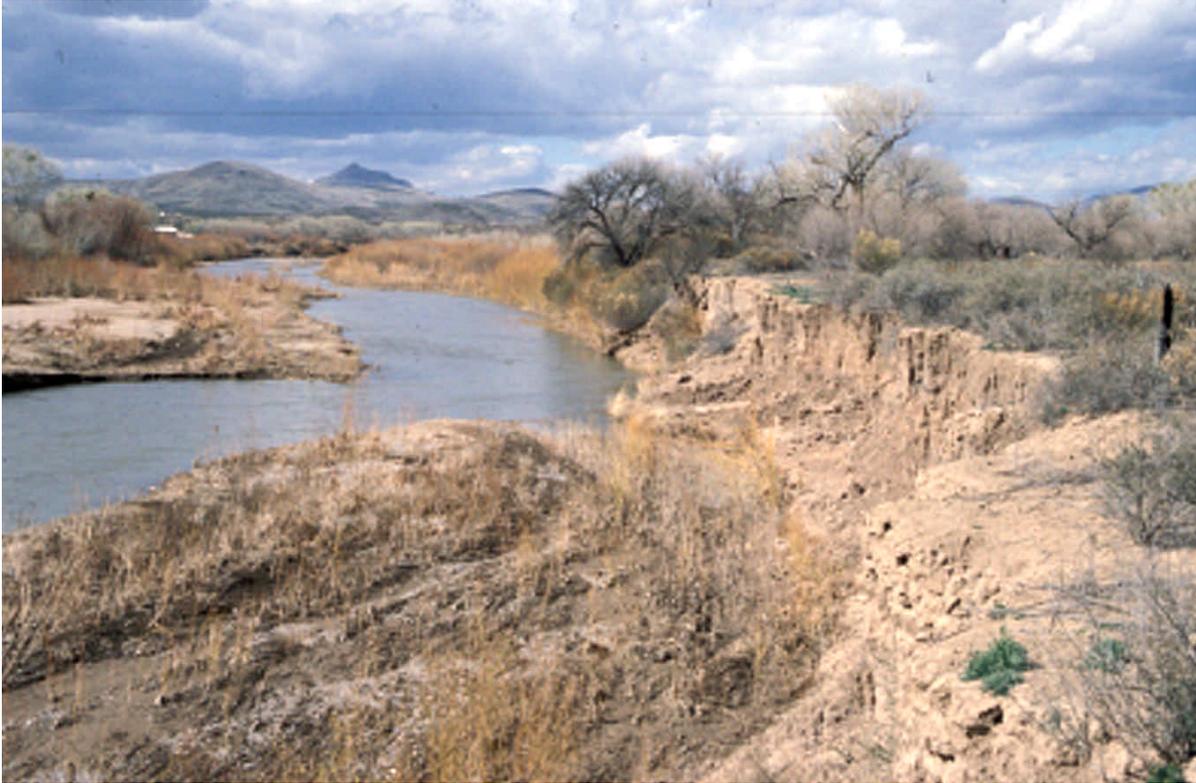
*Figure 23. View looking downstream at 3 m (9.8 ft) bank of alluvium associated with geomorphic limit of the Gila River.*

The geomorphic map shows that majority of eroding banks are part of the Gila alluvium, or alluvium that is considered to be part of the historical channel migration zone. This lateral migration is typical for the Gila River as it shifts its channel in response to peak flows and sediment flux. The Gila River is currently eroding banks composed of Pima alluvium, which is hundreds of years old, in fewer locations than the Gila alluvium. Alluvium that is mapped as part of the Geomorphic Limit is currently being eroded in a few locations, the majority of which are in Duncan Valley (Figure 23). This alluvium is estimated to be at least 1,000 years old. This information confirms that as the age of the alluvium increases, the less likely it is to be currently eroding along the Gila River.

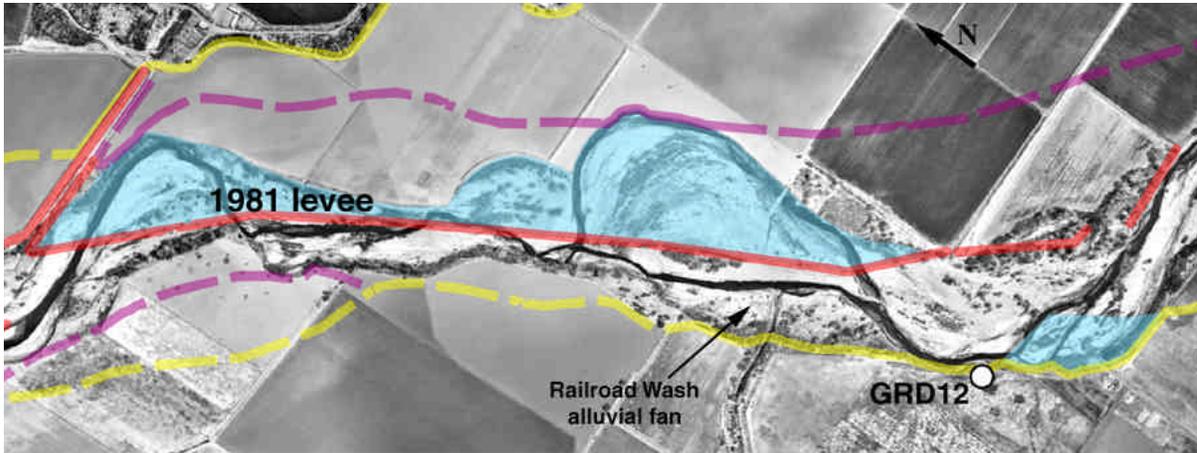
Figure 24. Geomorphic map of the Railroad Wash reach. Flow is from right to left.

the critical combination of the erosive nature of the 1993 flood and extensive levees enhanced the erosion of agricultural land (Figure 24). In the Whitefield Wash reach downstream of Duncan Bridge, the levees were breached, causing erosion of Pima alluvium behind the levees and propagation of erosion downstream into opposing stream banks. The exposed banks are mapped as part of the Geomorphic Limit (Figure 25). The Watson and Butler wash reach in Safford Valley shows a similar pattern, where a levee constructed upstream of Butler Wash following the 1978 flood is breached during subsequent floods. It is most probable that reentrant flow from behind the levee initiated the erosion of agricultural property on alternating banks and effectively increased channel sinuosity for approximately two miles downstream. The majority of this property is mapped as Gila alluvium, with the exception of land near the corner of Safford-Bryce road, which exposes the Pima soil (Figure 26).

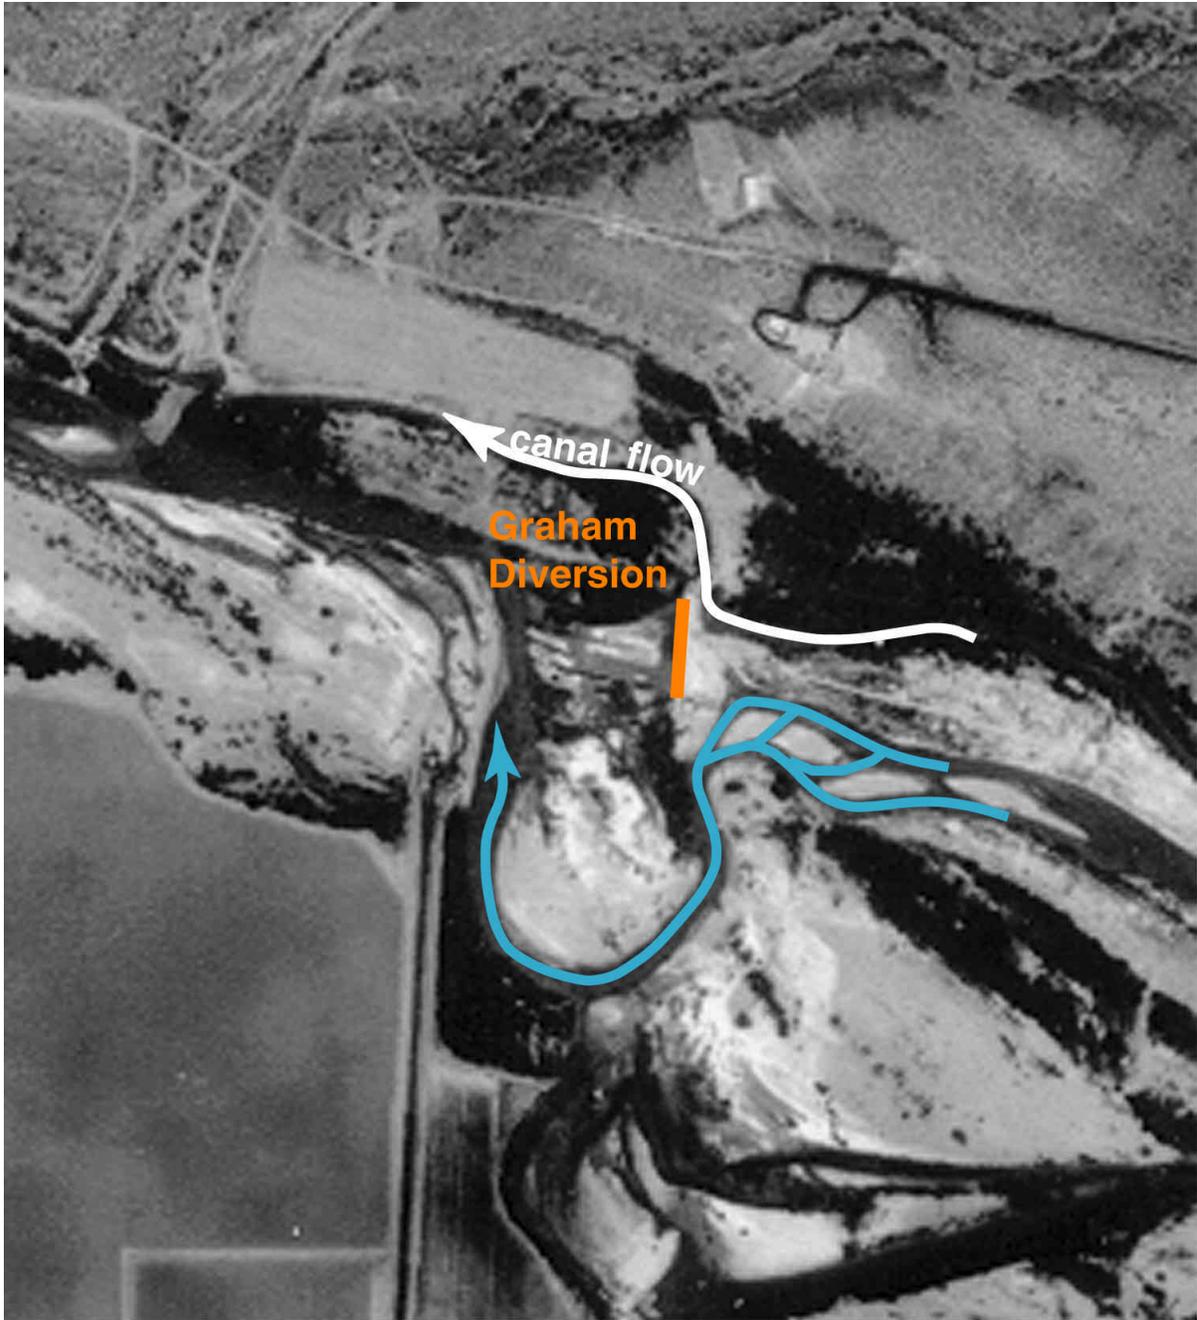
*Figure 27. Redirection of low flow around Graham diversion (blue flow lines), resulting in erosion of the left bank. Aerial photograph dated 1999.*

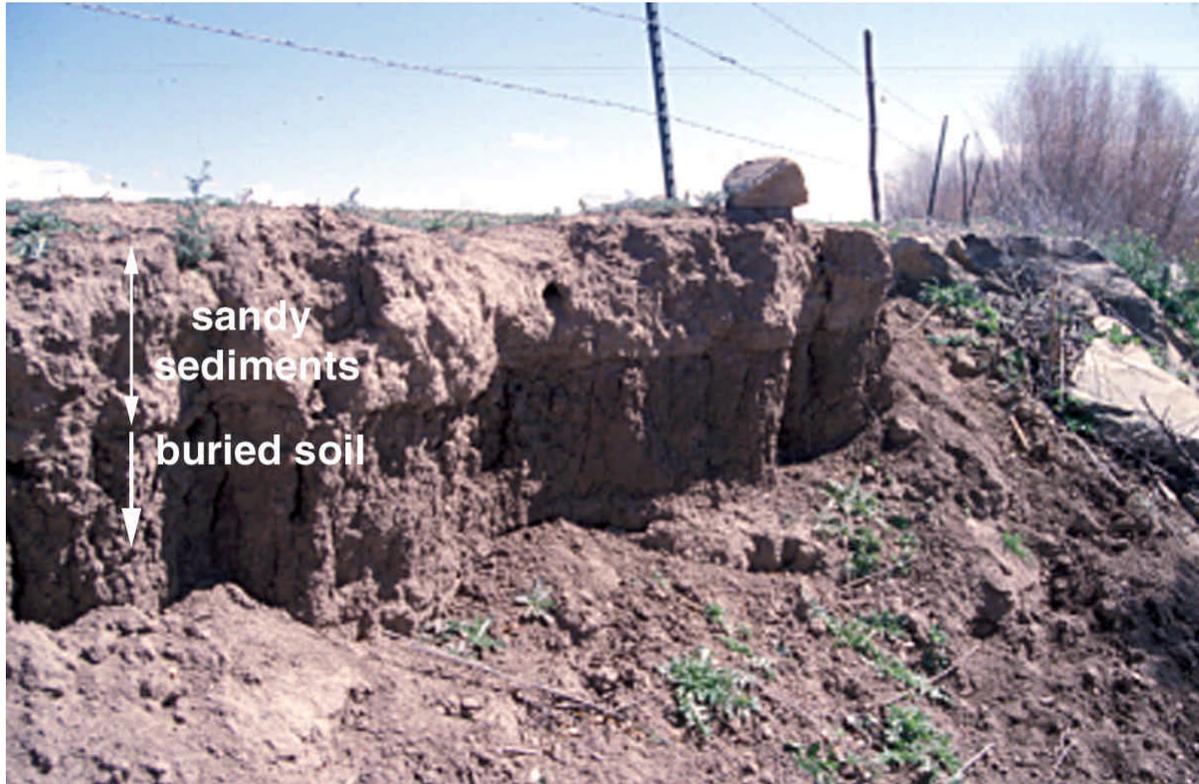
*Figure 29. Photograph of the right bank upstream of Duncan Bridge showing wedge of sediment. We submit that this sediment aggraded due to bridge and levee/embankment construction.*

In Duncan and Safford valleys, bridges act as constrictions along the Gila River. The most obvious effect from bridge construction along the Gila River is the reduction in sediment transport through the bridge opening and subsequent aggradation of the bed upstream. At Duncan Bridge this effect is apparent, evidenced by a wedge of sediment that is thickest near the bridge and thins with distance upstream (Figure 29). It is important to note, however, that levees and embankments constructed to focus flow under the Duncan bridge opening also may be partly responsible for the aggradation.

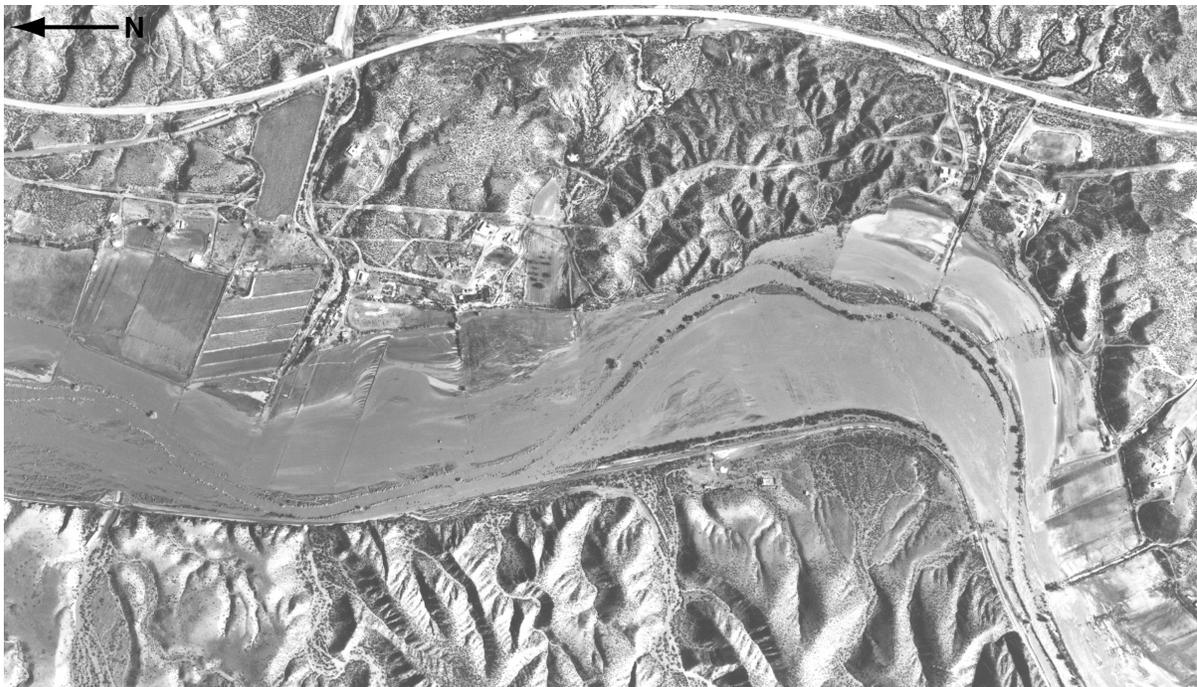
*Figure 30. Flood waters inundating young alluvium near Sheldon, AZ. Photography dated Dec. 21, 1978. Flow is from right to left.*

In Safford and Duncan valleys, the geomorphic record fails to show that major changes in the upper basin have propagated to the downstream valleys. Impacts on the Gila River from land use change in the form of deforestation through logging or agriculture would destabilize hill slopes and result in an increased sediment influx from the upper watershed. Stratigraphy in downstream reaches should show recent system-wide deposition of sediment on developing soils. Instead, observations suggest that the Gila River is not currently undergoing widespread aggradation in Safford and Duncan Valleys. This is based on the absence of young sediments overlying older soils associated with the Pima Soil Boundary and Geomorphic Limit. Multiple buried soils in units such as the Gila alluvium are part of natural floodplain formation, where the vertical accretion of sediment occurs as floods access their floodplains and deposit sediment. If substantial degradation had occurred, the river would not be able to access its floodplain. This is not the case in both areas where there is substantial modification and in areas where there are few human modifications to the river and its floodplain. For instance, in northern Duncan Valley, where there are few structures, thick young deposits of vertically accreted alluvium are present and are still inundated during large floods (Figure 30).

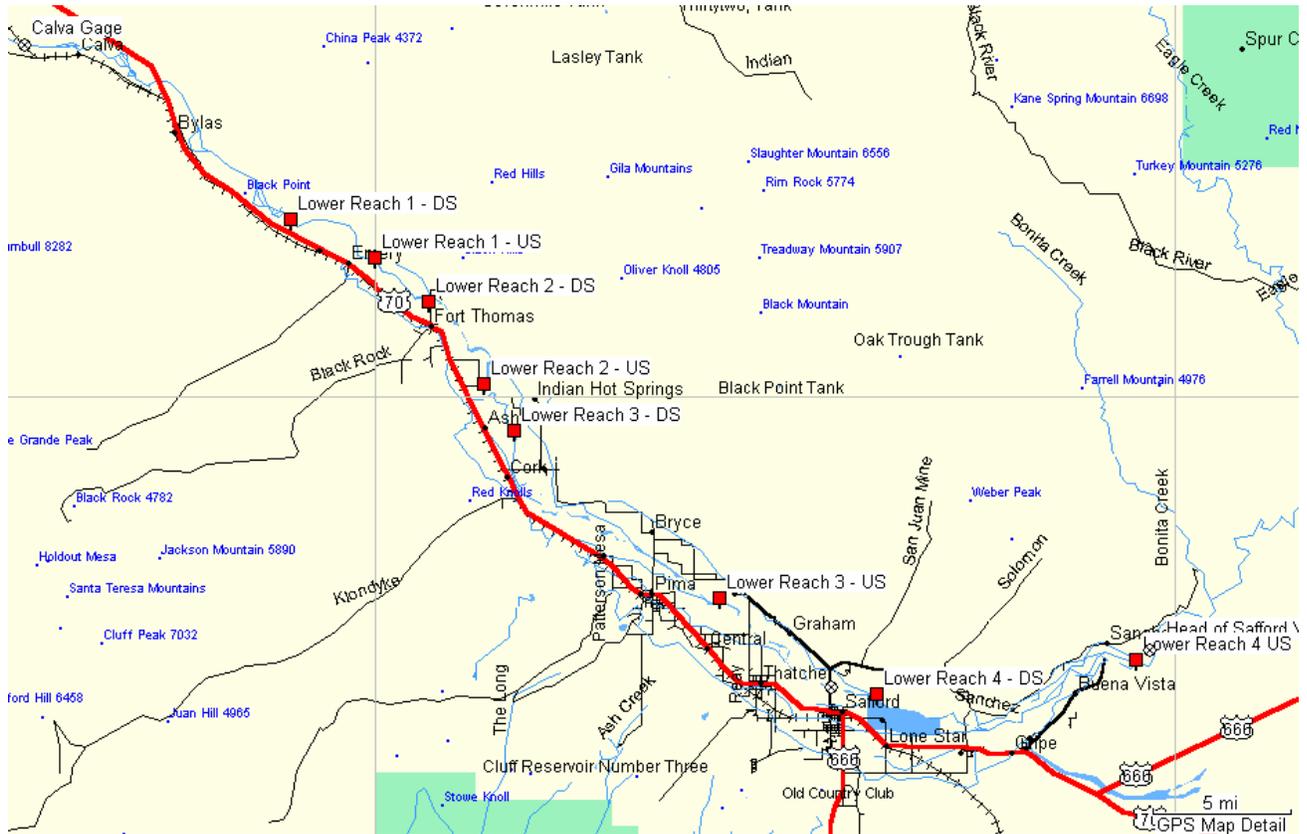
Figure 32. Lower Reaches 1 through 4, delineated by red squares. Note USGS gages at Calva and Head of Safford Valley.

Sub-reaches were selected based upon observed geomorphic changes in those areas, as well as differences in geology, indicated by the relative width of the geomorphic limit. The selections were subjective based upon the expertise of the study Principal Investigators.

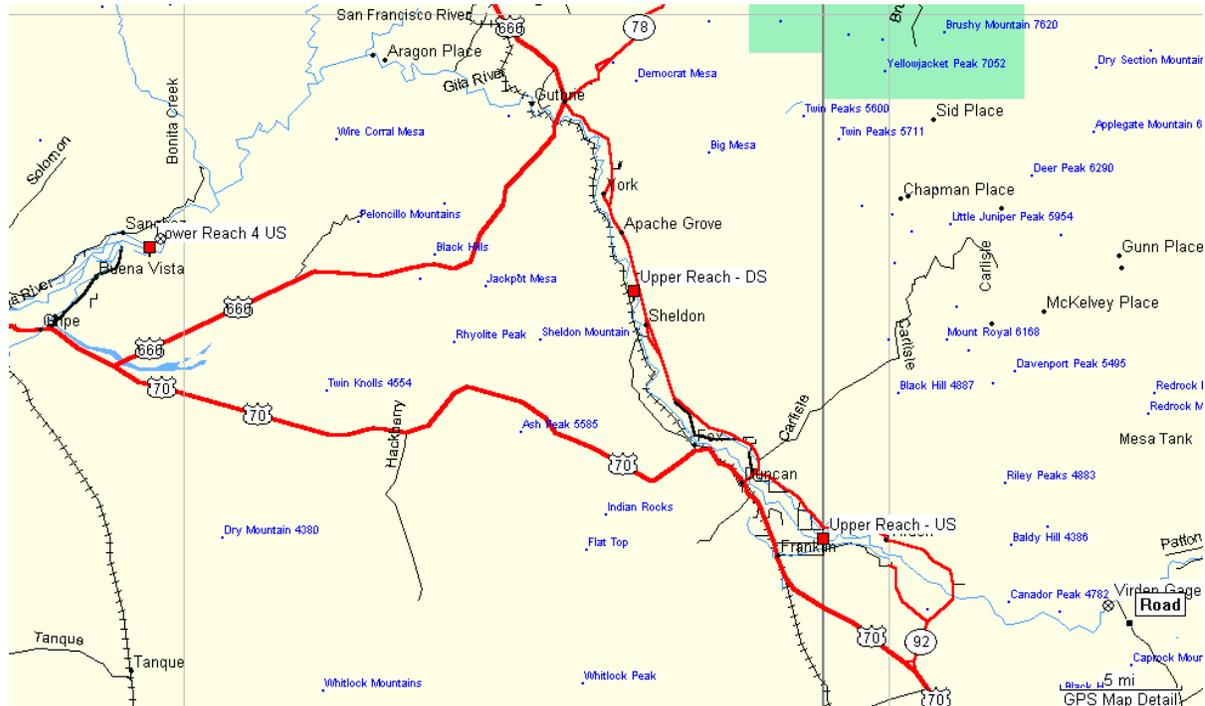
Figure 33. Upper Reach, delineated by red squares. Note USGS gage near Virden, New Mexico.

Figure 33 shows the upper reach, located in the York-Sheldon-Duncan-Virden valley. The downstream boundary of the Upper Reach is between Bitter Creek and Sanders wash, downstream of Sheldon. The Upper Reach continues upstream roughly 17.14 river miles, or 27.6 km. The upstream boundary is the Arizona-New Mexico State line.

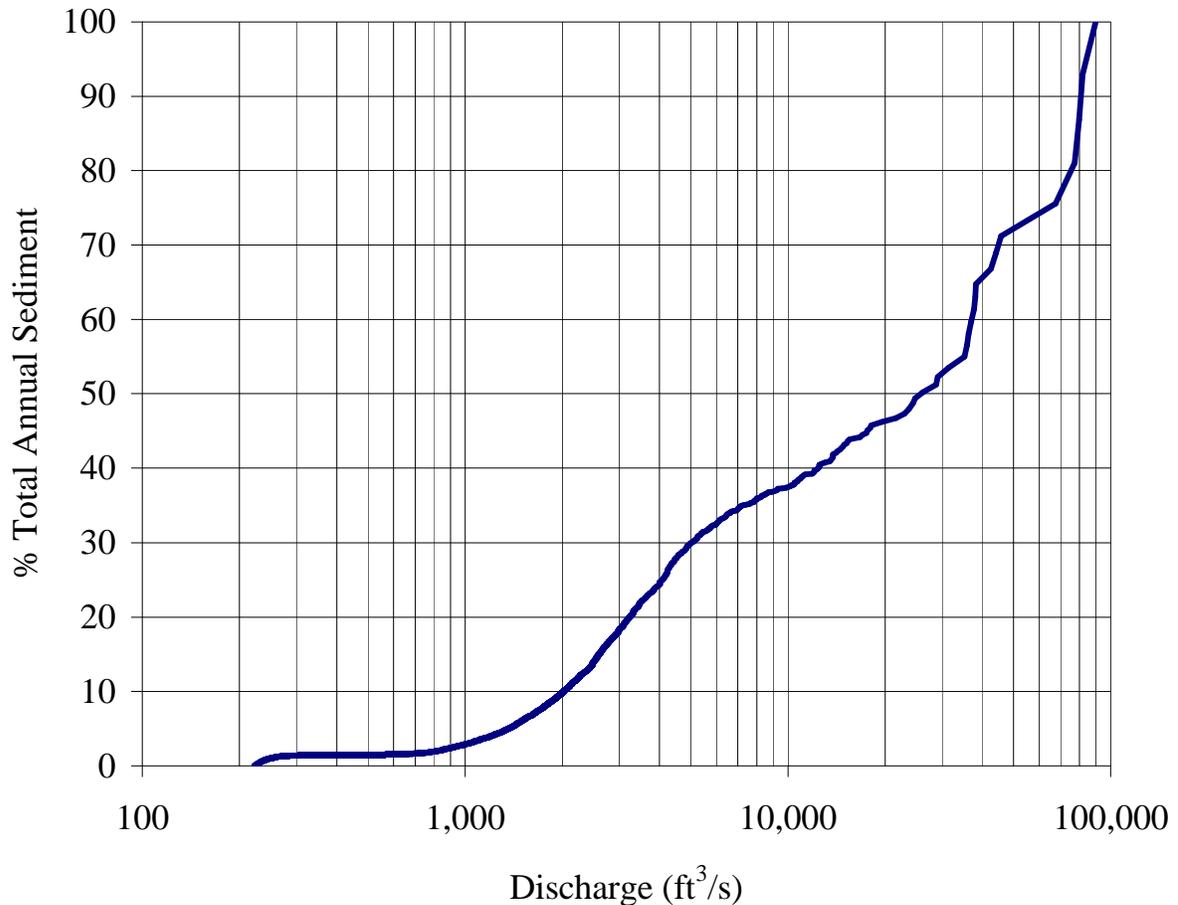
Figure 39. Cumulative sediment transport at Calva from 1929 to 2000.

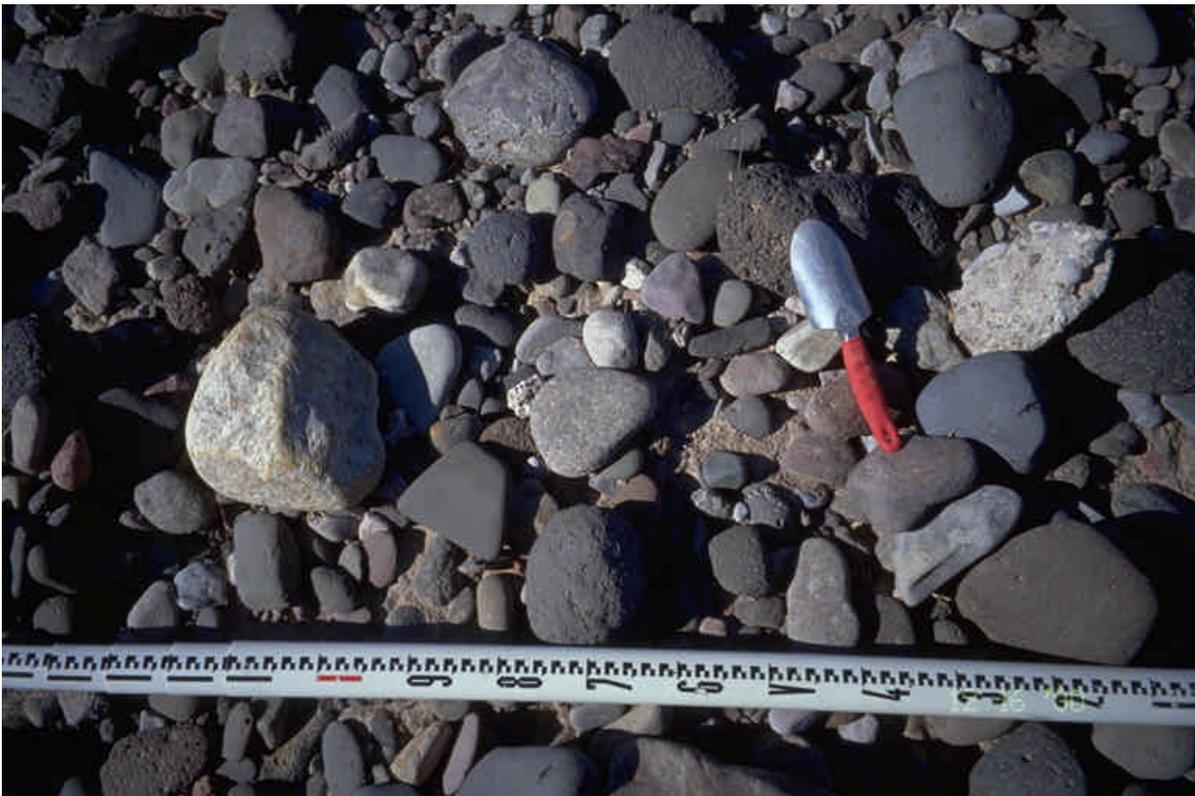
*Figure 40. Photographic sample 44A near Holyoke, Arizona.*

Photographic samples were collected first. Then, after removing the large surface particle, a volume of one to three times of the largest particle of finer particles beneath the large particle was collected into a plastic sample bag, using a hand trowel. Care was exercised to collect material immediately below the surface by keeping the walls of the excavation vertical. Photographs of the river in the upstream and downstream directions were also taken from the sample location. Samples were logged and transported to the laboratory for analysis. Figure 40 shows Photographic Sample 44A, near Holyoke, Arizona.

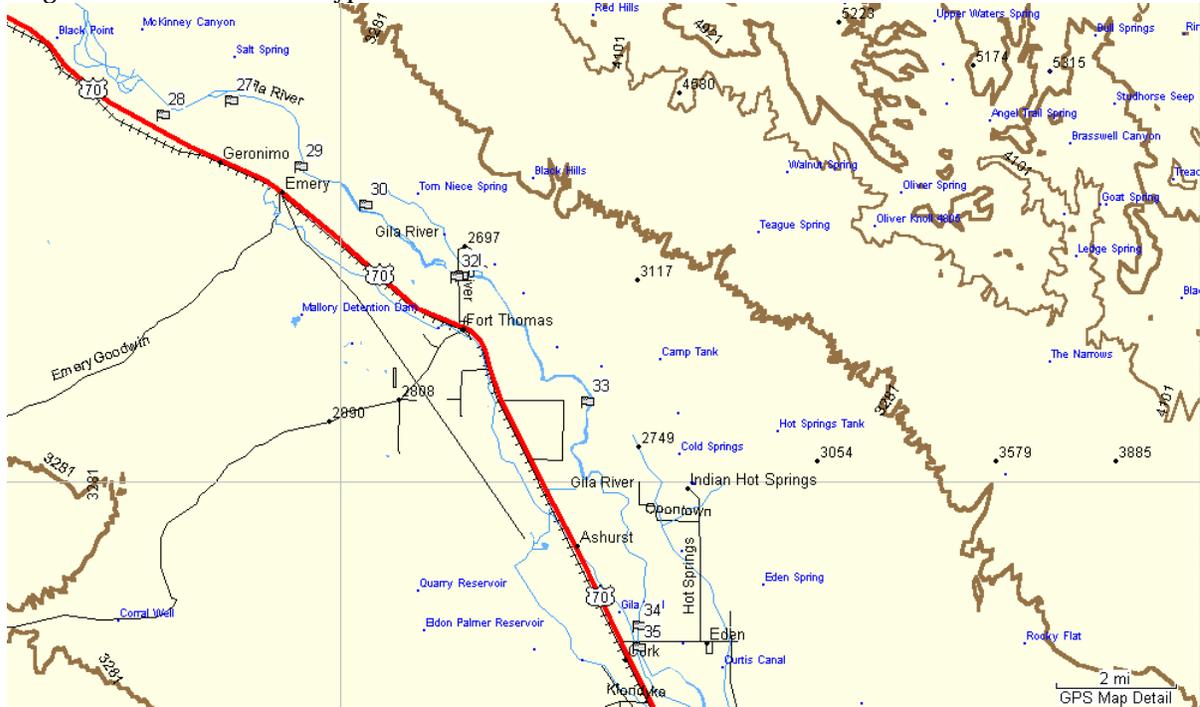
Figure 41. Study reach between San Carlos Reservation and the Eden area.

The following maps show the locations of the individual samples, indicated by the flag symbol. In some cases the symbols overlap due to the close proximity of the sample locations. The general scheme specified locations upstream and downstream of bridges and diversions, as well as selected locations in long reaches between those types of structures.

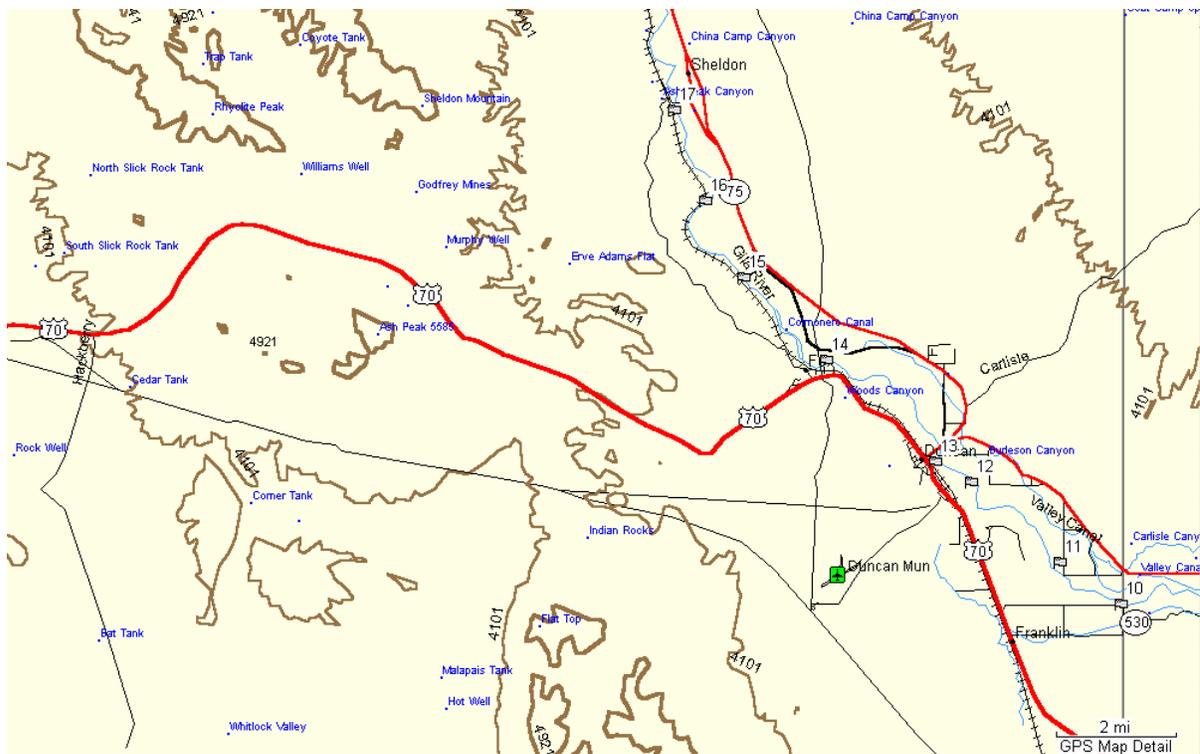
Figure 45. Study reach between Sheldon and the New Mexico state line.

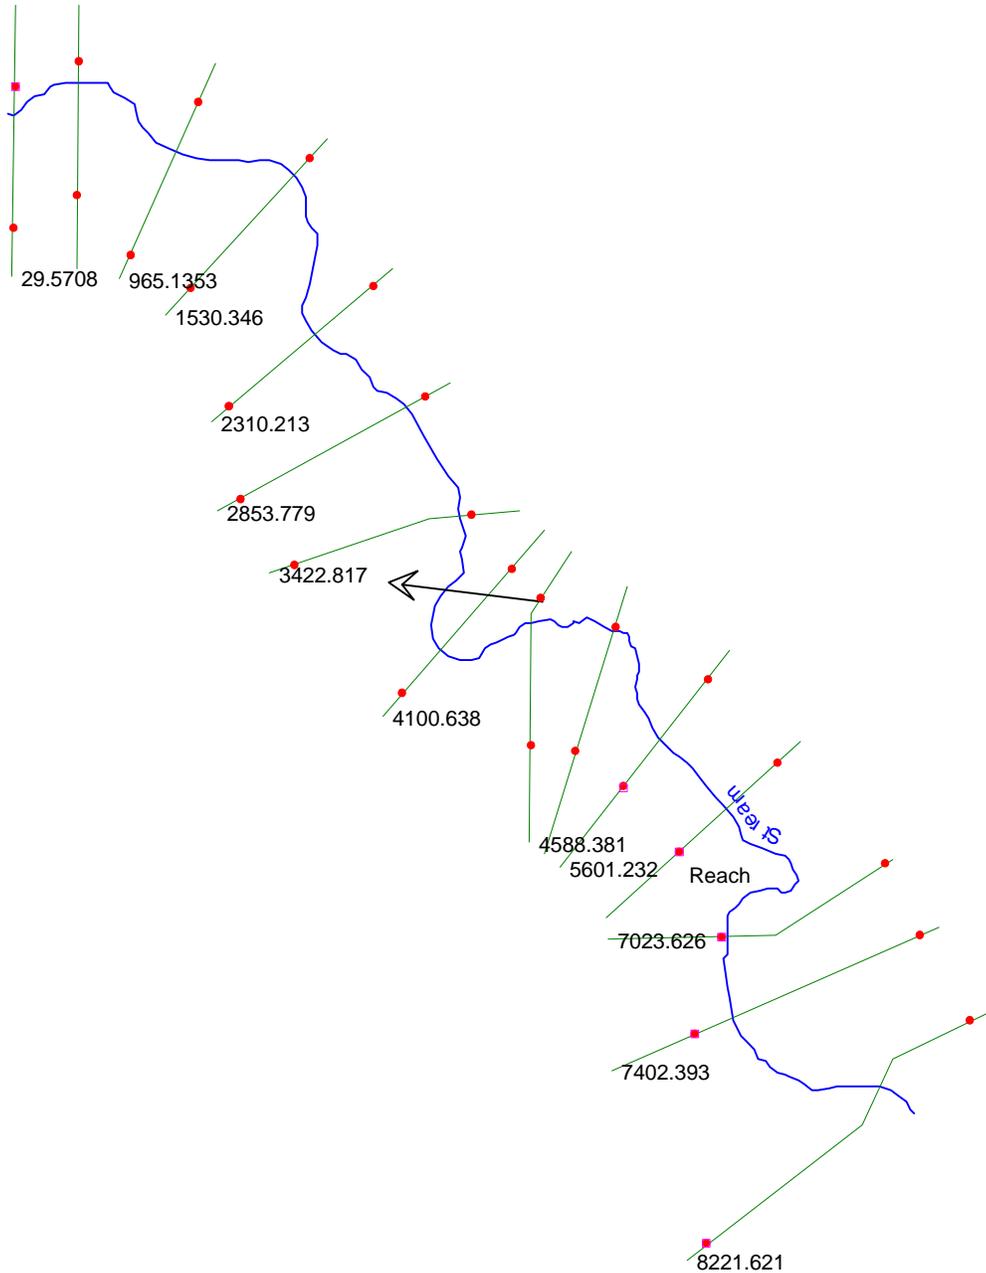
Figure 54. Plan view of HEC-RAS sections and channel in Lower Reach 2. (meters)

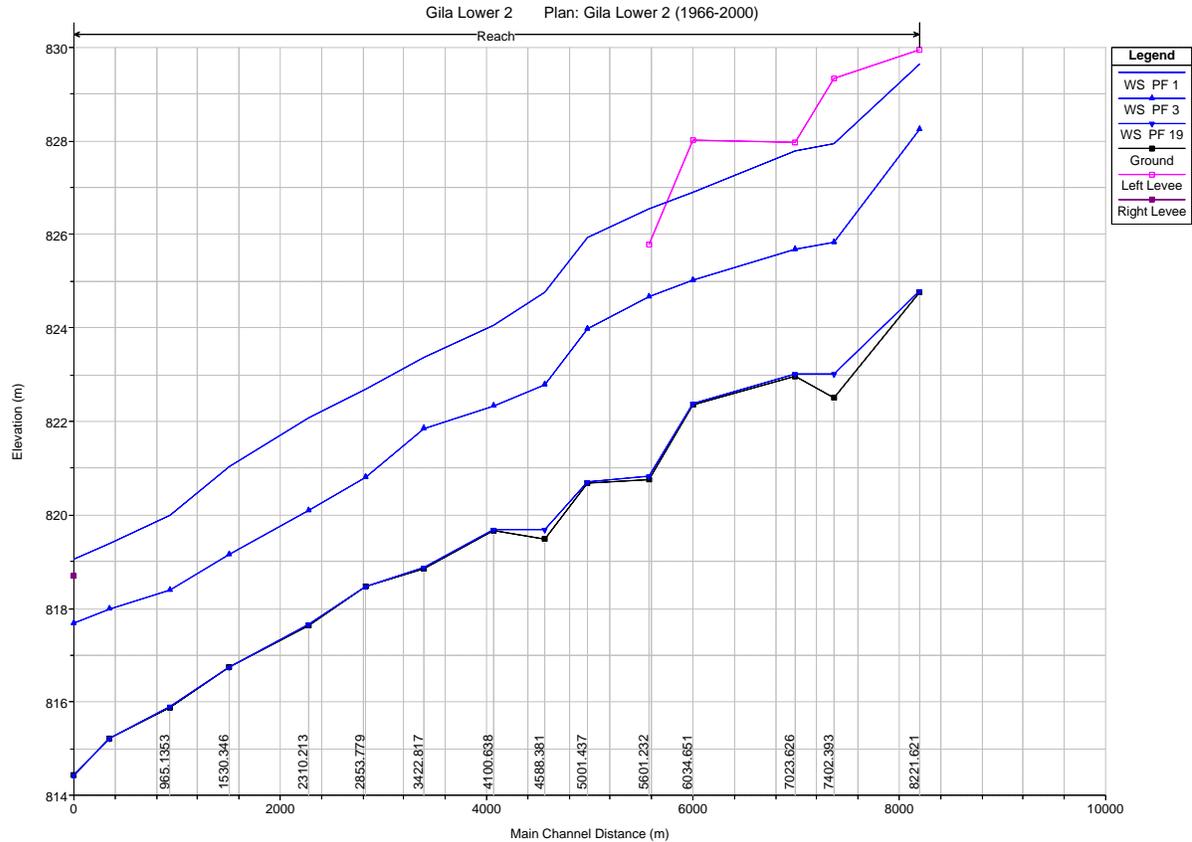
Figure 55. Profile of Lower Reach 2, showing water surface profiles at  $2,329 \text{ m}^3/\text{s}$  ( $82,252.68 \text{ ft}^3/\text{s}$ ) (PF1),  $422 \text{ m}^3/\text{s}$  ( $14,907.88 \text{ ft}^3/\text{s}$ ) (PF 3), and  $0.002 \text{ m}^3/\text{s}$  ( $0.08 \text{ ft}^3/\text{s}$ ) (PF 19).

Figure 55 plots the stream bed profile and water surface profiles (PF) at discharges of 2,329 m<sup>3</sup>/s (82,252.68 ft<sup>3</sup>/s) (PF1), 422 m<sup>3</sup>/s (14,907.88 ft<sup>3</sup>/s) (PF 3), and 0.002 m<sup>3</sup>/s (0.08 ft<sup>3</sup>/s) (PF 19).

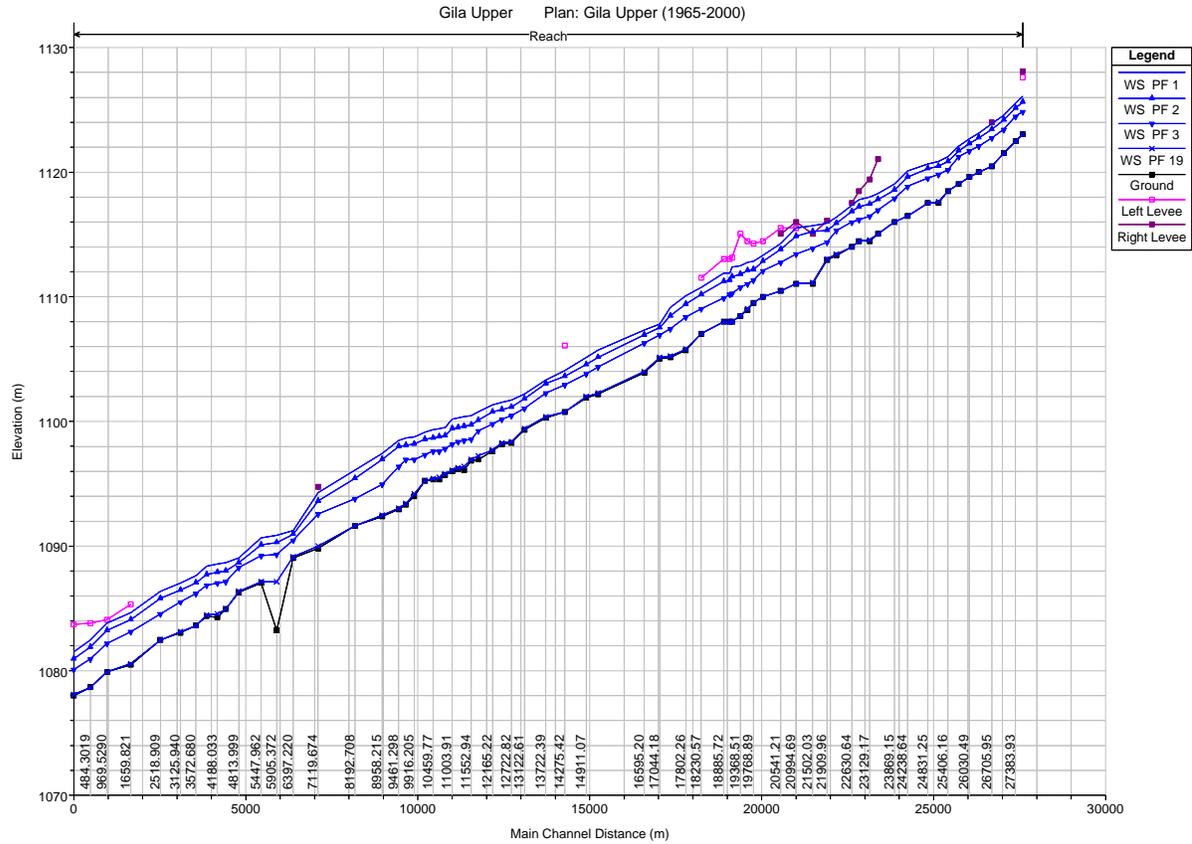
Figure 61. Profile of Upper Reach, showing water surface profiles at  $652.26 \text{ m}^3/\text{s}$  ( $23,034.46 \text{ ft}^3/\text{s}$ ) (PF 1),  $402.72 \text{ m}^3/\text{s}$  ( $14,221.95 \text{ ft}^3/\text{s}$ ) (PF 2),  $152.47 \text{ m}^3/\text{s}$  ( $5,384.36 \text{ ft}^3/\text{s}$ ) (PF 3), and  $0.033 \text{ m}^3/\text{s}$  ( $1.17 \text{ ft}^3/\text{s}$ ) (PF 19).
