# UPPER GILA RIVER FLUVIAL GEOMORPHOLOGY STUDY

STREAM CORRIDOR ASSESSMENT  
ARIZONA

US Department of the Interior  
Bureau of Reclamation

MARCH 5, 2004

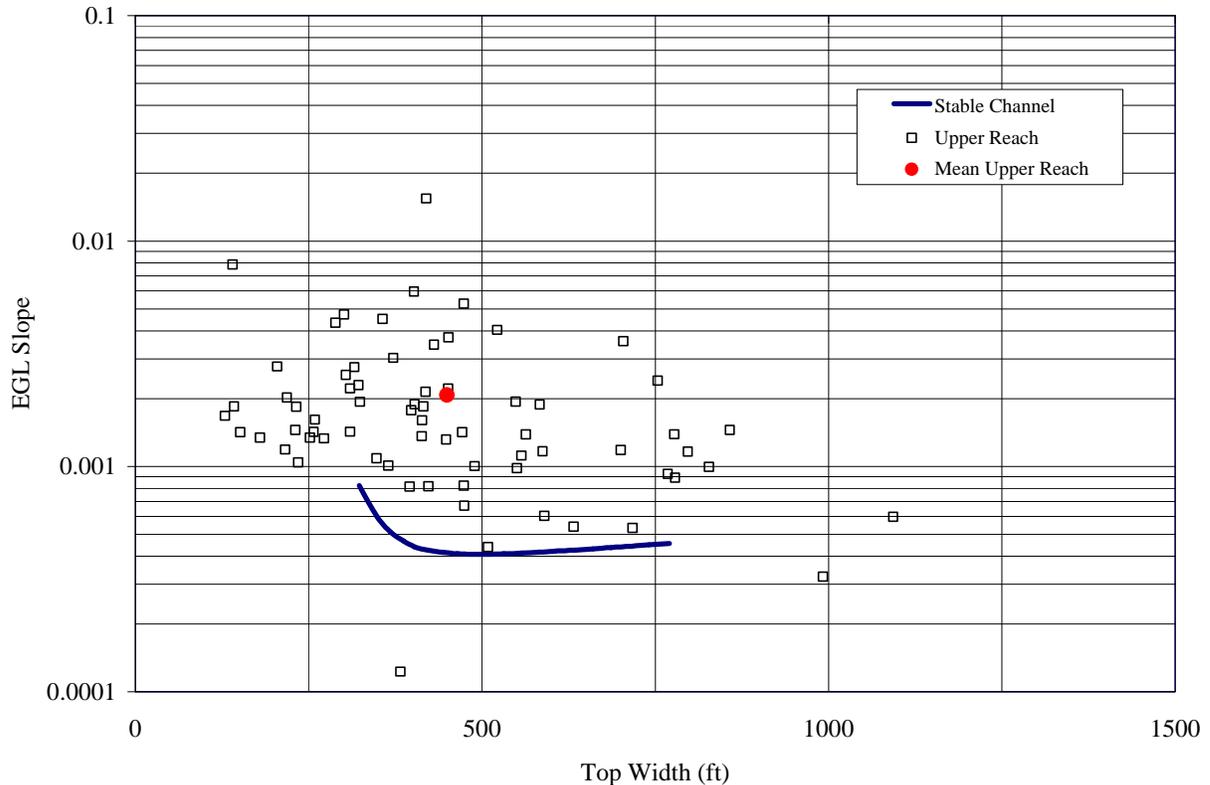
Figure 94. Stable channel analysis in the Upper Reach.

There is evidence (Klawon, 2001) of bed rock controls in the lower portion of the Upper Reach. There also appear to be areas of hydraulic control that are not alluvial. The stable channel analysis does not apply to reaches in these areas, and likely produces outliers on the stable channel curve.
