## **Trends of Aggradation and Degradation Along the Central Platte River: 1985 to 2005**

U.S. Department of the Interior  
Bureau of Reclamation  
Technical Service Center  
Denver, Colorado

February 2006

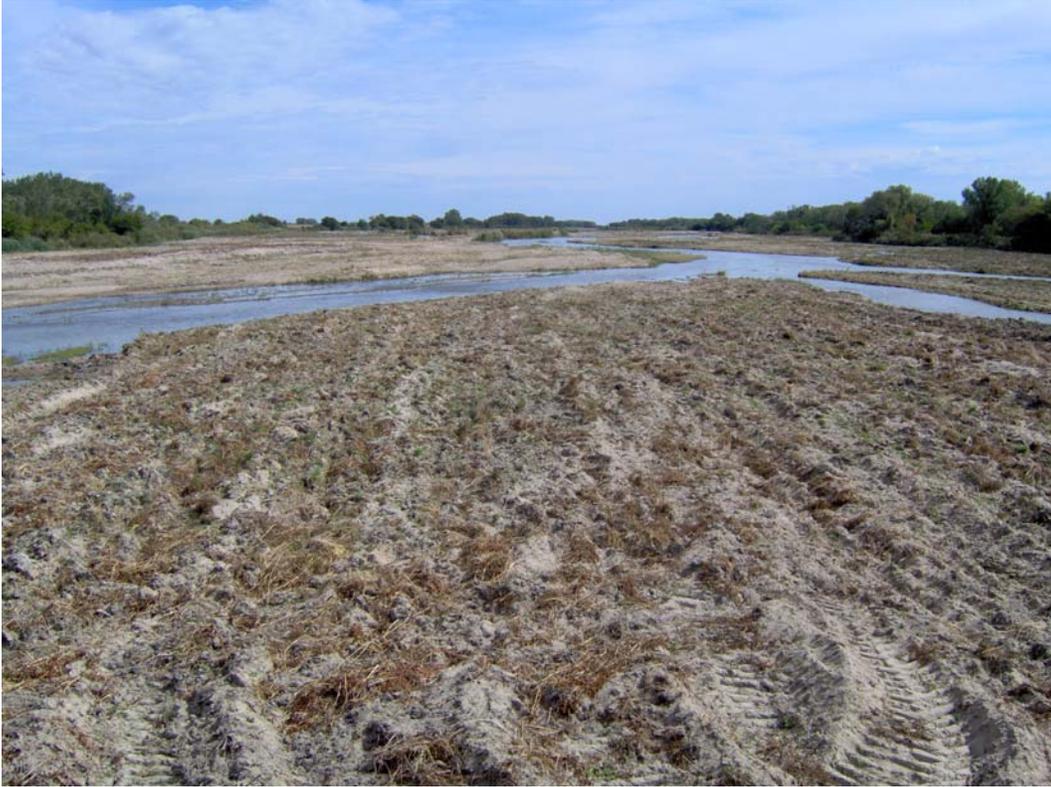
**Figure 1.2. End result of mechanical clearing of vegetation.**

In addition, several non-governmental organizations, including the Nature Conservancy, The Platte River Whooping Crane Trust, and the Audubon Society, have implemented actions intended to benefit the target species and other species, by reducing vegetation in the flood plain (Figure 1.2) and restoring side channels (Figure 1.3). Their activities have included public outreach and education, land acquisition and management, and mechanical modifications of the river.

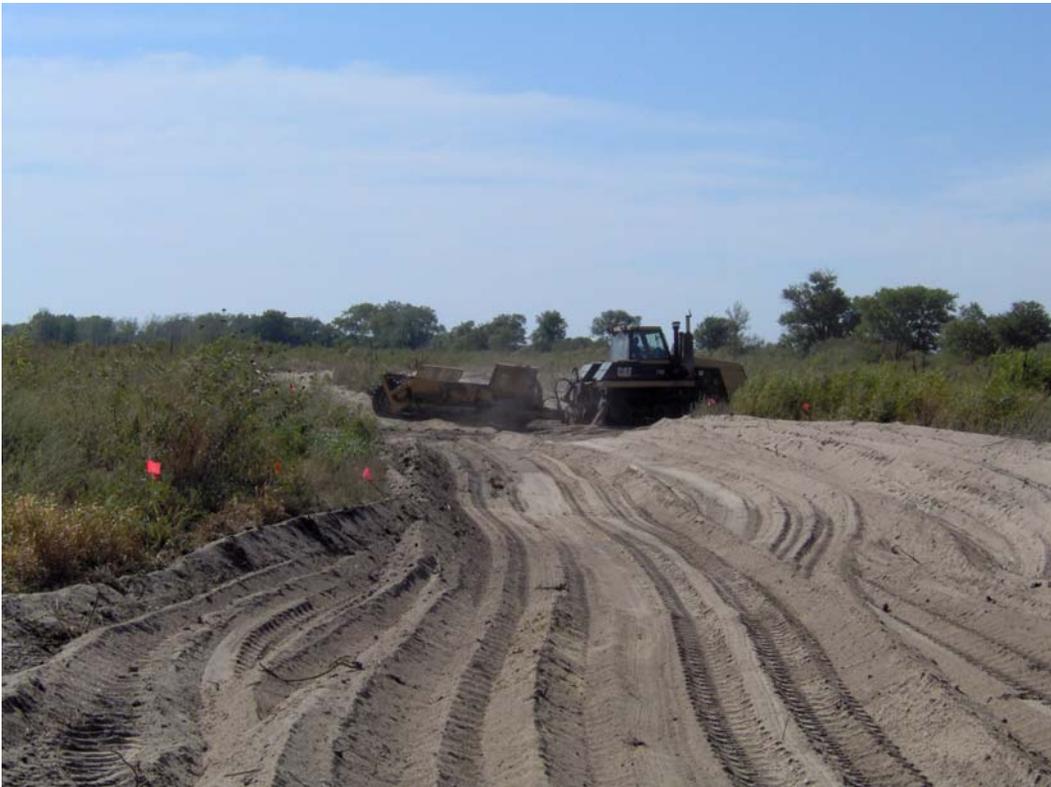
**Figure 1.3. Construction of a side channel on the left bank of habitat site 6.**

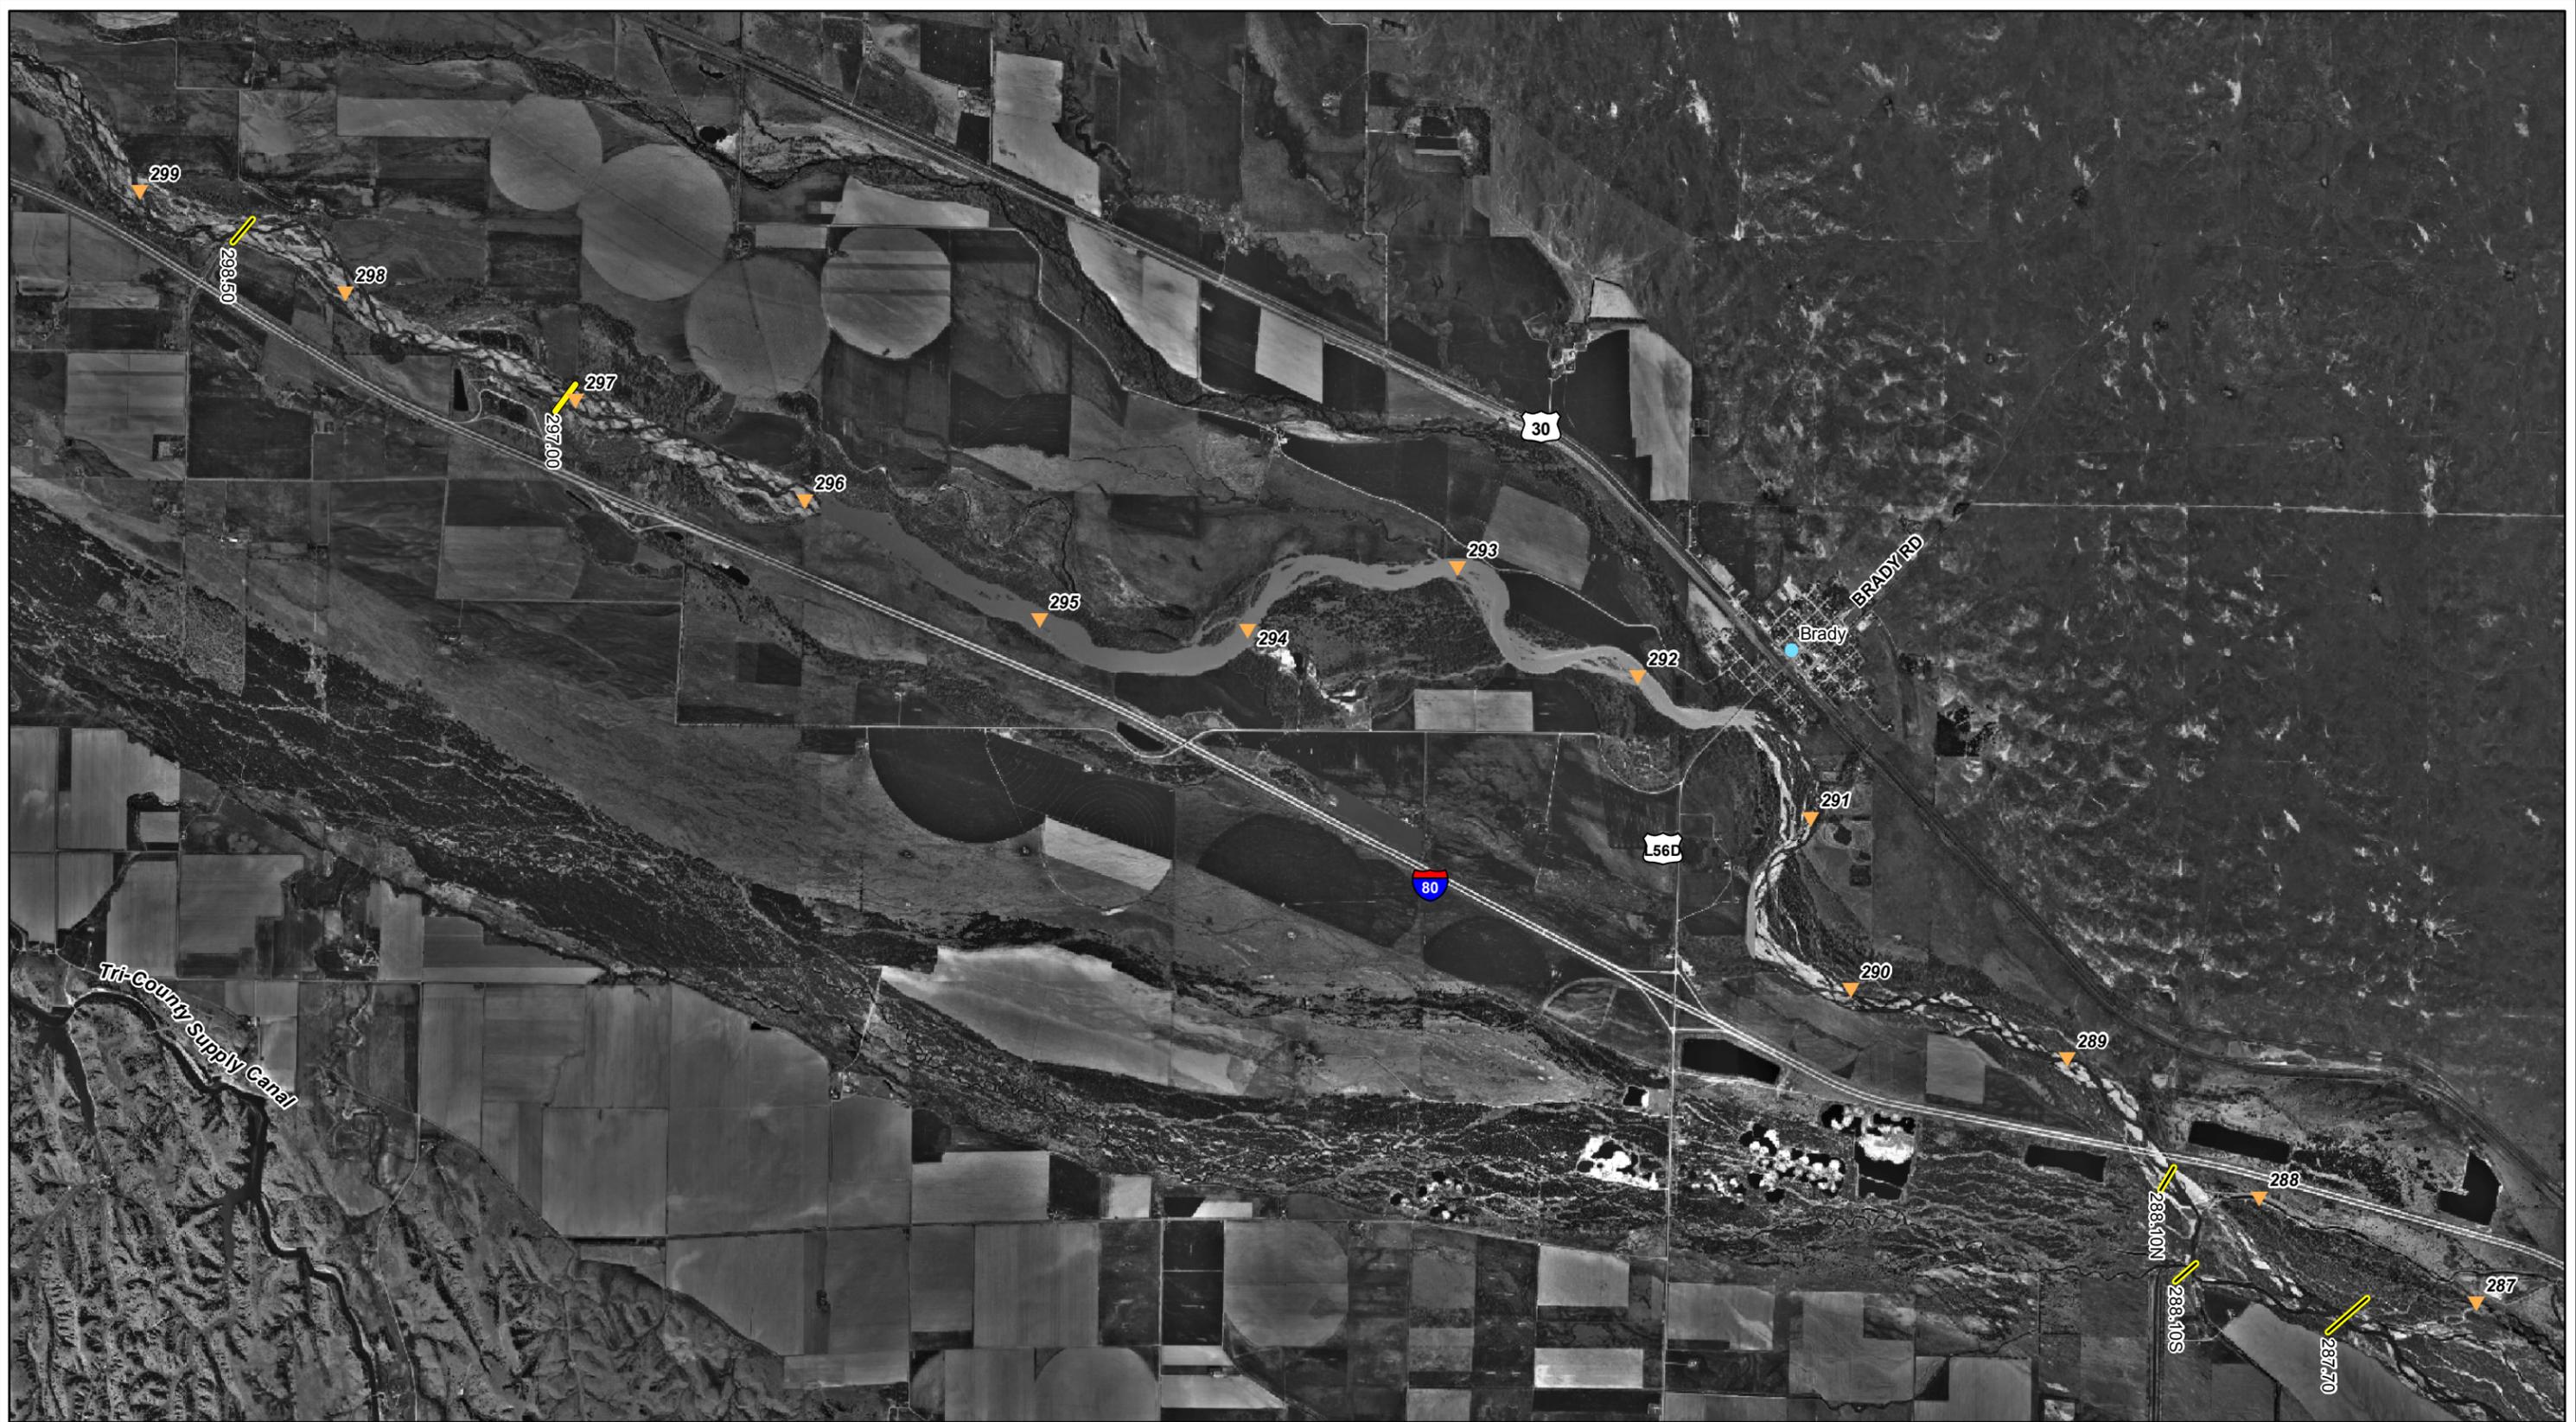
**Figure 3.2.**  
**Cross Section Locations: Sheet 1**  
**RECLAMATION**  
*Managing Water in the West*

Key to Features	
	City/Town
	River mile
	1989 cross section not used in analysis
	1989 repeat cross section used in analysis
	1985 repeat habitat transects not used in analysis
	1985 repeat habitat transect used in analysis

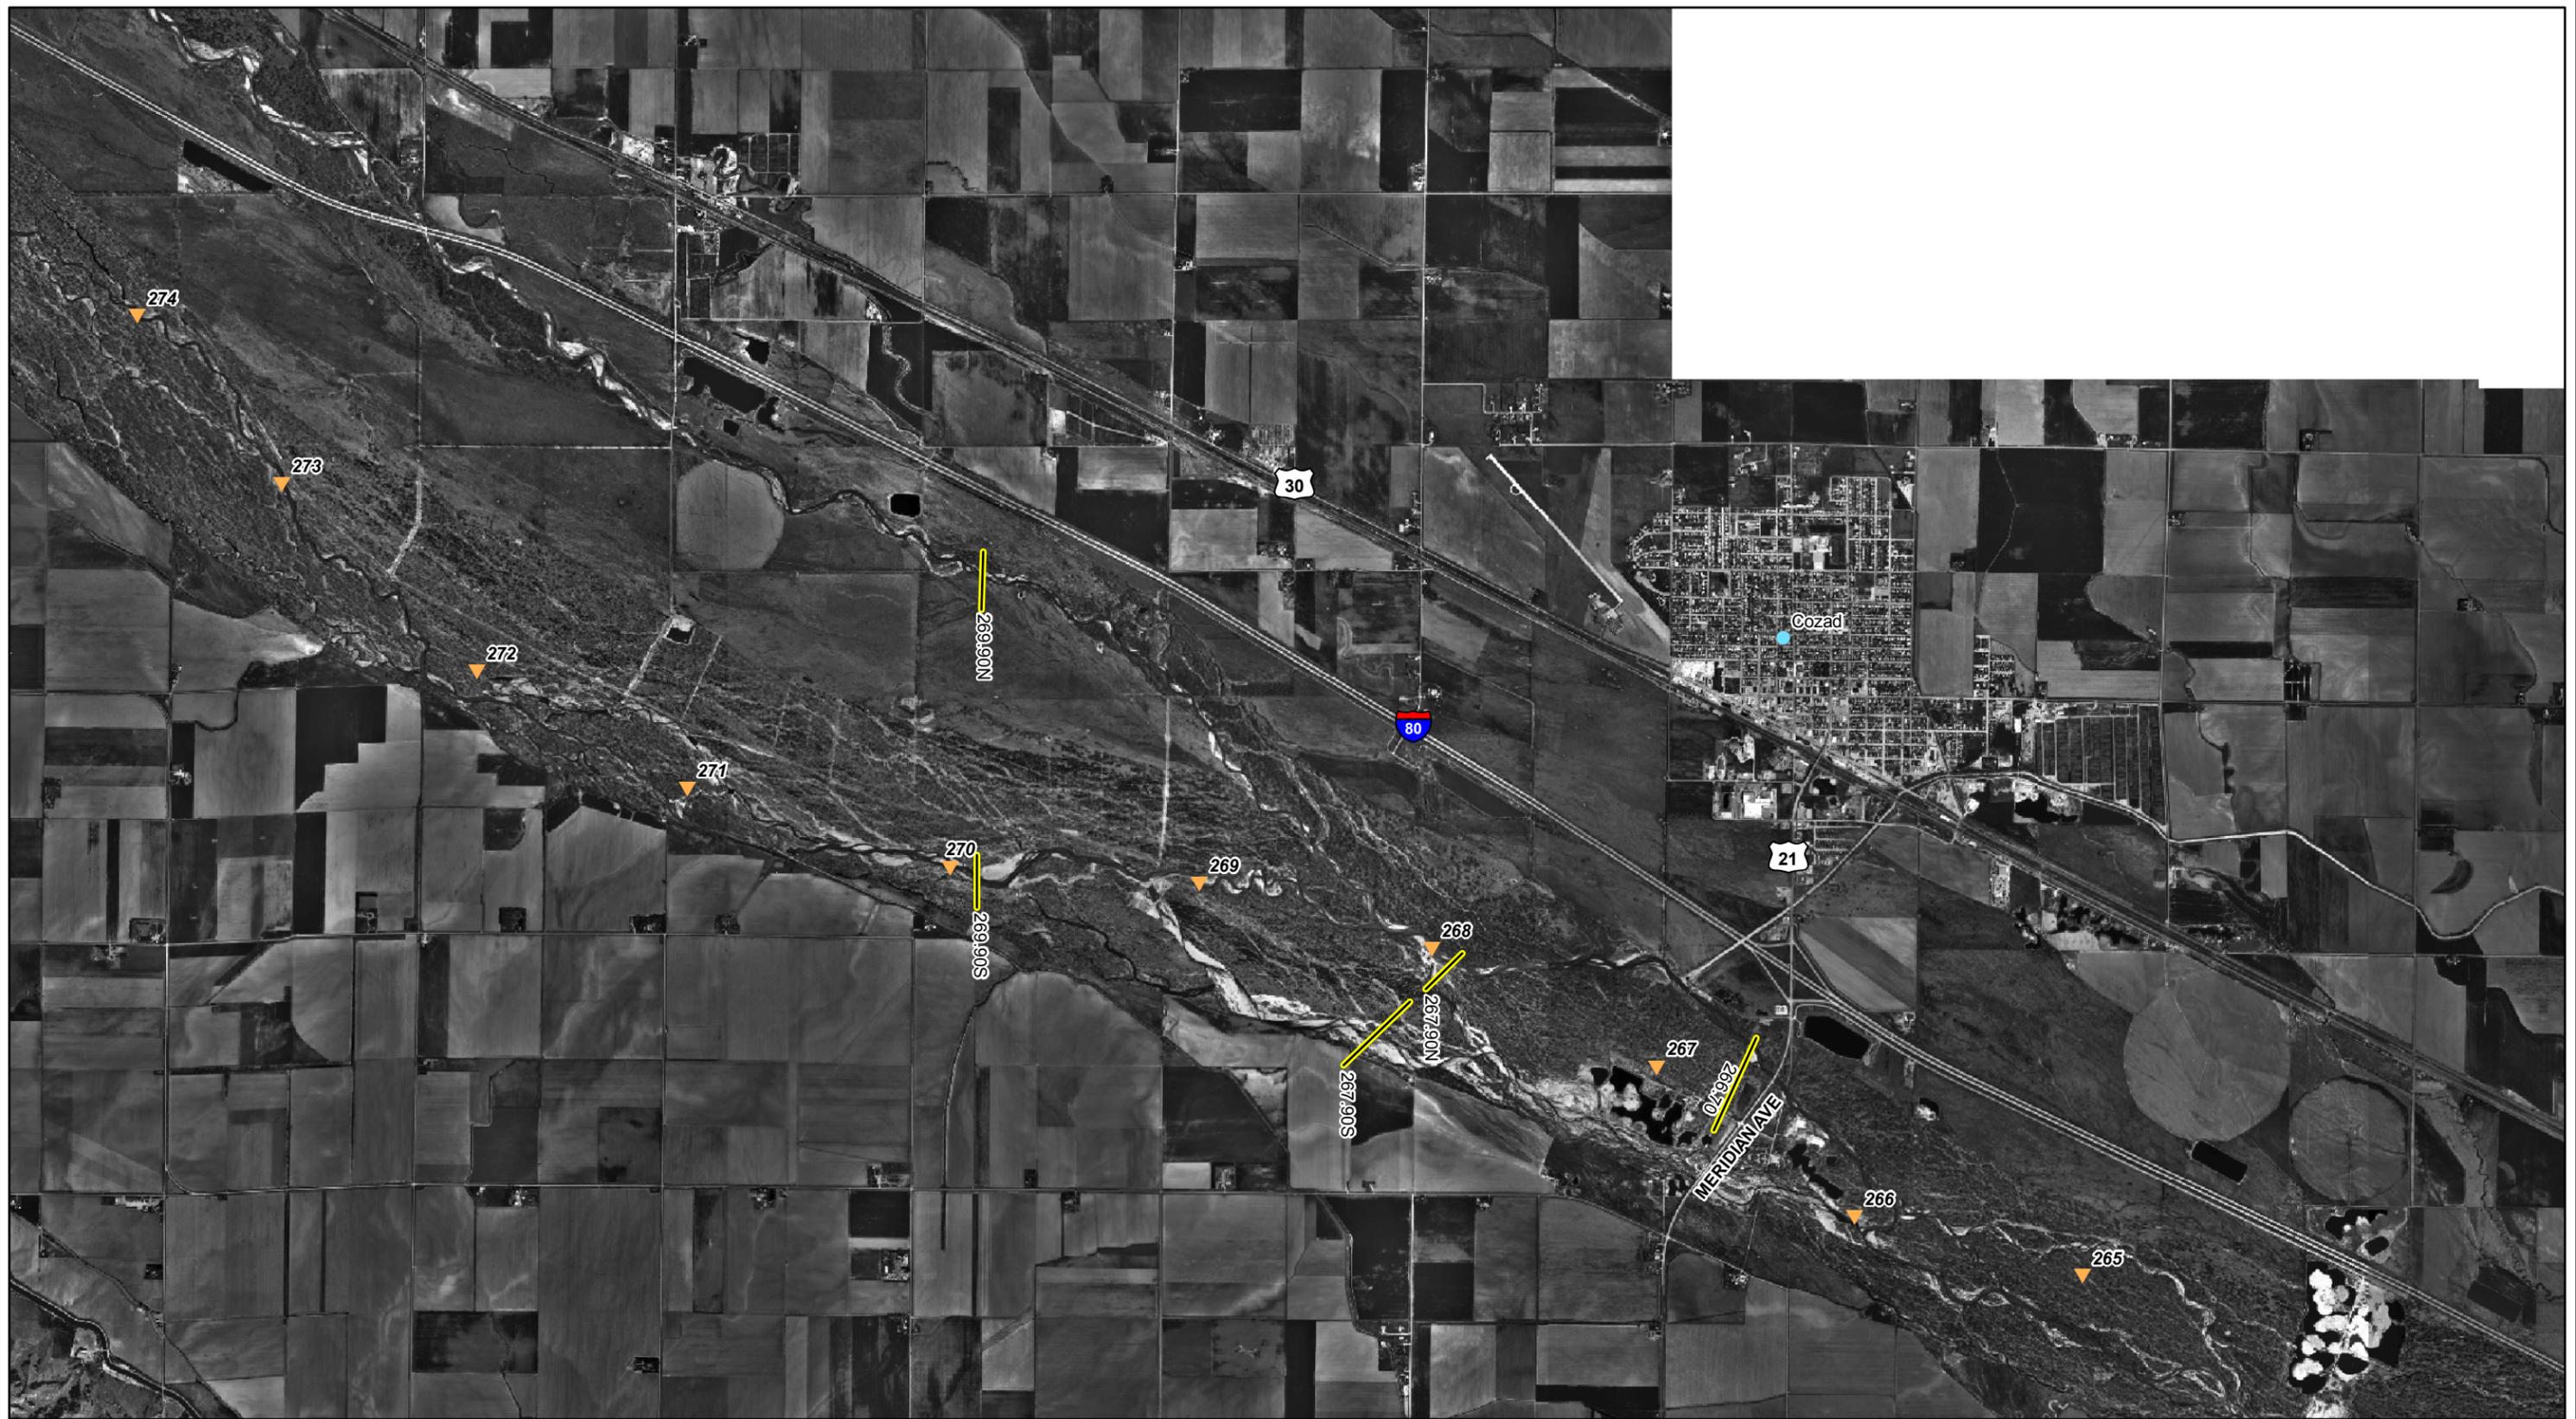
**Figure 3.4.**  
**Cross Section Locations: Sheet 3**  
**RECLAMATION**  
*Managing Water in the West*

- City/Town
- ▲ River mile
- 1989 cross section not used in analysis
- 1989 repeat cross section used in analysis
- 1985 repeat habitat transects not used in analysis
- 1985 repeat habitat transect used in analysis

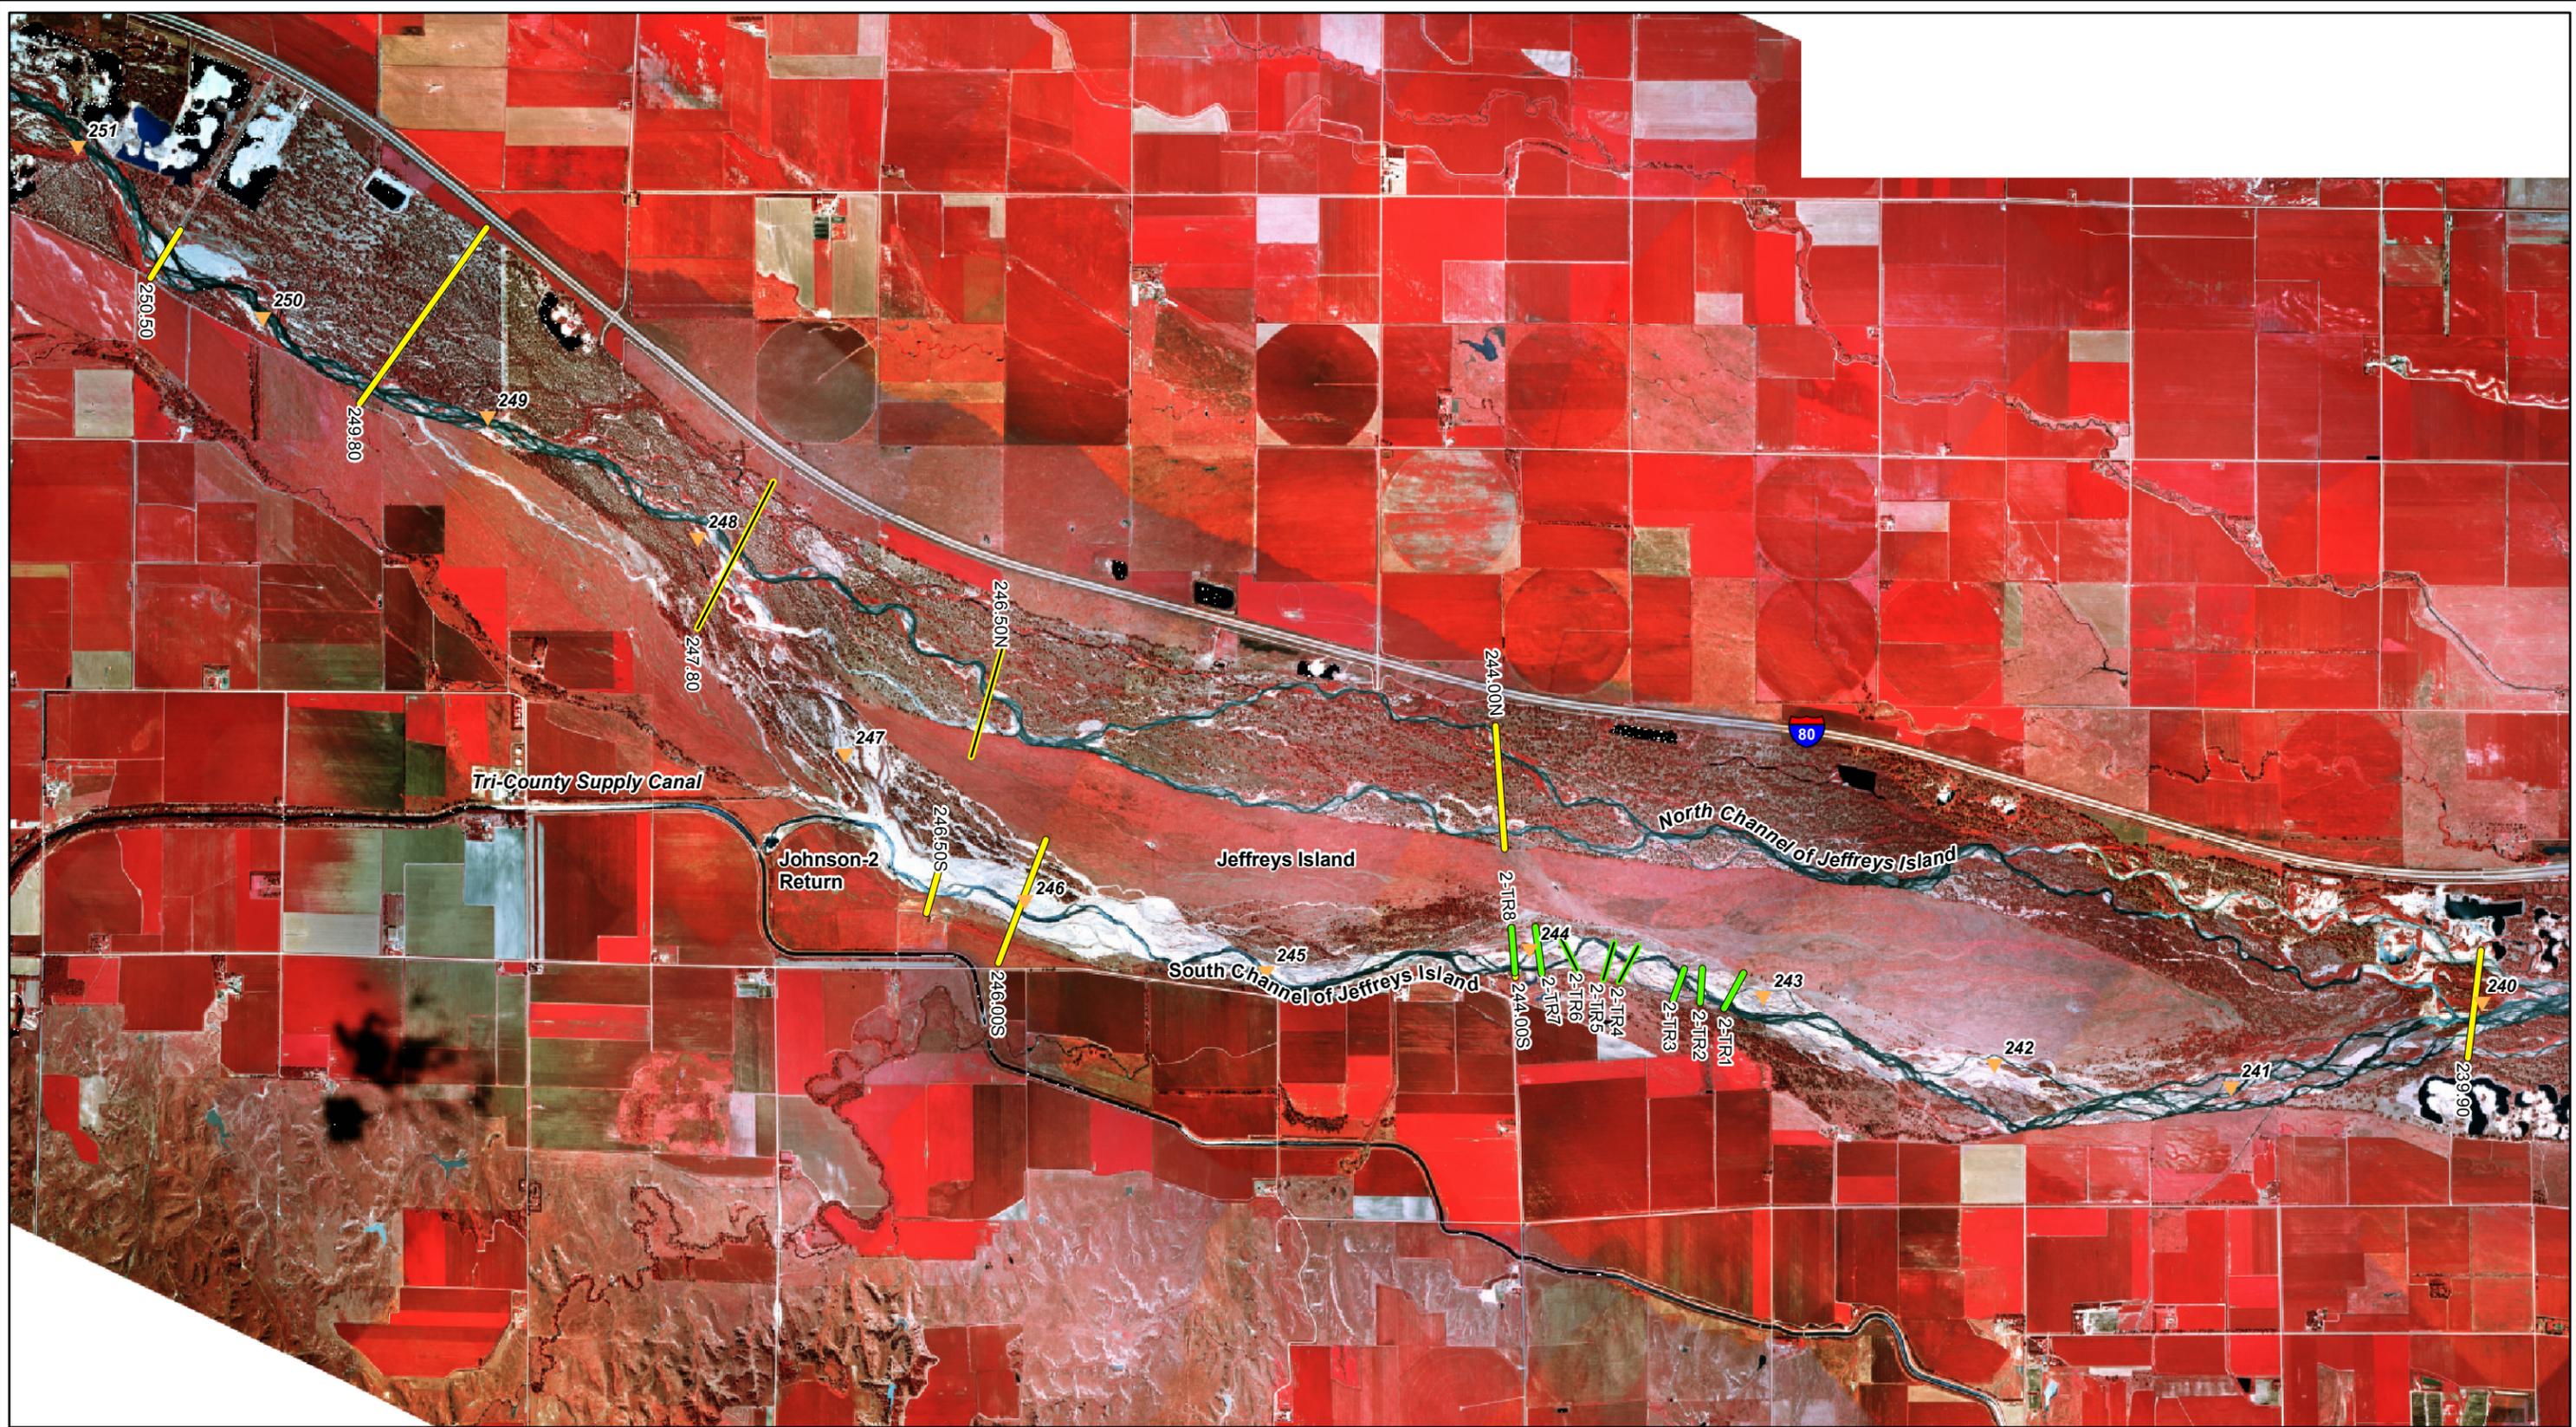
**Figure 3.6.**  
**Cross Section Locations: Sheet 5**  
**RECLAMATION**  
*Managing Water in the West*

- City/Town
- ▲ River mile
- 1989 cross section not used in analysis
- 1989 repeat cross section used in analysis
- 1985 repeat habitat transects not used in analysis
- 1985 repeat habitat transect used in analysis

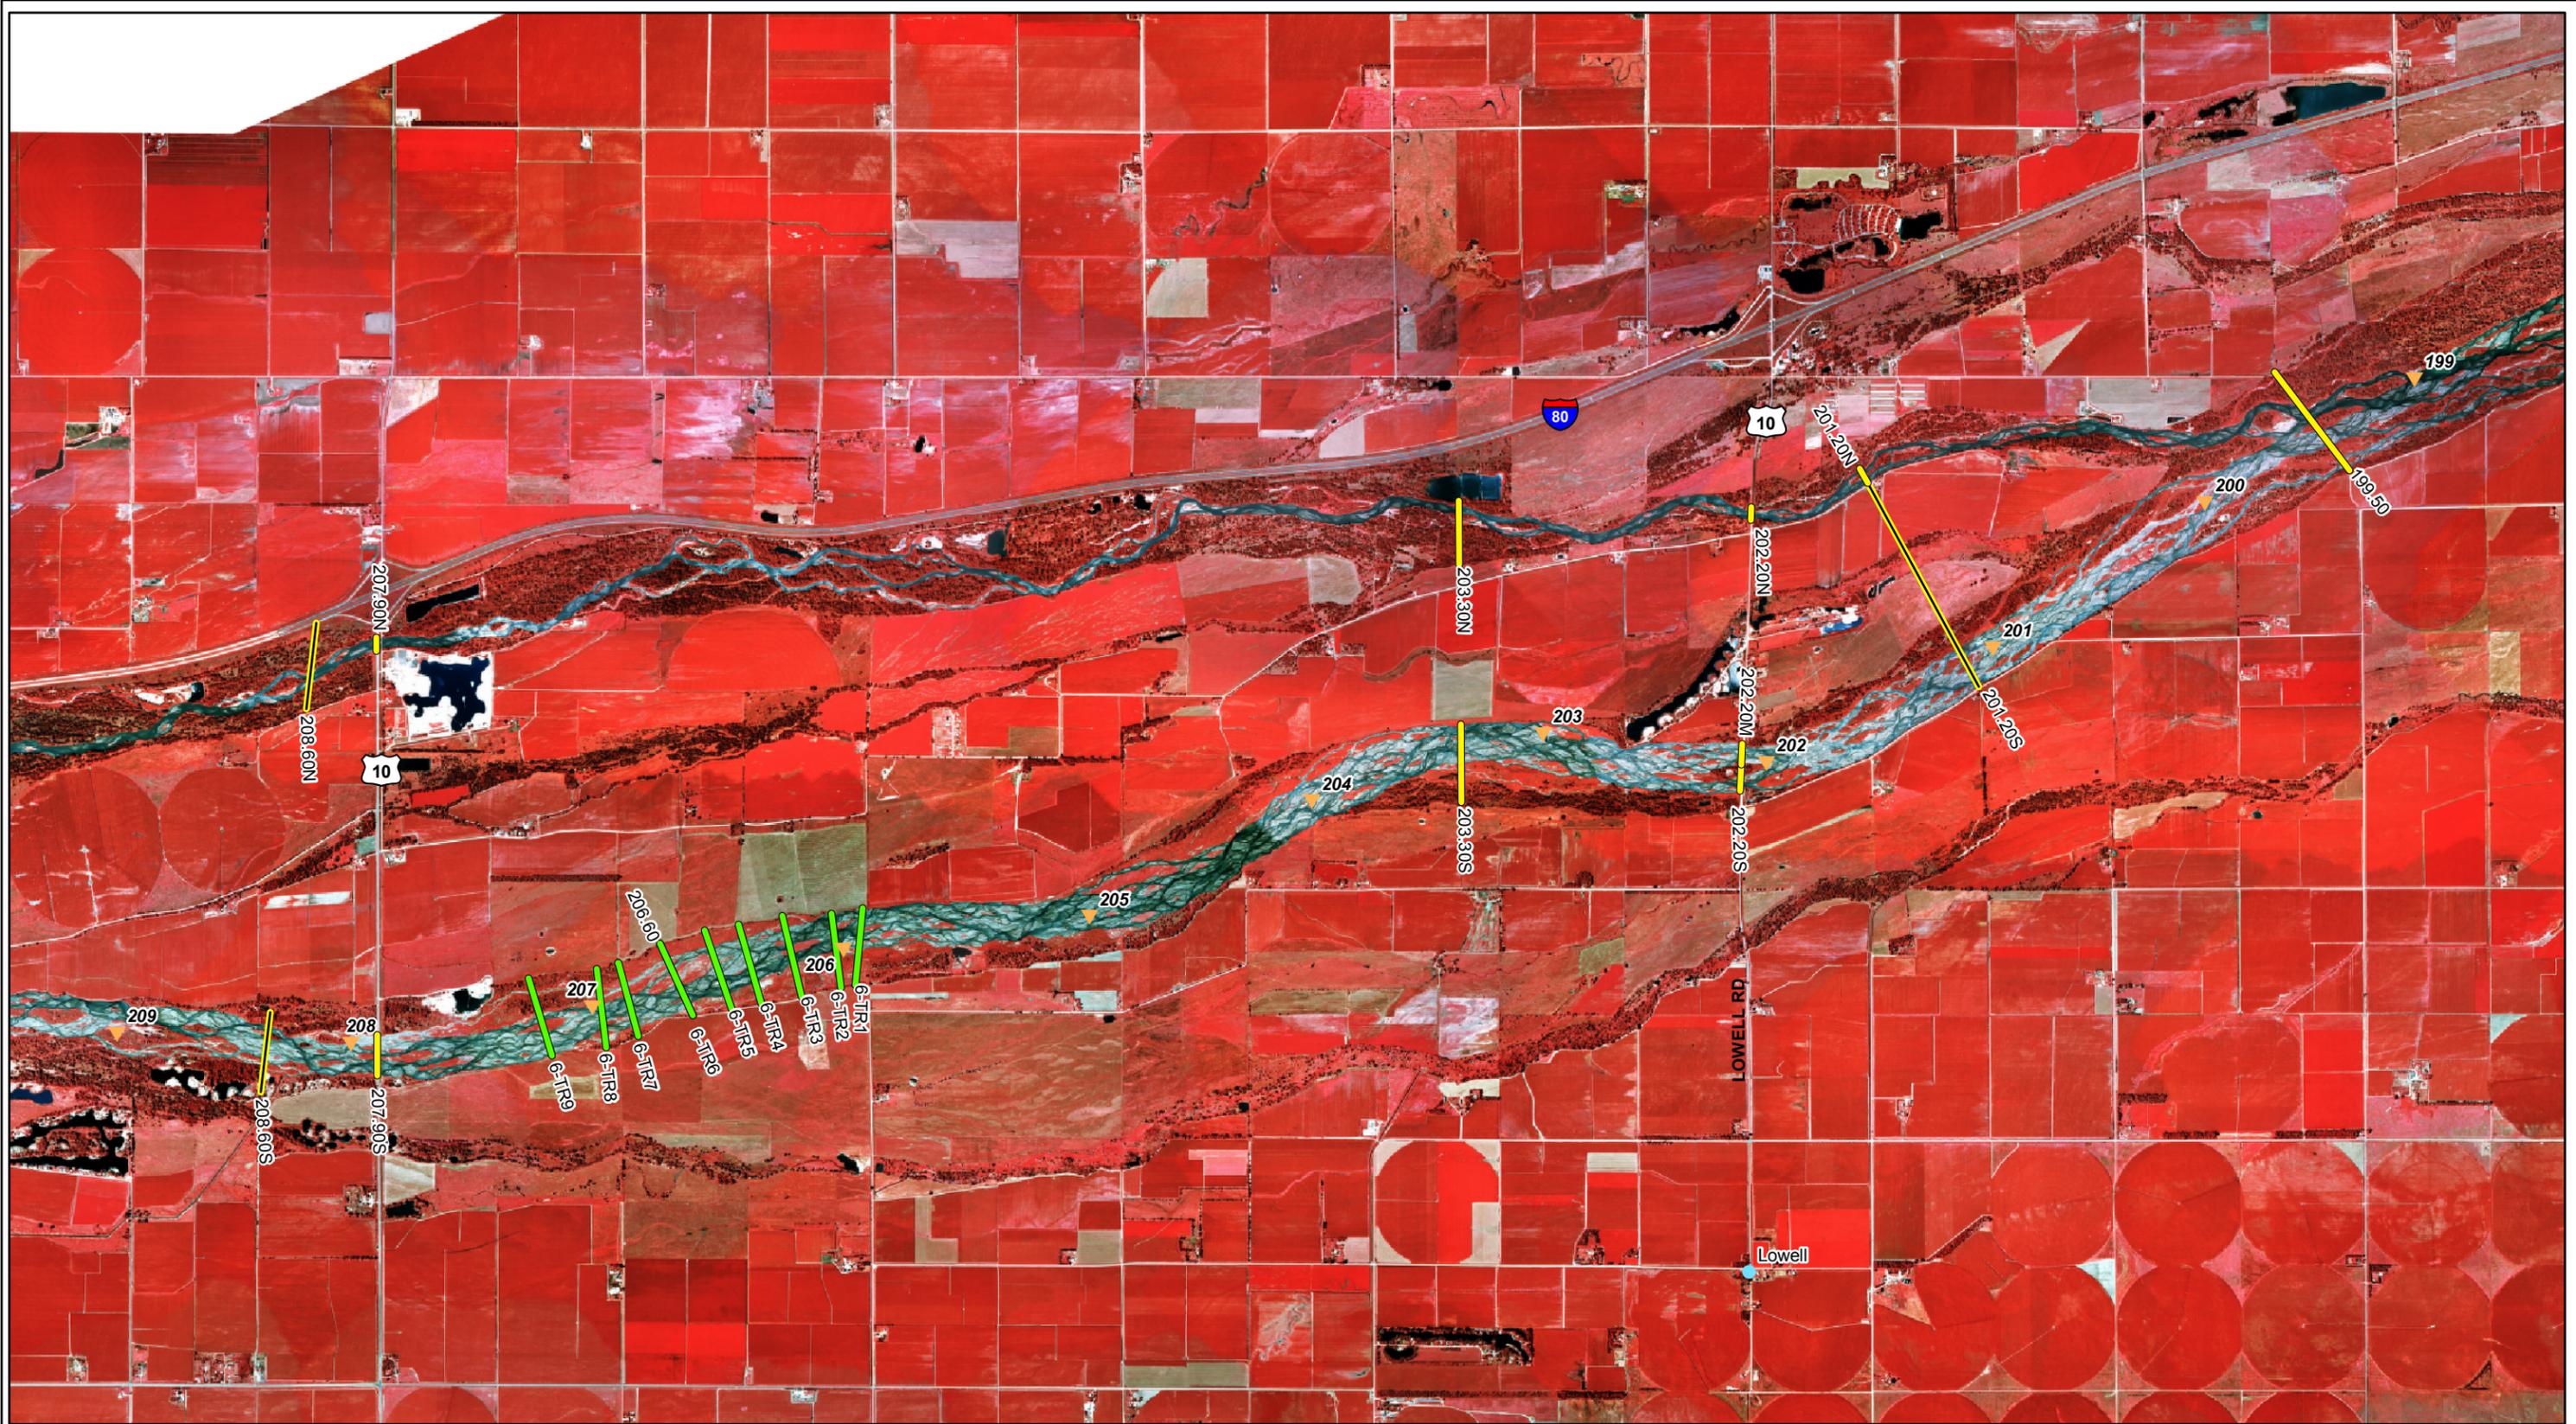
**Figure 3.10.**  
**Cross Section Locations: Sheet 9**  
**RECLAMATION**  
*Managing Water in the West*

- City/Town
- 1989 cross section not used in analysis
- 1989 repeat cross section used in analysis
- ▲ River mile
- 1985 repeat habitat transect not used in analysis
- 1985 repeat habitat transect used in analysis

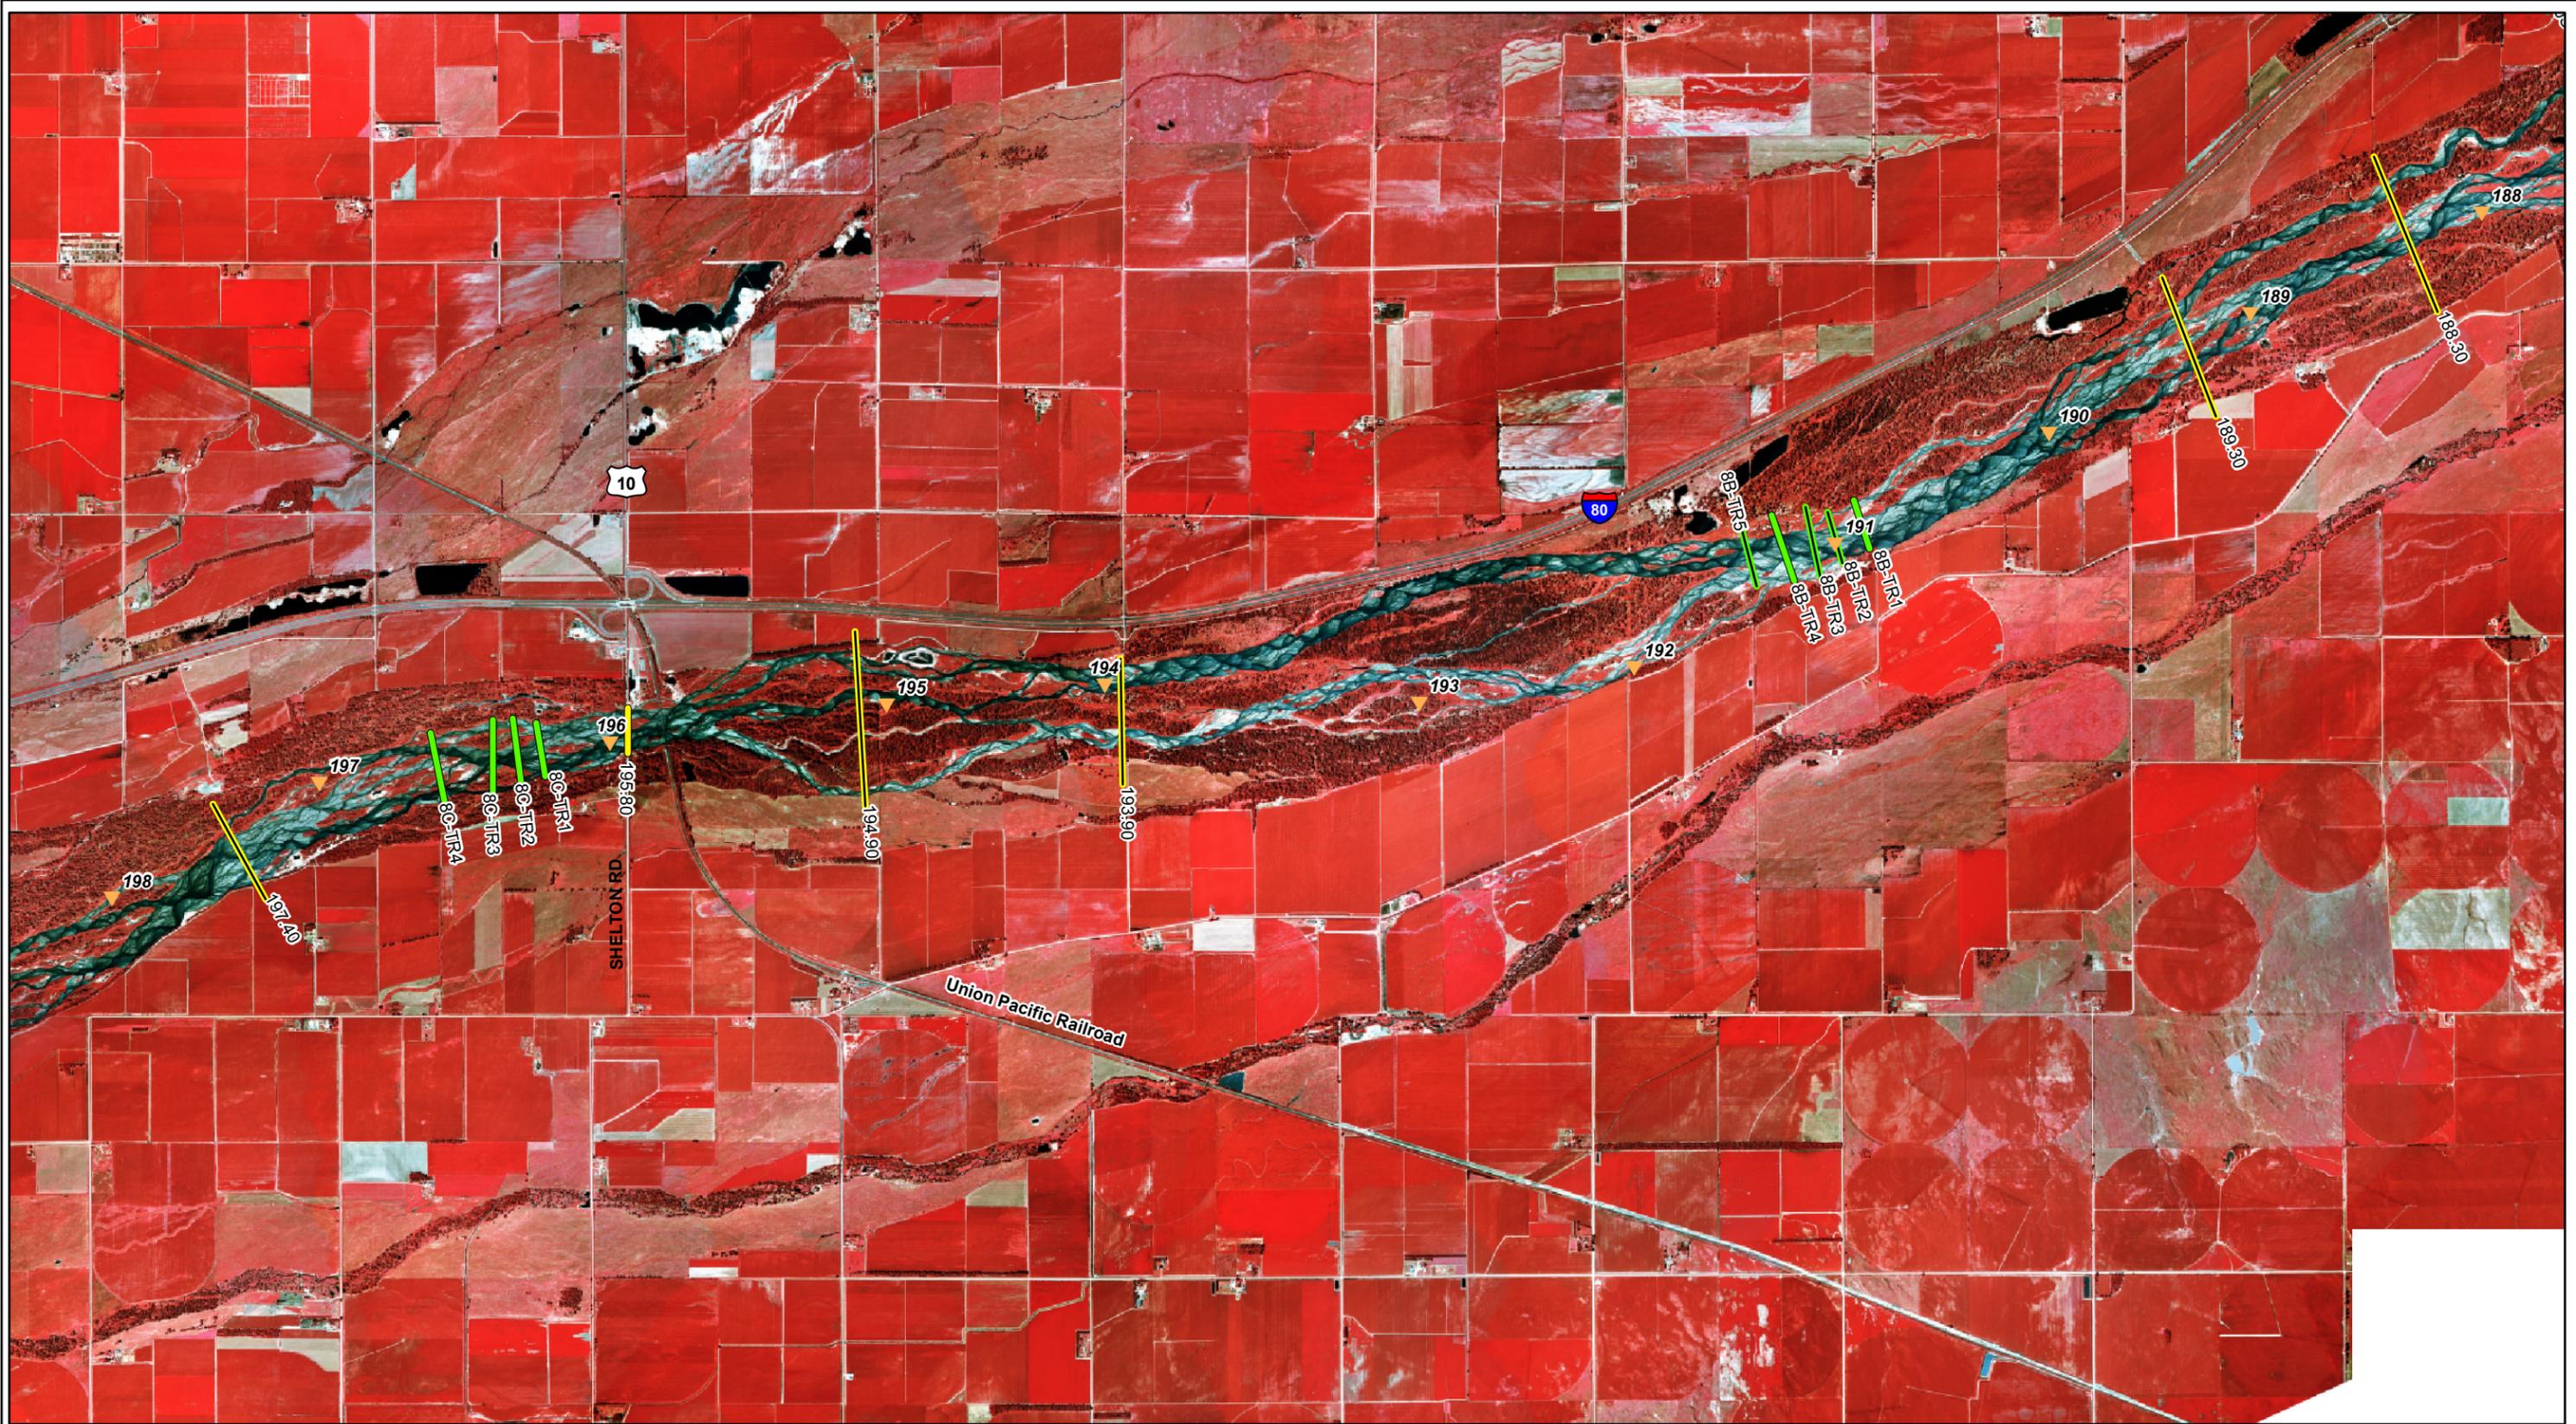
**Figure 3.11.**  
**Cross Section Locations: Sheet 10**  
**RECLAMATION**  
*Managing Water in the West*

- City/Town
- ▲ River mile
- 1989 cross section not used in analysis
- 1989 repeat cross section used in analysis
- 1985 repeat habitat transect not used in analysis
- 1985 repeat habitat transect used in analysis
