## **Trends of Aggradation and Degradation Along the Central Platte River: 1985 to 2005**

U.S. Department of the Interior  
Bureau of Reclamation  
Technical Service Center  
Denver, Colorado

February 2006

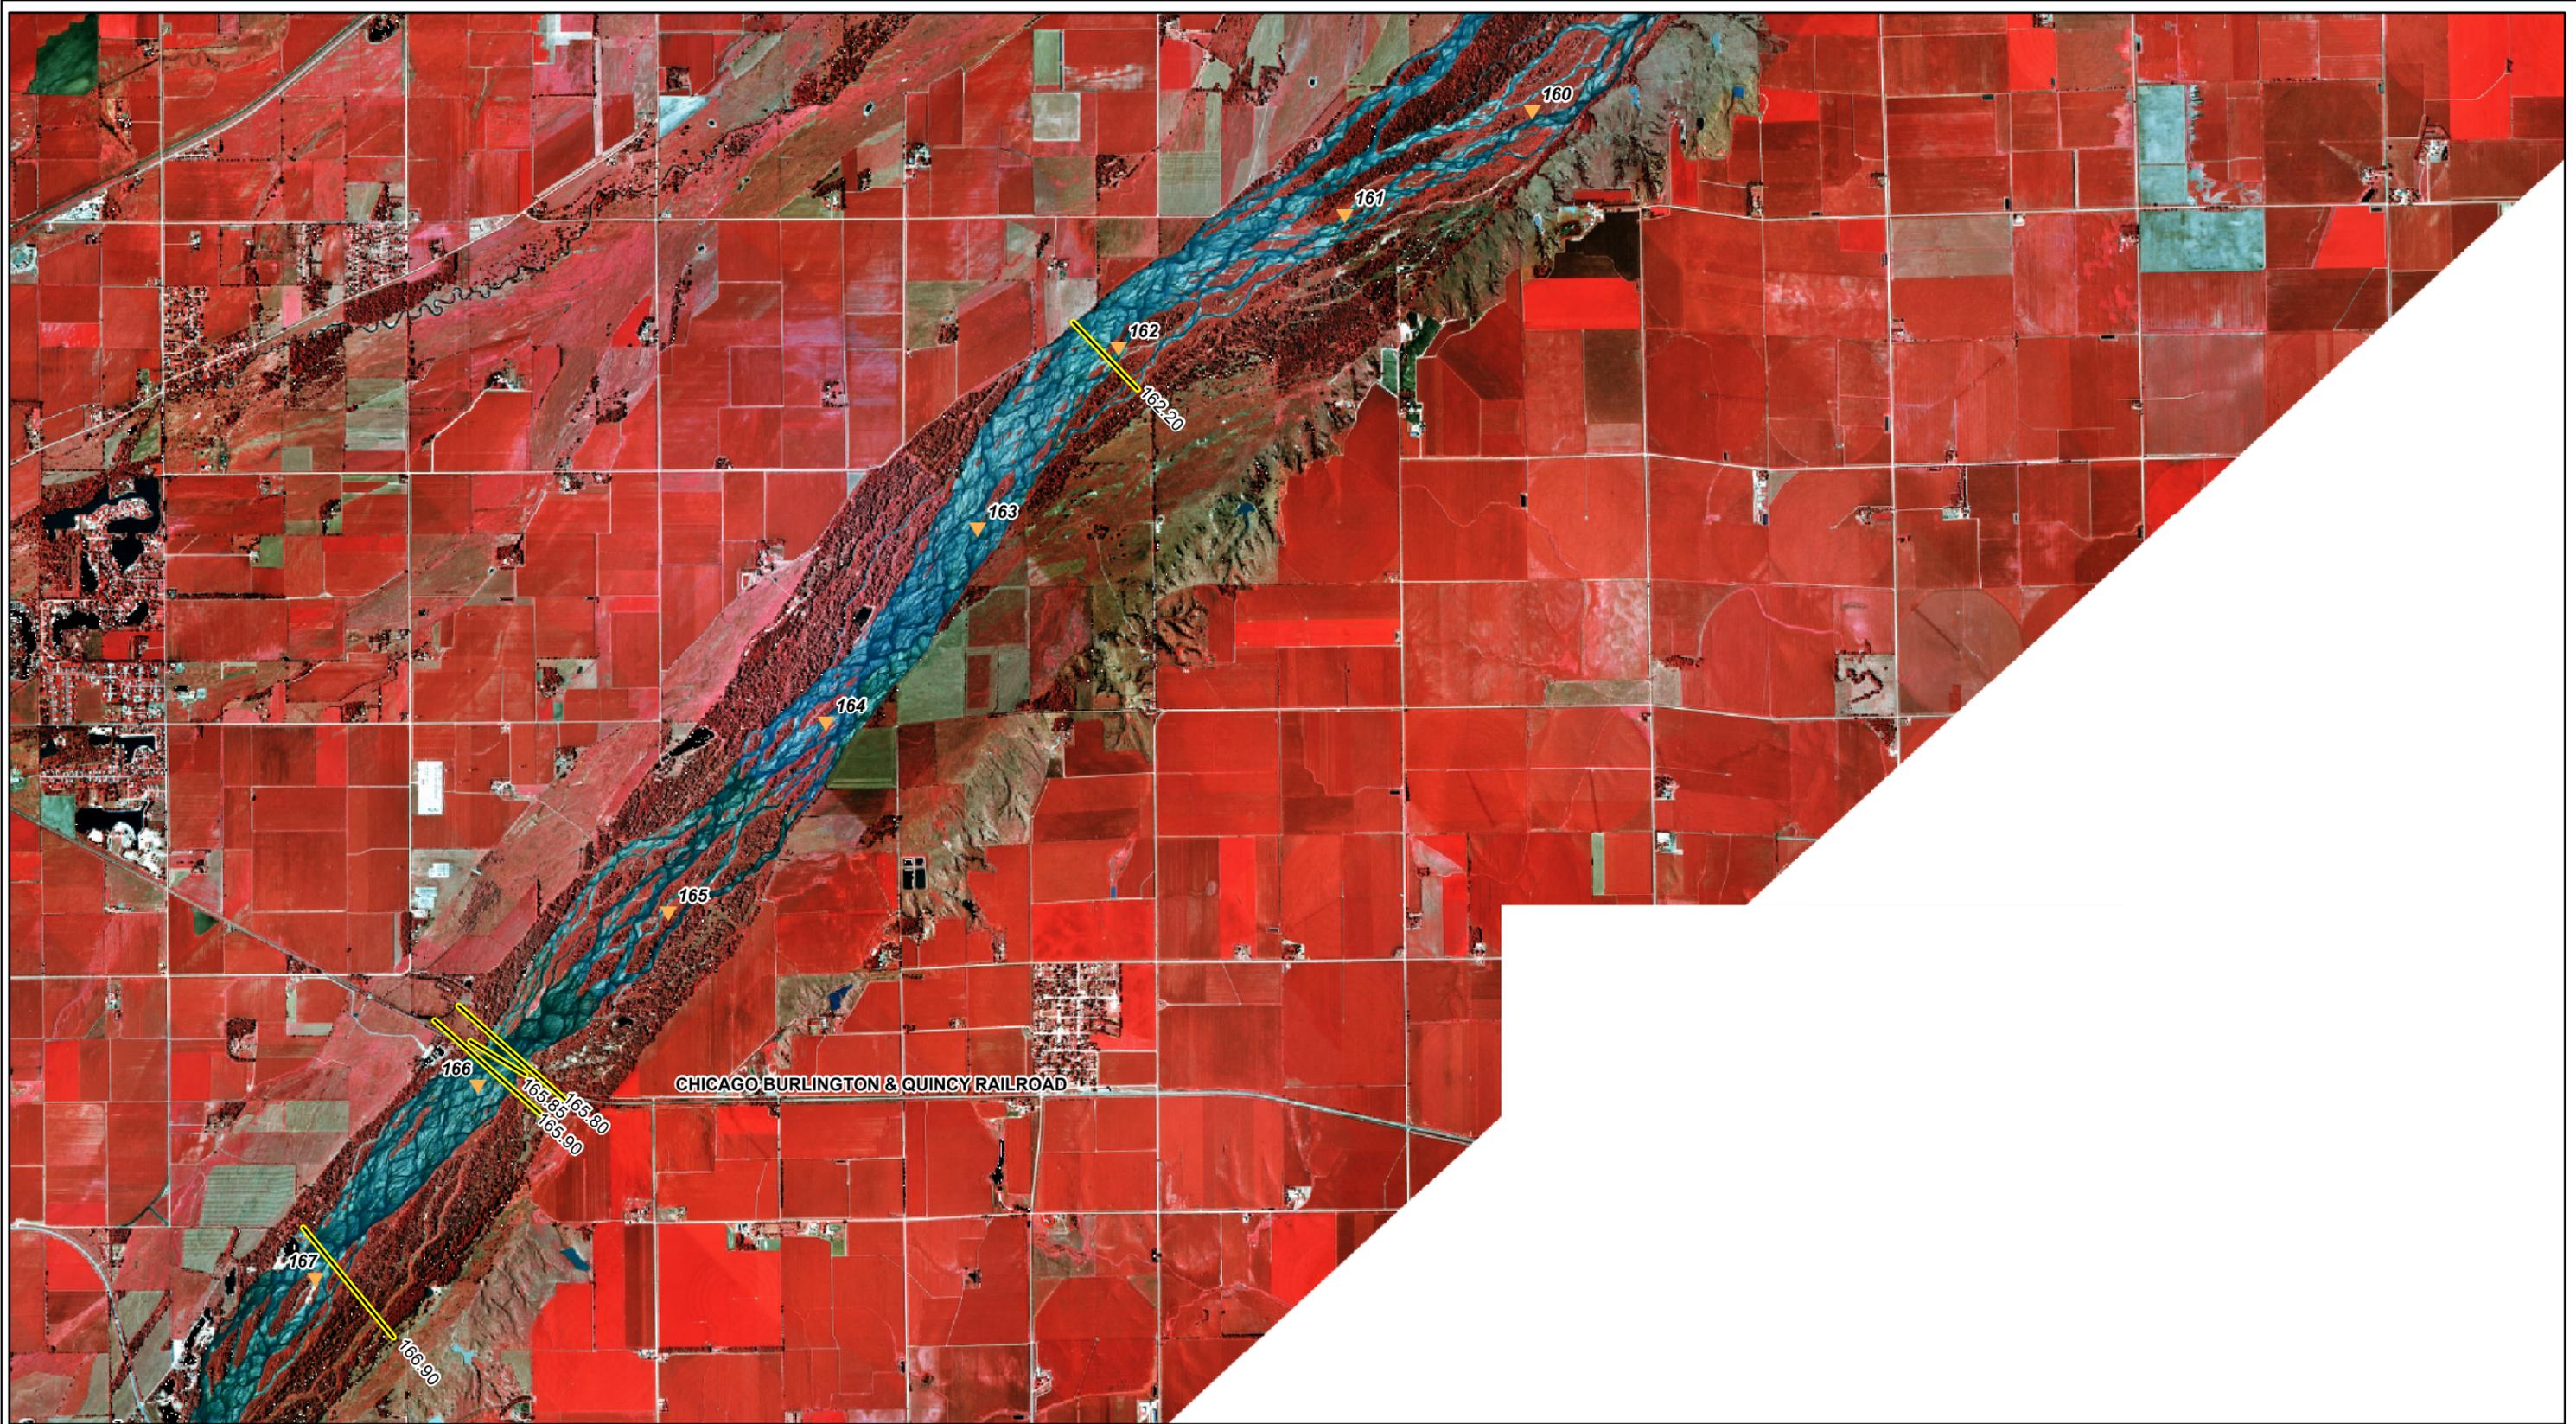
**Figure 3.14.**  
**Cross Section Locations: Sheet 13**  
**RECLAMATION**  
*Managing Water in the West*

- City/Town
- ▲ River mile
- 1989 cross section not used in analysis
- 1989 repeat cross section used in analysis
- 1985 repeat habitat transects not used in analysis
- 1985 repeat habitat transect used in analysis

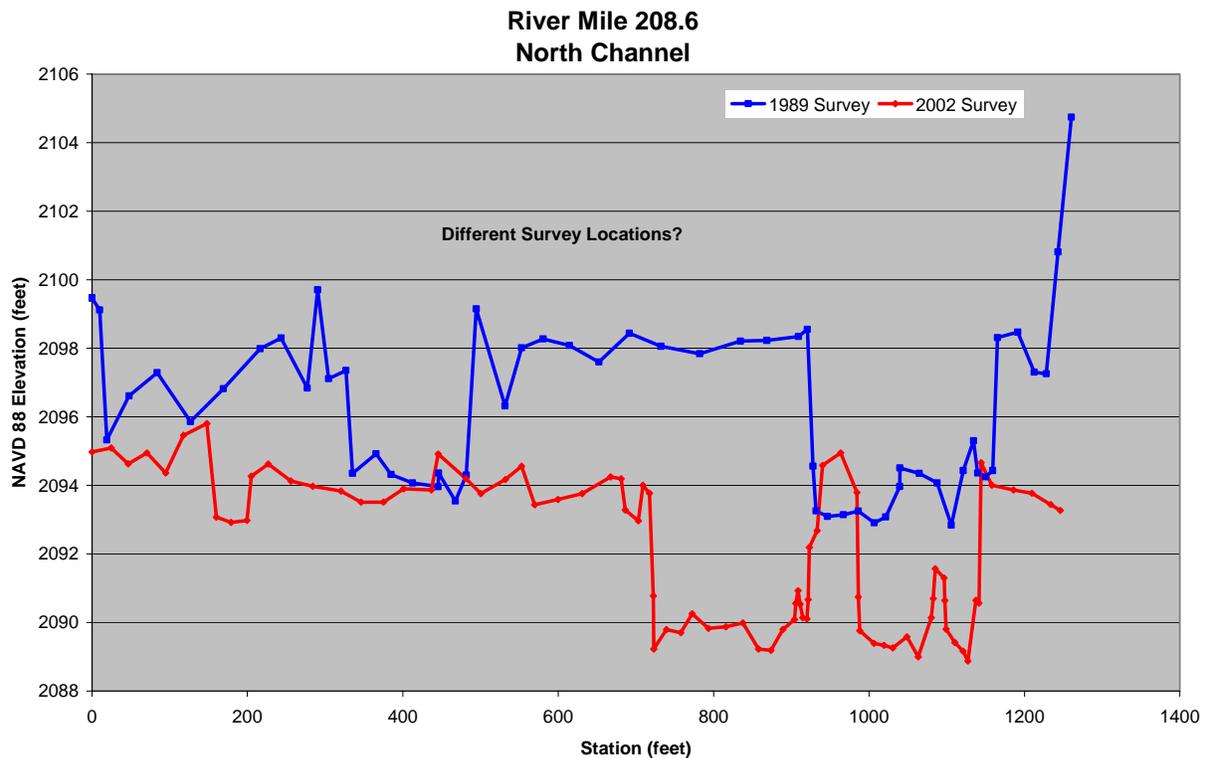
Figure 5.1. Example of a repeat cross section that was not considered for analysis due to either a skewed angle or possible different location than the original survey.

Repeat survey sites were not considered for analysis of aggradation and degradation if the repeat cross section or transect appeared to be at a skewed angle or at a different location than the original site (e.g. Figure 5.1). At several locations, overlaying repeat surveys indicated bank erosion. At sites where aerial photography verified the bank erosion, the surveys were retained for analysis of aggradation and degradation. The ground photo in Figure 5.2 illustrates a site where bank erosion was apparent.

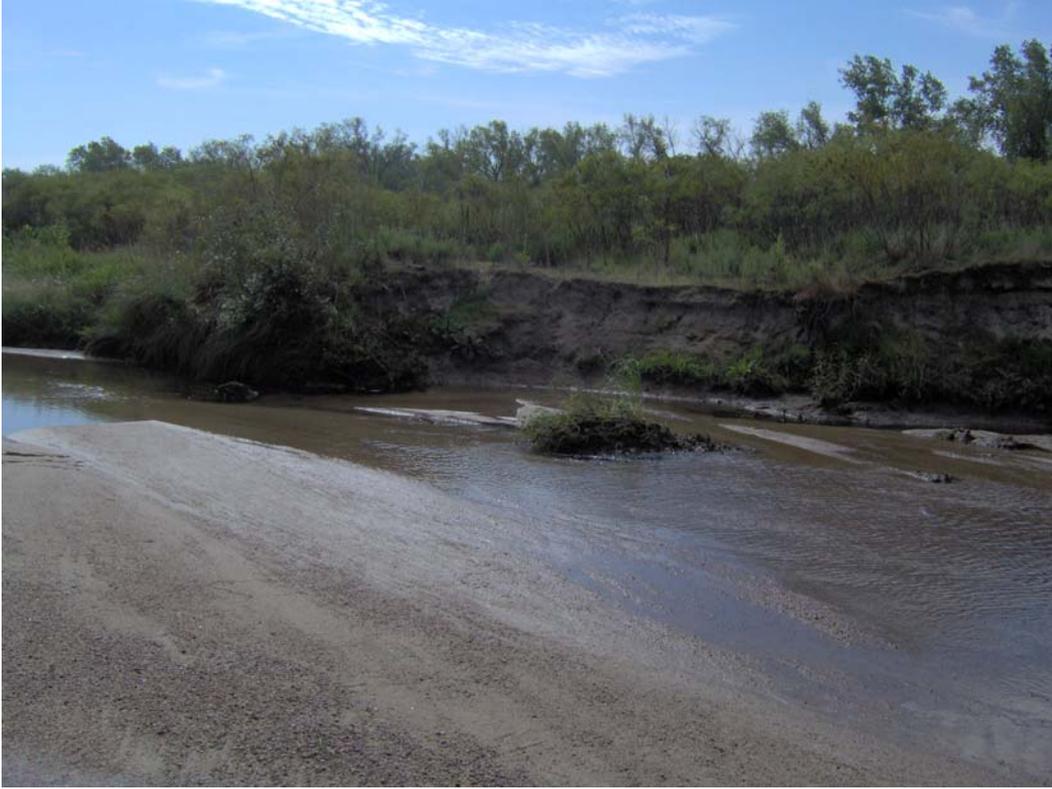
**Figure 5.2. Photograph demonstrating occurrences of bank erosion.**

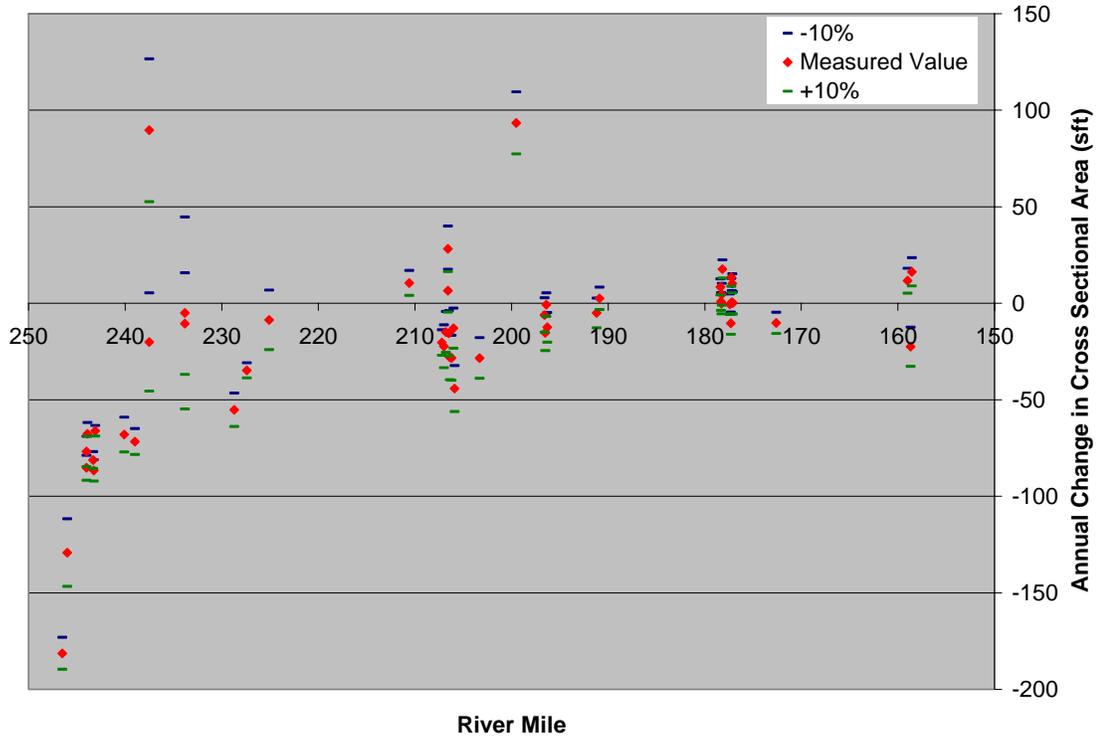
**Figure 6.1. Average annual change in cross-sectional area on main channel. Red points indicate change in cross-sectional area calculated using measured vertical transformations. Green and blue bars are calculated changes in cross-sectional area following a 10% increase and decrease in the value of the vertical transformation, respectively.**

Additional analyses were performed to examine the sensitivity of the results to changes to the vertical adjustments for the main channel of the Habitat Reach. Analyses were performed on the vertical adjustments to calculate potential limits of aggradation and degradation for determining the sensitivity of the average annual change in cross-sectional area to the vertical adjustment. To represent a maximum and minimum degradation value at each cross section and transect in the main channel of the Habitat Reach, the vertical adjustment was modified by adding and subtracting ten percent of its original value, resulting in two new cross-sectional areas (Figure 6.1). Values of plus or minus ten percent of the original vertical adjustment were selected to represent the most expected range of error in the vertical transformation. Small changes in the vertical adjustment

resulted in substantial differences in the average annual change in cross-sectional area. Although these modifications to the vertical adjustments altered the average annual change in the cross-sectional area at each site, they did not confuse general trends in degradation or aggradation from upstream to downstream.

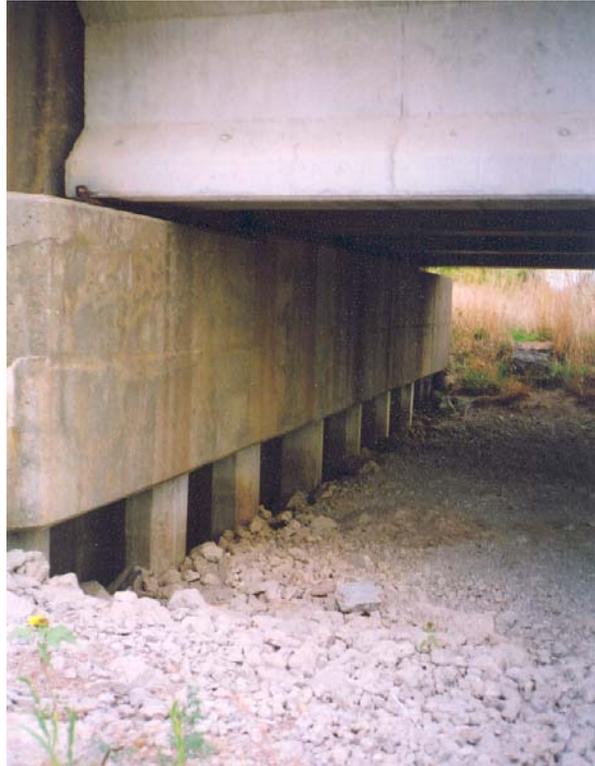
**Figure 8.1.** Example of bridge protection on the Central Platte River, Nebraska

Banks may have protection, such as riprap, crib walls or deflectors, to prevent erosion of the bridge abutments (e.g. Figure 8.1).
