## Forrest Conservation Area Reach Assessment Middle Fork John Day River

Grant County, Oregon

U.S. Department of the Interior  
Bureau of Reclamation  
Pacific Northwest Region  
Pacific Northwest Regional Office, Boise, Idaho

August 2010

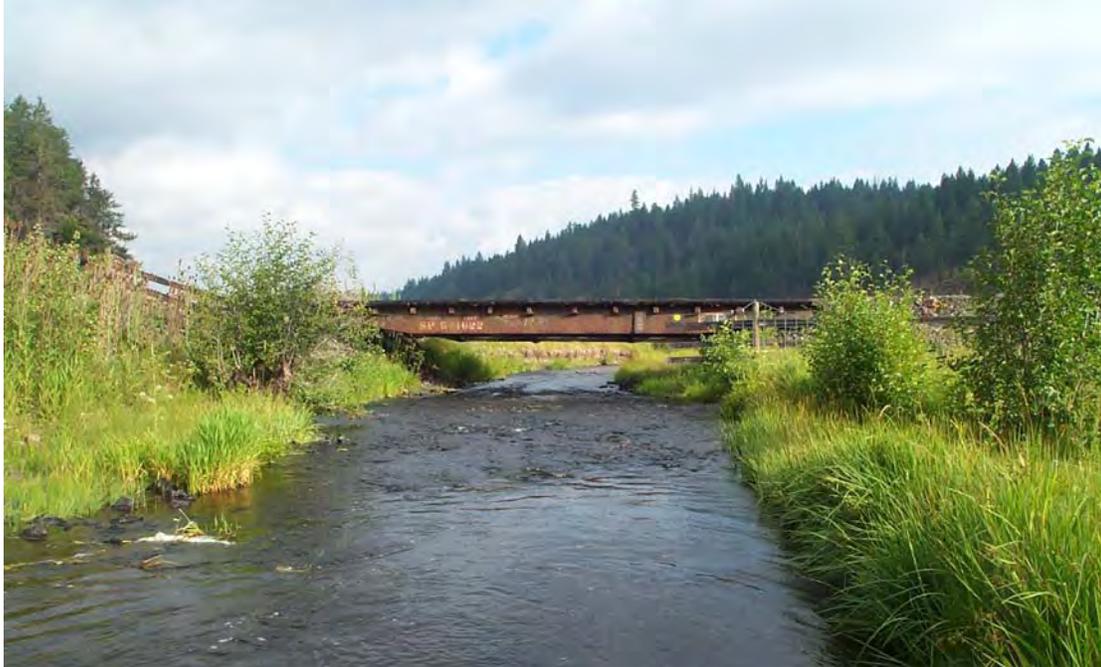
**Figure 9. View is to the northwest looking downstream at bridge crossing that restricts lateral channel migration.** Middle Fork John Day River, Oregon – Bureau of Reclamation Photograph by E. Lyon, July 19, 2007.

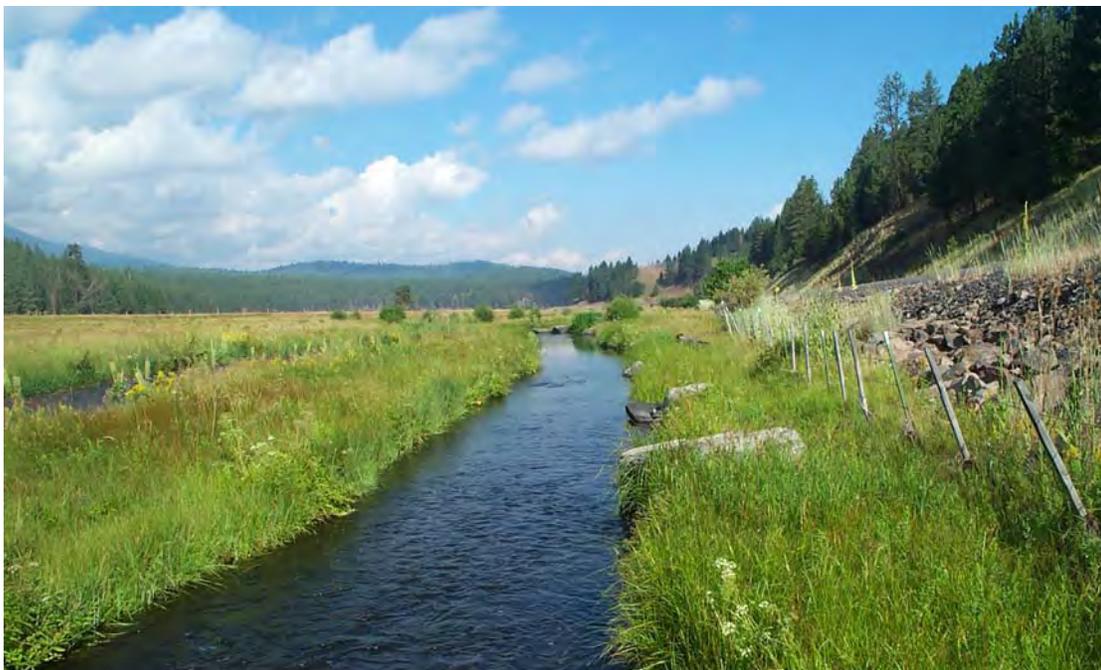
**Figure 10. View is to the northwest looking downstream at a series of rock spurs placed along river right.** Middle Fork John Day River, Oregon – Bureau of Reclamation Photograph by E. Lyon, July 19, 2007.

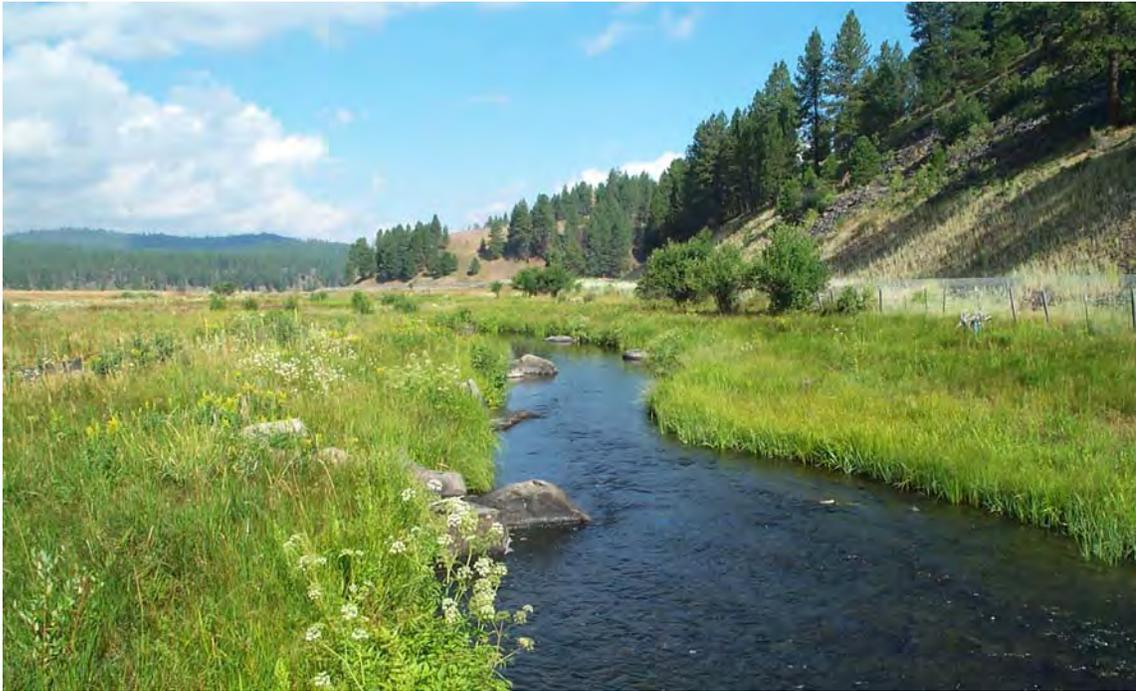
**Figure 12. View is to the northwest looking downstream at a series of rock spurs.** Middle Fork John Day River, Oregon – Bureau of Reclamation Photograph by E. Lyon, July 19, 2007.

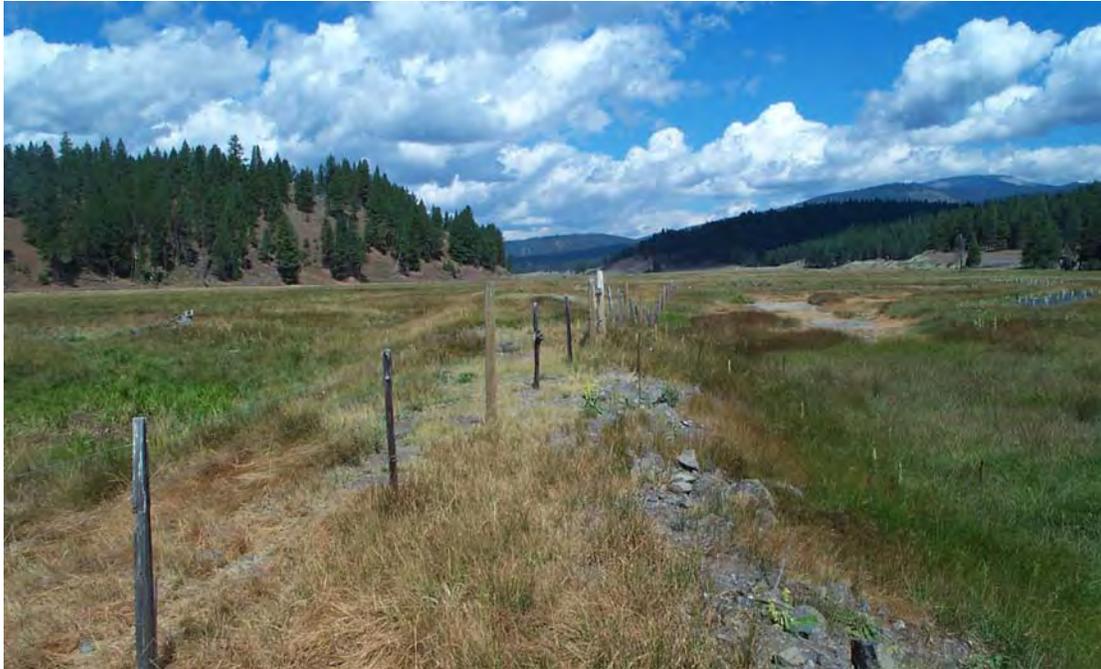
The most notable impacts to physical and ecological processes in this area include (1) stream channelization disconnecting historic channel paths, (2) reduction in floodplain connectivity due to the railroad grade (Figure 14), (3) restricted lateral channel migration due to bank protection (Figure 15), (4) stream bank instability along sections that do not have bank protection and lack woody riparian vegetation, (5) lack of a woody riparian buffer zone to provide shading and fish cover, and (6) lack of instream large wood.

**Figure 14. View is to the northwest looking downstream along the railroad grade where it bisects historic channel path in subreach FR-DIZ-3c. Middle Fork John Day River, Oregon – Bureau of Reclamation**  
Photograph by E. Lyon, July 19, 2007.

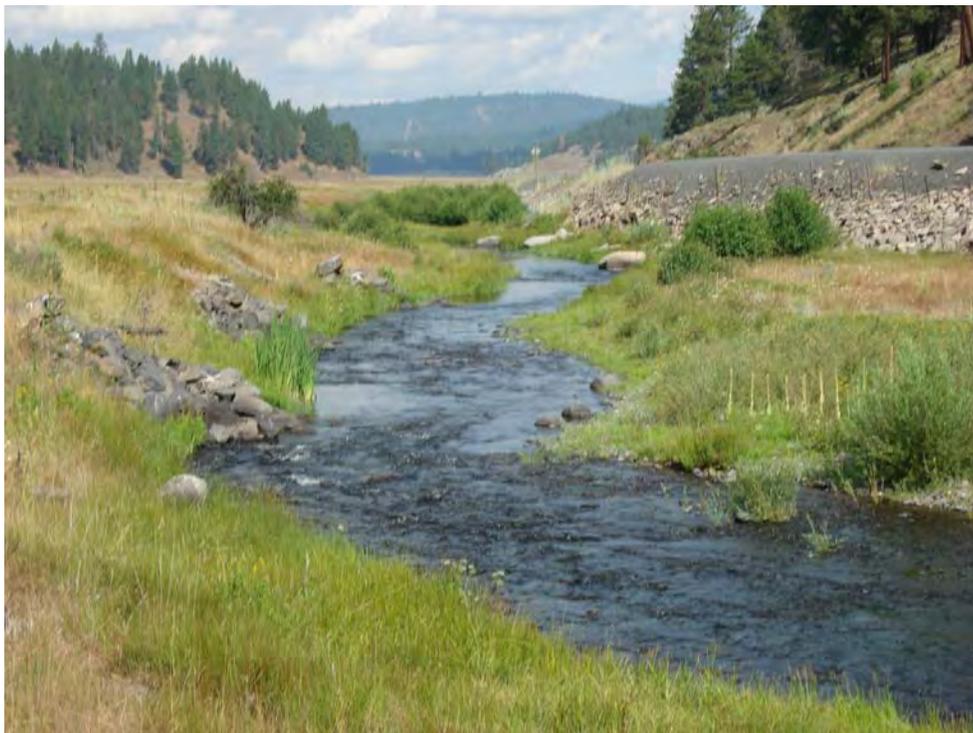
**Figure 15. View is to the northwest looking downstream at rock spurs placed along river left and boulders placed along river right along road embankment. Middle Fork John Day River, Oregon – Bureau of Reclamation**  
Photograph by R. McAfee, July 19, 2007.

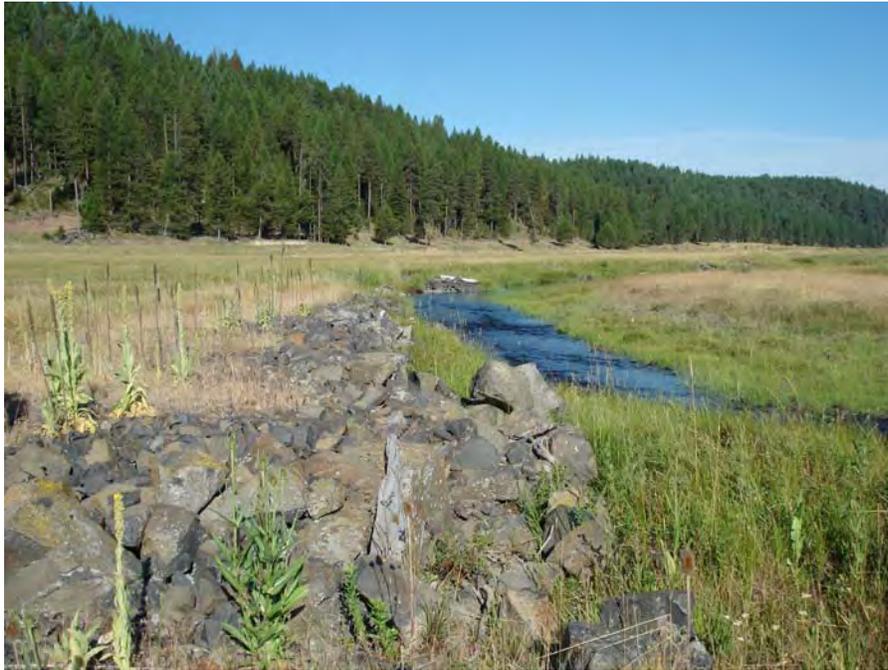
The most notable impacts to physical and ecological processes in this area include (1) reduction in floodplain connectivity, (2) restricted lateral channel migration due to bank protection (Figure 17), (3) stream bank instability along sections that lack appropriate woody riparian vegetation, (4) lack of woody riparian buffer zone to provide fish cover and shading, and (5) lack of instream large wood.

**Figure 17. View is to the west looking downstream at riprap placed along river left.** – Middle Fork John Day River, Oregon – Bureau of Reclamation Photograph by R. McAfee, July 20, 2007.

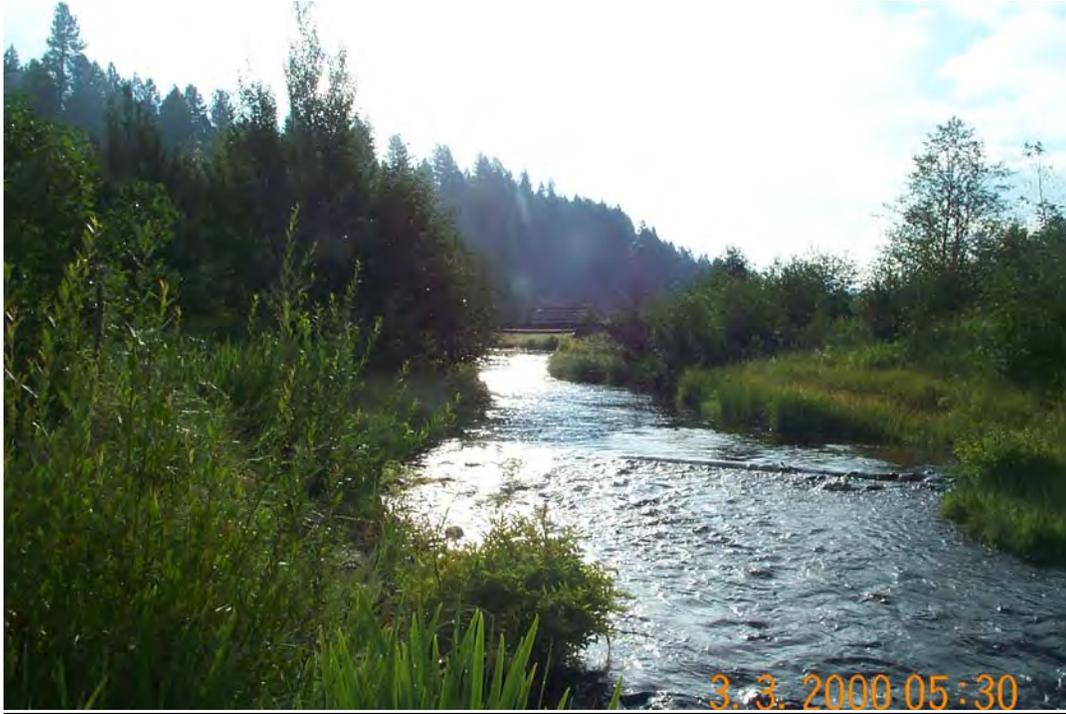
**Photograph No. 1. View is to the east looking upstream at bridge crossing. Middle Fork John Day River, Oregon – Bureau of Reclamation Photograph by E. Lyon, July 19, 2007.**

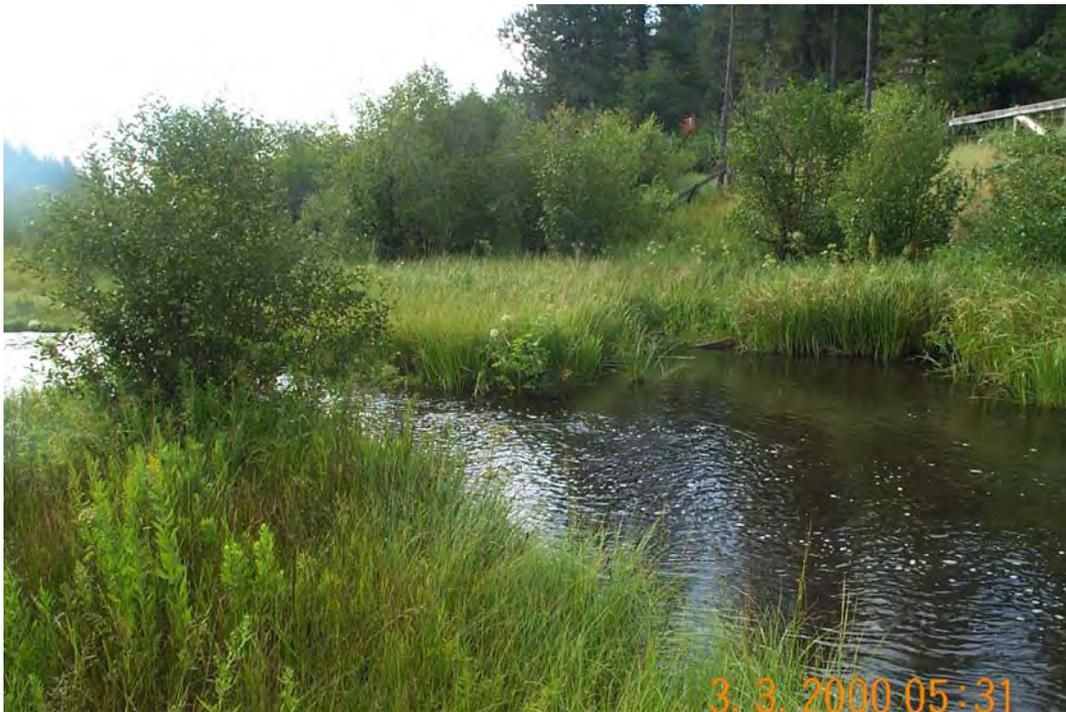
**Photograph No. 2. View is to the southeast looking upstream at wetland area (seep?) along river left. Middle Fork John Day River, Oregon – Bureau of Reclamation Photograph by E. Lyon, July 19, 2007.**

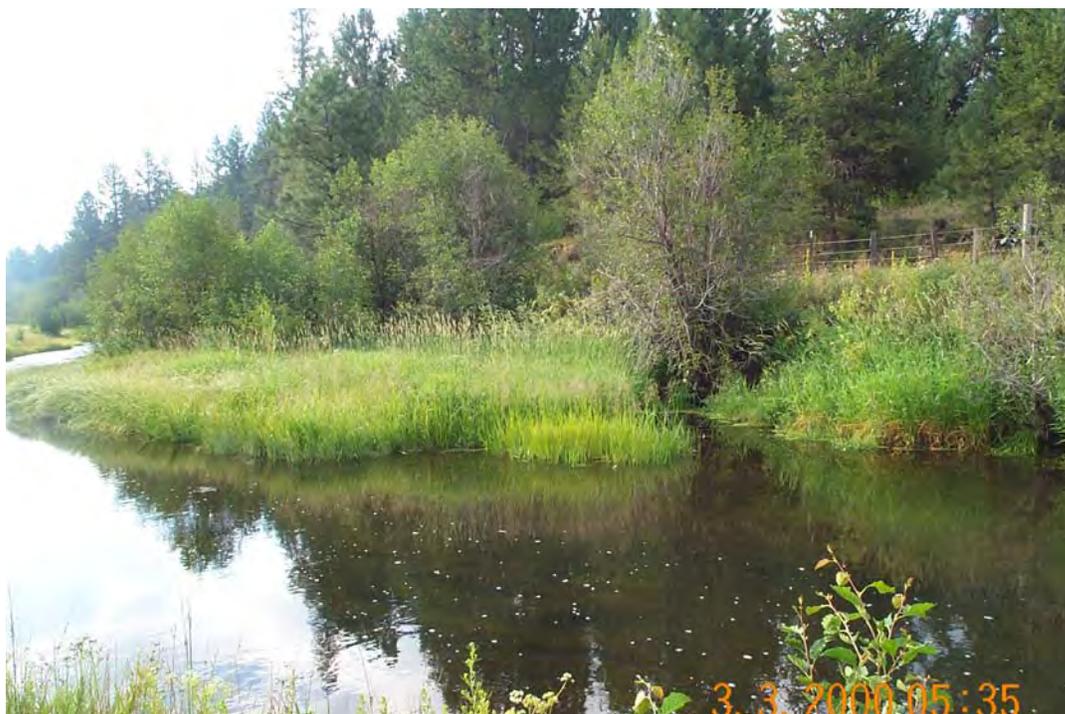
**Photograph No. 4. View is to the south looking upstream at wetland area (seep?) along river left. Middle Fork John Day River, Oregon – Bureau of Reclamation Photograph by E. Lyon, July 19, 2007.**

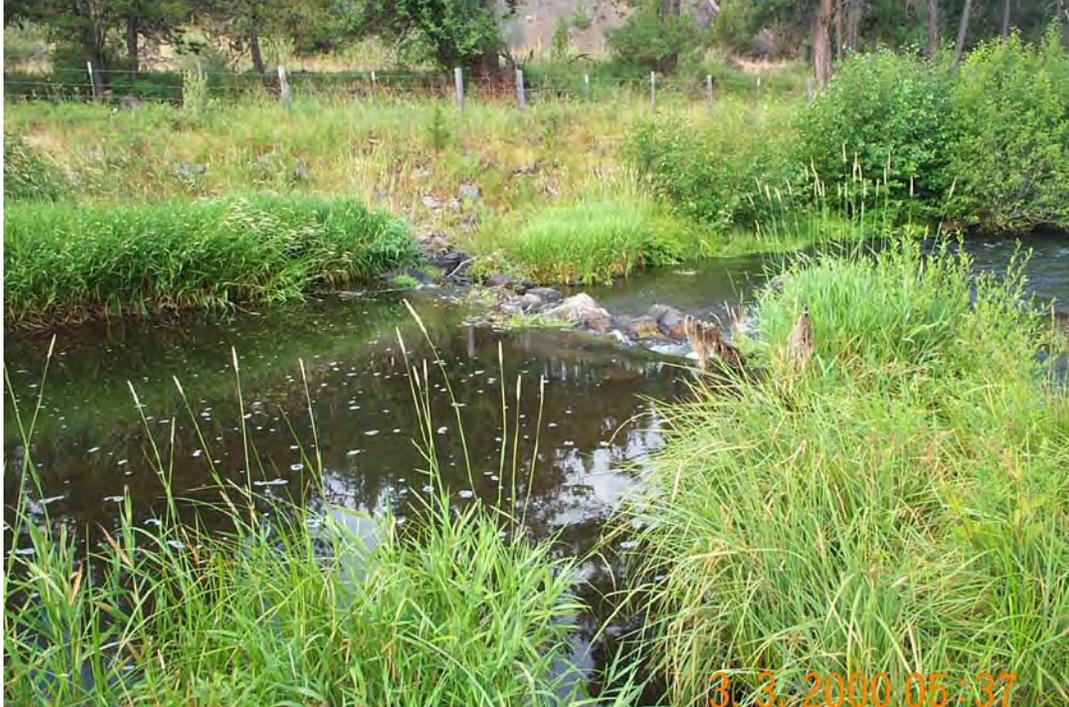
**Photograph No. 5. View is to the west looking downstream at irrigation diversion dam. Middle Fork John Day River, Oregon – Bureau of Reclamation Photograph by E. Lyon, July 19, 2007.**

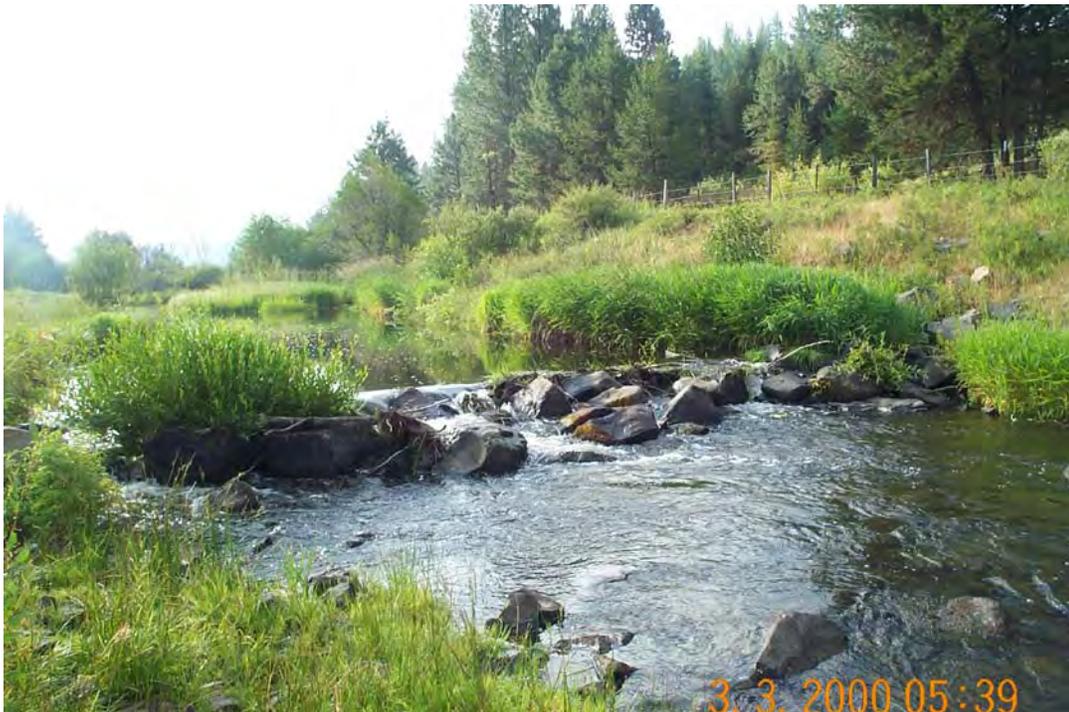
**Photograph No. 6. View is to the southwest looking upstream at irrigation diversion dam that appears to be a partial fish passage barrier. Middle Fork John Day River, Oregon – Bureau of Reclamation Photograph by E. Lyon, July 19, 2007.**

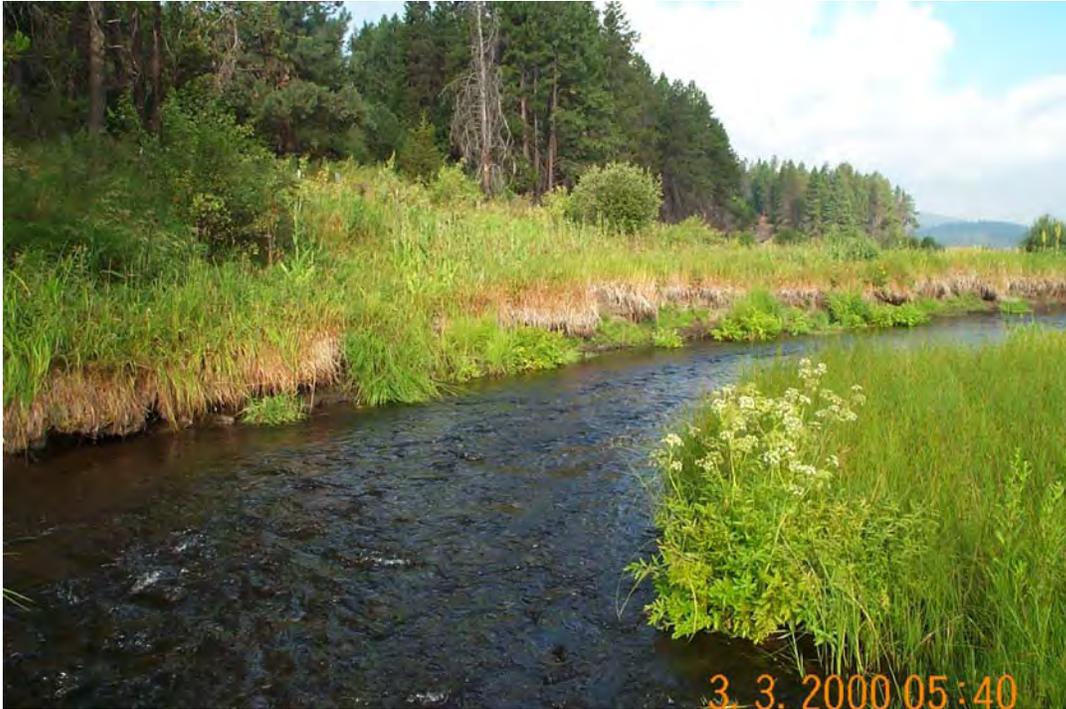
**Photograph No. 7. View is to the west looking downstream at bank erosion occurring along river left. Middle Fork John Day River, Oregon – Bureau of Reclamation Photograph by E. Lyon, July 19, 2007.**

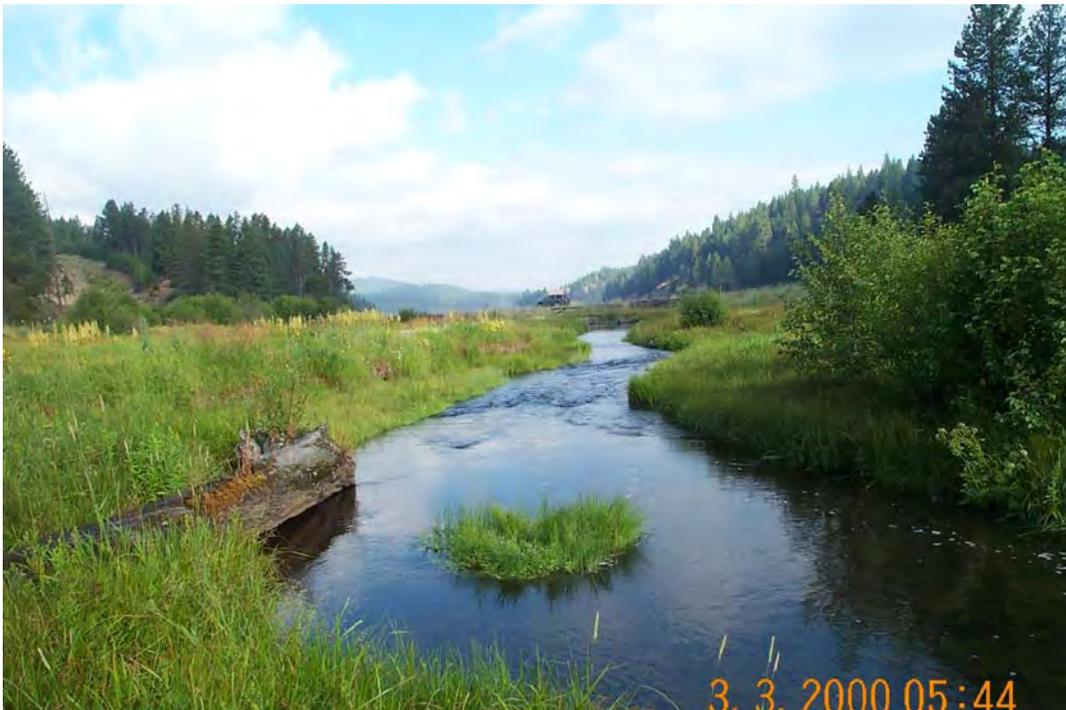
**Photograph No. 8. View is to the northwest looking downstream at one of the few pieces of large wood observed in the assessment area. Middle Fork John Day River, Oregon – Bureau of Reclamation Photograph by E. Lyon, July 19, 2007.**

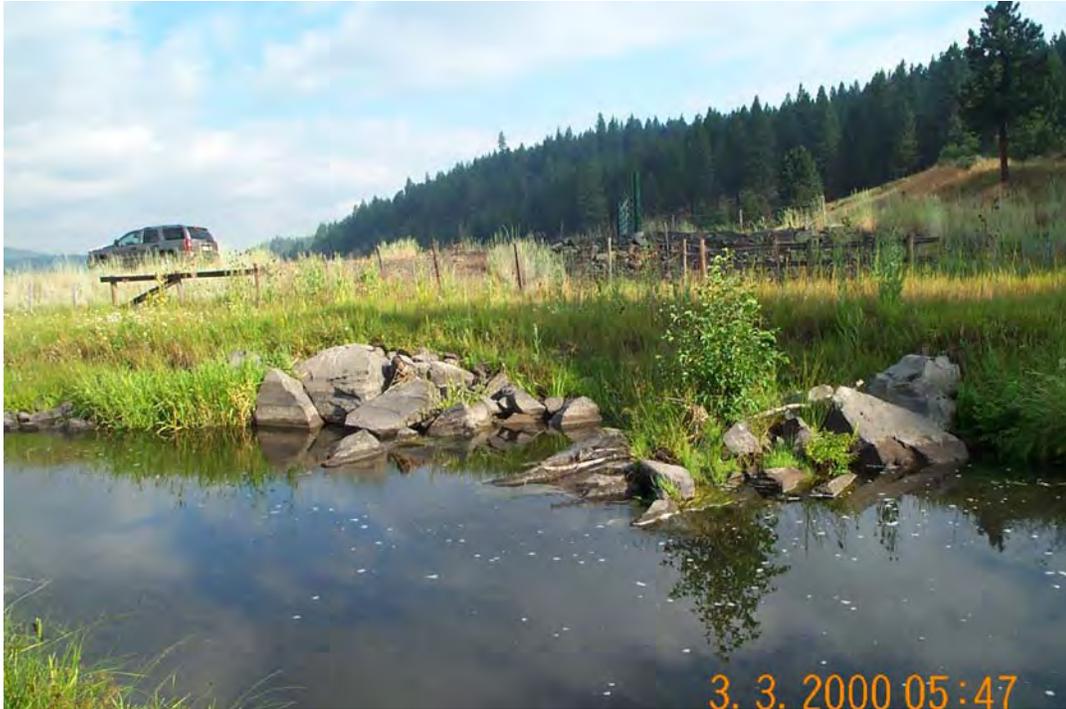
**Photograph No. 9. View is to the northwest looking downstream at rock spurs placed along river right. Middle Fork John Day River, Oregon – Bureau of Reclamation Photograph by E. Lyon, July 19, 2007.**

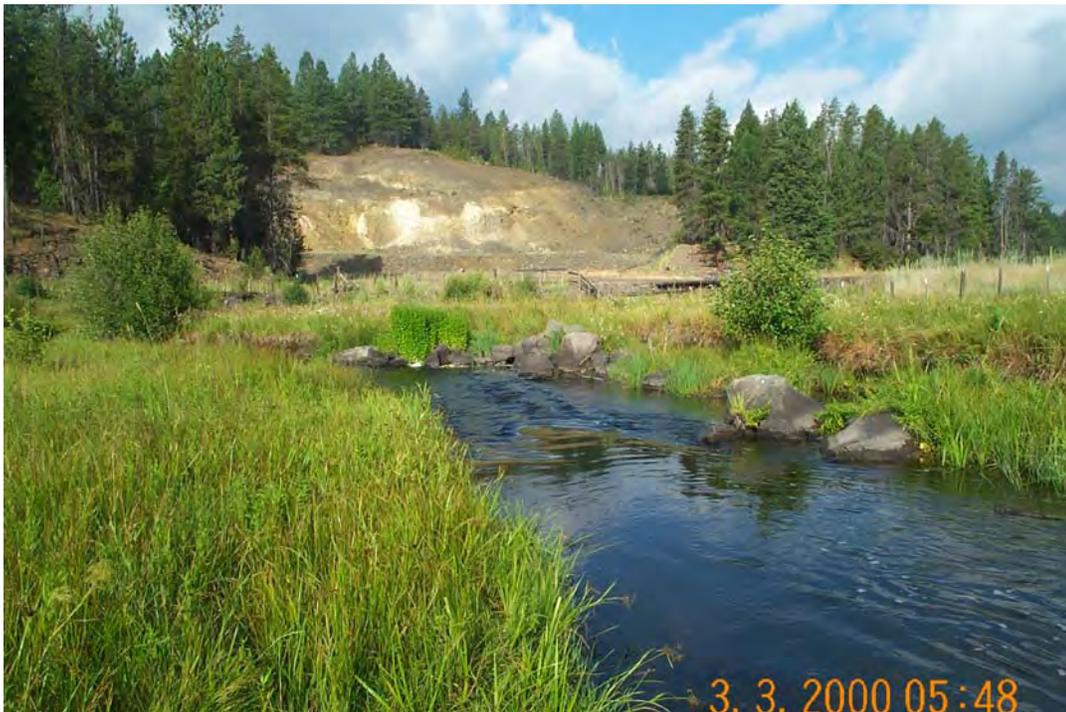
**Photograph No. 10. View is to the west looking downstream at rock spurs placed along river right. Middle Fork John Day River, Oregon – Bureau of Reclamation Photograph by E. Lyon, July 19, 2007.**

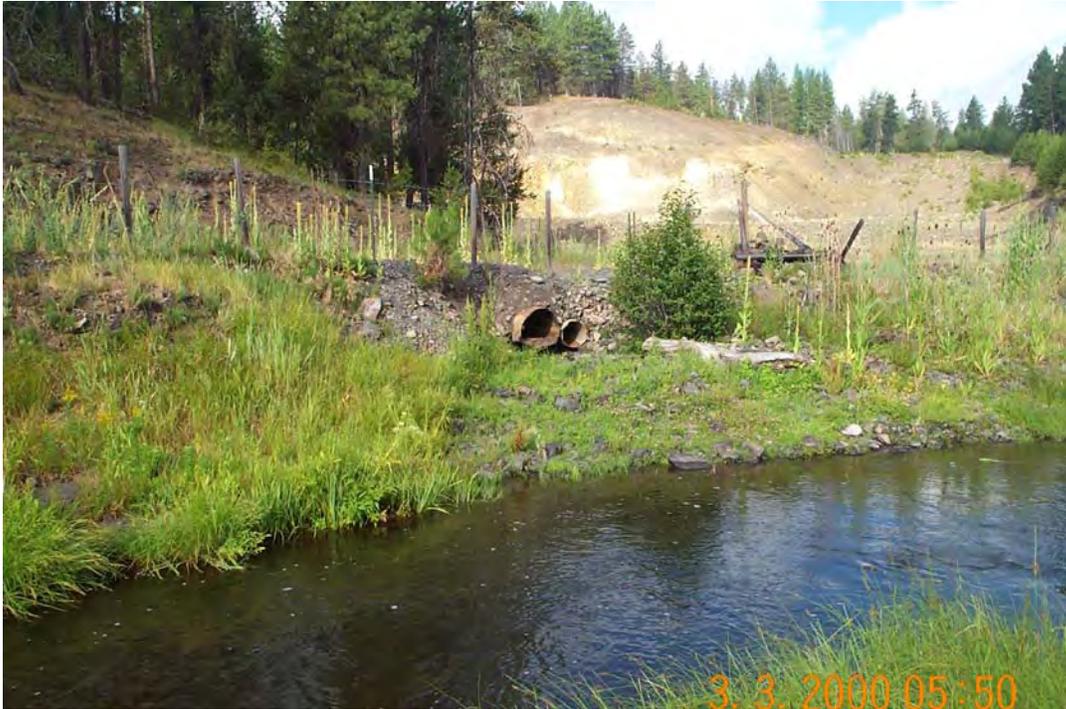
**Photograph No. 11. View is to the west looking at elevated culverts placed through road embankment that pass tributary flows. Middle Fork John Day River, Oregon – Bureau of Reclamation Photograph by E. Lyon, July 19, 2007.**

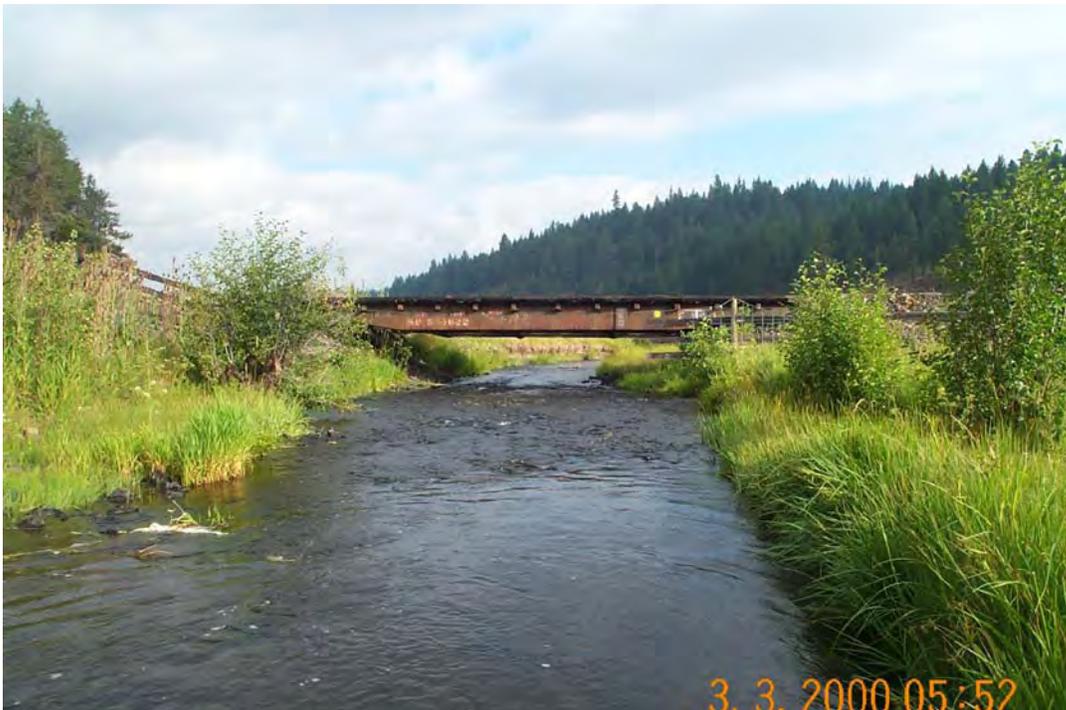
**Photograph No. 12. View is to the northwest looking downstream at bridge crossing that restricts lateral channel migration. Middle Fork John Day River, Oregon – Bureau of Reclamation Photograph by E. Lyon, July 19, 2007.**

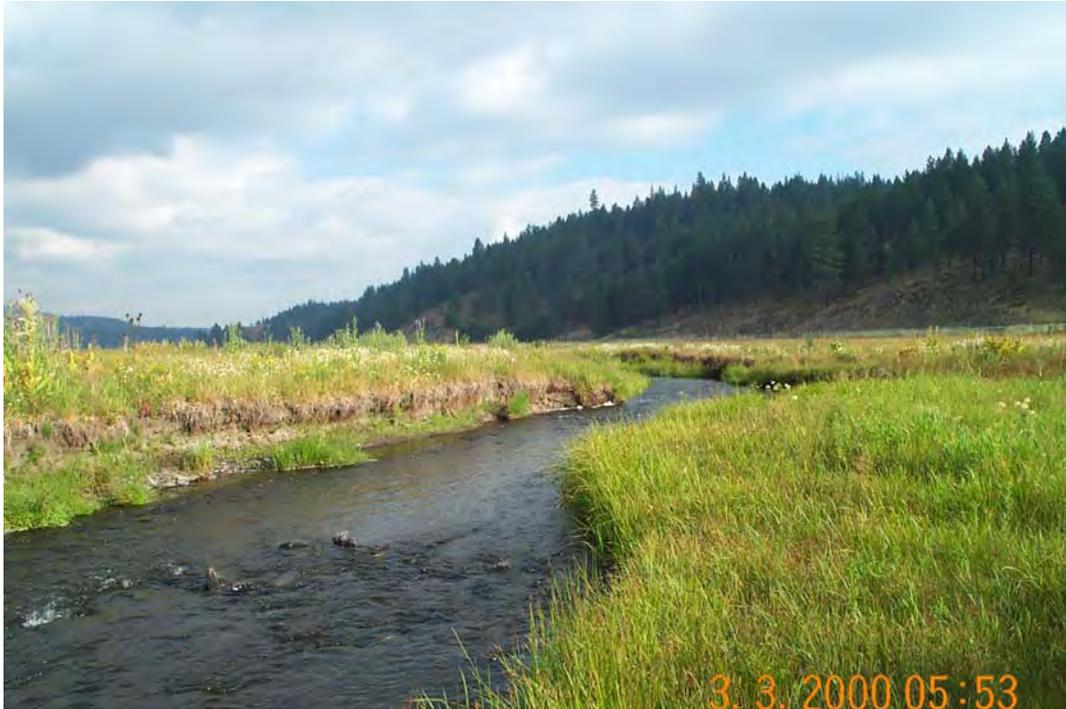
**Photograph No. 13. View is to the northwest looking downstream at bank erosion along river left. Middle Fork John Day River, Oregon – Bureau of Reclamation Photograph by E. Lyon, July 19, 2007.**

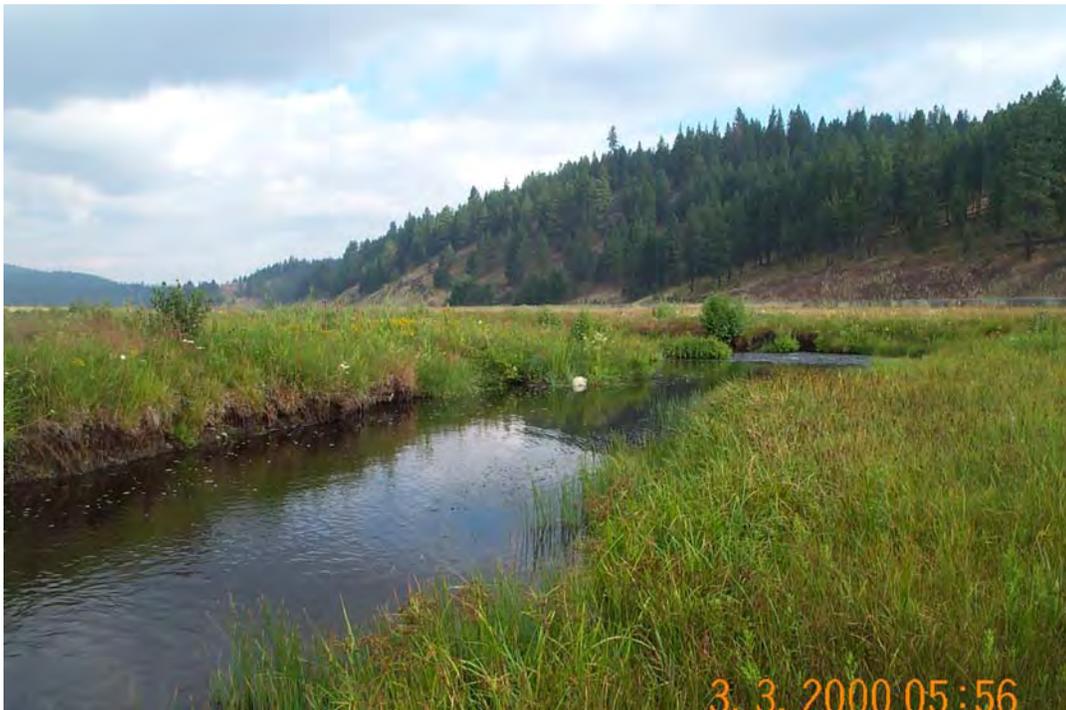
**Photograph No. 14. View is to the north looking downstream at bank erosion occurring along river left. Middle Fork John Day River, Oregon – Bureau of Reclamation Photograph by E. Lyon, July 19, 2007.**

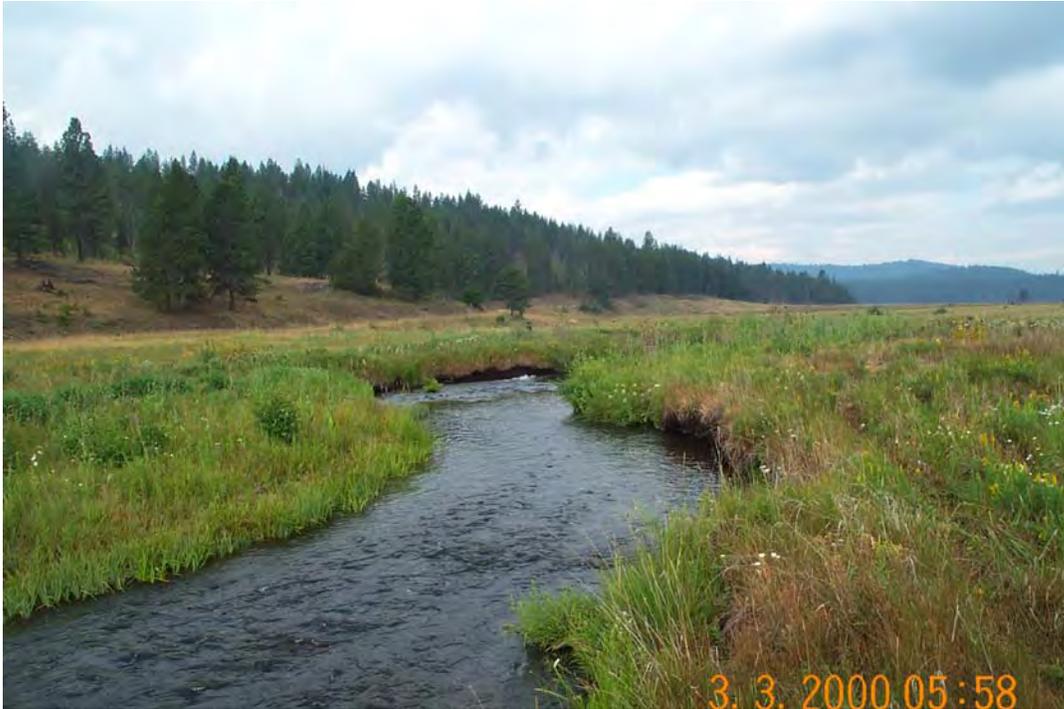
**Photograph No. 15. View is to the west looking downstream at bank erosion occurring along both riverbanks. Middle Fork John Day River, Oregon – Bureau of Reclamation Photograph by E. Lyon, July 19, 2007.**

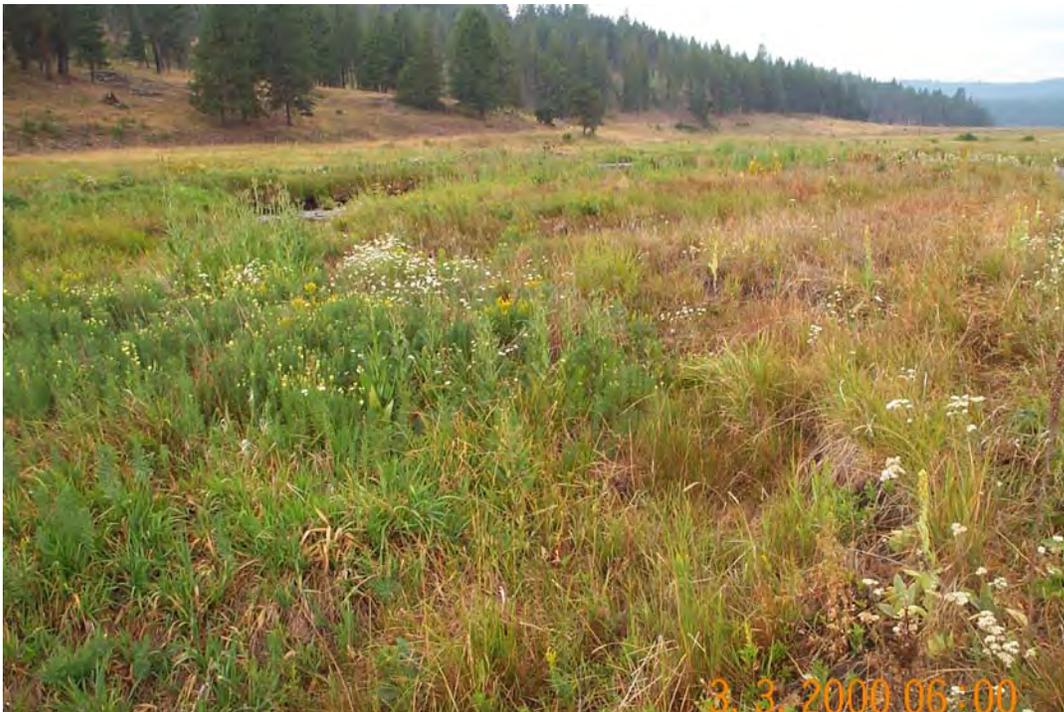
**Photograph No. 16. View is to the west looking downstream along overflow channel on river right. Middle Fork John Day River, Oregon – Bureau of Reclamation Photograph by E. Lyon, July 19, 2007.**

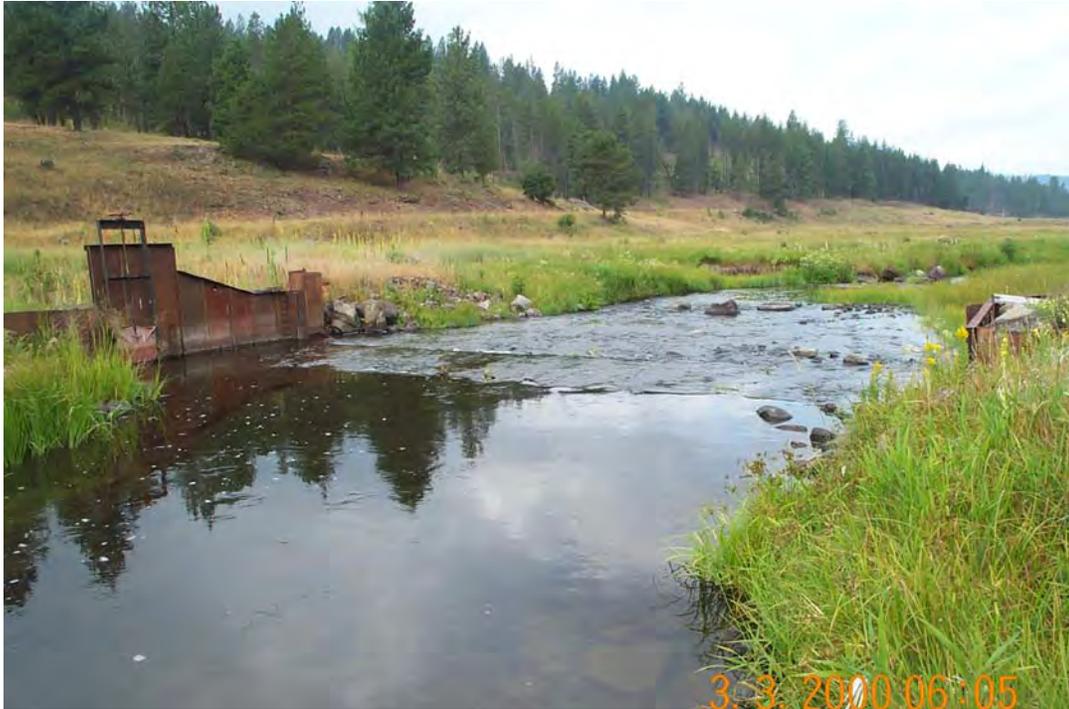
**Photograph No. 17. View is to the west looking downstream at irrigation diversion dam. Middle Fork John Day River, Oregon – Bureau of Reclamation Photograph by E. Lyon, July 19, 2007.**

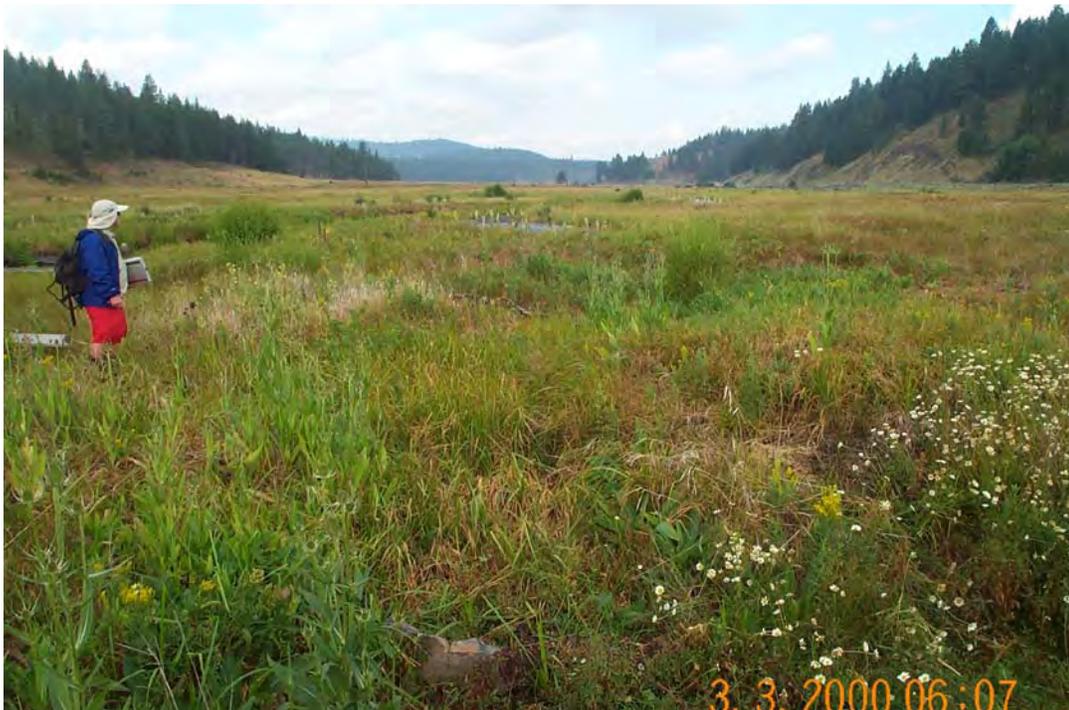
**Photograph No. 18. View is to the northwest looking downstream along historic overflow channel path or irrigation ditch. Middle Fork John Day River, Oregon – Bureau of Reclamation Photograph by E. Lyon, July 19, 2007.**

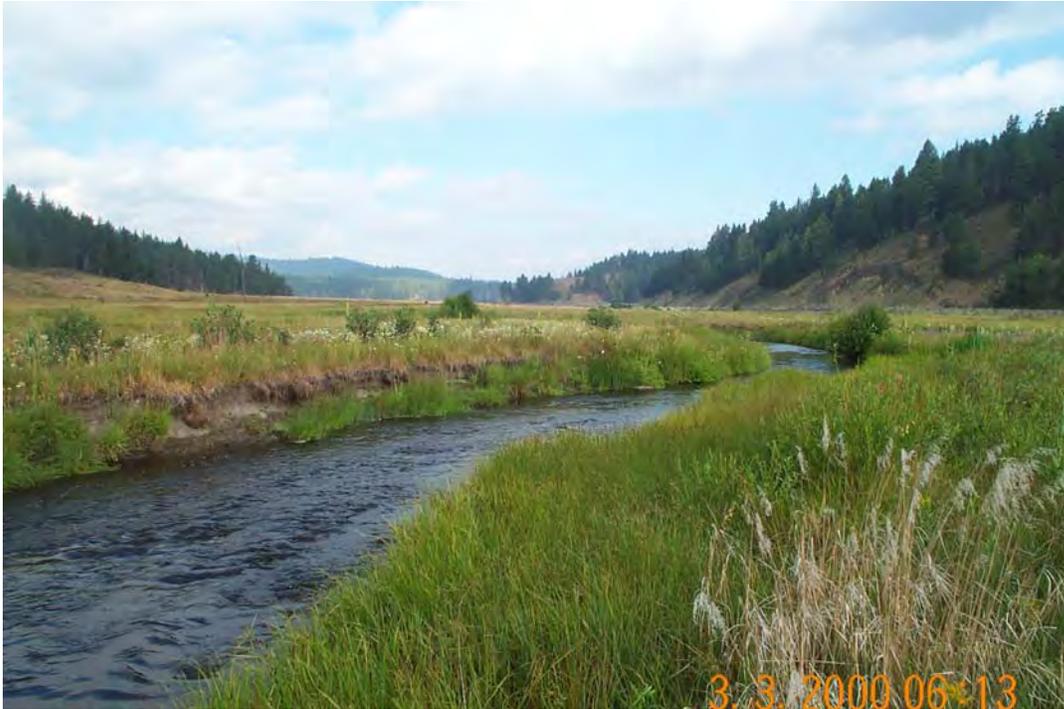
**Photograph No. 19. View is to the northwest looking downstream at bank erosion occurring along river left. Middle Fork John Day River, Oregon – Bureau of Reclamation Photograph by E. Lyon, July 19, 2007.**

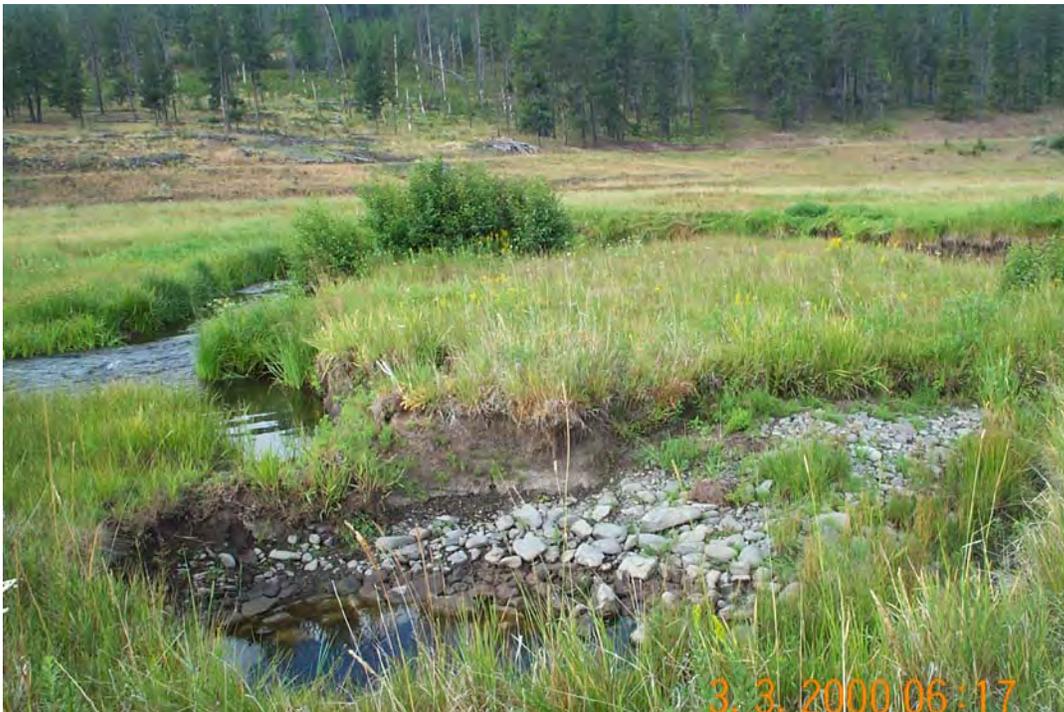
**Photograph No. 20. View is to the west looking at a potential river avulsion site. Middle Fork John Day River, Oregon – Bureau of Reclamation Photograph by E. Lyon, July 19, 2007.**

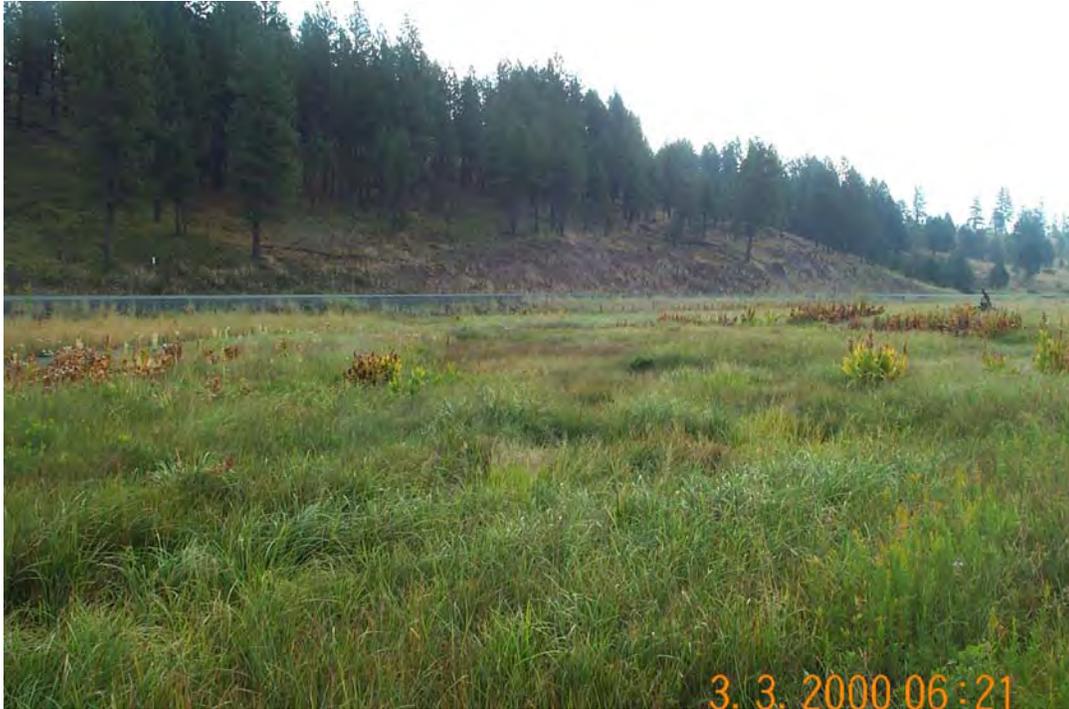
**Photograph No. 21.** View is to the southeast looking upstream at historic overflow channel path or irrigation ditch. Middle Fork John Day River, Oregon – Bureau of Reclamation Photograph by E. Lyon, July 19, 2007.

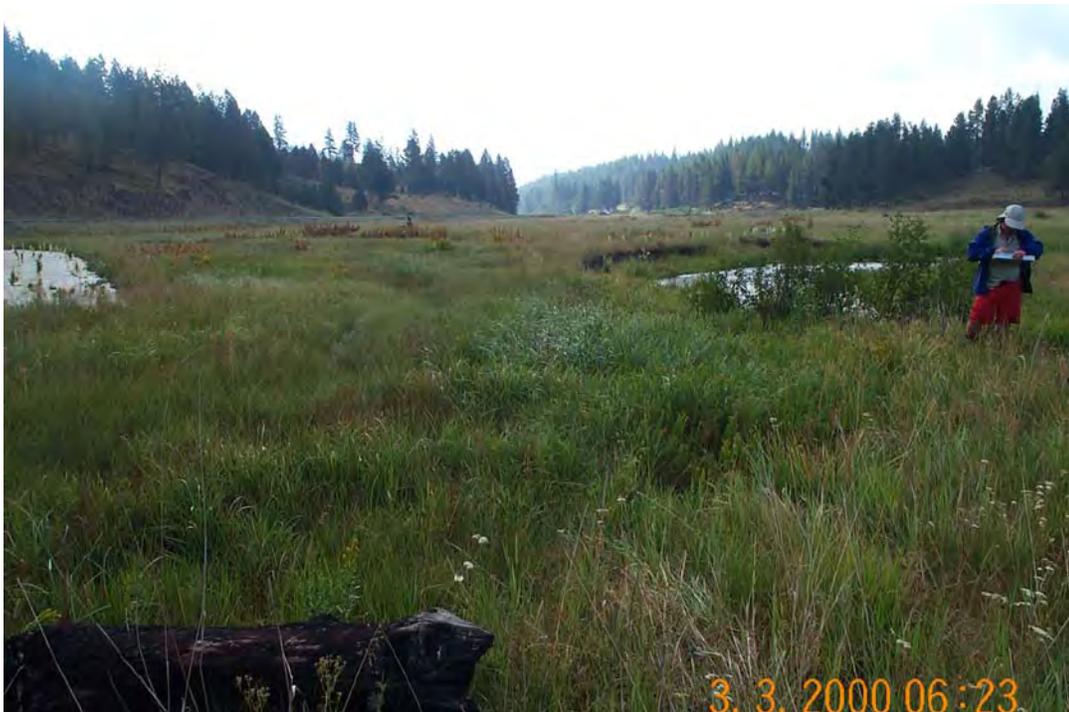
**Photograph No. 22.** View is to the south looking upstream along overflow channel path. Middle Fork John Day River, Oregon – Bureau of Reclamation Photograph by E. Lyon, July 19, 2007.

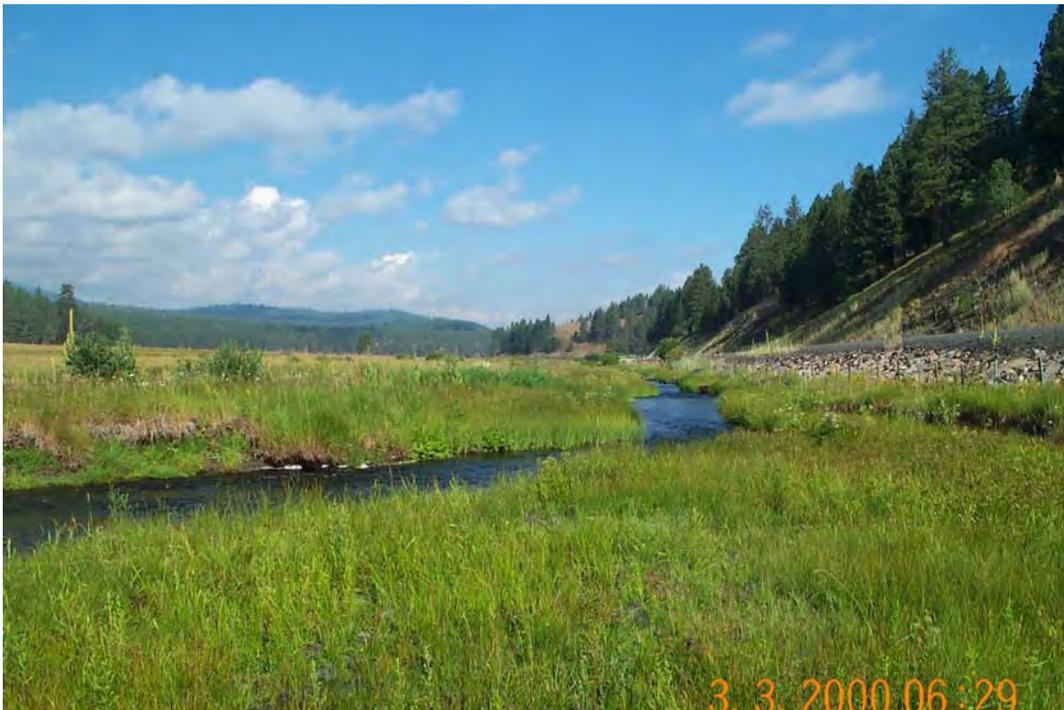
**Photograph No. 24. View is to the northwest looking downstream at bank erosion occurring along river left. Middle Fork John Day River, Oregon – Bureau of Reclamation Photograph by E. Lyon, July 19, 2007.**
