## Forrest Conservation Area Reach Assessment Middle Fork John Day River

Grant County, Oregon

U.S. Department of the Interior  
Bureau of Reclamation  
Pacific Northwest Region  
Pacific Northwest Regional Office, Boise, Idaho

August 2010

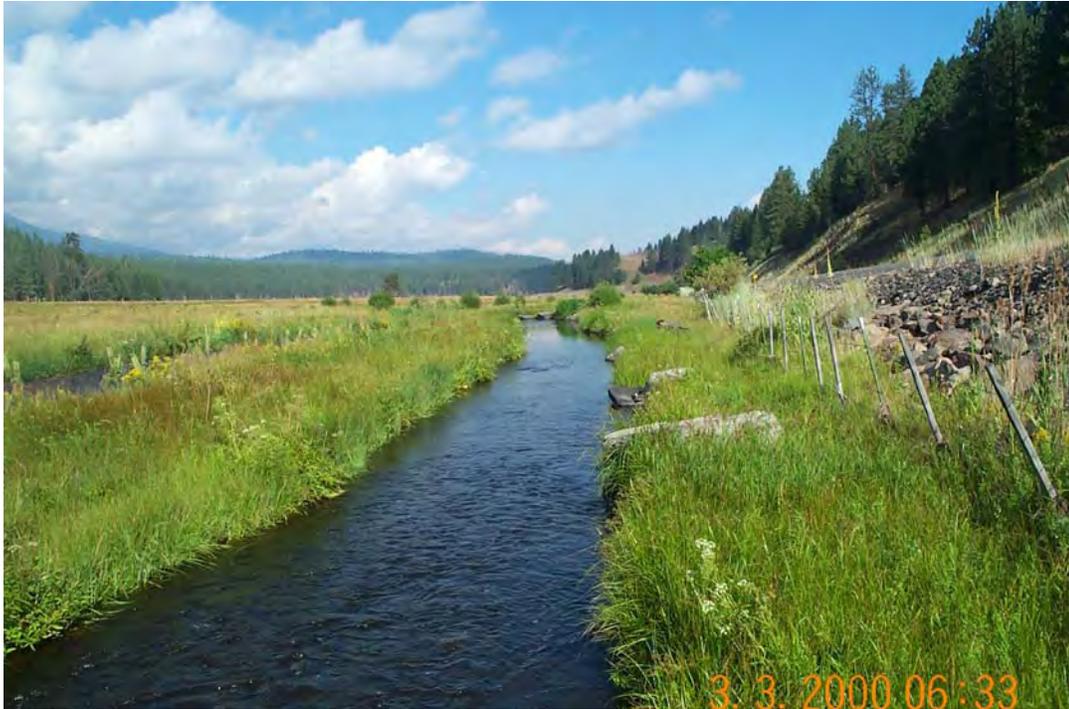
**Photograph No. 25. View is to the northwest looking downstream at a series of rock spurs placed along river right. Middle Fork John Day River, Oregon – Bureau of Reclamation Photograph by E. Lyon, July 19, 2007.**

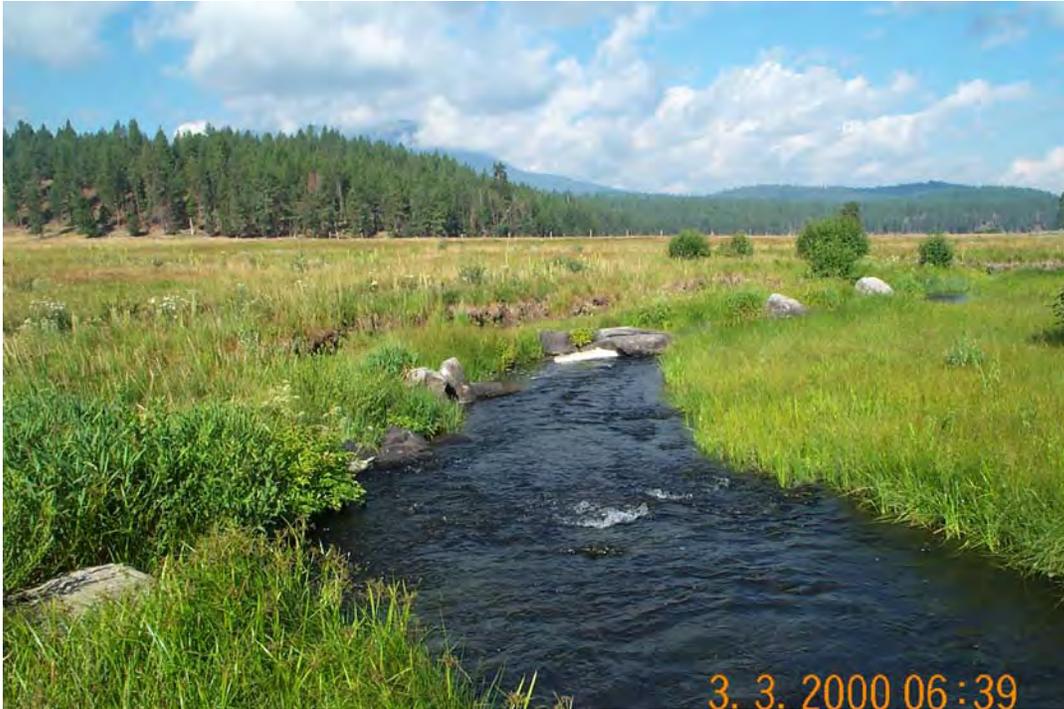
**Photograph No. 27.** View is to the northwest looking downstream at a series of rock spurs placed along river left. Middle Fork John Day River, Oregon – Bureau of Reclamation Photograph by E. Lyon, July 19, 2007.

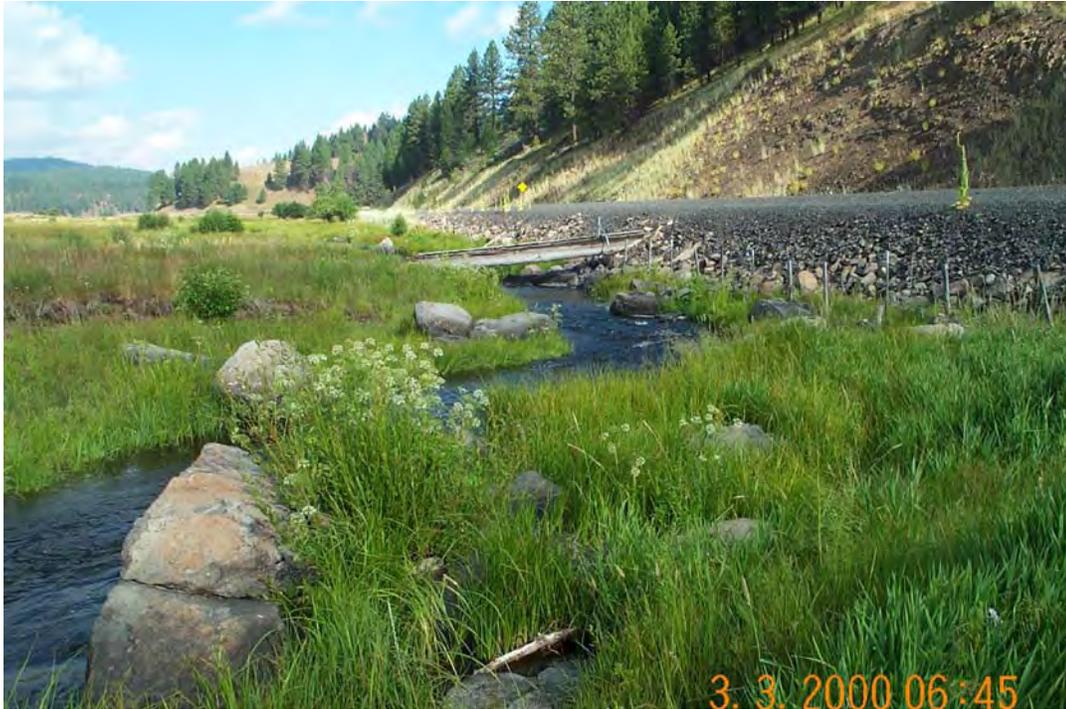
**Photograph No. 29.** View is to the northwest looking downstream at a series of rock spurs and footbridge. Middle Fork John Day River, Oregon – Bureau of Reclamation Photograph by E. Lyon, July 19, 2007.

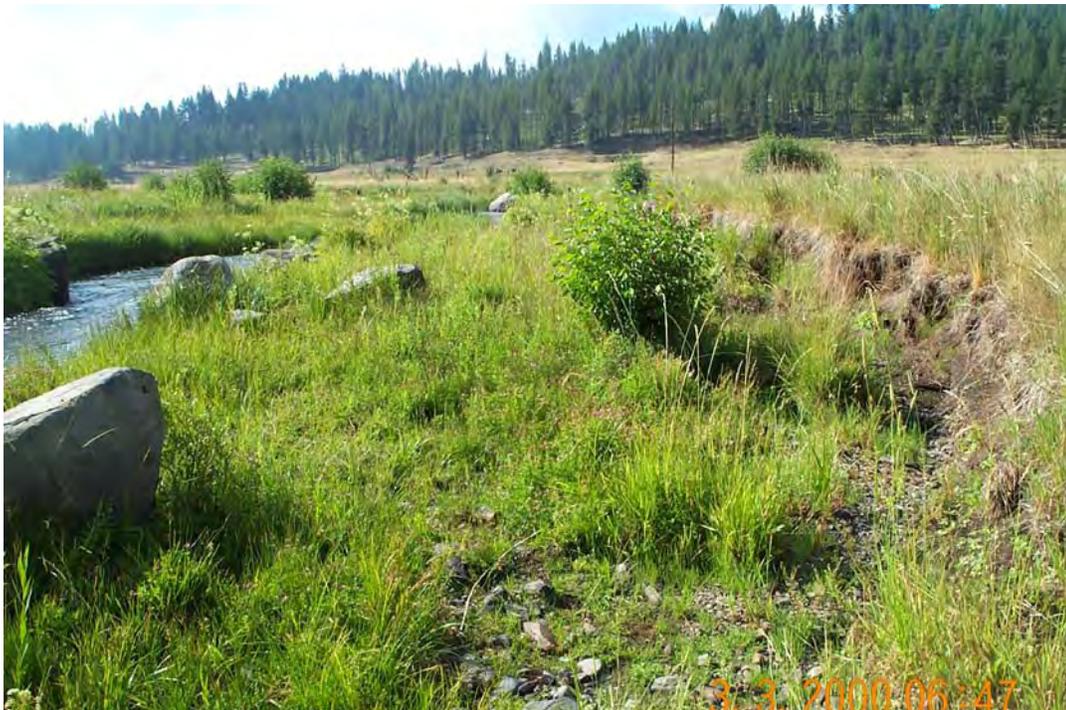
**Photograph No. 30.** View is to the south looking upstream at bank erosion behind rock spurs along river right. Middle Fork John Day River, Oregon – Bureau of Reclamation Photograph by E. Lyon, July 19, 2007.

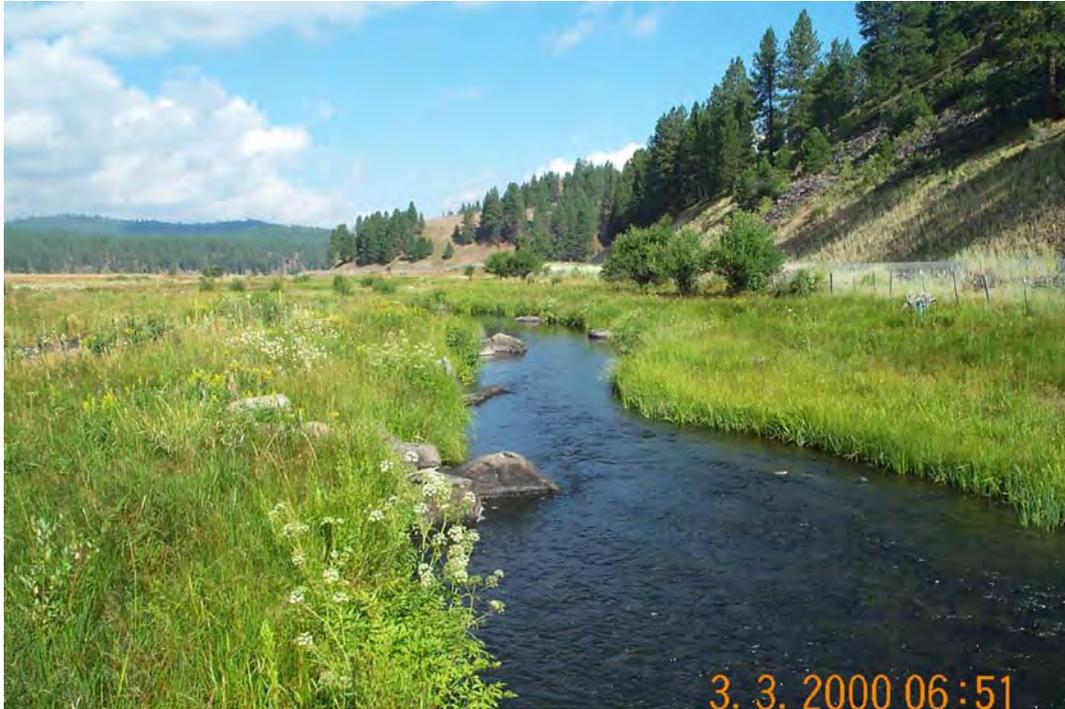
**Photograph No. 31. View is to the northwest looking downstream at a series of rock spurs. Middle Fork John Day River, Oregon – Bureau of Reclamation Photograph by E. Lyon, July 19, 2007.**

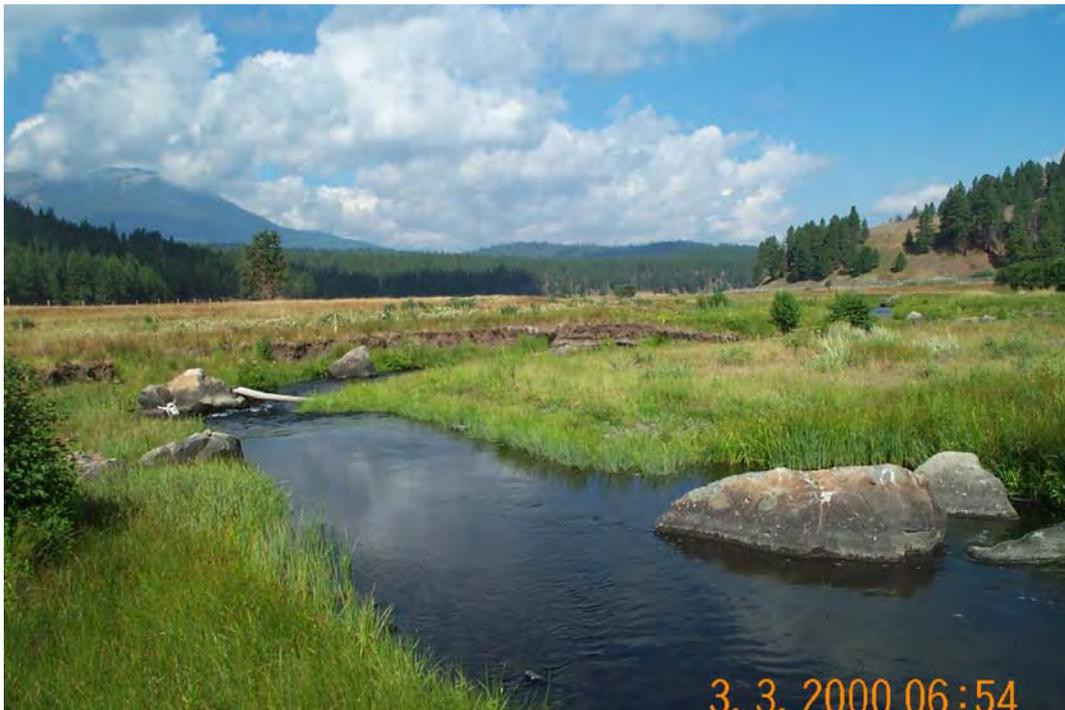
**Photograph No. 32. View is to the northwest looking downstream at a series of rock spurs. Note the bank erosion behind the rock spurs along river left. Middle Fork John Day River, Oregon – Bureau of Reclamation Photograph by E. Lyon, July 19, 2007.**

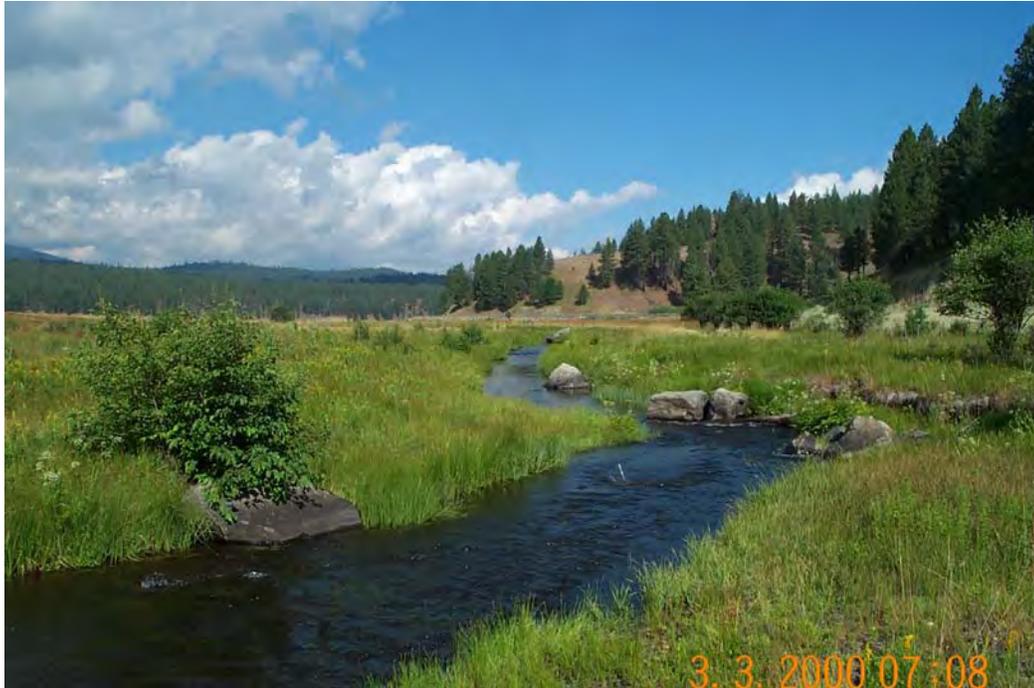
**Photograph No. 33.** View is to the northwest looking downstream at a series of rock spurs. Note bank erosion occurring behind the rock spurs along river right. Middle Fork John Day River – John Day Subbasin, Oregon – Bureau of Reclamation Photograph by E. Lyon, July 19, 2007.

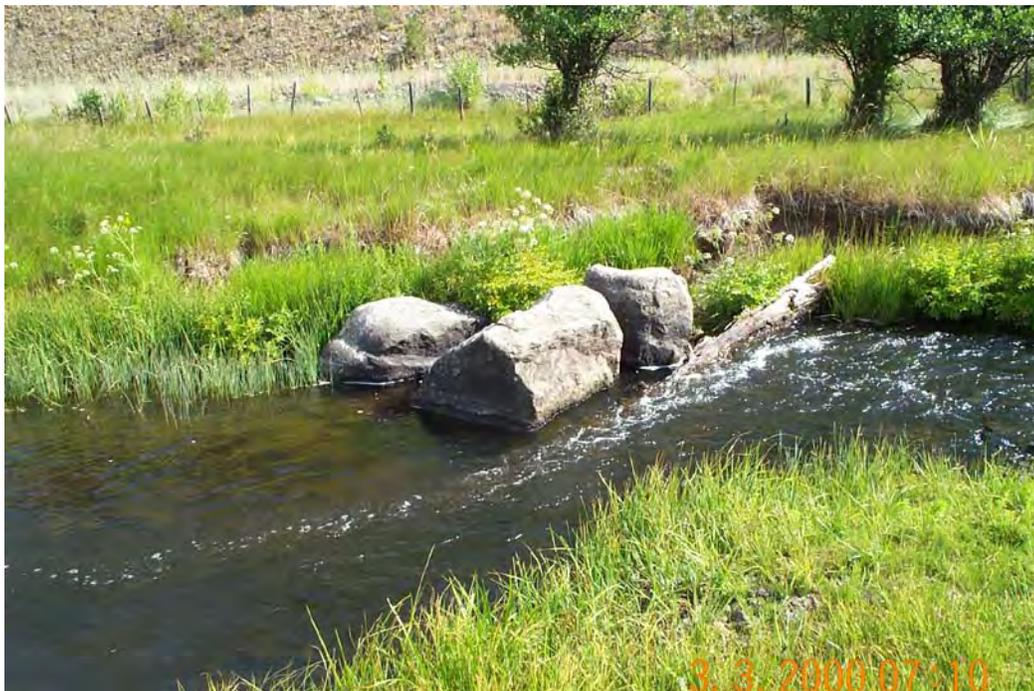
**Photograph No. 34.** View is to the northeast looking at rock spur with large woody debris. Note the pool (about 3-feet in depth) downstream and bank erosion behind the rock spur. Middle Fork John Day River, Oregon – Bureau of Reclamation Photograph by E. Lyon, July 19, 2007.

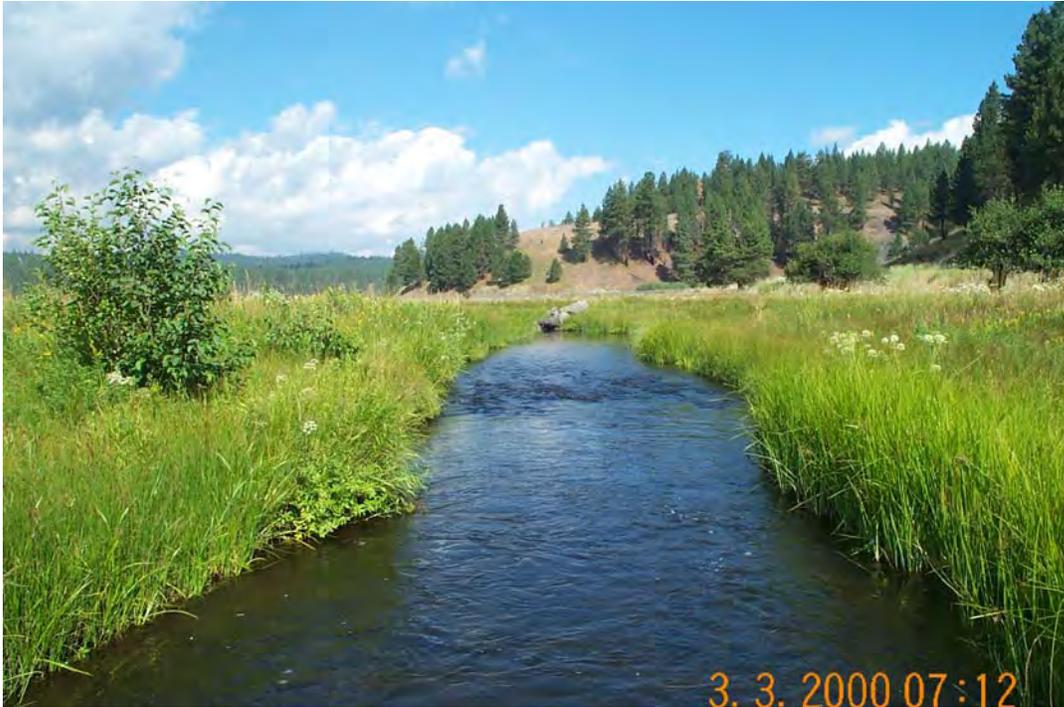
**Photograph No. 35. View is to the northwest looking downstream at rock spur along river right. Middle Fork John Day River, Oregon – Bureau of Reclamation Photograph by E. Lyon, July 19, 2007.**

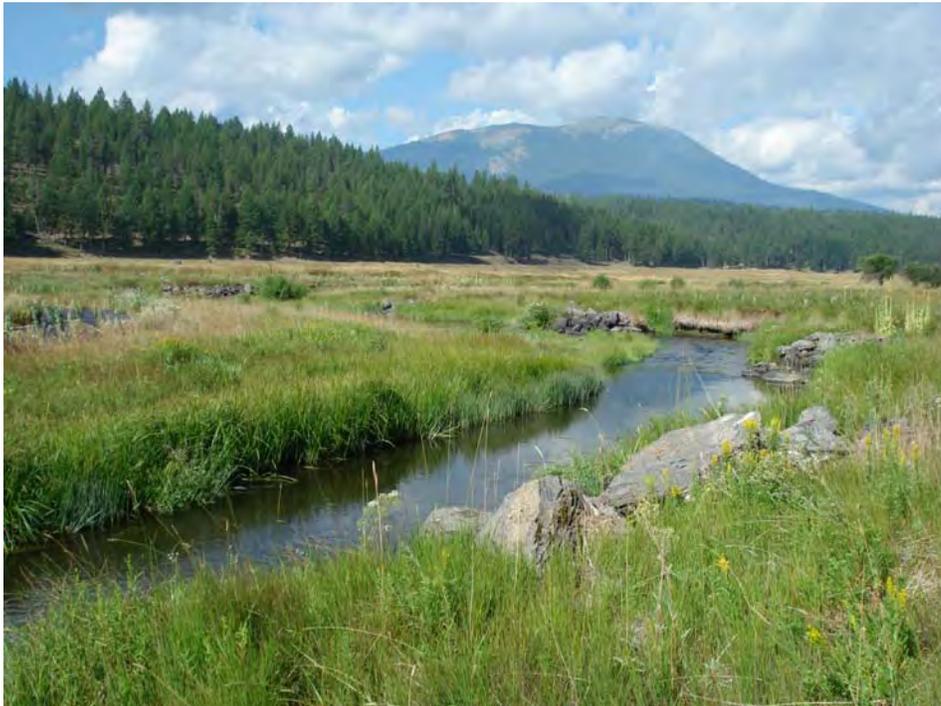
**Photograph No. 36. View is to the northwest looking downstream at rock spurs placed along river right. Middle Fork John Day River, Oregon – Bureau of Reclamation Photograph by R. McAfee, July 19, 2007.**

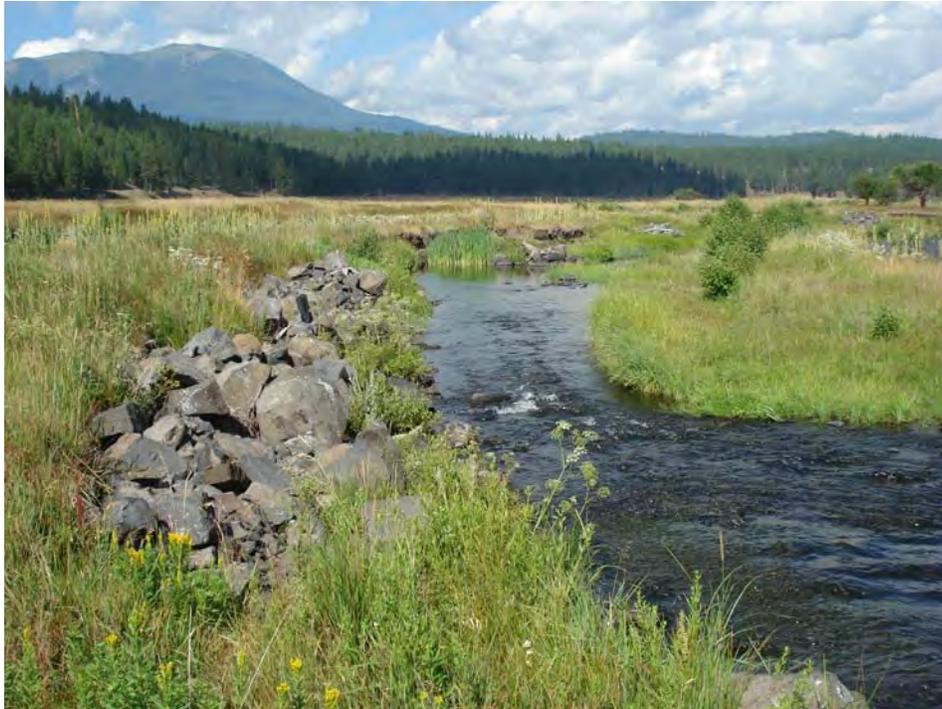
**Photograph No. 37.** View is to the northwest looking downstream at riprap placed along river left. Note the bank erosion occurring downstream of riprap. Middle Fork John Day River, Oregon – Bureau of Reclamation Photograph by R. McAfee, July 19, 2007.

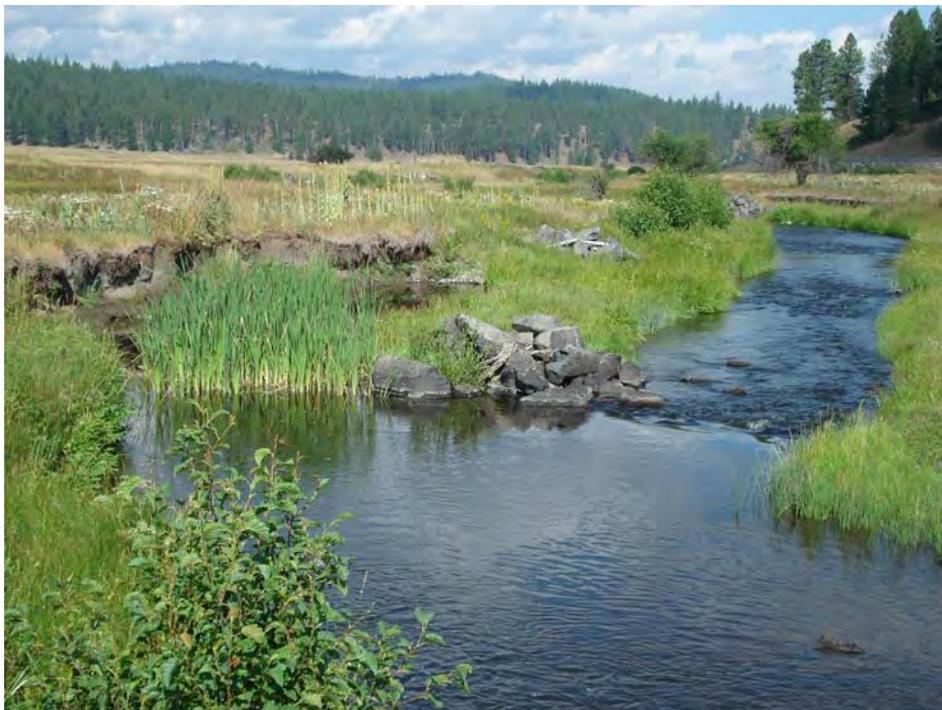
**Photograph No. 38.** View is to the northwest looking downstream at rock spurs placed along river left. Note the bank erosion occurring around the rock spurs along river left. Middle Fork John Day River, Oregon – Bureau of Reclamation Photograph by R. McAfee, July 19, 2007.

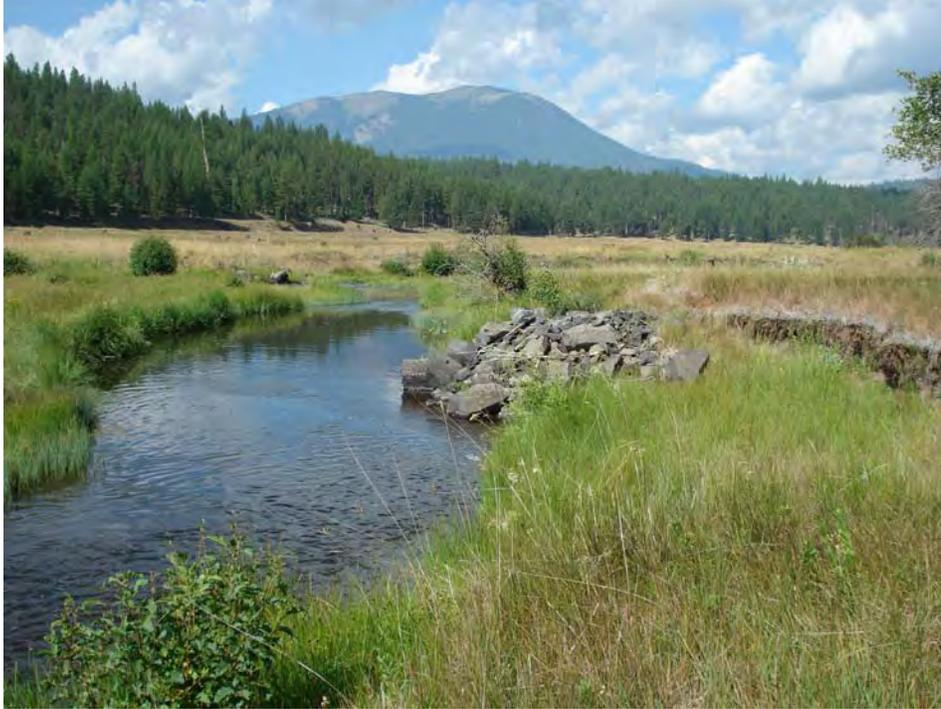
**Photograph No. 39. View is to the northwest looking downstream at rock spur along river right. Middle Fork John Day River, Oregon – Bureau of Reclamation Photograph by R. McAfee, July 19, 2007.**

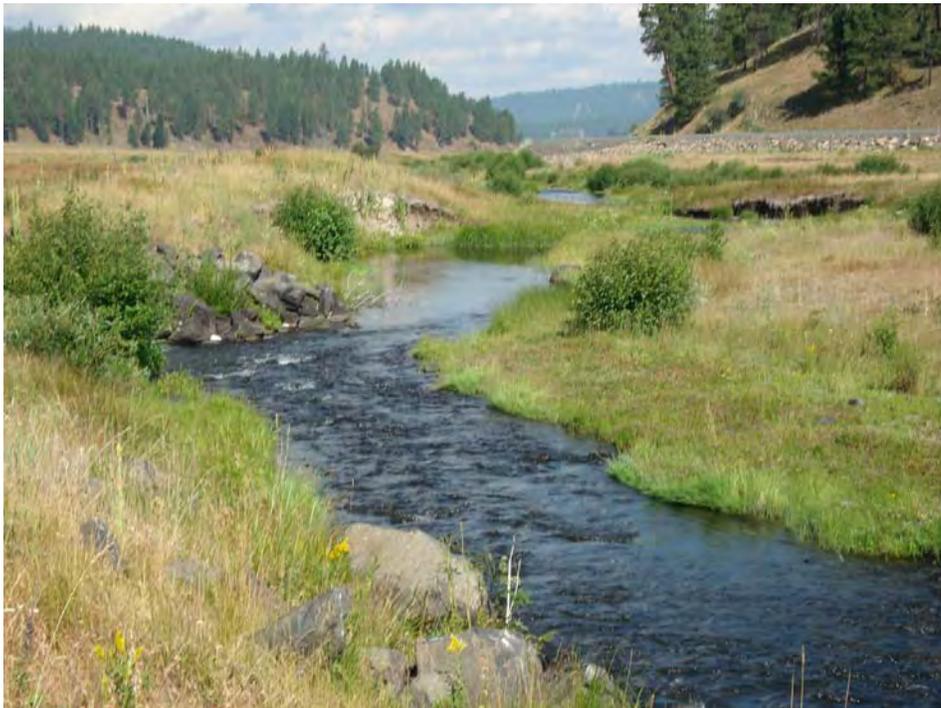
**Photograph No. 40. View is to the northwest looking downstream at rock spurs placed along river left. Middle Fork John Day River, Oregon – Bureau of Reclamation Photograph by R. McAfee, July 19, 2007.**

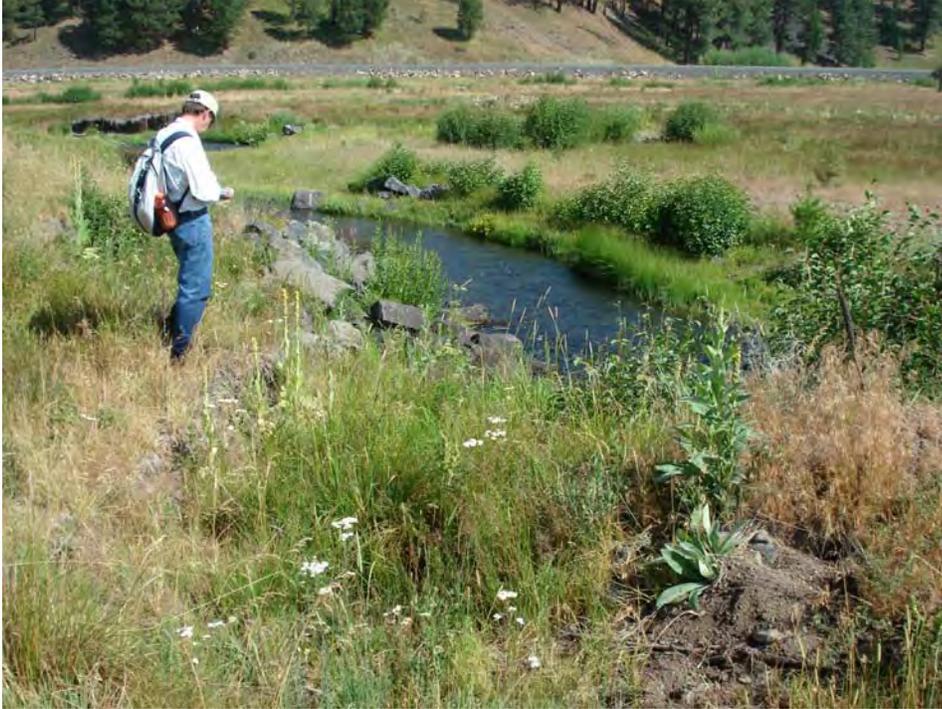
**Photograph No. 41. View is to the north looking downstream where the railroad grade is being eroded along river left. Middle Fork John Day River, Oregon – Bureau of Reclamation Photograph by R. McAfee, July 19, 2007.**

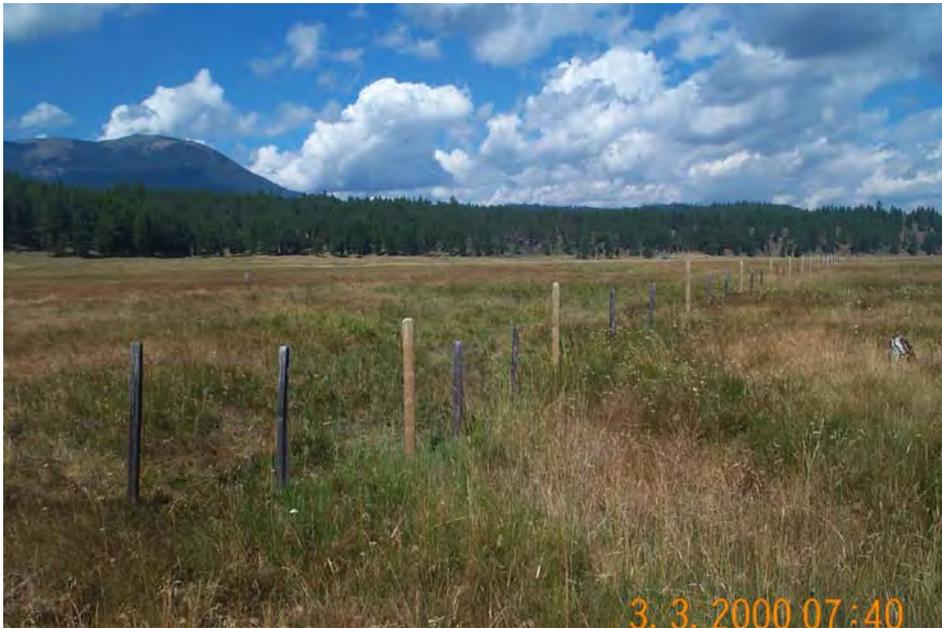
**Photograph No. 42. View is to the west looking downstream at historic channel path that appeared to be elevated above the active channel by about 2-feet. Middle Fork John Day River, Oregon – Bureau of Reclamation Photograph by E. Lyon, July 19, 2007.**

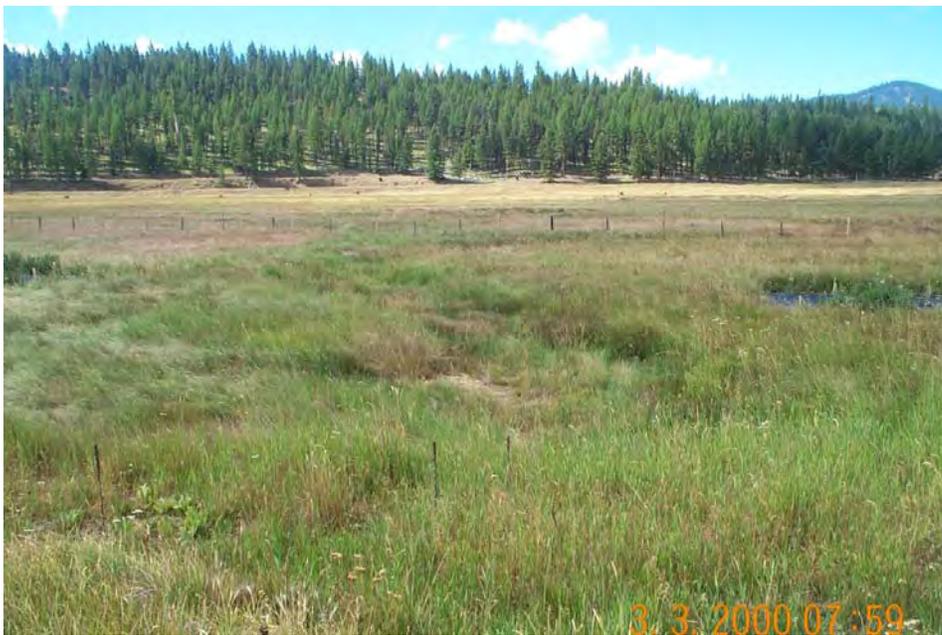
**Photograph No. 44. View is to the south looking upstream along historic channel path that is about 3-feet above the active channel. Middle Fork John Day River, Oregon – Bureau of Reclamation Photograph by E. Lyon, July 19, 2007.**

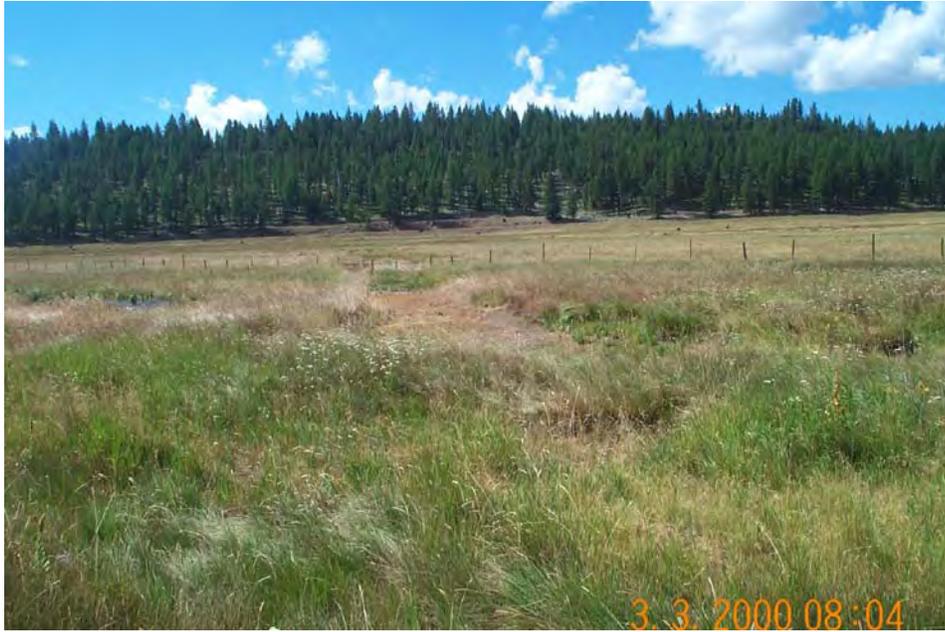
**Photograph No. 45. View is to the south looking upstream along historic channel path that is elevated about 2-feet above the active channel. Middle Fork John Day River, Oregon – Bureau of Reclamation Photograph by E. Lyon, July 19, 2007.**

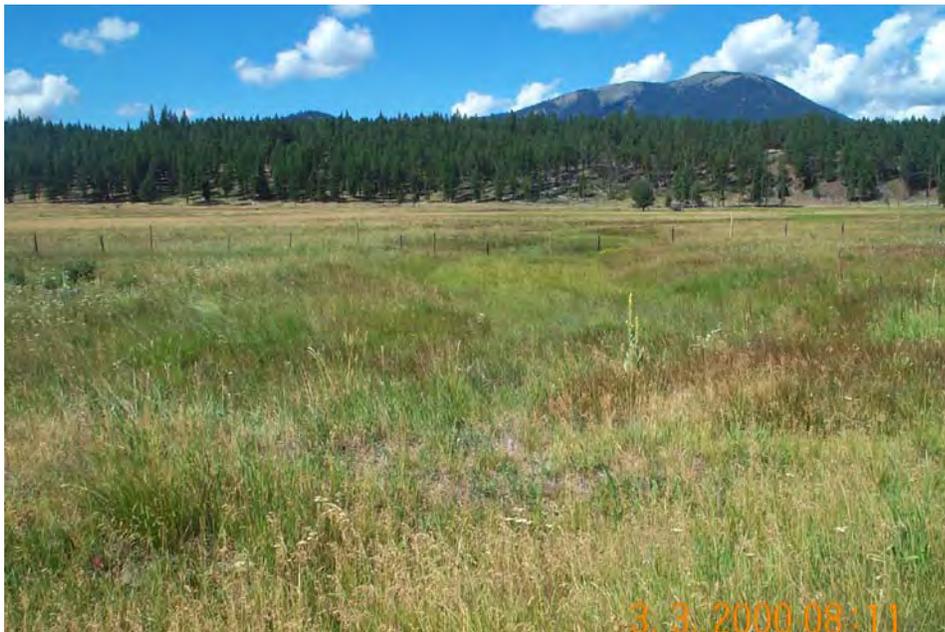
**Photograph No. 46. View is to the southwest looking downstream along historic channel path that is elevated about 3-feet above active channel. Middle Fork John Day River, Oregon – Bureau of Reclamation Photograph by E. Lyon, July 19, 2007.**

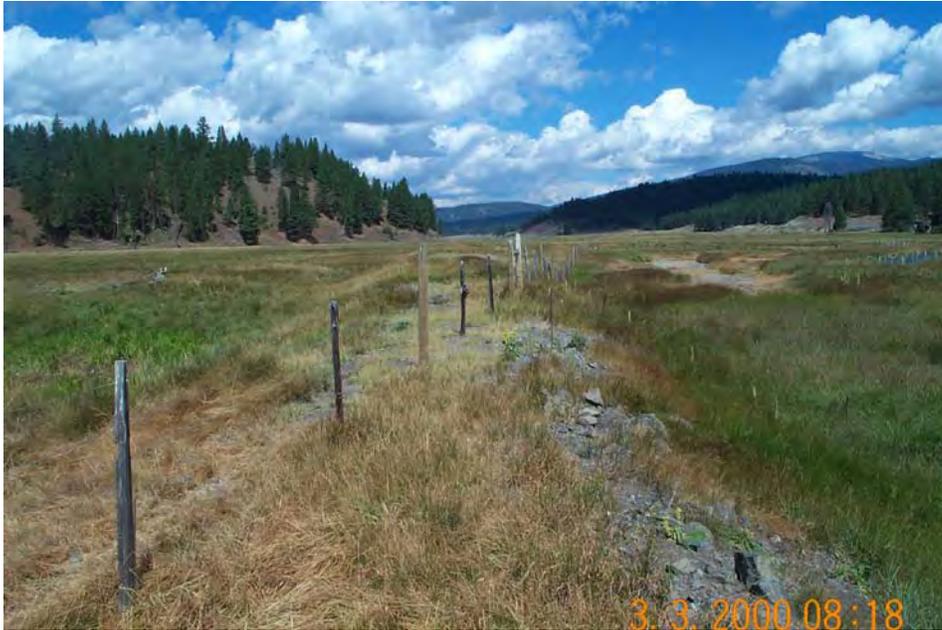
**Photograph No. 47. View is to the northwest looking downstream along the railroad grade where it bisects historic channel path. Middle Fork John Day River, Oregon – Bureau of Reclamation Photograph by E. Lyon, July 19, 2007.**

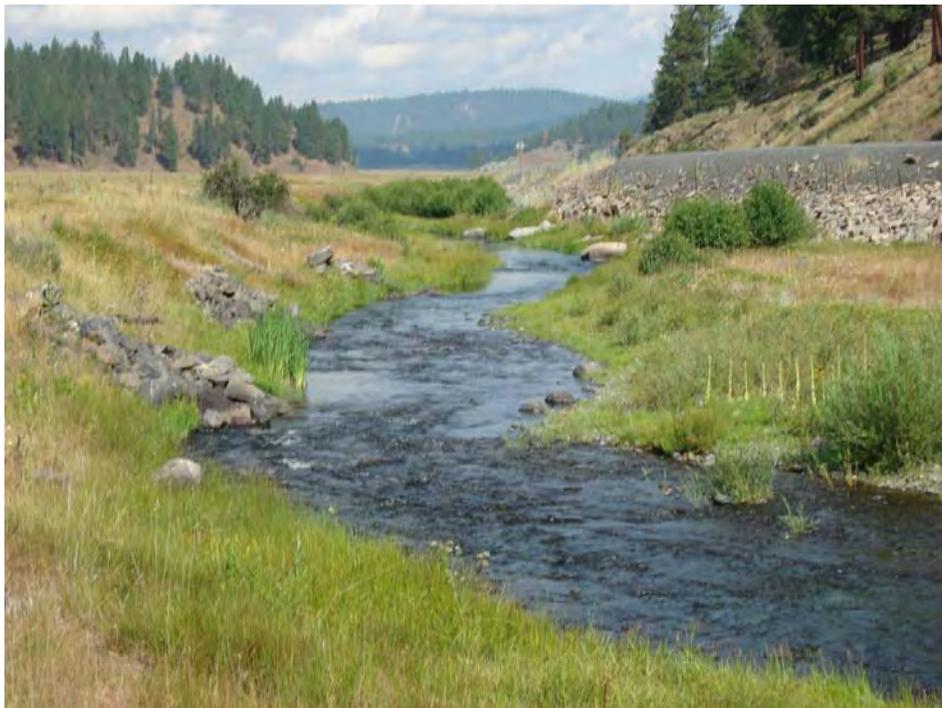
**Photograph No. 48. View is to the northwest looking downstream at rock spurs placed along river left and boulders placed along river right along road embankment. Middle Fork John Day River, Oregon – Bureau of Reclamation Photograph by R. McAfee, July 19, 2007.**

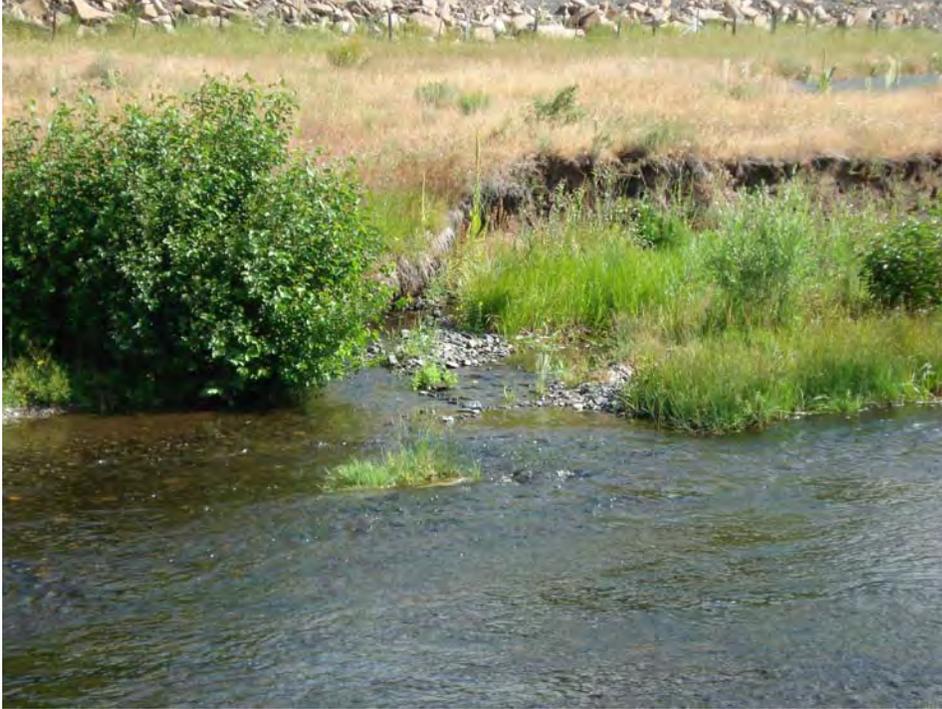
**Photograph No. 49. View is to the north looking at mouth of Vinegar Creek entering the Middle Fork. Middle Fork John Day River, Oregon – Bureau of Reclamation Photograph by R. McAfee, July 19, 2007.**

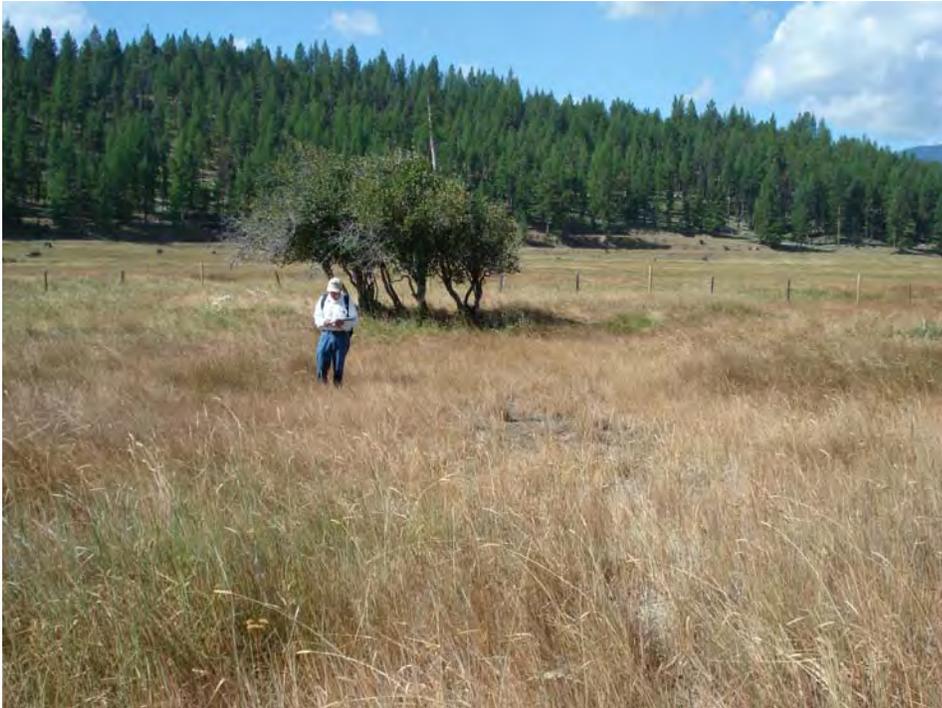
**Photograph No. 50. View is to the southwest looking at historic channel path behind the railroad grade. Middle Fork John Day River, Oregon – Bureau of Reclamation Photograph by R. McAfee, July 19, 2007.**

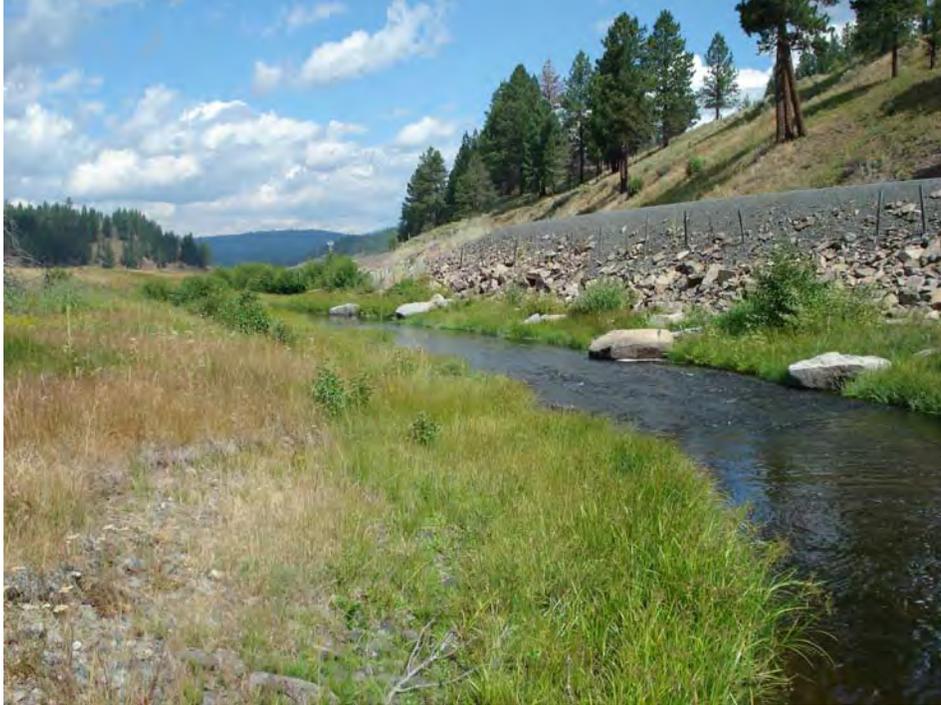
**Photograph No. 51. View is to the northwest looking downstream at boulders placed along river right. Middle Fork John Day River, Oregon – Bureau of Reclamation Photograph by R. McAfee, July 19, 2007.**

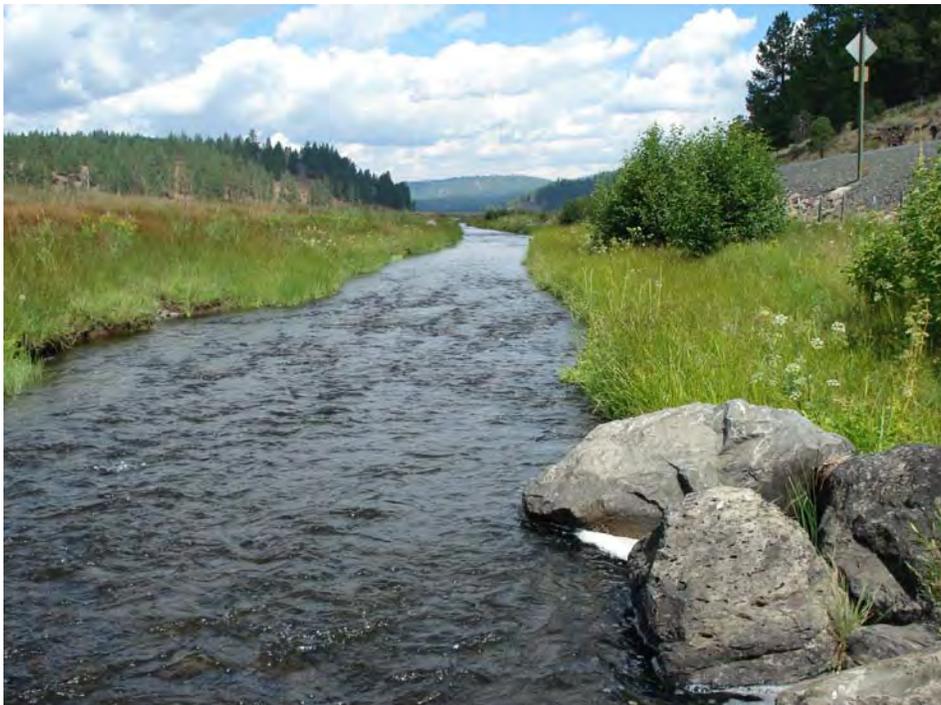
**Photograph No. 52. View is to the northwest looking downstream at a rock spur placed along river right. Middle Fork John Day River, Oregon – Bureau of Reclamation Photograph by R. McAfee, July 19, 2007.**

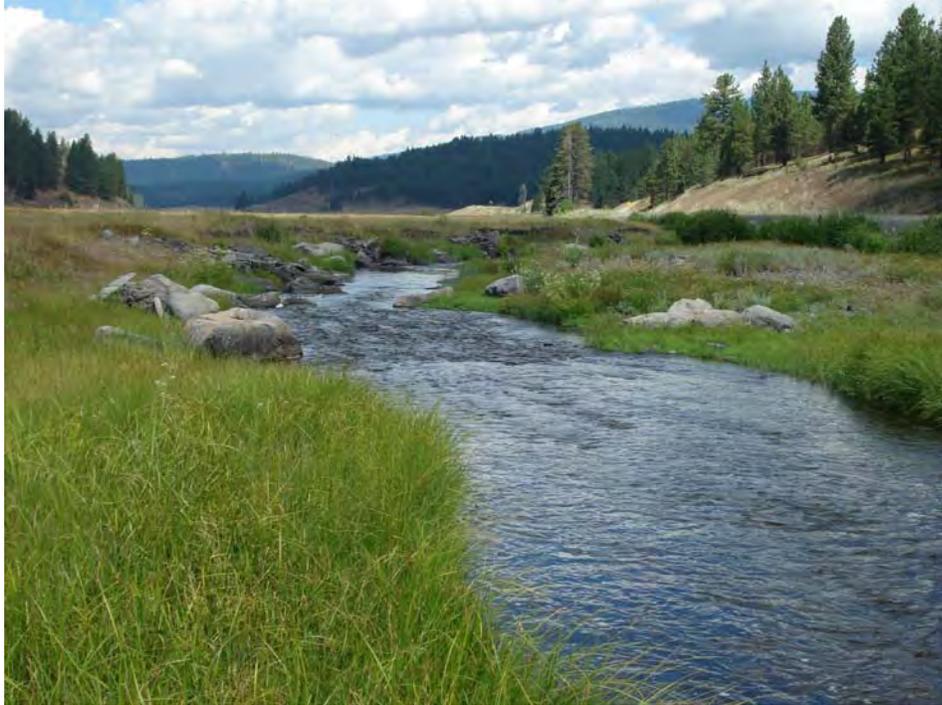
**Photograph No. 53. View is to the northwest looking downstream at rock spurs placed along both riverbanks. Middle Fork John Day River, Oregon – Bureau of Reclamation Photograph by R. McAfee, July 19, 2007.**

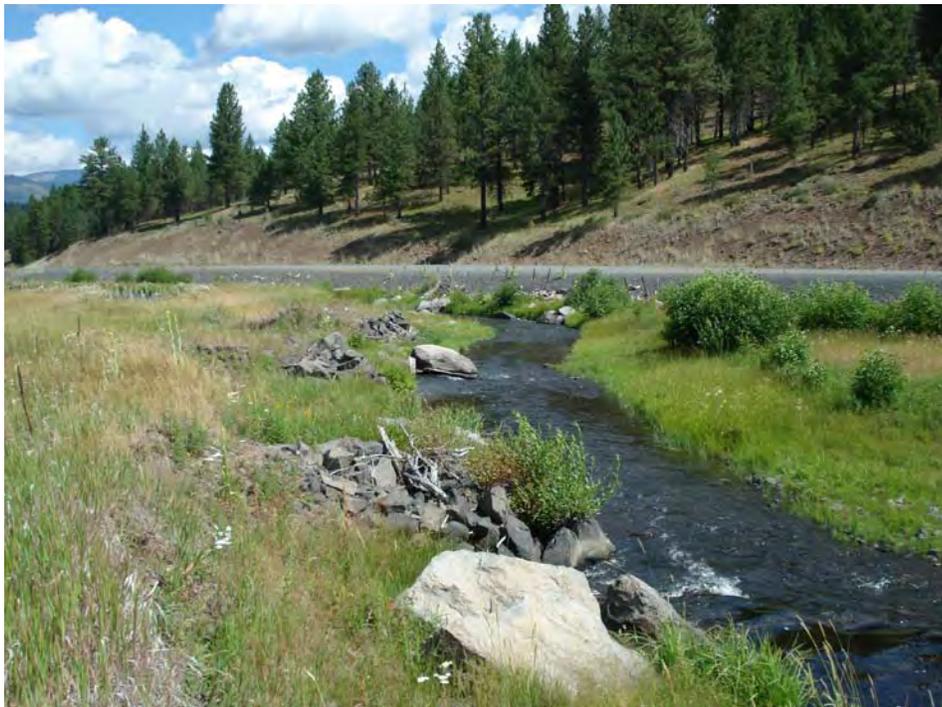
**Photograph No. 54. View is to the northwest looking downstream at rock spurs placed along river left and along the toe of the road embankment on river right. Middle Fork John Day River, Oregon – Bureau of Reclamation Photograph by R. McAfee, July 19, 2007.**

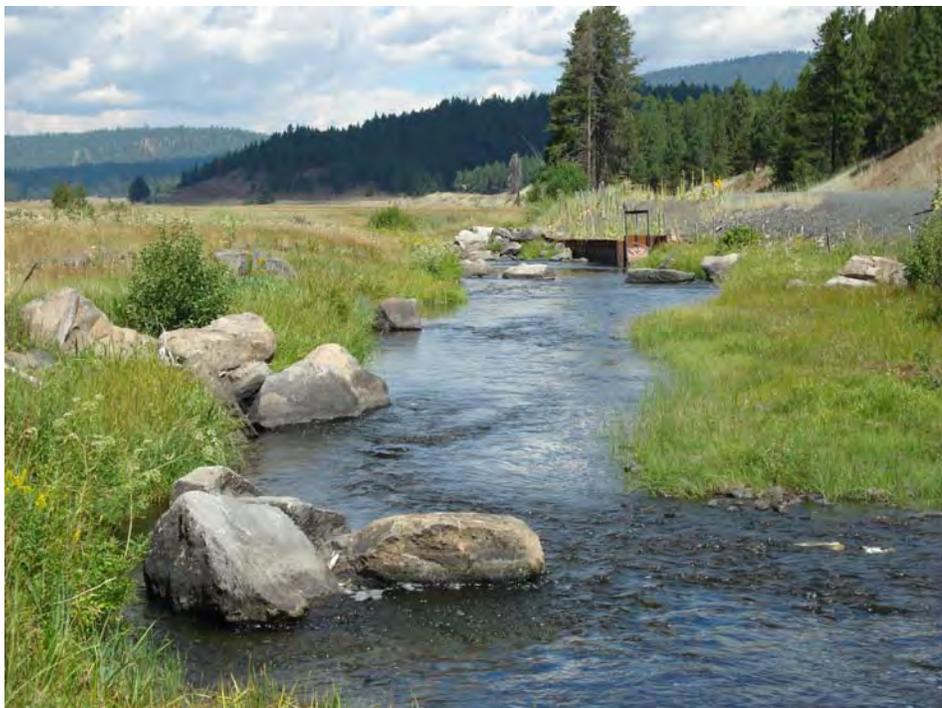
**Photograph No. 55. View is to the northwest looking downstream at rock spurs placed along both riverbanks and irrigation diversion near road embankment. Middle Fork John Day River, Oregon – Bureau of Reclamation Photograph by R. McAfee, July 19, 2007.**

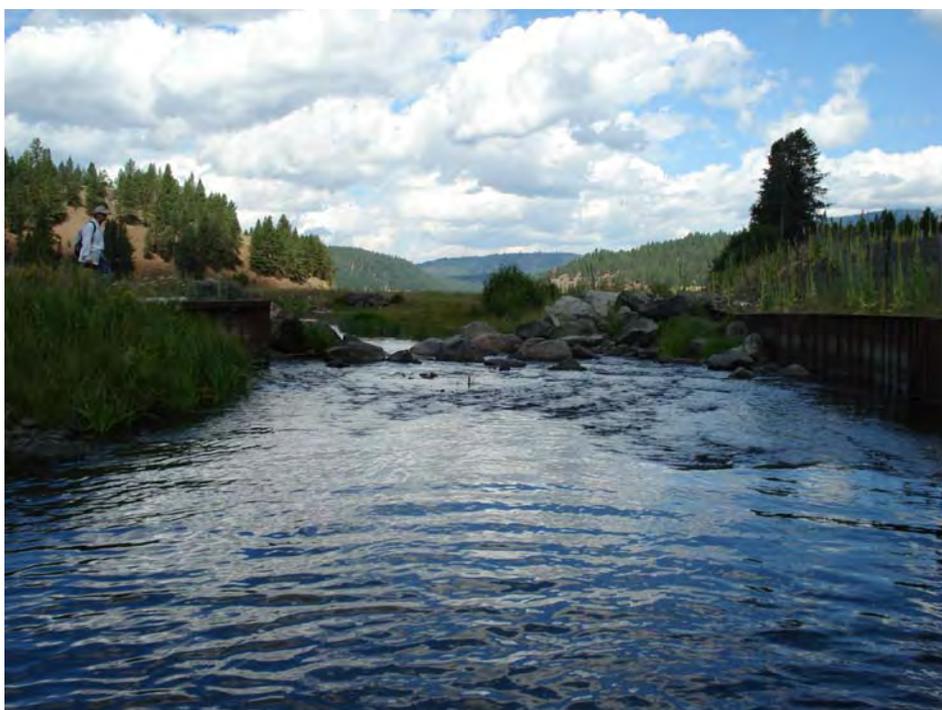
**Photograph No. 56. View is to the northwest looking downstream at rock spurs used to raise water elevation for the irrigation diversion located out of view along river right. Middle Fork John Day River, Oregon – Bureau of Reclamation Photograph by R. McAfee, July 19, 2007.**

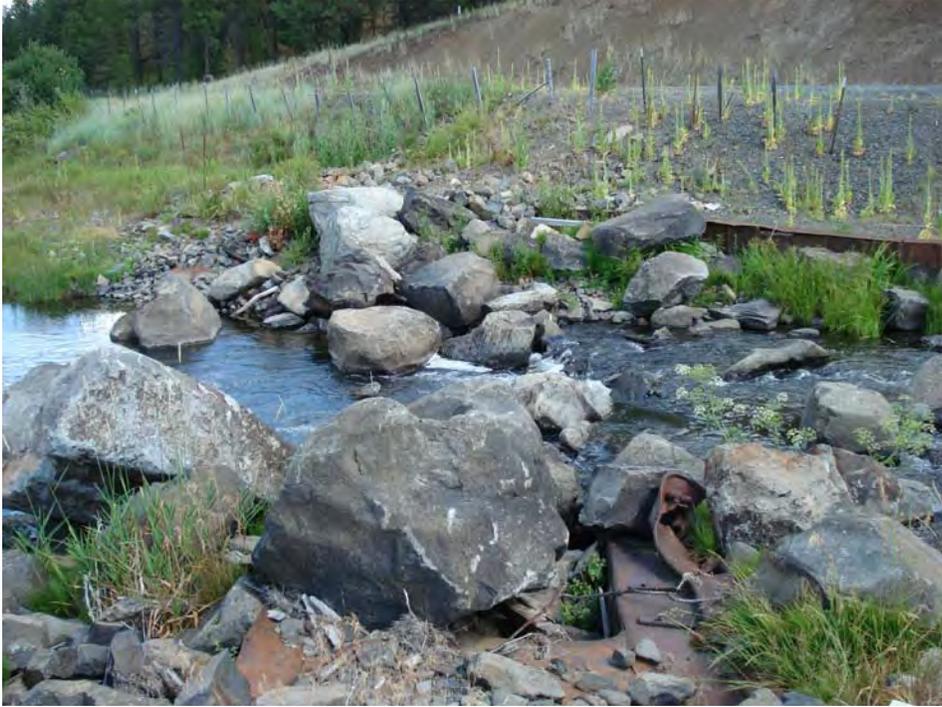
**Photograph No. 57.** View is to the north looking across irrigation diversion structure. Middle Fork John Day River, Oregon – Bureau of Reclamation Photograph by R. McAfee, July 19, 2007.

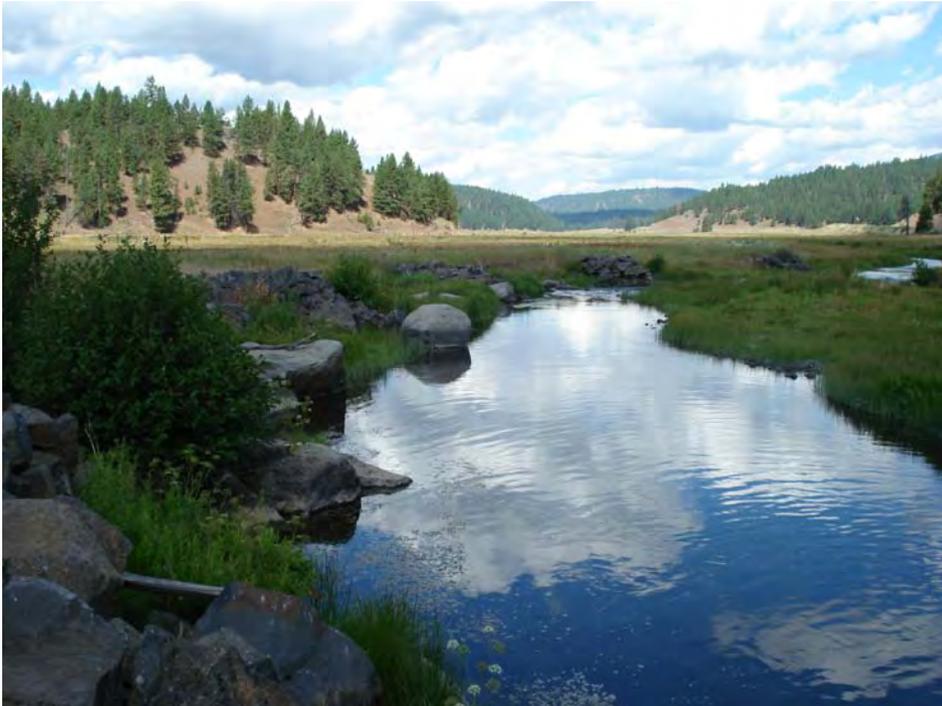
**Photograph No. 58.** View is to the northwest looking downstream at rock spurs placed along river left. Middle Fork John Day River, Oregon – Bureau of Reclamation Photograph by R. McAfee, July 19, 2007.
