## Forrest Conservation Area Reach Assessment Middle Fork John Day River

Grant County, Oregon

U.S. Department of the Interior  
Bureau of Reclamation  
Pacific Northwest Region  
Pacific Northwest Regional Office, Boise, Idaho

August 2010

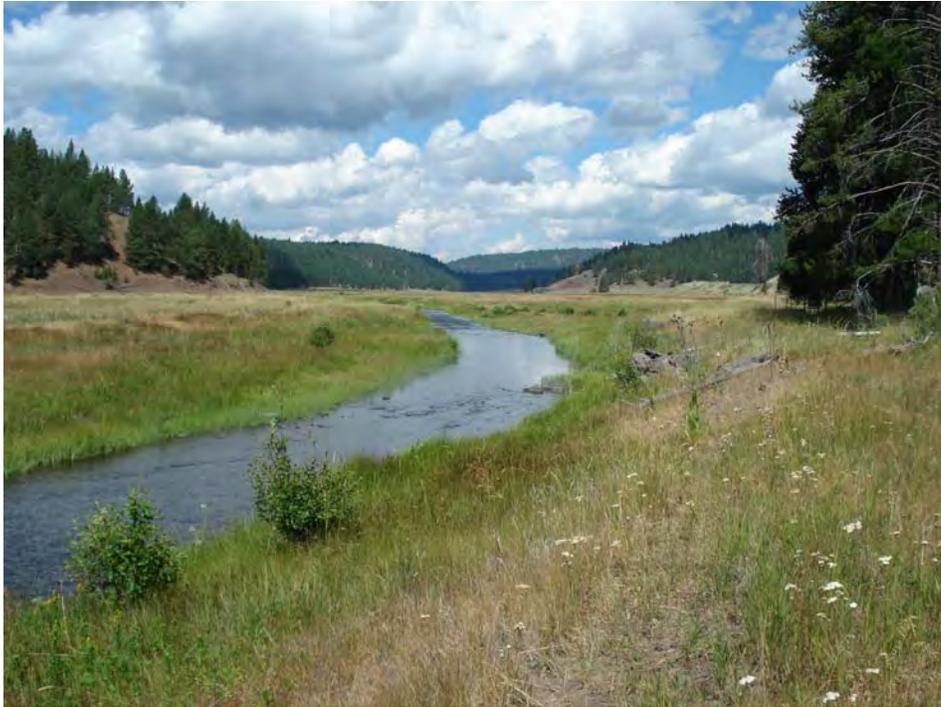
**Photograph No. 59. View is to the northwest looking downstream at rock spur placed along river right. Middle Fork John Day River, Oregon – Bureau of Reclamation Photograph by R. McAfee, July 19, 2007.**

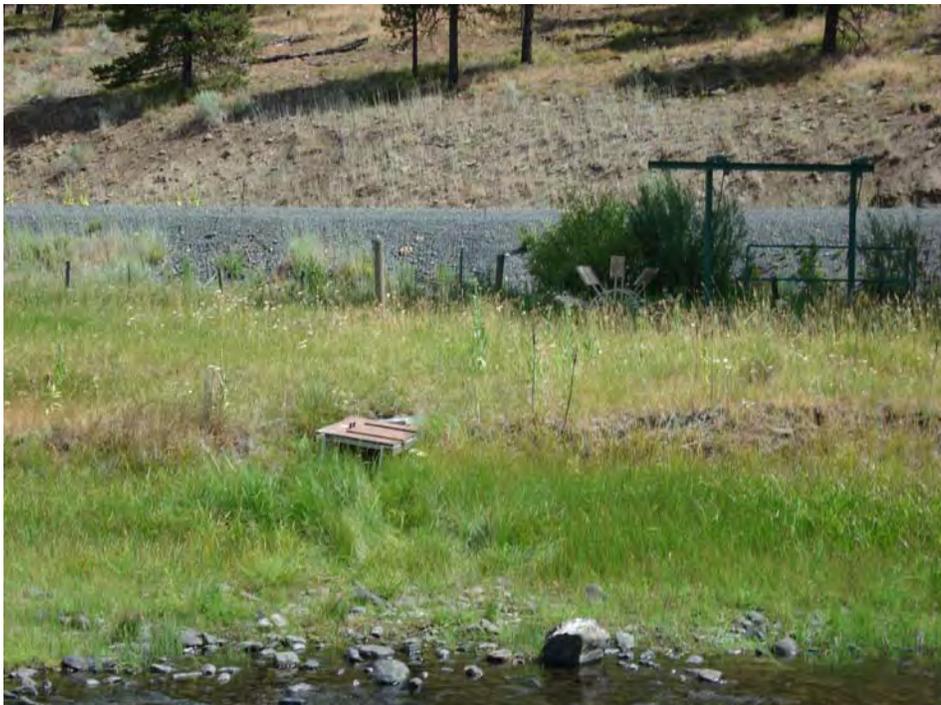
**Photograph No. 60. View is to the north looking across the river at fish return that no longer intercepts the river along river right. Middle Fork John Day River, Oregon – Bureau of Reclamation Photograph by R. McAfee, July 19, 2007.**

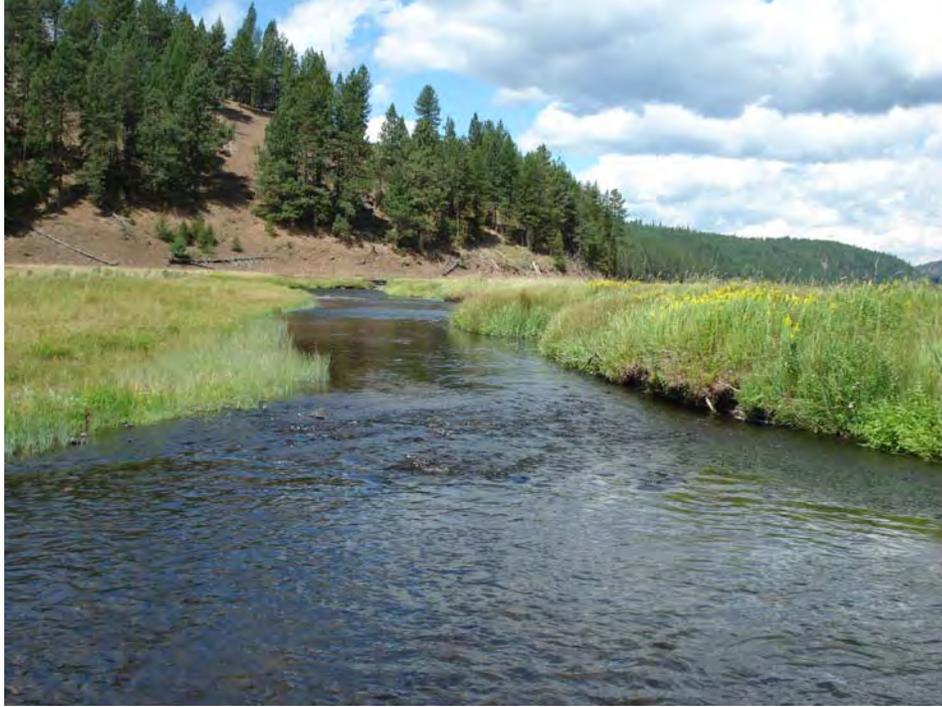
**Photograph No. 61.** View is to the northwest looking downstream at bank erosion occurring along river right. Middle Fork John Day River, Oregon – Bureau of Reclamation Photograph by R. McAfee, July 19, 2007.

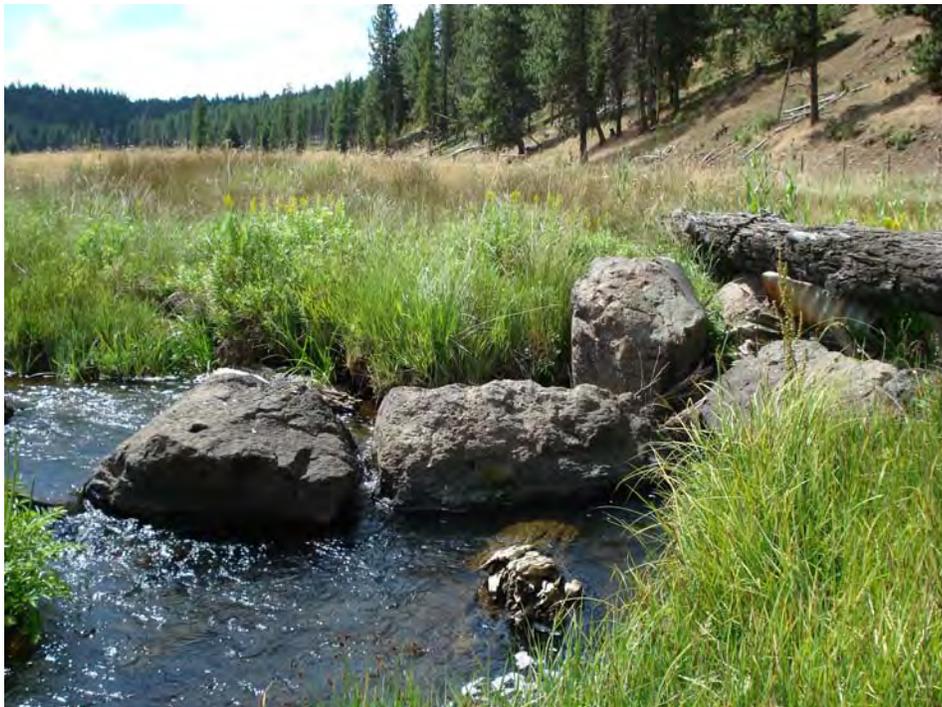
**Photograph No. 62.** View is to the southeast looking upstream at rock spur placed along river left. Middle Fork John Day River, Oregon – Bureau of Reclamation Photograph by R. McAfee, July 19, 2007.

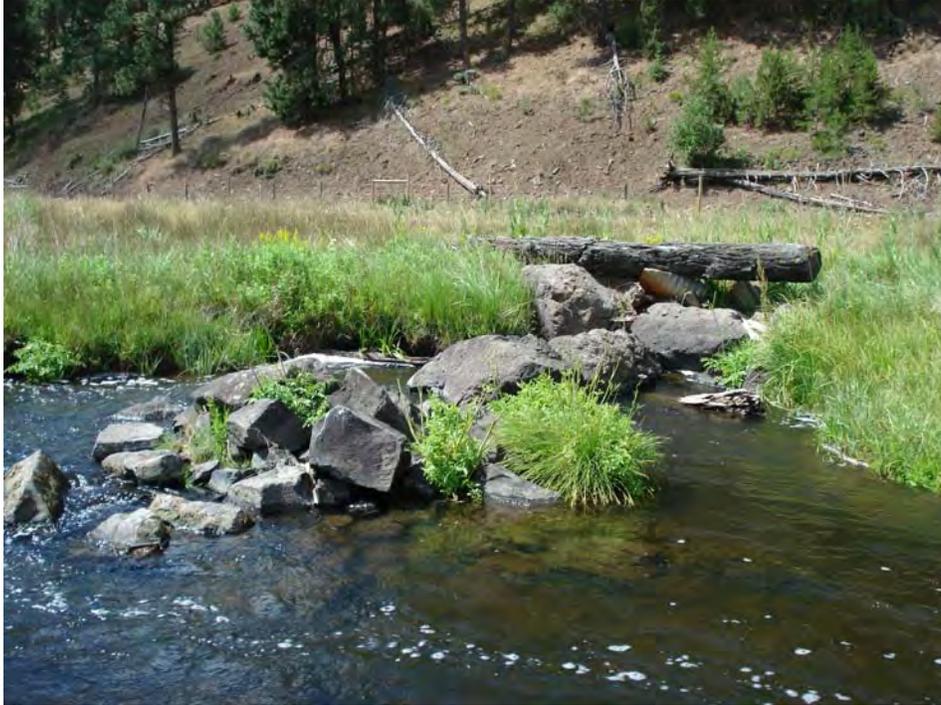
**Photograph No. 63. View is to the south looking across the river at rock spur placed along river left. Middle Fork John Day River, Oregon – Bureau of Reclamation Photograph by R. McAfee, July 19, 2007.**

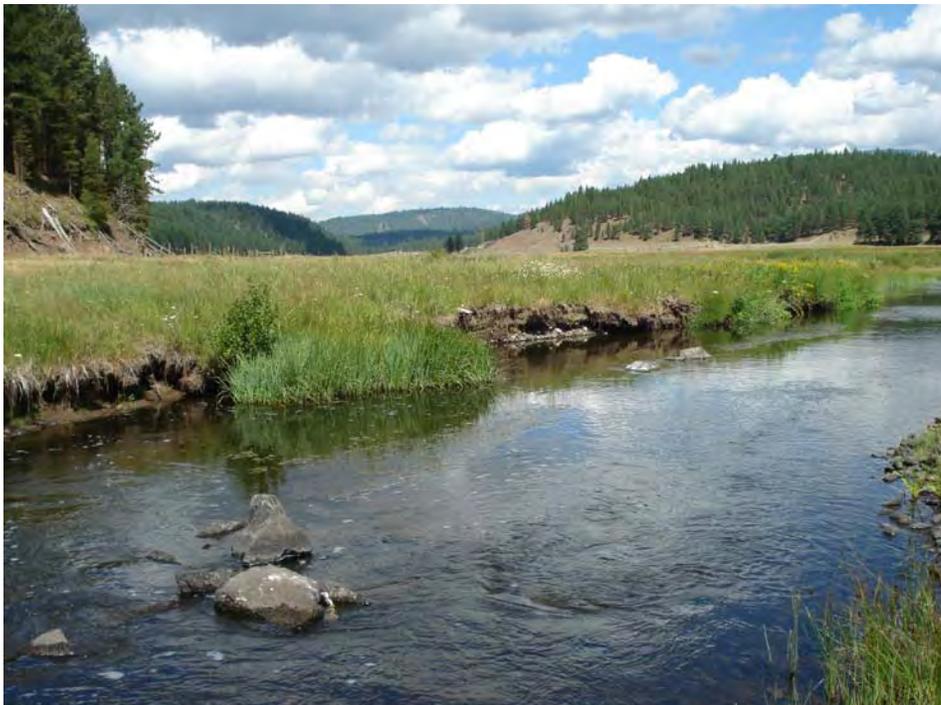
**Photograph No. 64. View is to the northwest looking downstream at bank erosion occurring along river left. Middle Fork John Day River, Oregon – Bureau of Reclamation Photograph by R. McAfee, July 19, 2007.**

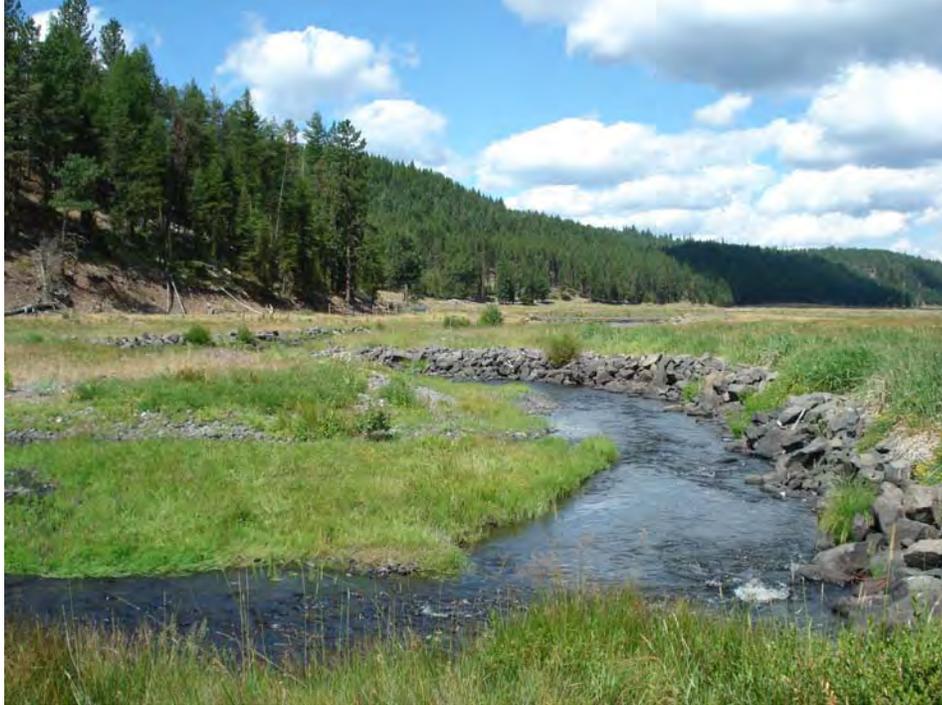
**Photograph No. 65. View is to the west looking downstream at riprap placed along river right. Middle Fork John Day River, Oregon – Bureau of Reclamation Photograph by R. McAfee, July 19, 2007.**

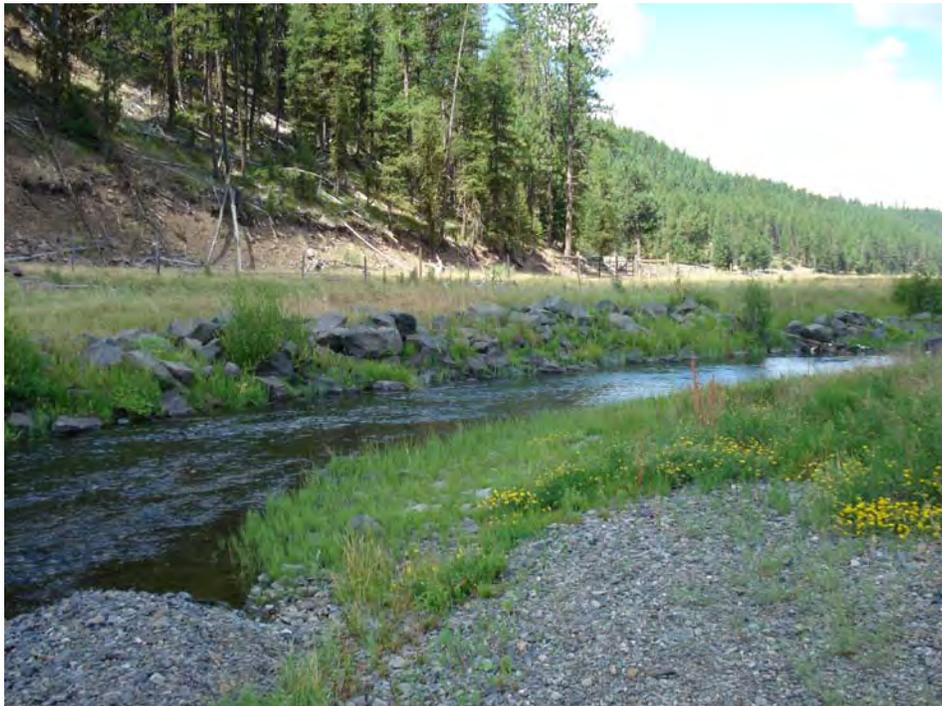
**Photograph No. 66. View is to the west looking downstream at riprap placed along river left. Middle Fork John Day River, Oregon – Bureau of Reclamation Photograph by R. McAfee, July 19, 2007.**

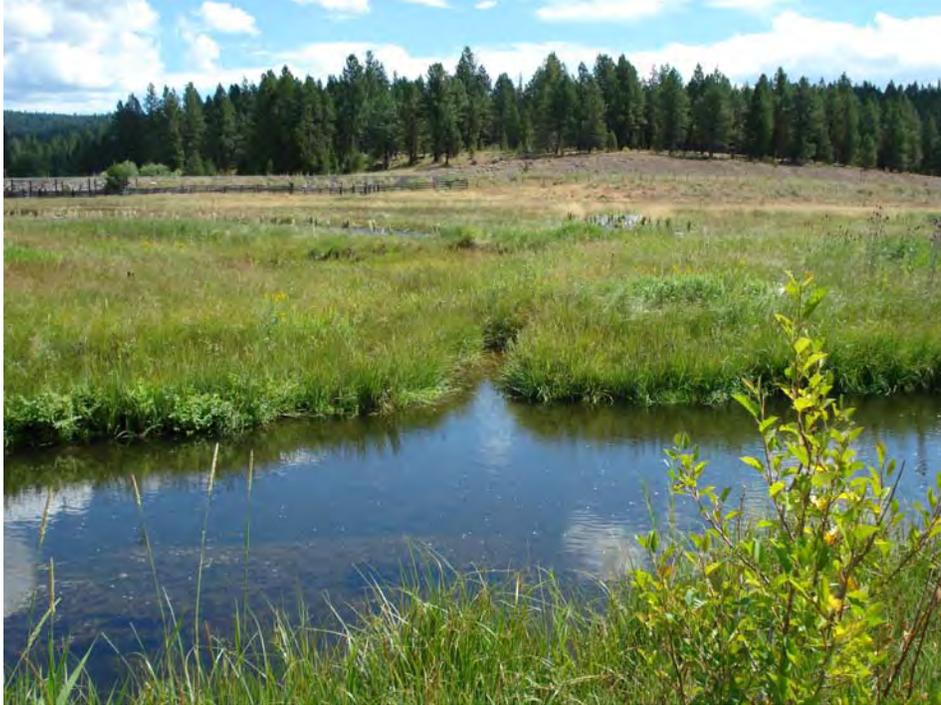
**Photograph No. 67. View is to the north looking at a tributary entering the Middle Fork. Middle Fork John Day River, Oregon – Bureau of Reclamation Photograph by R. McAfee, July 19, 2007.**

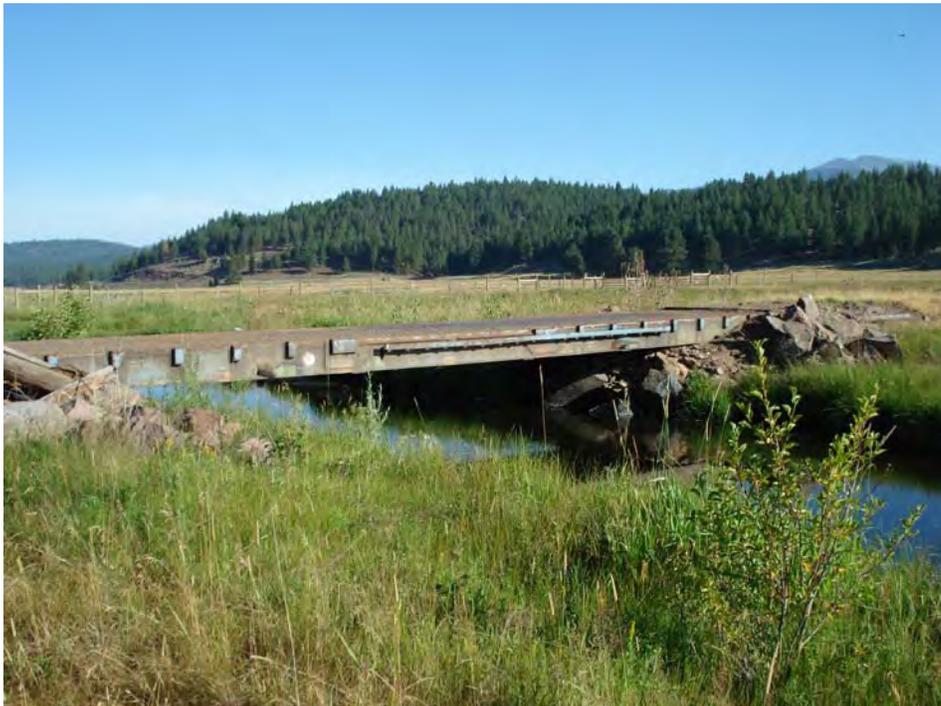
**Photograph No. 68. View is to the north looking downstream at bridge crossing. Middle Fork John Day River, Oregon – Bureau of Reclamation Photograph by R. McAfee, July 20, 2007.**

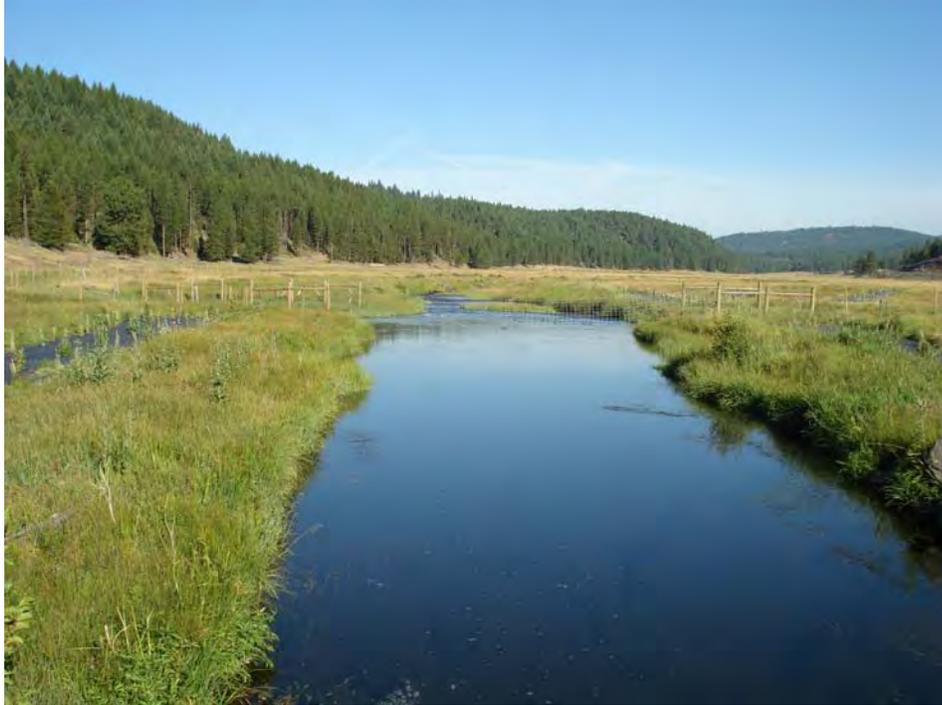
**Photograph No. 69. View is to the northwest looking downstream at ford crossing. Middle Fork John Day River, Oregon – Bureau of Reclamation Photograph by R. McAfee, July 20, 2007.**

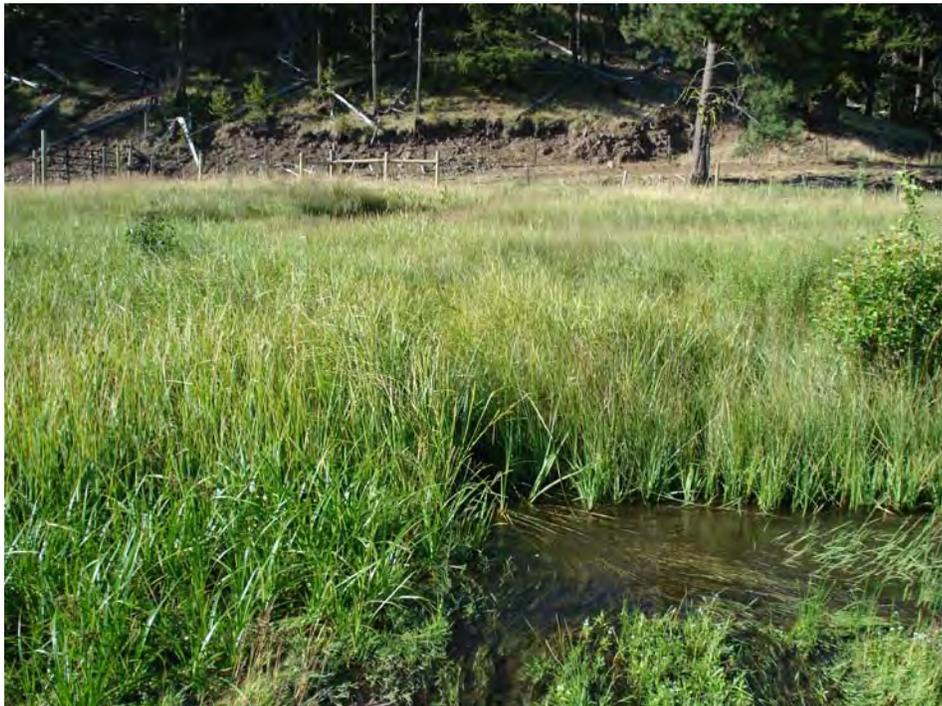
**Photograph No. 70. View is to the south looking at tributary entering the Middle Fork. Middle Fork John Day River, Oregon – Bureau of Reclamation Photograph by R. McAfee, July 20, 2007.**

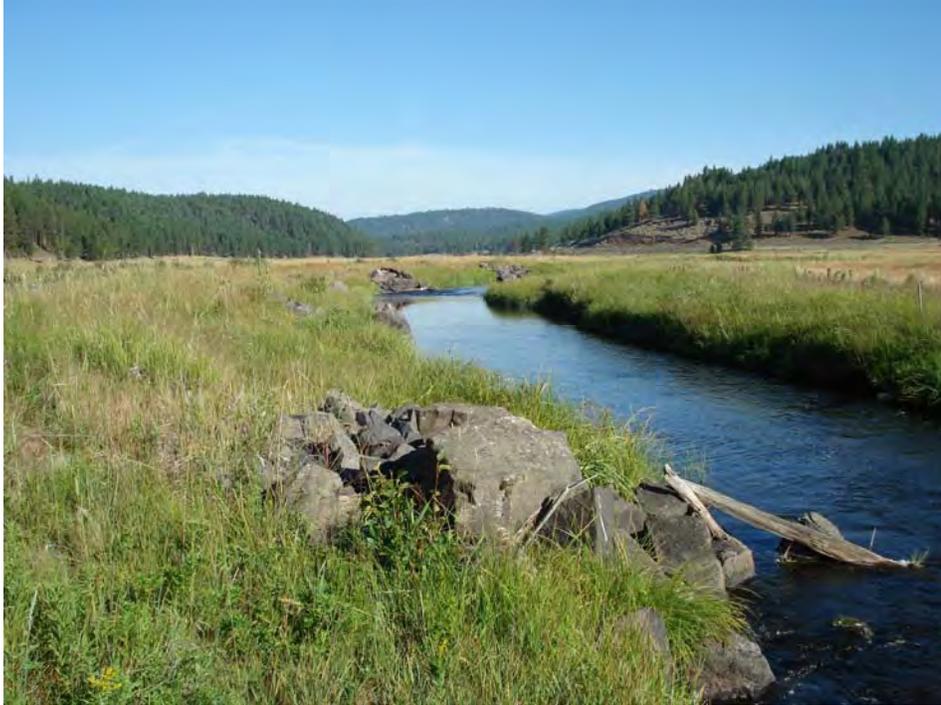
**Photograph No. 71. View is to the northwest looking downstream at rock spurs placed along river left. Middle Fork John Day River, Oregon – Bureau of Reclamation Photograph by R. McAfee, July 20, 2007.**

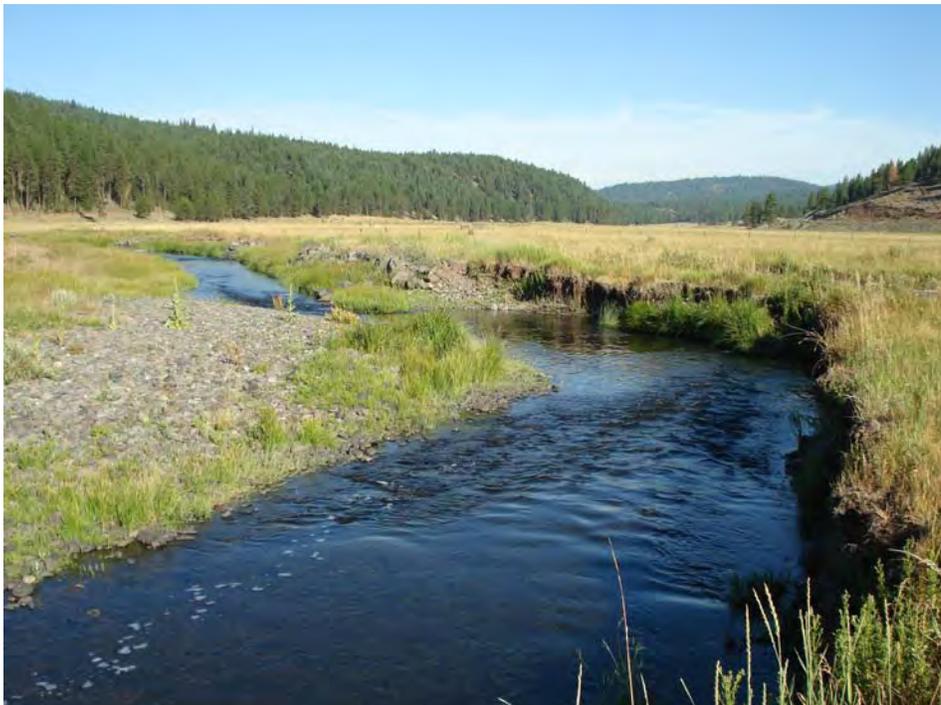
**Photograph No. 72. View is to the west looking downstream at bank erosion occurring along river right. Middle Fork John Day River, Oregon – Bureau of Reclamation Photograph by R. McAfee, July 20, 2007.**

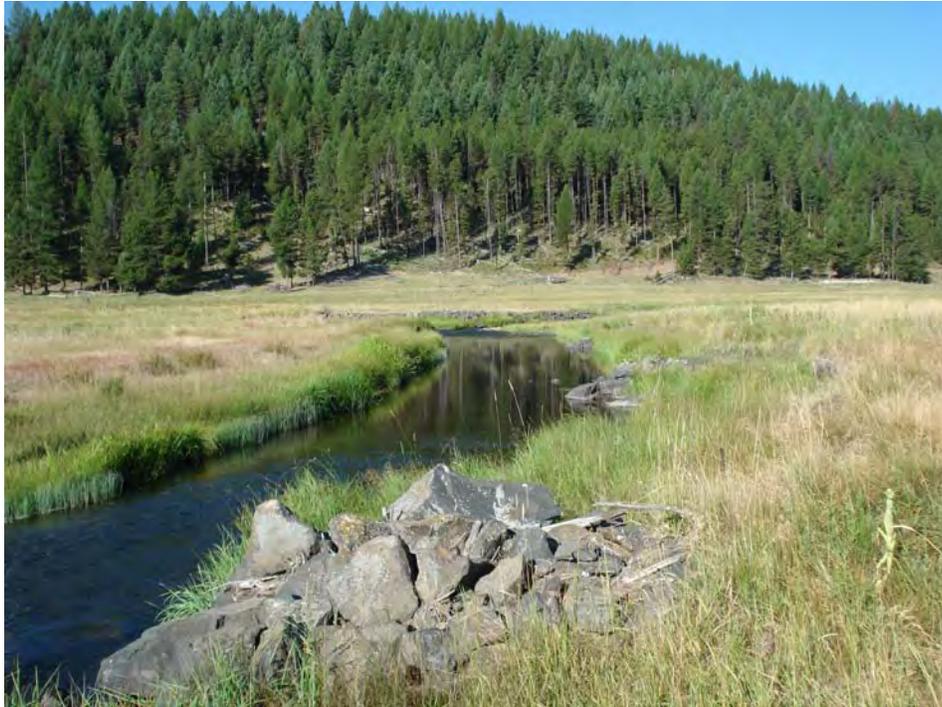
**Photograph No. 73. View is to the southwest looking downstream at rock spurs placed along river right. Middle Fork John Day River, Oregon – Bureau of Reclamation Photograph by R. McAfee, July 20, 2007.**

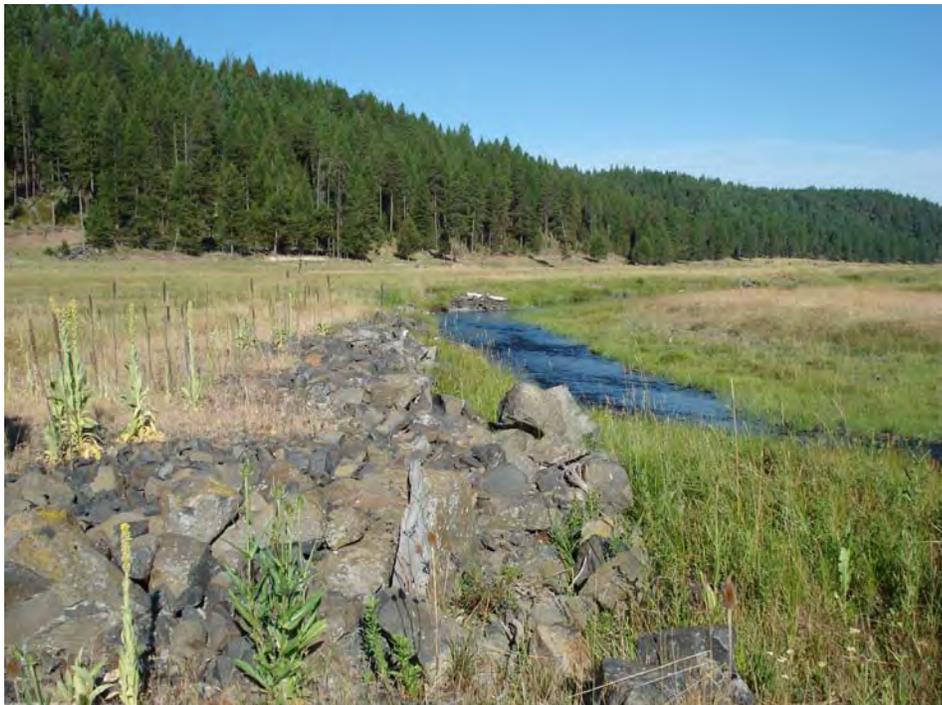
**Photograph No. 74. View is to the west looking downstream at riprap placed along river left. Middle Fork John Day River, Oregon – Bureau of Reclamation Photograph by R. McAfee, July 20, 2007.**

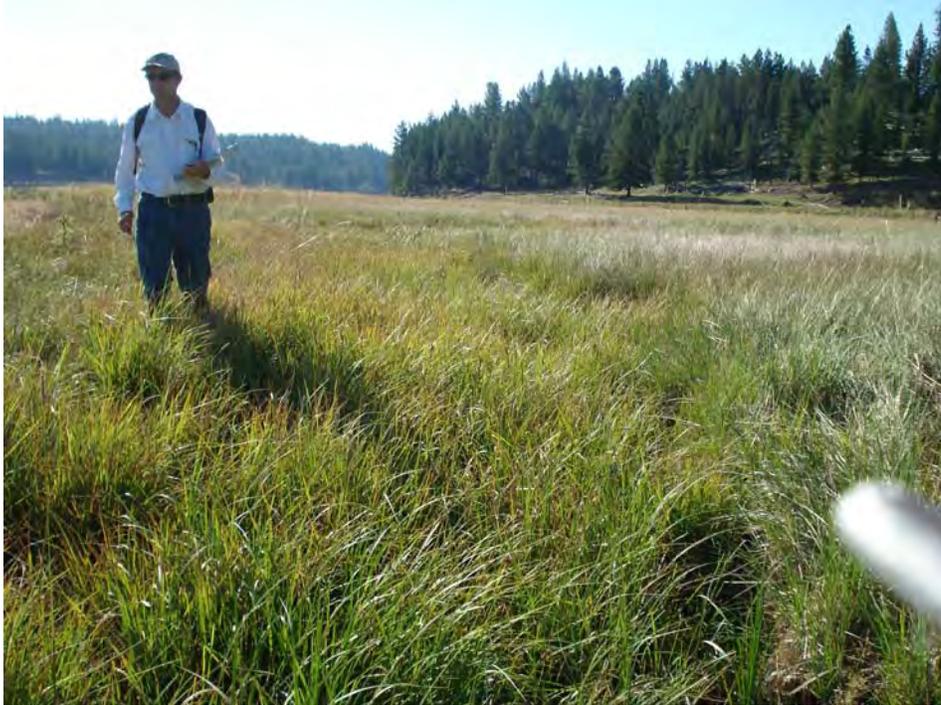
**Photograph No. 75. View is to the southeast looking upstream at ephemeral tributary channel. Middle Fork John Day River, Oregon – Bureau of Reclamation Photograph by R. McAfee, July 20, 2007.**

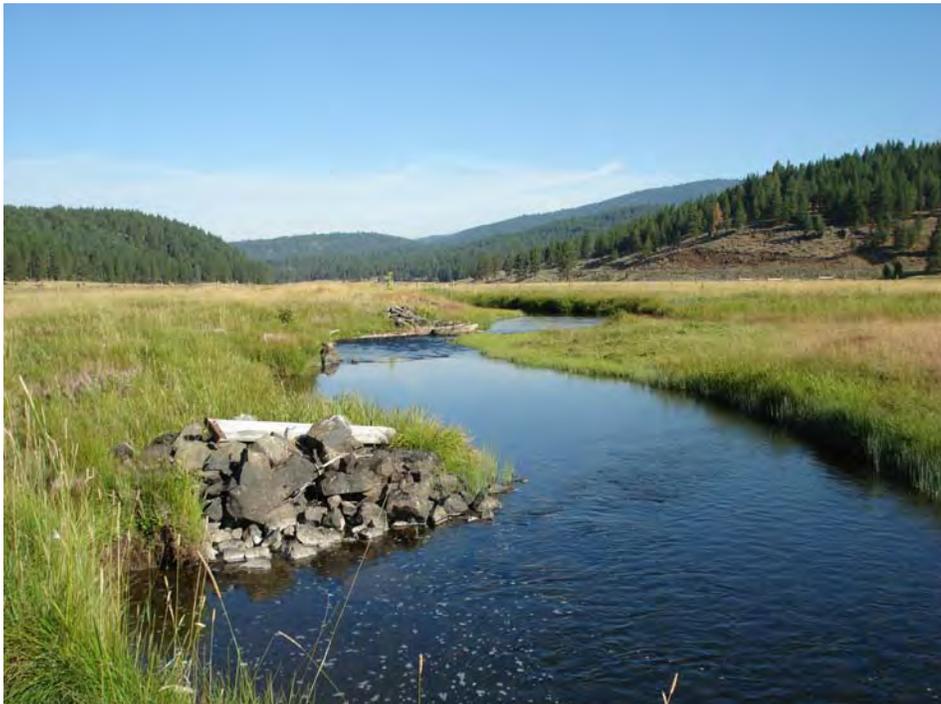
**Photograph No. 76. View is to the northwest looking downstream at rock spurs placed along river left. Middle Fork John Day River, Oregon – Bureau of Reclamation Photograph by R. McAfee, July 20, 2007.**

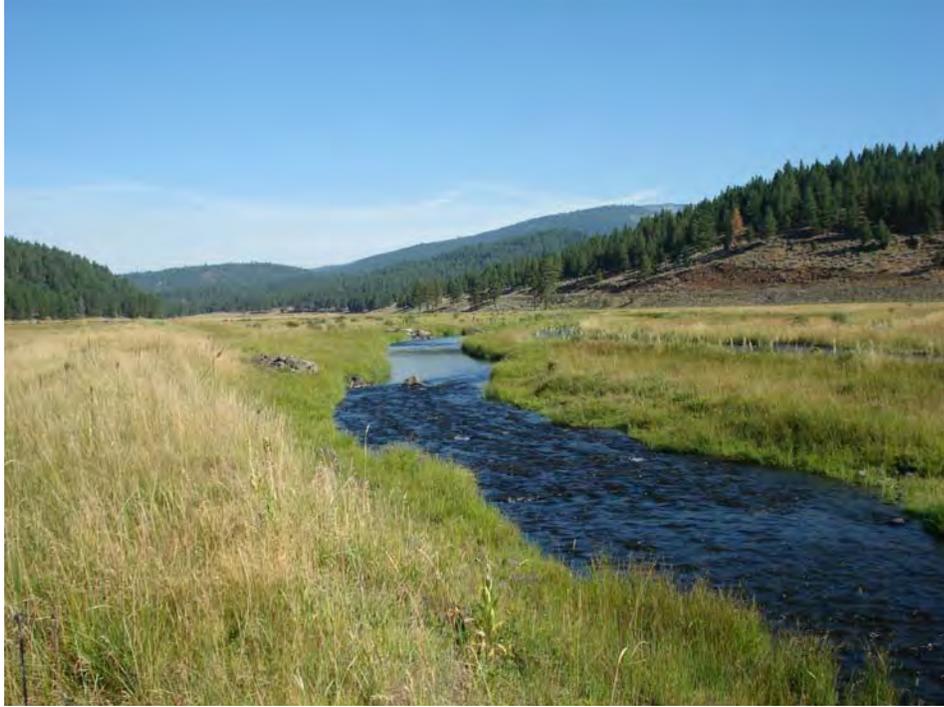
**Photograph No. 77. View is to the northwest looking downstream at rock spur placed along river left. Middle Fork John Day River, Oregon – Bureau of Reclamation Photograph by R. McAfee, July 20, 2007.**

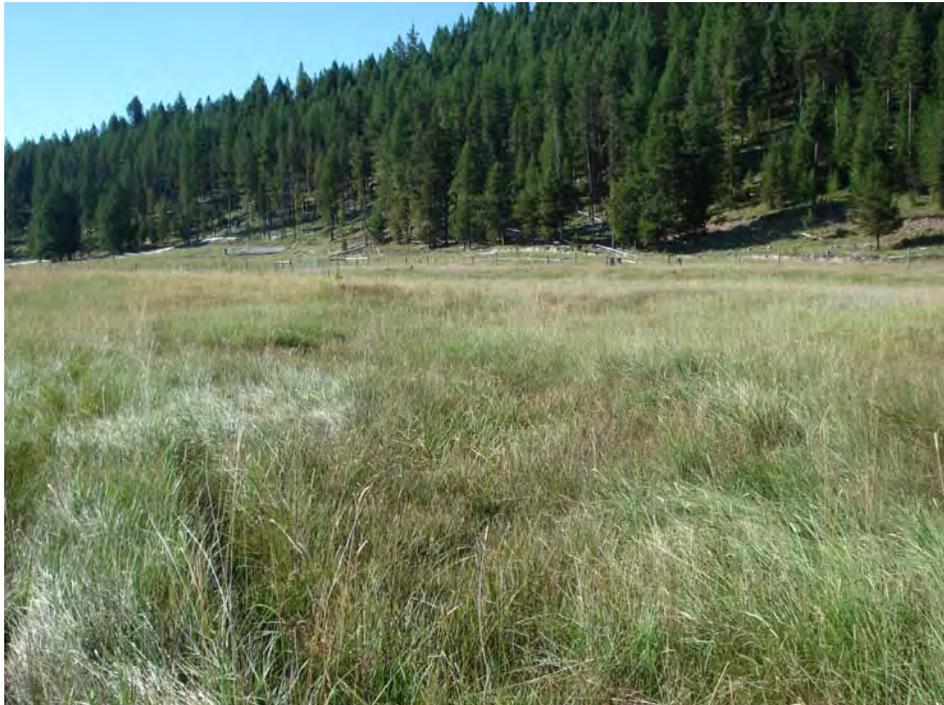
**Photograph No. 78. View is to the south looking upstream at ephemeral tributary channel. Middle Fork John Day River, Oregon – Bureau of Reclamation Photograph by R. McAfee, July 20, 2007.**

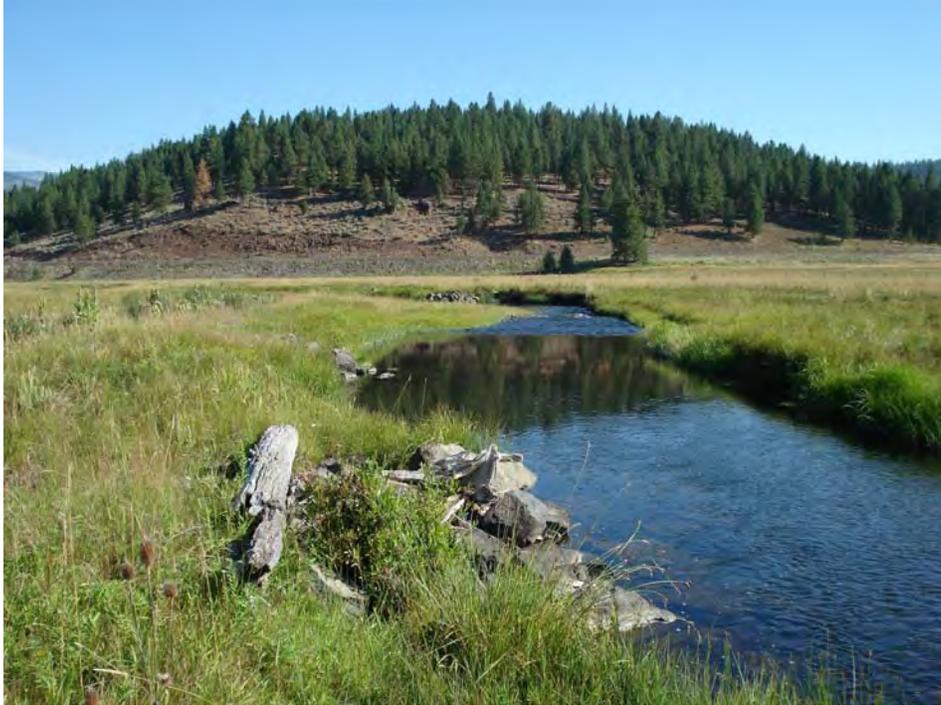
**Photograph No. 79. View is to the north looking downstream at rock spur placed along river left. Middle Fork John Day River, Oregon – Bureau of Reclamation Photograph by R. McAfee, July 20, 2007.**

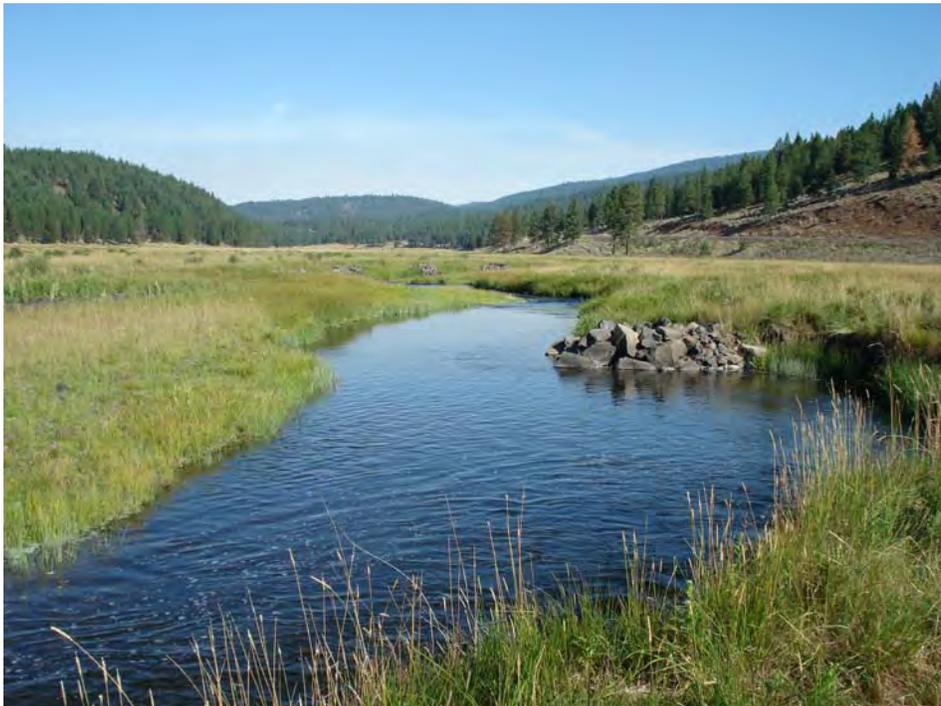
**Photograph No. 80. View is to the northwest looking downstream at rock spur placed along river right. Middle Fork John Day River, Oregon – Bureau of Reclamation Photograph by R. McAfee, July 20, 2007.**

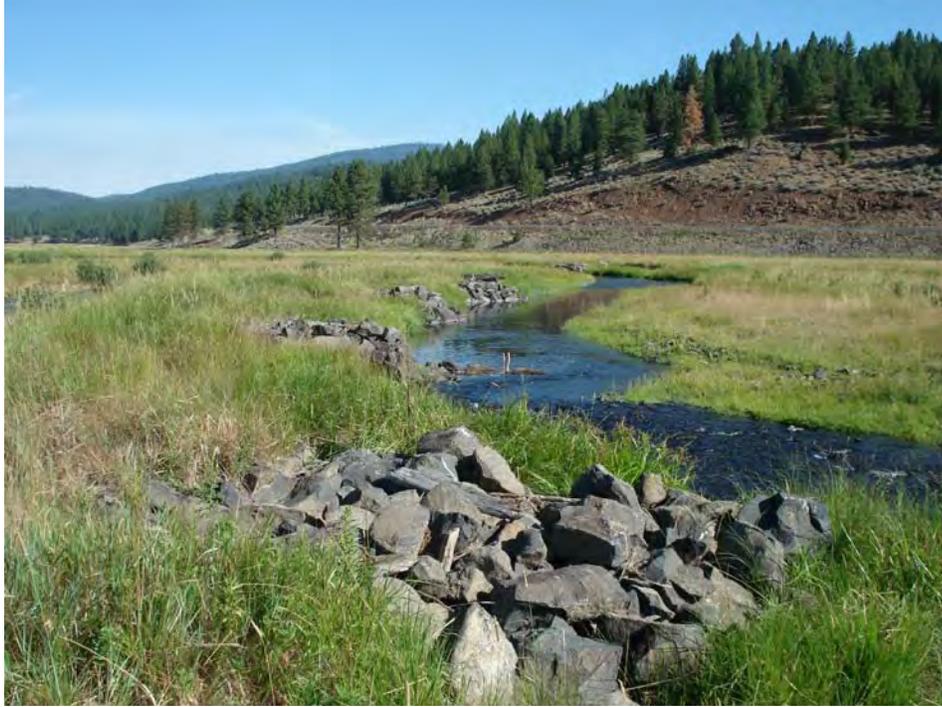
**Photograph No. 81.** View is to the northwest looking downstream at rock spurs placed along river left. Middle Fork John Day River, Oregon – Bureau of Reclamation Photograph by R. McAfee, July 20, 2007.

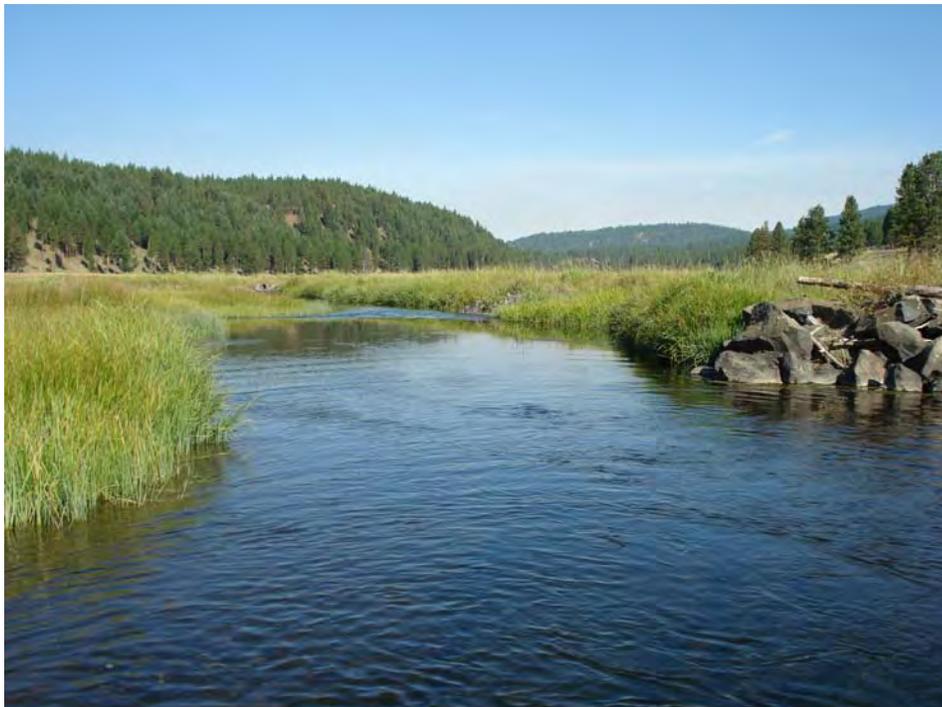
**Photograph No. 82.** View is to the northwest looking downstream at rock spur placed along river right. Middle Fork John Day River, Oregon – Bureau of Reclamation Photograph by R. McAfee, July 20, 2007.

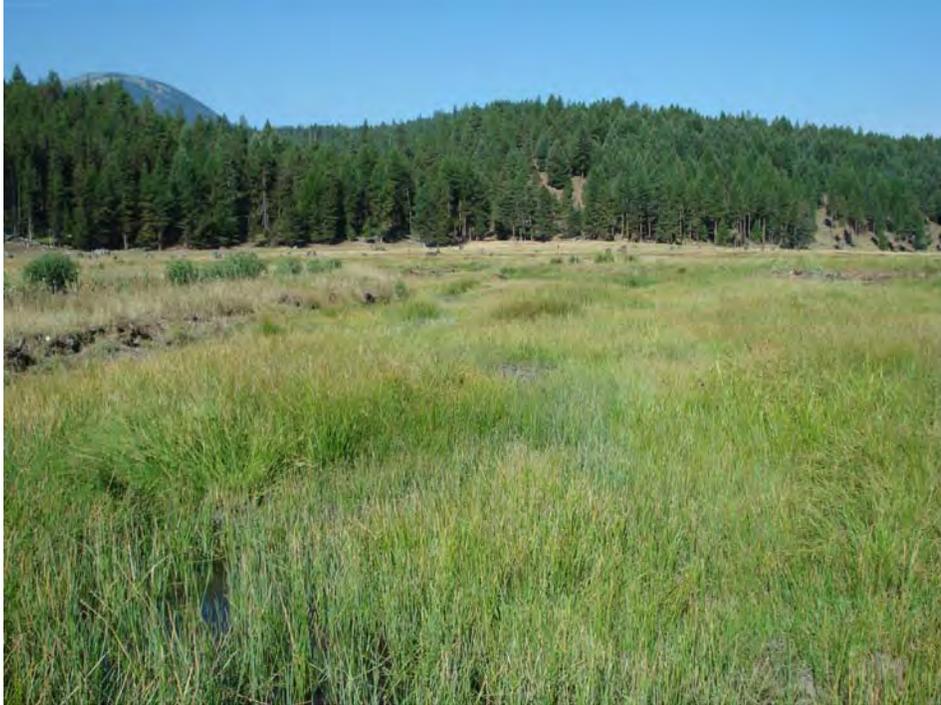
**Photograph No. 83. View is to the west looking downstream at head of a side-channel flowing along river left. Middle Fork John Day River, Oregon – Bureau of Reclamation Photograph by R. McAfee, July 20, 2007.**

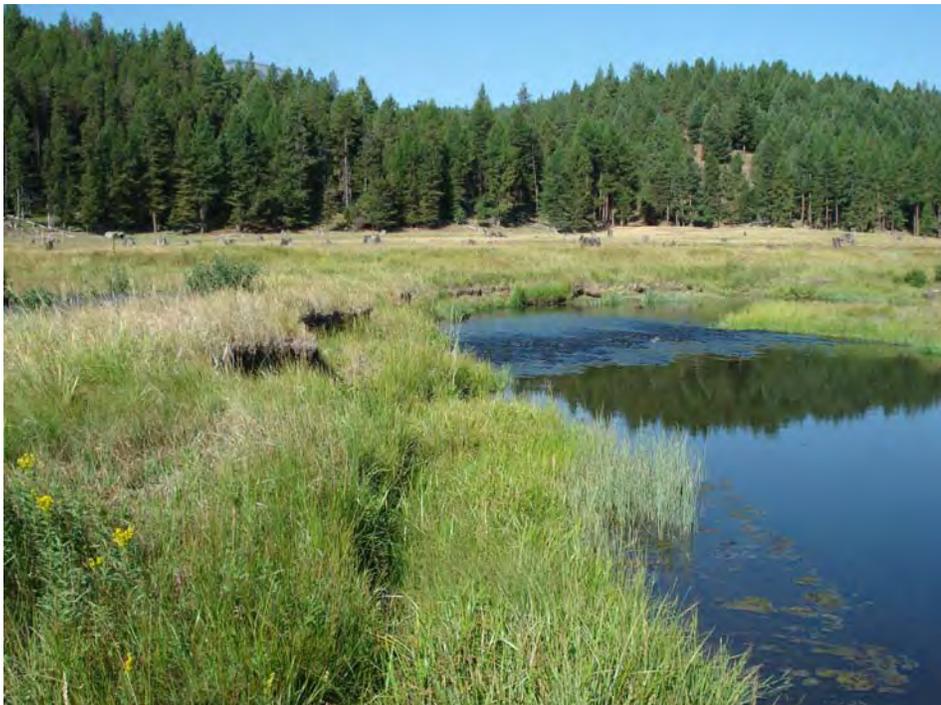
**Photograph No. 84. View is to the west looking downstream at bank erosion occurring along river left. Middle Fork John Day River, Oregon – Bureau of Reclamation Photograph by R. McAfee, July 20, 2007.**

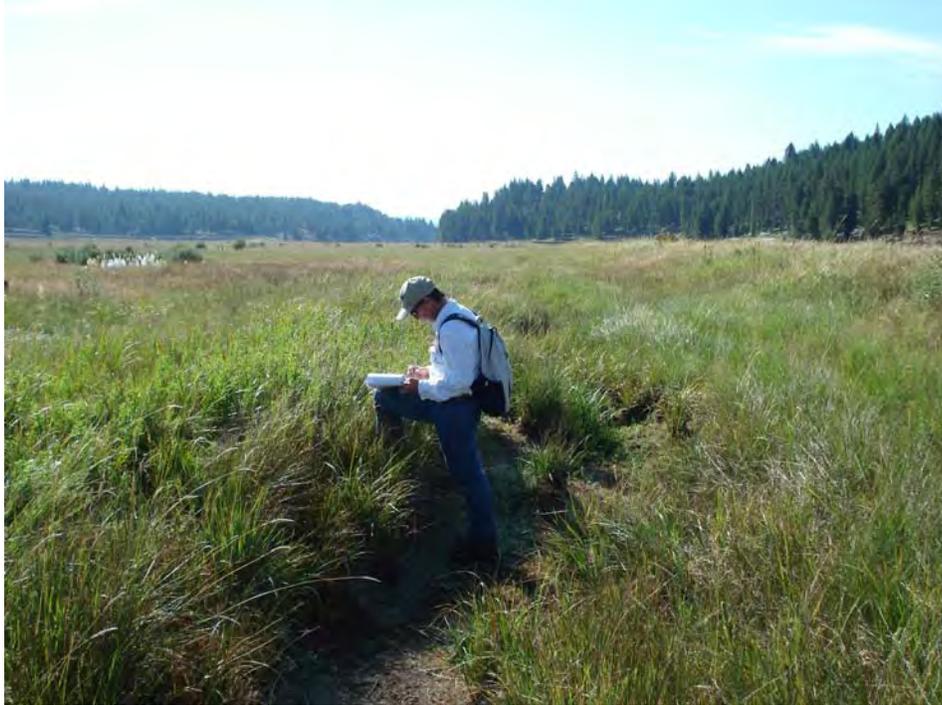
**Photograph No. 85. View is to the southeast looking upstream at ephemeral tributary channel. Middle Fork John Day River, Oregon – Bureau of Reclamation Photograph by R. McAfee, July 20, 2007.**

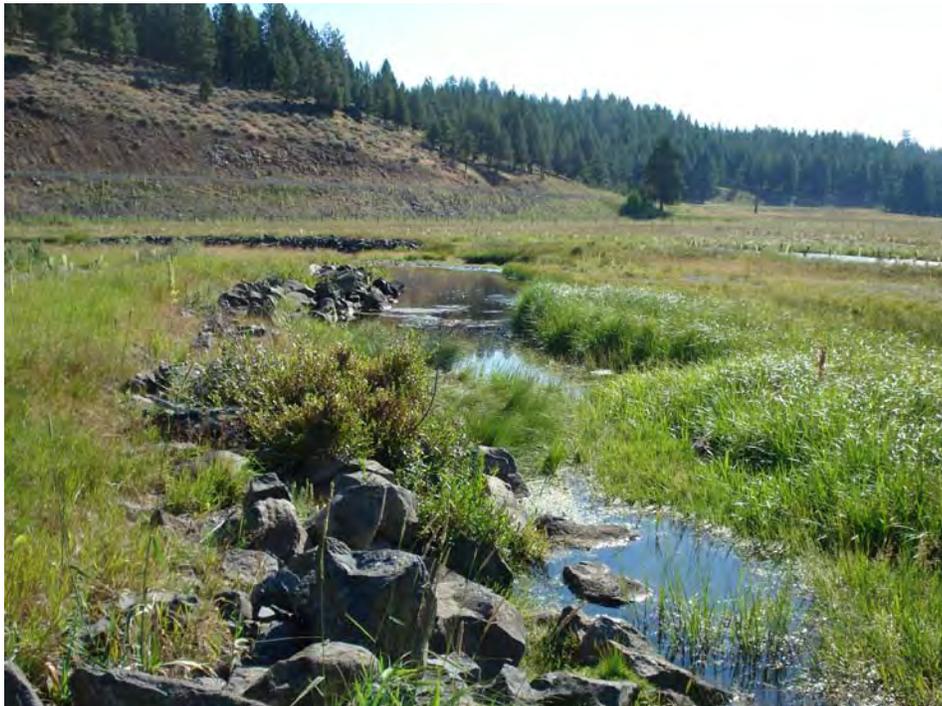
**Photograph No. 86. View is to the northeast looking downstream at riprap placed along the left bank of a historic channel path. Middle Fork John Day River, Oregon – Bureau of Reclamation Photograph by R. McAfee, July 20, 2007.**

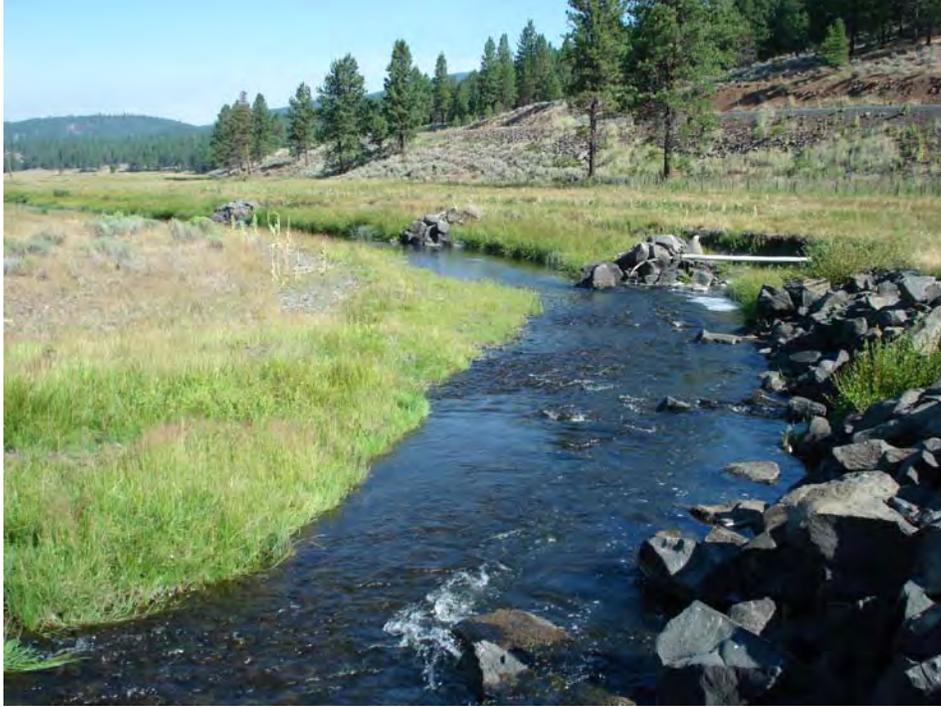
**Photograph No. 87. View is to the north looking downstream at rock spurs placed along river right. Middle Fork John Day River, Oregon – Bureau of Reclamation Photograph by R. McAfee, July 20, 2007.**

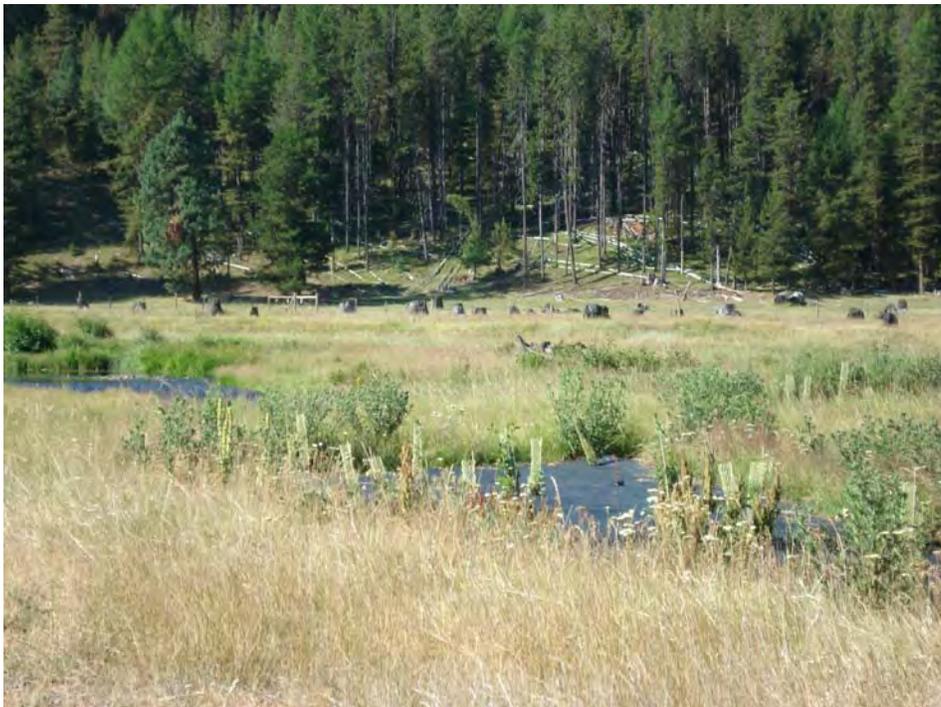
**Photograph No. 88. View is to the southwest looking at timber harvest area conducted on an alluvial fan. Middle Fork John Day River, Oregon – Bureau of Reclamation Photograph by R. McAfee, July 20, 2007.**

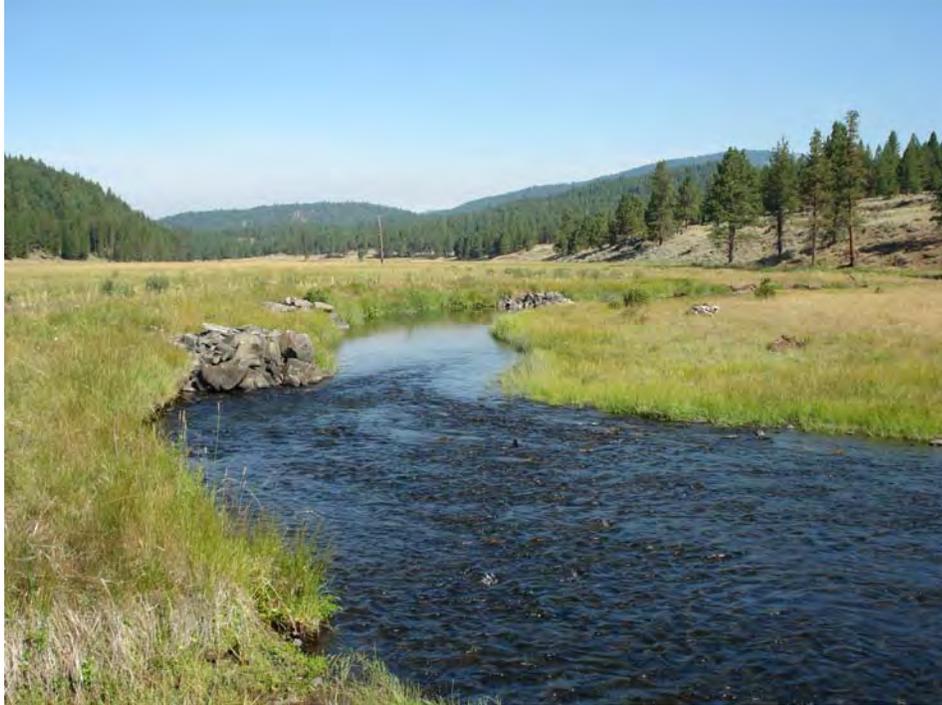
**Photograph No. 89.** View is to the northwest looking downstream at rock spurs placed along river left. Middle Fork John Day River, Oregon – Bureau of Reclamation Photograph by R. McAfee, July 20, 2007.

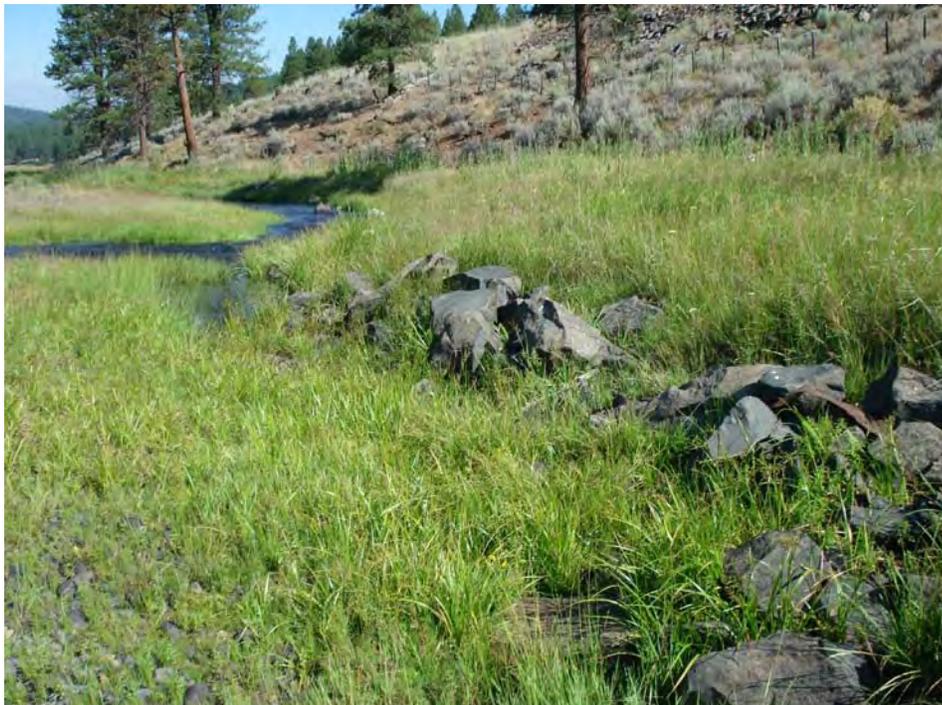
**Photograph No. 90.** View is to the northwest looking downstream at riprap placed along river right. Middle Fork John Day River, Oregon – Bureau of Reclamation Photograph by R. McAfee, July 20, 2007.
