## Forrest Conservation Area Reach Assessment Middle Fork John Day River

Grant County, Oregon

U.S. Department of the Interior  
Bureau of Reclamation  
Pacific Northwest Region  
Pacific Northwest Regional Office, Boise, Idaho

August 2010

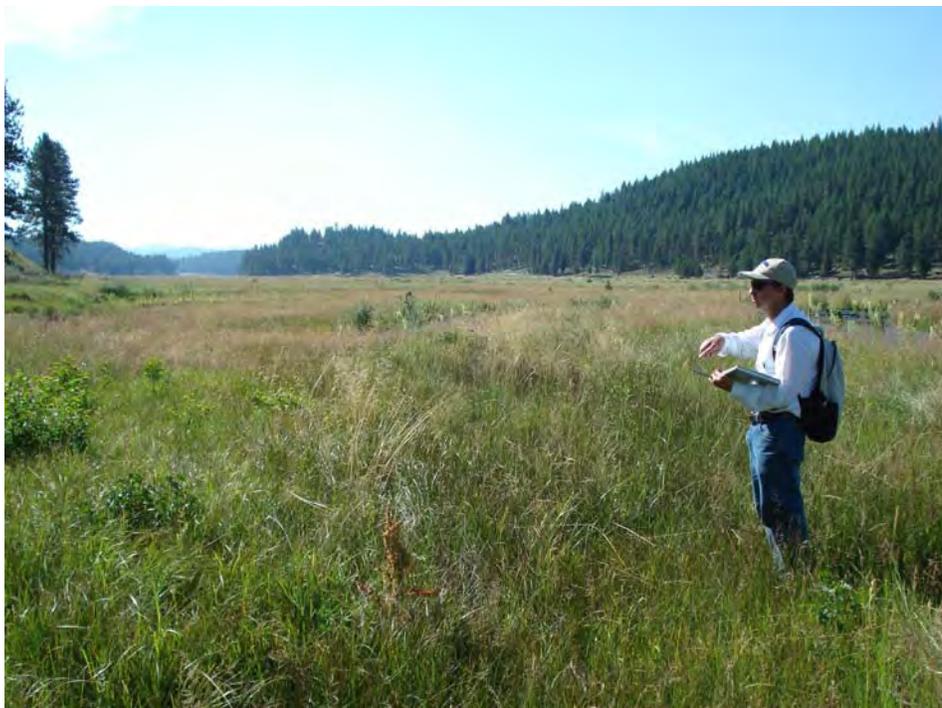
**Photograph No. 91. View is to the south looking at the mouth of a historic side-channel that appears to be elevated approximately 2' above the active channel. Middle Fork John Day River, Oregon – Bureau of Reclamation Photograph by R. McAfee, July 20, 2007.**

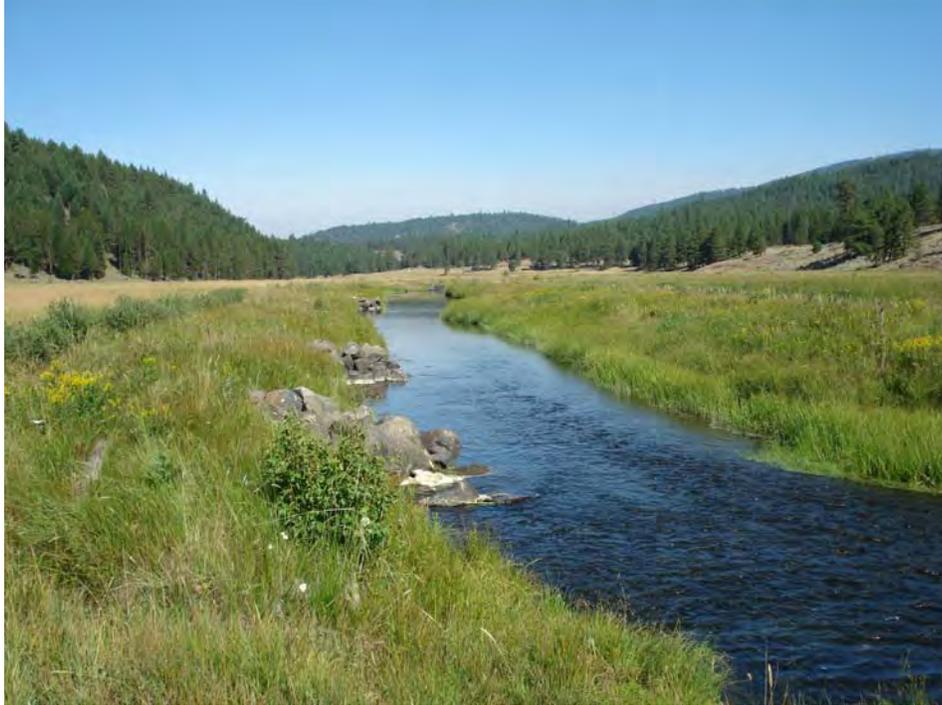
**Photograph No. 93.** View is to the northwest looking at rock spurs placed along river left. Middle Fork John Day River, Oregon – Bureau of Reclamation Photograph by R. McAfee, July 20, 2007.

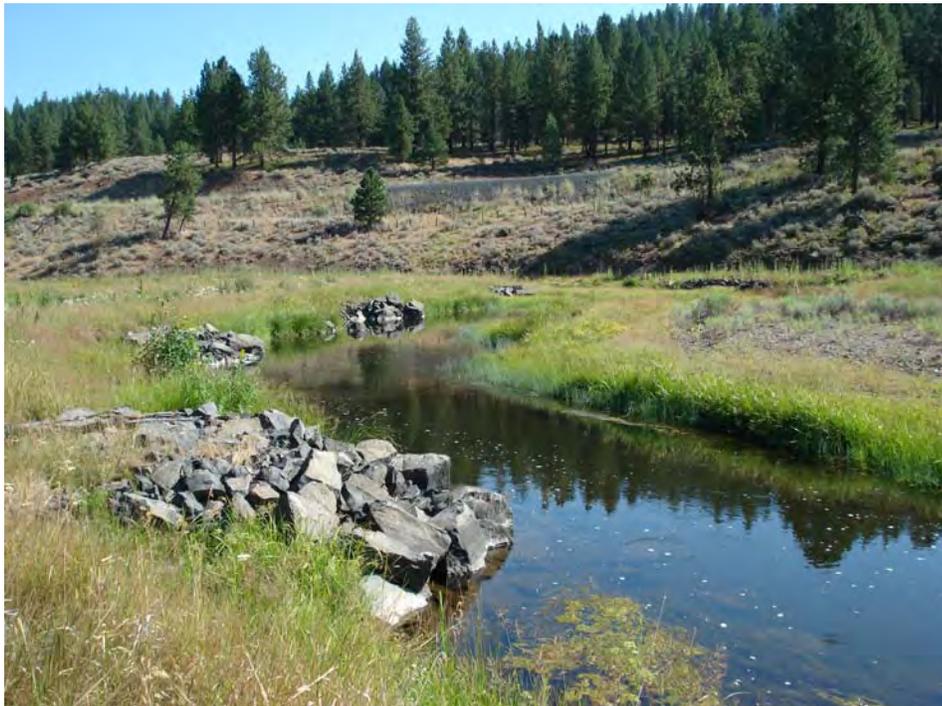
**Photograph No. 94.** View is to the north looking downstream at rock spurs placed along river left. Middle Fork John Day River, Oregon – Bureau of Reclamation Photograph by R. McAfee, July 20, 2007.

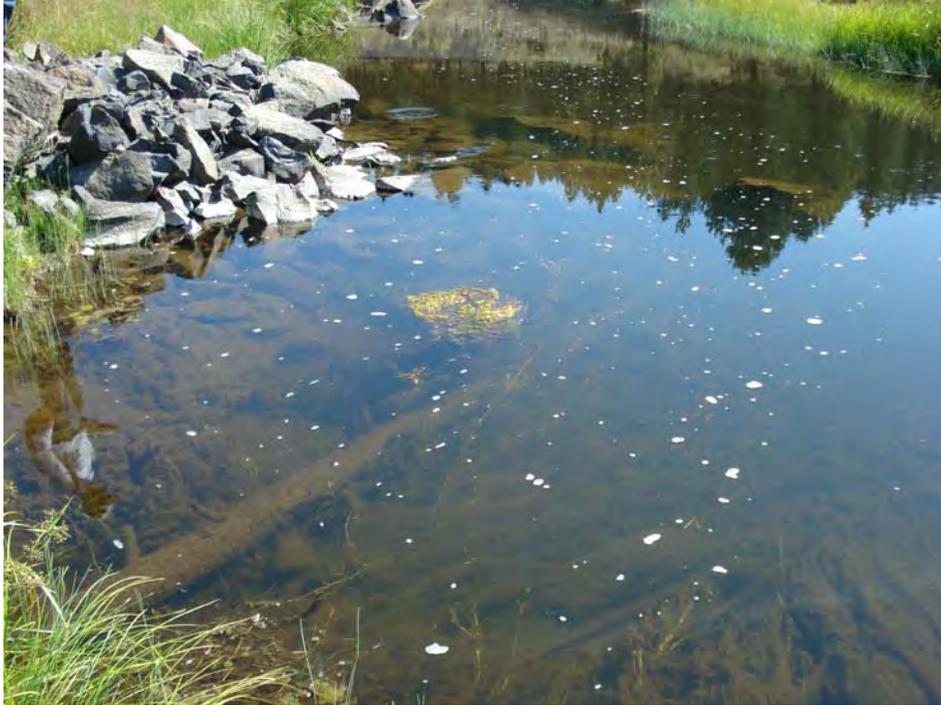
**Photograph No. 95. View is looking at a submerged log that provides protective cover for fish. Numerous fish were observed around the log and adjacent moss growth. Middle Fork John Day River, Oregon – Bureau of Reclamation Photograph by R. McAfee, July 20, 2007.**

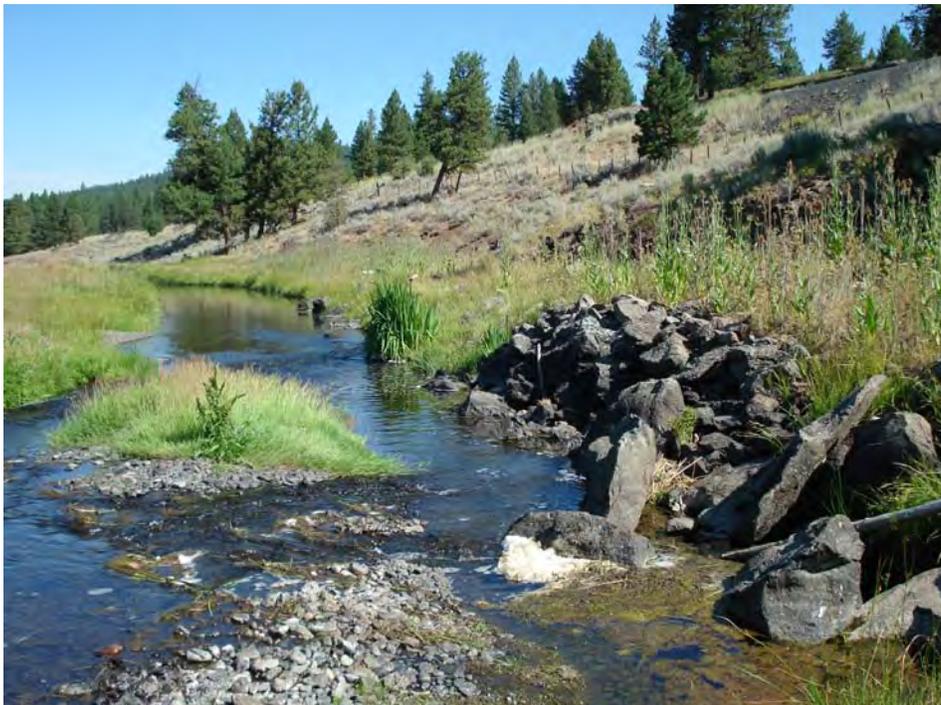
**Photograph No. 96. View is to the north looking downstream at riprap placed along river right. Middle Fork John Day River, Oregon – Bureau of Reclamation Photograph by R. McAfee, July 20, 2007.**

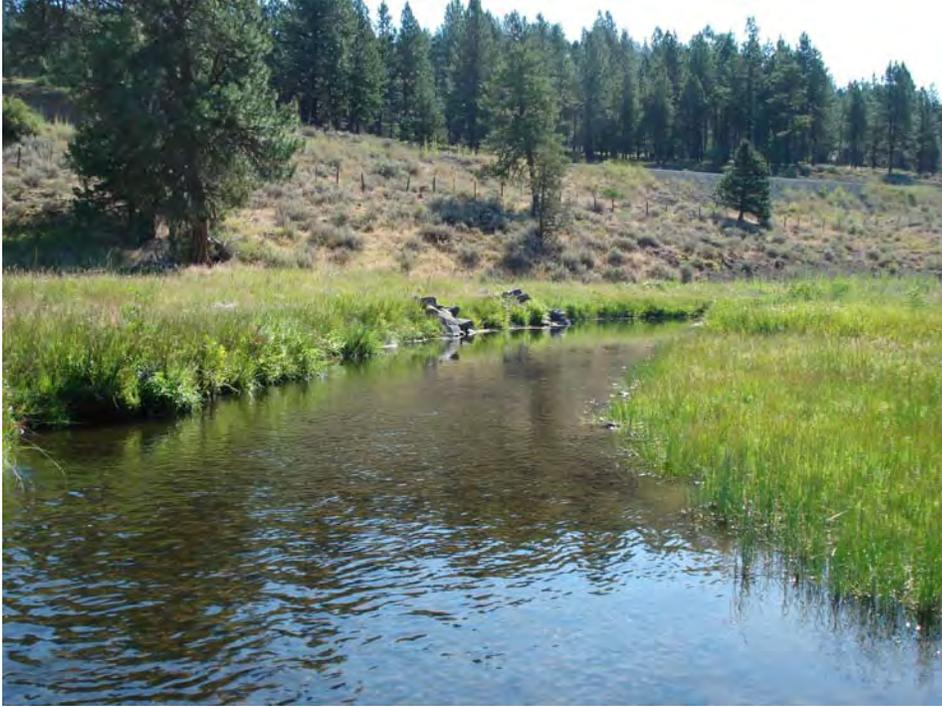
**Photograph No. 97. View is to the east looking upstream at rock spurs placed along river right. Middle Fork John Day River, Oregon – Bureau of Reclamation Photograph by R. McAfee, July 20, 2007.**

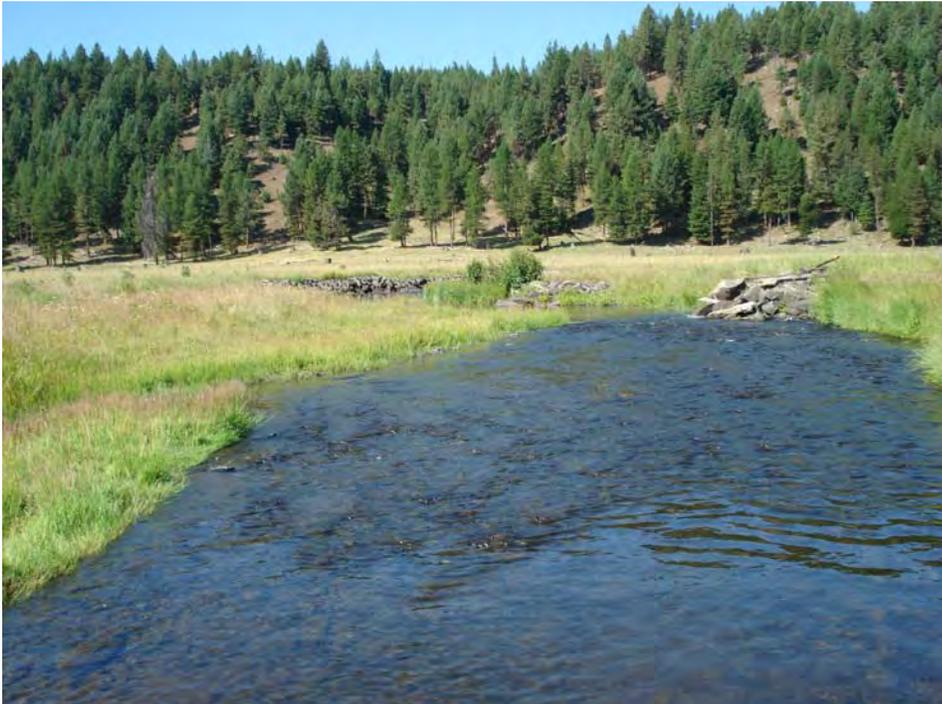
**Photograph No. 98. View is to the west looking downstream at rock spurs placed along river right. Middle Fork John Day River, Oregon – Bureau of Reclamation Photograph by R. McAfee, July 20, 2007.**

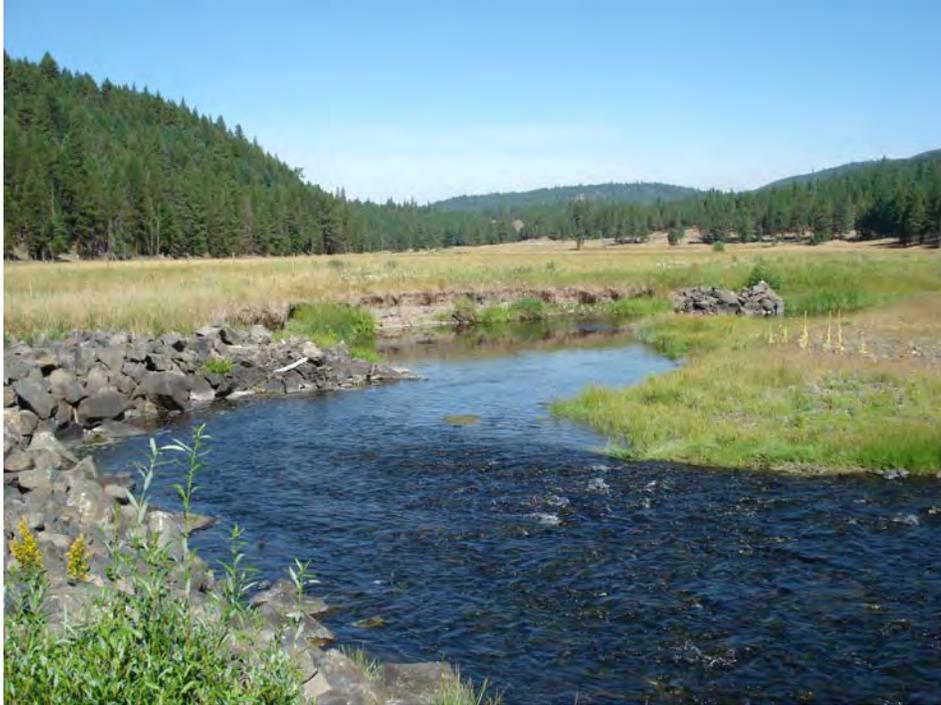
**Photograph No. 99. View is to the southwest looking downstream at riprap and rock spurs placed along river left. Note the bank erosion downstream of riprap. Middle Fork John Day River, Oregon – Bureau of Reclamation Photograph by R. McAfee, July 20, 2007.**

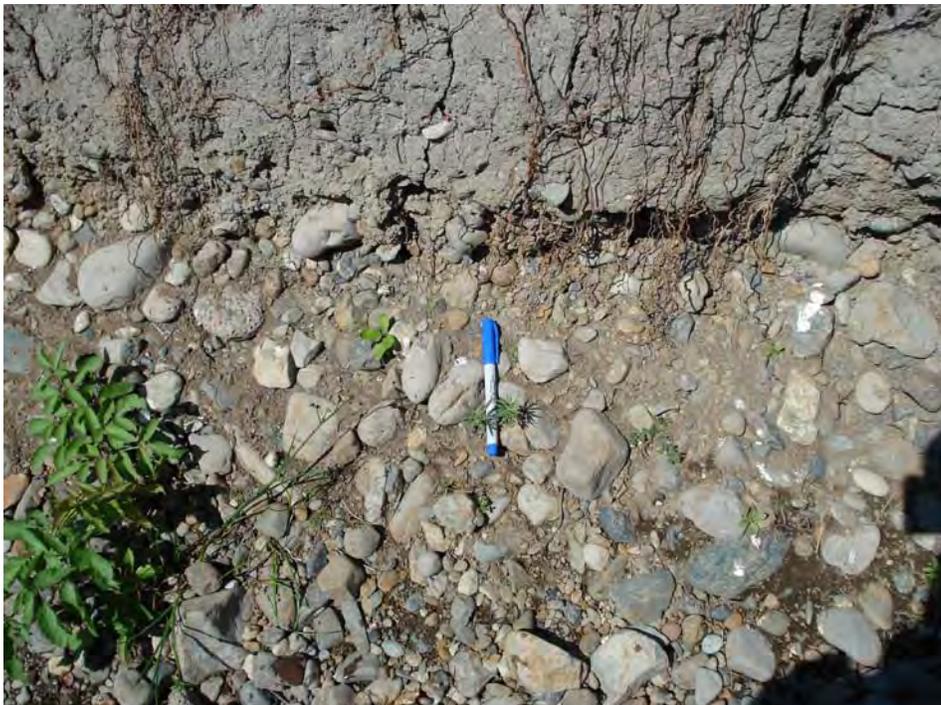
**Photograph No. 100. Eroding streambank comprised of clayey silt overlying gravels. Middle Fork John Day River, Oregon – Bureau of Reclamation Photograph by R. McAfee, July 20, 2007.**

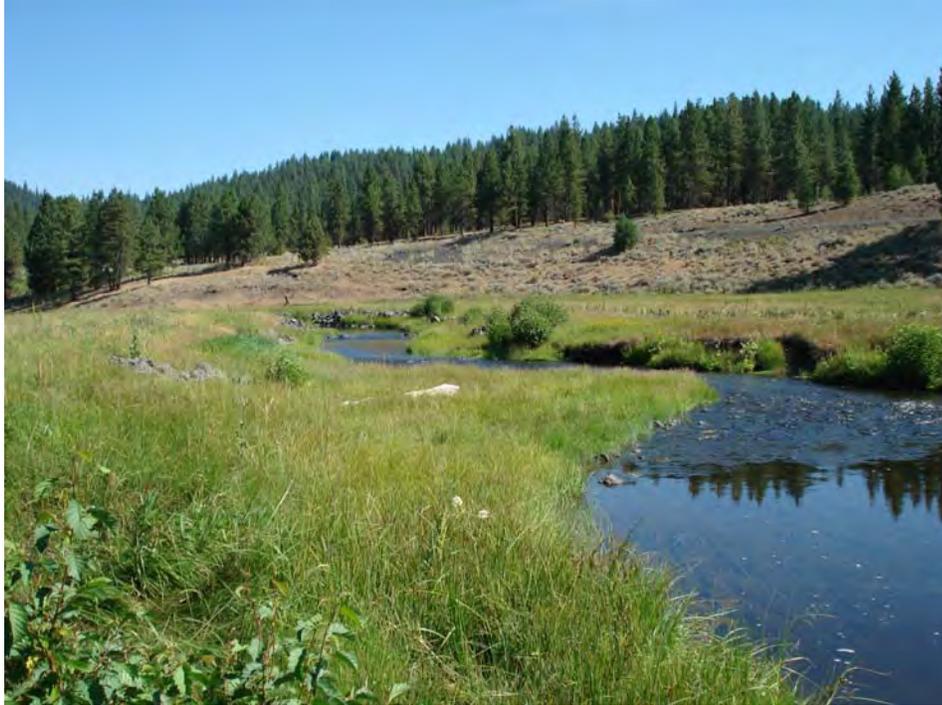
**Photograph No. 101. View is to the north looking downstream at a rock spur along river left and bank erosion occurring along river right. Middle Fork John Day River, Oregon – Bureau of Reclamation Photograph by R. McAfee, July 20, 2007.**

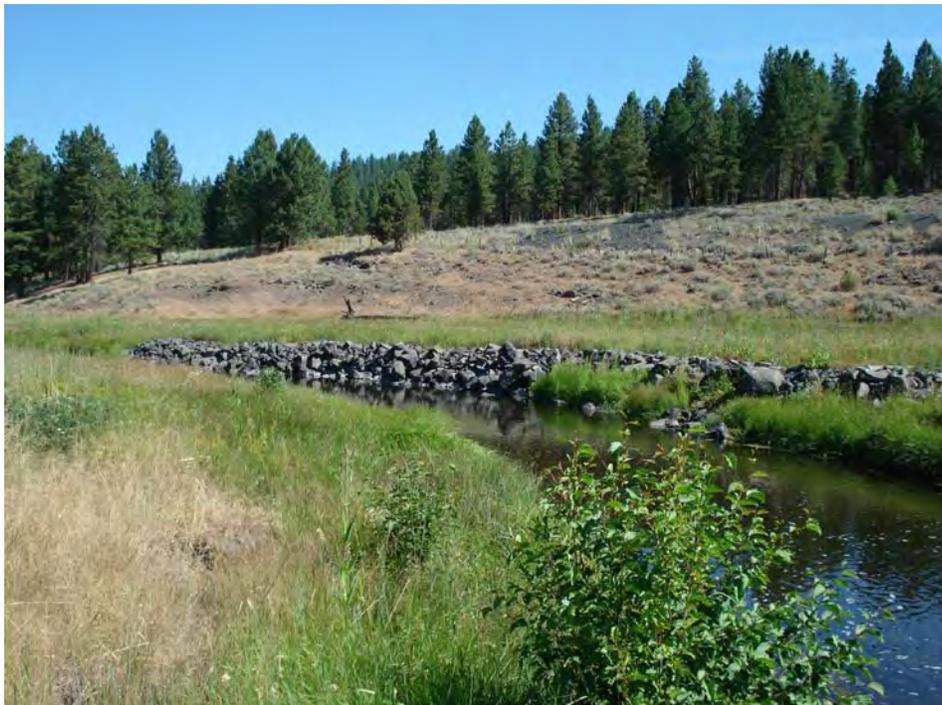
**Photograph No. 102. View is to the northwest looking downstream at riprap placed along river right. Middle Fork John Day River, Oregon – Bureau of Reclamation Photograph by R. McAfee, July 20, 2007.**

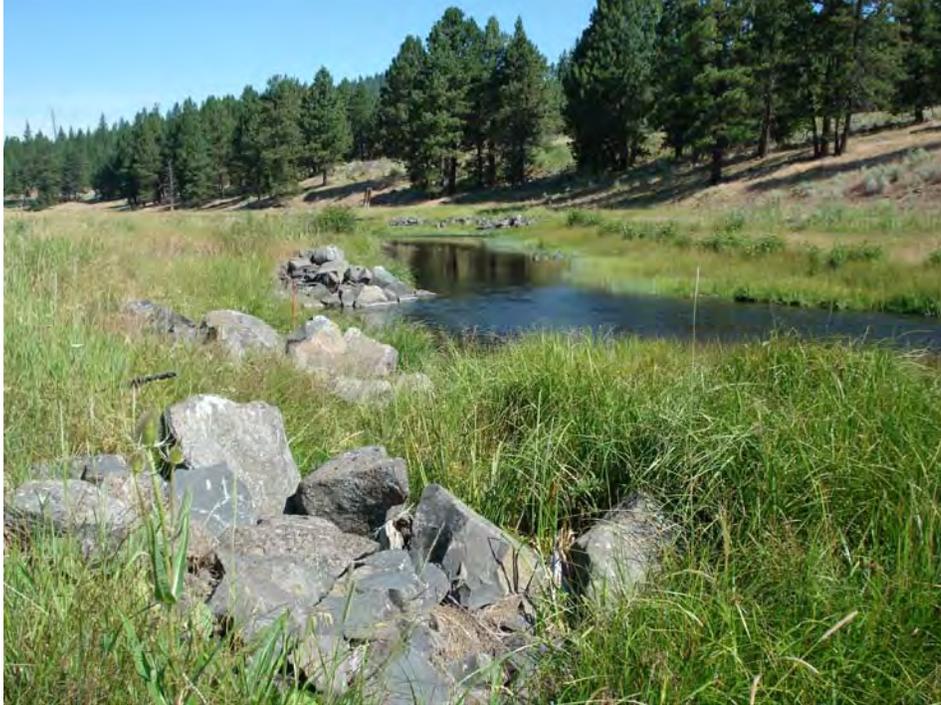
**Photograph No. 103.** View is to the northwest looking downstream at rock spurs placed along river left. Middle Fork John Day River, Oregon – Bureau of Reclamation Photograph by R. McAfee, July 20, 2007.

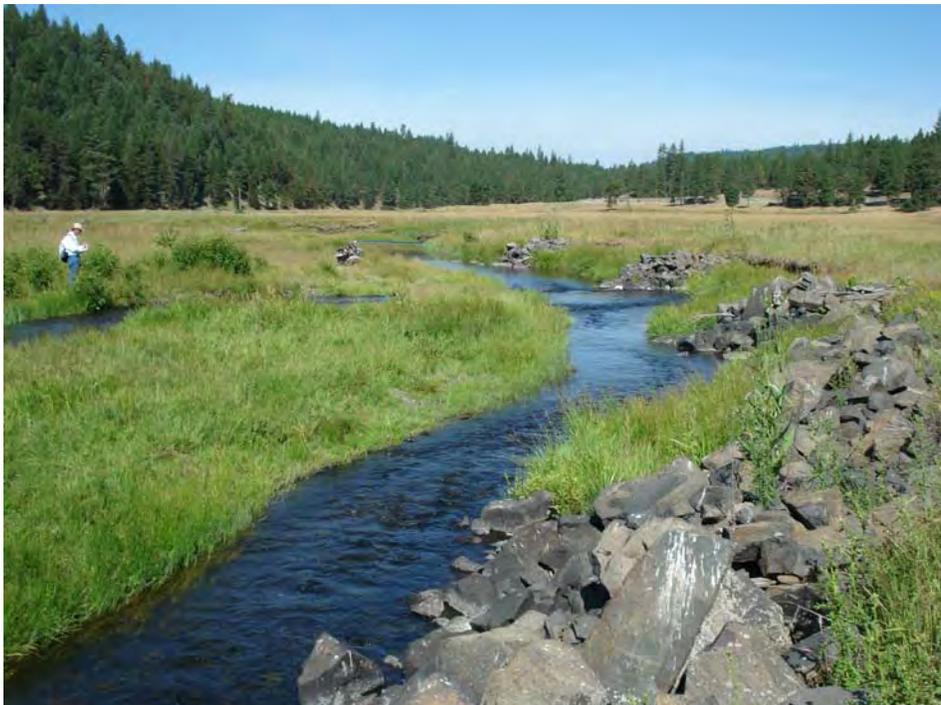
**Photograph No. 104.** View is to the northwest looking downstream at riprap and rock spurs placed along river right. Middle Fork John Day River, Oregon – Bureau of Reclamation Photograph by R. McAfee, July 20, 2007.

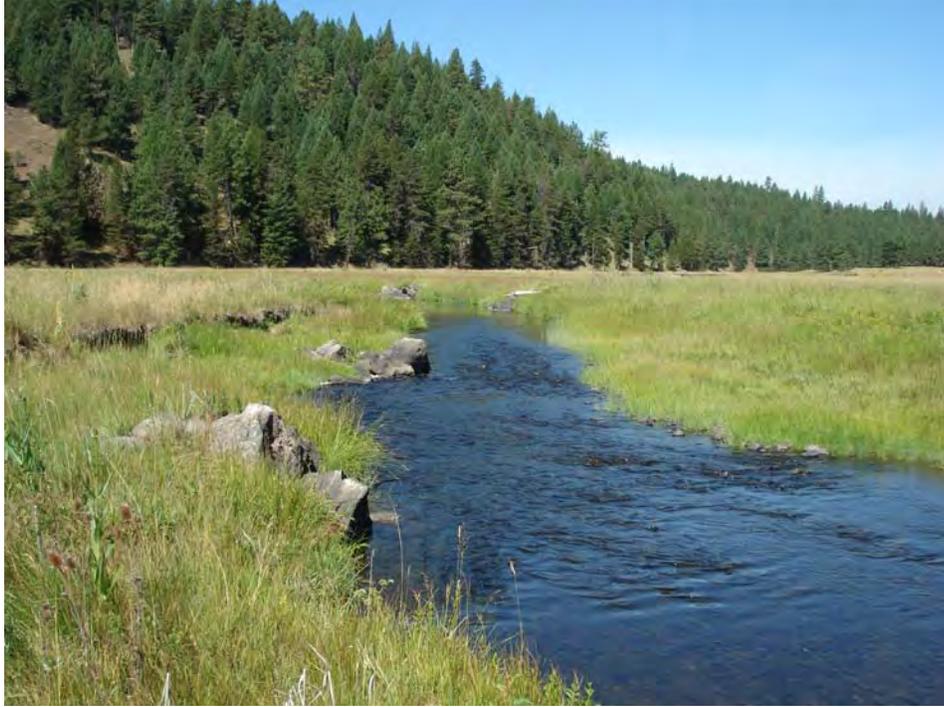
**Photograph No. 105. View is to the west looking downstream at rock spurs placed along river left. Project Area RM 63.6-64. Middle Fork John Day River, Oregon – Bureau of Reclamation Photograph by R. McAfee, July 20, 2007.**

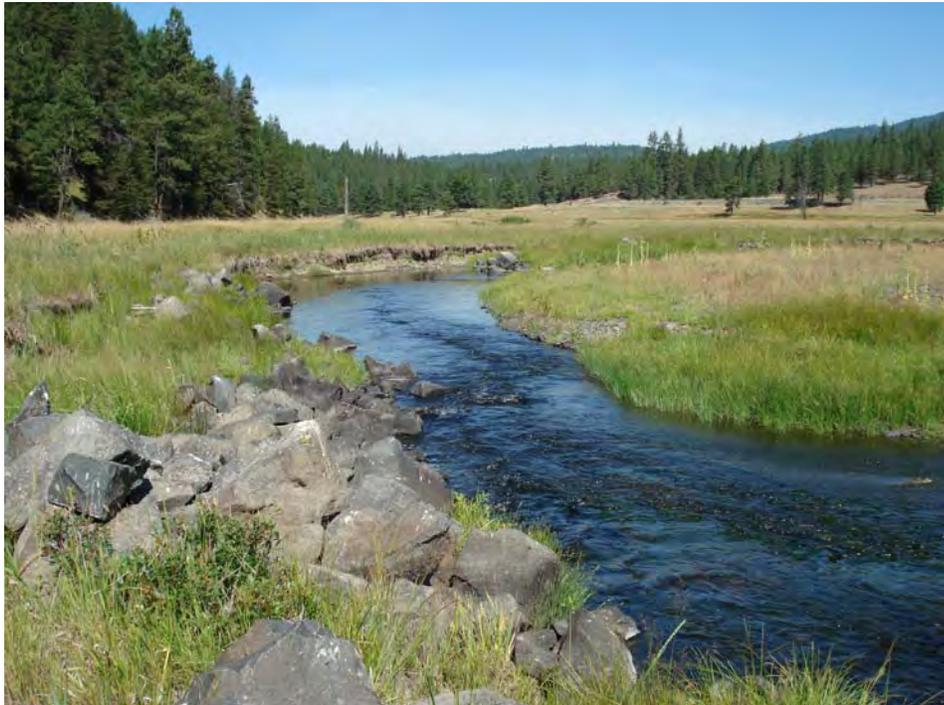
**Photograph No. 106. View is to the northwest looking downstream at rock spurs placed along river left and the bank erosion occurring downstream of the rock. Middle Fork John Day River, Oregon – Bureau of Reclamation Photograph by R. McAfee, July 20, 2007.**

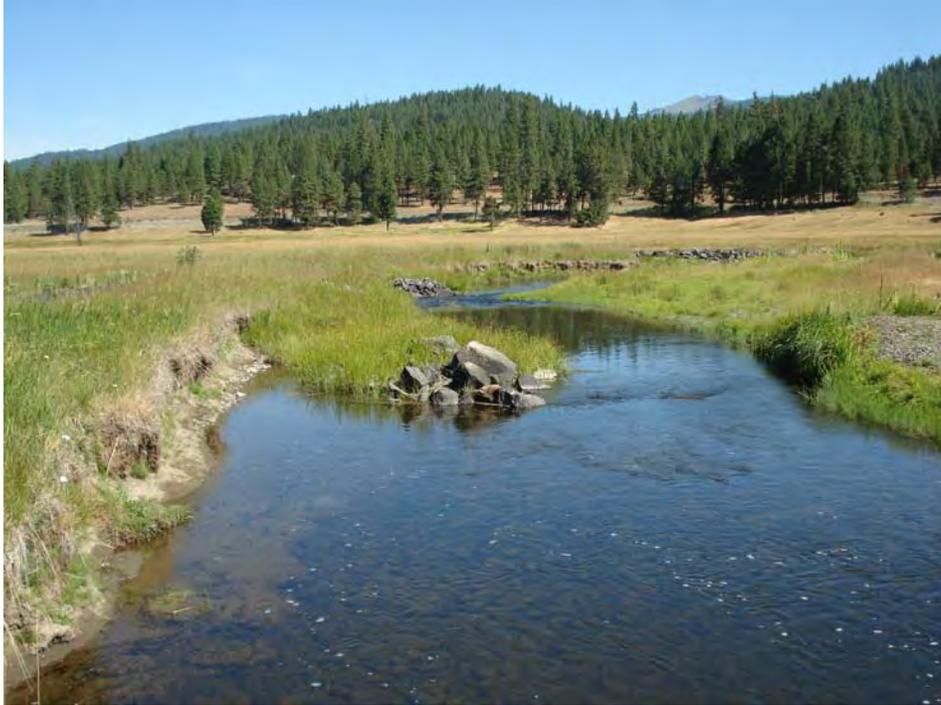
**Photograph No. 107.** View is to the north looking downstream at bank erosion around a rock spur. Middle Fork John Day River, Oregon – Bureau of Reclamation Photograph by R. McAfee, July 20, 2007.

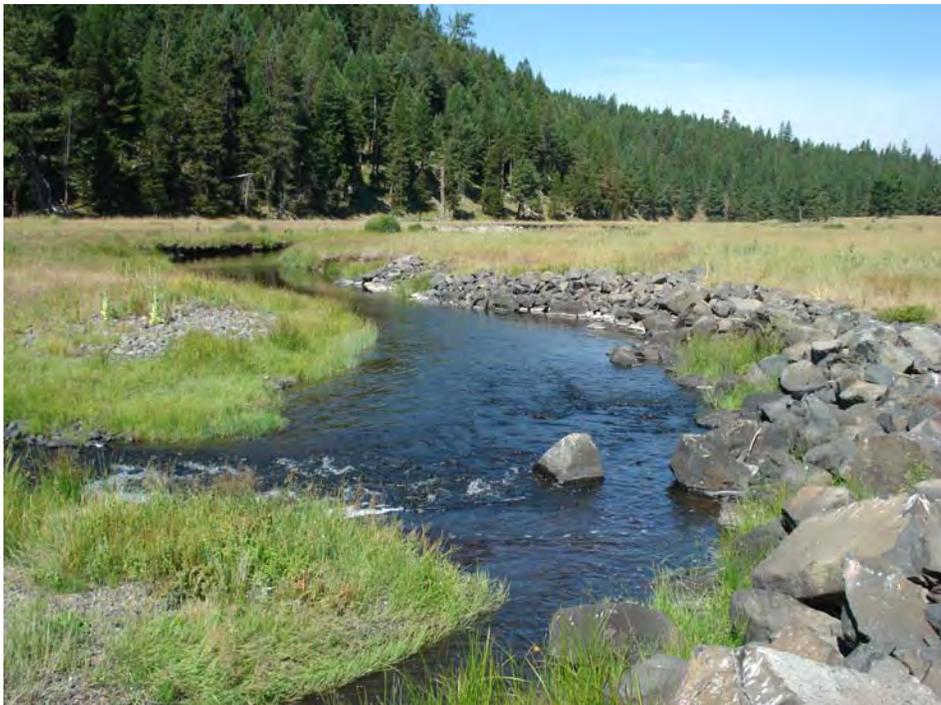
**Photograph No. 108.** View is to the northwest looking downstream at riprap placed along river right. Middle Fork John Day River, Oregon – Bureau of Reclamation Photograph by R. McAfee, July 20, 2007.

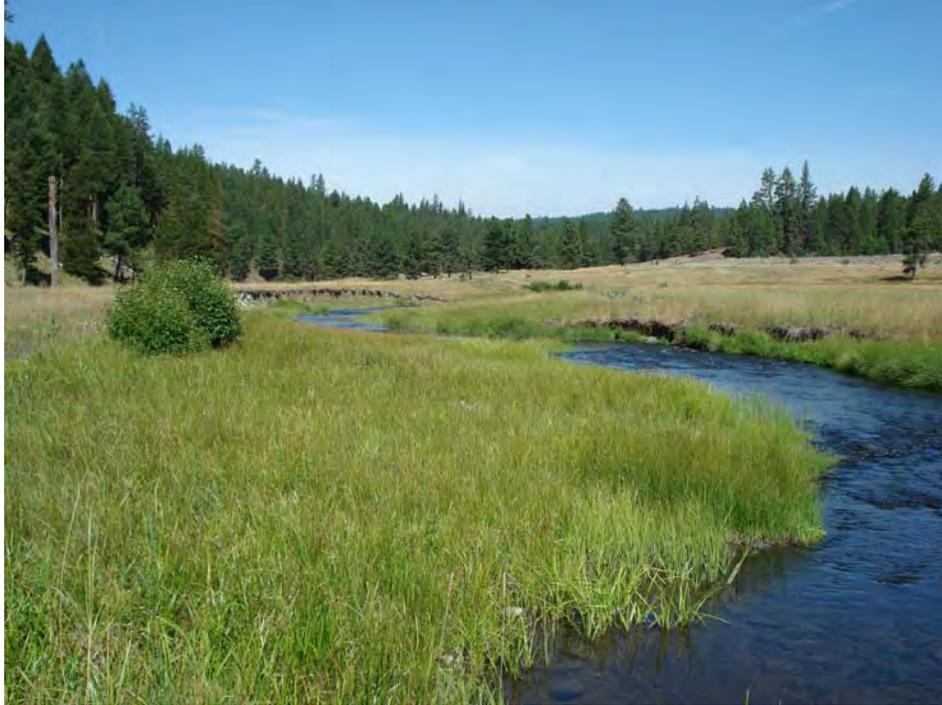
**Photograph No. 109.** View is to the northwest looking downstream at bank erosion along river right. Middle Fork John Day River, Oregon – Bureau of Reclamation Photograph by R. McAfee, July 20, 2007.

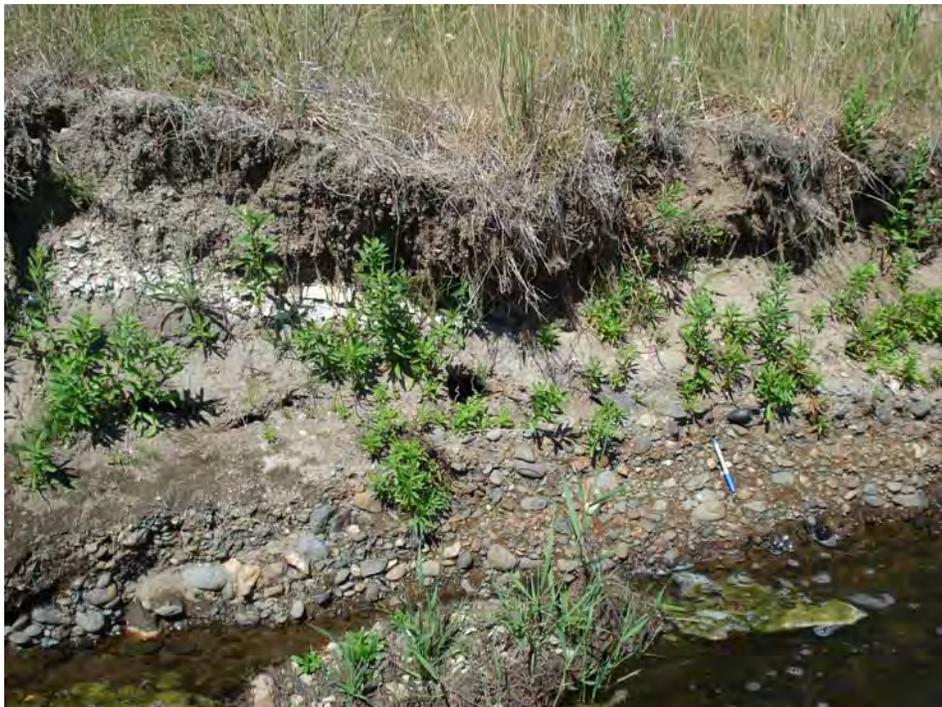
**Photograph No. 110.** View of erosion occurring along the railroad grade on river left. Middle Fork John Day River, Oregon – Bureau of Reclamation Photograph by R. McAfee, July 20, 2007.

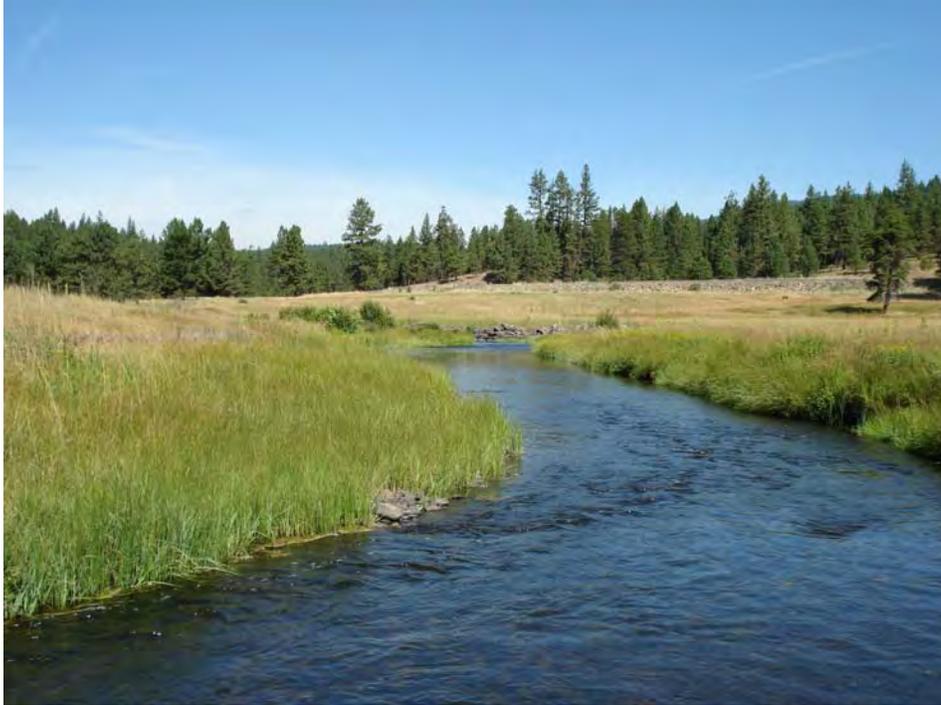
**Photograph No. 111. View is to the northwest looking downstream at grass covered banks that are being undercut along river right. Middle Fork John Day River, Oregon – Bureau of Reclamation Photograph by R. McAfee, July 20, 2007.**

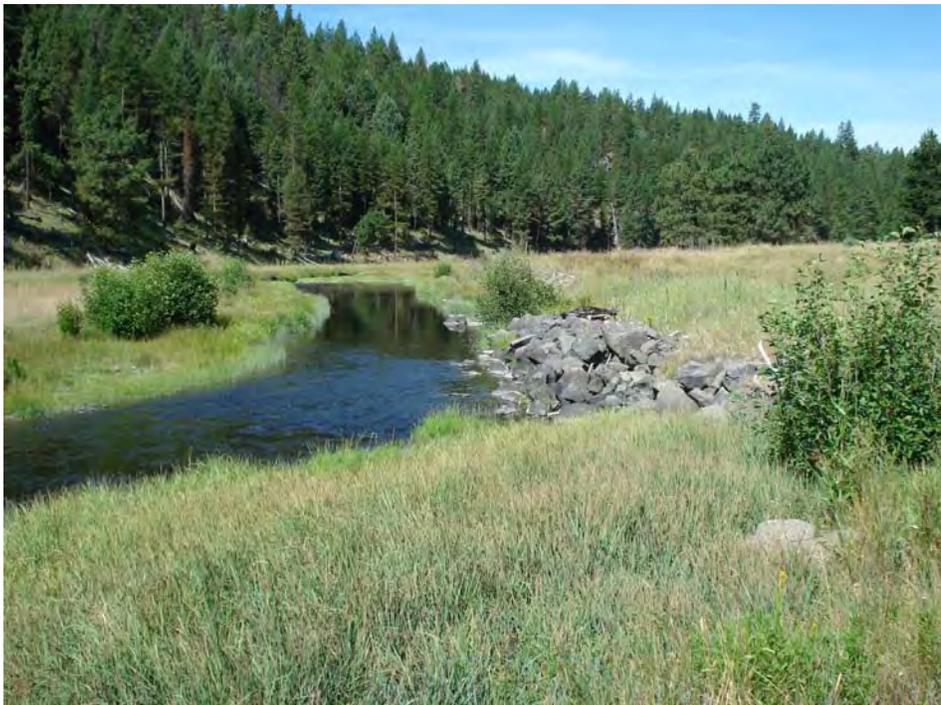
**Photograph No. 112. View is to the west looking downstream at riprap placed along river right. Middle Fork John Day River, Oregon – Bureau of Reclamation Photograph by R. McAfee, July 20, 2007.**

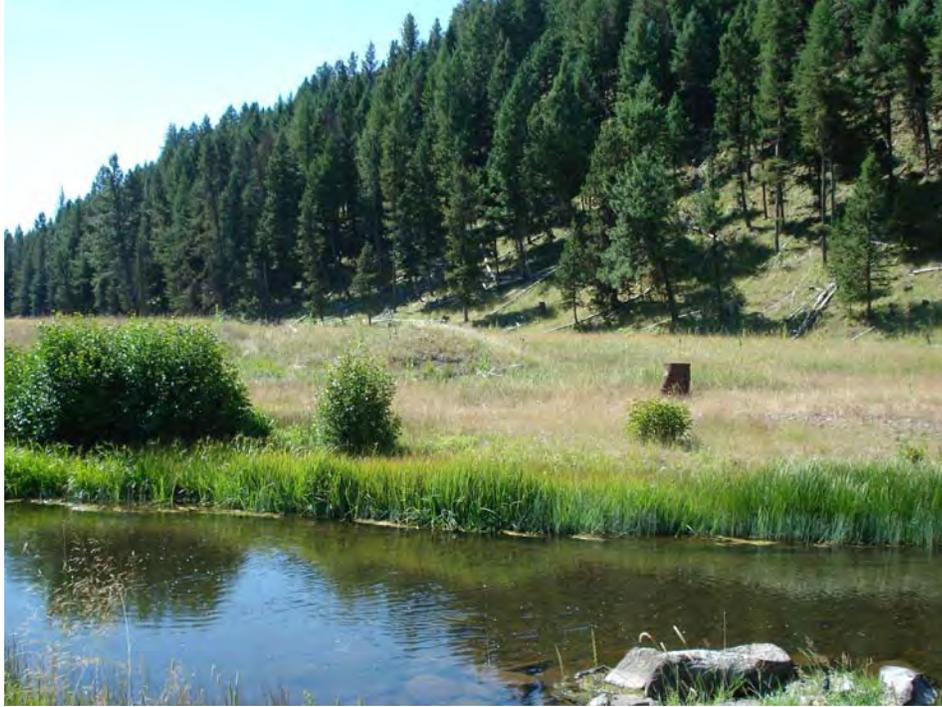
**Photograph No. 113. View is to the south looking at the left abutment of a historic bridge along the railroad grade. Middle Fork John Day River, Oregon – Bureau of Reclamation Photograph by R. McAfee, July 20, 2007.**

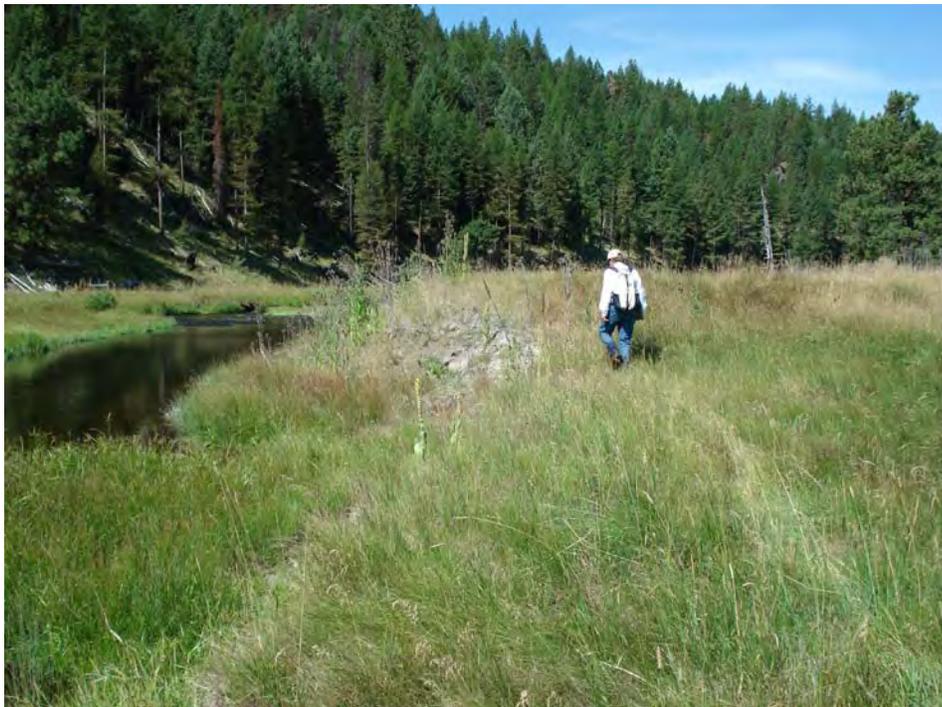
**Photograph No. 114. View is to the northwest looking downstream at the right abutment of a historic bridge along the railroad grade. Middle Fork John Day River, Oregon – Bureau of Reclamation Photograph by R. McAfee, July 20, 2007.**

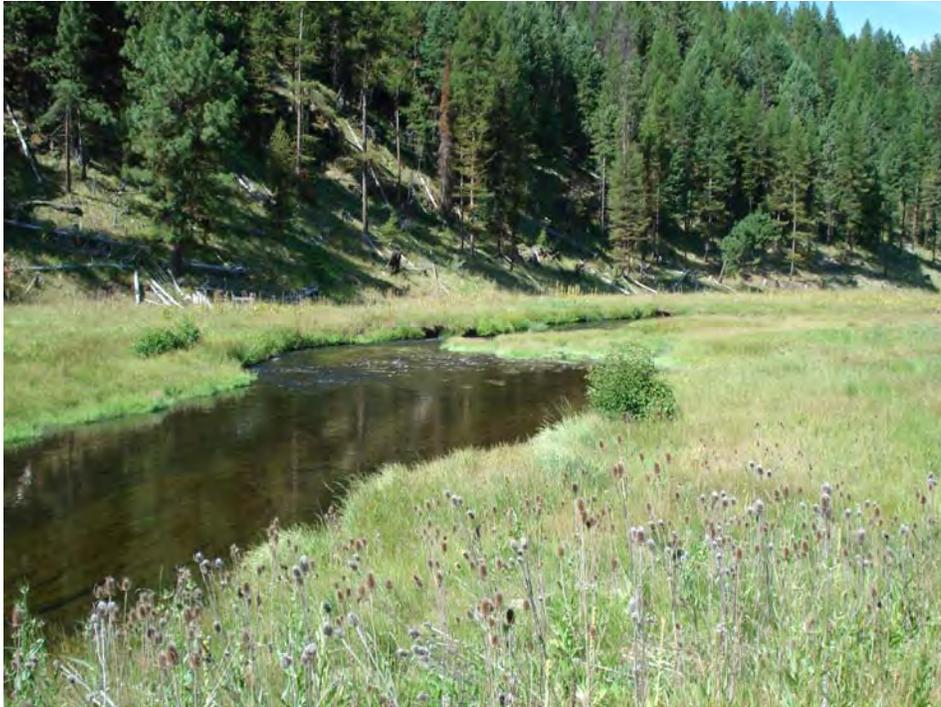
**Photograph No. 115.** View is to the southwest looking downstream at undercutting occurring along river left. Middle Fork John Day River, Oregon – Bureau of Reclamation Photograph by R. McAfee, July 20, 2007.

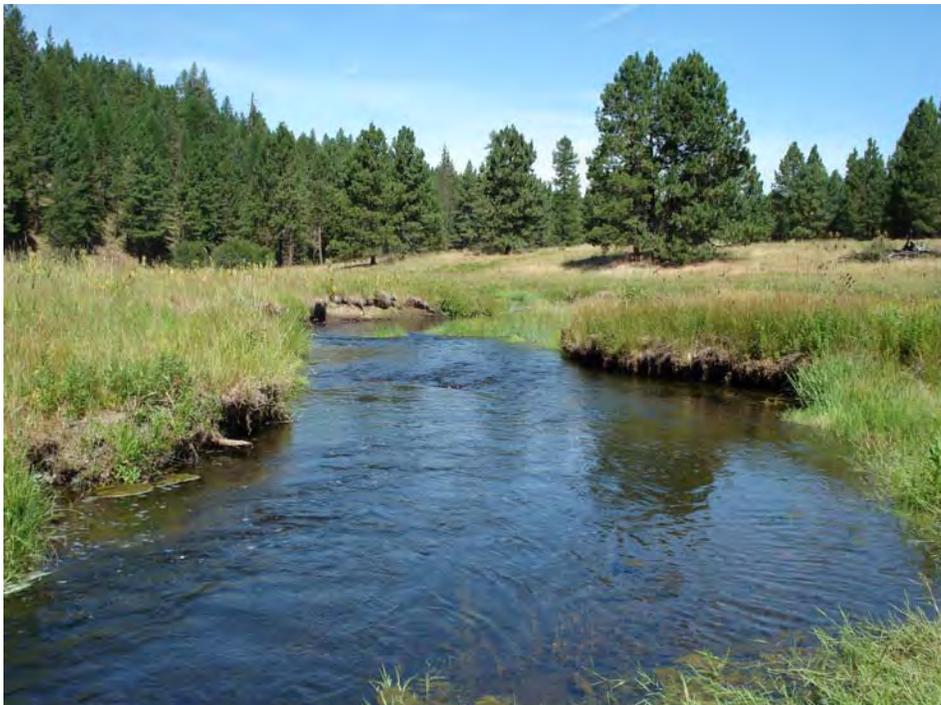
**Photograph No. 116.** View is to the west looking downstream at erosion occurring along both river banks. Middle Fork John Day River, Oregon – Bureau of Reclamation Photograph by R. McAfee, July 20, 2007.
