**Savage Rapids Dam**

**06SP101619**

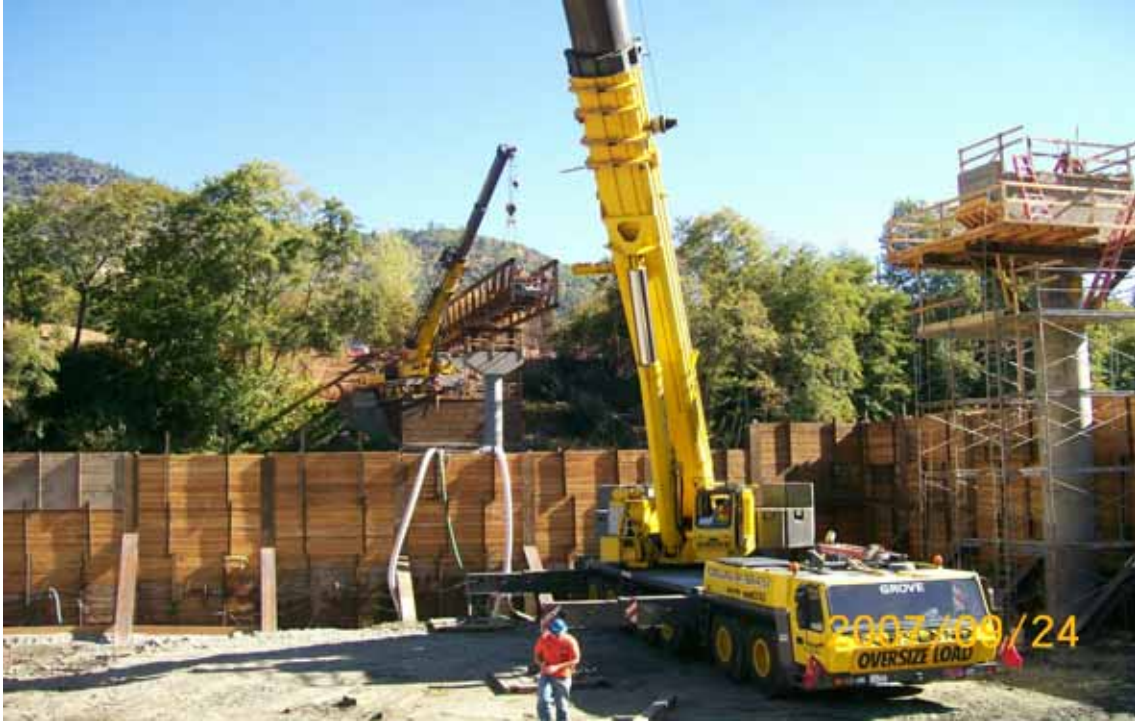
**Photo # :** Savagr617kw

**Description:** From the South side of the river inside the soldier pile coffer dam as the 350 ton crane is being positioned to the West side of pier 1 for setting bridge section B to the in place section C on the North side of the river.

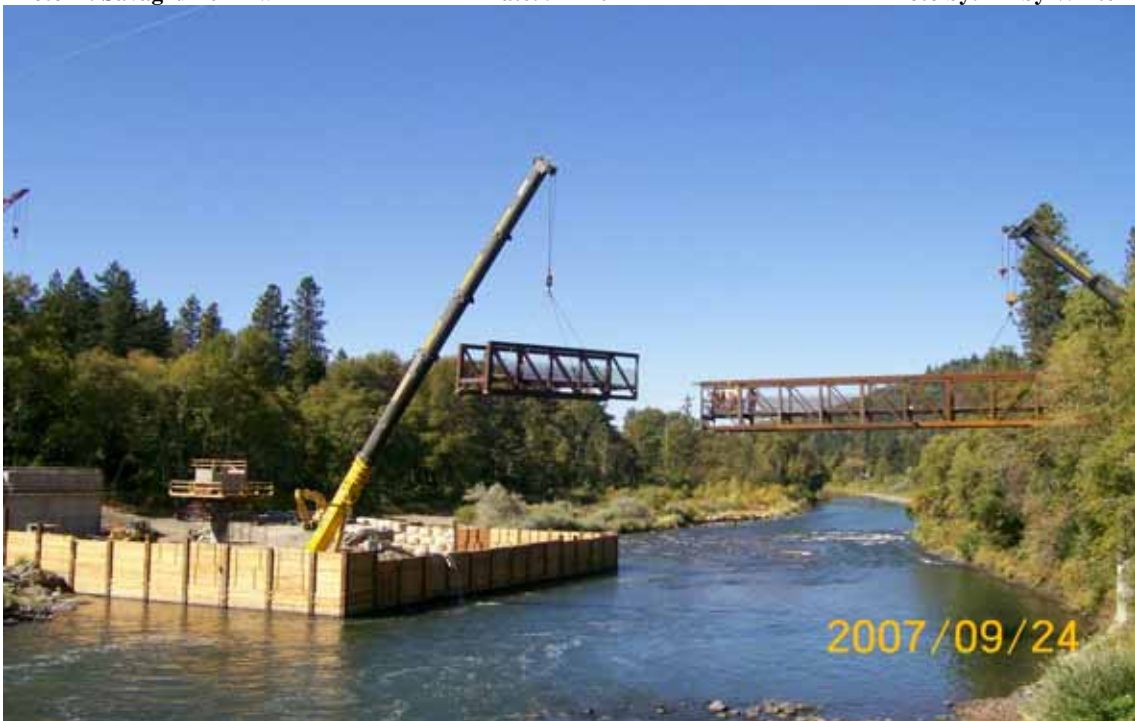
**Photo # :** Savagr620kw

**Description:** To the West of the bridge assembly. Sections B, C, D and E have all been bolted together and are resting on abutment 2 and pier 2 with the 120 ton crane aiding in supporting the loads protruding out past pier 2. The 350 ton crane inside the coffer dam on the South side of the river is swinging in bridge section A.

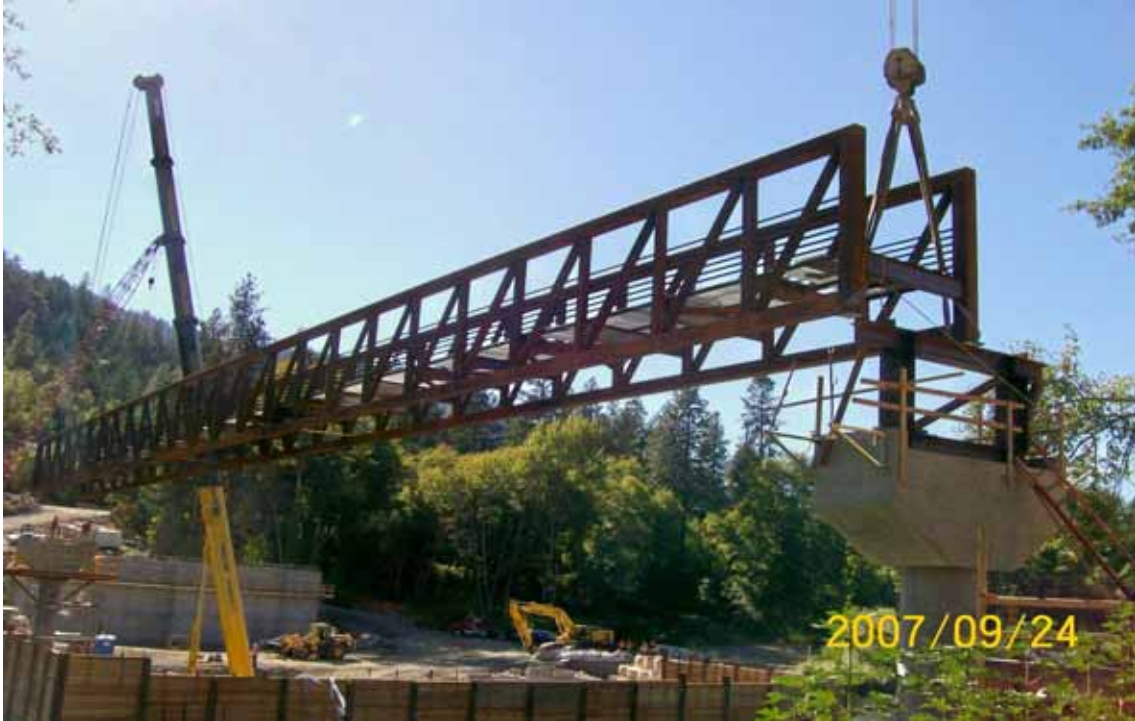
**Photo # :** Savagrdm635kw

**Description:** Rigging of the 120 ton crane to the North end of the bridge has been completed and the two cranes working in unison are now swinging the bridge over piers 1 and 2. Crew is waiting on pier 1 to align the South end of the bolts on pier1. The North end of the bridge has 2 inches of clearance between the end of the bridge and the frame.

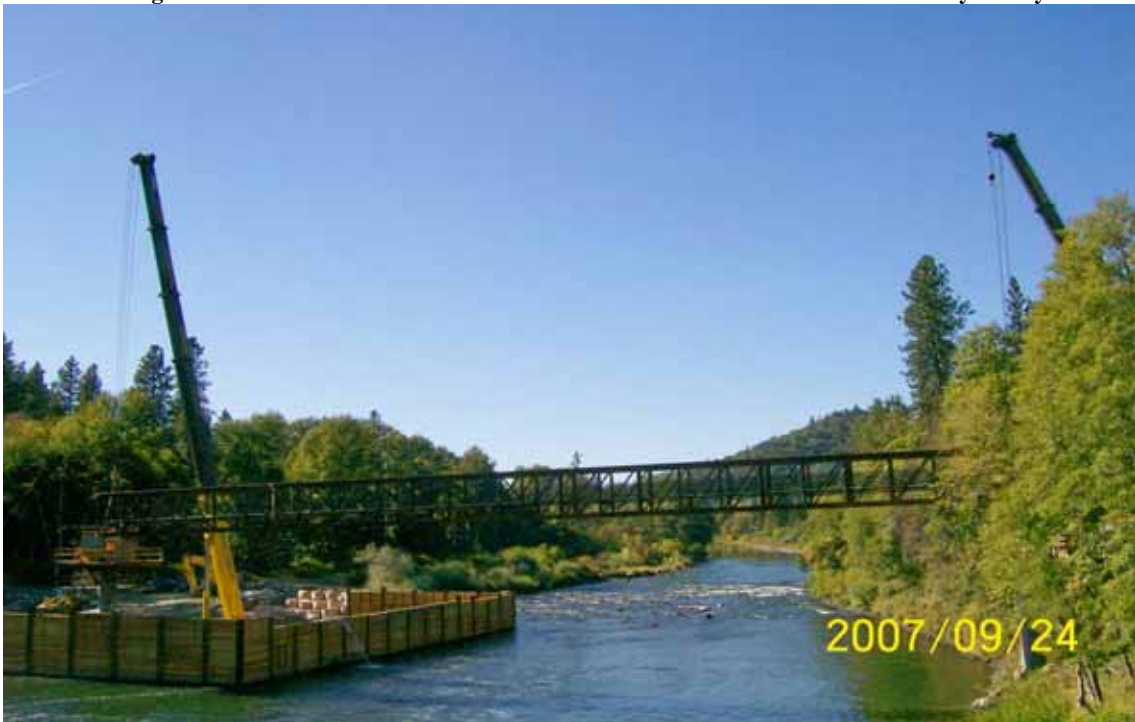
**Photo # :** Savagrdm636kw

**Description:** To the West from the existing pumping plant with the 5 sections of bridge set in position between piers 1 and 2. Note the slope of the bridge now that the North end is setting on pier 2 instead of the leveling frame.

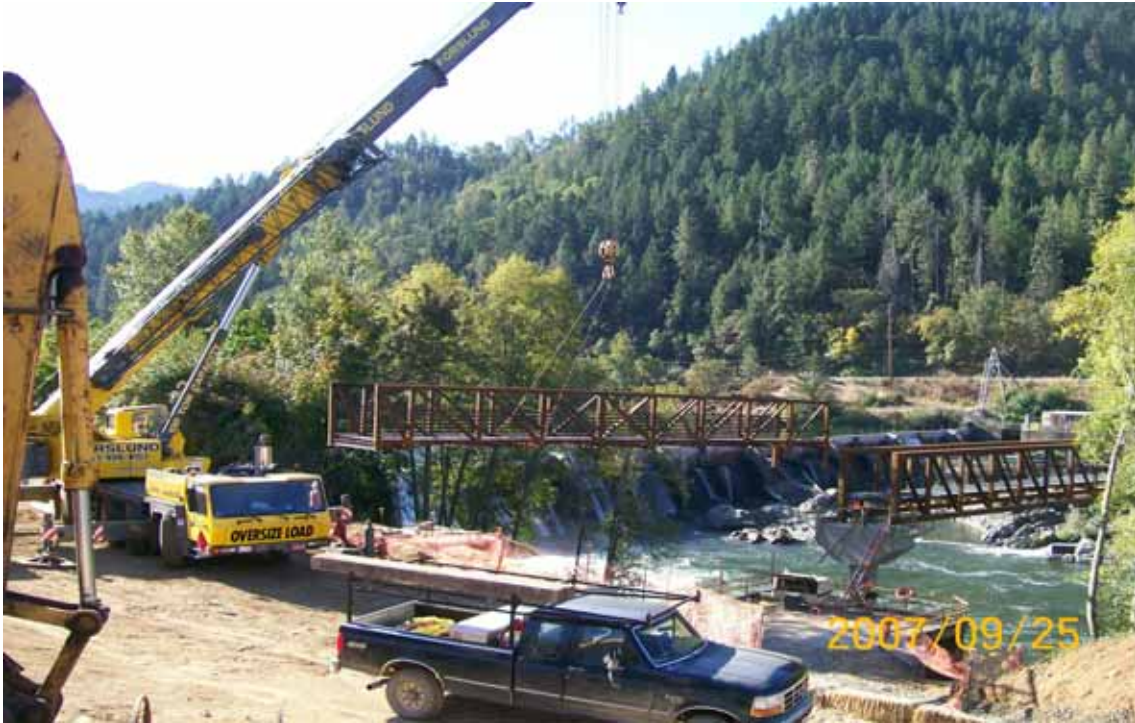
**Photo # :** Savagrdm638kw

**Description:** The day after setting the main section of the bridge between piers 1 and 2, section F on the North end of the bridge between pier 2 and abutment 2 was set using the 120 ton crane.

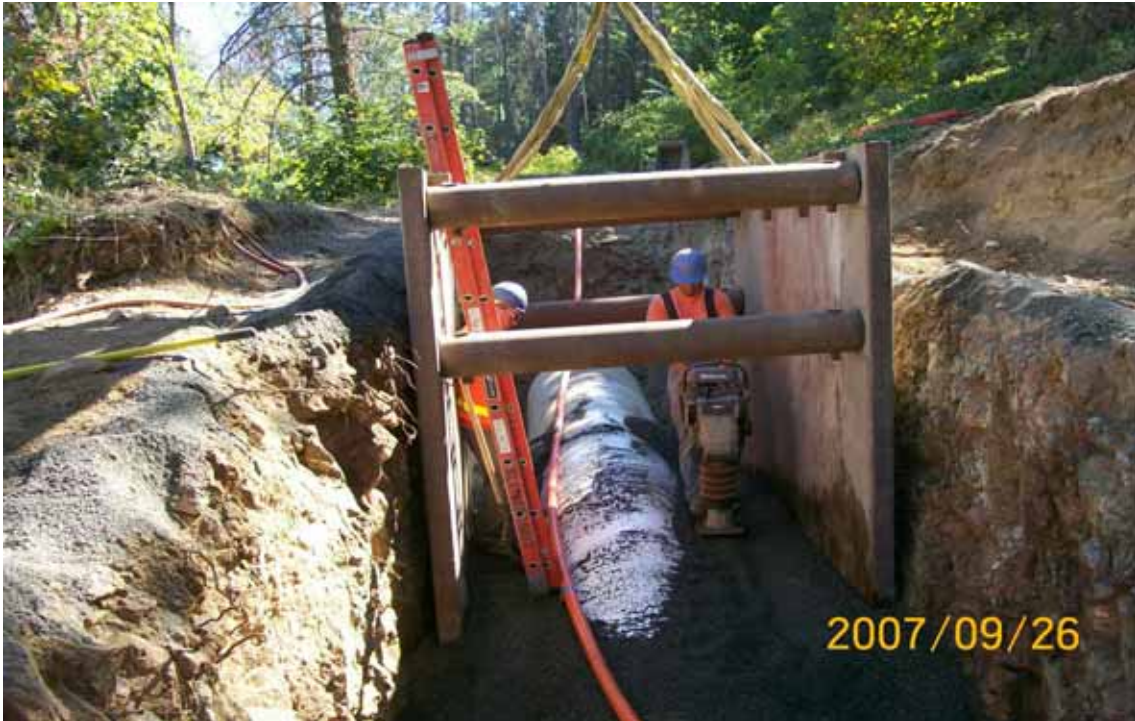
**Photo # :** Savagrmd642kw

**Description:** Photo to the SE of the crew compacting the bedding around the 42" pipe leading to the Highline Savage canal. The trench is still too deep to work without the trench box.
