Department of the Interior
Bureau of Reclamation

OPERATION AND MAINTENANCE EQUIPMENT AND PROCEDURES

RELEASE NO. 27

January, February and March 1959

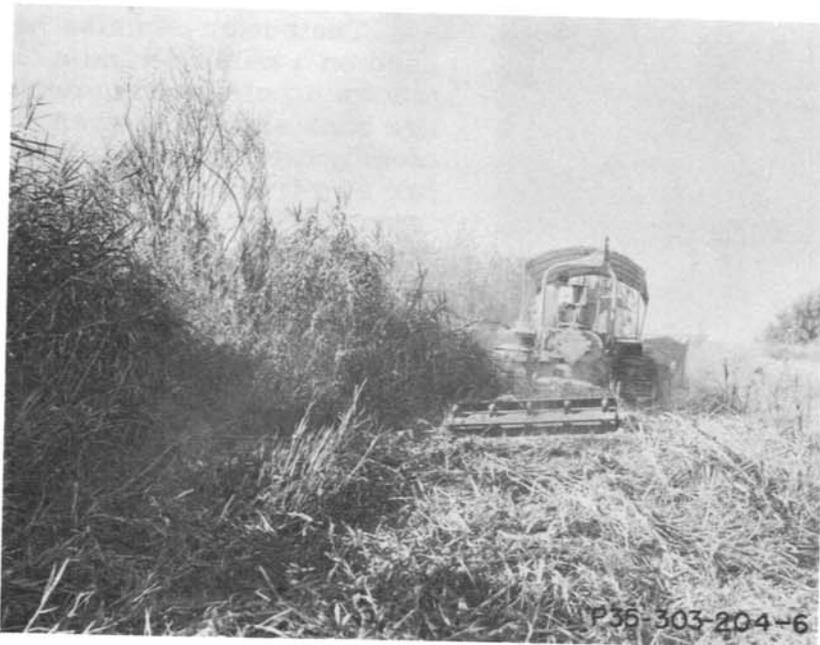
The machine consists principally of large drums equipped with heavy-duty, double-edged reversible blades, with drum and blade assembly carried in a heavy-duty towing frame. The machine is versatile, as shown in the photographs on the following page, and units can be used side by side or in tandem, and can be set with or without angle, depending on the

work to be done. The drums can be filled with water if additional weight is desired.

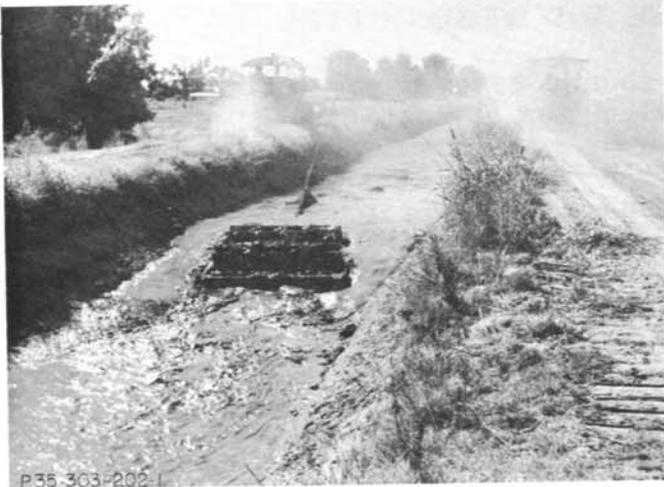
When the cutter is used to remove algae or aquatic weeds, as shown in the top photo of the next page, it is set up tandem and offset so that when pulled forward it has a vigorous action and the cutting edges on the two units overlap each other, cutting the growth into lengths of approximately 12 inches. The vigorous action of the cutting edges in

the tandem offset style tears the growth loose and in many instances uproots the aquatic weeds. White roots are often seen floating in the lateral after the machine passes. After the growth is torn loose, it can be floated out with the irrigation water.

A single D-8 tractor has been used to pull the 7-foot long cutter on much of the work, except where shown in the top photo clearing a lateral

choked with a growth of algae and aquatic weeds. Here the tandem cutter was towed by a Model D-7 and a Model D-8 Caterpillar tractor.

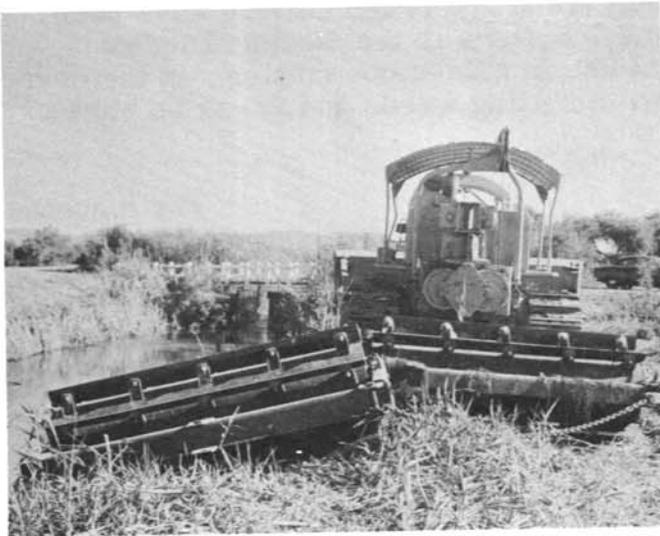
When the cutter is set up with the drums side by side, the unit can be used with one drum running on top of the bank and the other drum on the slope, either on the inside or the back side of the canal. A drain bank recently cleared of arrow weed and carrizo cane with the cutter is shown in the lower photograph.

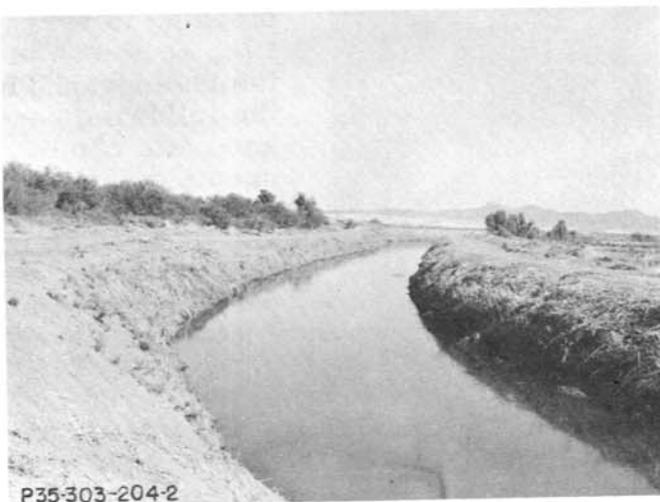
The cutter can also be used on a cable behind a tractor to clean along drainage bank slope and when closely hitched to the drawbar of a tractor, the cutter is an excellent piece of equipment to clear wide flood channels of undergrowth. In this manner, the machine can also be used to clear land preparatory to land leveling.

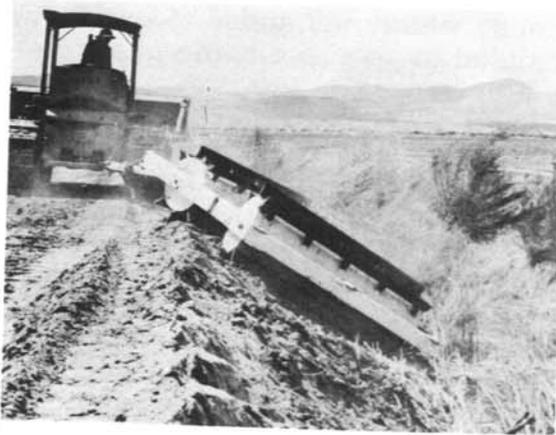
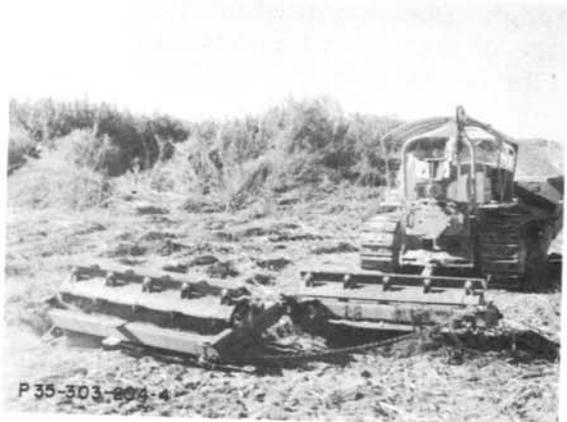
Several of the photographs included in the description of the cutter were supplied by the Yuma Equipment Co., P. O. Box 1630, Yuma, Arizona, from whom additional information concerning the cutter can be obtained. The cutters are obtainable in several lengths and diameters.

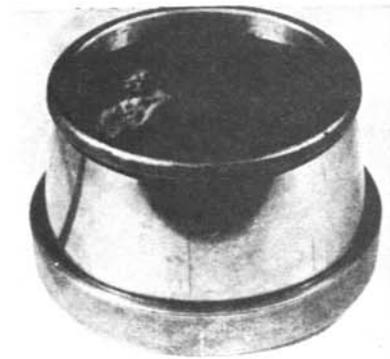
DANGER SIGNAL—First signs of wear are hairline marks on rollers and race that have been exposed to contaminated grease.

In many instances, breathing builds up enough water to damage bearings without producing noticeable changes in the bearing lubricant. Long before contamination shows up to the naked eye, bearing damage can occur in the form of hairline marks on rollers and races. When this happens, the next step is pitting and flaking that ruins bearings.

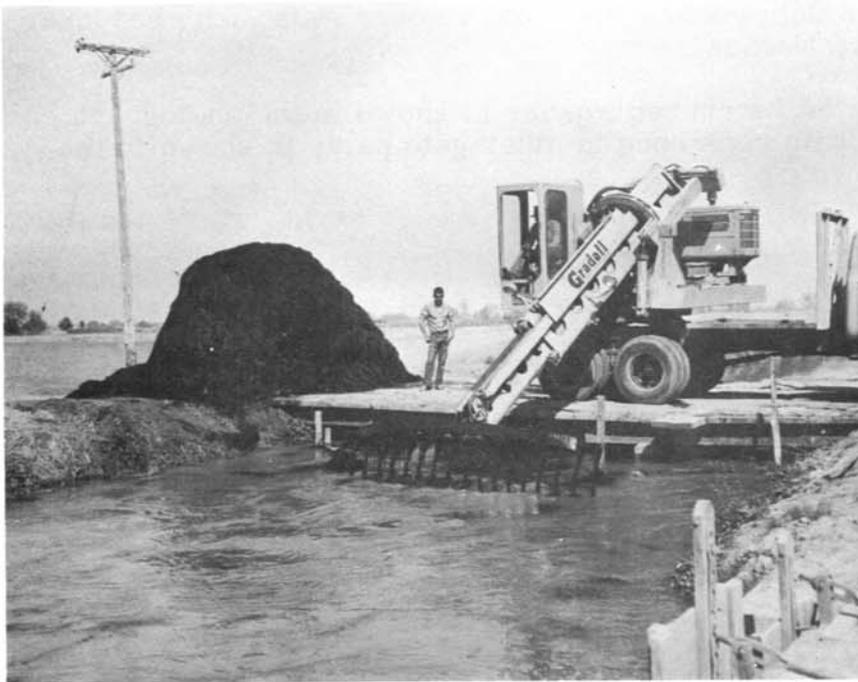
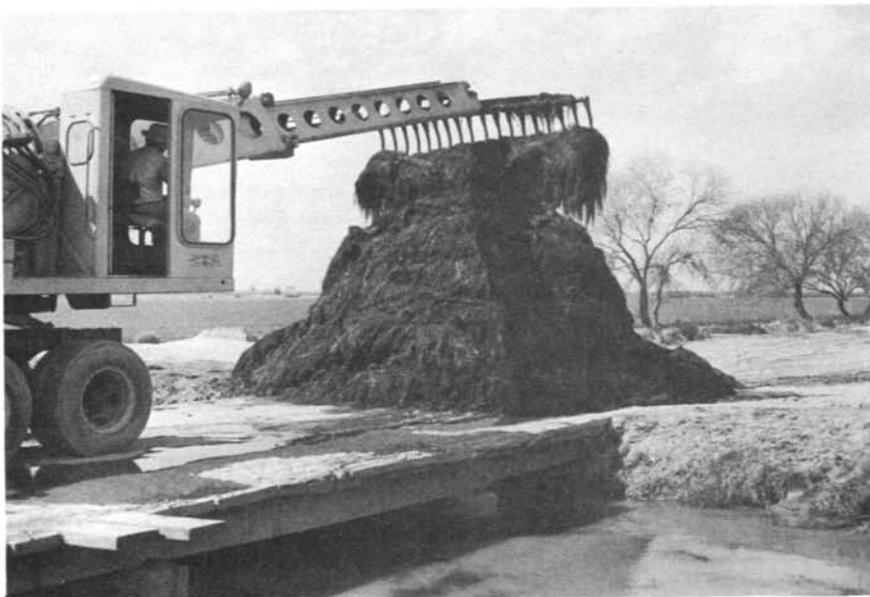
A fork-type attachment used on a truck-mounted Gradall to facilitate the removal of floating moss or other debris that accumulates in a canal or drain has been developed by the Yuma County Water Users' Association, which operates and maintains a portion of the Yuma Project, Arizona. Photographs of the Gradall and attachment are shown below.

The Gradall and attachment has been used particularly in connection with a brush cutter (similar to the Marden described in a previous article). Material that is cut on the bank slopes often falls into the canals or the drains and the algae or aquatic weeds that are cut loose also float with the irrigation or drainage water. When this dislodged debris amounts to so much that it cannot be floated through the turnouts with the irrigation water, it is necessary to remove the material from the canal. The Gradall with the fork-type attachment has proved to be a very efficient unit for the work.

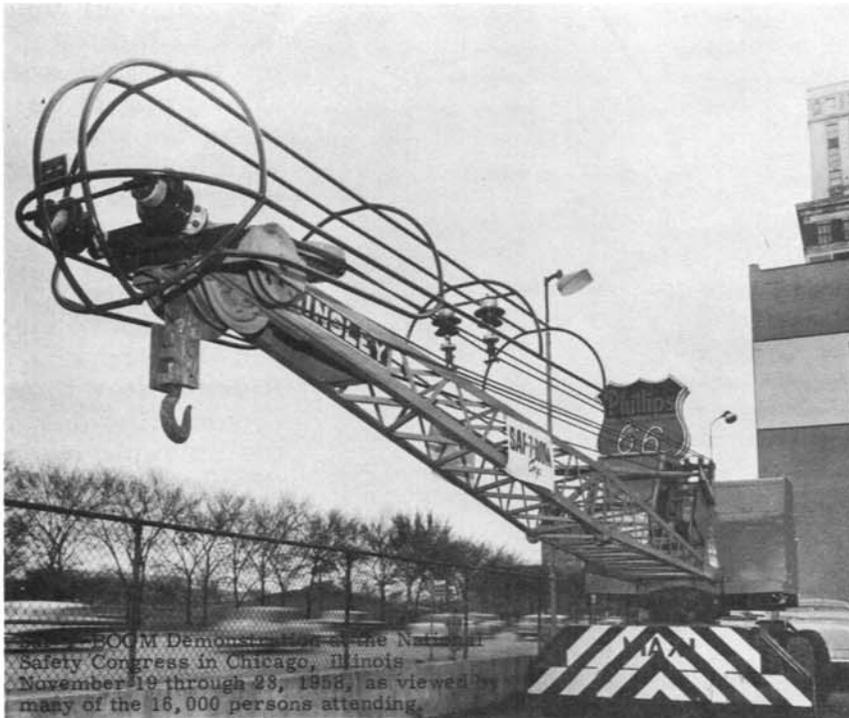
The shield of tubular framework is supported at four points by 15-kv insulators and is so constructed that it will support a load at any point in excess of the safe working loads for the supporting insulators. The shields are built to fit individual booms so that a minimum clearance of 10 inches is maintained between the framework of the boom and the framework of the shield. After fabrication the shield is coated with a three-coat application of Steelcote Epo-Lux, an Epoxy and Versamid resin product, in excess of 15 mils in thickness. Although the shield does not depend upon the coating applied for any of its dielectric properties, the Steelcote Manufacturing Company claims from data supplied them that a dielectric strength exceeding 2,000 volts per mil can be obtained from carefully coating the metal parts.

There is possibility, of course, that the vertical load line could contact an overhead power line below the end of the protective framework and care must still be exercised by an operator of a machine equipped with the device; however, contacting a power line is less likely and the shield could prove useful in providing boom protection under power lines with voltages up to 30,000.

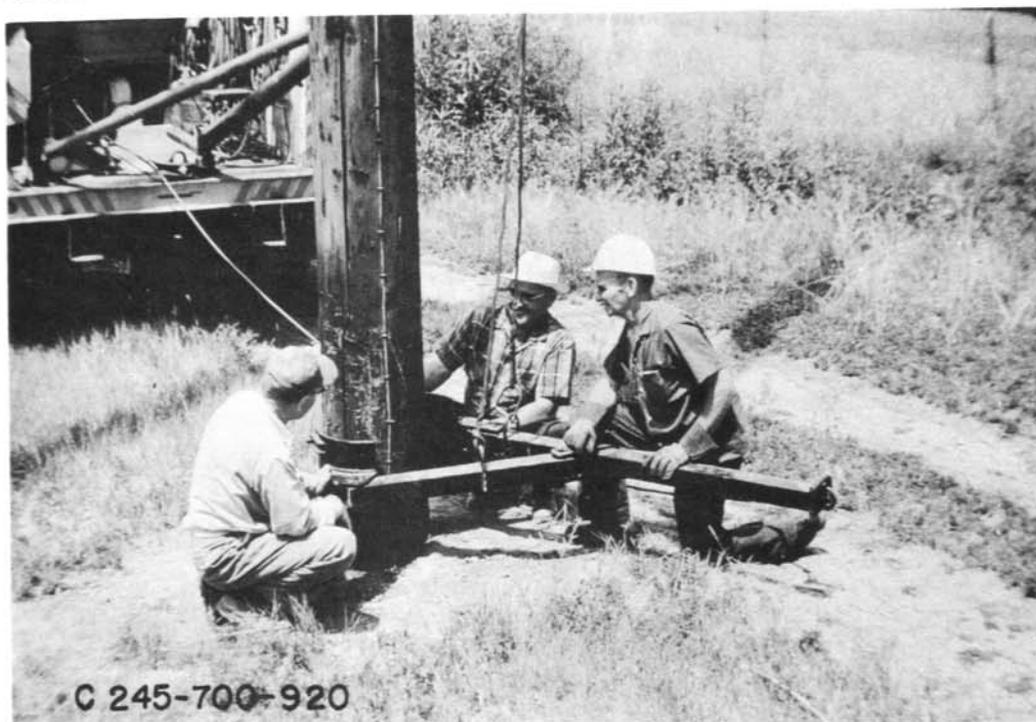
Several attempts to straighten the structures had not been satisfactory, so the "tool" shown below was constructed and is being used by maintenance crews. The "tool" shown in more detail in other photographs and a drawing on the following pages has given very satisfactory results.

The clock-wise twist of the 70-foot long poles in the photograph at the top of page 20 is representative of the misalignment. As one end of the crossarms is thrust forward, the other end is thrust backward. The effect is that the conductor sag is thrown out of balance with the forward span being pulled tighter and the back span loosened. Poles are pulled away from the vertical position and the hardware of the crossarms is twisted and weakened.

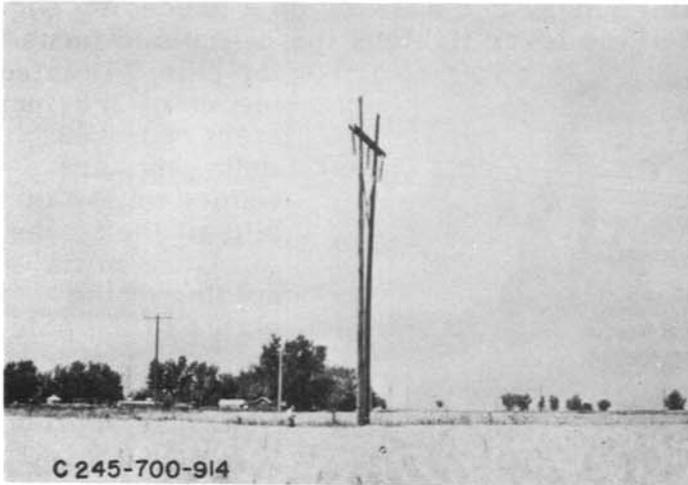
C 245-700-914

Prior to fabrication of the "tool," the method of straightening a structure involved first guying it with ropes to keep it in place while the poles were being turned. At least three holes were then dug around the base of each pole with hand augers and shovels. After loosening the earth, men then turned the pole with a cant hook and muscle power, photograph at left.

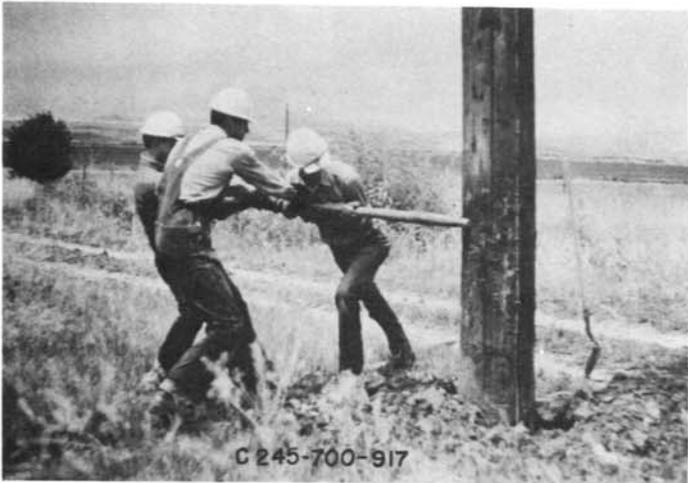
C 245-700-917

Care had to be taken to avoid excessive damage to the pole from the use of the auger, shovels, and cant hook. Breaking into the treated pole butt could mean early replacement because of decay. Finally, the backfill had to be replaced around the pole. This was done with air tampers.

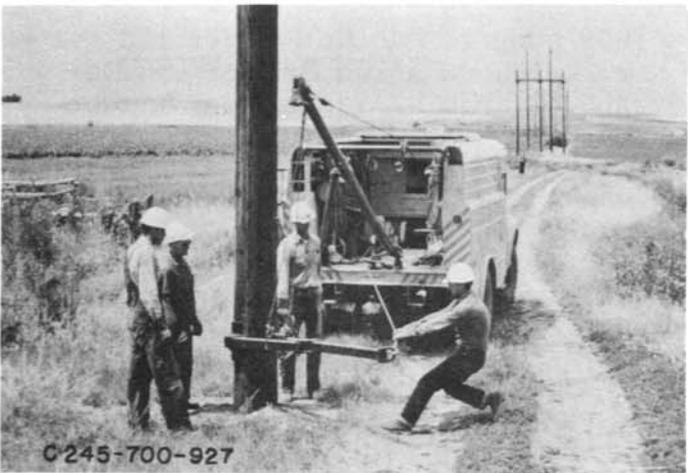
C 245-700-927

The operation was accomplished much more simply, a lot more quickly, and with much less physical effort by use of the constructed device, photograph at left. Actually, the poles could be turned with the device in 15 minutes. About 2 hours were required to perform the task by hand methods. Hole digging equipment is not required when the twisting device is used and the use of air tamping equipment is considerably reduced.

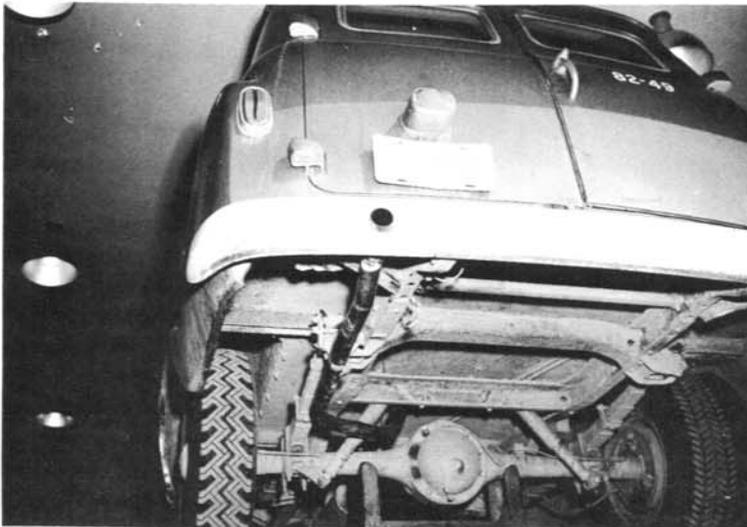
In an area where the terrain is very rough, tail pipes are easily damaged and Alden H. Sepulveda suggested that a hole be drilled in the bumper, bringing the tail pipe out through the

hole, as shown in the photograph above. It is reported that one vehicle on which this was done a year ago for experimental purposes has not needed tail pipe repairs or replacement and plans are being made to make similar replacement on other vehicles of this type.
