Water Operation and Maintenance Bulletin

No. 223

Miniature Pest, Giant Problem Causing Havoc
in Southwest

March 2008

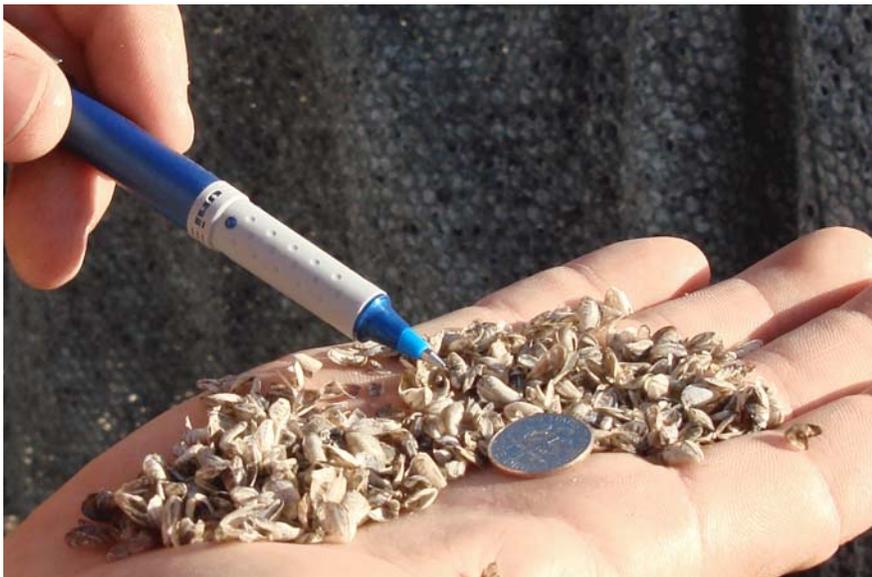
Cover photograph *Appearing almost as nutshells, nearly 100 shells of dead quagga mussels fit on a person's hand. In the background is a fishnet that should be transparent, but is encrusted with quagga mussel remains and is now a solid curtain.*

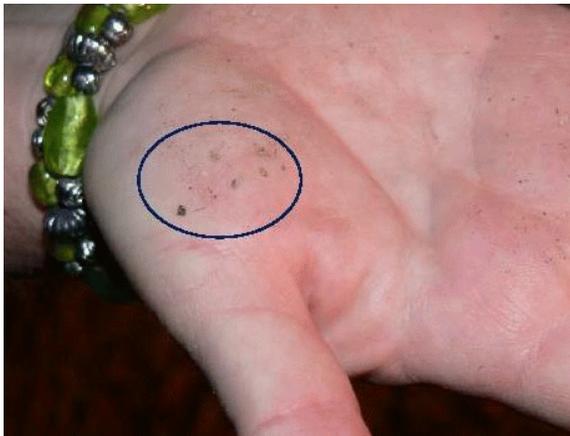
Young quagga mussels.
LCR photo by Leonard Willett.

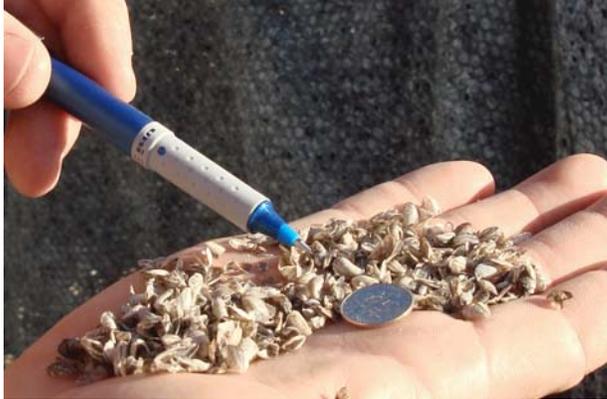
Appearing almost as nutshells, nearly 100 shells of dead quagga mussels fit on a person's hand. In the background is a fishnet that should be transparent, but is encrusted with quagga mussel remains and is now a solid curtain. LCR photo by Steve León.

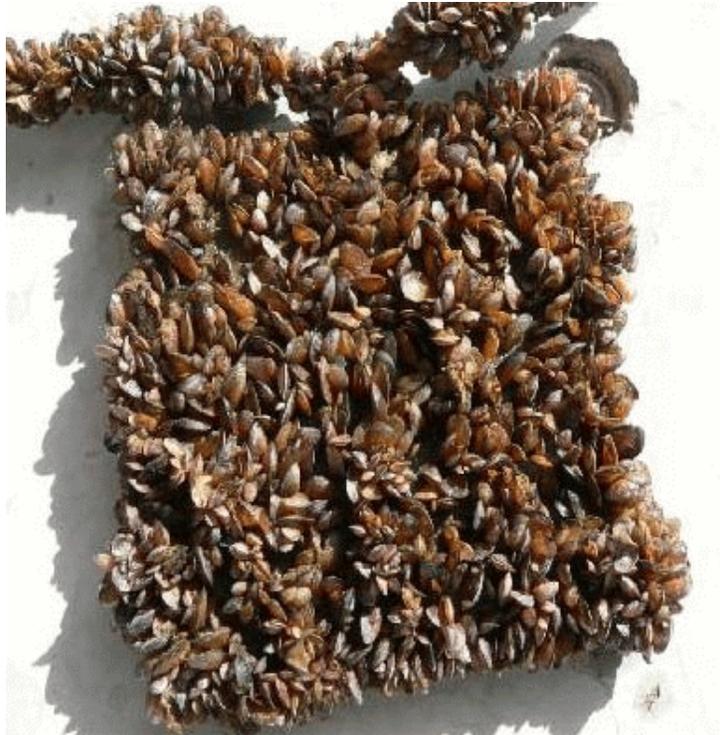
A 12-inch long steel monitoring plate retrieved from near Parker Dam is encrusted with quagga mussels.

- Installation of monitoring equipment and replacement strainers
- Installation of smooth metal or stainless steel plates at 10 foot intervals in the fore bay of each dam near the intakes and tail bay areas. Smooth plates are preferred because half of the plate will be scraped on a monthly basis to determine new mussel settlement. The remaining un-scraped half of the plate will be observed for colonization over time.

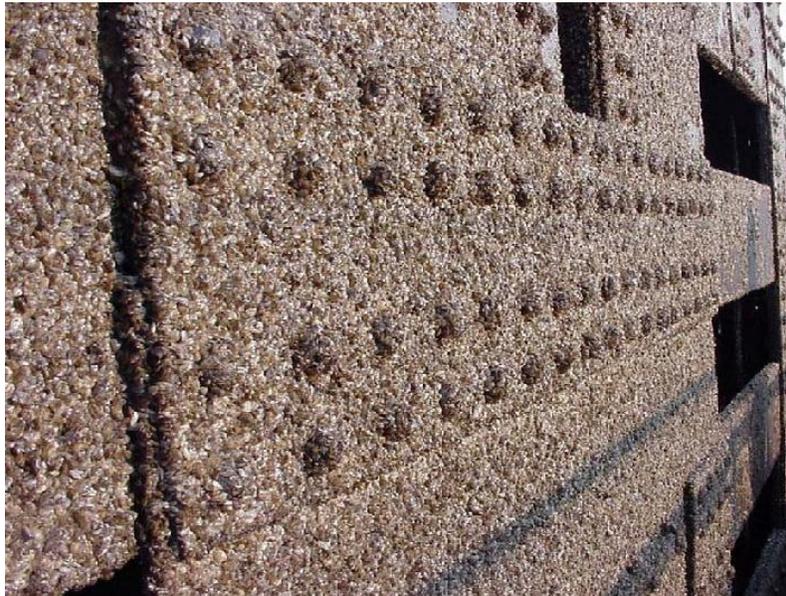
A Davis Dam gate is literally coated with quagga mussels.
LCR photos courtesy of Leonard Willett.

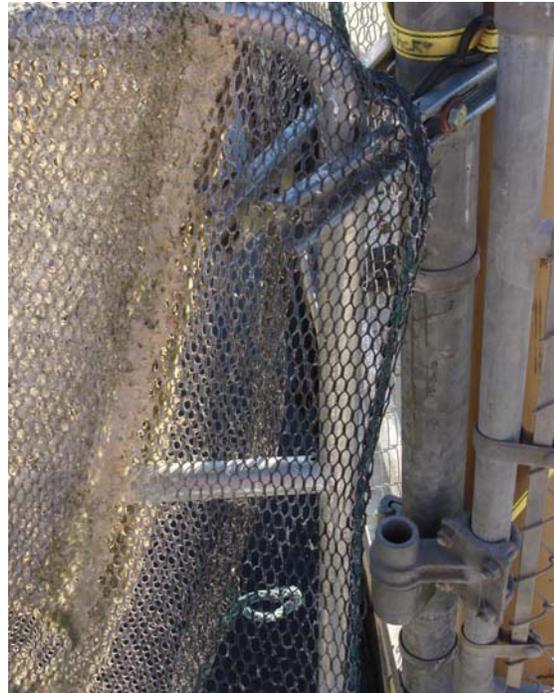
A fish breeding net from the Willow Beach fish hatchery is rendered useless after colonization by quagga mussels. LCR photo by Steve León.

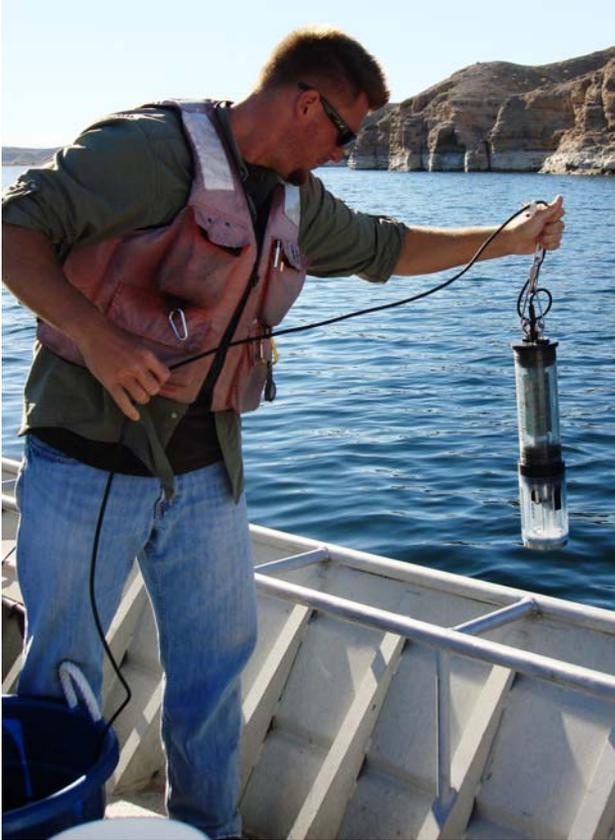
Near Cottonwood Cove, one of the four quagga mussel monitoring sites downstream of Hoover Dam and Willow Beach, Jim Stolberg prepares to drop a water quality probe to determine current water quality parameters (temperature, conductivity, pH, dissolved oxygen, and turbidity). The unit is lowered to the lake bottom at each site and measurements are taken at specified intervals. Depths depend on the monitoring site, and range from 10-45 meters or about 30-130 feet (all measurements are recorded in metric units). LCR photo by Steve León.

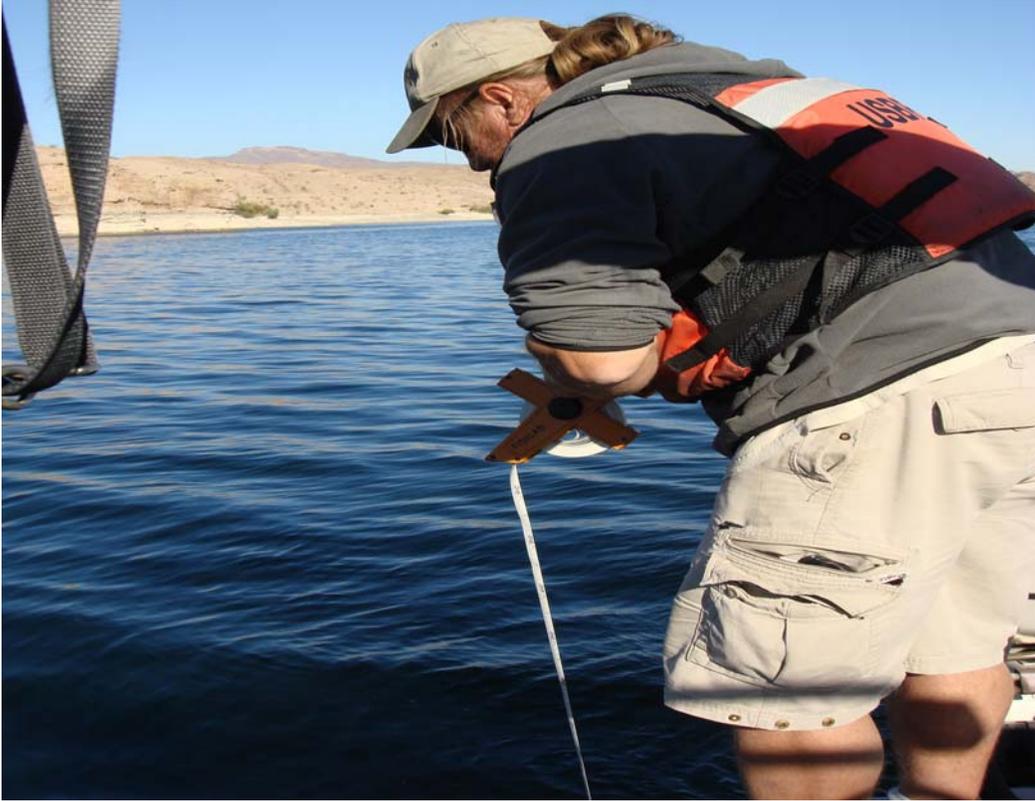
Jon Nelson lowers a 12-inch in diameter Secchi disk painted with two black and two white alternating quadrants to measure and record the turbidity of water quality at survey sites in the Colorado River. Clear water is one indicator of mussel presence. LCR photo by Steve León.

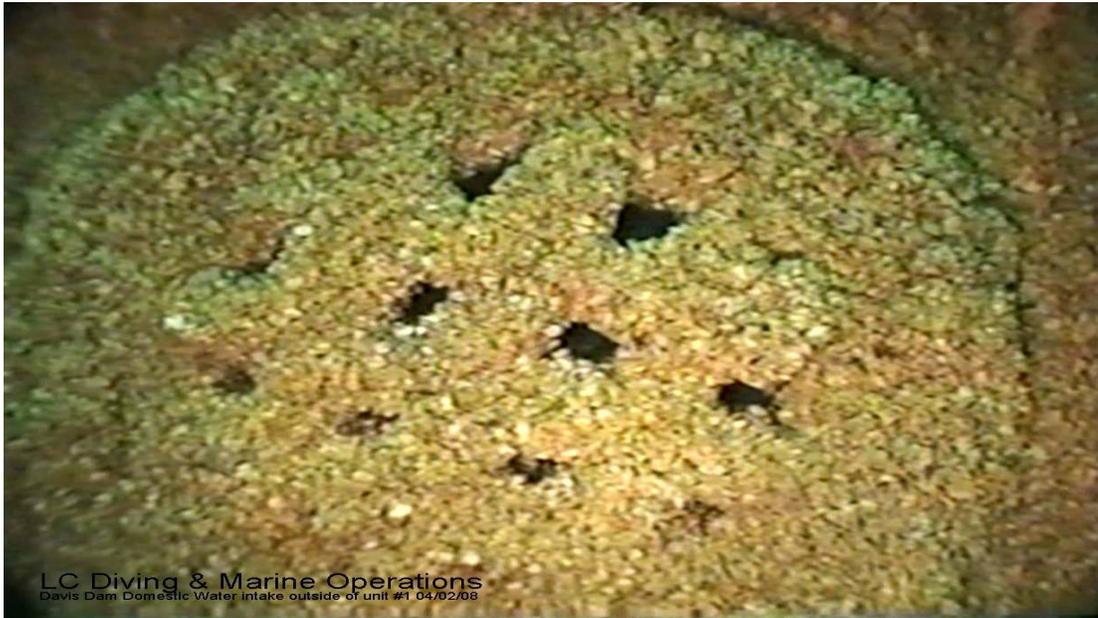
A water intake at Davis Dam outside Unit 1. LCR photo courtesy of Leonard Willett.

“Additionally, the domestic water supply line is being colonized and staff members are evaluating the better option between hot water flushes or mechanical cleaning,” Willett said. “On the exterior in the forebay the inlet is becoming colonized and mussels will need to be removed by divers or by the use of high-pressure water in the near future.”
