**Memo for Record- April 2009**

**Subject: Carlsbad Vegetation Management Team Meeting**

**Pecos River Salt Cedar Management Demonstration Project**  
**Bureau of Reclamation Quarterly Report**  
**January 1, 2009 through March 31, 2009**

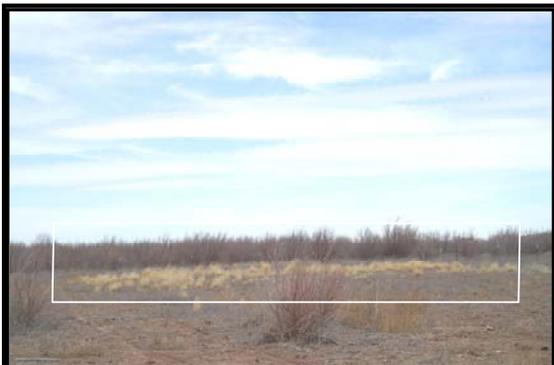
Figure 1. Artesia Alkali-Scald Site - Site is barren of vegetation and soil is cracked.

Five out of fifteen of the grass test plots at the Artesia Revegetation Site planted in late summer of 2005 were successful. Each of the planting techniques were successful in at least one of the replicated (3) plots. The planting techniques tested were: broadcast seed followed by roller chopper (Figure 3); broadcast seed followed by imprinter (Figure 4); no-till grass drill; Laird Range drill. Galleta grass, alkali sacaton, and blue grama are the most persistent of the eight grasses planted. Alkali sacaton is somewhat clouded as it was growing at the site before the plots were initiated; some

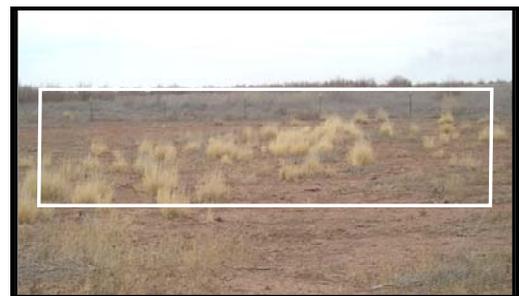
Figure 4. Artesia Revegetation Site – Broadcast seeding with imprinter.

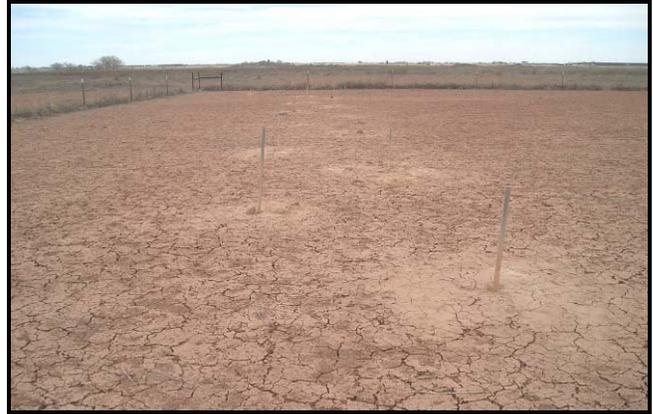
Figure 2. Artesia Alkali-Scald Site - Grass sprigs planted in 10-foot zeolite cores, April 2008, did not survive the droughty spring and summer. The plants appear to be dead.

April of 2008 survived the summer (Figure 2).

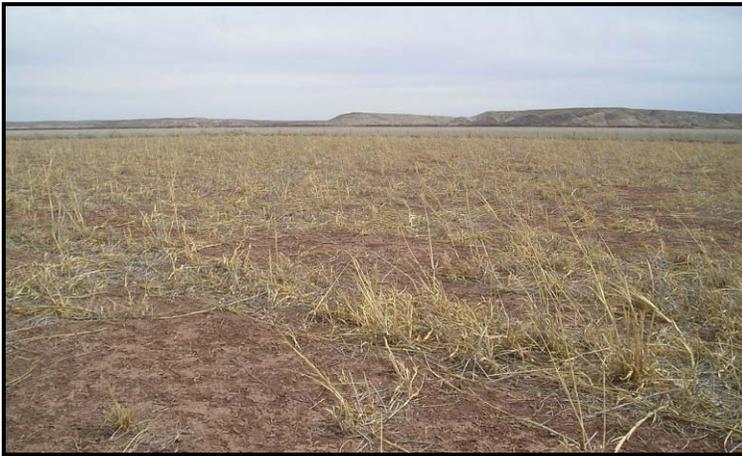
Figure 5. McMillan Lakebed Site - Site is relatively clean of kochia with last year's (second year) sorghum stubble remaining.

sorghum alnum did (Figure 5). The roots of the sorghum alnum appear to be healthy and growing at the time of this report (Figure 6). It will be interesting to find out if the sorghum alnum is successful a third year, as we were advised it would only persist only through a second year.

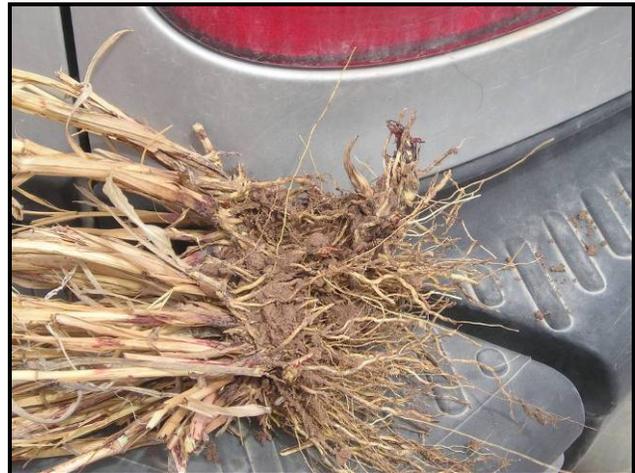
Figure 6. McMillan Lakebed Site – Dormant sorghum alnum plants (March 10, 2009) have healthy roots and stolons.

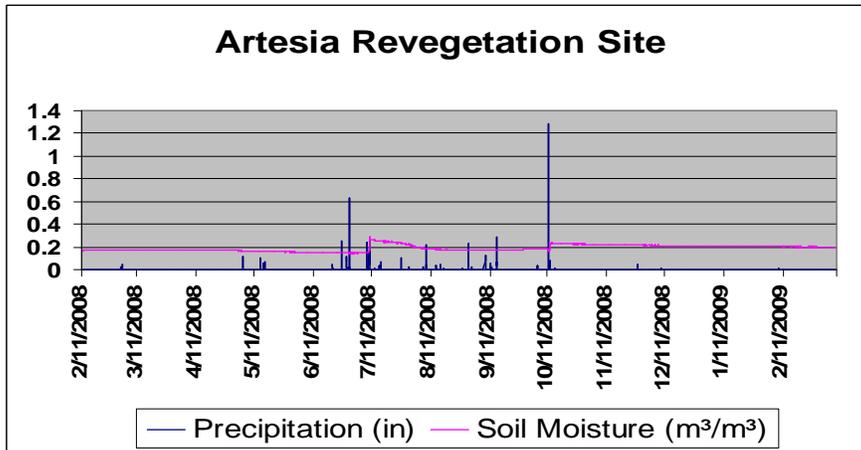
Chart 1. Precipitation and soil moisture at the Artesia Revegetation Site.

The last meaningful precipitation occurred around October 11, 2008 at both sites. Soil moisture has held around 20% throughout the winter at the Artesia site (perched water table) (Chart 1). Soil moisture at the McMillan site was highest after the monsoon season at 15% and has dropped

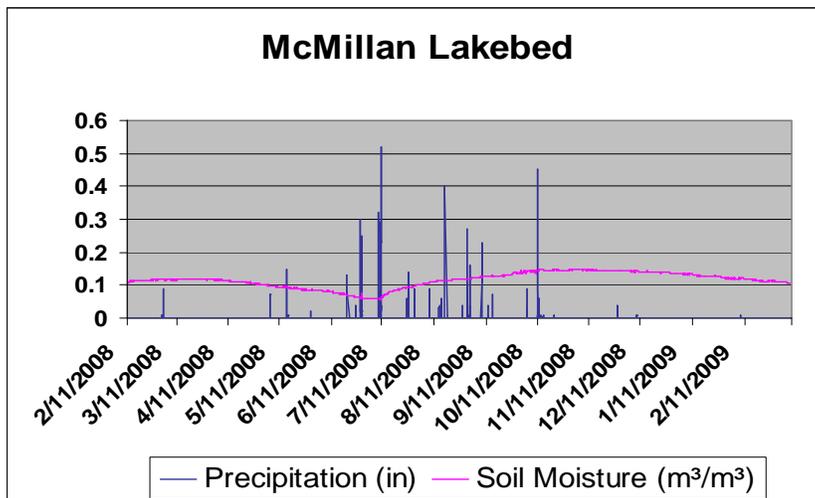
Chart 2. Precipitation and soil moisture at the McMillan Revegetation Site.

over the winter to 10%, which is essentially the wilting point (Chart 2).
