Stranding of Rainbow Trout during Experimental Fluctuating Releases from Glen Canyon Dam on the Colorado River

July 9, 2003

EcoPlan Biological Resources Report 02-606

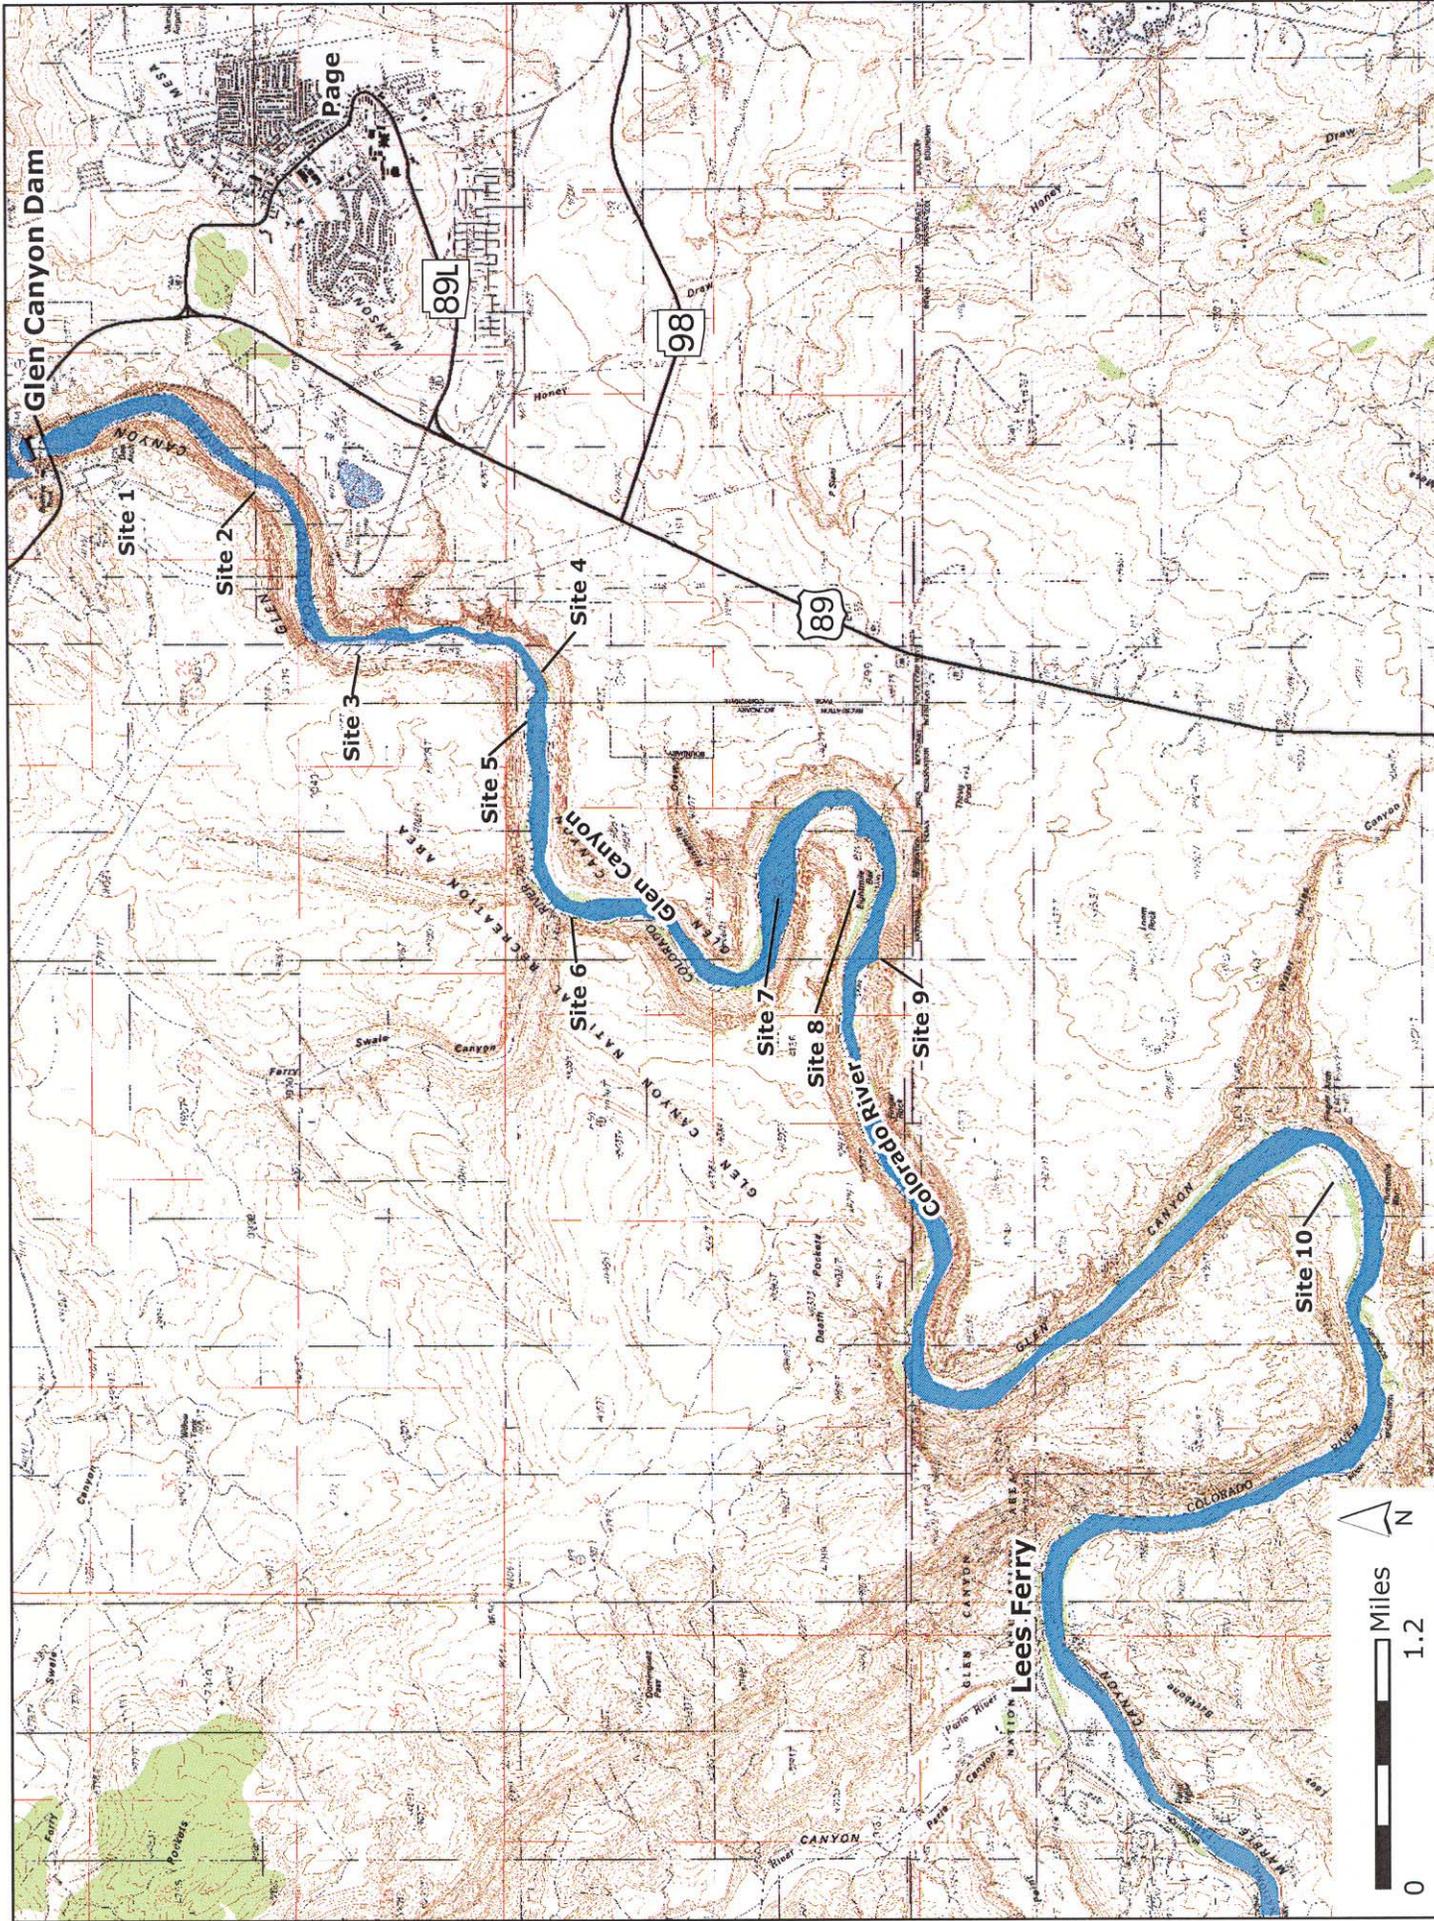
Figure 2. Project vicinity

Figure 2. Project Vicinity Showing Sites Monitored for Stranded Trout.

As part of this 2003-2004 experiment, the hypothesis that pre-1990 daily fluctuations and ramp rates suppressed natural recruitment of trout and present stabilized flows have benefited recruitment of trout and resulted in higher numbers will be tested. The 2003 experimental flow proposal included a daily high fluctuating flow element (a minimum of 5,000 cubic feet per second [cfs] beginning at 0100 and a maximum of 20,000 cfs beginning at 1200 with ramping down or up, respectively, prior to these times) starting January 1, 2003 and continued through March 31, 2003. The fluctuating flows were intended to disrupt spawning and subsequent survival of the non-native RBT. In addition to benefiting native fish, a secondary purpose of the experiment was to improve the quality of the Lees Ferry (River Mile¹ [RM] 0.0) trout fishery by reducing the numbers of RBT produced immediately below the dam [RM -15.80] with the expected result being larger fish. One expected, but unintended consequence of fluctuating releases during the experiment was stranding of adult trout in shallow, lower flow areas. In this part of the experiment, EcoPlan Associates, Inc. (EcoPlan) was asked to examine the spatial and temporal extent of trout stranding by determining the number of stranded fish in the 15.80-mile reach below Glen Canyon Dam (Lees Ferry Reach [Figure 1 and Figure 2]).

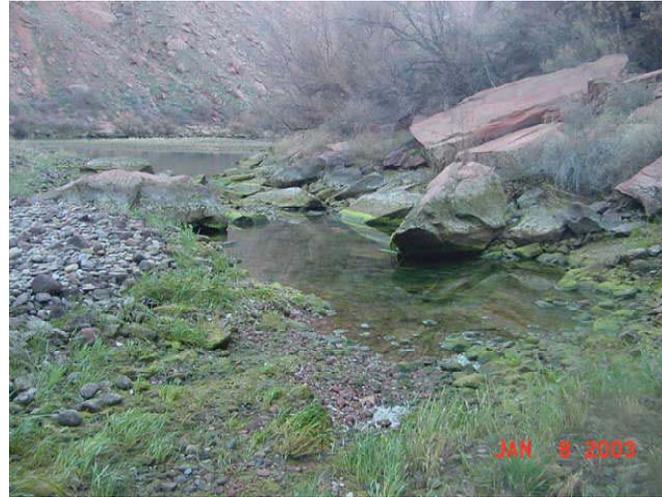
Photo 6. View looking at a pool immediately south of Location C of Site 1. The pool has a river connection.

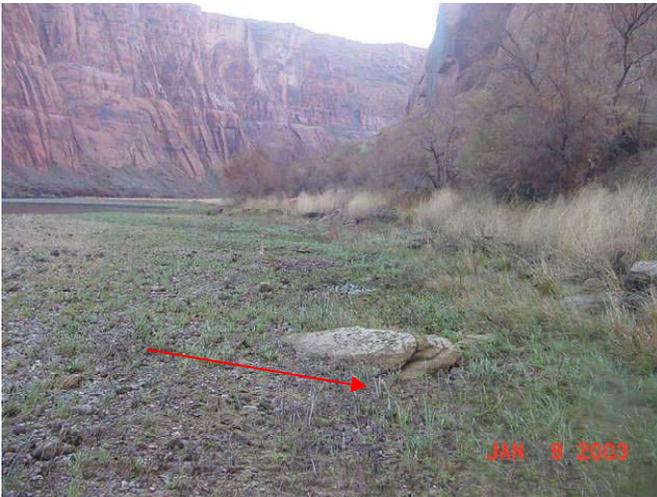
Photo 11. View looking at the middle of Site 3. The rock has been an area of stranding (red arrow).

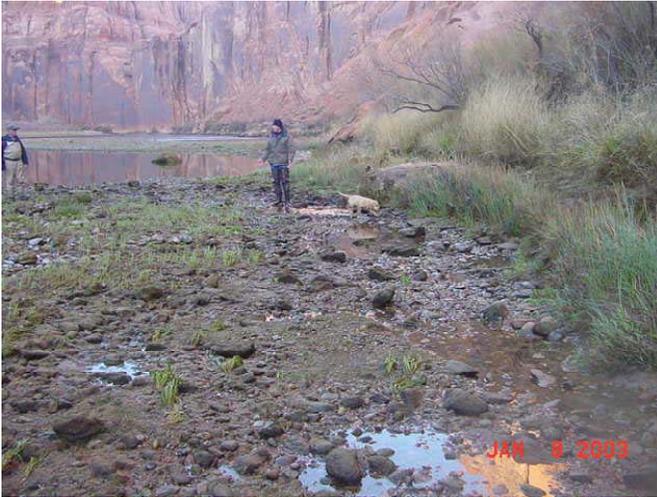
Photo 17. View looking south at the large pool just south of Location C in Site 5. The pool traps fish, but is deep enough for them to survive.

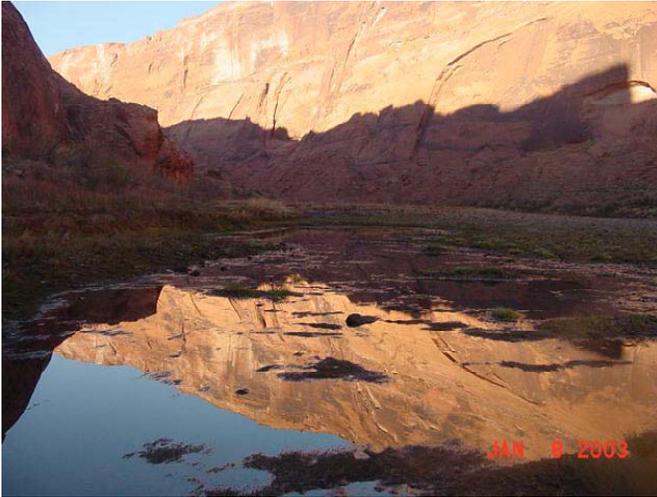
Photo 29. View looking south at the pond that is found along the inside of Site 9.
