Flathead-Stillwater Watershed Restoration Plan

**Final Version
Fall 2017**

**Prepared by:
Sarah Bowman, BSWC Member
Flathead Conservation District
133 Interstate Lane
Kalispell, MT 59901
406-752-4220
www.flatheadcd.org**

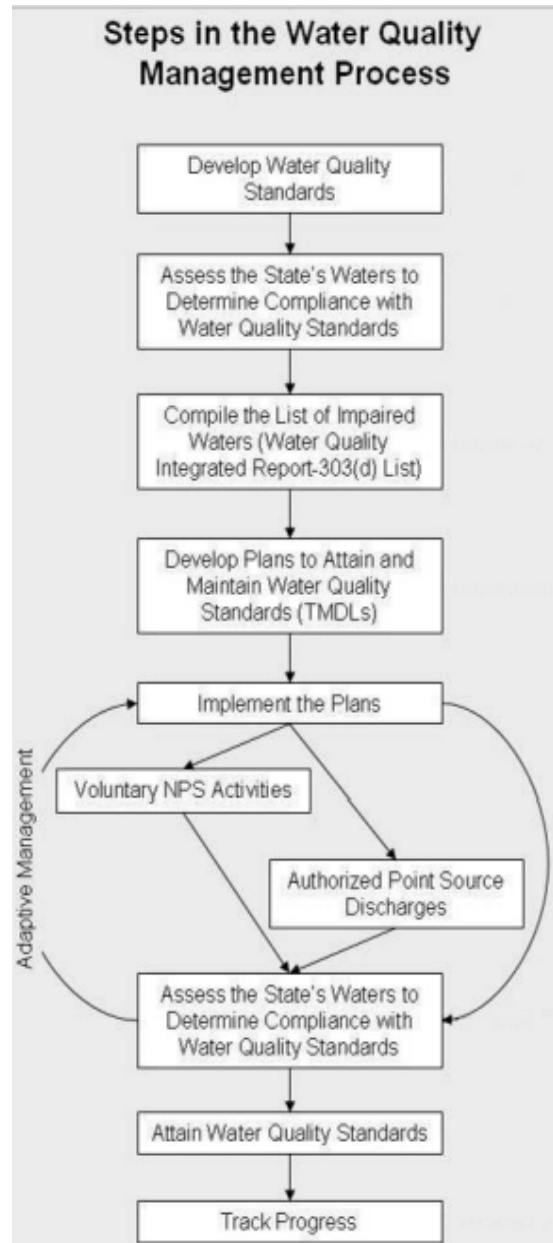
Figure 1. Montana DEQ's Adaptive Water Quality Management process

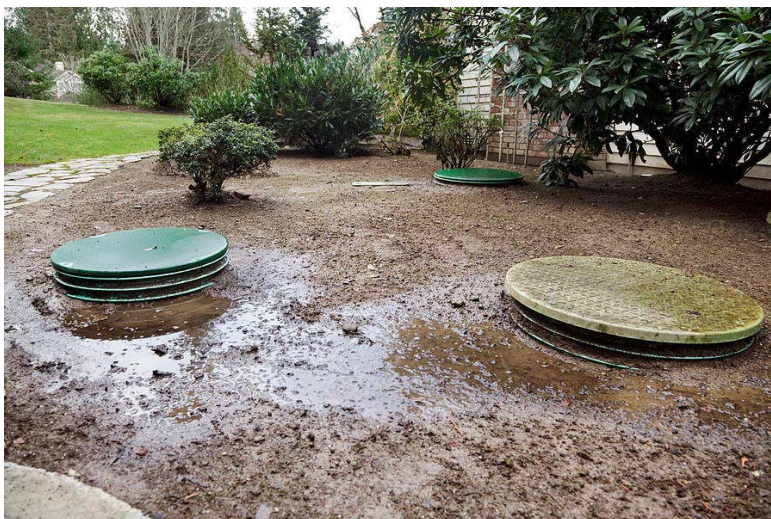
Figure 14. Leaking septic system in a residential yard. Surface leaks such as this can runoff over surfaces and impair nearby waterbodies (www.hardwareandtools.com).

Septic systems serve as onsite wastewater disposal systems for homes and other buildings that are not connected to a city or county sewer system. Septic systems are designed to drain away human waste underground at a slow, harmless rate. However, an improperly designed, located, constructed, or

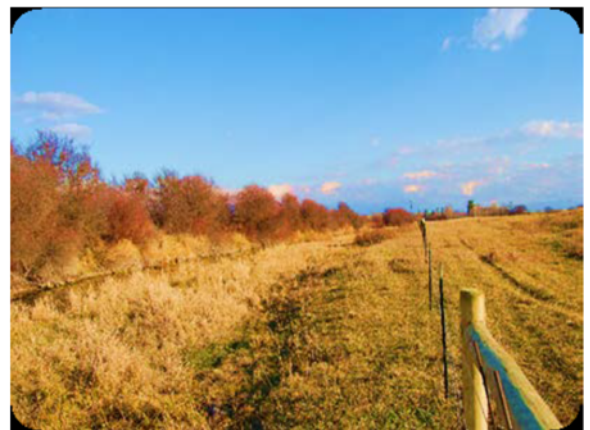
Figure 19. Livestock fence installed along the ½ mile stream property to keep cows and other livestock out of the riparian area.

The River Steward program partners are exploring opportunities to collaborate with landowners on Ashley Creek. A recent project on lower Ashley restored about ½ mile of riparian forest. A wildlife-friendly fence was installed to create a 30-40-foot-wide buffer to prevent trampling of the creek banks and deer browse (Figure 19). Native trees and shrubs were planted inside the enclosure (Figures 20 and 21), and a water gap was installed to control livestock access. This project is expected to result in several tons of sediment reduction per year, several pounds of nutrient reductions per year, and a temperature reduction of up to 1°F.

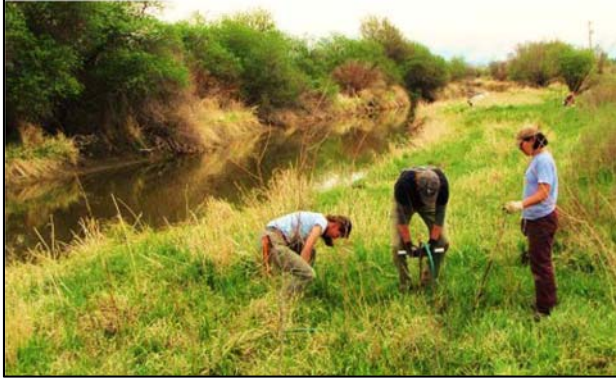
Figure 20. Volunteers planting willow stakes into the ground with water jet stinger.

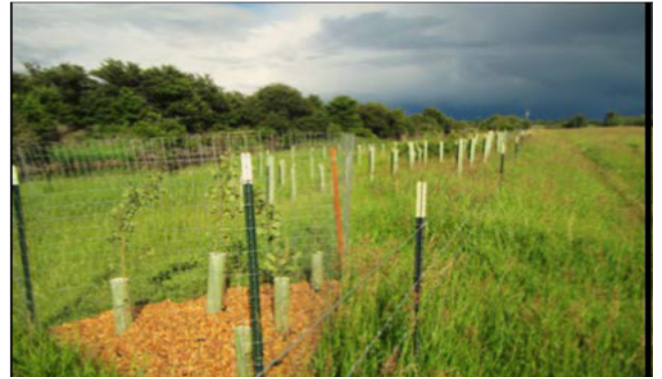
Figure 21. Small fenced area with bark mulch that provides weed protection and green tubes to eliminate vole damage.

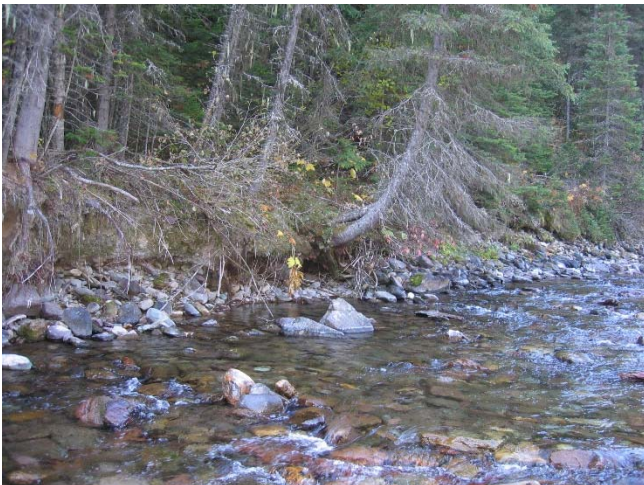
Figure 23. Common stream bank condition in Coal Creek (Sylte, 2008).

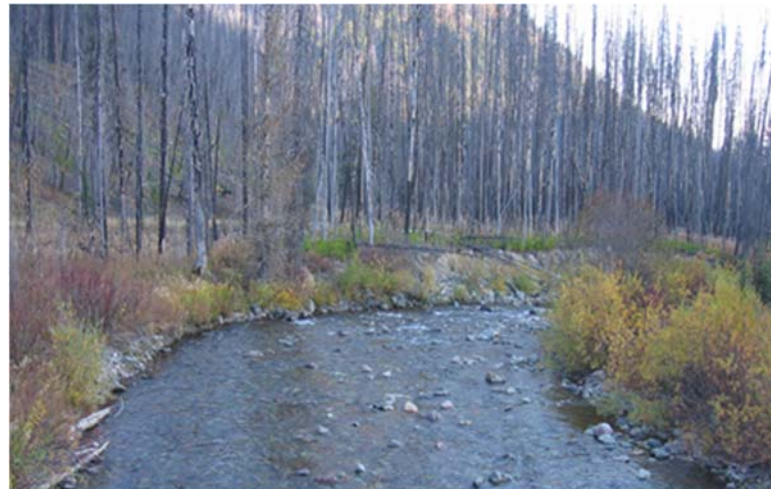
Figure 24. Riparian zone burn from the Moose Fire (2001) in Lower Coal Creek (Sylte, 2008).

Wildfire is one of the natural drivers of sediment contributions to Coal Creek. In 2001, the Moose Fire burned 14,938 acres of the lower watershed, including portions of the Coal Creek mainstem riparian zone (Figure 24). The riparian shrub community was not substantially altered and continues to act as a stabilizing force to the stream banks, though the majority of trees for approximately two miles along the riparian corridor were killed. Over time, these trees fell into the stream, forming debris jams and bank stress, which potentially increased erosion. The 2006 Sundog Fire burned approximately 1,570 acres on South Fork Coal Creek (Sylte, 2008).

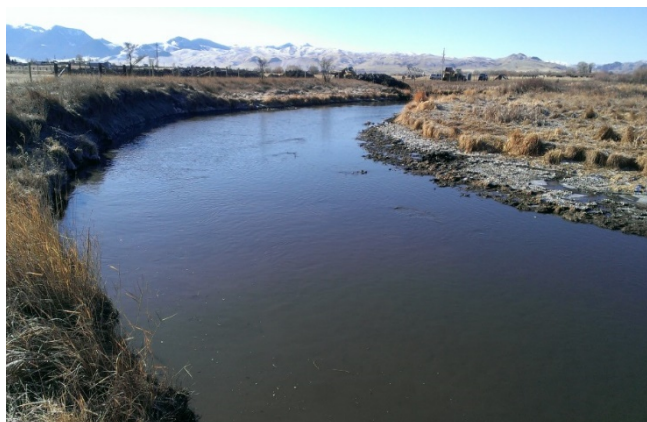
Figure 27. Example of effect of fluctuating water levels on Flathead River (Poindexter Slough).

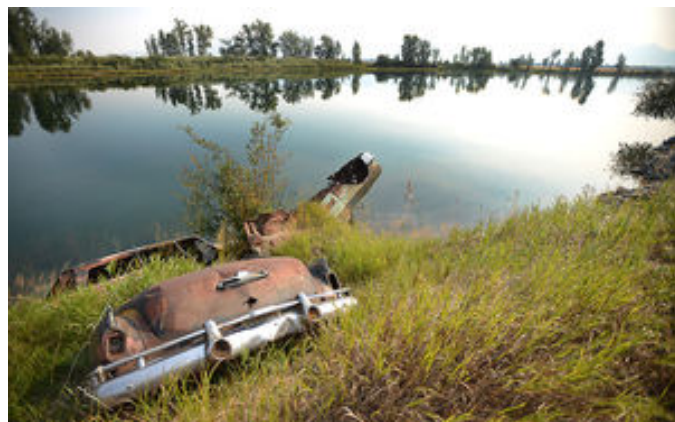
Figure 28. Historical streambank stabilization technique using car bodies on Flathead River near its confluence with the Stillwater River.

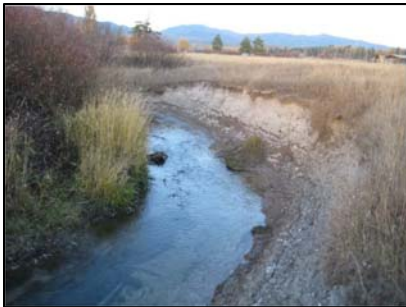
Figure 31. A segment of the Reimer reach before project implementation.

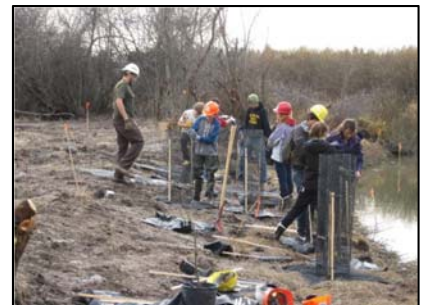
Figure 33. Project FREEFLOW students planting riparian vegetation on excavated floodplain.

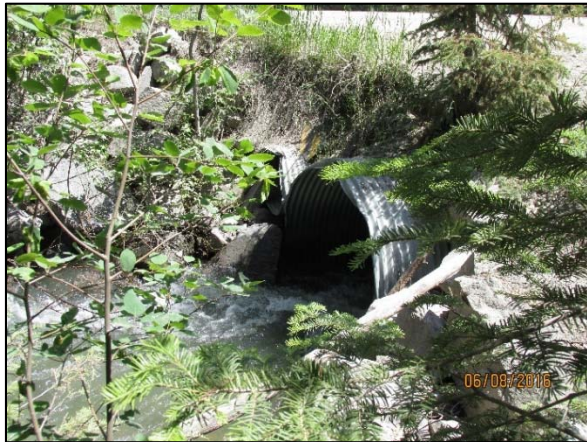
Figure 34. Upstream end of Haskill Basin Rd. culvert.

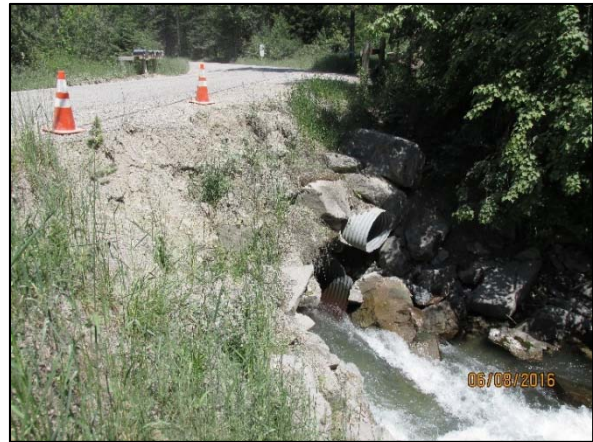
Figure 35. Downstream end of Haskill Basin Rd. culvert.

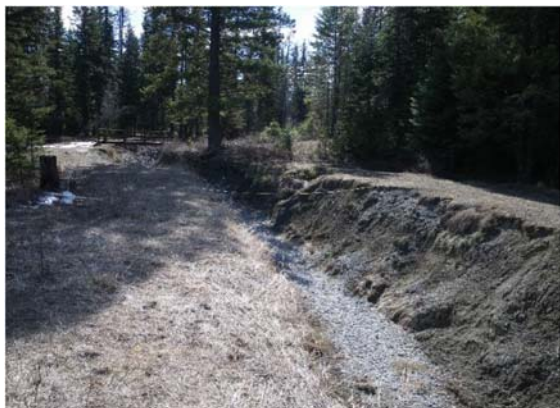
Figure 37. Krause Creek incising on lower reach before spring flow occurred, view from outside creek channel.

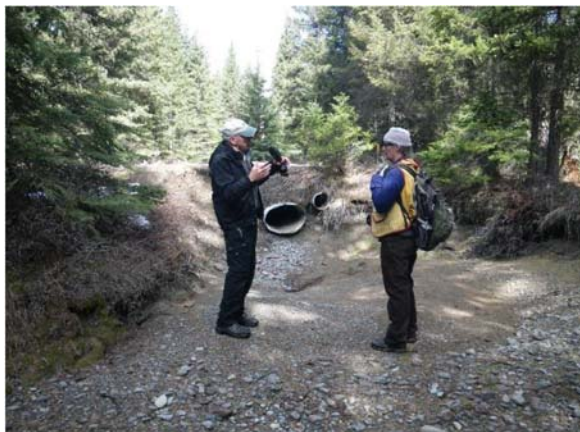
Figure 39. Undersized culvert.

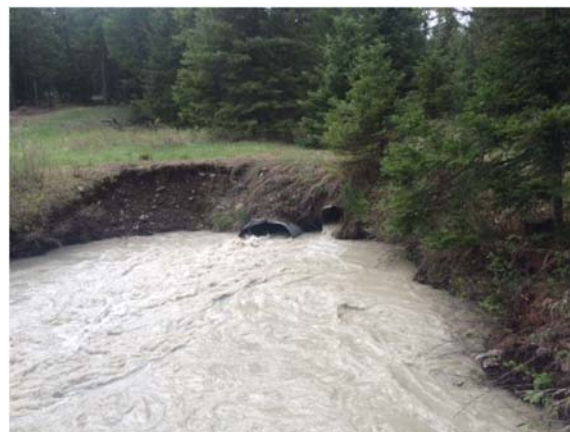
Figure 40. Undersized culvert during spring runoff.

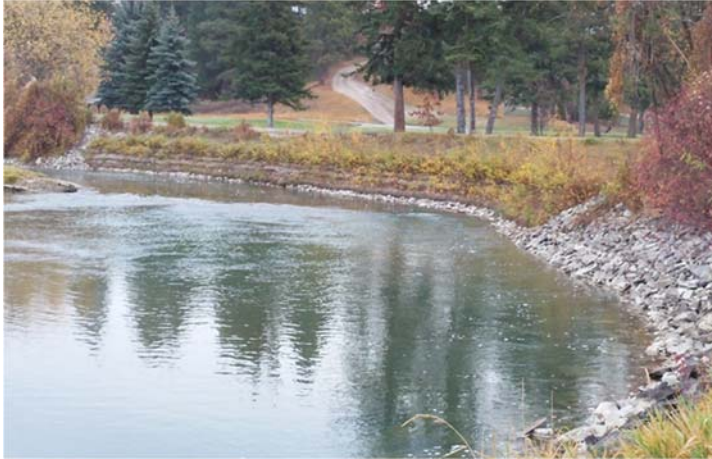
Figure 47. New willow lift along eroded shoreline on the Buffalo Hills property along the Stillwater River.

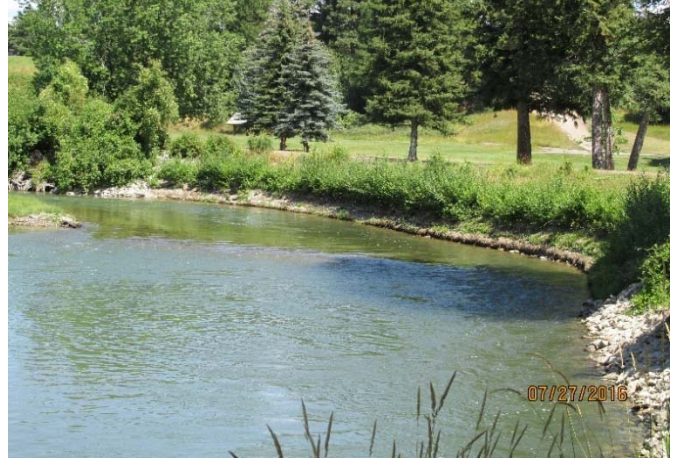
Figure 48. Same willow lift with willows growing out of the top layer and rip rap at the toe.

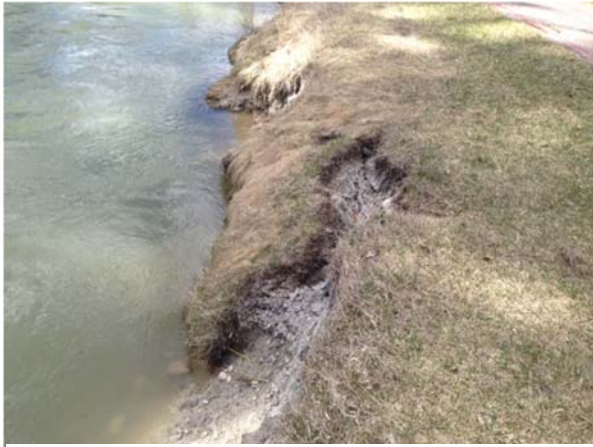
Figure 49. Bank undercutting and streambank erosion along cart path along the western shore of the Stillwater River.

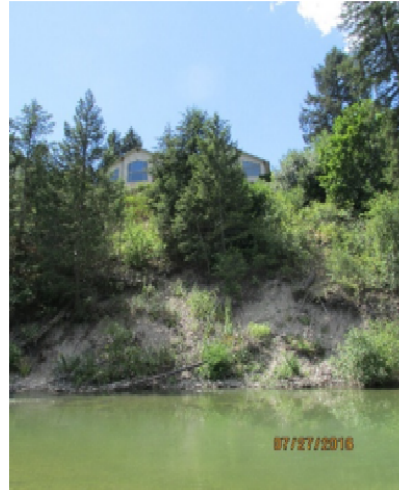
Figure 50. Mass failure of streambank on east shore of Stillwater River, across from the golf course under Juniper Bend housing developments.

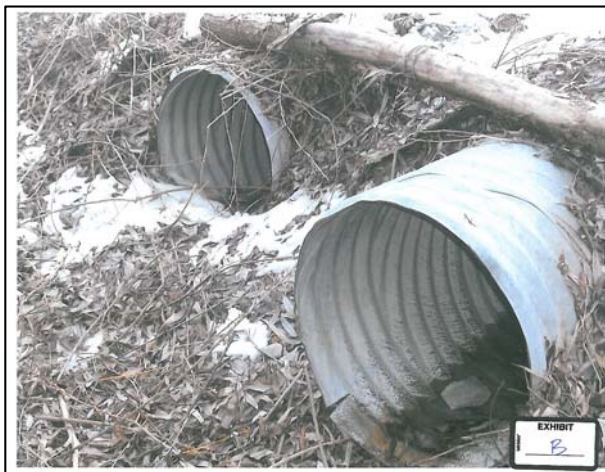
Figure 56. Undersized culverts at Olympia Way crossing before spring flow.

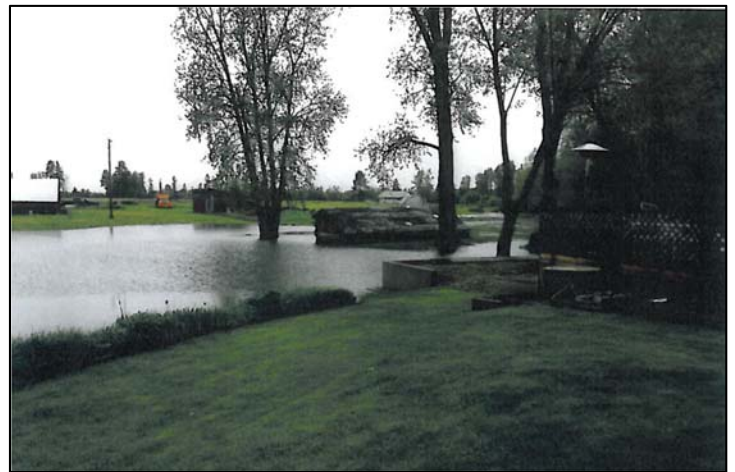
Figure 57. Flooding during spring flow caused by backed-up waters from undersized culverts.
