OPERATION AND MAINTENANCE EQUIPMENT AND PROCEDURES

RELEASE NO. 30

October, November and December 1959

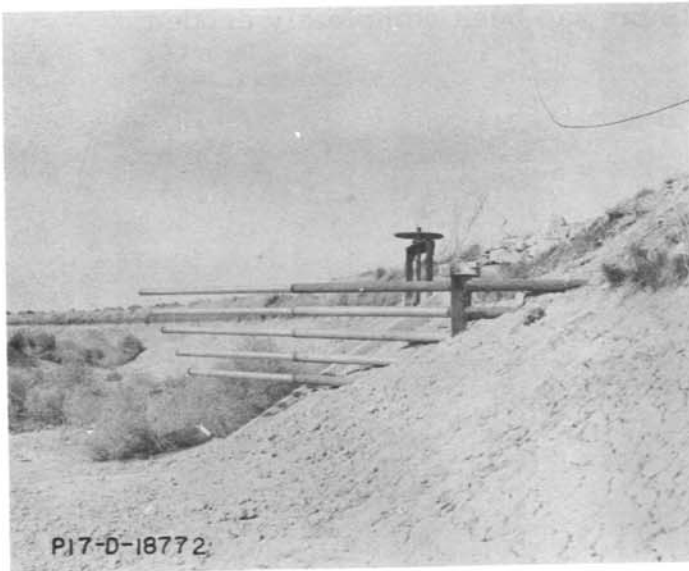
The weed deflector shown in the photographs below was constructed at the request of and in accordance with plans prepared by Mr. Donald T. Mutch, Watermaster, West Branch of the North

The deflector is constructed of pipe throughout. Two large diameter pipes embedded in concrete in the side slopes of the canal serve as supports for the five horizontal pipe components shown. The large vertical pipes are drilled to accommodate the larger horizontal pipe which is welded to the vertical support for added structural rigidity.

The smaller horizontal pipe components are of such diameter that they fit into the larger horizontal pipe. The smaller pipe must be of such length that it can be telescoped outwardly into the canal as required to provide for adjustment and the best possible setting at a

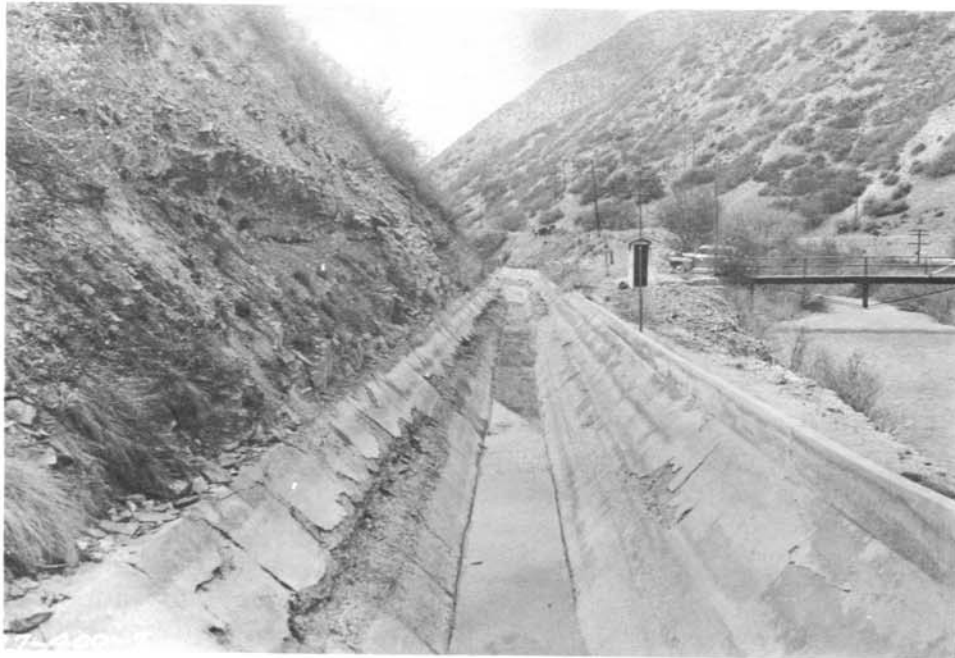
Winter operation of a power canal on the Strawberry Valley Project in north-central Utah over a period of about 50 years resulted in complete deterioration of a band of concrete lining located at about the winter water operating level. The deterioration, as shown in the photograph below and on the following pages, was so severe in some reaches of the canal that the lining had been completely eroded.

Repaired with unreinforced pneumatically applied portland cement mortar in 1950 and 1956, a recent examination of the lining discloses repairs are holding up exceptionally well, with no apparent deterioration of any kind. The present condition of the lining is shown in photographs on page 7.

Specifications provided that the portland cement mortar mix consist of one part portland cement to four parts of sand for canal lining repair. For work in the tunnels, the sand content was increased to four and one-half parts. It was required that the sand be washed, and that it be durable and evenly graded from fine to coarse particles. It was also required that the moisture content of the sand prior to mixing with the cement be maintained at between three and five percent.

In the fall of 1950, repairs were made on the diversion dam, concrete structures at the head of the penstock, the tunnel sections and the most critical sections of the canal. A total of 9,530 square feet of lining was placed in the canal at a cost of \$1.18 per square foot; 4,770 square feet of tunnel lining was replaced at a cost of \$2.06 per square foot; and 1,570 square feet of surface on the diversion dam and intake structures were repaired at a cost of \$2.70 per square foot.

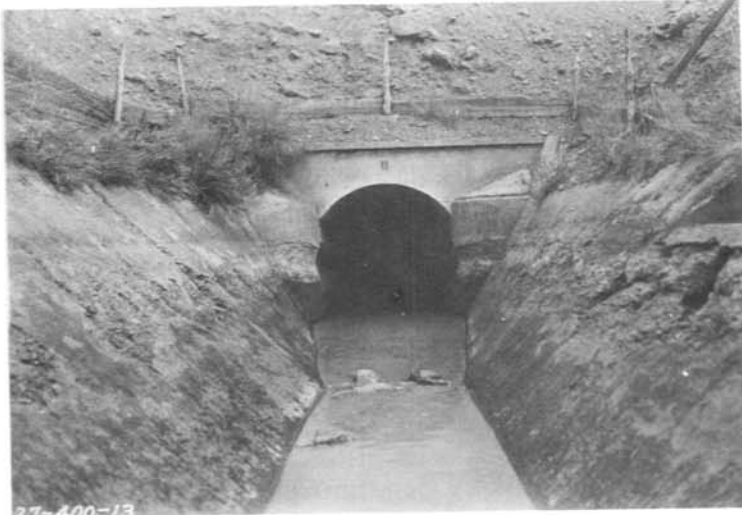
The water surface elevation in portions of the canal fluctuates up to about three feet daily during winter operations in the process of providing additional storage in the canal for power peaking purposes. This fluctuating water surface coupled with the frost action contributed materially to deterioration of a band of concrete side slope lining of the canal, which averaged about three feet in width. The remainder of the lining, however, was in reasonably good operating condition and did not warrant repair or replacement.

The deteriorated lining, which in some instances as shown below, had been completely eroded, reduced the carrying capacity of the canal and it was evident that repair or replacement of this eroded and deteriorated band was necessary. After a study of methods of making the repairs to the lining and the deteriorated concrete in other structures, the water users entered into a contract with an experienced contractor for the application of the shotcrete as well as the related work.

Under terms of the contract the contractor furnished all materials, prepared the surfaces including the removal of deteriorated concrete, placed the shotcrete, cleaned up and removed all waste materials resulting from the operation. However, in the filling of large pockets, such as those shown in the photograph at left, rock and broken concrete were

The balance of the canal lining was repaired in 1956, when the same contractor was engaged to place 14,350 square feet of deteriorated concrete lining at a cost of \$1.10 per square foot.

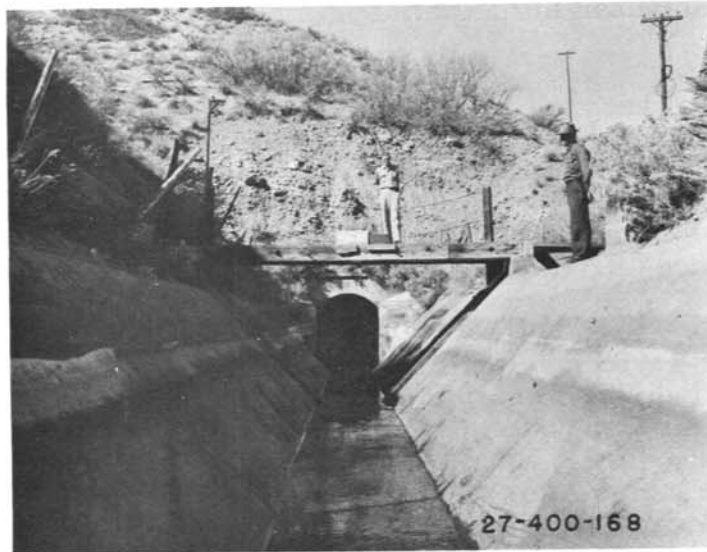
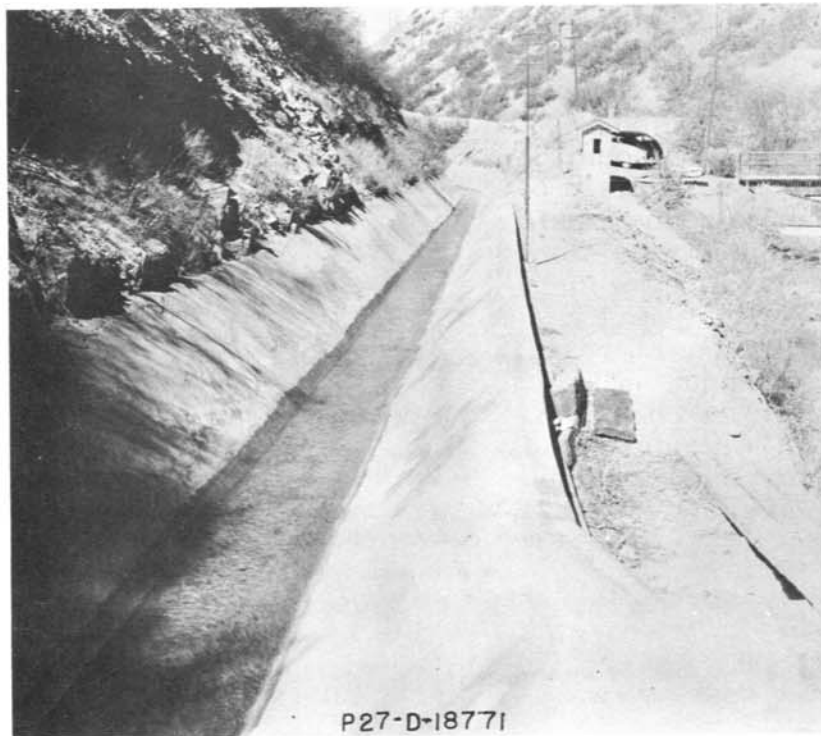
The condition of the unreinforced pneumatically-applied portland cement mortar repairs of the canal lining and the approach to one of the tunnels is shown in the photographs below. The photographs were taken in the fall of 1958.

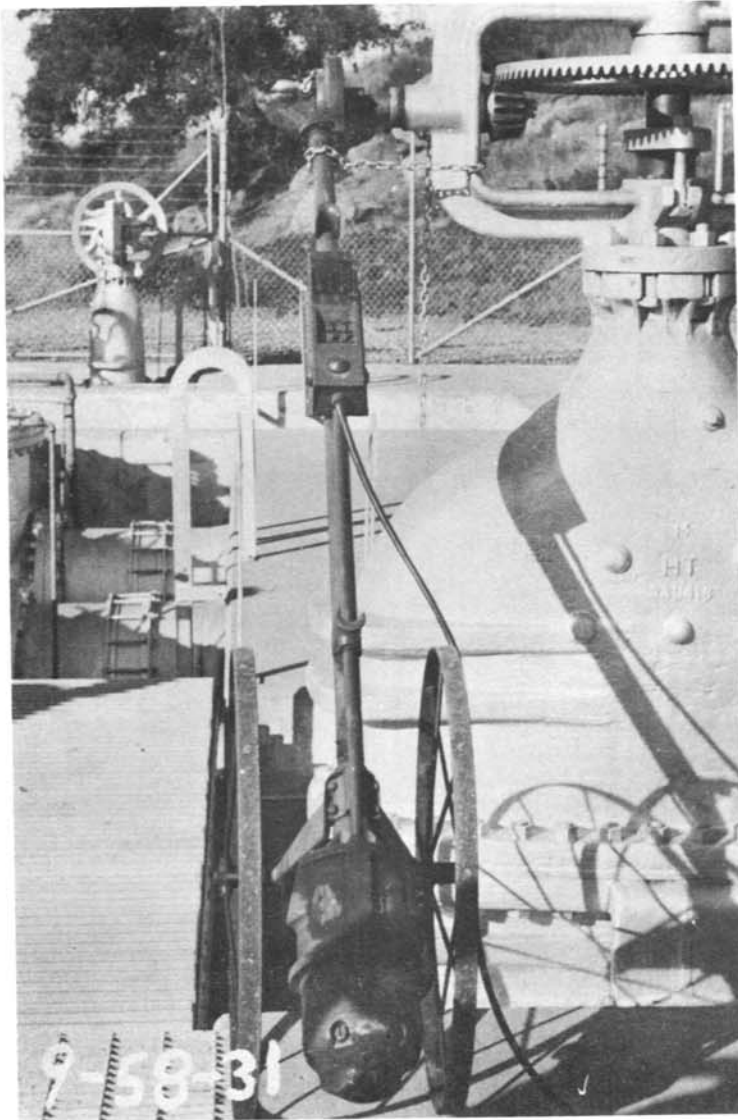
A pipe threading machine has been modified and is being utilized for operating large valves on the South Coast Conduit of the Cachuma Project, California. As shown in the photograph below, the machine is used particularly at control stations by the Cachuma Operation and Maintenance Board, which operates and maintains the works constructed by the Bureau of Reclamation.

the machine is used particularly at control stations by the Cachuma Operation and Maintenance Board, which operates and maintains the works constructed by the Bureau of Reclamation.

The threading machine is powered by a 1/2-horsepower, universal electric motor. The project advises that the machine has been very useful and calls attention to the fact that similar portable power drives are obtainable from several manufacturers.
