Department of the Interior
Bureau of Reclamation

OPERATION AND MAINTENANCE EQUIPMENT AND PROCEDURES RELEASE NO. 47

January, February and March 1964

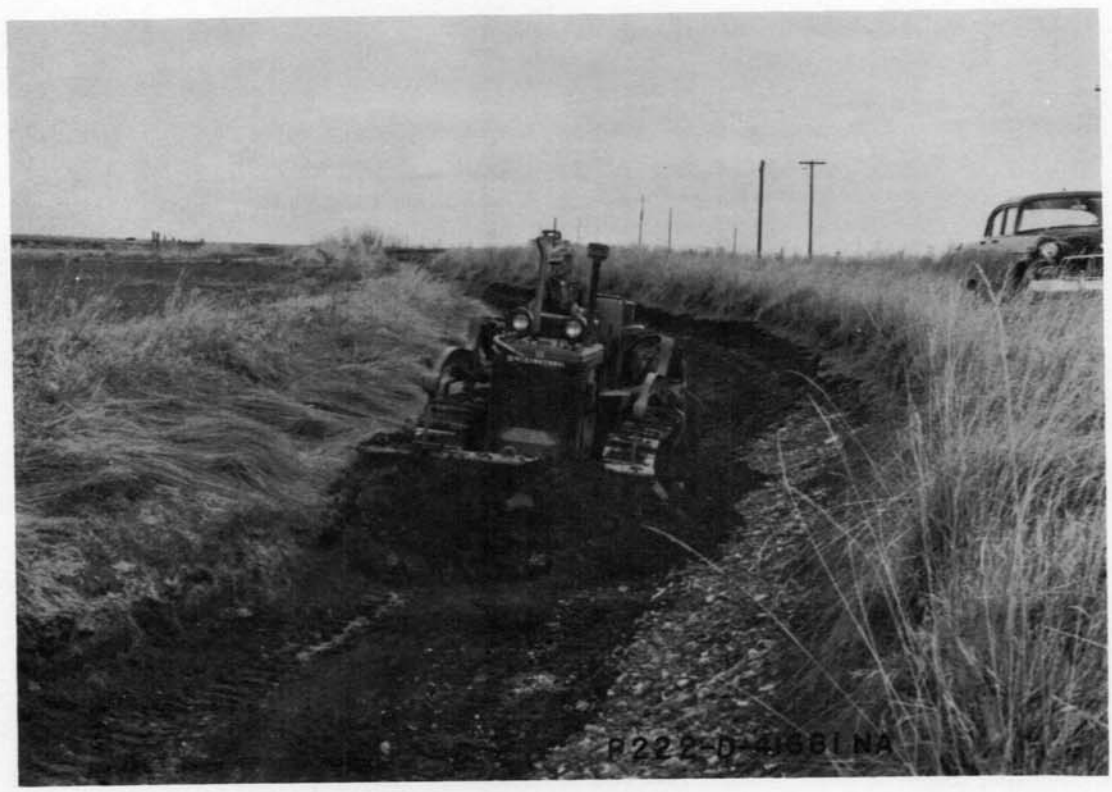
Cover Sheet. Photograph shows a surplus dozer blade cut down and mounted at an angle on a dozer so that the width of the blade is the same width as the dozer tracks. This equipment has adequate power and yet is small enough to work in laterals of 5- and 6-foot bottom widths. P222-D-41681NA

A surplus dozer blade was cut down and mounted at an angle on a dozer so that the width of the blade was the same width as the dozer tracks. Photographs No. 5, 6 and on the front cover show the machine in operation.

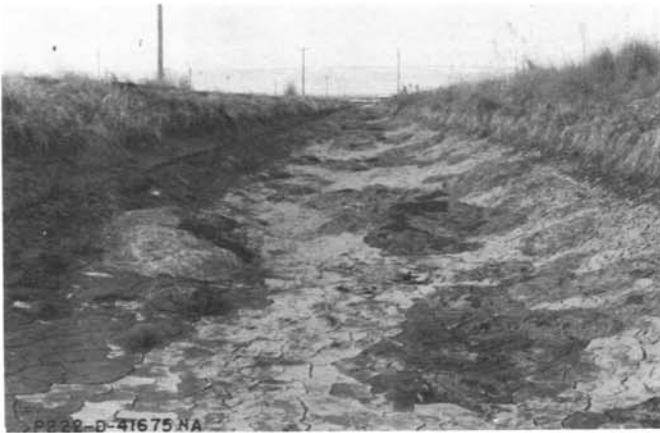
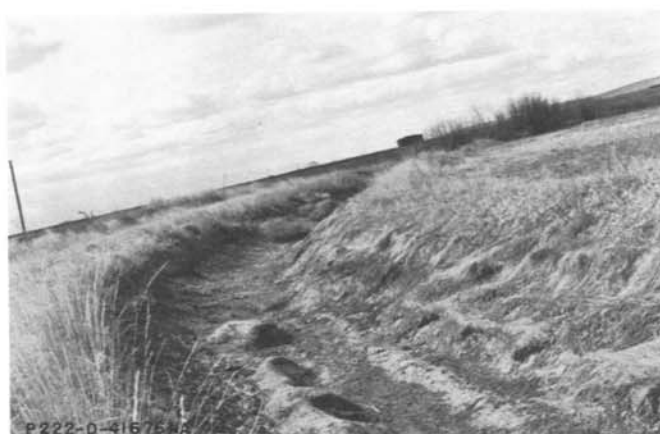
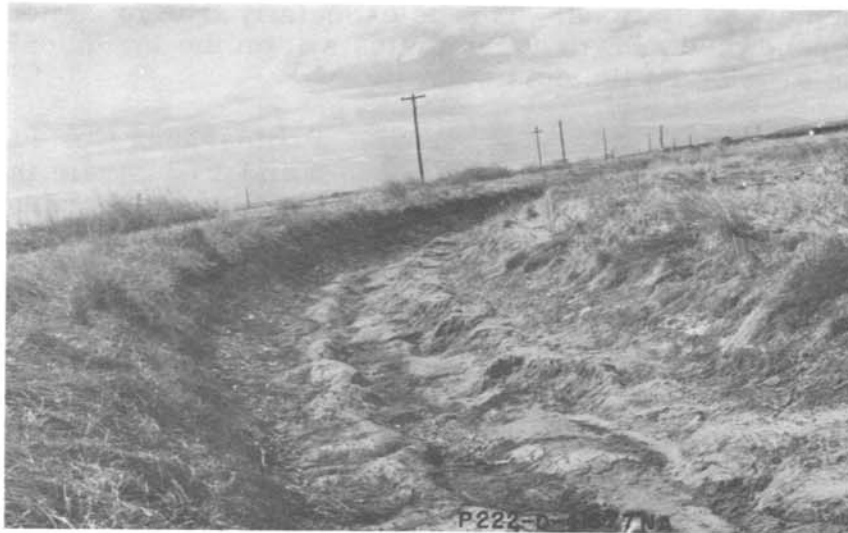
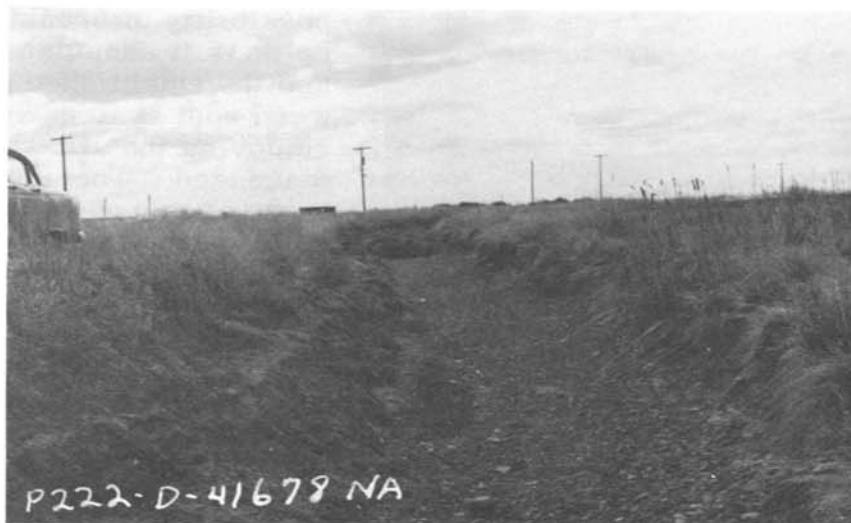
Silt accumulations in the moss growth starts erosion of the channel around such accumulations. This is especially true in contour laterals where pondweed growth accumulates silt on the inside of curves and causes erosion on the outside.

Photographs No. 1, 2, 3 and 4 illustrate the conditions described during the 1960 irrigation season.

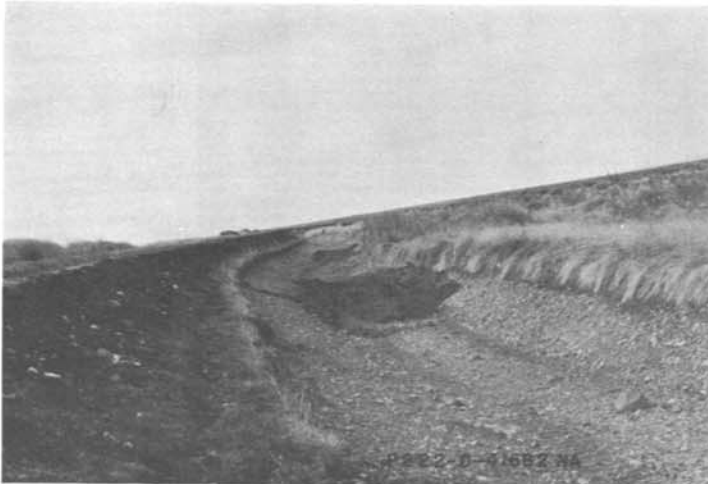
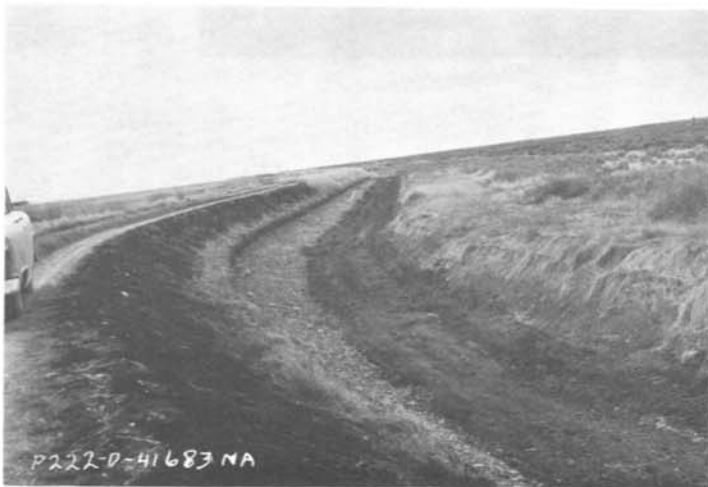
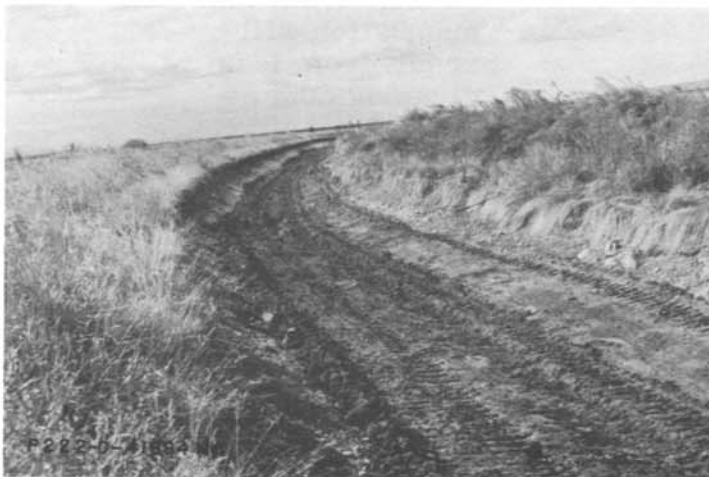
Photographs No. 8, 9 and 10 on the following page show the finished job.

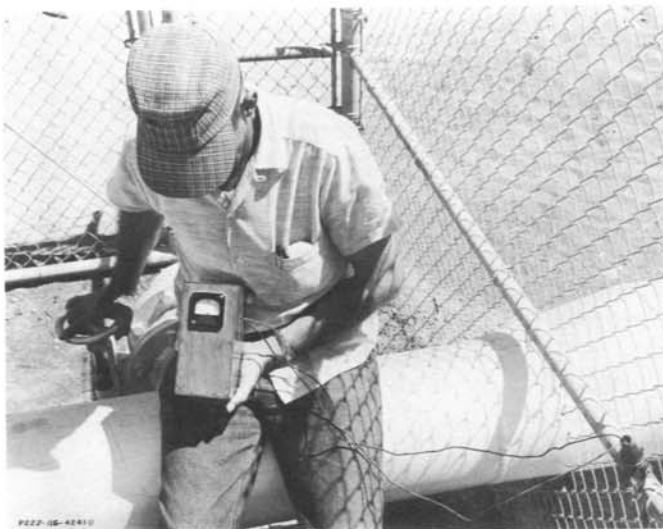
Photo No. 1

There was obviously no point in having an ammeter and a battery at each pump plant. A wooden box about 3" x 3" x 5" was constructed to house the battery and hold the ammeter. The ammeter was installed in one side of the box so that the dial would be easy to read. One end of a double conductor electric wire was connected to the battery and ammeter, and the other end connected to a standard two-prong male electric plug. Each ditchrider therefore, required only

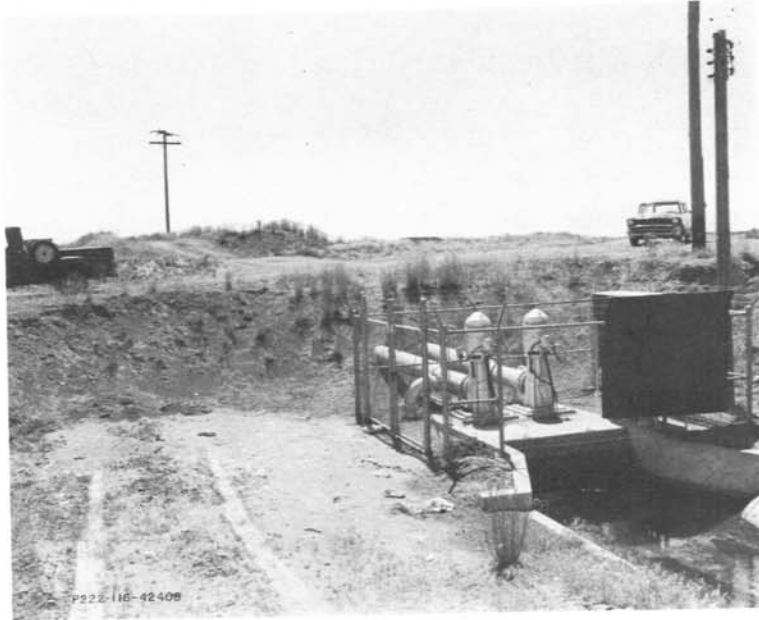
Photo No. 3

Photograph No. 3 shows a general view of Lateral W20F24 pumps and discharge. The discharge box is right of the power pole in the upper left of the picture. Each of the 15 HP pumps can deliver 6-1/2 cfs at the 13.4-foot lift.

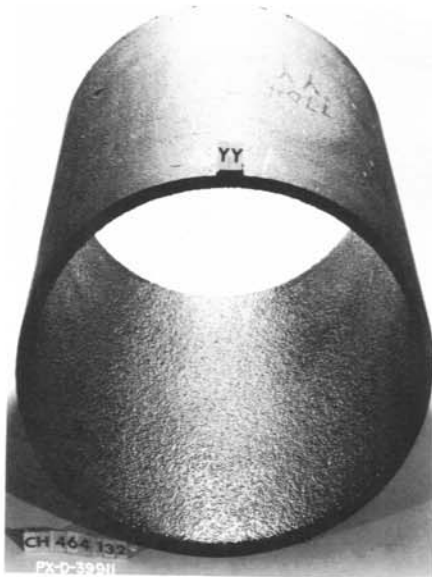
Fig. 2A. Pipe "YY" before testing. Three coats of coal-tar paint, CA-50, second coat reinforced with ASTM C-190 Ottawa sand.

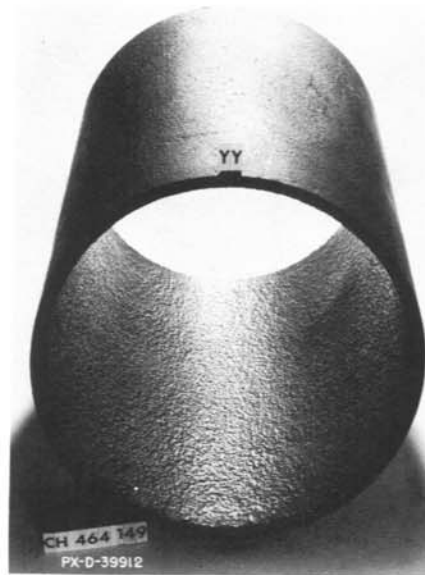
Fig. 2B. Pipe "YY" after testing. The only visible damage is the removal of the CA-50 from the tops of sand grains. View shows condition after four runs.

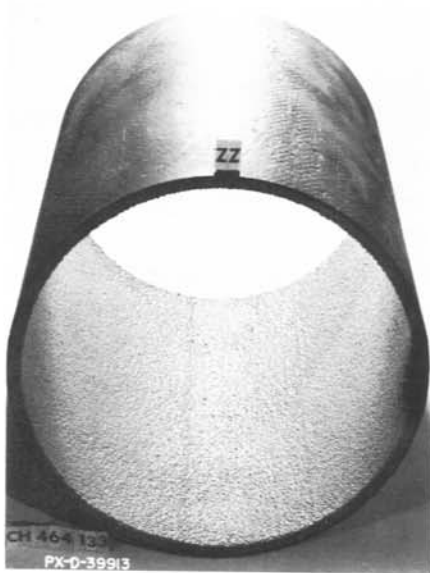
Fig. 2C. Pipe "ZZ" before testing. Lining consists of four coats of red-lead priming paint, TT-P-86a, Type IV, second coat reinforced with No. 20-30 mesh Ottawa sand (ASTM C-190).

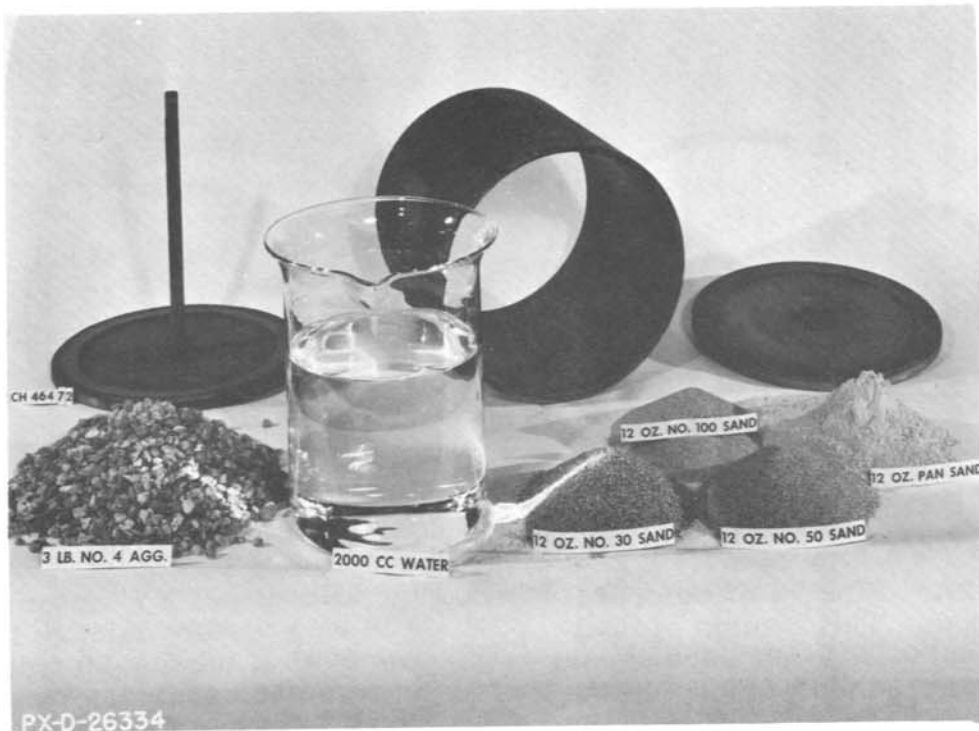
The sand charges consisted of 3 pounds of sand plus 2,000 c. c. of water. The gravel charge was made up of 3 pounds of No. 4 aggregate plus 2,000 c. c. of water. The charge occupied about one-third of the pipe section volume. Figure 3 shows a typical section with the erosive charges used.

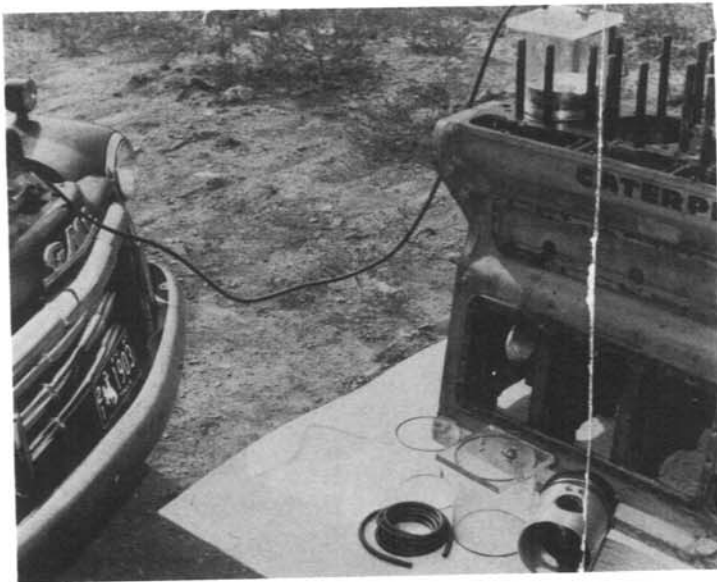
Photograph at left shows tool in position with piston raised and the tube to the engine providing the source of vacuum.

The tool and method is extremely simple, but the use of a vacuum as the pulling power is very unusual. Basically the tool consists of a plastic cylinder of the proper diameter with rubber seals at top and bottom. On top of this cylinder is placed a square plastic cap with two openings. One is attached to the suction source and the other is a valve to control the amount of vacuum and the resulting pull. Operation is as simple as the parts of the tools themselves. Place the lower end of the transparent cylinder in the proper location over the piston in the engine, being sure to seat the neoprene ring seal. The cap is then placed over the upper end using a similar ring seal. With the valve open the hose is attached to the vacuum source (engine intake or small vacuum pump) and the power started with the valve open. This intake valve is then closed slowly to develop the vacuum until the piston is raised past the first ring. Control of the raising is simple and easy. The freeing of the rings from the cylinder breaks the vacuum seal, and the expansion of the ring or rings hold the piston up until it can be removed by hand.

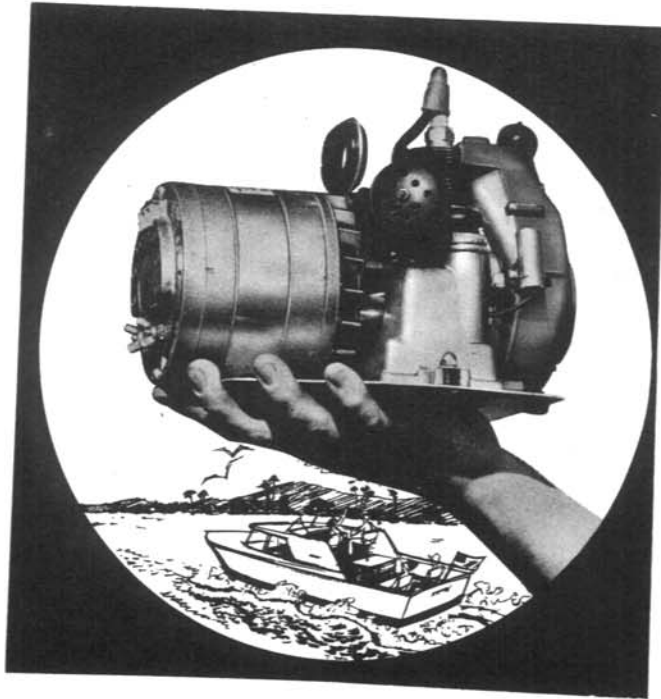
Figure 1

The other generator is a portable, gasoline-powered unit. A 3/4-horsepower 2-cycle gasoline engine turns this generator at 6,300 rpm. The unit is very compact, it occupies less than 0.4 of a cubic foot of space and weighs only 12 pounds.

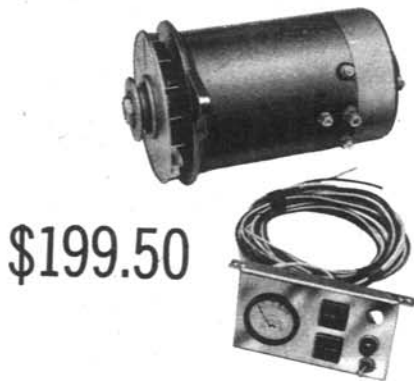
Figure 2 below shows the standard-type generator that can be mounted in a vehicle.

One of these generators is designed to replace the standard automobile generator. Under normal operation it supplies 12 volts direct current; but by flipping a switch mounted on the dashboard; it is converted to a 110-volt alternating-current generator. This generator produces 2,300 watts at 110 volts. The generator is only slightly larger than the standard automotive generator and can be installed in any car or truck without alterations. The generator and control panel will cost approximately \$200.
