# ***WATER OPERATION AND MAINTENANCE***

**BULLETIN NO. 100**

JUNE 1977

## DROUGHT ASSISTANCE FOR 1976-1977<sup>1</sup>

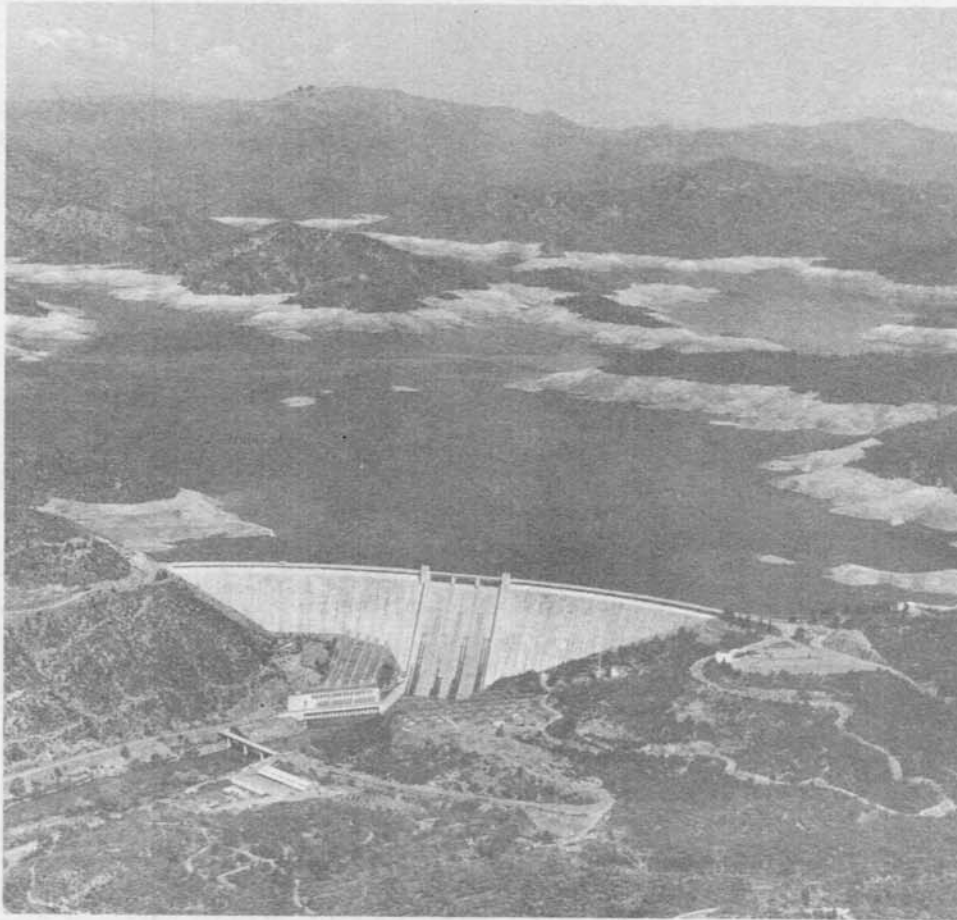
COVER PHOTOGRAPH:

This is an aerial view looking upstream at Shasta Dam and Lake on the Sacramento River north of Redding, California, during low water elevations. Storage capacity of reservoir is 5615 million cubic meters (4 552 000 acre-ft). Storage in reservoir when photo was taken is 1590 million cubic meters (1.291 000 acre-ft).

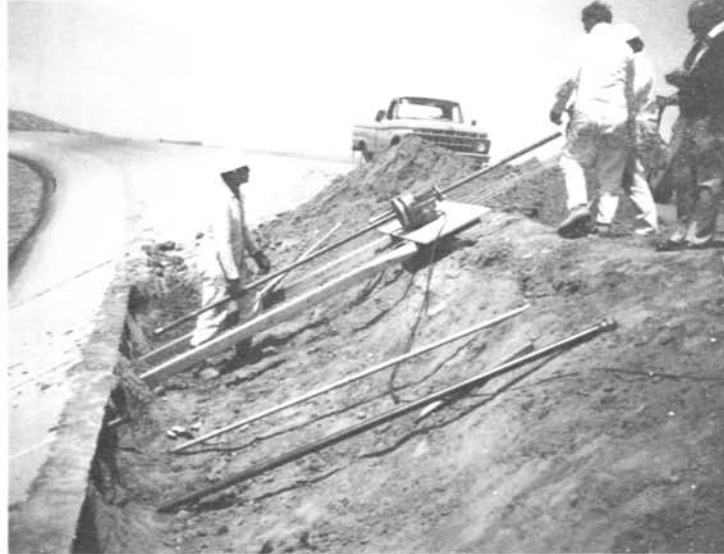
Figure 3

the bit into the earth. The boom cable hauled the motor back up when it came time to attach more drill pipe. Figures 3 and 4 show two views of this setup.

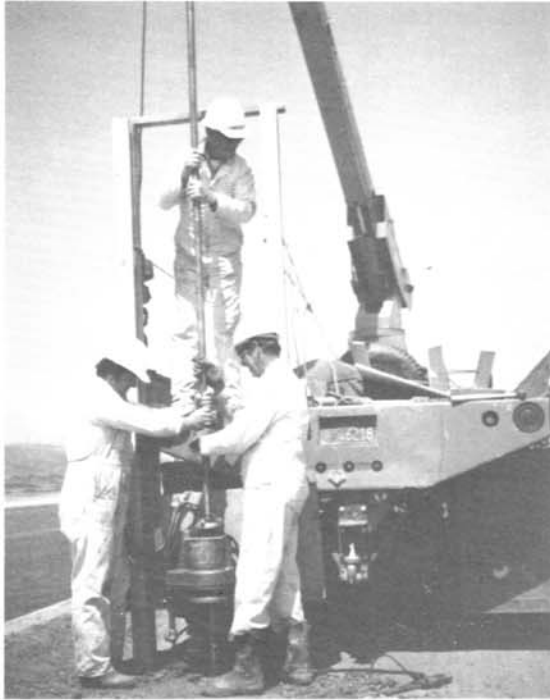
After the holes were drilled beneath the lining, pipes were inserted and then grout was introduced at low pressure, almost gravity-flow pressure, so there would be no danger of lifting the aqueduct lining. This first grouting slowed the leaks but did not eliminate them. The drilling operation was then moved back onto the bank, where plans were made to drill a group of grout holes. The support uprights for the drill-motor slide were installed and staked in place. The tailgate of the boom truck formed the working platform, and also helped to brace the uprights. During drilling, the crew climbed on the plywood slide and rode the drill down. More drill pipe was added from the pile kept on the truck. In this way, the holes were sunk to a depth of 10.5 m (35 ft) below the surface of the maintenance road. Figure 5 shows drilling in progress; figure 6 shows more pipe being added.

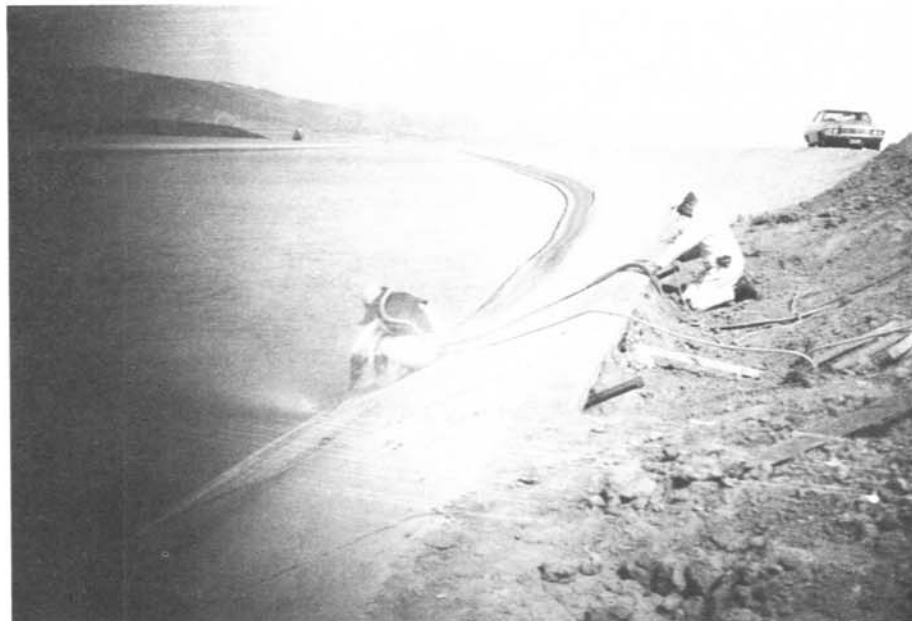
in the area. As a final chore, the crew puts on protective clothes to sandblast the areas where grout had seeped through cracks in the lining. These places were then cleaned and treated. Figure 7 shows this activity.

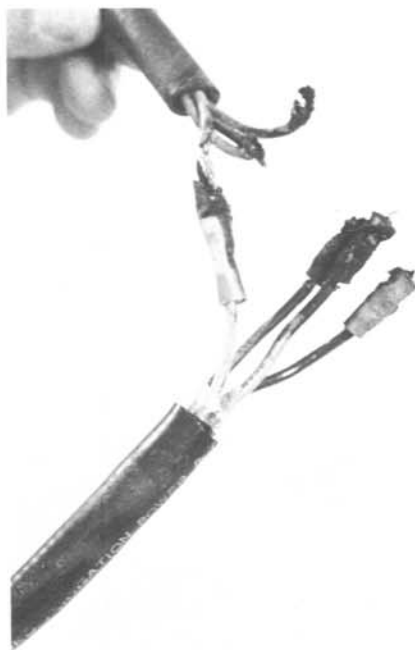
Frayed wiring, such as this piece removed from a center pivot, caused death of a Wyoming man this year.
