WATER OPERATION AND MAINTENANCE

BULLETIN NO. 106

DECEMBER 1978

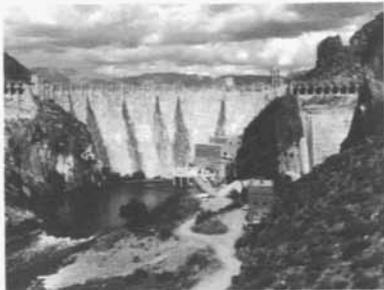
Theodore Roosevelt Dam, Salt River Project, Arizona. Located on the Salt River in the south-central part of Arizona, about 48 km (30 mi) from Globe, Theodore Roosevelt Dam was one of the first large dams built under the Reclamation Act of 1902. Completed in 1911, the masonry arch dam impounds Theodore Roosevelt Lake which provides storage for irrigation, power production, and flood control. The lake is also extensively used for recreation purposes.

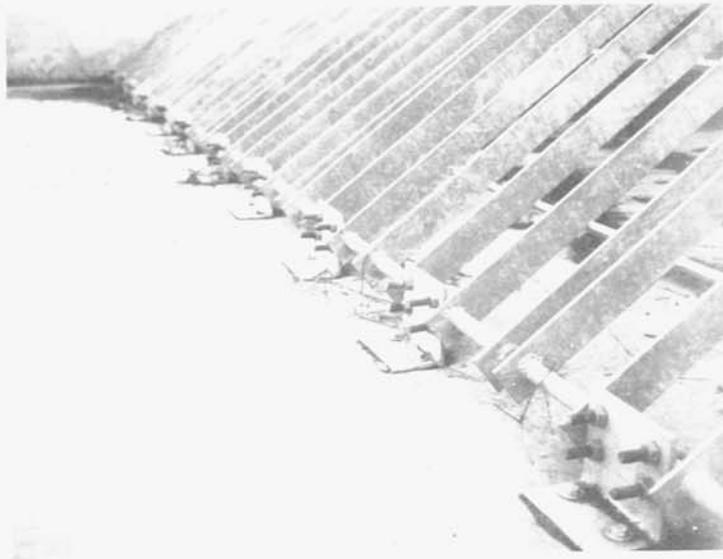
Figure 2.—Safety rack with hinges relocated to the base.

To make sure such a problem did not occur again, the top hinges were removed and placed on the base of the rack. These base hinges were moved far enough away so that the rack could be dropped down without striking the drain top. The racks were fastened in an upright position with a short length of small chain secured in a slot cut in a piece of metal angle, which was anchored to the existing top hinge anchor bolts.

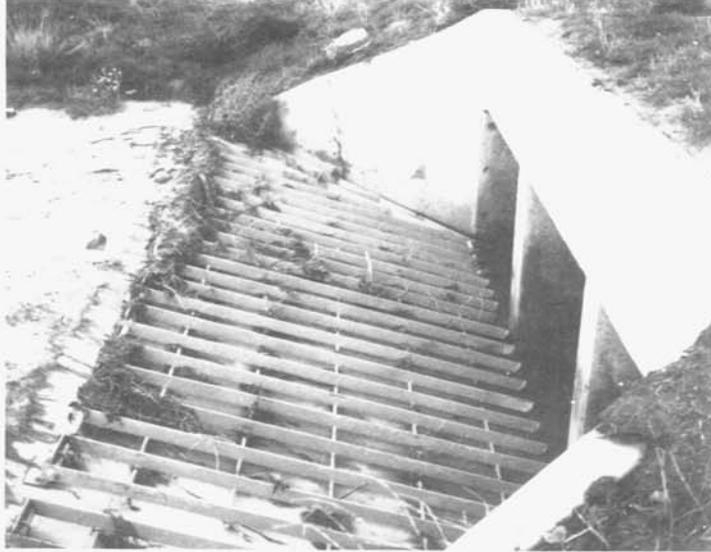
Figure 3.—Safety rack, new installation, with rack in the open position.

During flood season, the racks could be opened quickly to relieve the heavy waterflows by cutting the chain and allowing the rack to drop. Afterwards, the racks could be lifted and secured back into position undamaged and ready to serve their safety purpose.

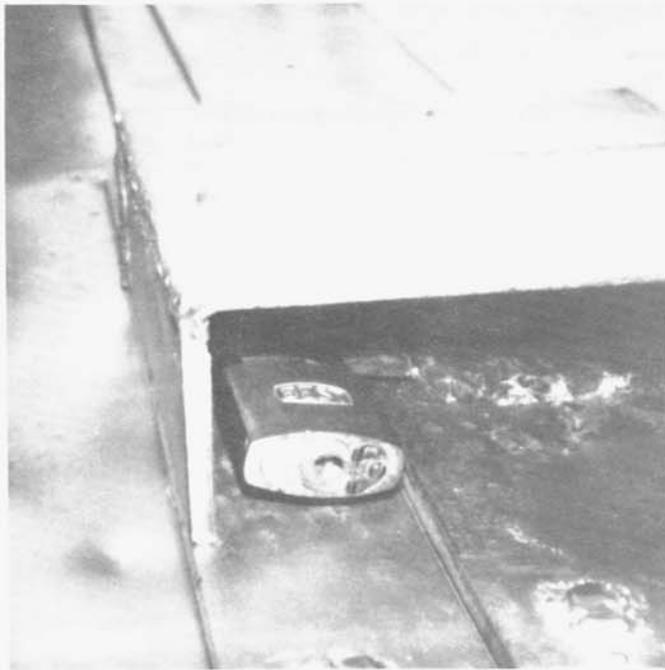
Figure 5.—Door closed. Lock hidden, so that it is impossible to break with rocks.

The padlocks used on the doors and hatches or lids at these installations were being battered or broken off by hammers, rocks, screwdrivers, bars, etc. Mr Abe Miller, Plant Mechanic at Alcova, Wyoming, designed and installed covers for these exposed padlocks. These covers can be permanently installed on the doors, or hinged so they can be swung out of the way when not in use. Similar covers can be constructed over built-in door locks that will protect them from external damage.

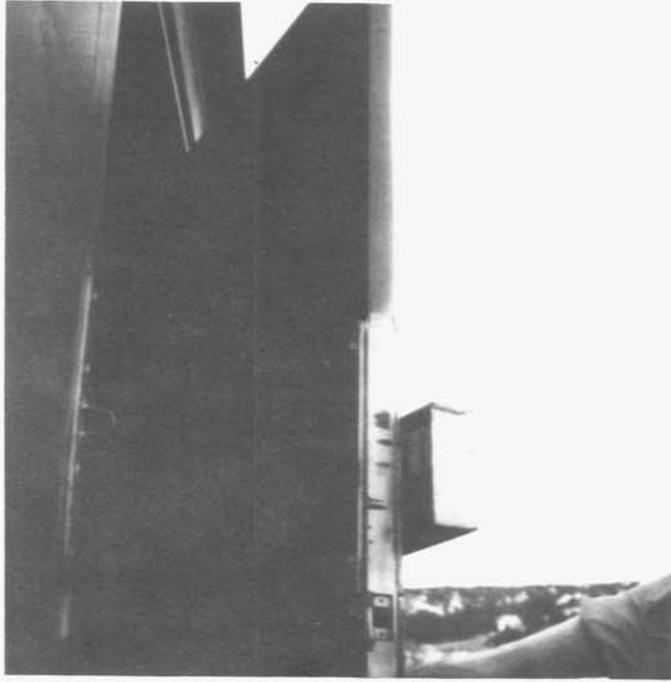
Figure 6.—Door open (hasp visible).

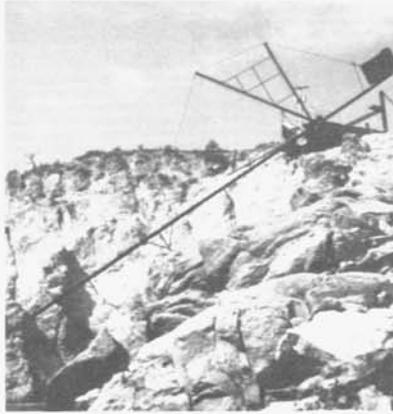
Figure 9.—This view, taken at low water on the lake, shows the extreme variation that occurs at the pump site.

A 61-m (200-ft) steel beam is weighted on the lake end by a floating barge which consists of decking, motor, and pump on four 3800 L (1000 gal) tanks. It is counterbalanced with a 2.44- by 3.66-m (8- by 12-ft), dirt-filled steel box.

The first 45.7 m (150 ft) of mainline pipe is attached to the beam from the floating platoon to the switchbox platform on shore. There, a hinged 90° elbow permits the pipe to automatically swivel on the continuing stationary pipe as the water level rises or lowers.
