WATER OPERATION AND MAINTENANCE

BULLETIN NO. 113

September 1980

COLLAPSIBLE HANDRAILS – GRAND COULEE DAM ¹

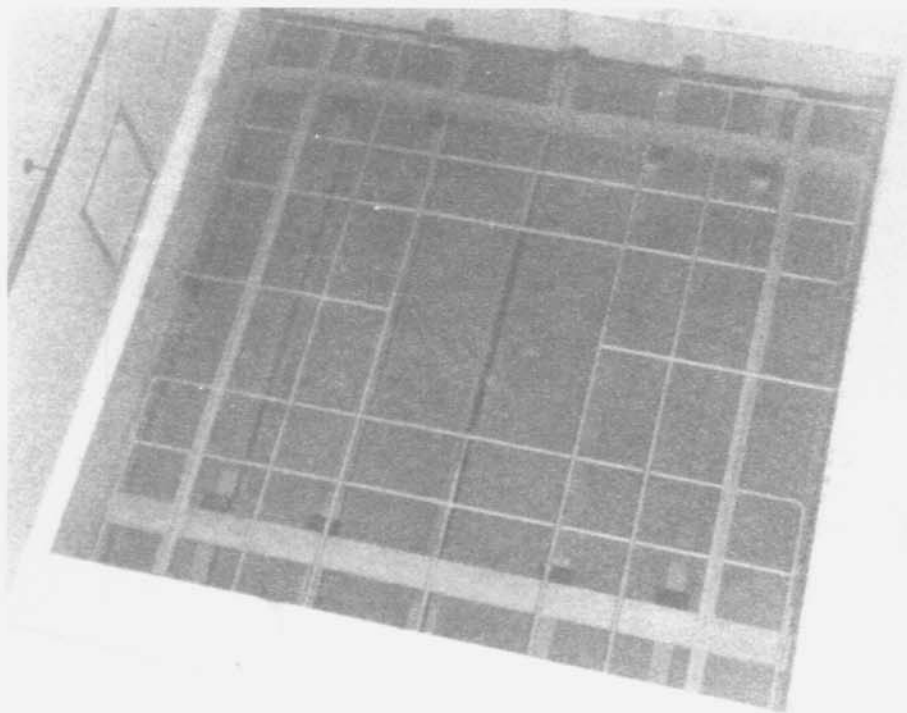
Figure 1.—Self-storing safety rails in the down or stored position.

The hatchways are rectangular openings that are used for access to lower levels for maintenance and equipment installation and removal of equipment. When the hatchway is not in use, a hatch cover is laid over the opening with the collapsible railing in a folded position.

When the hatchway is to be used, the hatch cover is removed by crane, exposing the collapsible handrailing. Workmen use rods with hooks on the end to engage the handrails, raising them to the upright position. After the work is accomplished, the railings are lowered

to their stored position. The railings in their lowered position also serve as a safety device blocking the hatchway until the hatch cover is replaced.

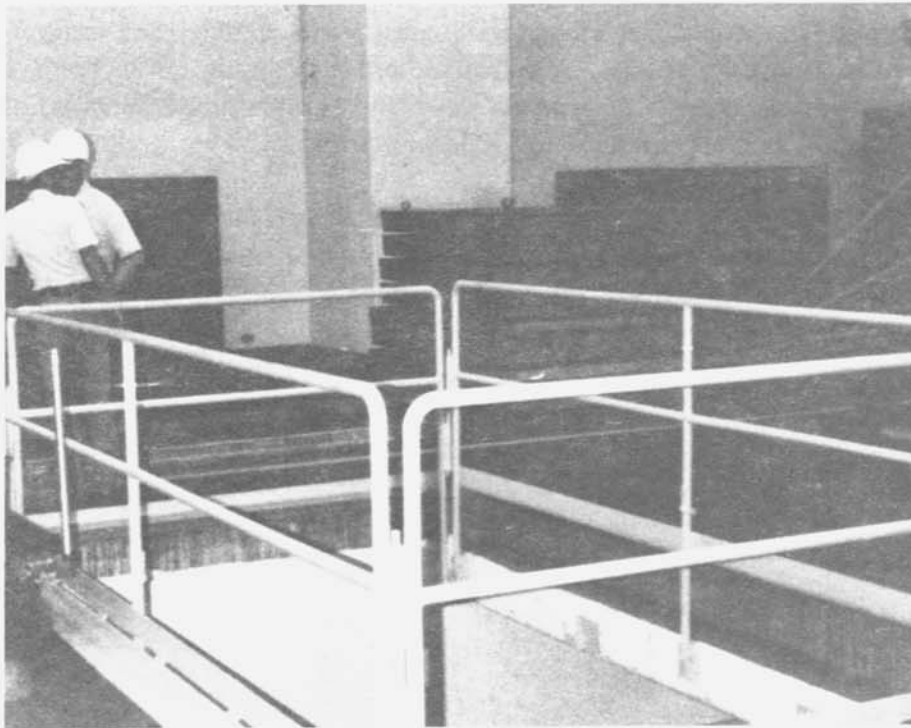
Figure 2.—Self-storing safety rails in upright position to protect access hatch.

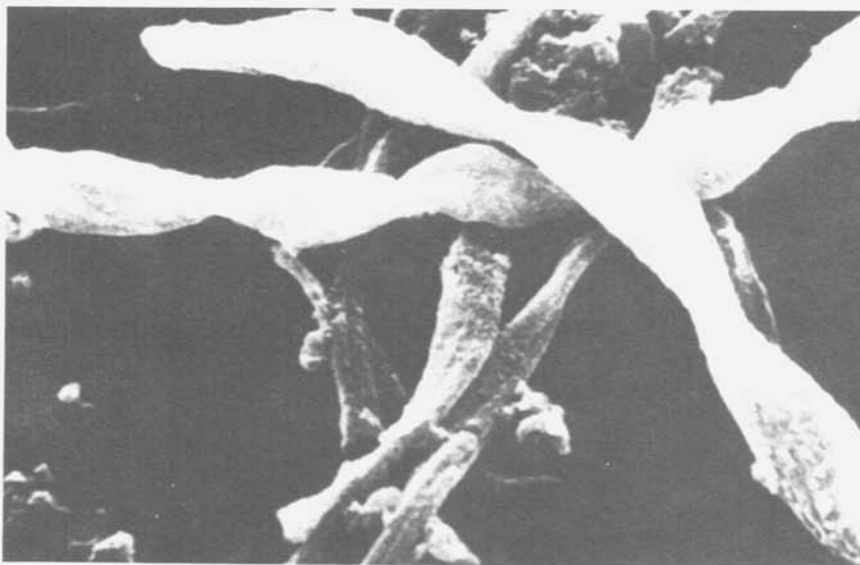
Figure 3.—*Gallionella ferruginea*.

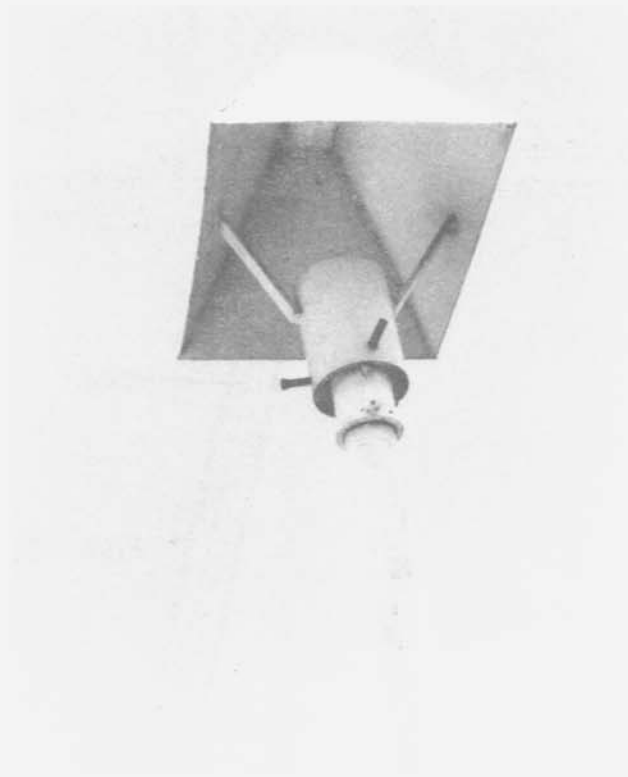
Figure 4 illustrates a protective device for light bulbs. To protect the light bulb from vandalism, such as rocks and gun shots, etc., the bulb is placed inside a 76-mm (3-in), heavy duty pipe. This heavy duty pipe is a part of the reflector section, which is a separate item from the power standard pole. Replacing the light bulb is a simple task. By loosening three set screws, the reflector can be lifted off the pole, providing easy access to the bulb. A diagram of the device is shown on the following page.

Figure 4.—Protective device for light bulbs.

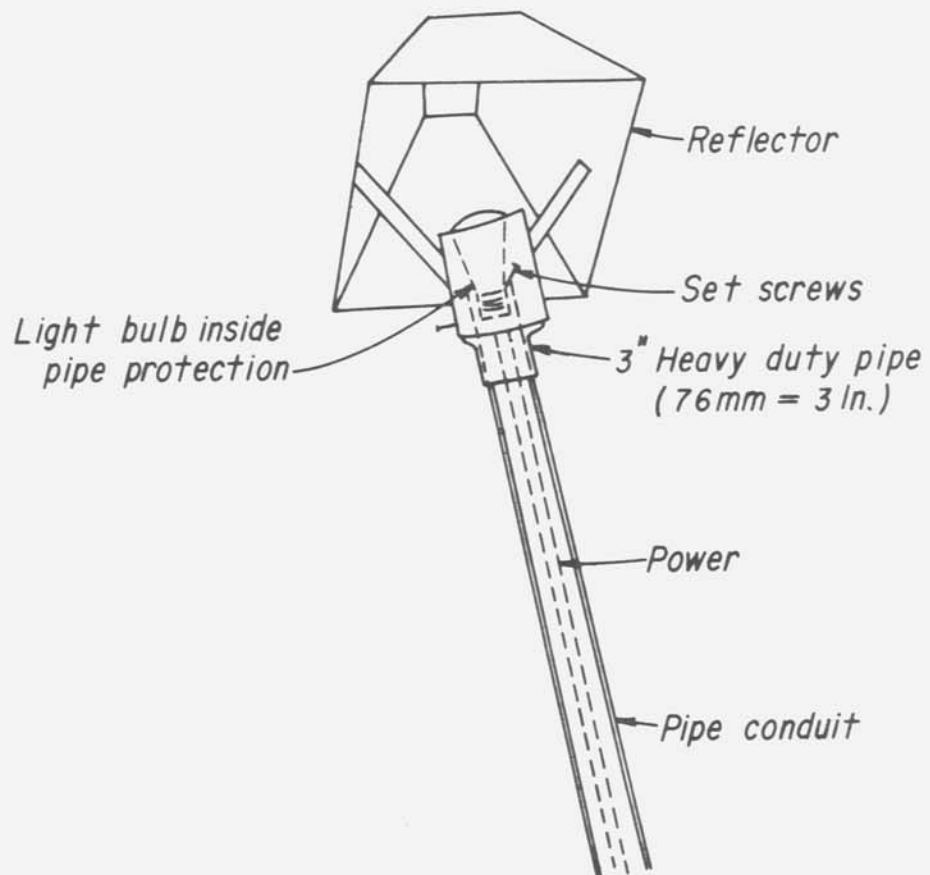
Figure 5.—Protective device for light bulb.

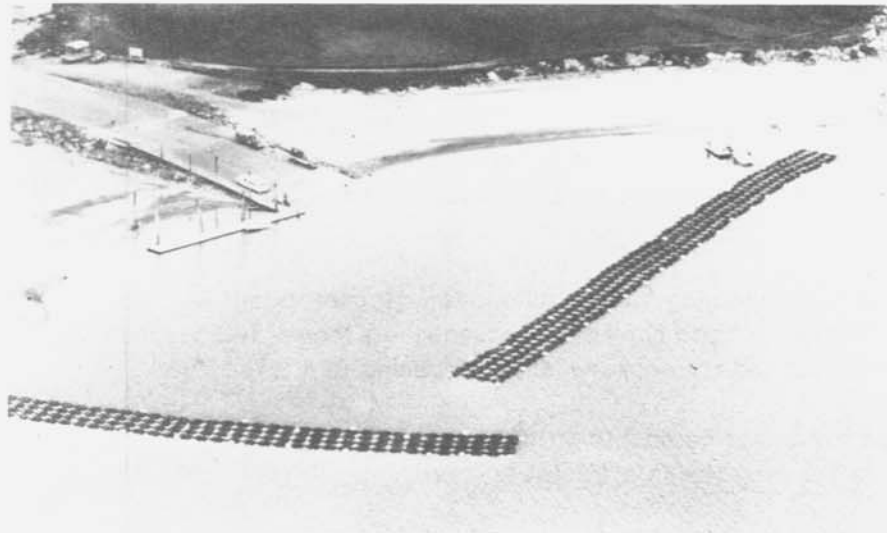
Figure 6.—Long mats of foam-filled tires form a haven for boaters on Cascade Reservoir.

Utilizing its patented process for filling old tire casings with polystyrene foam, Topper Industries, Inc., of Vancouver, Washington, built and installed two floating breakwaters made of the tires. The two extend from the shoreline at an angle and overlap to create a protected launch ramp harbor. One breakwater is 76.2 m (250 ft) long; the other 137.2 m (450 ft).

The floating breakwater system is not only more economical than a permanent concrete structure, but poses less maintenance problems since the Topper breakwater has the flexibility to withstand the reservoir's virtually solid freeze in the winter. Although this breakwater will be left anchored in place during the winter, it could be towed to shore and reanchored in the spring.

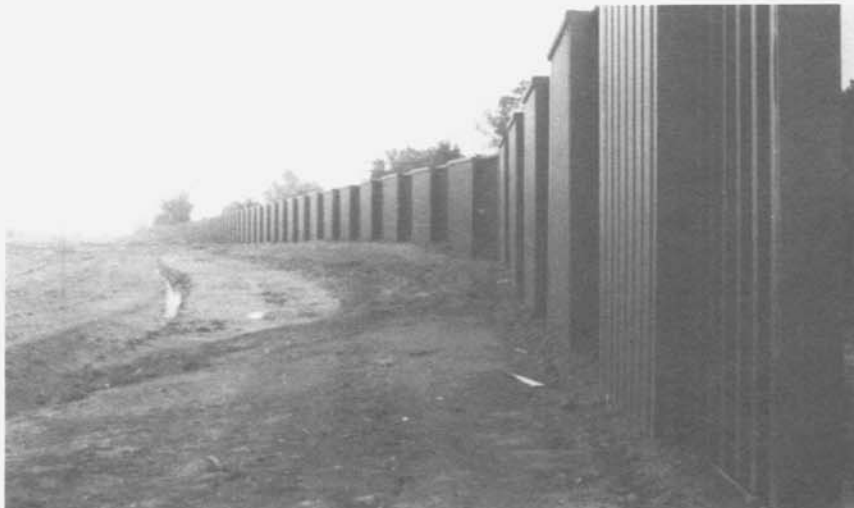
Figure 7.—Besides being easy to clean, the steel highway noise barrier will shield neighborhood from traffic noise.

Along Ohio Route 315, just north of Ohio State University, the city's first steel highway noise barrier will not only reduce the sound of highway traffic but also provide a pleasant appearance for residents and travelers alike. The 1.2 to 4.6-m (4 to 15-ft) high wall is constructed of "Steelox" panels manufactured by the Metal Products Division of Armco Steel Corporation, Middletown, Ohio. The panels are covered with a Colonial Red coating of "Tedlar" PVF film, a protective plastic film made by the DuPont Company

Instead, the city chose the Armco barriers because of a wide selection of colors, the shadowbox design, and a surface from which graffiti could be cleaned easily. The more than 1524-m (5,000 lineal ft) of wall that border both sides of the roadway through the residential

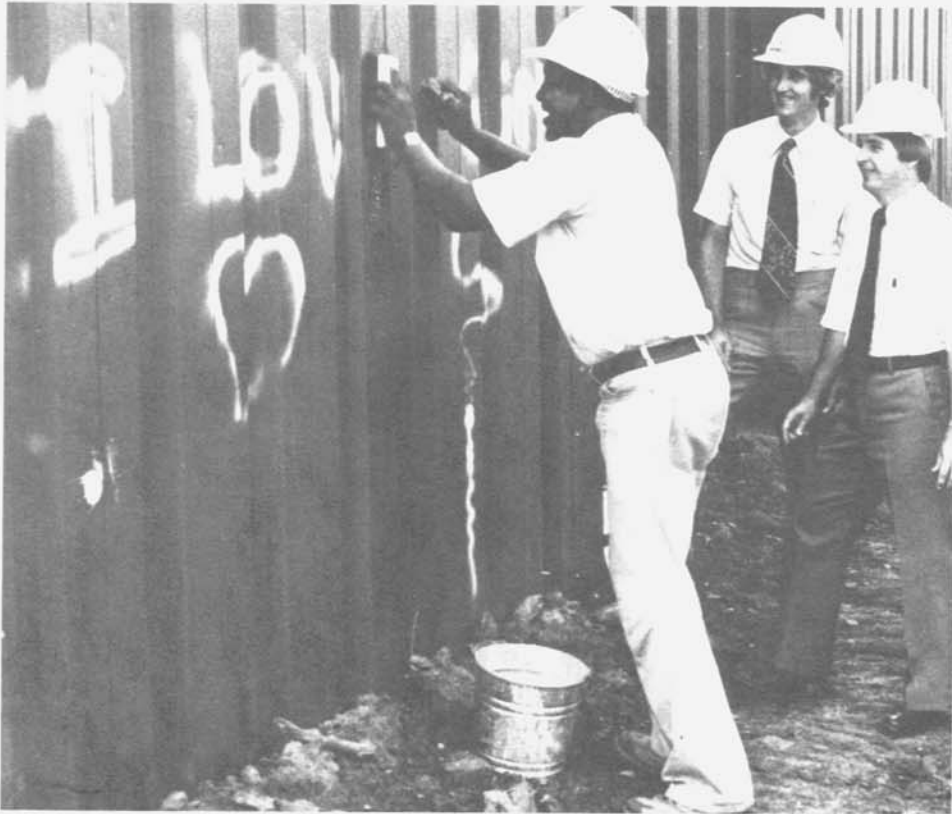
Figure 8.—Wall panels of steel highway noise barrier are covered with washable plastic film to permit easy graffiti removal.

area can be cleaned with a commercial solvent, because the tough plastic coating resists paint, lipstick, ink, and tar. It also provides excellent corrosion protection for galvanized steel, giving it longer life.

The ease of cleaning the wall was demonstrated recently when city and state government people visited the wall to witness the removal of graffiti. A commercial cleaning solvent removed spray paint that had defaced two sections of the barrier for approximately 2 months. The cleaning completely restored the wall to its original condition without a trace of damage to the chemically inert coating.

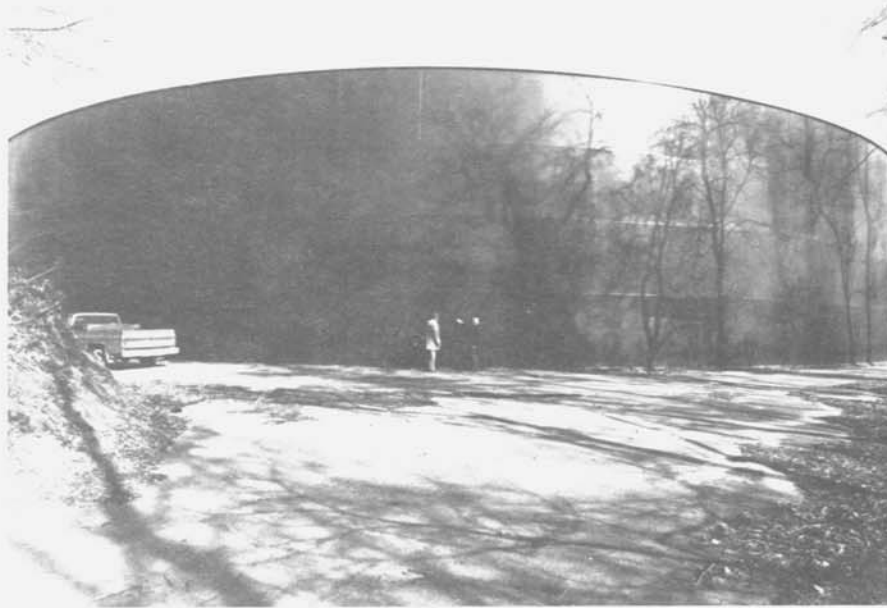
Figure 9.—An invitation to graffiti artists, such as this tank, demands special mark-resistant coating.

New protective coatings were recently applied to the exterior and interior of a 37.8-ML (10-million gal) capacity steel reservoir serving 30,000 families in the Monroeville, Pennsylvania area. The tank, owned and operated by the Monroeville Water Authority, was built in 1963.

The original coatings, supplied by Koppers Company, Inc., Pittsburgh, were in excellent condition, with minor exceptions. There were graffiti marks on the exterior and minor corrosion of metal purlins inside the tank.

The new protective coatings also were supplied by Koppers. Bitumastic Super Tank Solution was applied to both the interior roof and girders. The base of the tank, coated with 70-B hot enamel originally, needed spot repairs using the same material on only 2 percent of the area.

After sandblasting the graffiti-marred areas of the tank's exterior, a coat of Koppers Pug Primer followed by two coats of Rustarmor 500 were applied forming a tough, flexible elastic film with long-term weathering properties. Finally, a graffiti-resistant clear coating, Koppers GrafPruf, was applied up to a 4.9-m (16-ft) height around the tank exterior. This material
