WATER OPERATION AND MAINTENANCE

BULLETIN NO. 118

DECEMBER 1981

EARTHEN CANAL SEALANTS
WHAT ABOUT FLY ASH FOR SEALING CANALS?
GRADATION OF SAND AND GRAVEL CANAL COVER LAYERS
MEMBRANE LINER SEALS 112.5-HECTARE (278-ACRE) RESERVOIR

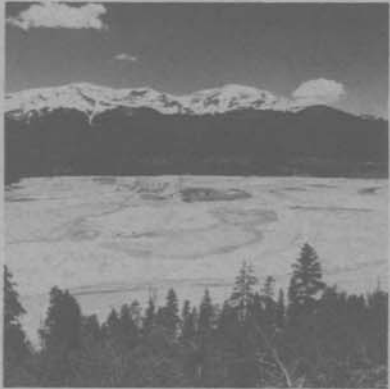
Cover photo:

Mt. Elbert Forebay reservoir, Fryingpan-Arkansas Project, Colorado. The reservoir is being prepared for placement of membrane lining.

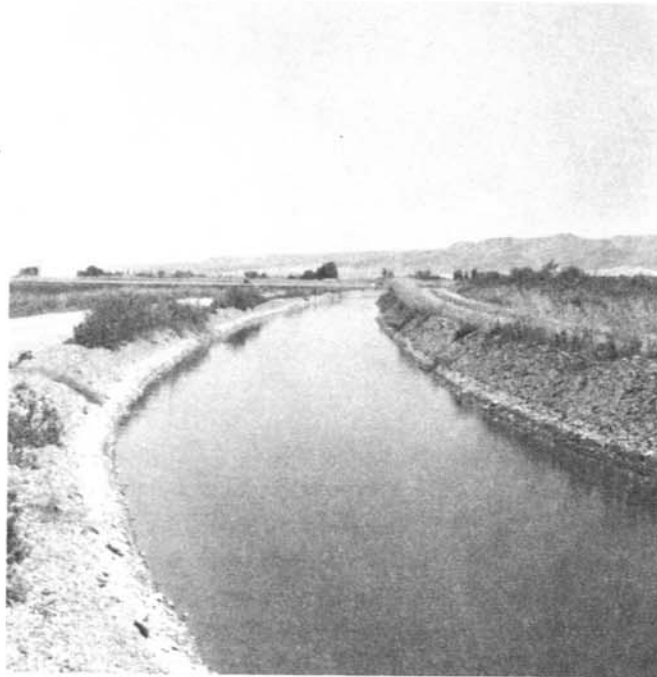
Figure 3.—"G" canal in the second year of operation after lining work.

Seepage testing was done through the use of the inflow-outflow method. It was best adapted due to the long test sections of the canal. The test section on the "G" canal began at 450 East 150 South, ended at 300 East 140 South (figs. 3 and 4).

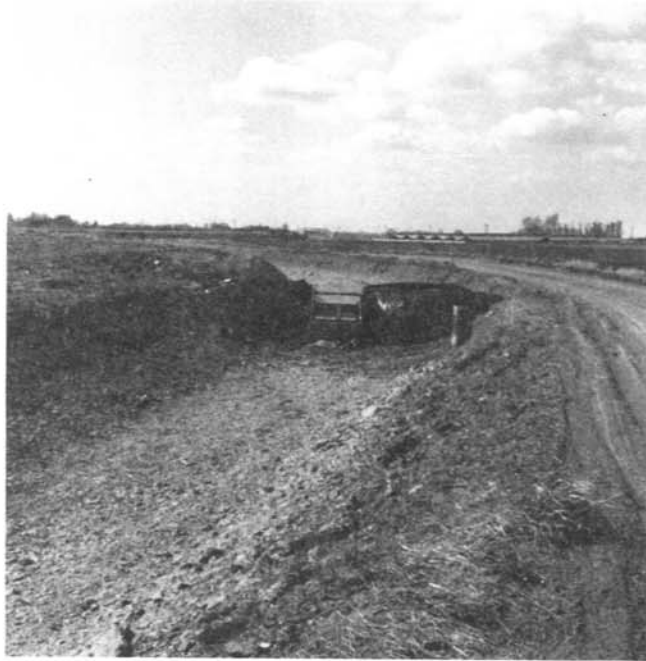
Figure 5.—Bulkhead/weir No. 2 with water stage recorder setup for inflow-outflow test on April 8, 1981.

Seepage was measured in the 24 + 68.9-m (81 + 00-ft) length of canal through use of four bulkhead/weir stations, for three test sections. The stations were installed at approximately 0 + 15.2, 7 + 01.0, 17 + 06.9, and 24 + 68.9 m (0 + 50, 23 + 00, 56 + 00, and 81 + 00 ft). A Stevens-type "F" water stage recorder (figs. 5 and 6), was installed on the upstream side of each station and correlated to weir blade height. The tests were conducted at the initiation of the irrigation seasons; first, prior to the canal lining work on April 20 through 23, 1979; and second, after the lining work plus 1 year's operation on April 8 through 11, 1981.

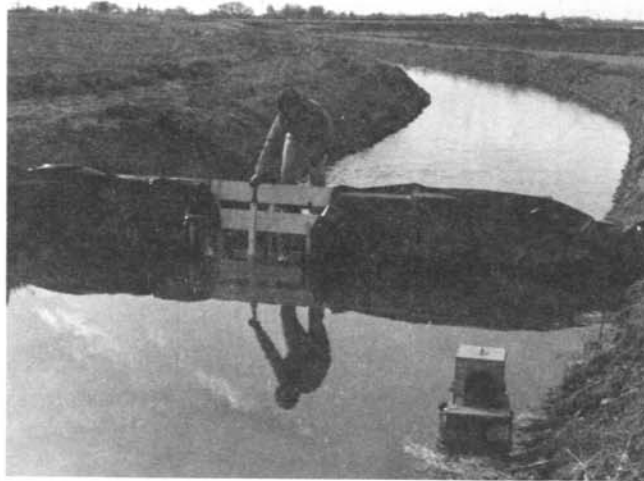
Figure 6.—Bulkhead/weir No. 2—Head being checked by Mr. Colianni and will be correlated to water stage recorder.

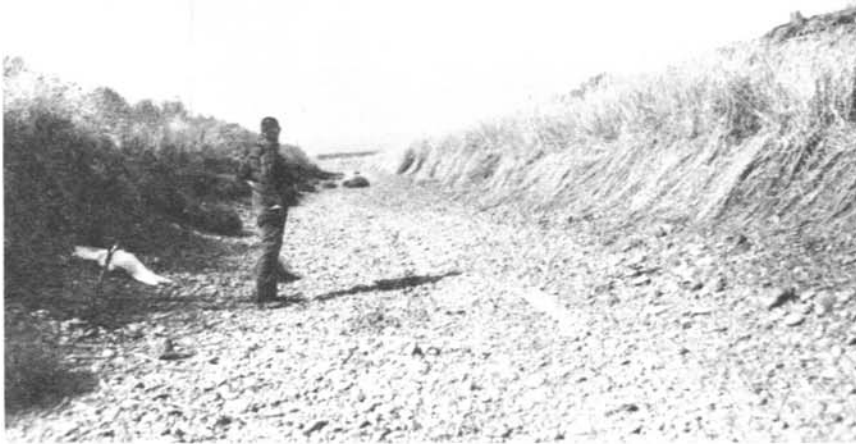
Figure 10.—Granular cover on Kennewick Main Canal.

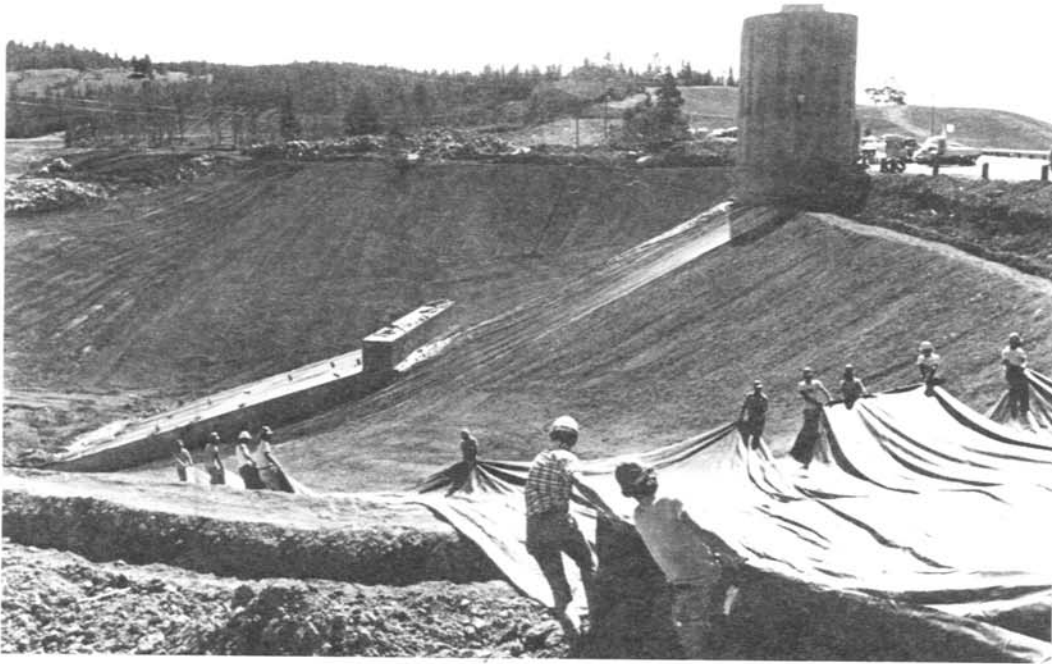
Figure 14.—Installation crew positions section of the membrane liner. Each section measures 1300 m^2 (14 000 ft^2).

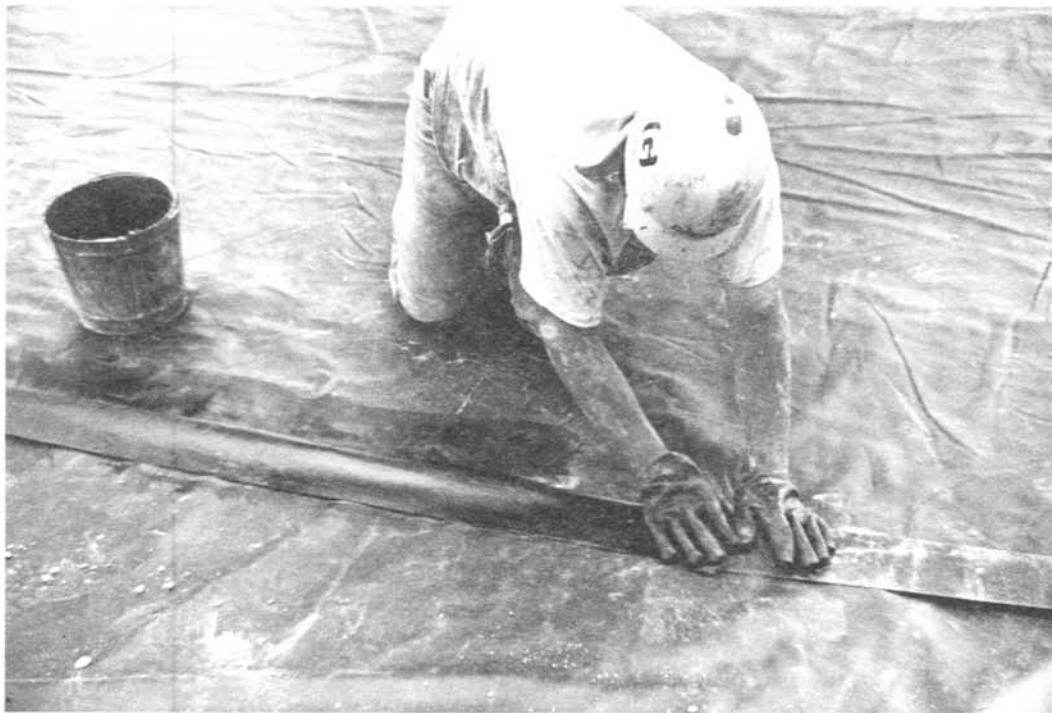
Figure 15.—Seams joining panels were sealed with special adhesive, then tested with an air gun. After inspection, a capping strip was applied.

Specifications for the membrane lining required a 150-mm (6-in) overlap along every seam (fig. 15), made in the field, with at least 112 mm (4 in) of the overlap bonded from the exposed edge inward. Before bonding, all edge sections were cleaned to remove dirt, dust, moisture, and other foreign materials. All cut edges were sealed with a CPE bodied solvent adhesive.

After each seam was bonded, it was tested with a 350-kPa (50-lb/in²) air gun in a procedure similar to that used in the inspection process at the manufacturing plant. No field seams were permitted to be made when the ambient air temperature dropped below 2 °C (35 °F). When the temperature was between 2 °C and 10 °C (35 °F and 50 °F), the panels were heated with a hot air gun prior to bonding.
