WATER OPERATION AND MAINTENANCE

BULLETIN NO. 119

MARCH 1982

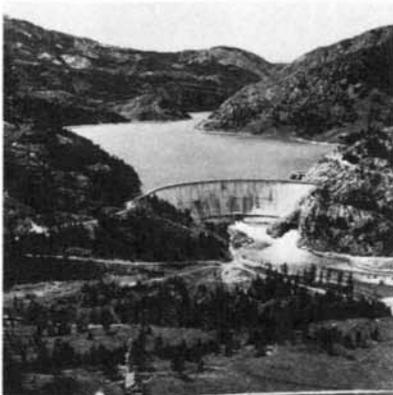
Cover photograph

Gibson Dam, Sun River Project, looking west (upstream). Gibson Dam is a concrete arch structure located in northwest Montana, approximately 112 km (70 mi) west of Great Falls. It is the principal water storage facility for the Sun River Project.

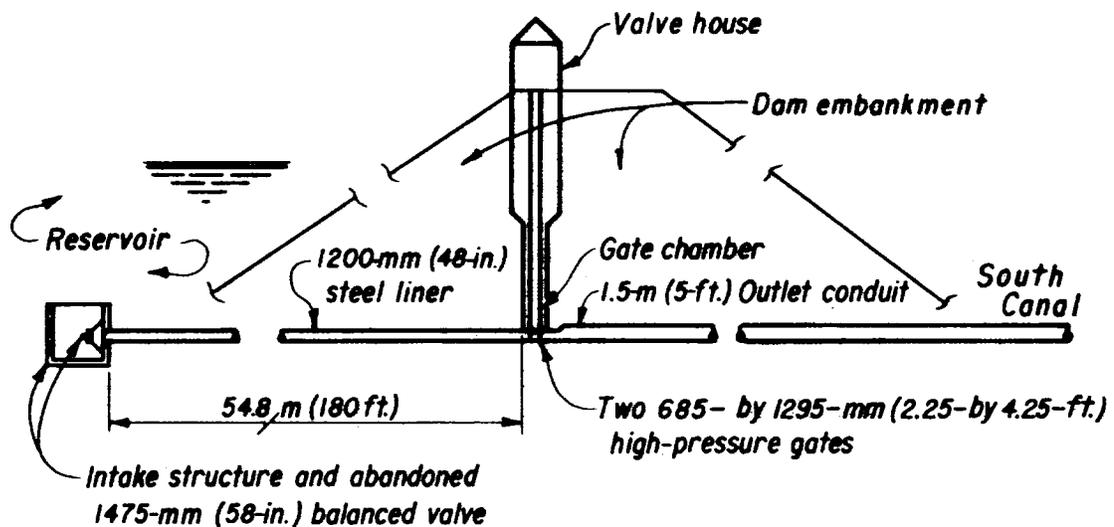
Figure 1.—South Canal outlet works.

Belle Fourche Dam and Reservoir are located in western South Dakota, approximately 24 km (15 mi) northeast of the city of Belle Fourche. The dam was completed in 1911, creating a reservoir with an active capacity of $228 \times 10^6 \text{ m}^3$ (185 000 acre-ft) of water for delivery to about 23 070 ha (57 000 acres). The dam contains two canal outlet works which are similar in design for controlling irrigation releases from the reservoir (fig. 1).

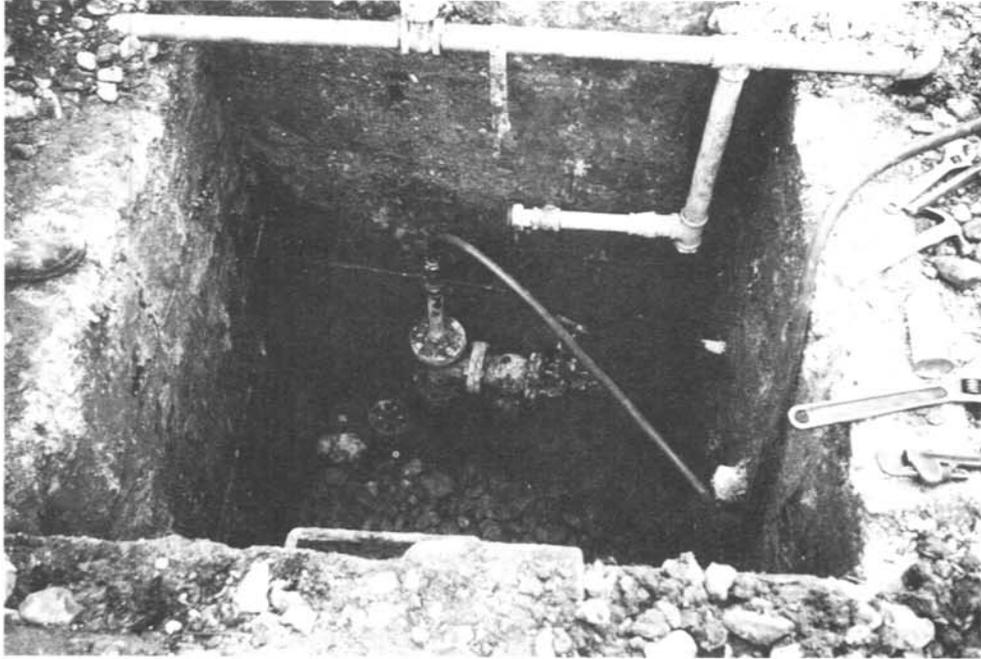
Figure 2.—Air compressor hose connected to balanced valve piping.

Another method attempted in trying to open the balanced valve involved filling the 1200-mm (48-in) outlet pipe upstream of the regulating gate and applying air pressure. A portable pump was set on the upstream face of the dam to supply water through a vent pipe to the upstream outlet pipe. The regulating gate in the gate chamber was closed. This procedure failed because the rate of leakage of the regulating gate exceeded the pump supply. While this attempt was being made, other personnel were trying to locate the intake structure by boat with the aid of a transit on the crest of the dam. The intake was located, but the wind was blowing so strongly that it was not possible to keep the boat over the structure. The plans were to run a pipe down to the structure and apply air pressure to disturb the silt, hoping this would break loose the blockage.

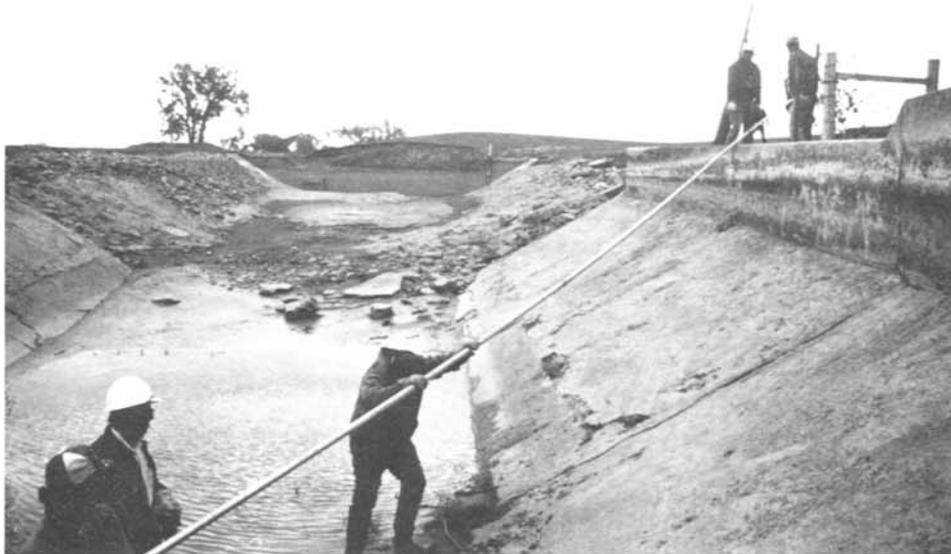
Figure 3.—32-mm (1-1/4-in) diameter standard pipe being coupled and fed into the 1200-mm (48-in) diameter outlet pipe.

Bureau personnel decided that another attempt would be made to investigate the upstream 1200-mm (48-in) pipe from inside. A Bureau employee walked to approximately 15 m (50 ft) of the intake structure where the pipe was found almost full of silt. It was then decided to try cutting through the silt using high-pressure water from the downstream portal. Ten 6.4-m (21-ft) long sections of 32-mm (1-1/4-in) pipe were placed in the canal outlet works from the outlet portal to the accumulation of silt upstream of the gate chamber (fig. 3). A fire nozzle was connected to the first section of pipe at the silted end. The regulating gate in the gate chamber was closed onto two 100 by 150 mm (4 by 6's) which were placed on the gate

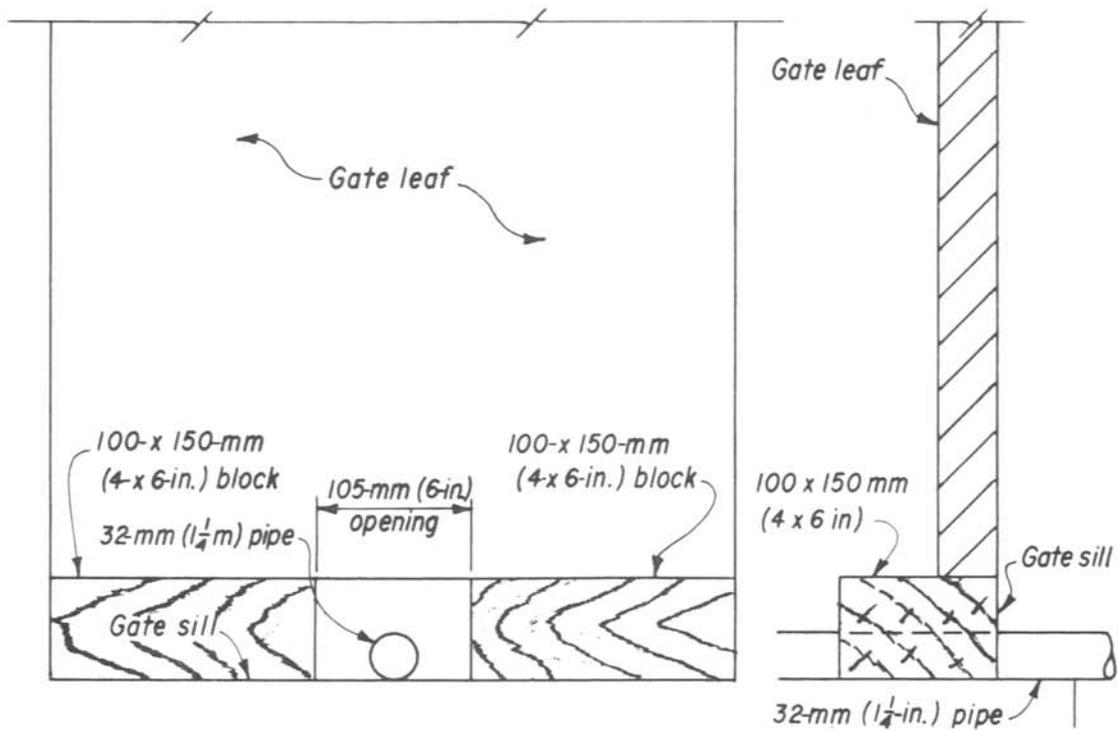
Figure 4.—High-pressure regulating gate closed on 100- by 150-mm (4- by 6-in) timbers.

sill leaving a 150-mm (6-in) opening near the middle of the outlet for the 32-mm (1-1/4-in) pipe (fig. 4). This arrangement would protect workers from the on-rush of water after the silt had been pierced. A fire truck had been secured from the city of Newell to supply the water pressure. As pressure was applied to the line from the fire truck, District and Bureau personnel proceeded to advance the pipe through the silt load near the intake structure until the nozzle assembly apparently hit the balanced valve. The pipe was rotated to get more movement in the silt, and after about 3 minutes, flow began to exit from the outlet. After the personnel left the outlet channel, the regulating gate was opened and a flow of about 2.8 m³/s (100 ft³/s) of heavily laden silted water occurred (fig. 5). After a short period of operation, the water cleared up and the irrigation season was underway.

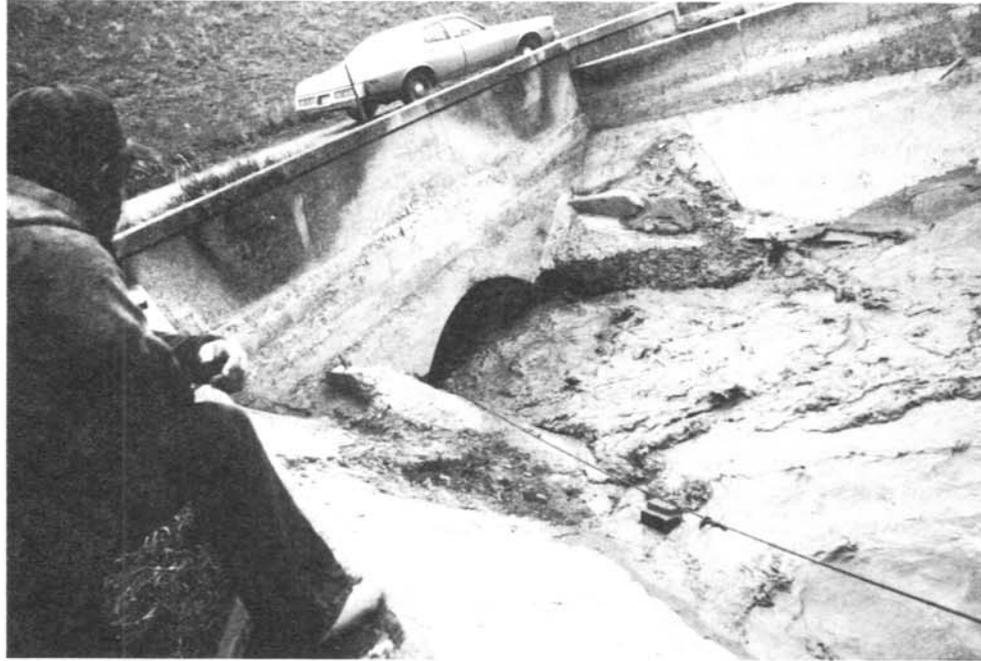
Figure 5.—Water flowing through outlet works after the regulating gate had been opened. The block of wood floating near the right side of the stilling basin was one of the blocks on which the gate was closed.

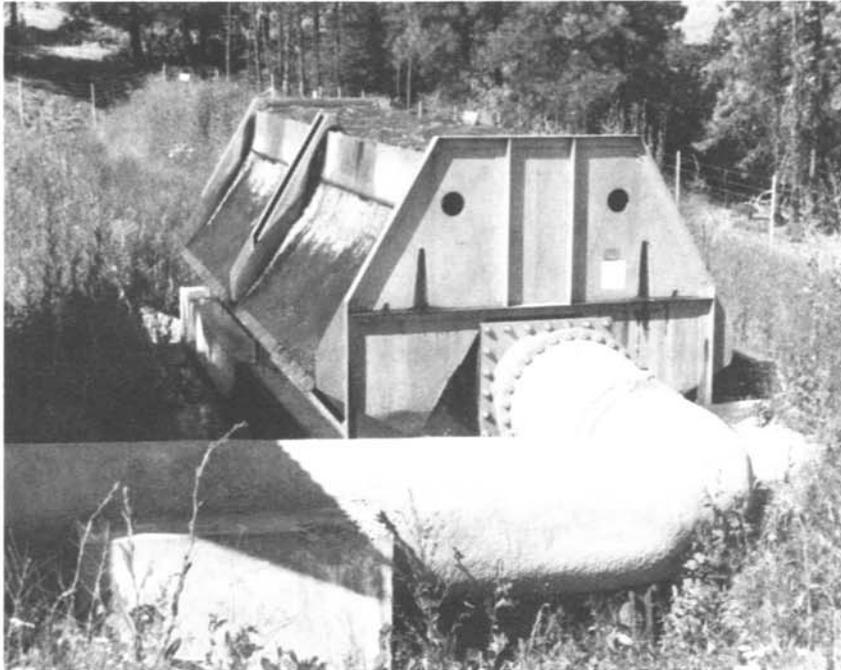
Figure 6.—Self-cleaning device.

The Wenatchee Heights Reclamation District in Washington has been using a self-cleaning device that is designed to allow water to enter into an elevated open top tank (fig. 6). The water flows over the sides of the tank onto a sloped, perforated screen (fig. 7). The slots in the screen can be made any size depending on the discharge requirement and the size of debris to be removed. When the water flows down the screen, it drops through the perforations into a sump which is connected to a pipeline or an open channel (figs. 8 and 9). As the water flows across the screen, the debris is separated and slides down the screen into a collection trough.

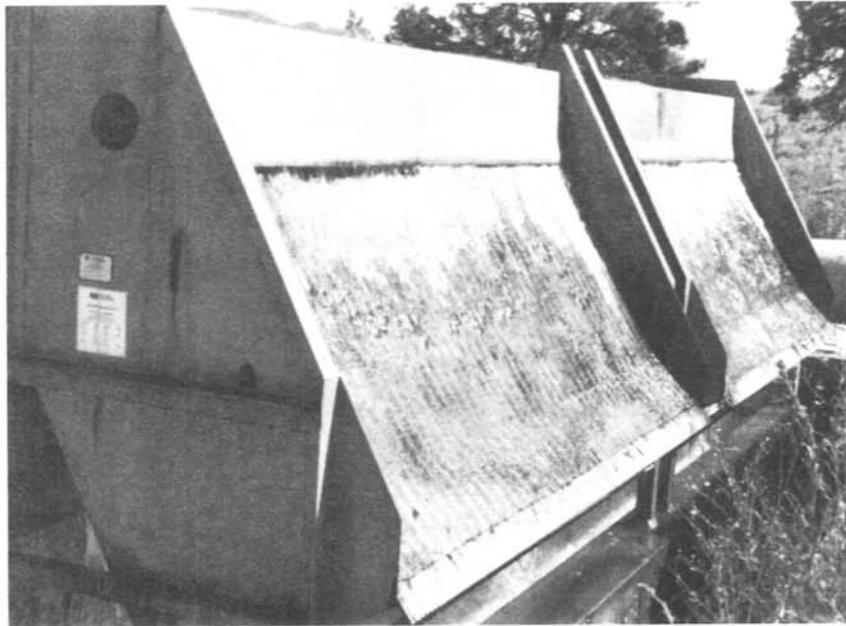
Figure 7.—Water flowing over side onto a sloped perforated screen.

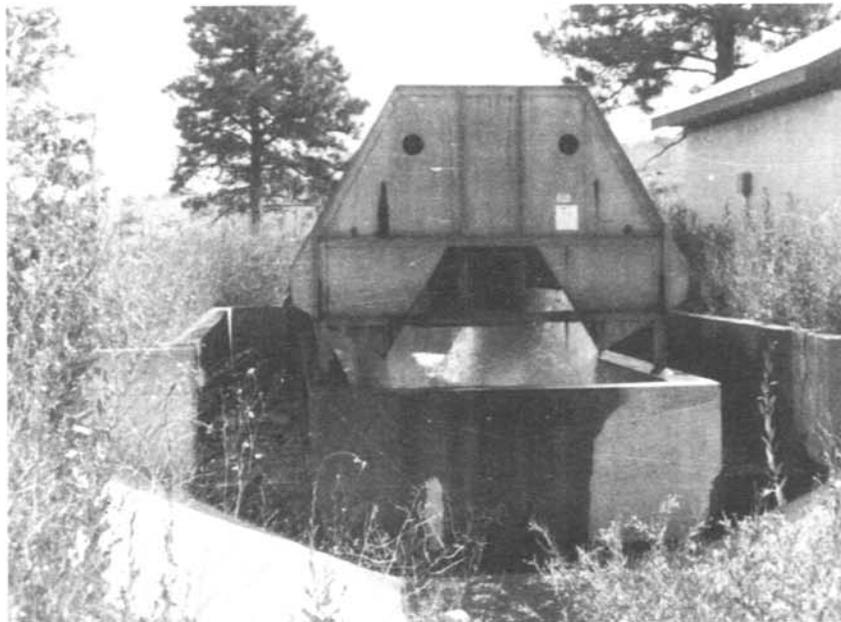
Figure 8.—Water drops through perforations into sump.

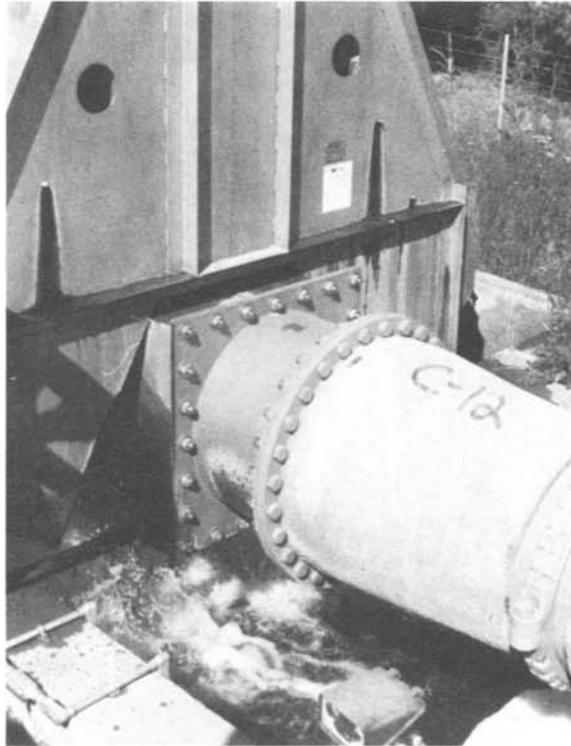
Figure 9.—Sump connected to pipeline or an open channel.

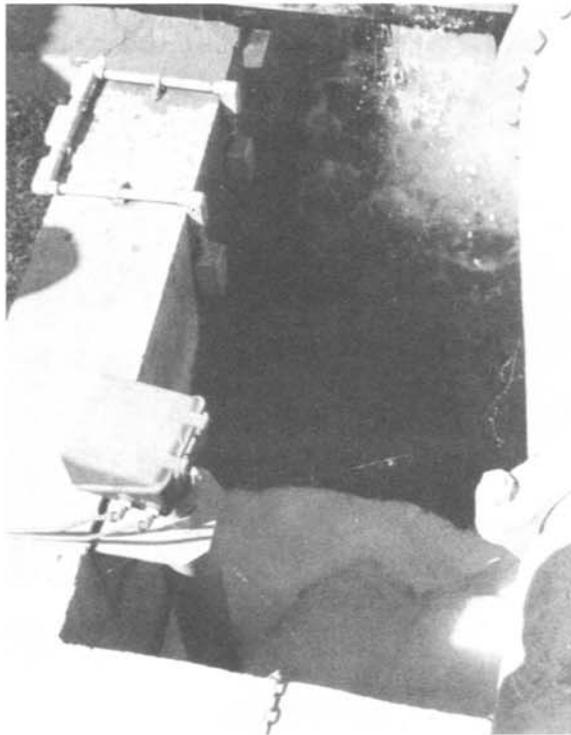
Figure 10.—Probes monitor the water elevation in the discharge sump.

The Wenatchee Heights screening system is equipped with a set of probes which monitors the water elevation in the discharge sump (fig. 10). If the water elevation changes, an air operated gate regulates the flows into the self-cleaning screen module. A set of probes is also located in the debris trough. If the screen plugs and water flows into the trough, a signal is transmitted to the operating office so corrective action can be taken.

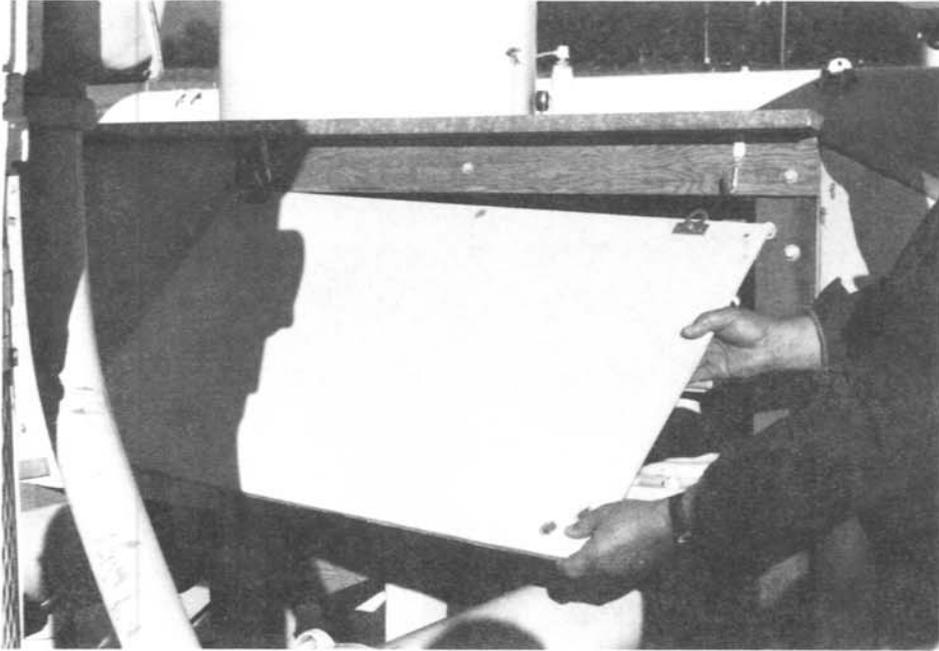
Figure 12.—Structure is made of plywood.

The Solano Irrigation District in California devised a simple shelter around the surge control valves at a pumping plant to prevent damage to them from inclement weather and freezing temperatures. The shelter is made of plywood and painted to preserve the wood. The whole structure is bolted together. Should the temperature drop below 5 °C (40 °F), a thermostatically controlled 100-W spotlight illuminates to provide heat to keep the valves warm. The shelter has proved successful because it is easy to assemble, as well as to take apart when service to the valves is required (see figs. 11 through 14).

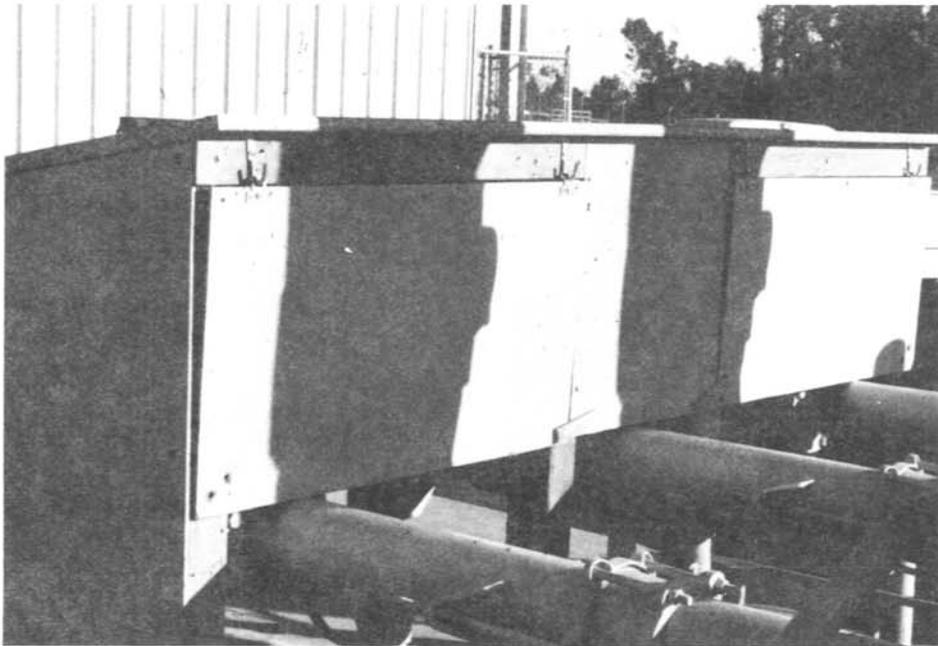
Figure 13.—Structure is bolted together.

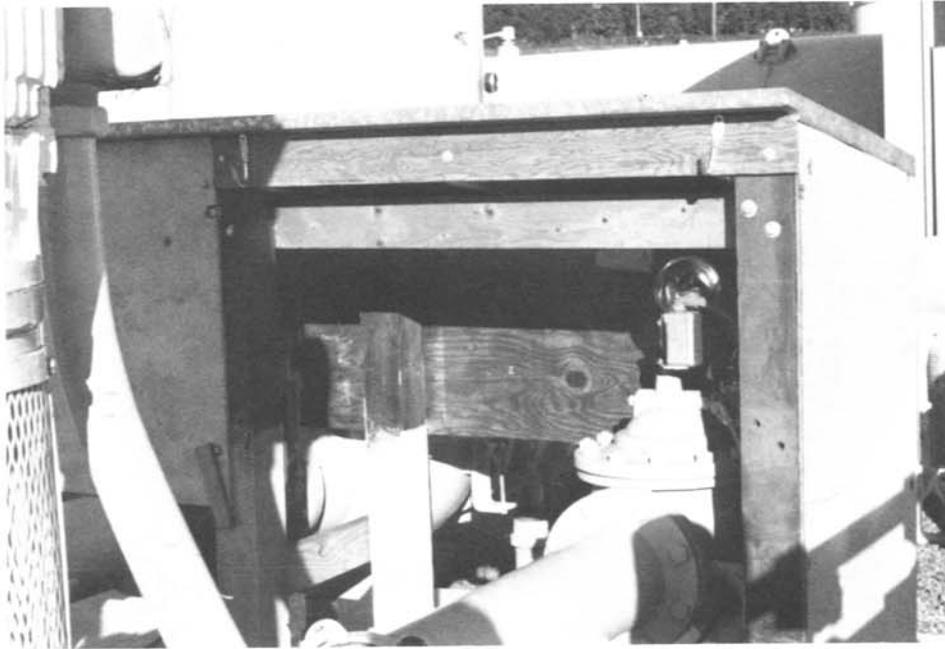
Figure 14.—Thermostatically controlled 100-W spotlight provides heat to keep valves warm.

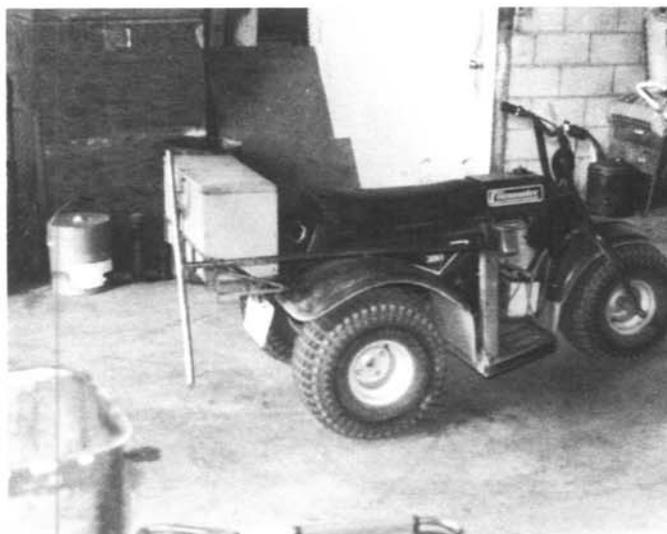
Figure 16.—Three-wheeled
motorcycle.

During the Bureau's regular examination of minor structures and facilities of the Brewster Flat Unit, Washington, the team was very impressed with the Brewster Flat Irrigation District's two residences and a combination office-shop building. These are excellently maintained, and the grounds are well landscaped and kept in good condition (fig. 15). They also purchased a 3-wheeled motorcycle, which is not only economical to operate, but also allows easier access through orchards to reach meters and turnouts (fig. 16).
