# **WATER OPERATION AND MAINTENANCE**

BULLETIN NO. 177

MARCH 1984

## SHUT-OFF VALVE REMOVAL – UNDER PRESSURE<sup>1</sup>

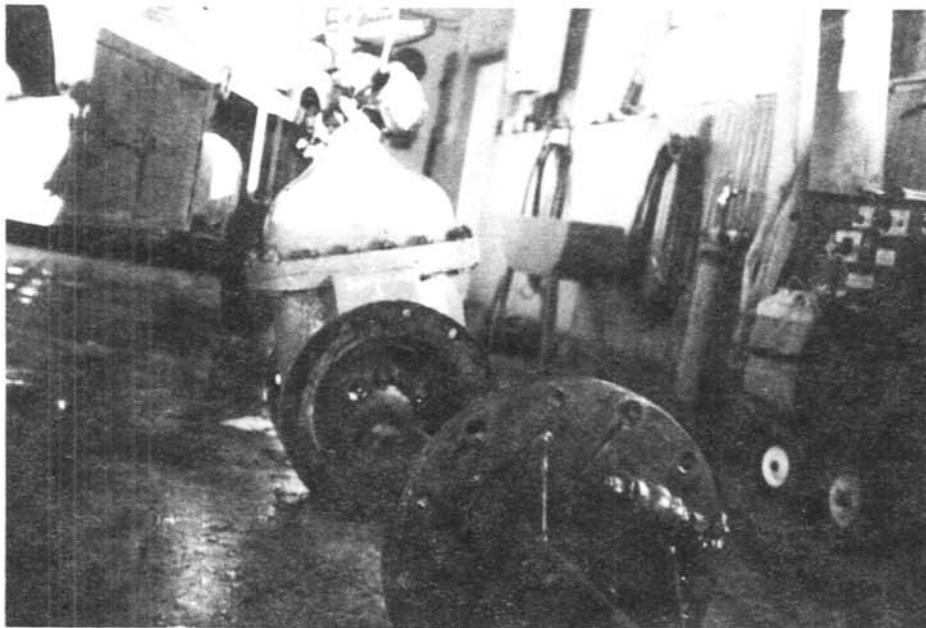
Figure 5.—The plug shown partially inserted in valve with position control device in foreground.

When placed in service, the tool flange was bolted to the damaged valve flange, thus effectively sealing the valve, allowing it to be fully opened. Balance pressure was admitted to the downstream side of the plug through the 1-in (25-mm) NPT connection, thus retaining the plug seal in the retracted position. The plug was then advanced the full travel length through the gate valve and into the upstream piping. Pretapped bosses were positioned and welded to the upstream piping 120° apart and as close to the flange as possible. After the plug was positioned in the upstream line beyond the retaining pin location, the balance valve was closed and the pressure relief valve (drain) opened, thus providing a pressure differential across the plug. This differential was necessary to expand the seal and allow the retaining pin holes to be completely drilled through the piping. The retaining pins were then screwed into position. Thrust loading was transferred to the retaining pins by retracting the plug into the pins.

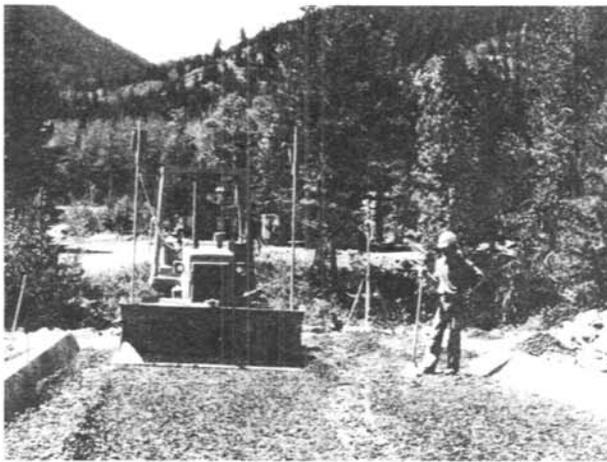
Figure 6.—The dry RCC is spread in horizontal layers with a dozer. The blade is controlled for grade by laser receivers. Notice the upstream and downstream facing elements which serve as the forms to contain the RCC.

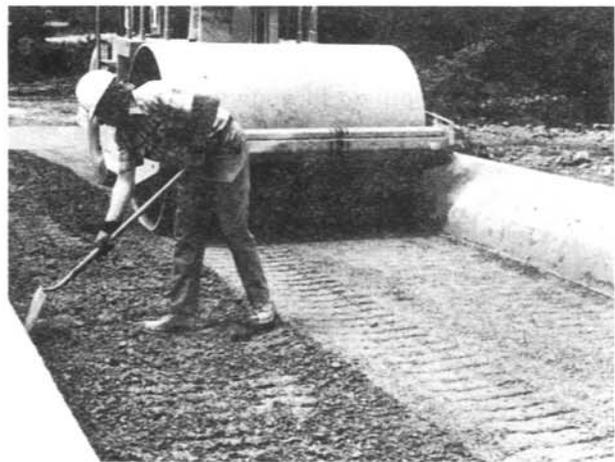
Figure 7.—After being spread into horizontal layers, the RCC is compacted by a smooth drum, vibrating roller. The roller can compact the RCC directly against the facing elements.

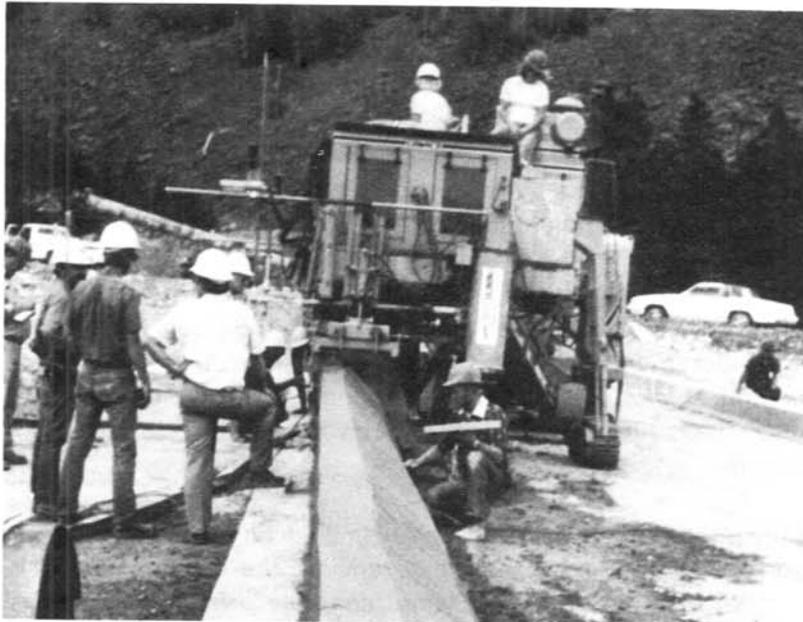
Figure 8.—The upstream facing element or "curb" is continuously slip-formed in a horizontal direction by a laser controlled paving machine traveling 1.6 ft/min (0.5 m/min). The paver is capable of slip-forming the vertical face without slumping.

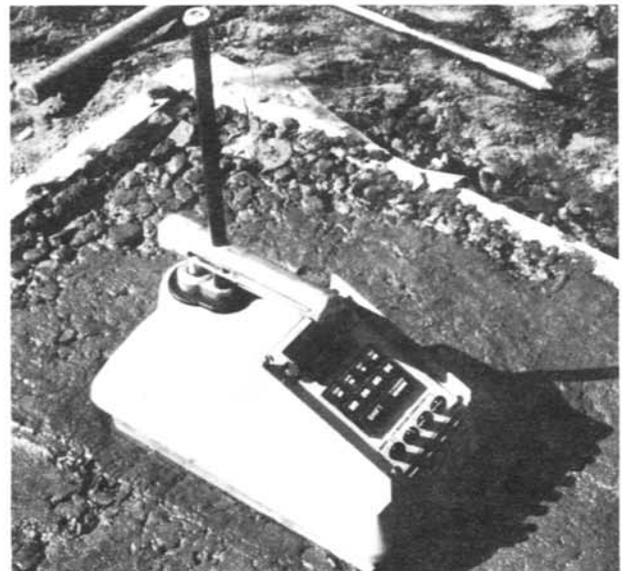
Figure 10.—To maintain quality control during construction, a nuclear density gage will be used to evaluate the compaction of RCC. The gage is capable of detecting voids below the RCC surface which would result from incomplete compaction.

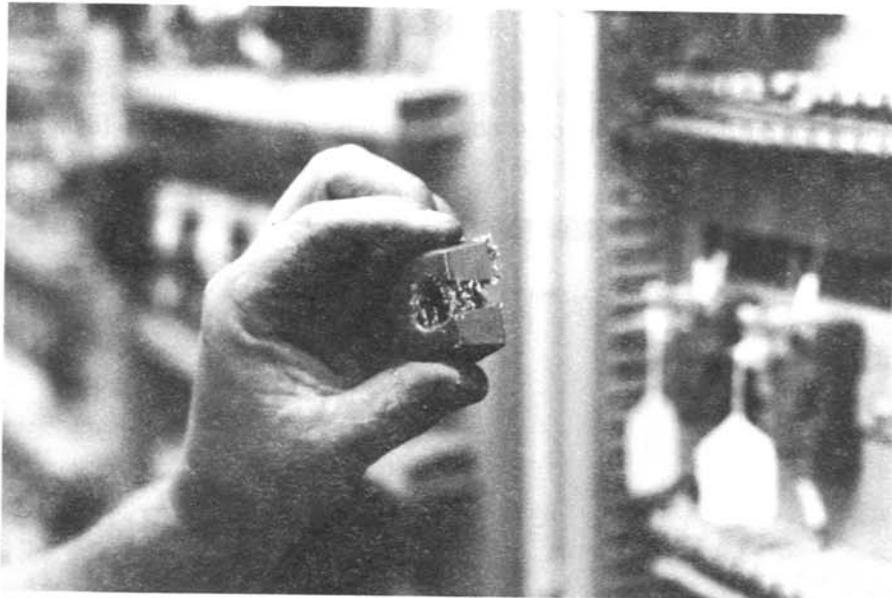
Figure 13.—Filings attached to magnet.

When drilling into metal plates or walls, have you wondered where the filings were falling? Machinery and equipment have been damaged in some cases because of metal filings falling into their systems. Using a magnet simplifies catching the filings (see figs. 11, 12, and 13).
