# **WATER OPERATION AND MAINTENANCE**

**BULLETIN NO. 135**

MARCH 1986

IRRIGATION EFFICIENCY IMPROVED IN WELLTON-MOHAWK DISTRICT  
RIVERTON PROJECT REHABILITATION AND BETTERMENT  
DIGEST STATEMENT—EMBANKMENT UPSTREAM SLOPE FAILURE—SAN LUIS  
DAM

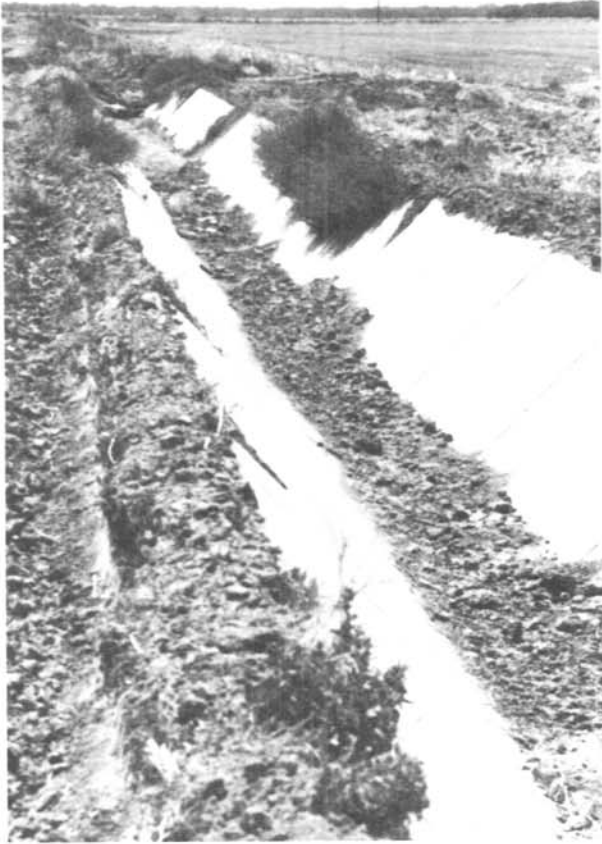
Examples of cracked, weed-filled irrigation ditches and gates.

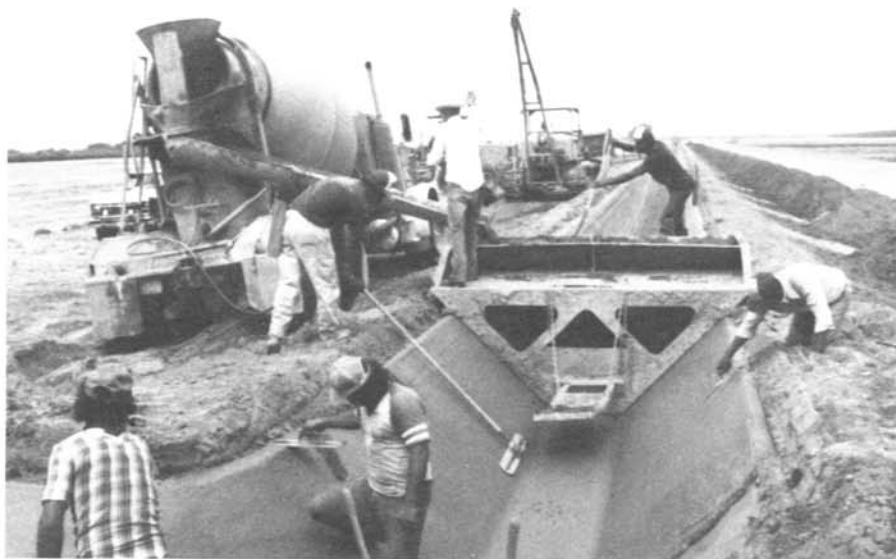
Pouring cement into a float, which forms the new irrigation ditch.

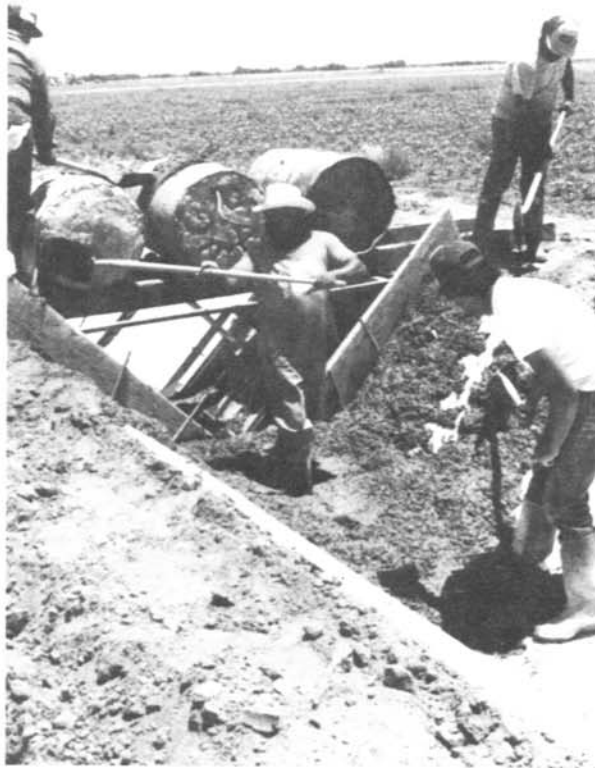
Installing a measuring flume for measuring the amount of water in a ditch.

In addition, a critical depth flume is installed near the farm's district turnout. This flume permits easy measurement of the irrigation flow, considered an important part of the evaluation and management of the irrigation system.

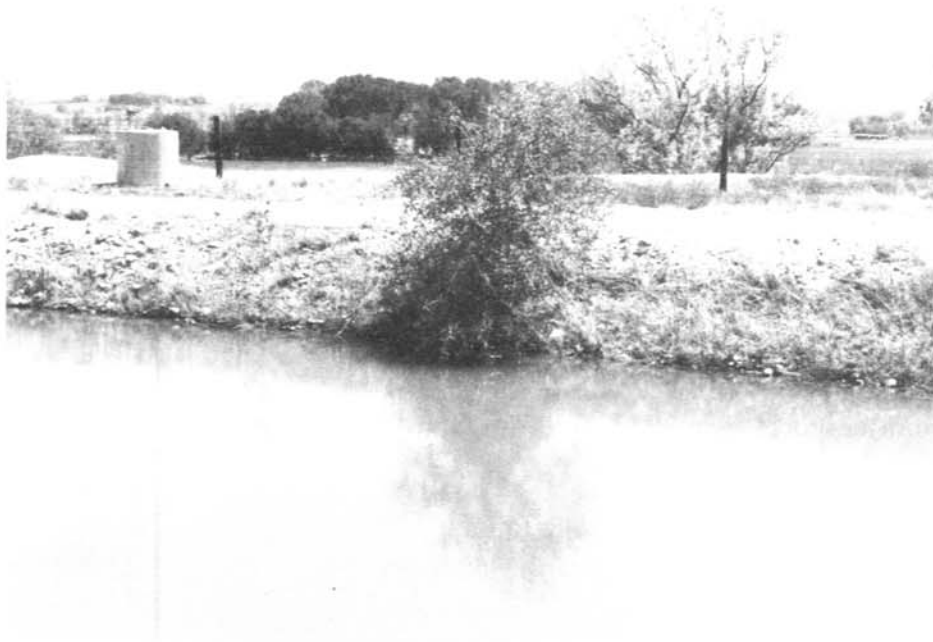
Photograph 1—Willows growing on membrane-lined ditch bank.

Another problem encountered was the propensity for willows to grow on membrane-lined ditchbanks as shown in photographs 1 and 2. This growth could have a damaging effect on the lining. No particular reason for this happening has been determined. Control to date has been by normal methods employed for this problem.

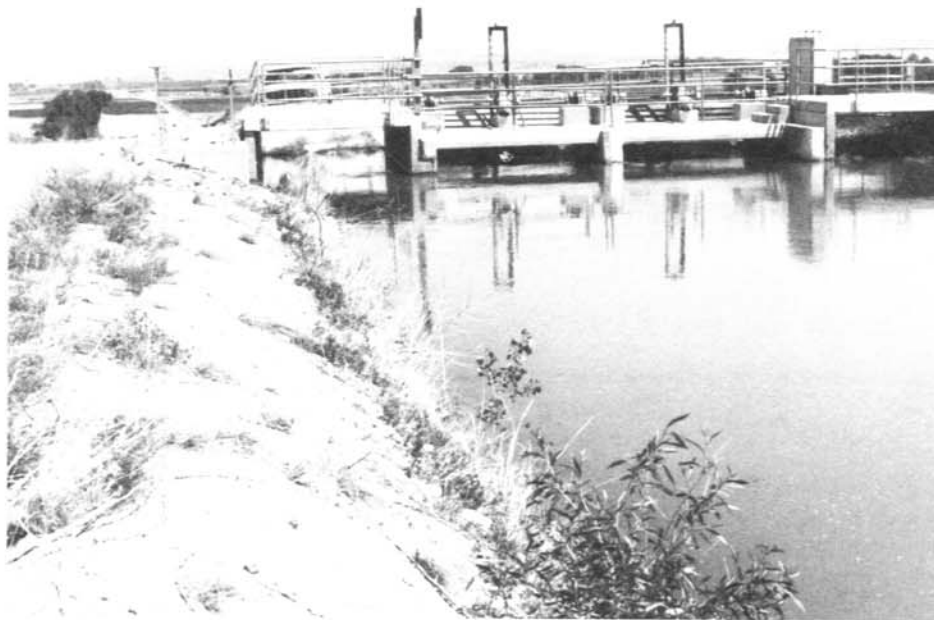
Photograph 2—Willows growing in membrane-lined ditch bank.

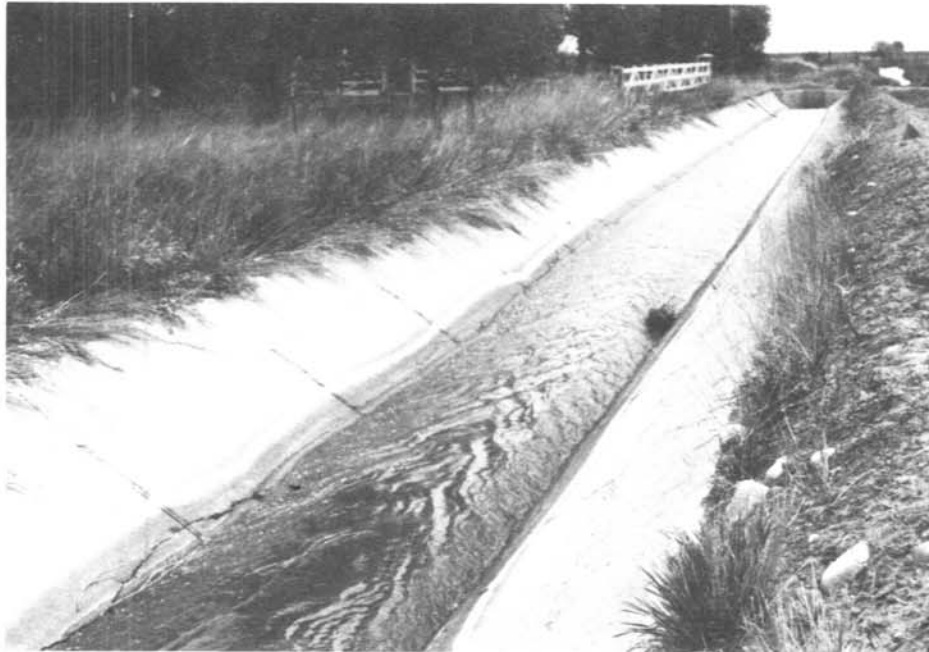
Photograph 3—Damage to concrete lining.

As mentioned earlier, the potential for severe freeze-thaw action is present in the Riverton area. Severe frost heave problems were encountered in a concrete-lined ditch within a short period after construction. A portion of the concrete lining as shown in photographs 3 and 4 was replaced. Photograph 5 shows a part of the lining which was not replaced. Due to freeze-thaw deterioration, problems with settlement and cracking, water table problems, etc., concrete lining should only be placed in ditches where membrane lining is impractical. Concrete lining may be considered if membrane lining is impractical – where the ditch can be elevated, where there is no irrigation on the uphill side, where there are free-draining soils, and no present or potential water table near the surface.

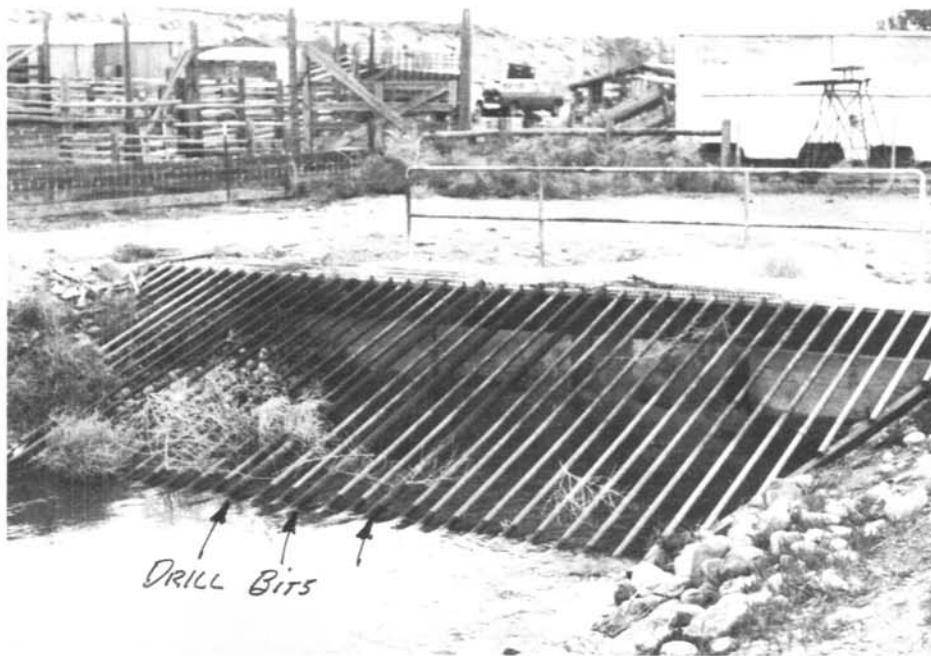
Photograph 6—A well designed and installed trashrack.

1. *Number, spacing, and strength of members.*—The rack should have no more members than necessary to provide the needed collection capability and strength for the anticipated load. The longitudinal members should always be parallel with no cross braces. Photographs 6 and 7 illustrate a well-designed rack. Drill stems were used to provide the needed strength in some of the longer spans (photograph 6).

3. *Self-cleaning capability.*—Although stationary trashracks are not totally self-cleaning, they can be designed to prevent plugging under normal operating conditions. The slope of the rack, conformity to the transition structure, and configuration are the most important aspects relative to self-cleaning (nonplugging). The rack in photographs 6 and 7 meets most requirements for an efficient trashrack.

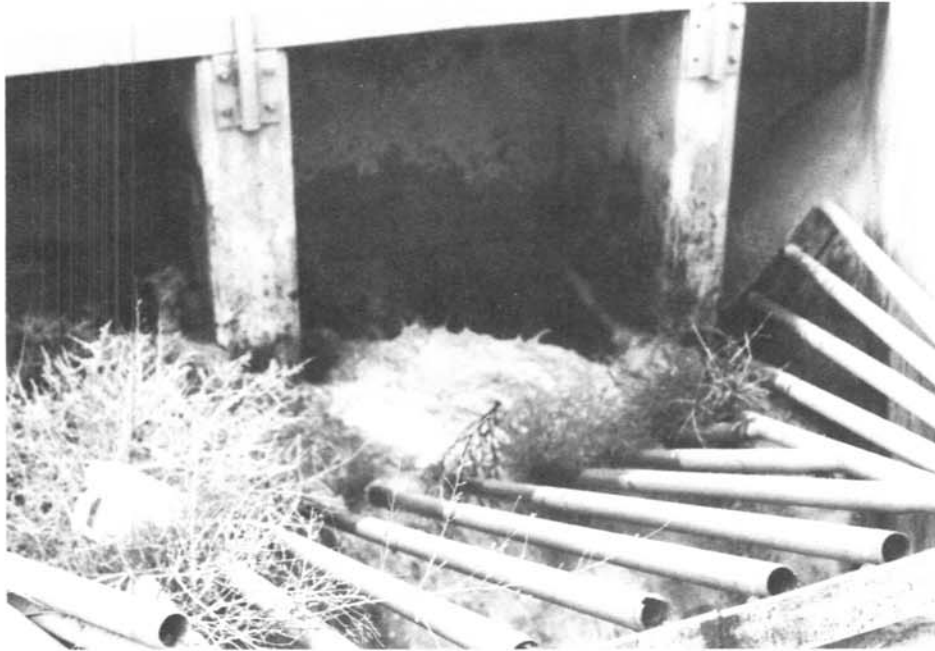
Photograph 8—A trashrack which has undesirable features (poor conformity, nonparallel members, steep, etc.).

6. *Conformity to transition structure and configuration.* The trashrack should conform as near as possible to the transition shape to prevent trash from moving past and/or hanging up on the structure. The configuration of the rack should be such that trash moves upslope easily. The members should be parallel, there should be no intermediate cross members, and the cross member on the bottom should conform smoothly to lateral members. Photograph 8 illustrates a trashrack which has several undesirable characteristics; i.e., poor conformity, nonparallel members, steep, etc. It should be kept in mind, however, that despite some undesirable characteristics, a trashrack must suit specific conditions.

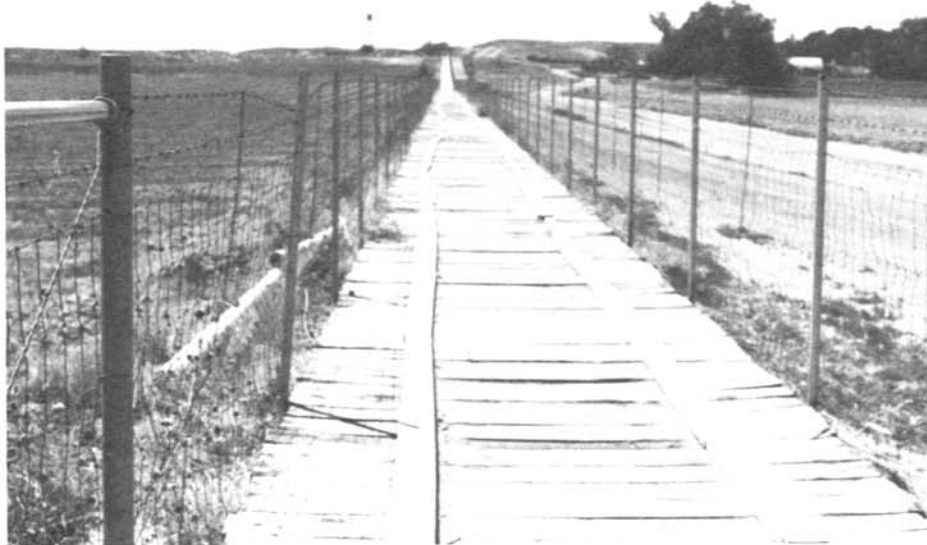
Photograph 9—The Pilot Canal Chute was covered with wooden members to control larvae activity. Uncovered portion is in background.

The Pilot Canal Chute is shown in photograph 9. This is a concrete-lined chute which experienced capacity problems as a result of larvae (caddis fly) activity. The chute was covered as shown in foreground of photograph 9 to minimize or eliminate this activity. Covering the chute to exclude sunlight proved to be an effective method of control after sandblasting the concrete surfaces clean.

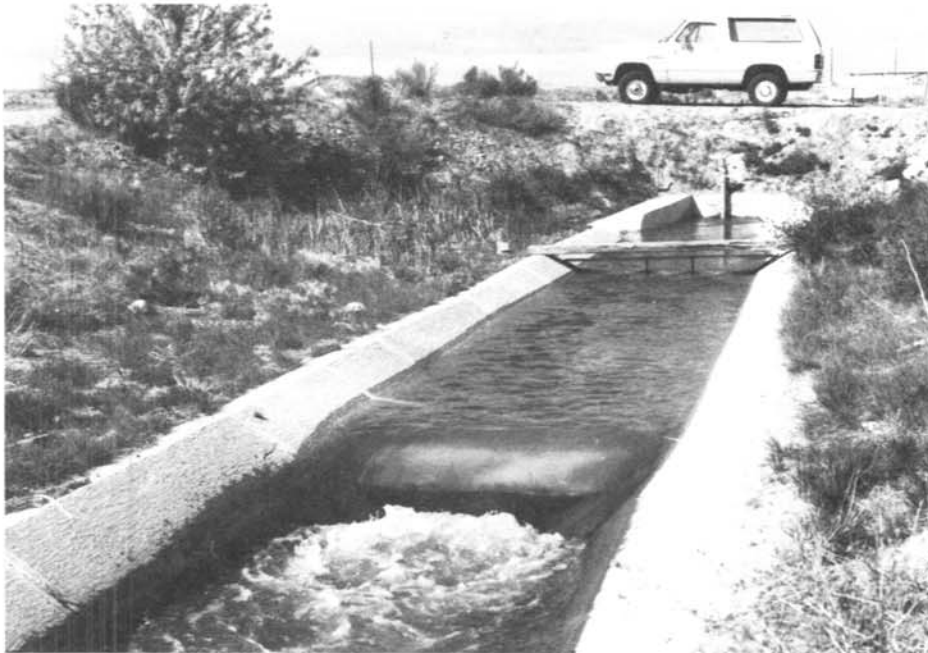
Photograph 10—Ramp flume and propeller meter (background).

Photograph 10 illustrates two methods of water measurement in an open channel. A propeller meter (background) and a ramp flume are being utilized in tandem to demonstrate the operation of the two methods. The propeller meter (photograph 11) is portable and can easily be transferred to other sites for use and can be stored inside when not in use. This is an accurate and economical way to measure water. The ramp flume (photograph 12) is a relatively recent device which is quite accurate, very economical, easy to install and operate, and is easily adaptable to field conditions. Special anchoring of the ramp flume should be accomplished to ensure it does not heave and reduce its accuracy.

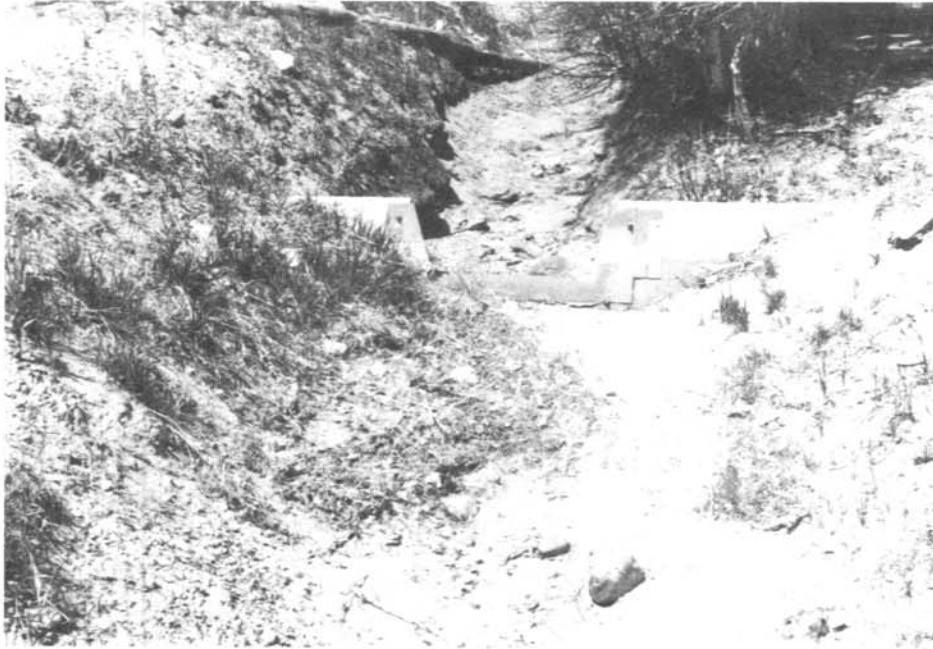
Photograph 13—Weir for making water flow measurements. Note silt accumulation in weir pool.

Photograph 13 shows a weir used to measure water on the project. This particular device has an excessive accumulation of silt in the weir pool area which will result in erroneous readings. These devices require frequent surveillance and maintenance (cleaning) to provide consistently accurate records.

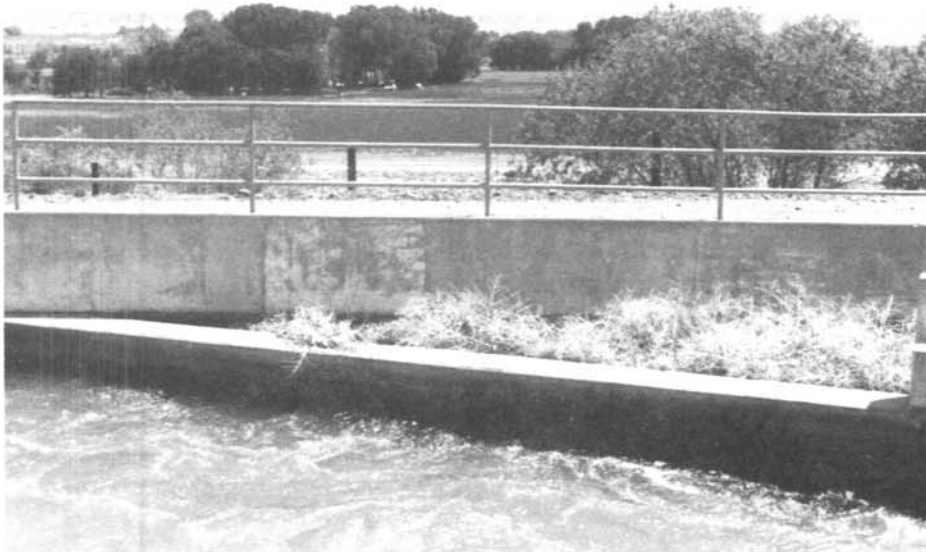
Photograph 18—Overflow spillway.

Provisions should be made at all structures to provide an overflow (spillway) capability to protect against canal washouts in case of high flows. Photographs 18 and 19 illustrate two overflow spillways constructed on the Riverton Project.

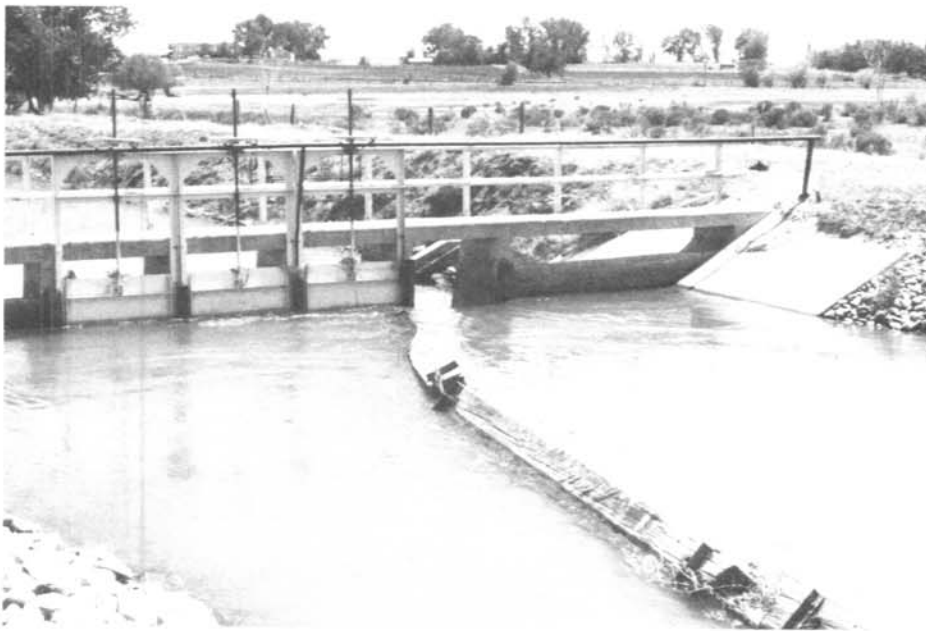
Photograph 19—Overflow spillway on check structure.

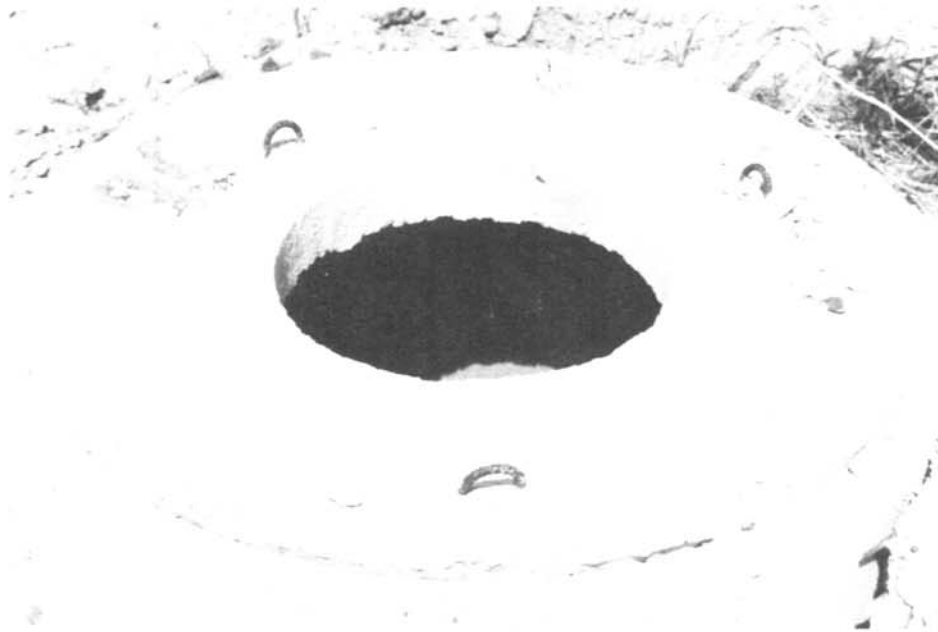
Photograph 21—Manhole cover deteriorating fast. Approximate age is 8 years old.

Photographs 20 and 21 show manhole covers in an advanced state of deterioration. These manholes are about 8 years old. The cause of the rapid deterioration is suspected to be poor quality control in the manufacturing process which has been difficult to correct. The attached drawing (fig. 2) shows a manhole cover fabricated from a 30-inch steel pipe and steelplate as proposed by Columbia Basin Project drainage personnel. This cover replaces the concrete inspection covers previously used and the first of this type is scheduled for installation in the fall of 1985. The weight of this cover is about the same as a concrete cover (40 pounds).

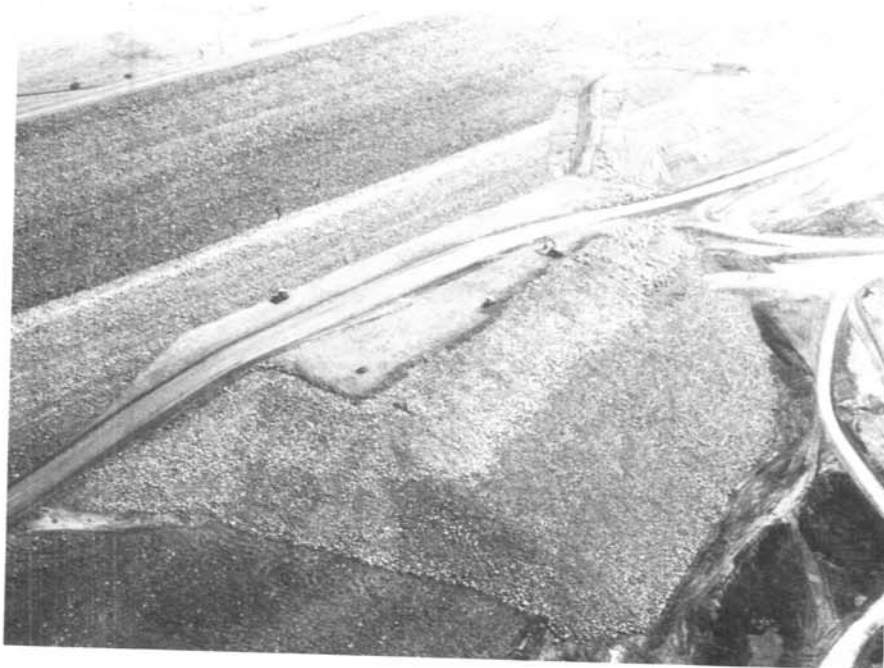
Construction of the stability berm.

2. An exploration and materials testing program was established to provide information on the mechanism for the slide and to provide reliable data for stability analysis.
3. Inclinometers were installed in several drill holes to locate the depth of the slide.
4. Piezometers were installed in other drill holes to monitor pore pressures.
5. An evaluation of other areas for potentially unstable areas was conducted.
6. A battery of soil tests including index testing, vane shear testing, and a review of historic testing data recovery were conducted.
7. A more detailed investigation was performed by a panel of consultants from the Bureau and the California Department of Water Resources. As a result of the above, a 2,100-foot-long stability berm was constructed, and the embankment was reconstructed from the slide elevation up to the crest.
