WATER OPERATION AND MAINTENANCE

BULLETIN NO. 137

SEPTEMBER 1986

Irrigation - Necessity and Imagination Transform an Ancient Task
Leaking Underground Storage Tanks Pose Costly Environmental Hazard
USBR Canal Lining Experience
A Programmed Approach to Chemical Weed Control
Screen Design Increases Flow, Reduces Cost of Irrigation Pumping
Spillway Deterioration—Big Sandy Dam—Digest Statement
Water Systems Operation and Maintenance Cost Index

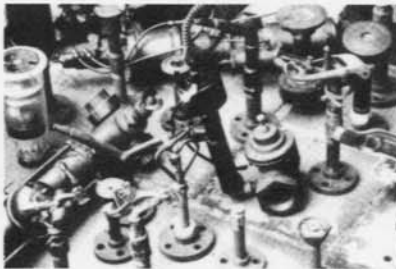
Cover photograph:

Yesterday's revolutionary new irrigation products often appear clumsy and quaint in comparison to current standards, but they cannot be slighted for durability.

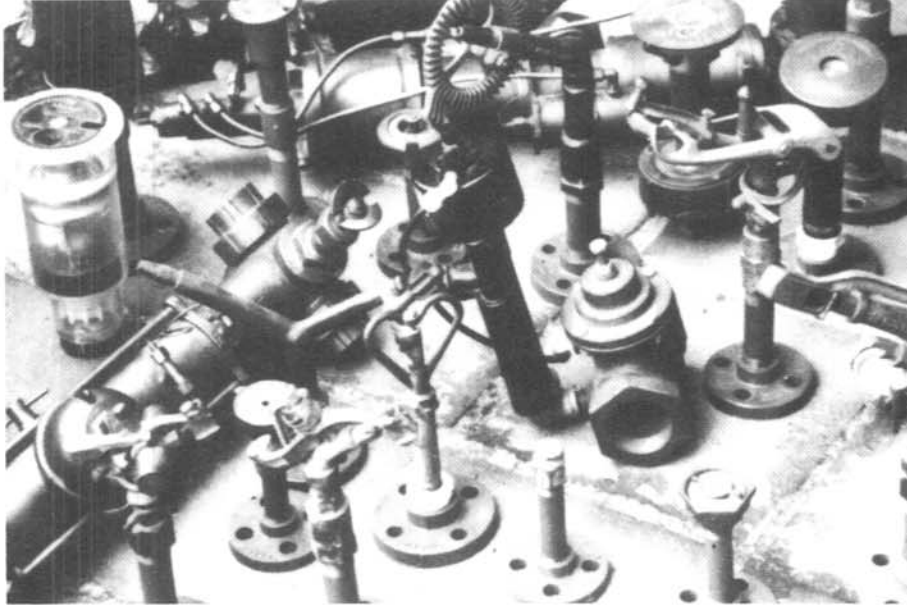
Yesterday's revolutionary new irrigation products often appear clumsy and quaint in comparison to current standards, but they cannot be slighted for durability.

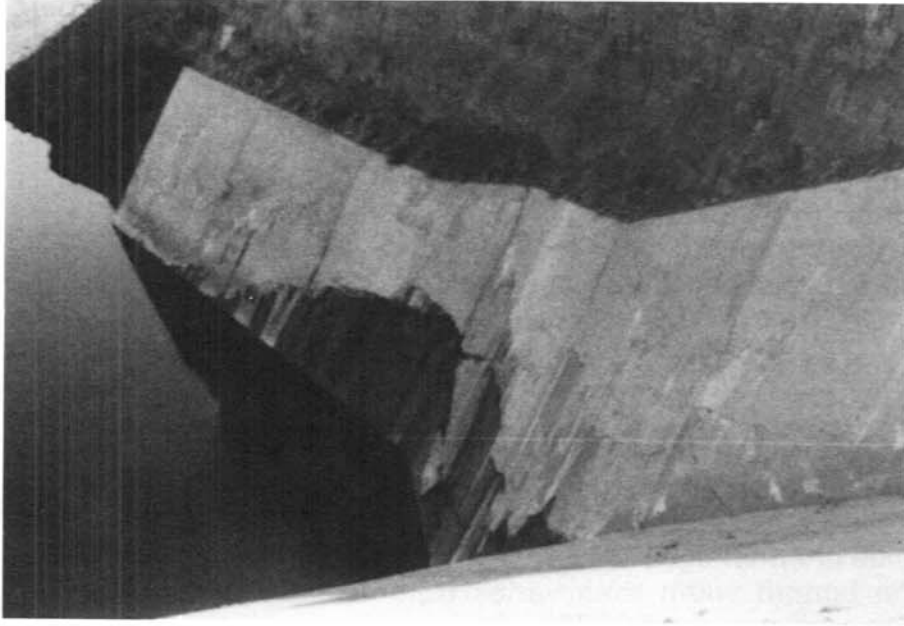
Big Sandy Dam—Cracks in stilling basin right wall. 10/8/80

Evidence: Serious cracking was evident in the lower portions of the right side panels of the inclined chute and stilling basin. Another area of distress was located at the spillway intake along the left side. This consisted of slab movement and associated heavy spalling at the toe of the crest structure along the horizontal contraction joint. Additionally, in 1983, the first full floor slab above the water level in the basin failed and had raised as much as 8 inches near the left wall. A large longitudinal crack occurred along the centerline of the slab between the adjacent contraction joints.

Causes: Environmental elements to which the structure is subjected, excessive seepage and insufficient drainage adjacent and beneath the structure, and underdesigned portions of the structure in distressed areas of frost action (expansion and heaving).

Remedy: Restrict reservoir elevation, construct a temporary cofferdam, and rehabilitate spillway structure. In 1985, construction efforts were completed which included grouting into the right abutment and a portion of the foundation under the spillway chute, replacing damaged concrete side linings and a floor slab, constructing a new chute and stilling basin, and installing new drains under various portions of the structure.

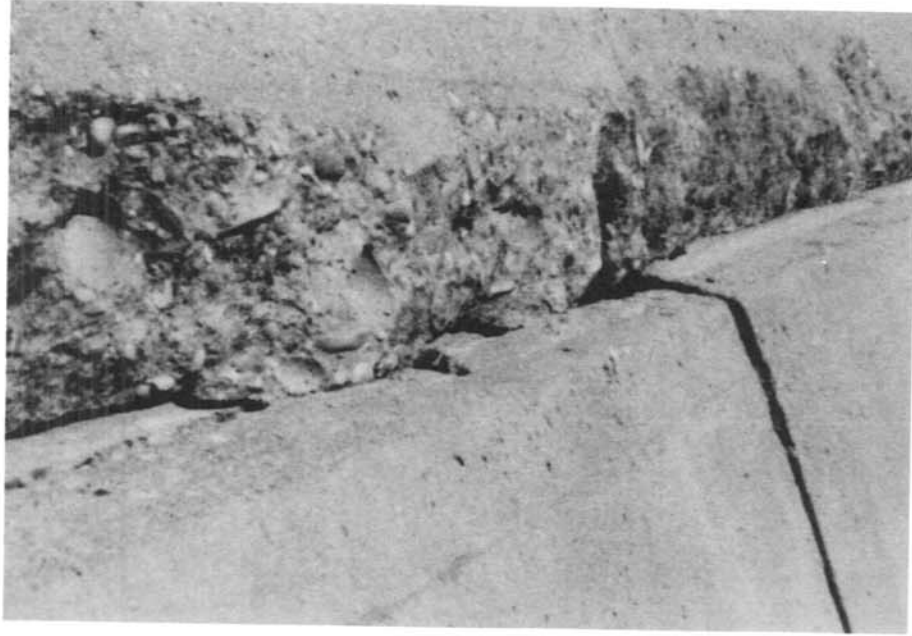
Big Sandy Dam—Spalled concrete and differential movement of spillway wall. 10/8/80
