SEALING CONTRACTION JOINTS AND RANDOM CRACKS IN CONCRETE-LINED CANALS

by Jay Swihart⁶

STUDIES OF ANTIFOULING PAINTS ON BUREAU SYSTEMS

By Victor S. Miyahara⁷

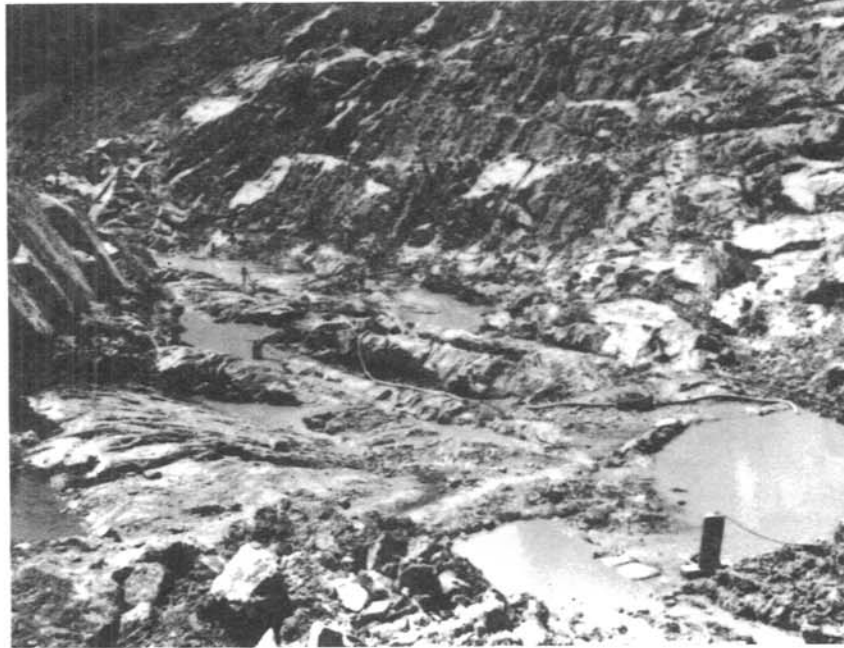
Figure 4. - A-joints on the left abutment that were nearly normal to the dam axis.

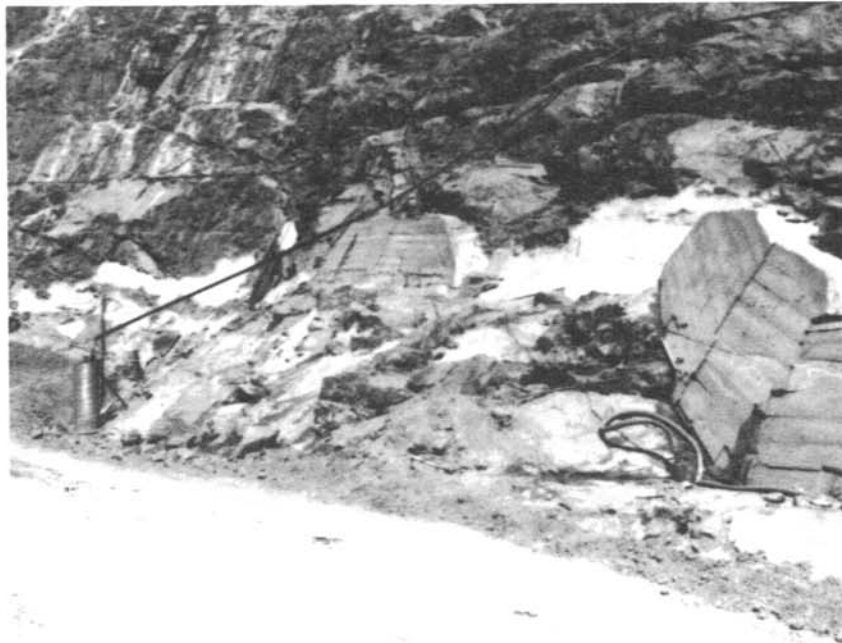
Figure 5. - Overhangs were backfilled by installing bulkheads and filling with conventional concrete.

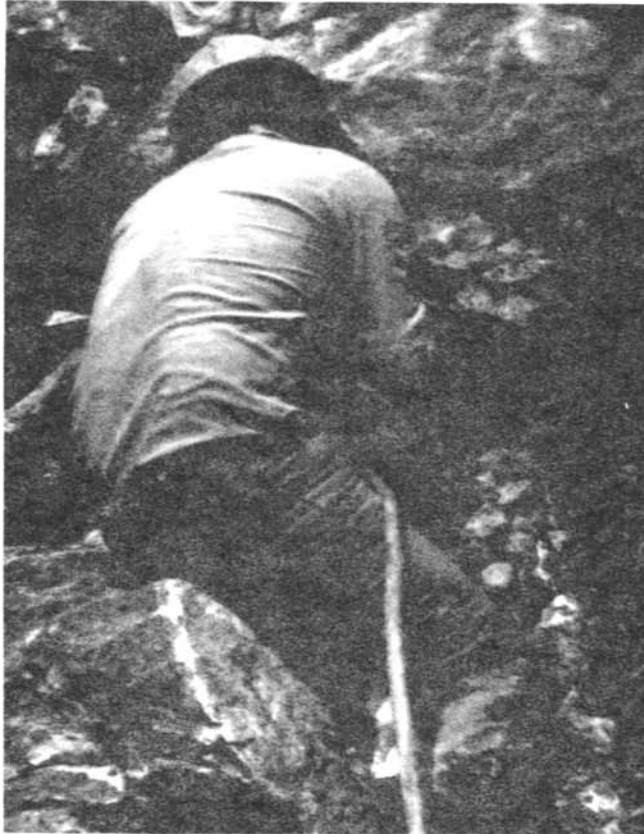
Figure 6. – Shear zones were removed with a hand-held air spade.

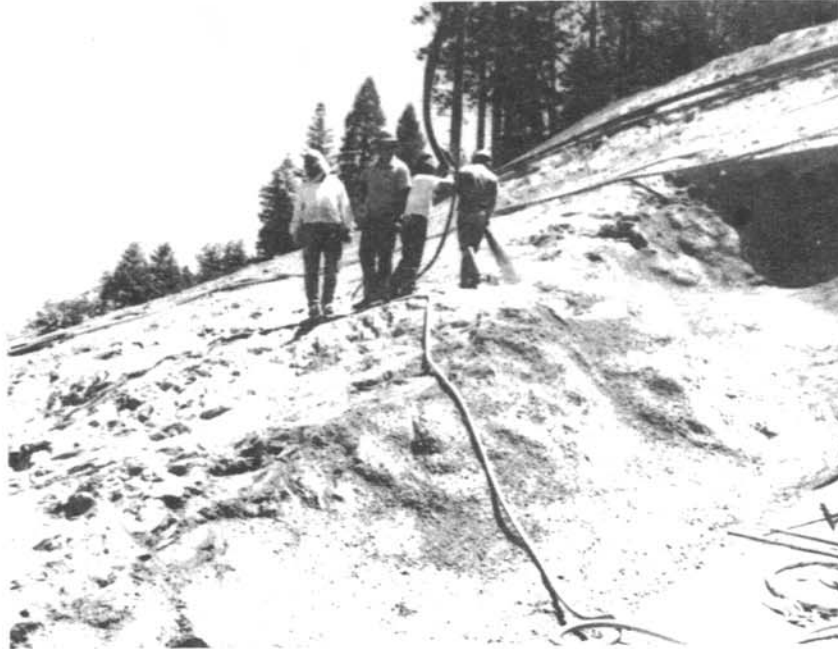
Figure 8. - Pneumatically applied concrete being placed on foundation material as protection against weathering.

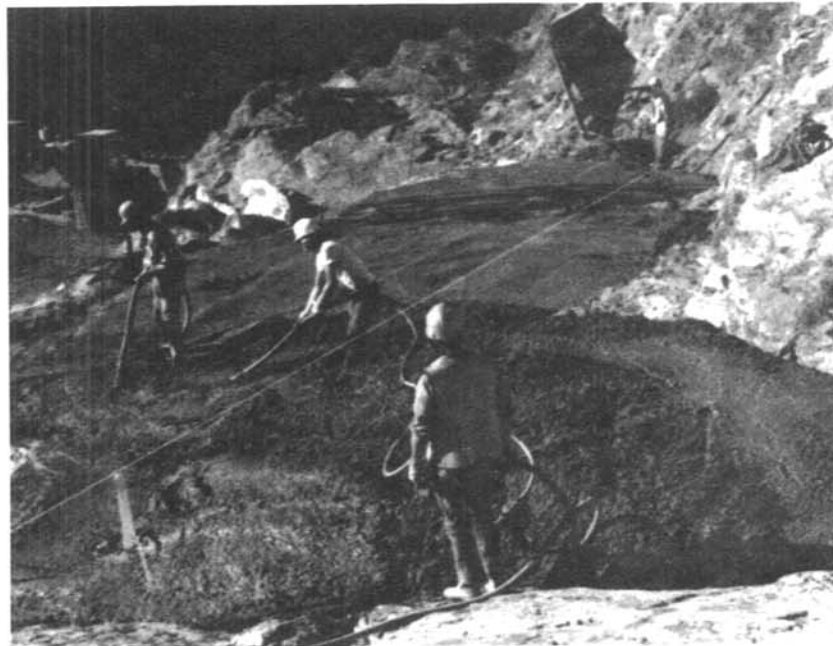
Figure 9. - Placing low slump dental concrete on a large bench along the right abutment. A crane and bucket were used for transporting and placing the concrete.

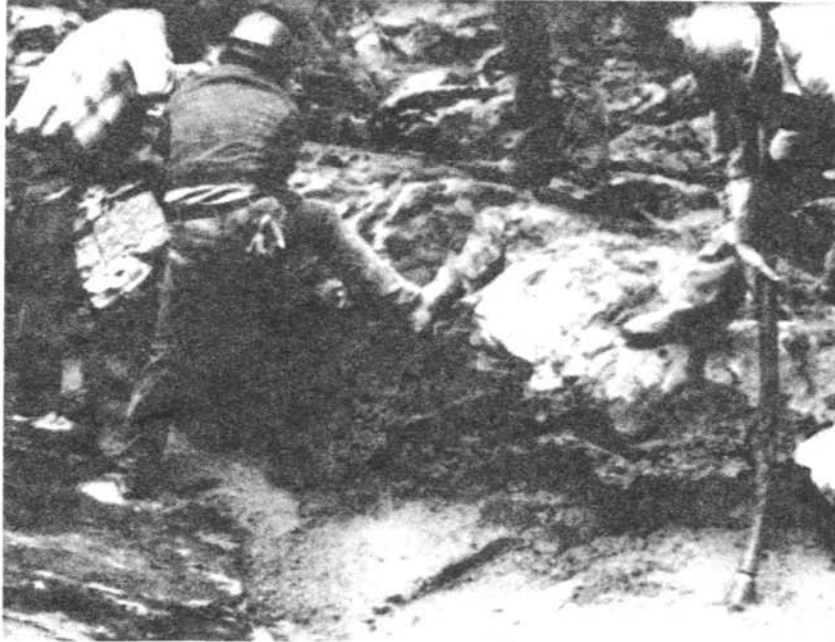
Figure 10. - Large holes in the river bottom were filled with dental concrete. Concrete was dumped from transit mixers and consolidated with a 3-inch vibrator.

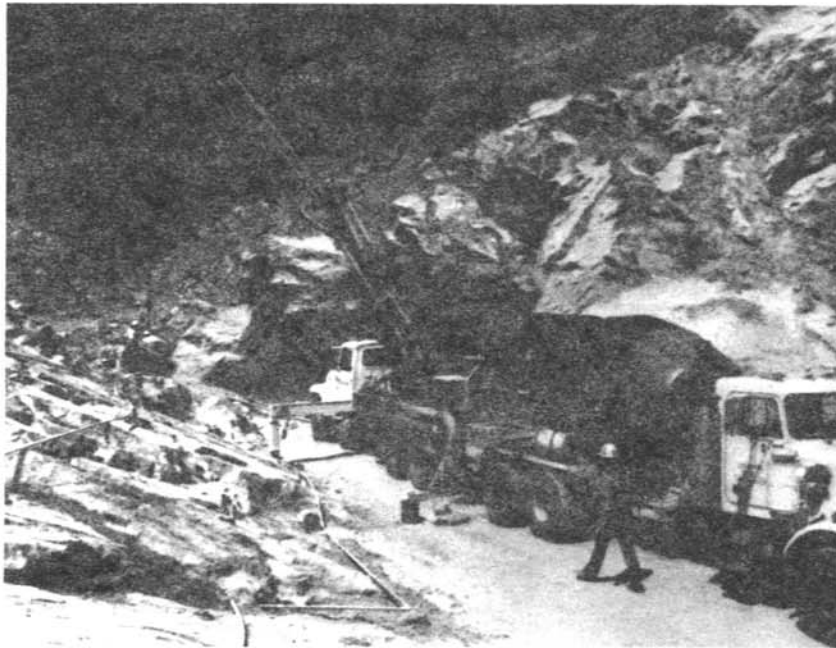
Figure 11. - Transit-mix truck delivering high slump concrete to the Thomsen 875 concrete pump. The truck boom and concrete delivery line are fully articulated and capable of rotating 360°.

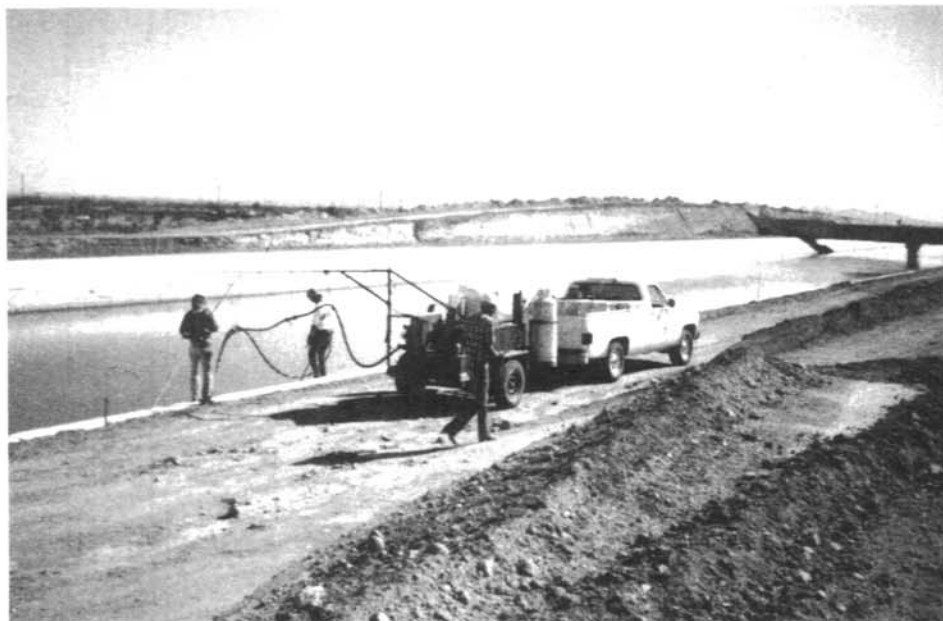
Figure 7. – Contractor seals contraction joints with hot-applied sealant on California Aqueduct.

The application equipment needed for this material (figs. 7 and 8) is similar to that for hot-applied asphalt. The Willows, California, office has such equipment and has been using hot-applied asphalt for many years. They are now switching to hot-applied coal-tar because of its superior performance at an only slightly higher price.

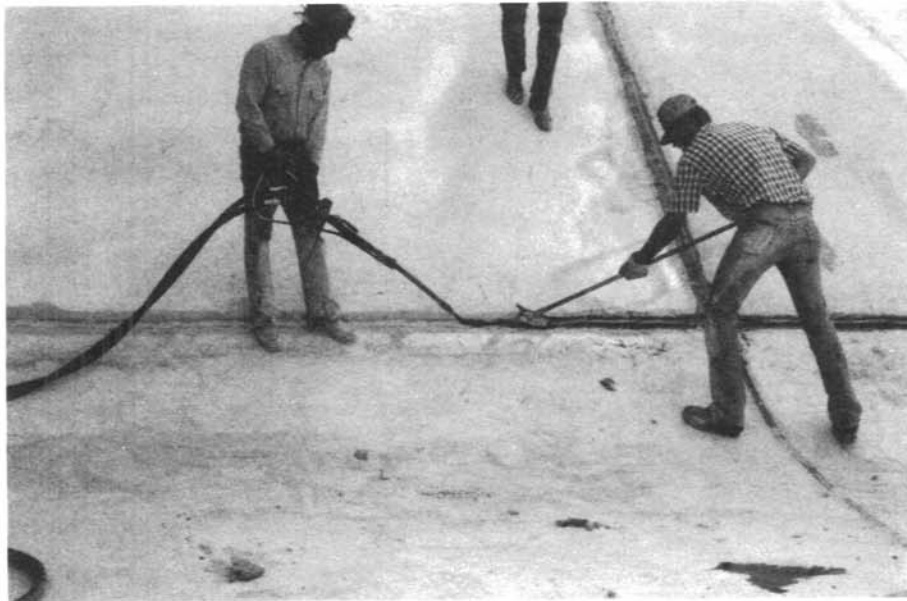
Figure 9. – Rapid-set, two-component sealant is used to seal both longitudinal and transverse contraction joints.

The drawback with this material is that it requires some rather special (expensive) application equipment (figs. 9 and 10) and an experienced crew to assure proper proportioning, mixing, and application. The CAP has purchased such equipment, and the cost for just the pair of positive displacement pumps was approximately \$10,000. This need for special equipment precludes the use of this product on small jobs.

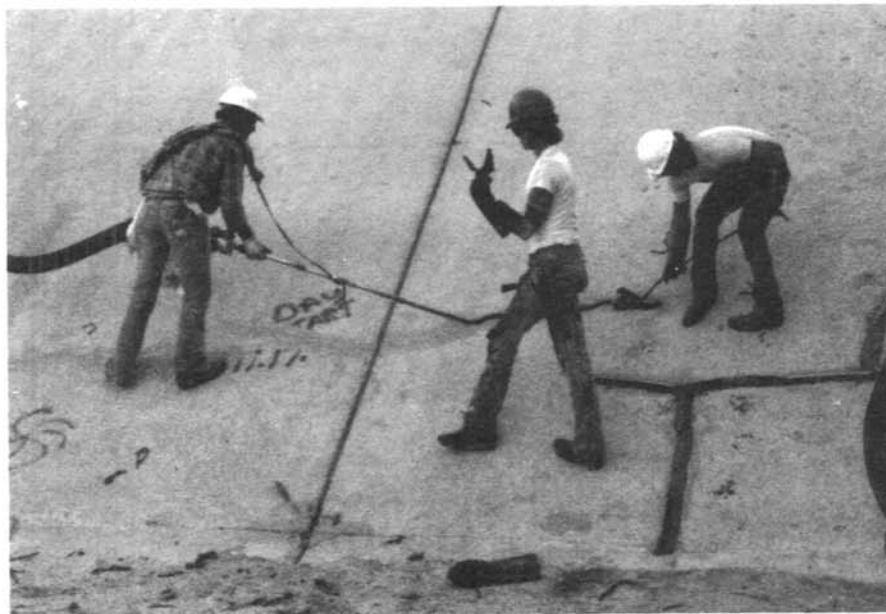
Figure 10. – Elastomeric cap-seal is tooled to correct shape with aid of a "shoe."

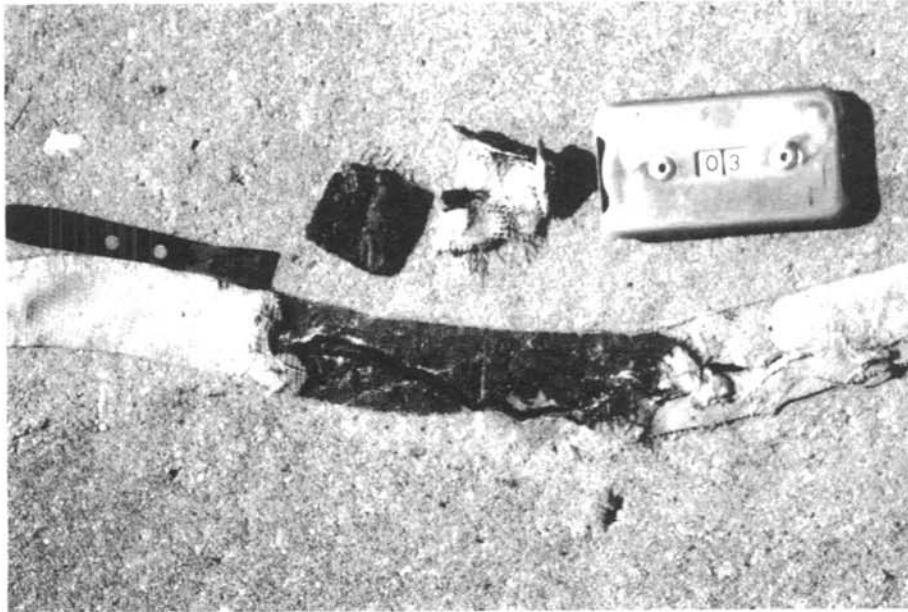
Figure 13. – Reinforced-asphalt mastic tape tends to deteriorate rather quickly, has relatively weak bond, and is difficult to center over wandering cracks.

Reinforced-asphalt mastic tape is also used as a cap-seal for random cracks, but it is not covered under the Bureau's M-41 Specifications. The reinforcement prevents cohesive failure, while movement is accommodated by shear within the thin mastic layer. This product can be used on any size job by an inexperienced crew because no special equipment is needed. Material costs are competitive with the previously mentioned products, but application is very labor intensive and installed costs may prove to be higher. Also, this material has questionable durability. An application in Ord, Nebraska, showed signs of deterioration after only 2 years; and it is doubtful if this material could last more than 5-10 years (fig. 13).

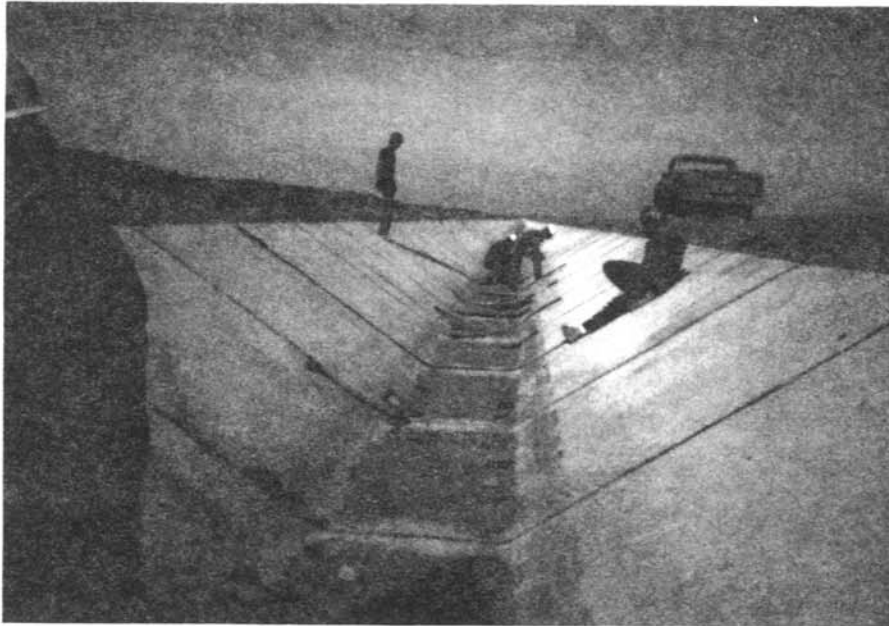
Figure 14. – Sealant is removed from the joint and replaced because of poor bond.

As shown in figure 14, it is generally cheaper to provide good initial surface preparation than to do the job over.
