# ***WATER OPERATION AND MAINTENANCE***

**BULLETIN NO. 147**

March 1989

# CONDENSED INTERIM REPORT ON CANAL LININGS USED BY THE BUREAU OF RECLAMATION<sup>1</sup>

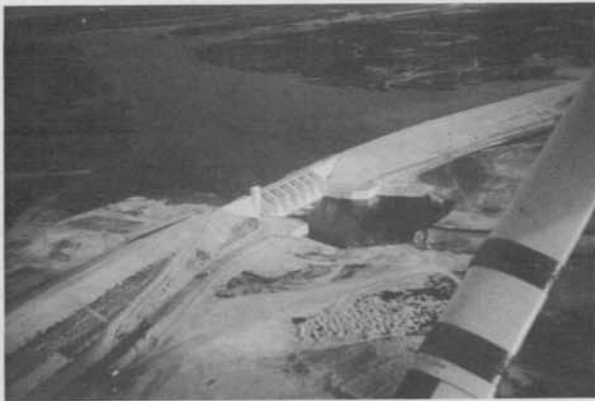
Cover photograph:

Aerial view of Brantley Dam and Reservoir showing maximum section of dam.

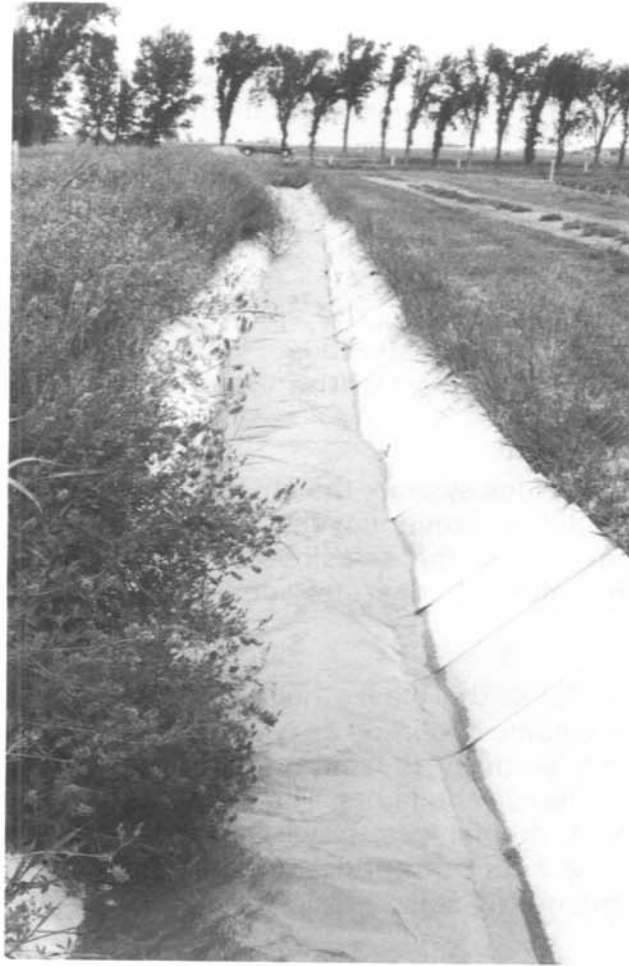
The sidewalk blocks, because they are not joined at the butt, have not suffered any cracking or misalignment from frost action.

With the concrete sidewalk block system, the channel is trimmed and graded to a smooth surface; a herbicide applied to prevent weed growth; the plastic sheeting laid down and keyed into the upper part of the sideslope; and finally, the 600- x 600- x 50-mm (24- x 24- x 2-inch) unreinforced concrete sidewalk blocks laid directly on top of the liner.

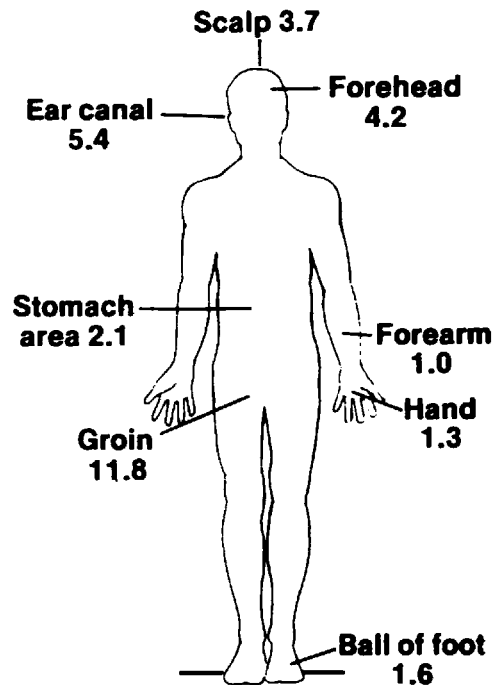
**INDEX OF ABSORPTION.** - This drawing illustrates the eight points on the human body where pesticide absorption can occur. The rates on a scale of 1 to 12 are based on a comparison using the forearm (1) as a base.

The drawing is the Index of Skin Pesticide Absorption, which is labeled with the Skin Absorption Rates. The rates, ranging on a scale of 1 to 12, are based on a comparison using the forearm (1) as a base.

Pesticides can enter the body through these eight points:

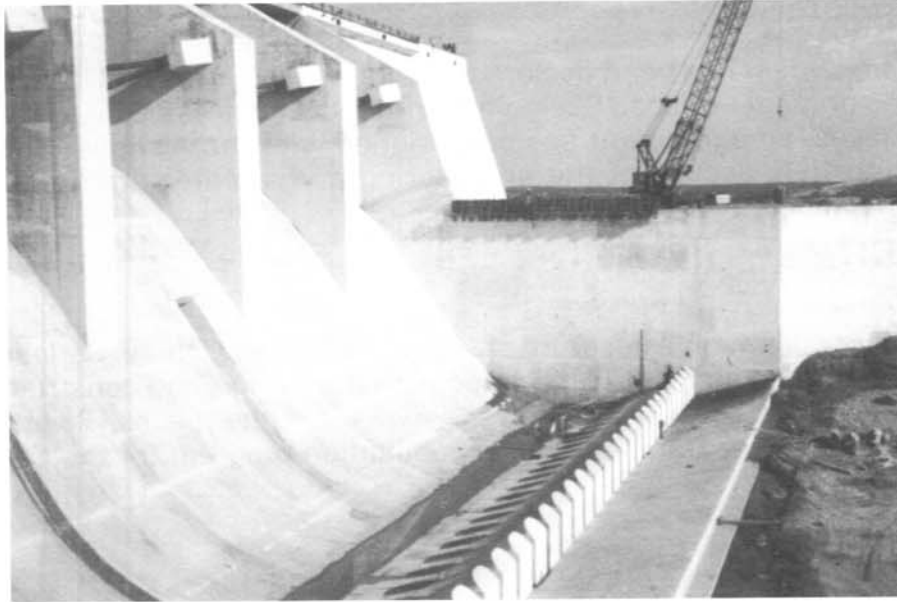
Figure 1. - Brantley Dam - Spillway chute and stilling basin.  
10/4/87

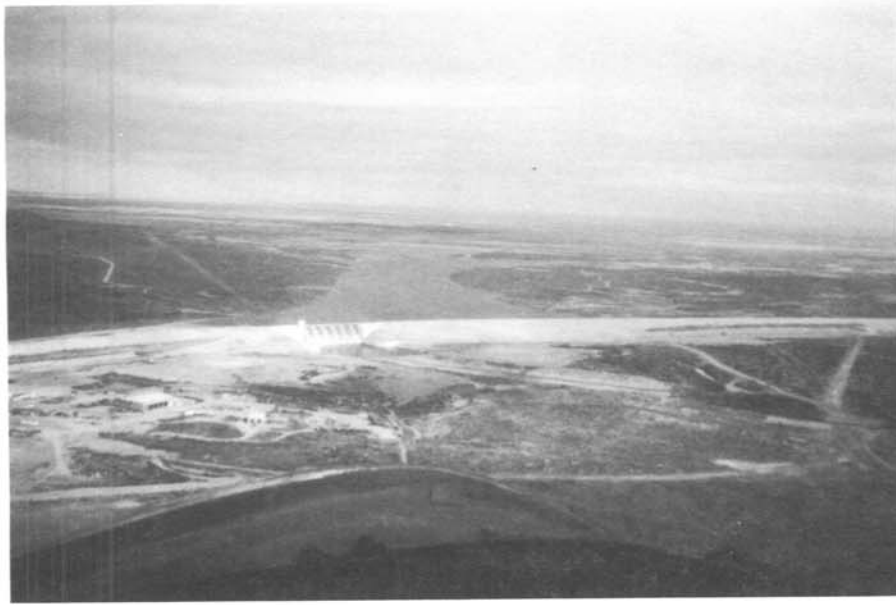
Figure 3. - Brantley Dam and Reservoir showing O&M complex in left foreground. 9/22/88

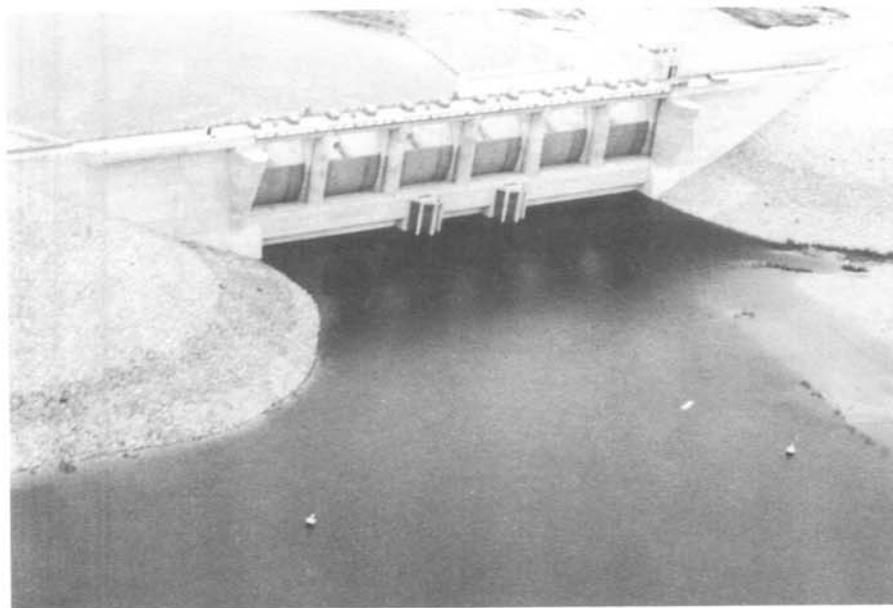
Figure 4. - Brantley Dam - Aerial view of the Reservoir and concrete structure. Note two safety buoys to which a safety float line will be connected between these buoys. 9/20/88

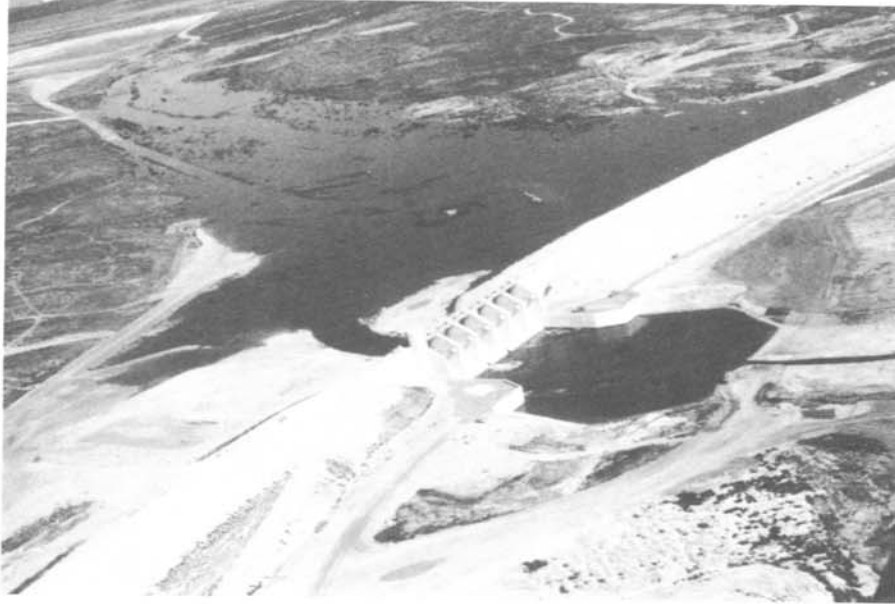
Figure 5. - Brantley Dam - Aerial view of concrete structure, stilling basin, left and right abutments, and Reservoir. 9/7/88

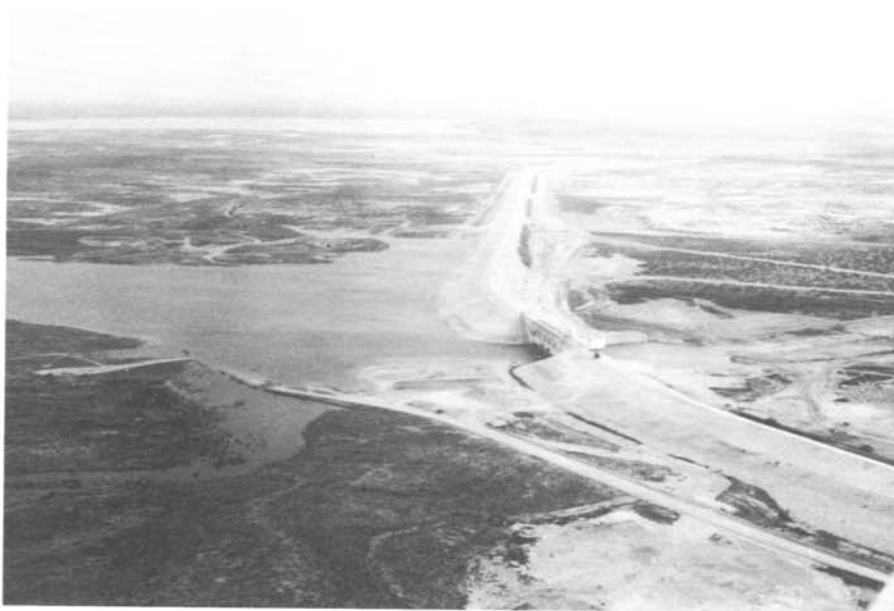
Figure 6. - Brantley Dam - Aerial view showing Dam and Reservoir. Lake McMillan can be seen in the background. Note curve of the earthen abutments. 9/29/88
