WATER OPERATION AND MAINTENANCE

BULLETIN NO. 149

September 1989

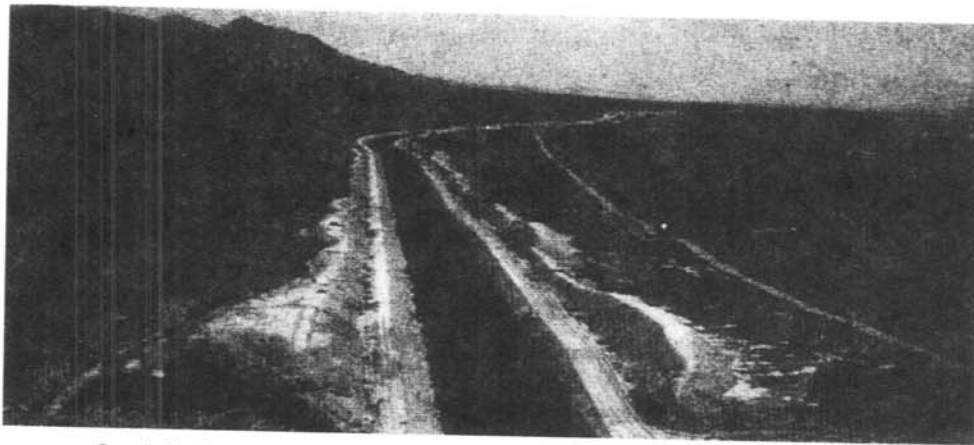
Coachella Canal in southeastern California is being relined to reduce water seepage.

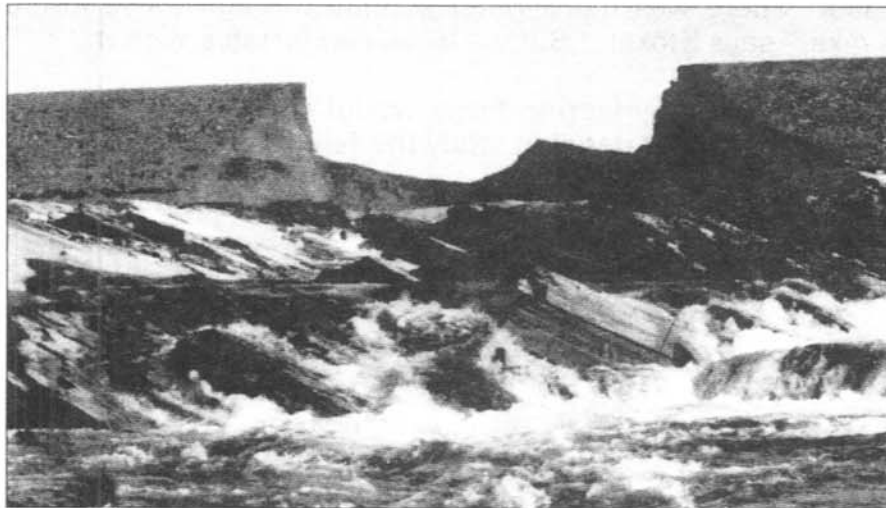
Earthfill dike that burst had history of leakage ever since its reservoir was first filled in 1985.

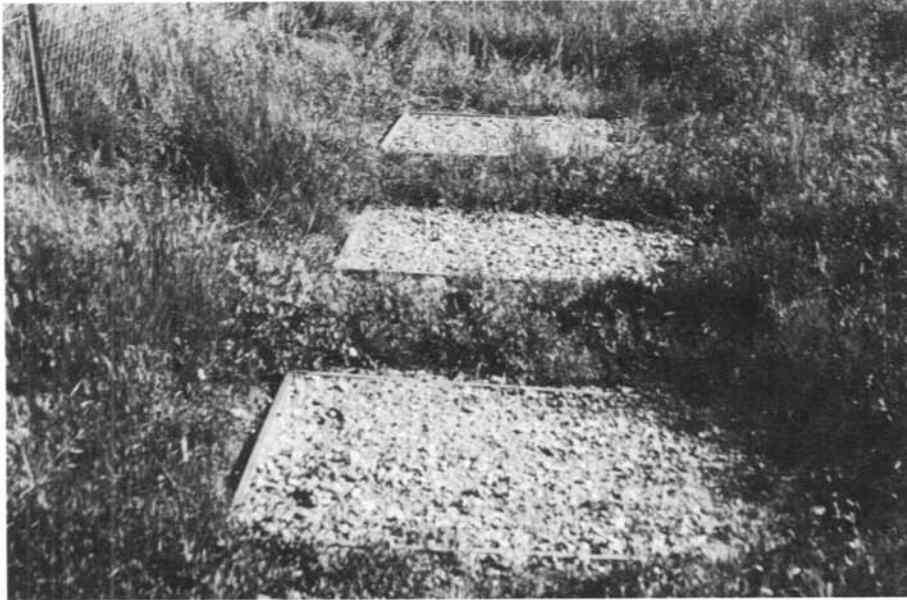
Picture showing the three plots in the 1987 study

A wooden frame was used to border each of the 1987 plots. A compacted soil-aggregate replaced the soil in each plot to simulate a switchyard area (see photograph). The soil-aggregate material used in the studies was made up to meet the standard specifications used by the Bureau of Reclamation. The herbicide used in the study contained 1.86 percent prometon (2-methoxy-4,6-bis isopropylamino triazine). This herbicide was applied with a garden sprinkler can at a rate of 22.76 pounds per acre active ingredient.

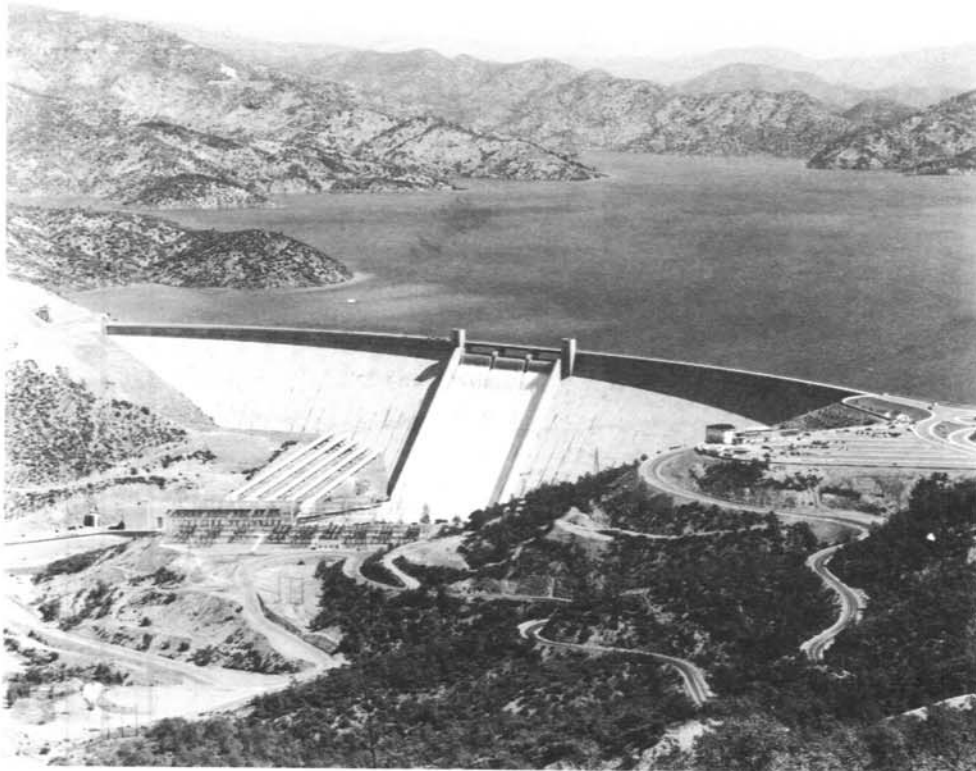
Photo 2. - Aerial view of Shasta Dam showing spillway gates operating — 7/18/51
