WATER OPERATION AND MAINTENANCE BULLETIN

No. 182

December 1997

RIVER OUTLET WORKS CAVITATION DAMAGE Folsom Dam

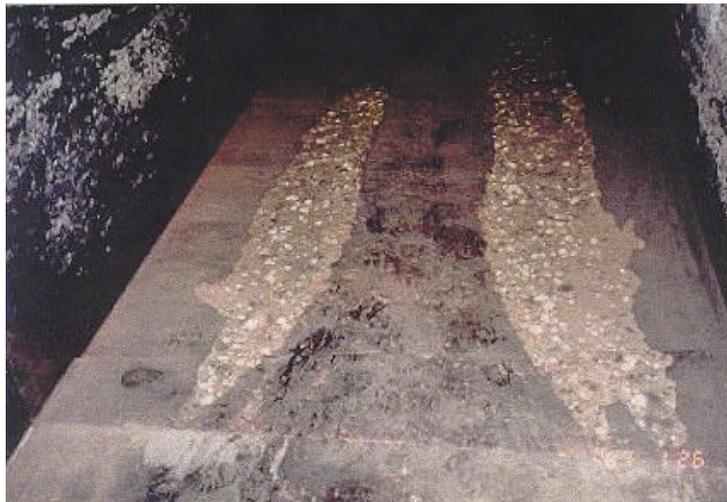
Cover photograph: *Cavitation damage on the floor of river outlet No. 2 beginning at the liner. From this photo, it is evident that the cavitation damage begins on the floor of the outlet just downstream of the liner.*

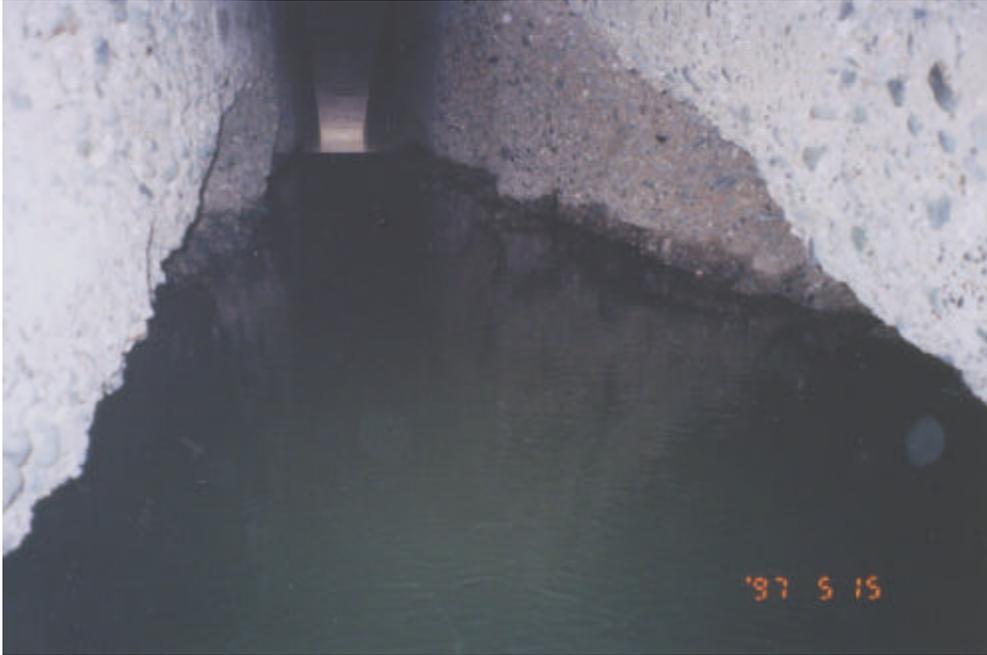
Photograph 1.—Inside river outlet No. 3 looking downstream.

An inspection in May 1997 revealed extensive cavitation damage inside river outlet No. 3 (photos 1 and 2). Subsequent inspections of the remaining outlets revealed similar damage in No. 4 (photo 3), minor damage in No. 2 (photo 4), and very little to no damage for the others. The severe damage in outlet Nos. 3 and 4 begins at the downstream edge of the liner and extends approximately 45 feet downstream. The damage essentially formed large caverns with the maximum dimensions on the order of 16 feet wide, 6 feet deep, and 5 feet above where the floor had been. The "hop-skip" pattern of minor damage in outlet No. 2 and the smaller cavern following a larger one in outlet No. 4 clearly indicated cavitation as initiating the damage. The steel liners of all outlets are in excellent condition with no loss of metal.

The most probable cause of the cavitation damage has to do with outlet Nos. 3 and 4 being the furthest away from the vent intake. The vent system consists of a 5-foot-diameter intake manifold at elevation 378. Each outlet is vented by a 30-inch-diameter riser connected to the manifold. The risers are approximately 163 feet in length for the lower tier outlets and approximately 93 feet in length for the upper tier outlets. Each vent riser attaches to an outlet tube immediately downstream of the service gate (photo 5 and figure 3). From observing the vent system on figures 1 and 2, it appears quite possible that outlet Nos. 3 and 4 are starving for air when multiple outlets are being operated simultaneously. The area of the 5-foot manifold is about half the combined areas of the 30-inch risers; therefore, the manifold is significantly under-sized when operating all outlets simultaneously.

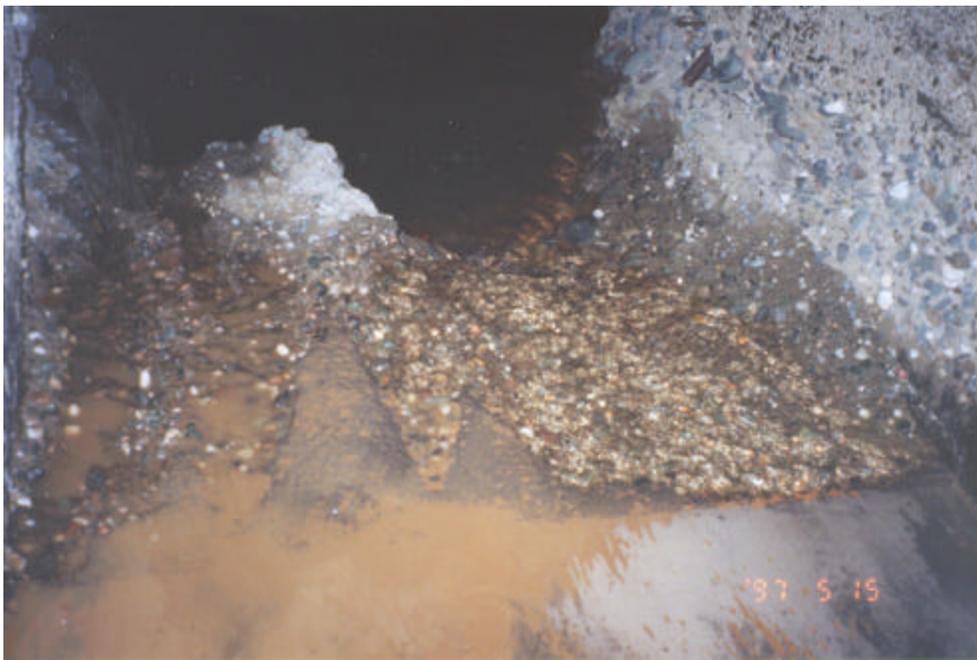
Photograph 2.—Inside river outlet No. 3 looking downstream from the metal liner. Cavitation damage begins at the end of the liner.

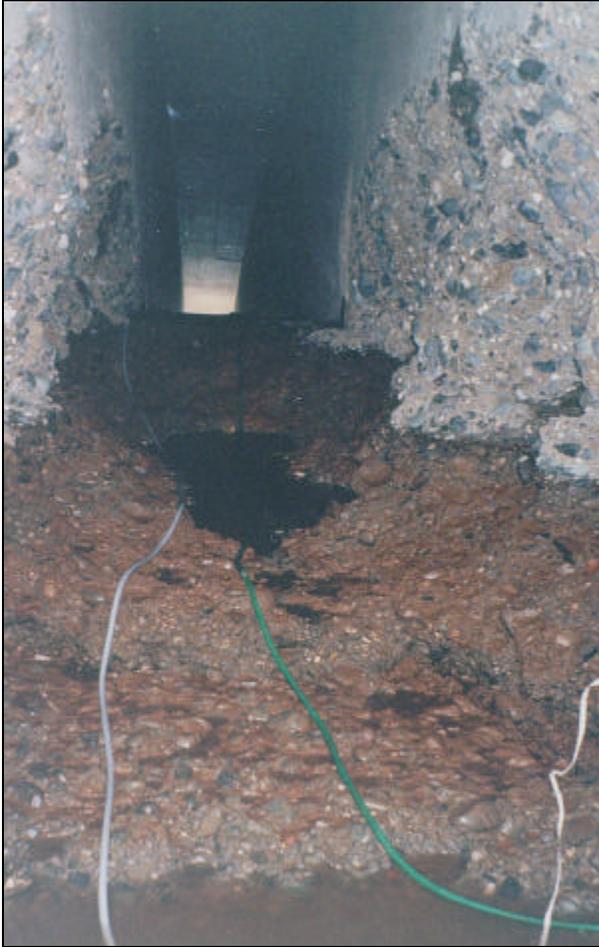
Photograph 3.—Gate 4 cavitation damage downstream of gate liner. Note second bowl-shaped damage downstream of smaller size which clearly indicates cavitation instead of strictly erosion.

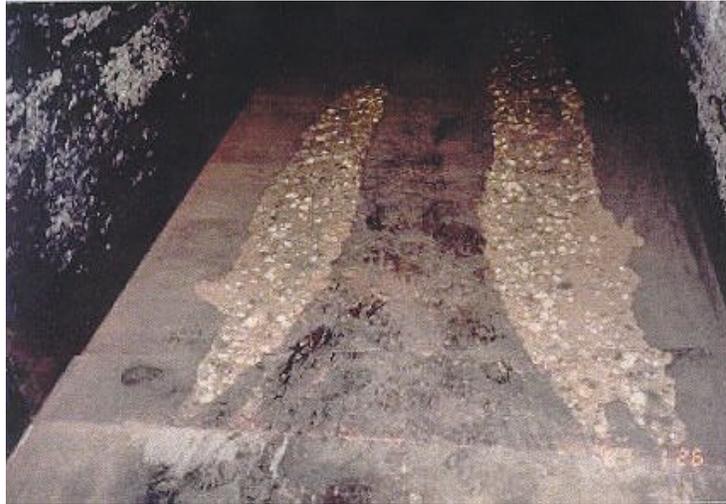
Photograph 4.—Cavitation damage on the floor of river outlet No. 2 beginning at the liner. From this photo, it is evident that the cavitation damage begins on the floor of the outlet just downstream of the liner.

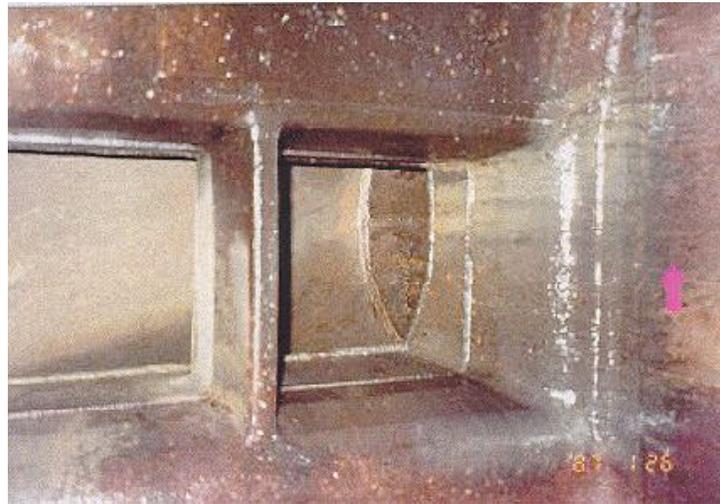
Photograph 5.—Typical view of the air vent inside the river outlets. The arrow indicates the direction of flow. The vents are located on the tube's ceiling immediately downstream of the service gate.

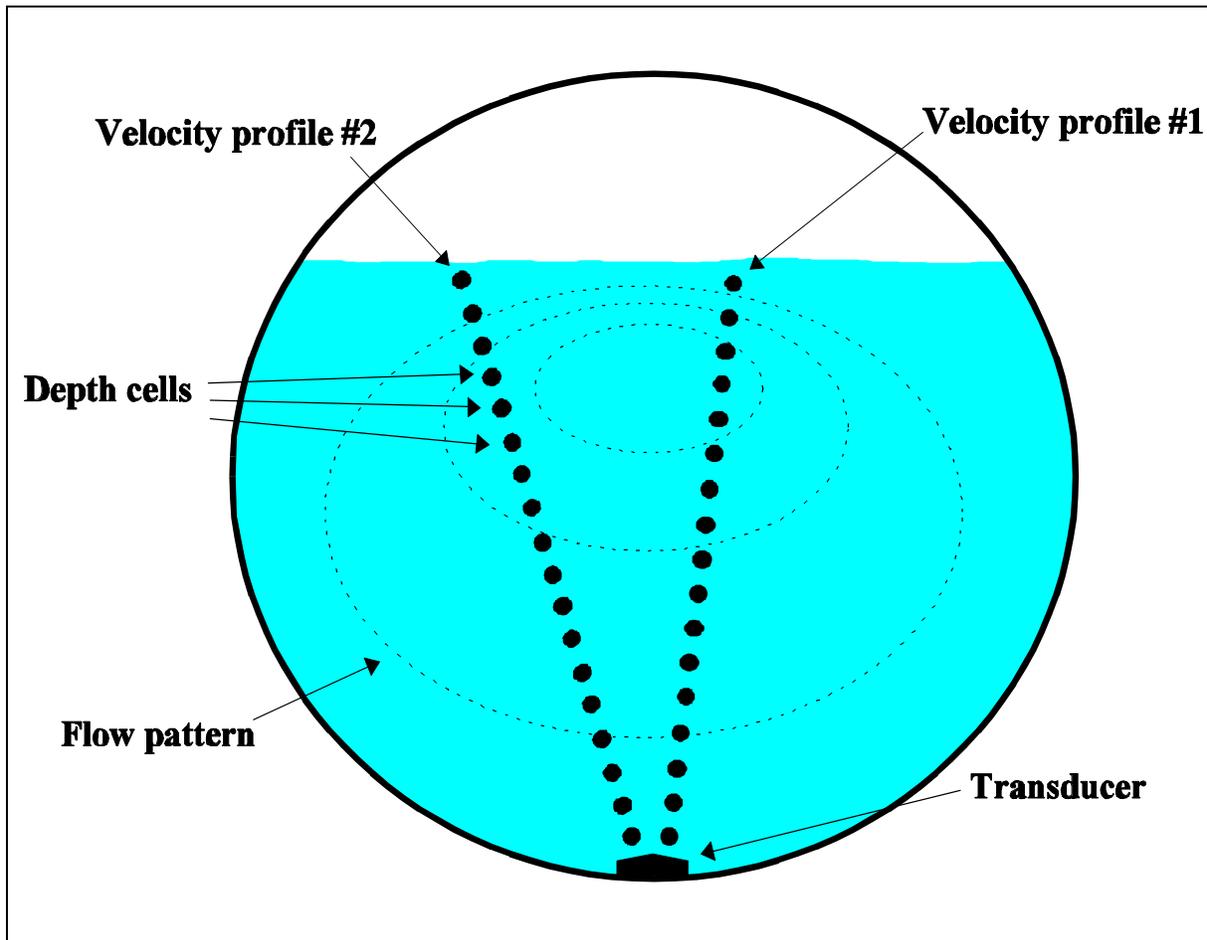
Figure 1.—Cross section view of typical Profiler application. This figure shows the spatial relationship of the depth cells and the profiles relative to the transducer housing.

Figure 1 shows a typical Profiler installation for measuring open channel flow in a pipe. A transducer assembly is mounted on the invert of a pipe or channel. Piezoelectric ceramics emit short pulses along narrow acoustic beams pointing in different directions. Echoes of these pulses are backscattered from material suspended in the flow. As this material has motion relative to the transducer, the echoes are Doppler shifted in frequency. Measurement of this frequency shift enables the calculation of the flow speed. A fifth transducer is mounted in the center of the transducer assembly and is used to measure the depth.

The Profiler divides the return signal into discrete regular intervals which correspond to different depths in the flow. Velocity is calculated from the frequency shift measured in each interval. The result is a profile, or linear distribution of velocities, along the direction of the beam. Each of the small black circles in figure 1 represents an individual velocity measurement in a small volume known as a depth cell.

The directions of the velocity profiles in figure 1 are based on the geometry of the Profiler's transducer assembly. Figure 2 shows a side view of the transducer assembly. The profiles shown in figure 1 are generated from velocity data measured by an upstream and downstream beam pair. The data from one beam pair are averaged to generate profile No. 1, and a beam pair on the opposite side of the transducer assembly generates profile No. 2.

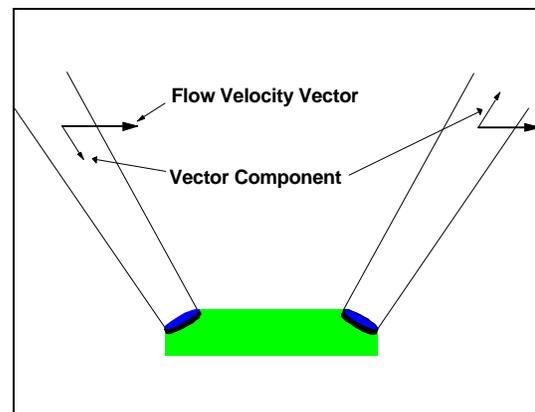
Figure 2.—Side view of the Profiler transducer assembly and its beam geometry.

Because Doppler measurements are directional, only the component of velocity along the direction of the transmit and receive signal is measured, as illustrated in figure 2. Narrow acoustic beams are required to accurately determine the horizontal velocity from the measured component. The narrow acoustic beams of the Profiler ensure that this measurement is accurate. Also, the range-gate times are short, and the depth cells occupy a small volume—cylinders approximately 5 centimeters (2 inches) long and 5 centimeters in diameter. These small sample volumes ensure that the velocity measurements are truly representative of that portion of the flow, and potential bias in the return energy spectrum due to range-dependent variables is avoided. The result is a very precise measurement of the vertical and transverse distribution of flow velocities.

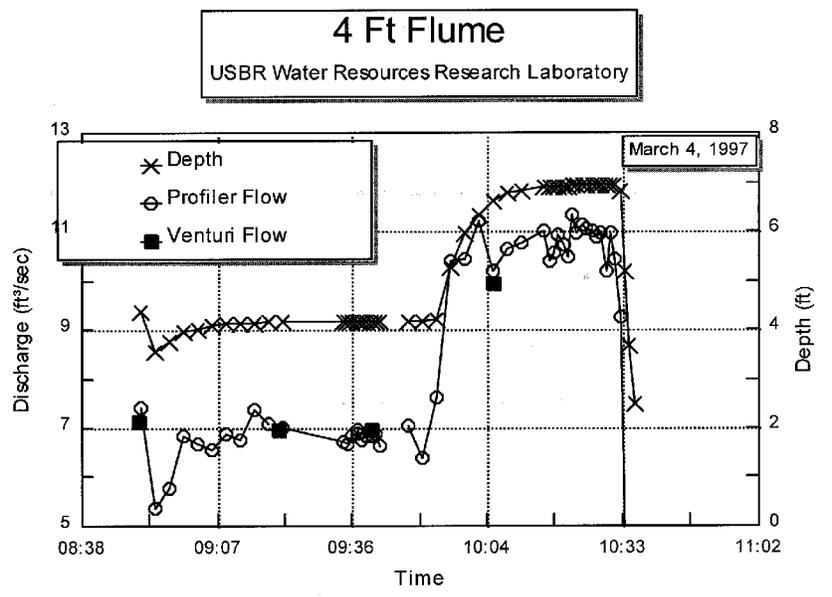
Figure 3.—Profiler and venturi flow rates measured in the 4-foot flume are plotted as a function of time. The Profiler’s depth reading is also plotted to illustrate the effect of fluctuating water surface level on the discharge measurement accuracy.

Figure 3 shows the results from the 4-foot flume tests. The round symbols represent the Profiler data, and the square symbols are the spot readings from the venturi meter. As shown in figure 3, the Profiler data agrees very well with the venturi meter readings.

At the beginning of the data record, there is some scatter to the Profiler data because the flow into the flume had just been set and the depth in the flume was still equilibrating. After the first few points, the flow rate readings and depth readings become steady. The Profiler measured an average flow rate of 6.86 cubic feet per second (ft^3/s) during the initial depth of flow of 4 feet (after depth equilibration), compared to 6.98 ft^3/s for the venturi readings during the same time period, a difference of -1.72 percent. We also see a change in the Profiler flow

rate measurement after the level was increased to 7 feet at around 10:00 a.m. The Profiler overpredicts the flow because one pair of acoustic beams intersects the walls of the flume. Consequently, the average velocity is skewed higher because it is measured near the middle of the flume where velocities are larger than near the wall.

The spacing on the x-axis is irregular because several sampling schemes, in which parameters such as bin size and sampling interval, were varied. In most cases, changing these parameters did not affect the overall accuracy of the flow rate measurement.

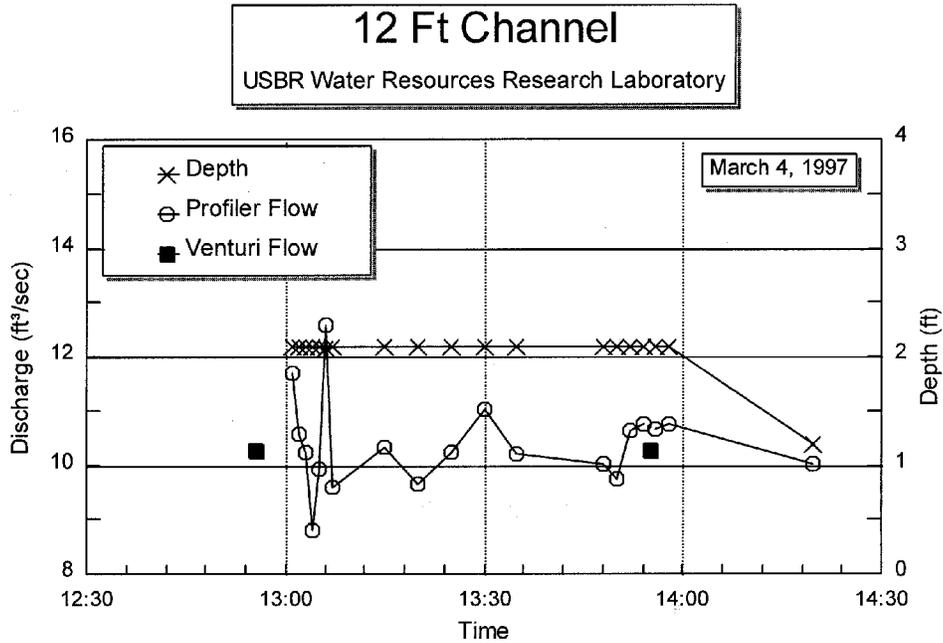
Figure 4.—Profiler and venturi flow rates measured in the 12-foot channel are plotted as a function of time. The Profiler’s depth reading is also plotted. Initially, the Profiler’s discharge measurements were variable but, with time, the accuracy improved to within 1 percent of the venturi-measured discharge.

Figure 4 shows the results from the 12-foot channel test. The round symbols are Profiler data, and the square symbols are spot readings from the venturi meter. For this test, the Profiler data were averaged over a variety of time periods. Figure 3 is a plot of “raw” flow data where each point corresponds to a individual measurement separated by an interval varying from 1 to 5 minutes. The first seven acoustic Doppler flow meter (ADFM) measurements were collected with a 1-minute averaging interval. The average of these seven measurements is 10.48 ft³/s. The venturi meter reading was 10.26 ft³/s, and this flow remained constant for the remainder of the test. The next five ADFM measurements were collected with an averaging interval of 5 minutes. The average of these five measurements is 10.29 ft³/s. The next six ADFM measurements were collected with an averaging interval of 2 minutes. The average of these seven measurements is 10.43 ft³/s. This test demonstrates how Profiler measurements become more precise as the number of measurements averaged together increases. The ability to average hundreds of flow measurements over a short period results in a very precise flow measurement. This is illustrated by comparing the average of the all 18 Profiler measurements with the 2 venturi meter readings. The Profiler average was +0.97 percent different from the venturi meter average. The last ADFM measurement was collected with an averaging interval of 2 minutes at a depth of 1.2 feet. The measured flow rate was 10.0 ft³/s. This measurement was made with a 10:1 width to depth ratio. This demonstrates the Profiler’s unique capability to measure flows in wide, shallow channels.

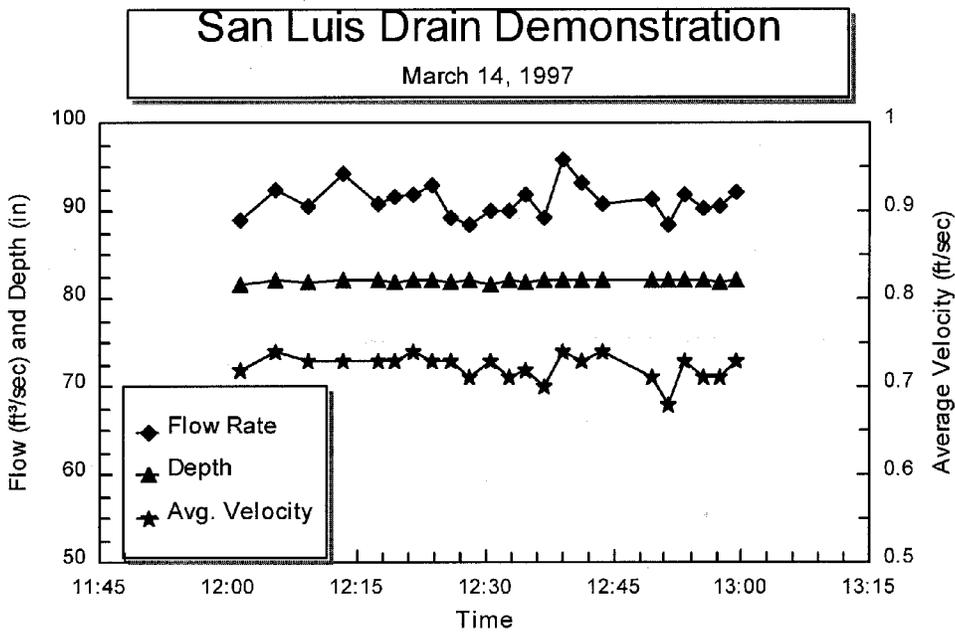
Figure 5.—Flow rate, depth, and average velocity plotted as a function of time. The average flow rate measured in the San Luis Drain was 9.1 ft³/s with a standard deviation of 2.0 percent.

Figure 5 contains a plot of the flow rate, depth, and average velocity measured in the San Luis Drain near Los Banos, California, on March 14, 1997. All three measured parameters were steady over the test period. Variations in the flow rate correlate with variations in the average velocity, as the depth remains fairly constant. The average flow rate over the duration of the test was 91.1 ft³/s. Flow rates of approximately 80 and 86 ft³/s were measured using traditional stream gauging methods. Stream gauging velocities were measured with a Marsh-McBirney Flo-Mate, which is an electromagnetic velocity meter.

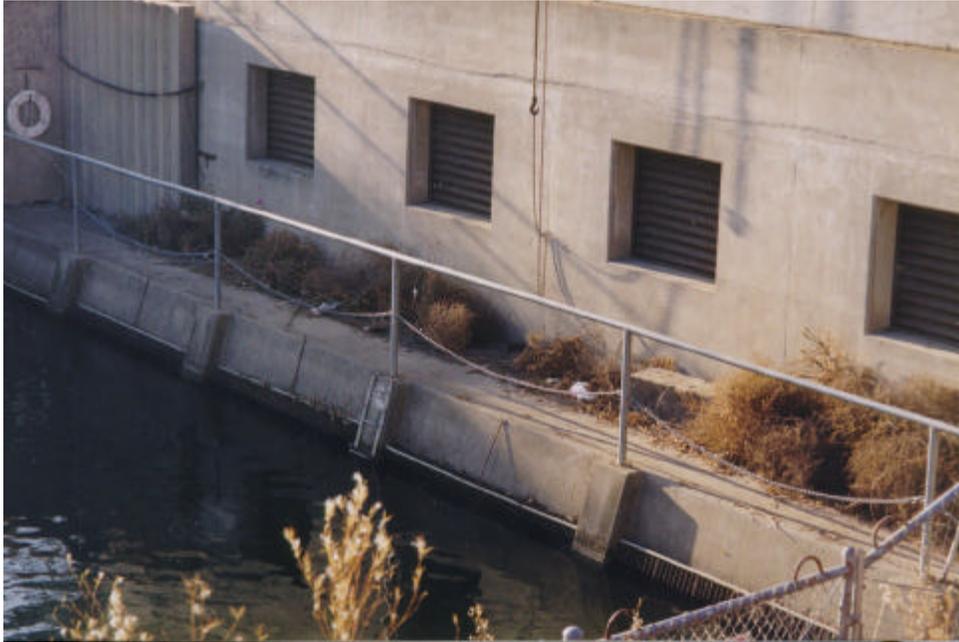
Photograph 1.—Typical inlet area to each pumping plant.

The improvements to each pumping plant were recently completed. On the wet well level of each plant, air filters were attached with a frame to the inside of the louvers (photographs 1 and 2), which replaced the original windows, to remove dust and dirt from the air. To improve air flow around the motors on the main level, aluminum grating (photograph 3), with a larger net open area, was installed. The lighter gratings can be lifted easily by one operator. Finally, new roof vents with motors (photograph 4) were placed atop the plants. The improved air flows from the canal water surface through the filtered louvers, up from the wet well to the aluminum grating, past the cooling motors, toward the roof vent motors, and out the roof of each plant. Hot air from other electrical controls also is drawn out of each plant. The net result keeps interior plant temperatures in an acceptable operating range.

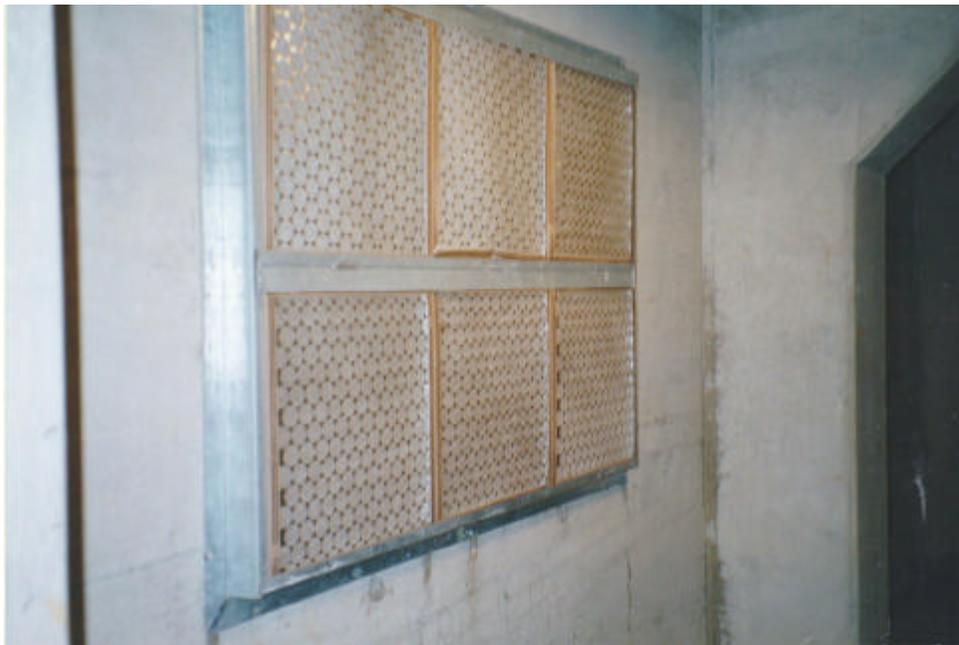
Photograph 2.—Air filters attached to the inside of the louvers.

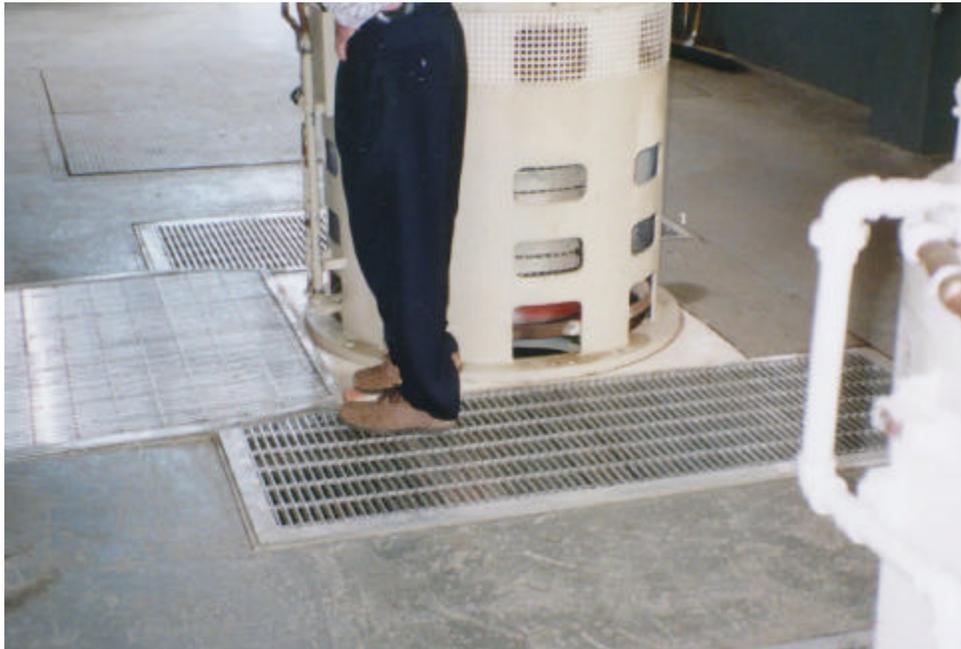
Photograph 3.—Aluminum grating over the floor openings adjacent to the motors.

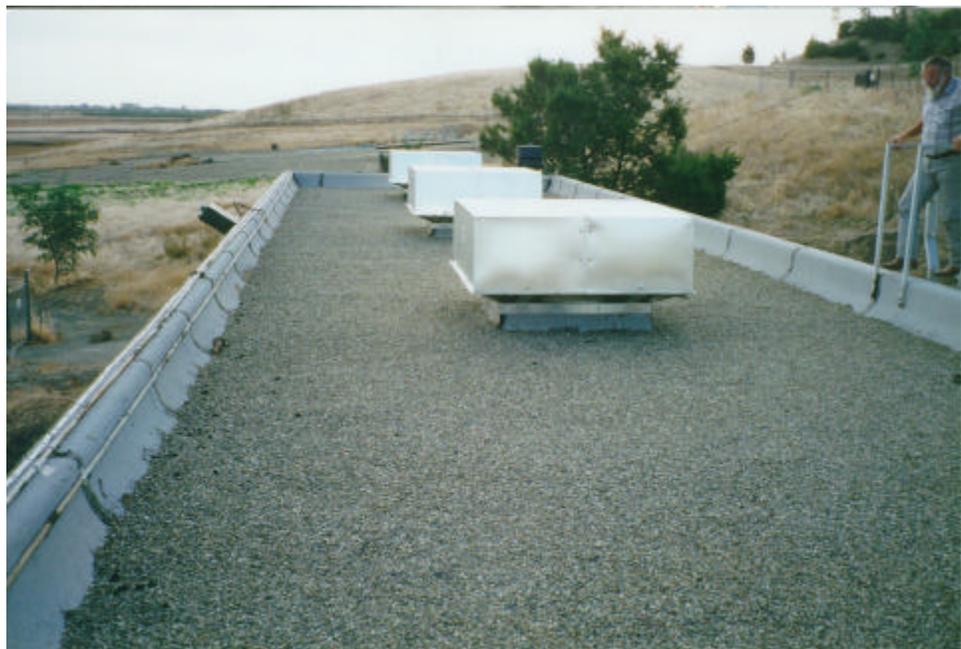
Photograph 4—New roof vent motors atop the pumping plants.
