WATER OPERATION AND MAINTENANCE BULLETIN

No. 187

March 1999

- Bendway Weirs and Highway Protection in Colorado:
A Case Study on the Blue River
- Summary of the Shasta Dam Temperature Control Device
and How it is Working
- Willow Creek Dam Outlet Repairs Using Cured-in-Place Pipe

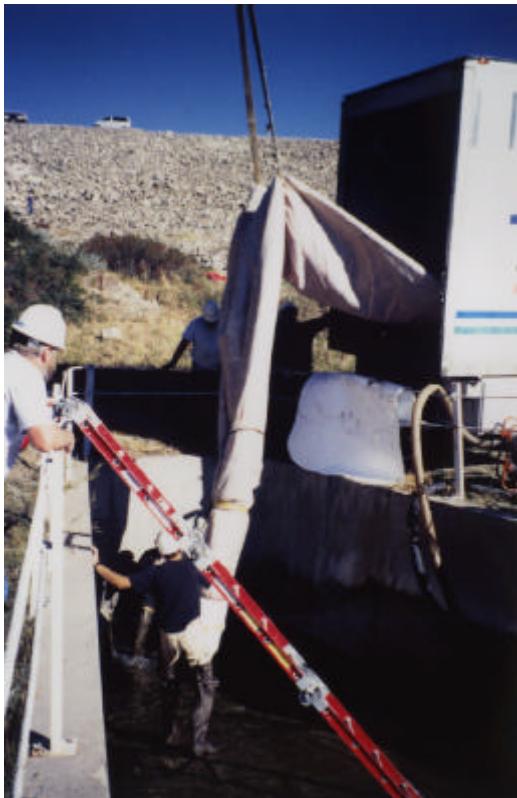
Cover photograph: Willow Creek Dam outlet repairs using cured-in-place pipe. Photo shows removal of resin liner from refrigerated truck at downstream tunnel portal, to be pulled upstream along tunnel to final position near regulating gate.

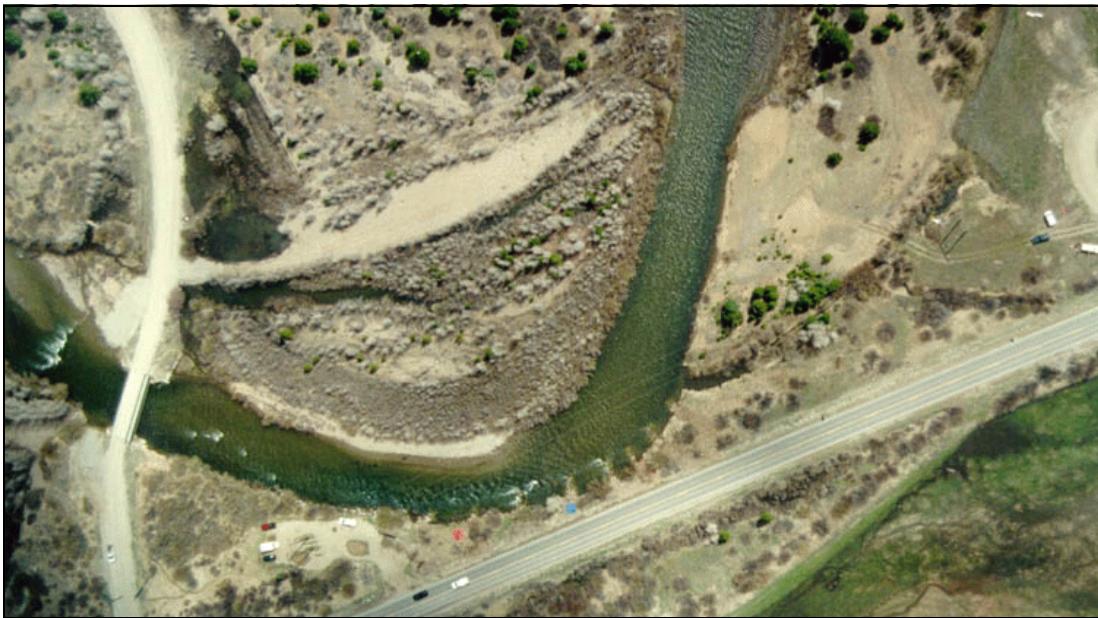
Figure 1.—Aerial view of Blue River downstream of Dillon Reservoir, near Silverthorne, Colorado (flow is right to left).

Figure 1 is an aerial view of the reach following installation of the bendway weirs. This section of the Blue River is just downstream of Dillon Reservoir. This regulated reach shows the remnants of an active geomorphology. The alluvial gravel bed stream is an ideal candidate for bendway weirs. There is a gentle head cut working its way upstream through the reach and an active point bar opposite the reach adjacent to the highway.

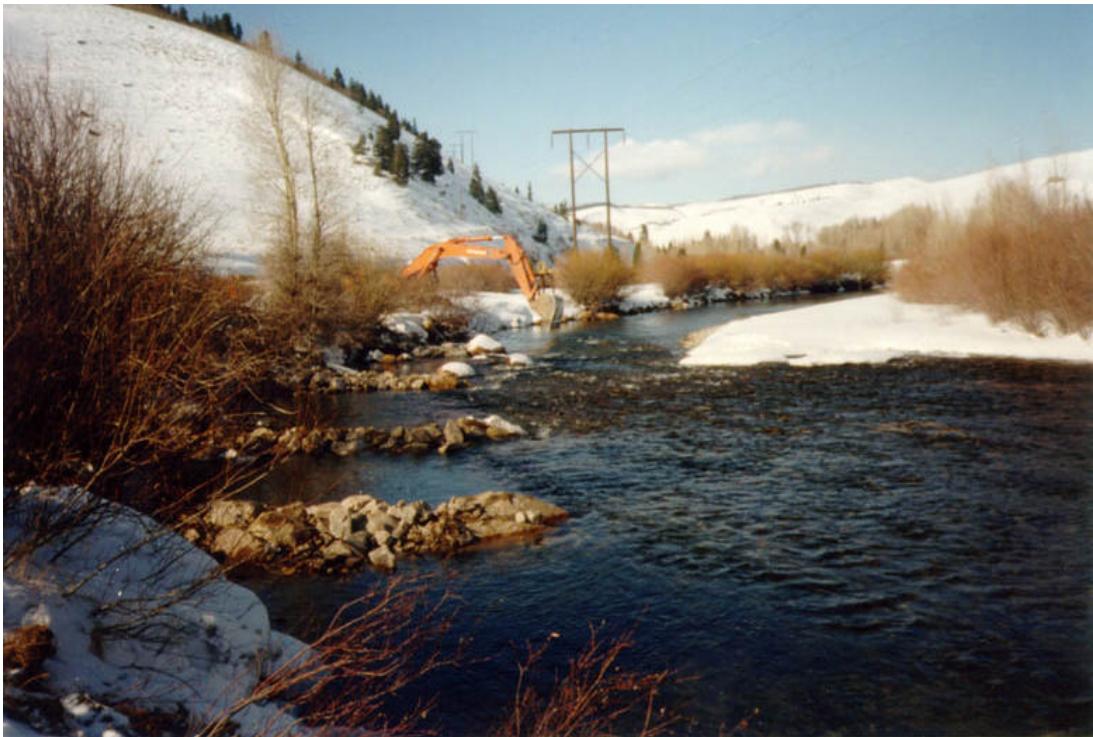
Figure 6.—View looking downstream while weirs are under construction.

Figures 6 and 7 show views of the site during construction and under spring flows. Figure 7 clearly shows the slack flow near the imperiled bank.

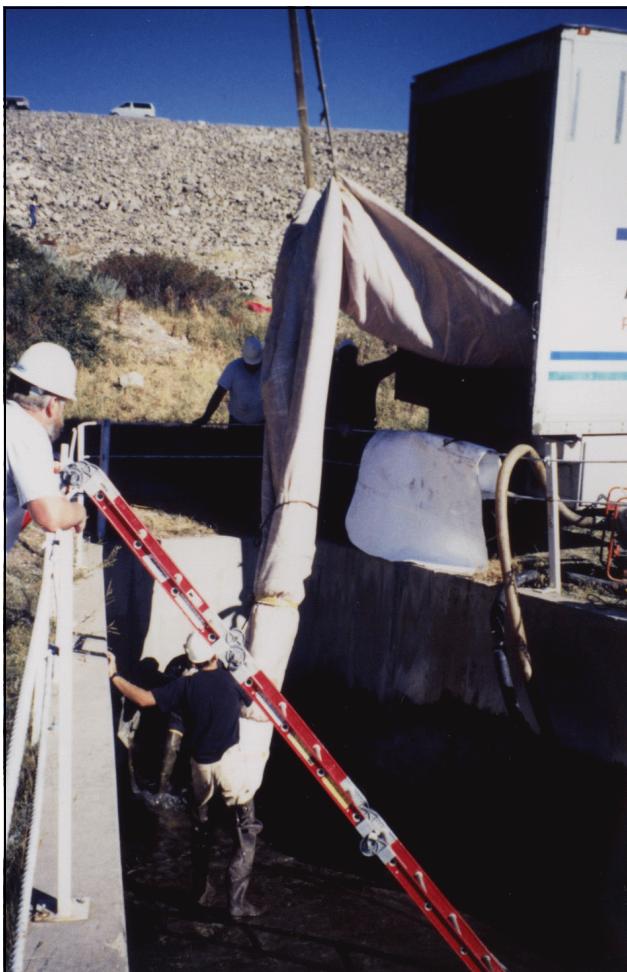
Figure 3

The resin-filled tube was delivered to the site on August 11 in a refrigerated truck. The nonwoven fabric tube was manufactured in Houston, Texas, at InLinerUSA headquarters, and the resin was added in Alma, Colorado, at a “wet-out” plant used by WSU. Total weight of the liner was 4,500 kg (10,000 pounds). The liner was removed from the refrigerated truck using a truck-mounted winch and was carefully fed into the tunnel at the downstream portal and slowly pulled upstream (see figure 3). The liner was pulled into final position in the tunnel within about 1.5 hours and was securely fastened to the steel elbow, outside the calibration hose. Reservoir water from the upstream gate shaft was pumped into the water column to begin inversion of the calibration hose under a 0.3 m (1 foot) head. Within 20 minutes, the calibration hose had been turned inside-out and extended the full length of the liner, pressing the liner tightly against the tunnel surface. Two perforated water supply hoses inside the calibration hose were used to circulate heated water from a heat exchanger truck under the full 3.7 m (12 foot) head.

Return water temperatures at the truck reached 57 °C (135 °F) in 2 hours and were held constant for 4 hours and then were raised to 79 °C (175 °F) within 1 hour and were held

rubber seal with three stainless steel bands spread by a hydraulic expanding device to ensure a tight fit. The work was completed on August 15, one week after site mobilization, for a total cost of about \$145,000. Subsequent laboratory tests on field samples confirmed the design parameters for tensile and flexural properties. Figure 4 shows the finished lining surface and intersection with the 0.25 m (10 inch) diameter air vent pipe at the tunnel crown. Minor wrinkles in the lining resulted from variations in the tunnel dimensions.
