# WATER OPERATION AND MAINTENANCE BULLETIN

No. 190

December 1999

**WATER OPERATION AND MAINTENANCE BULLETIN**  
**No. 190—December 1999**

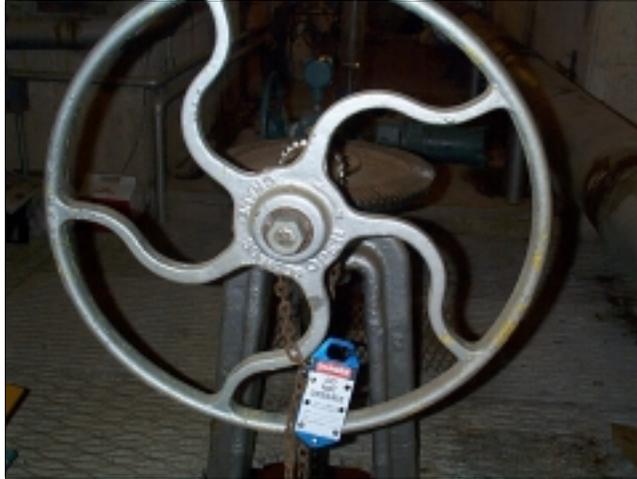
*Locked out inlet gate valve.*

***Cover photograph:*** Locked out inlet gate valve.

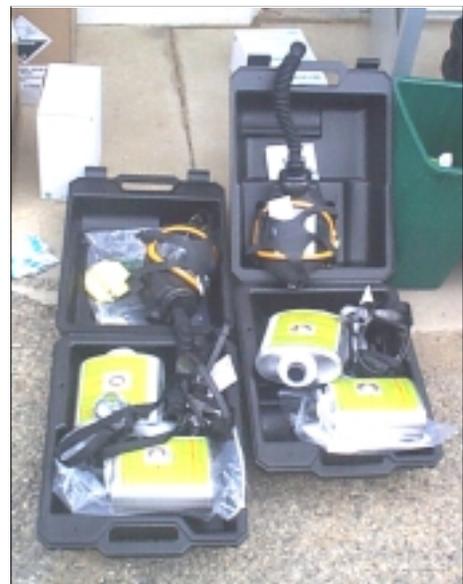
*Gas masks and H<sub>2</sub>S canisters.*

Most air purifying respirators for H<sub>2</sub>S are for escape use only. Because of the possible extended time to clear the area (possibly up to 45 minutes) and the need to continue the examination if possible, it was decided to provide canister-type gas masks. MSA Super Size Gas Masks with end-of-service-life indicating canisters were identified for this purpose. Team members were instructed to don the masks if H<sub>2</sub>S concentrations exceeded 10 parts per million (ppm) (Reclamation limit) but would be permitted to continue with the examination. If readings exceeded 20 ppm (OSHA permissible limit), they were to discontinue the activity immediately and proceed to the nearest point of egress (either the access at the intake structure or the tunnel outlet).

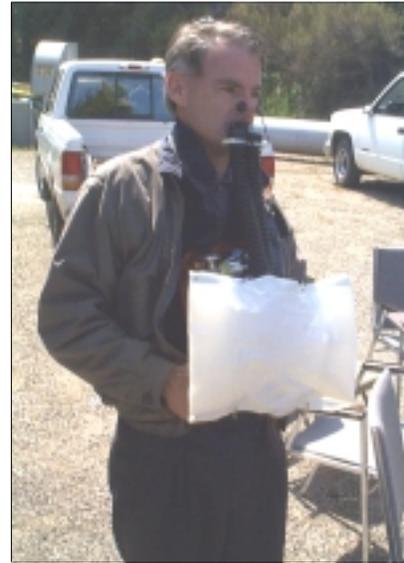
*Self-contained self-rescue unit.*

oxygen supply or oxygen-generating source and a chemical filtering system which converts  $\text{CO}_2$  back to  $\text{O}_2$ . For this purpose, Ocenco EBA 6.5 SCSRs were provided. These devices were certified to provide at least 90 minutes of breathing air and were lightweight and small enough to be carried on the wagon without difficulty.

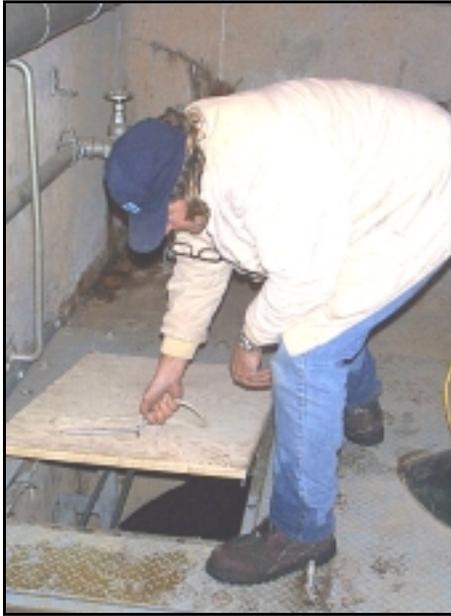
*Entry attendant checks air flow at the entry portal.*

On a cool, rainy morning in late March, the entry and support teams assembled at the north portal of the tunnel. The atmosphere at the tunnel portal was checked to ensure that it is nonhazardous and safe for entry. After the equipment wagon was lowered into the tunnel, the team entered and was on its way. After all the planning and preparation, the actual event was almost anticlimactic. The team had a 6-hour time limit to complete the examination; if not out by then, outside rescue teams were to be called. Because of the inability to communicate with the team while in the tunnel, communications were limited to telephone calls at regular intervals between the support teams at the entrance and exit portals.

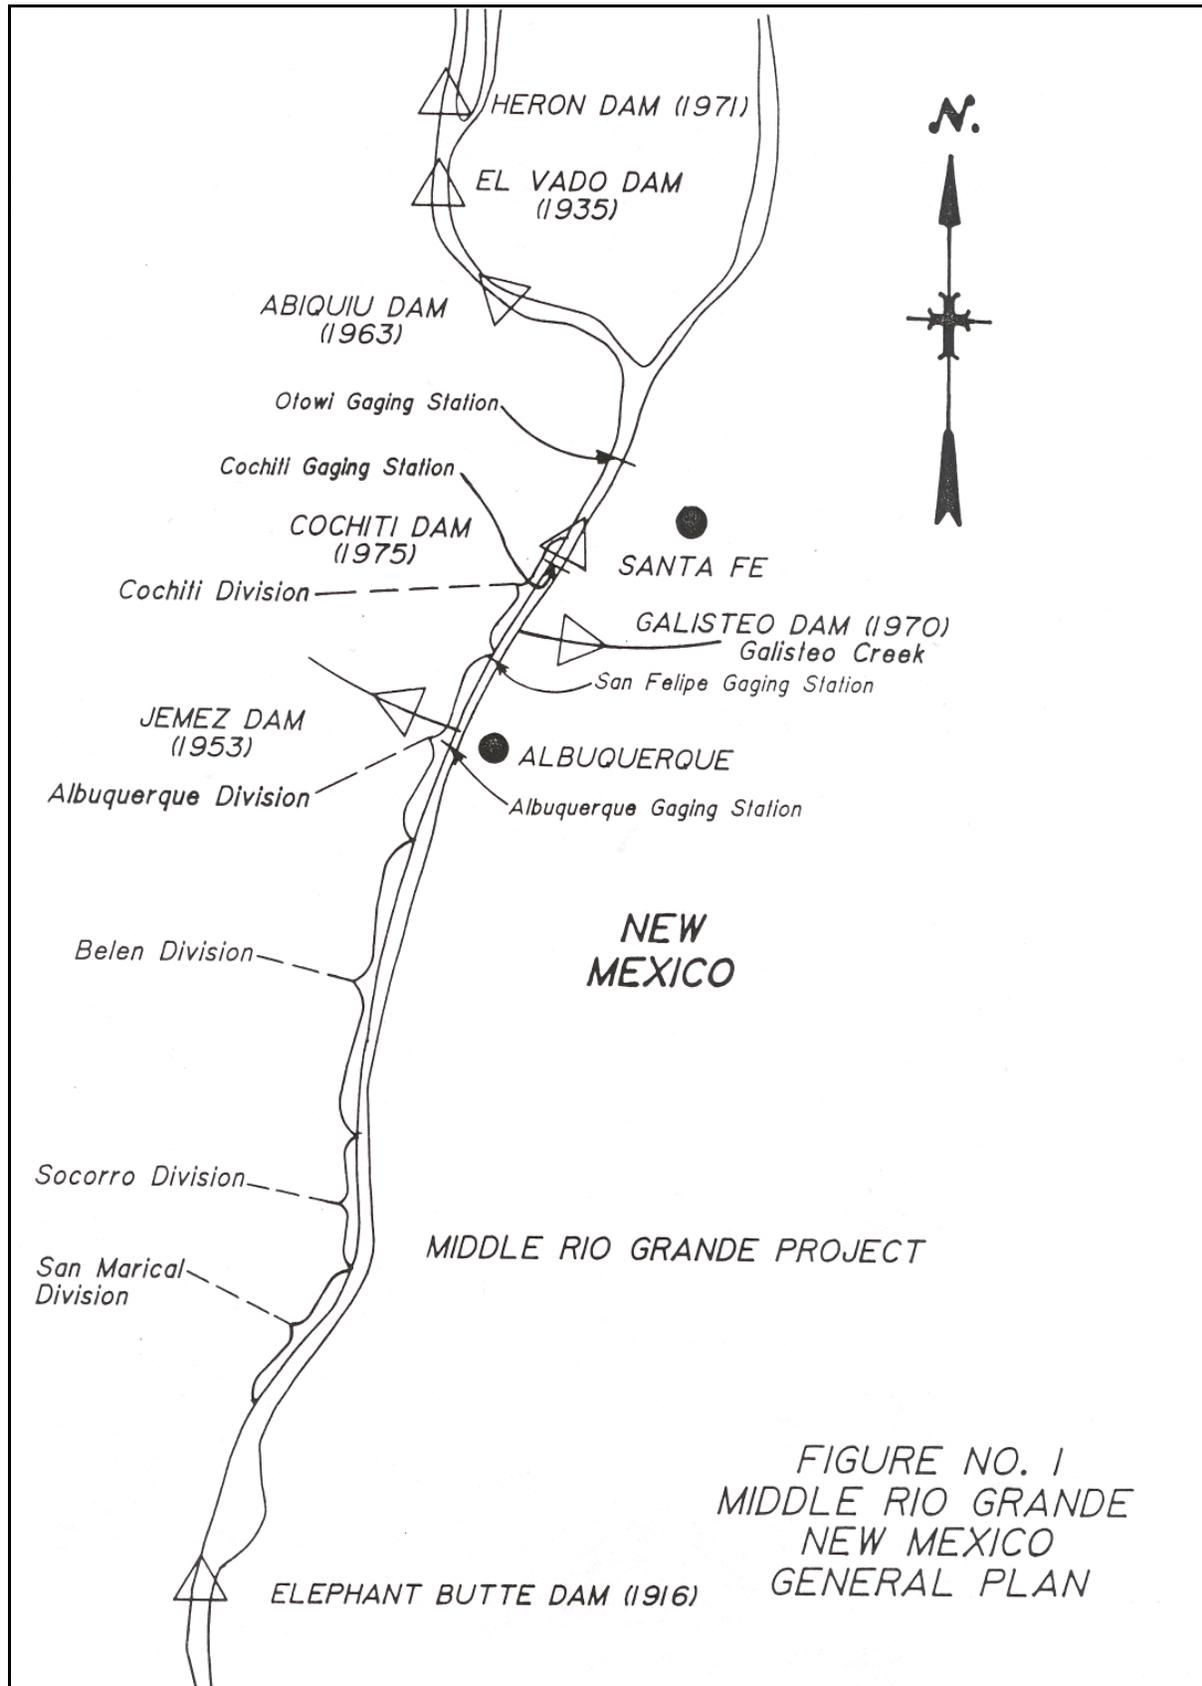
The location of the works described in this paper is the central portion of the Rio Grande Valley in New Mexico from Velarde, New Mexico, to Caballo Reservoir. Figure 1 shows the general location, the various river divisions, and the reservoirs constructed.
