WATER OPERATION AND MAINTENANCE BULLETIN

No. 201

September 2002

- ∞ Open Trench Failures Continue to Rise
- ∞ Gate Operation at the Fingertips
- ∞ High Dams and Large Reservoirs – The Evolution of Concrete Dams at the Bureau of Reclamation

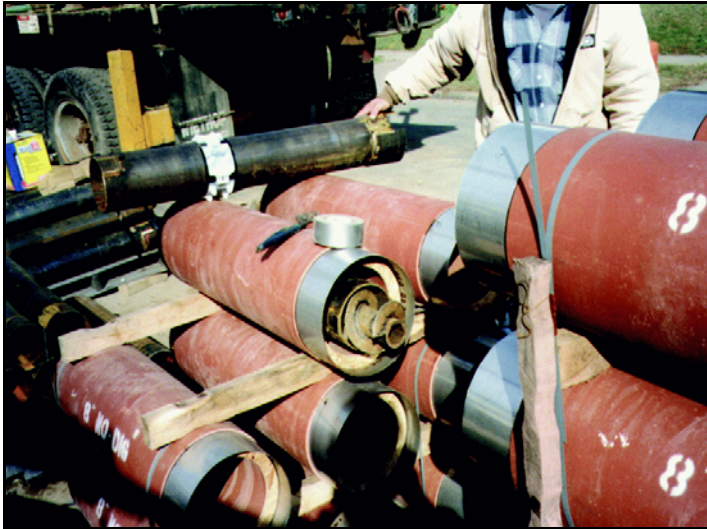
Sections of pipe await placement at one trenchless project. Increasingly, municipalities throughout the United States are specifying that contractors employ trenchless technologies for installing sewer and water lines.

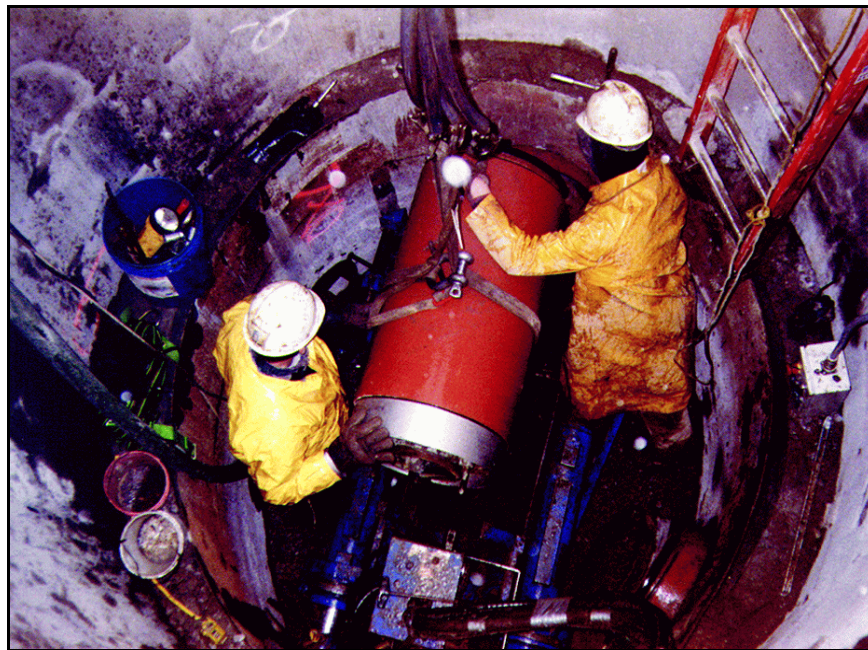
Sewer construction using pilot tube technology provides a safer alternative to open trenching.

The process of installing a sewer using pilot tube technology is similar to the microtunneling process, especially when clay pipe is used. Since 1992, NO-DIG (a company specializing in trenchless technology) has installed more than 220,000 linear feet of pipe using micro-tunneling techniques.

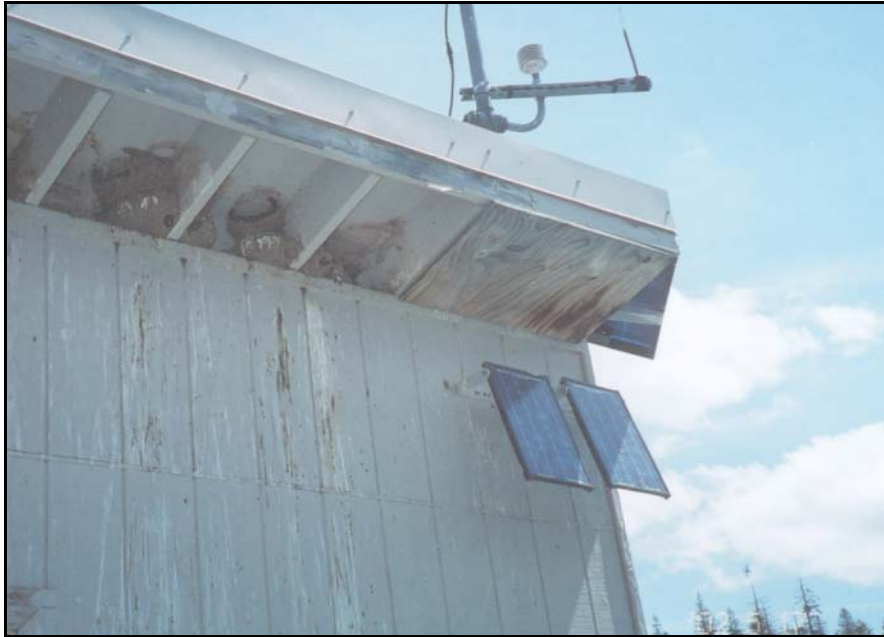
*Solar panels mounted on the outside wall of the gatehouse. Bird screens are attached to the roof eave above the panels to restrict bird nesting and subsequent debris. Note the lack of organic coatings on the gatehouse siding in the vicinity of the solar panels.*

The power for the system consists of a 20-watt solar panel, mounted on the gatehouse, that recharges a 12-volt truck battery (100 ampere-hours), thereby eliminating the need to run commercial power to the site located in a national forest. The battery provides the necessary power to operate a 12-volt Grainger electric motor that uses a drive chain to turn each regulating gate pedestal. The motors are not very large, providing 1/15 horsepower at 200 revolutions per minute, but they can raise a 3.5-foot-wide by 5-foot-high slide gate. Because of the remote gate operating system, it is critical that the district adhere to its

Vandalism is a normal concern with most solar panel installations in remote areas. In the summer, the district allows a camper to stay at the dam in exchange for their service as a volunteer caretaker of the dam. This presence deters mischief.

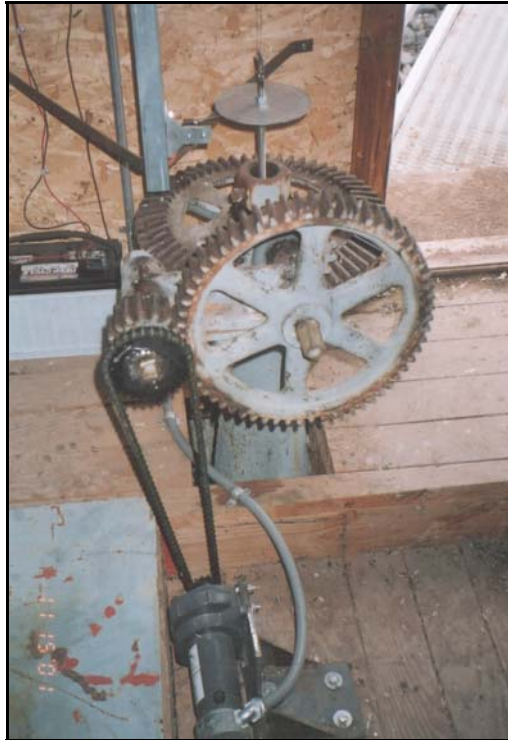
*Motor- and chain-driven gear drive for operating the left regulating gate hoist.*

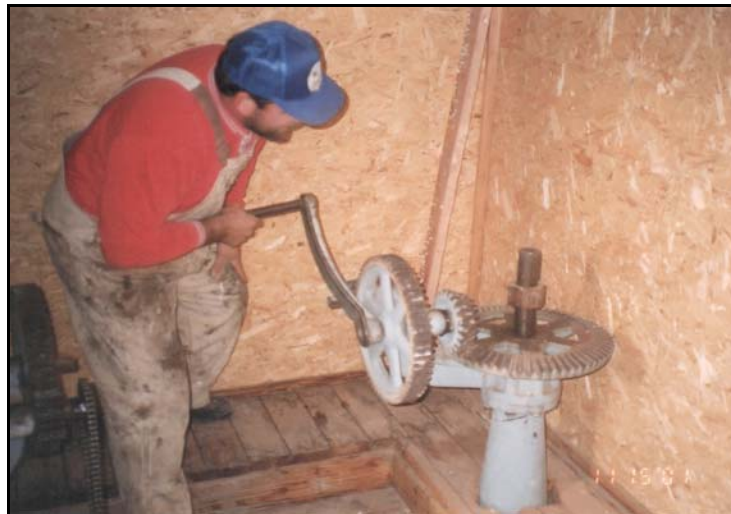
*District employee enthusiastically demonstrates the proper operation of the handcrank mechanism on an emergency gate hoist.*

The handcrank is still available to operate the emergency gates and the right regulating gate, and it can be used as a backup to operating the left regulating gate. After using the remote gate operating system, the district employees do not seem eager to return to their old procedure, which is still needed to operate the emergency gates. A portable generator set

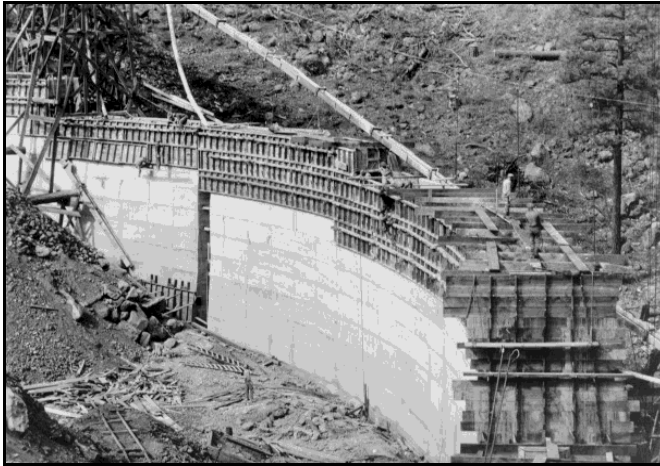
Figure 3.—Gerber Dam under construction.

In 1925, Reclamation completed Gerber Dam, a 25.9-meter (85-foot) high thin arch dam on Miller Creek in southern Oregon. The concrete was placed in 1.2-meter (4-foot) lifts between keyed contraction joints spaced at 15.2-meter (50-foot) centers. To facilitate cooling and contraction of the dam, closure slots were left on each side of the central overflow spillway section, as shown in figure 3. Concrete was placed in these slots at low temperature conditions once the dam had cooled. Extensive field testing was used for quality control, including sieve tests of the sand and aggregate, compression tests on concrete cylinders of concrete taken from the forms, and slump tests. A slump up to 3 inches was permitted to allow the concrete to flow through the placement chutes. Gerber Dam represents the first use

of instrumentation in a Reclamation concrete dam. Electric resistance thermometers, Berry strain gages, and survey targets were installed in the dam. Despite the success of the thin arch dams of the 1920s, Reclamation would opt for thicker and more massive structures throughout the next few decades.

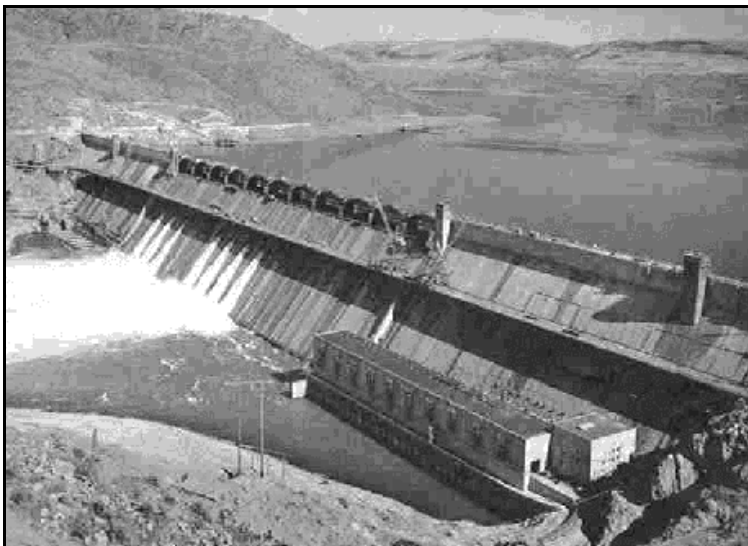
Figure 5.—Grand Coulee Dam under construction.

put to work in completing large multipurpose dams with associated powerplants. Many of these were constructed on large and wide rivers, where it became necessary to construct concrete gravity dams. The largest, and perhaps best known, is Grand Coulee Dam (figure 5) in Washington State, which has been studied and emulated around the world (Reclamation, 1953). As finally constructed, this structure is 550 feet high and nearly 1 mile long. The central spillway section is capable of passing a flow of  $28,300 \text{ m}^3/\text{s}$  ( $1,000,000 \text{ ft}^3/\text{s}$ ).

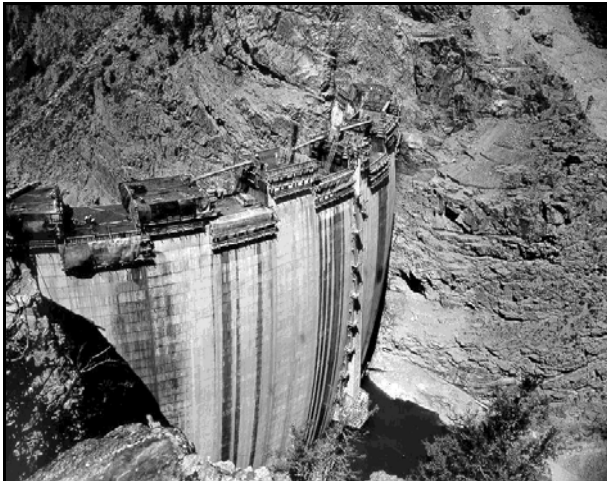
Figure 6.—Upstream face of Morrow Point Dam during construction.

tion of loads within the structure. A double-curvature arch is curved in section view as well as plan view. This results in somewhat of a “bowl” shape. The undercutting at the heel of the dam and the inward curvature on the downstream face that results from this shape eliminate areas where tensile stresses typically develop in arch dams.

The first double-curvature dam constructed by Reclamation is Morrow Point Dam (figure 6). At a height of 143 meters (468 feet), the dam is located in a narrow section of the Black Canyon of the Gunnison River in Colorado. The trial load method of analysis provided

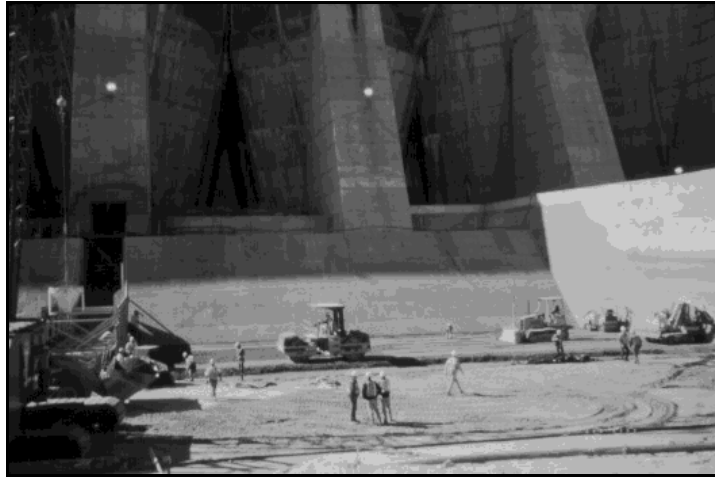
Figure 7.—RCC placement at Pueblo Dam.

The concept of roller-compacted concrete (RCC) involves placement of a lean and dry concrete mix by spreading it in thin layers with a bulldozer and compacting it with vibratory drum rollers. The lean mix reduces the generated heat, and rapid production rates can be achieved using a mechanized construction process. Reclamation began testing a high paste (cement plus flyash) RCC mix in 1980. This resulted in a strong and stiff material with similar properties to conventional concrete and allowed gravity dams of this material to be designed using conventional methods. In 1985, placements began at Upper Stillwater Dam, Reclamation's first RCC dam and, at the time, the world's largest. The straight gravity dam is about 85.3 meters (280 feet) high, 823 meters (2,700 feet) long, and contains over 1,220,000 m<sup>3</sup> (1,600,000 yd<sup>3</sup>) of concrete. Laser-guided slip forms were used to place concrete elements forming the upstream and downstream face of the dam. RCC was placed between the facing elements. The RCC contained more than twice as much flyash as cement. In 1986, over 547,000 m<sup>3</sup> (715,000 yd<sup>3</sup>) of RCC was placed in less than 5 months, and the peak shift placed over 4,100 m<sup>3</sup> (5,400 yd<sup>3</sup>). The major drawback to the design and construction of Upper Stillwater Dam was the exclusion of contraction joints. This resulted in formation of vertical cracks through the structure and significant leakage, requiring remedial measures. Methods were subsequently developed to include joints and waterstops in RCC structures.
