Water Operation and Maintenance Bulletin

No. 228

Repairing Leaking Expansion Joints at Reclamation Facilities

March 2012

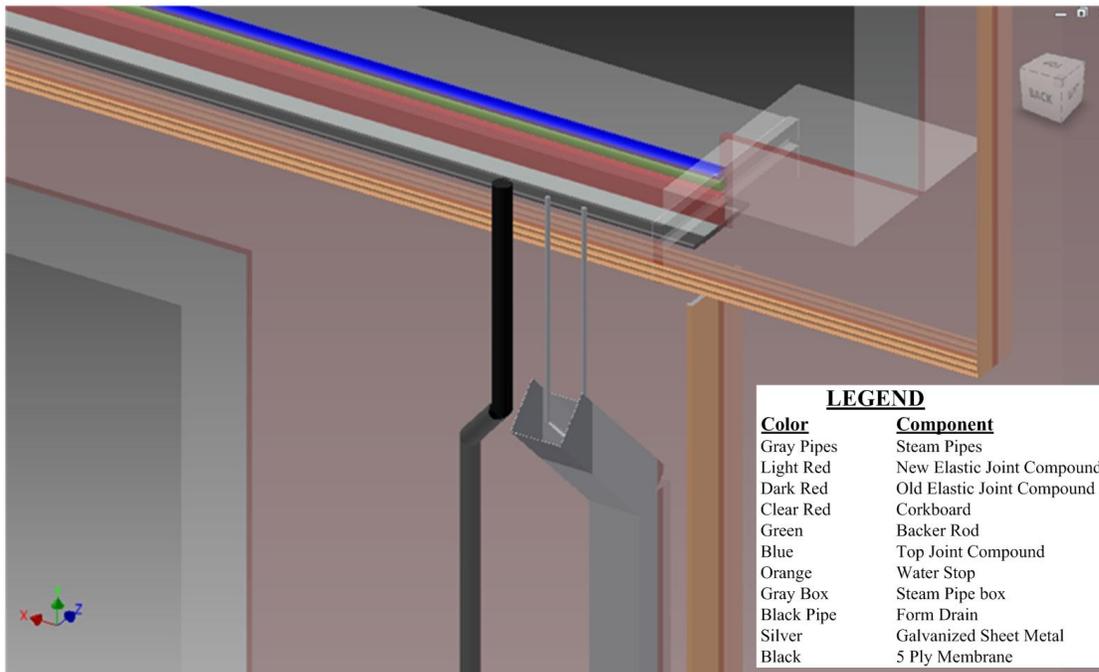
Cover photograph: 3-D diagram of a typical expansion joint at Folsom Dam Powerplant.

The first step to determine the best way to repair the joints was to create a 3-D cross-section drawing of a typical expansion joint at Folsom Dam Powerplant (figure 5). We decided to do this to capture all of the relevant information about the joint, which included the position of the metal plate and water stop, the location of any formed drains that might be present, and the location of embedded steam pipes and asphalt grout channels in or near the joints. We needed to know this for several reasons:

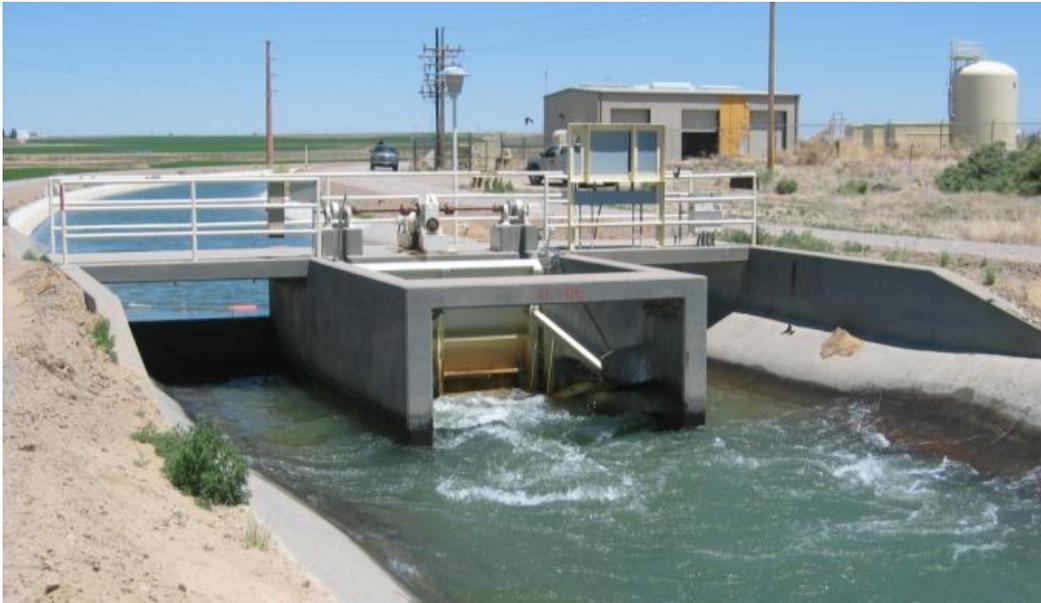
Check structure on the Amarillo Canal, Farmington, New Mexico.

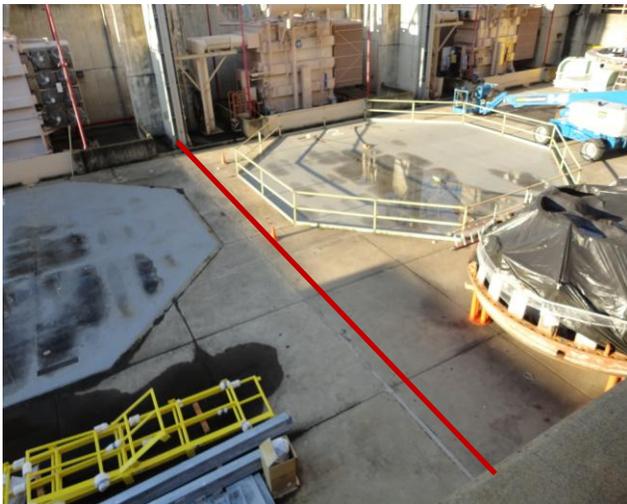
Figure 1.—Folsom Dam Powerplant deck. The red line indicates one of the two expansion joints treated to stop water leaks. To the right, trash cans are used to collect leaking water.

Repairs were performed on the Folsom Dam Powerplant deck (figure 1), the Grand Coulee Pump Generation Plant deck (figure 2), and the Davis Dam Powerplant and transformer decks as well as vertical expansion joints below the transformer deck (figure 3) over about the last 12 months. The facilities were experiencing water leakage through expansion joints, leading to maintenance issues in the spaces below. At Folsom and Davis Dams, the water leakage was threatening electrical components in the powerplant. At Grand Coulee, the water leakage was affecting workers, materials, and equipment in the machine shops below the deck of the Pump Generation Plant.

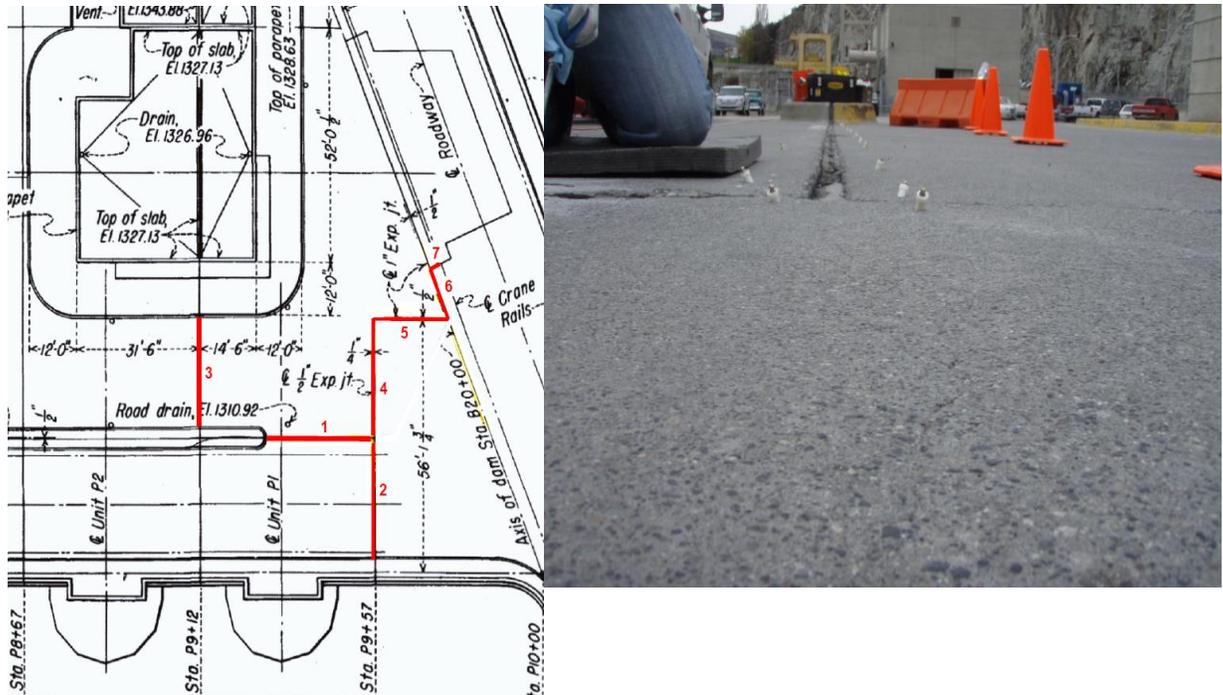
Figure 2.—A portion of Grand Coulee drawing 222-D-11209 showing the Pump Generation Plant deck joints that were grouted and line 1 with grout ports and zerks installed.

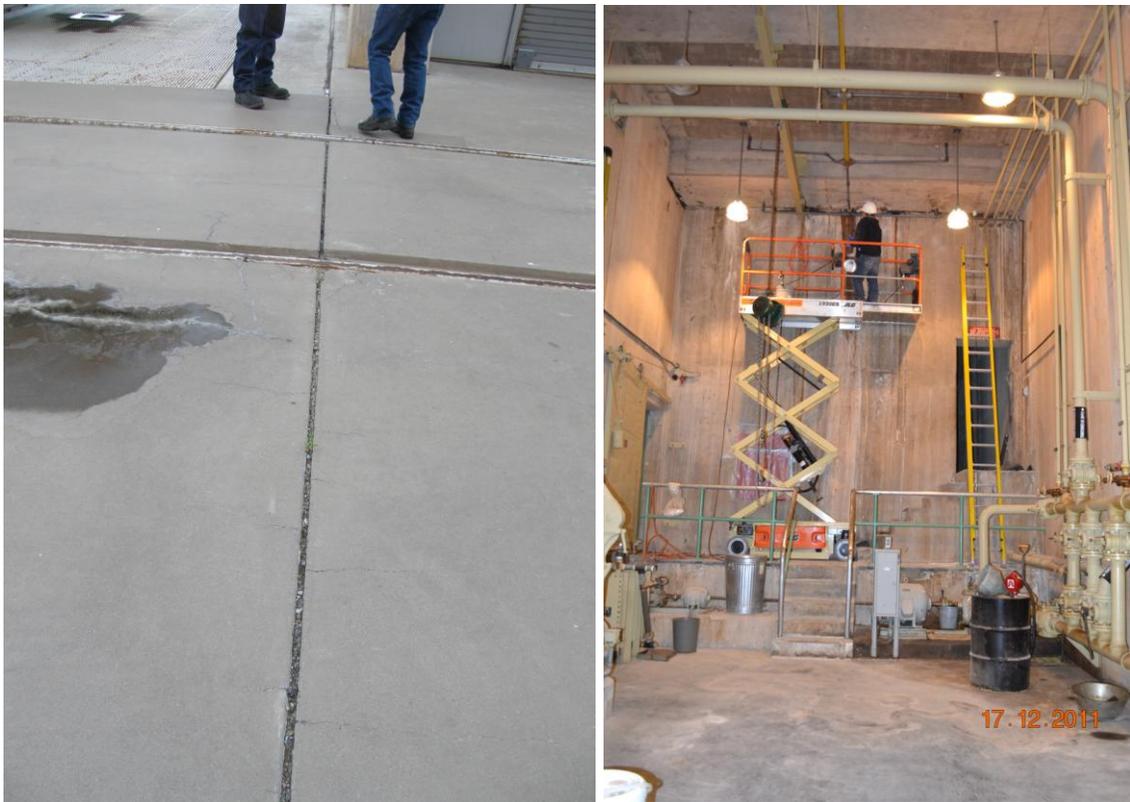
The specific reason that the joints started to leak is unknown. However, we saw evidence at Davis Dam that the joint compound and the cork board were badly deteriorated in some areas. In other areas, there may be a combination of failing membrane waterproofing and existing rock pockets or poorly consolidated concrete that allows moisture to eventually move around the waterstop. During injection work at Folsom, we observed stagnant water being pushed out of the joints by the expanding grout. We also observed several locations where grout easily flowed out the bottom of the joint, indicating there was a path around the rubber waterstop in some locations.

Figure 3.—A typical expansion joint on the transformer deck before repair at Davis Dam and repairs being performed below the transformer deck.

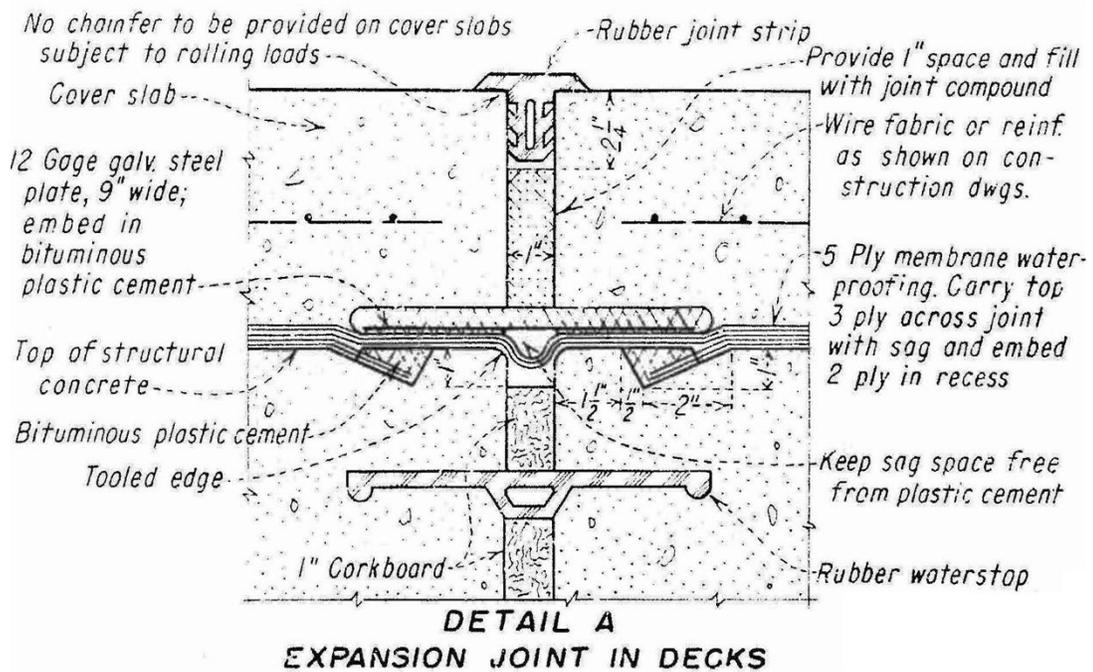
Figure 4.—Typical expansion joint detail.

Many of our facilities are built with a common expansion joint detail (figure 4). While this detail looks like it should last essentially forever, many of our facilities are experiencing leaks through these joints. MERL was first approached about trying to find a way to prevent leaks through the expansion joints at Folsom Dam Powerplant by Peter Funkhouser after he took our Concrete and Concrete Repair class. Previously, staff at Folsom had tried to repair the leaks by replacing the joint compound and rubber joint strip. However, the repairs appeared to have been short lived.

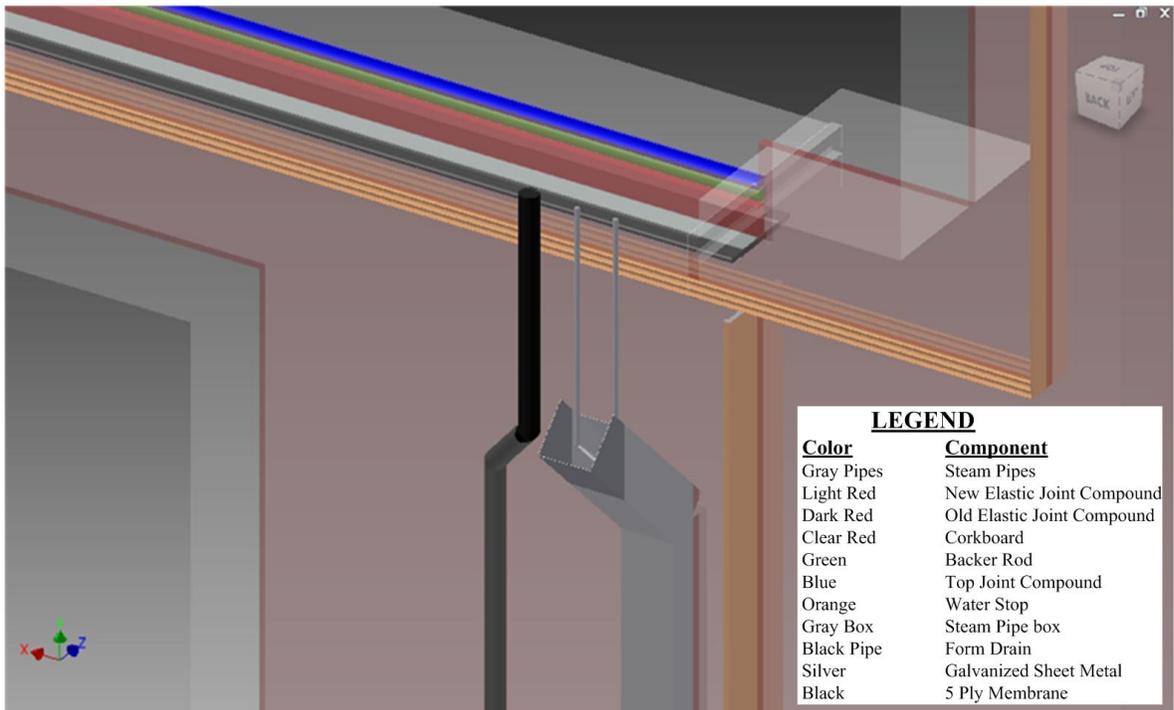
Figure 5.—3-D diagram of a typical expansion joint at Folsom Dam Powerplant.

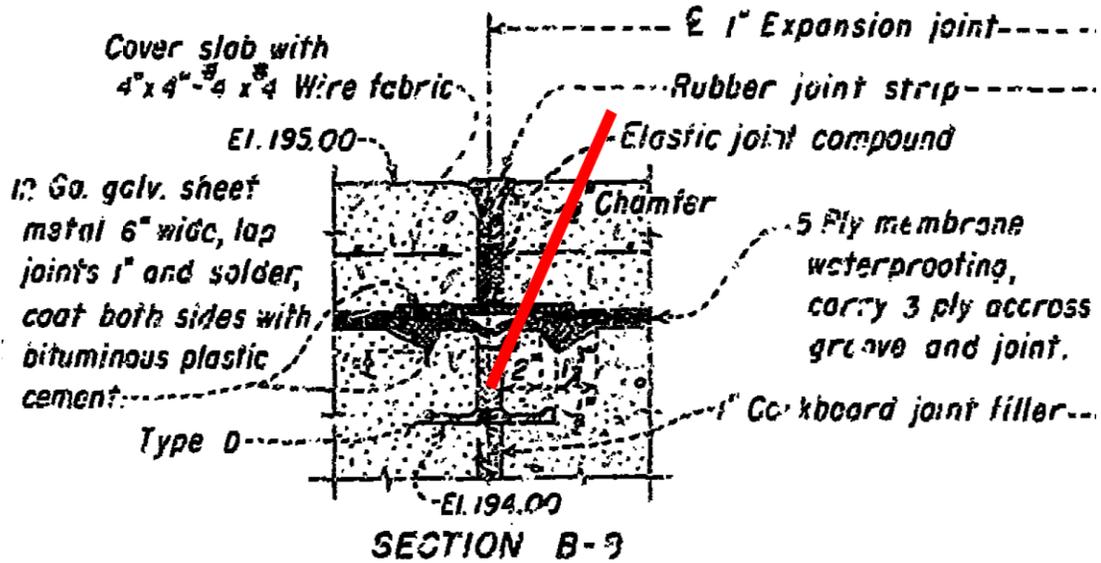
Figure 6.—Angled drilling holes as shown on joint detail from drawing 485-D-73 for Folsom Dam.

After examining the joint details, we determined that the best approach would be to drill ports that were angled to deliver the grout between the top metal plate and the lower rubber waterstop (figures 6 and 7). The metal plate and rubber water stop would serve to help contain the grout as it expanded, which would result in a much more durable repair.

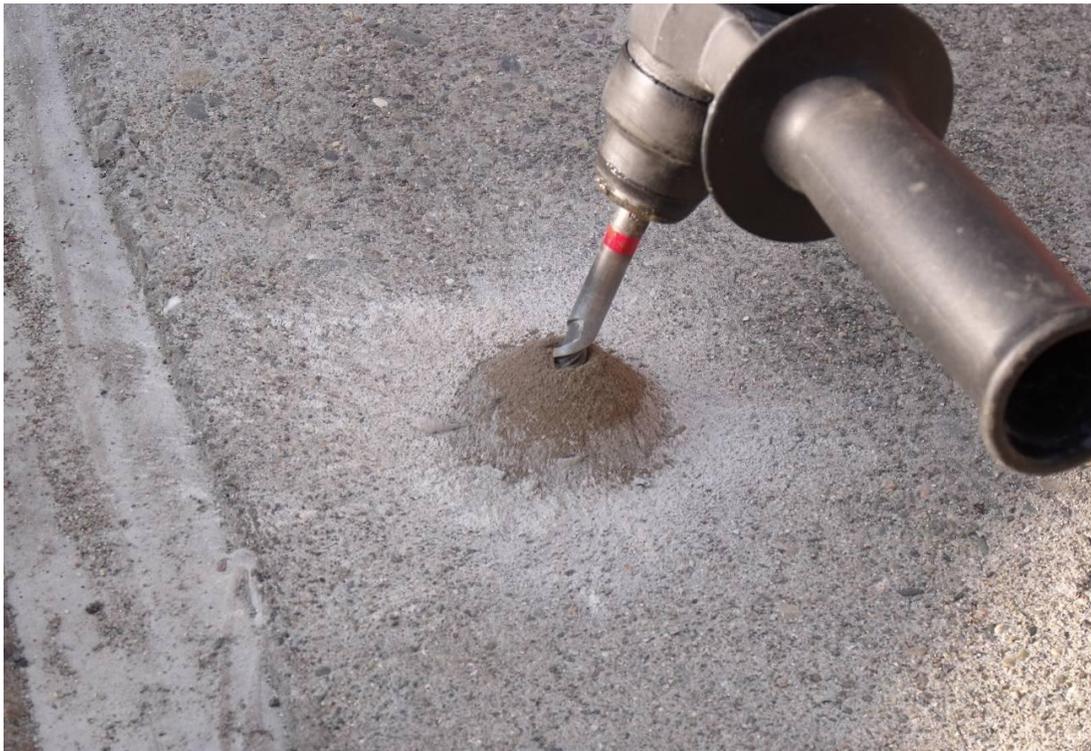
Figure 7.—Drilling holes for inserting grout injection ports. Holes were offset from the expansion joints and drilled at an angle to intercept the joint between the metal seal and the rubber waterstop. Note the change in color of the drill cuttings, indicating the cork board has been intercepted.

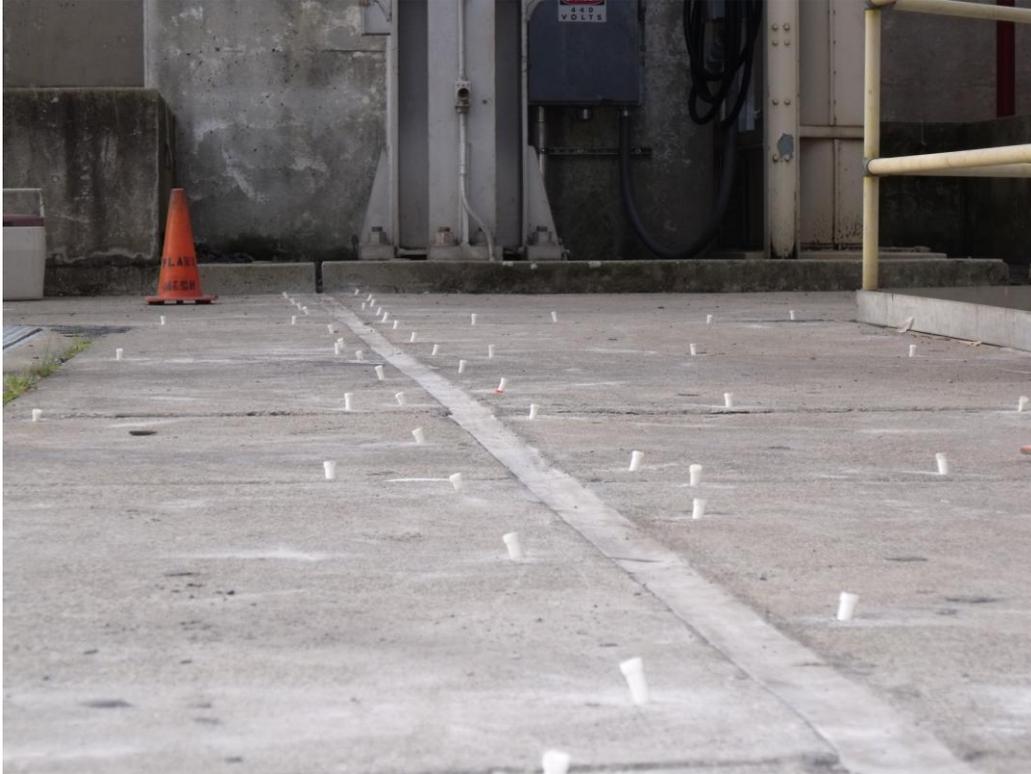
Figure 8.—This photo shows 3/8” plastic hammer-in ports used for chemical grout injection into one of the expansion joints and surrounding area of the Folsom Dam Powerplant deck.

Since the majority of the grouting would be at relatively low pressure, we were able to use simple, plastic hammer-in ports (figure 8) for most of the work. After the plastic ports were installed, grease zerks were pushed into the open ends of the ports for attachment to the grouting assembly.

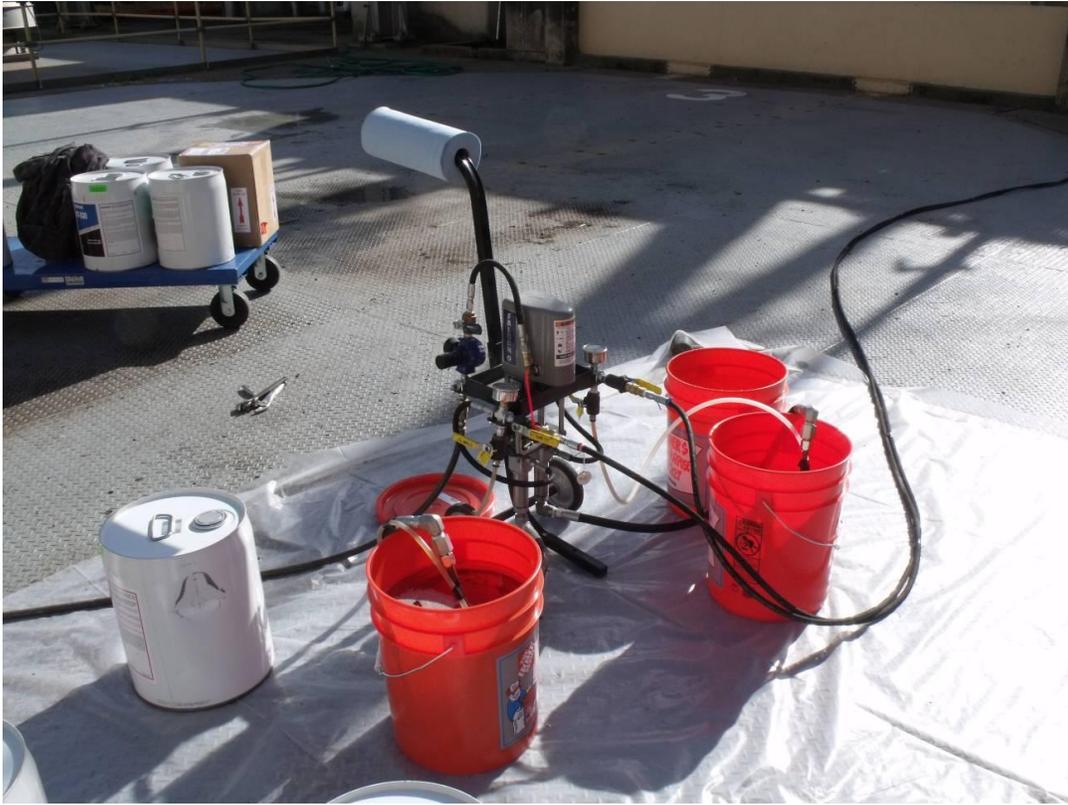
Figure 9.—Air-powered, two-cylinder pump that is pumping a single component polyurethane resin (left bucket).

Because of these conditions and requirements, polyurethane grouts were selected for use. There are many types of polyurethane grouts to choose from. For most of the work, we selected a single component water-activated hydrophilic resin. These resins tend to cure relatively quickly and form a flexible foam product. For this type of work, these resins are usually mixed with equal parts water using

special pumping equipment (figure 9). The resin and water are pumped separately to an “F-assembly” where water and resin are mixed just prior to injection (figure 10).

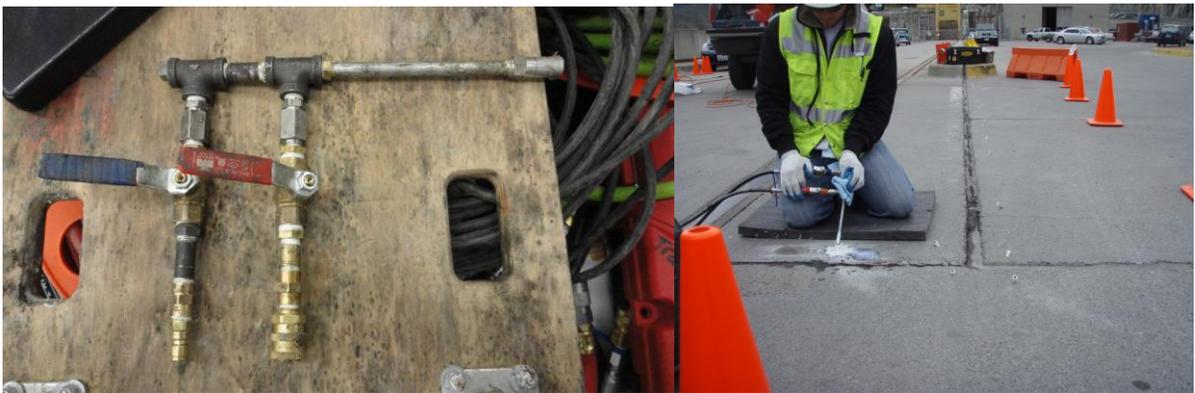
Figure 10.—A MERL employee injects a single component, water-activated polyurethane grout into an expansion joint of the Grand Coulee Pump Generation Plant deck. The fixture attached to a port is called an “F-assembly,” which mixes the water and resin together.
