Water Operation and Maintenance Bulletin

No. 235

Epoxy Grouting of the Hansen Siphon Pier Damaged During
the Colorado Flooding
Cost-Effective SCADA Development for Irrigation Districts: A
Nebraska Case Study

EPOXY GROUTING OF THE HANSEN SIPHON PIER DAMAGED DURING THE COLORADO FLOODING

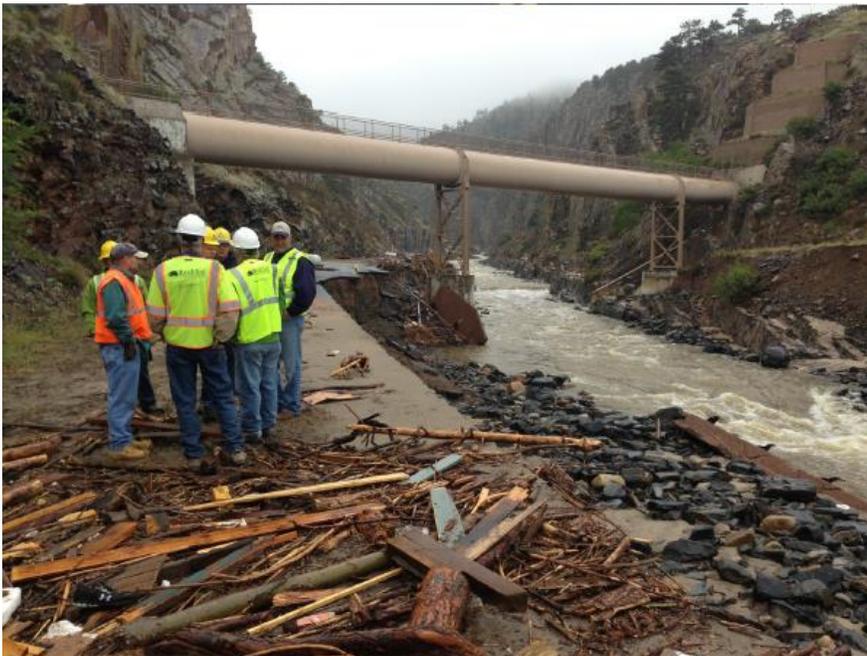
Cover photograph: Flood damage after historic September flooding in Colorado. Photo is looking west at what was Highway 34 next to the Big Thompson River at the Hansen Siphon crossing between Loveland and Estes Park, Colorado.

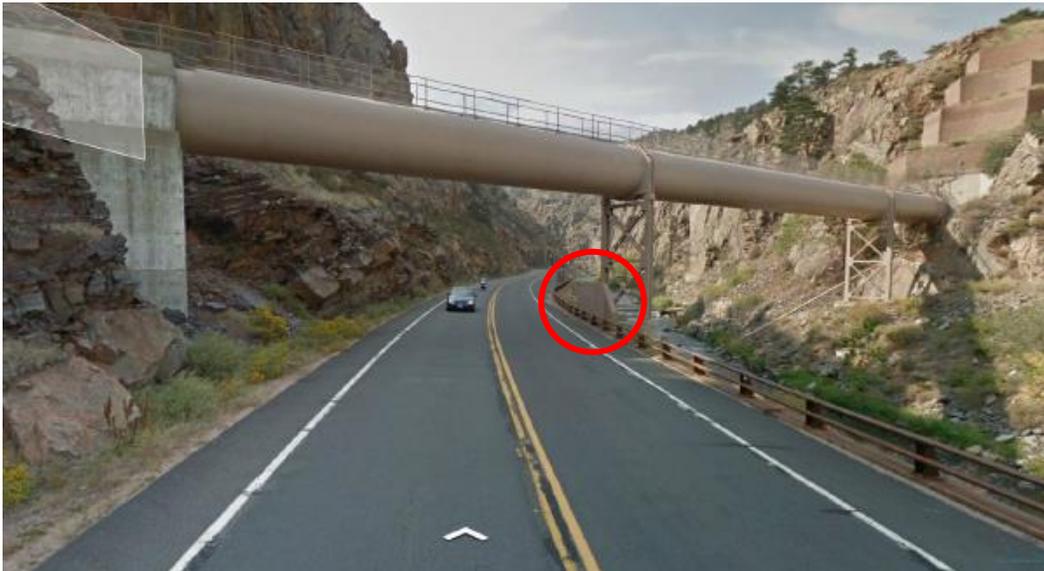
Figure 1.—View of Highway 34 looking west before the flood event. Note the retaining wall circled in red.

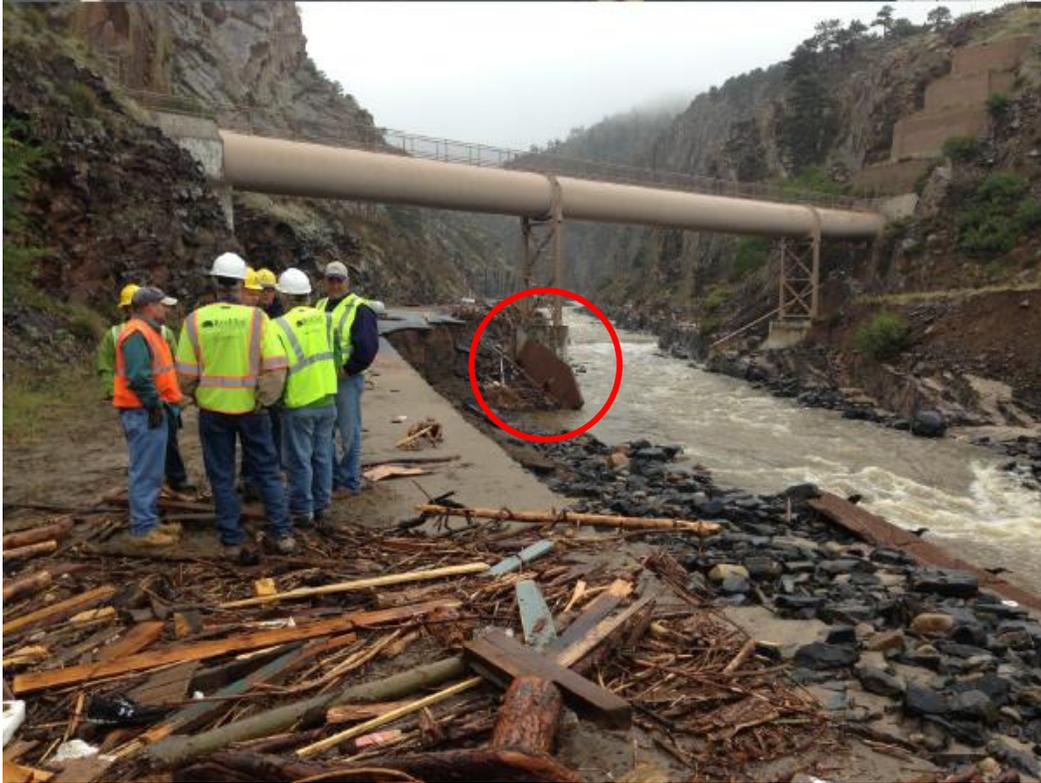
Figure 2.—View of Highway 34 looking west after the flood event. Note the retaining wall circled in red.

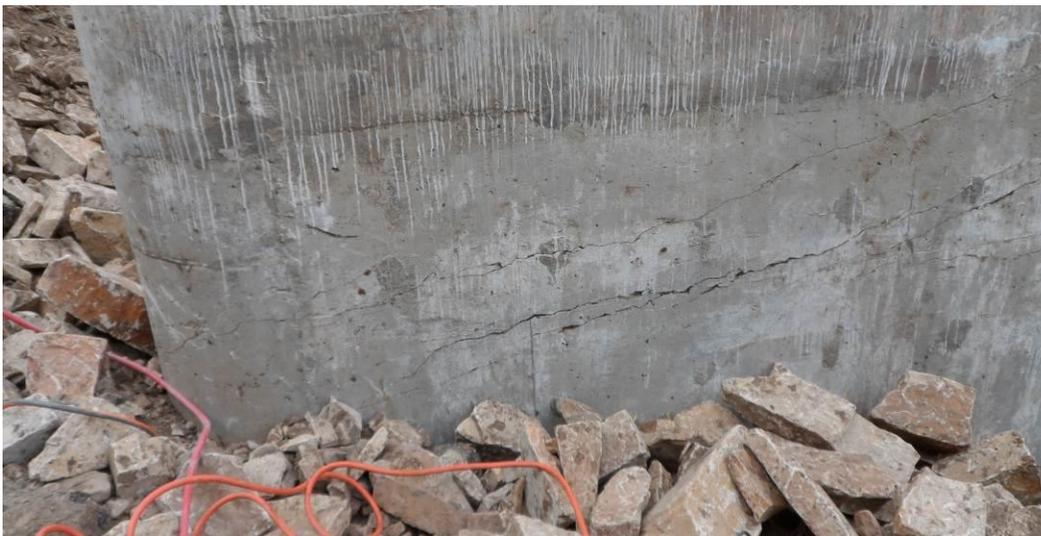
Figure 3.—Cracking on the upstream, roadside face of the pier.

An examination of the damage by Kurt von Fay and Tim Brown of the Technical Service Center (TSC) lead to the conclusion that it could be repaired and structurally rebonded via epoxy injection. The timeline to perform the repairs was short and urgent due to the construction schedule for rebuilding Highway 34 between Loveland and Estes Park, Colorado, and coincided with the recent Government shutdown. At that time, Westin Joy, Brandon Poos, and Warren Starbuck of MERL performed the repairs.

After the initial site visit and inspection, structural calculations were completed for the pier. TSC personnel determined that the structural capacity of the pier could be regained by injecting a structural epoxy into the cracks. MERL staff had previously conducted epoxy injection into concrete walls and slabs and offered to perform these repairs. The use of Bureau of Reclamation employees would fast-track the repair work, allowing the highway contractor to proceed with work on Highway 34 near the pier.

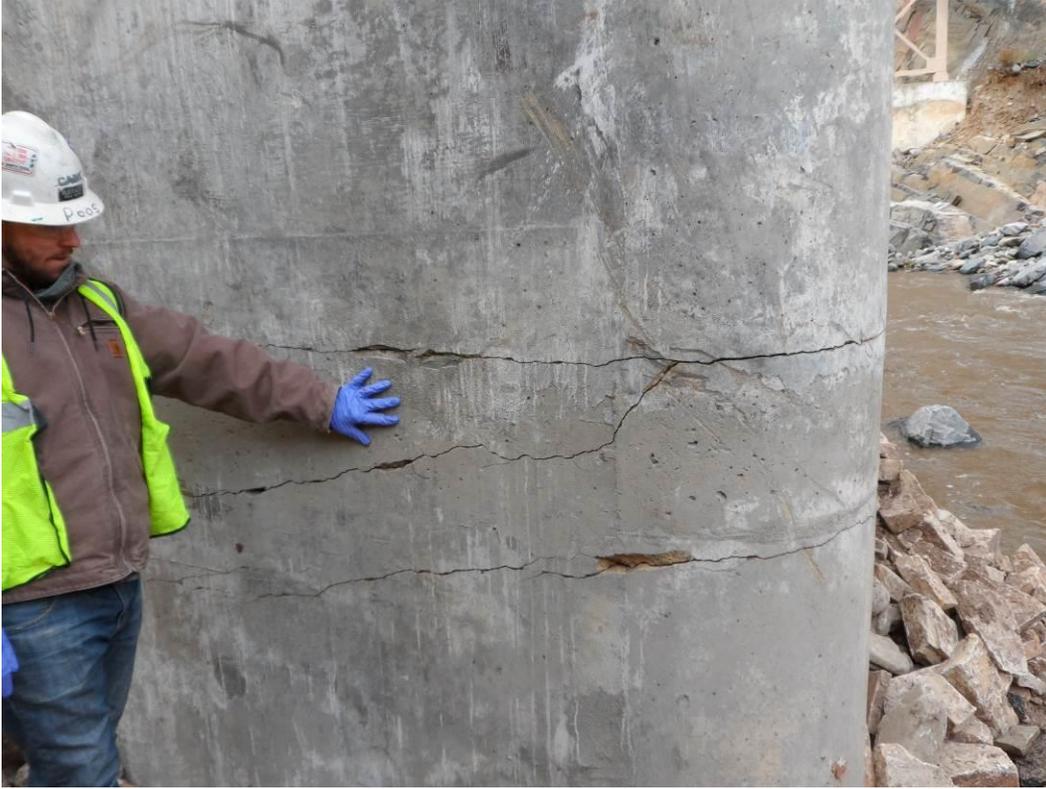
Figure 4.—Closeup of largest cracks. Cracks were largest on the downstream, roadside face and get smaller as they progressed upstream on the roadside face. No cracks were visible on the streamside of the pier.

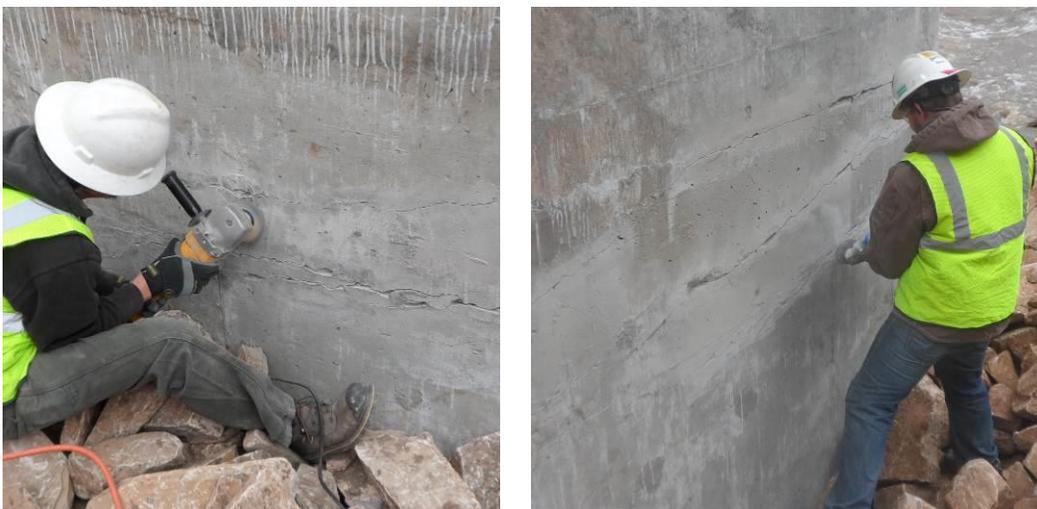
Figure 5.—The crew used angle grinders fitted with abrasive discs to remove debris and flatten the surface prior to attaching injection ports and sealing the cracks.

Surface preparation also plays a vital role in achieving a successful, long-lasting repair. In the case of epoxy injection, the surface needs to be prepared to allow for proper adhesion of the injection ports and capping material over the surface of the cracks. This was accomplished by grinding the surface of the concrete directly over and around the cracks (figure 5), which removes debris from the surface and creates a flat surface for the injection port. After grinding is complete, the surface and the inside of the cracks should be air blasted to remove any remaining dust and debris.

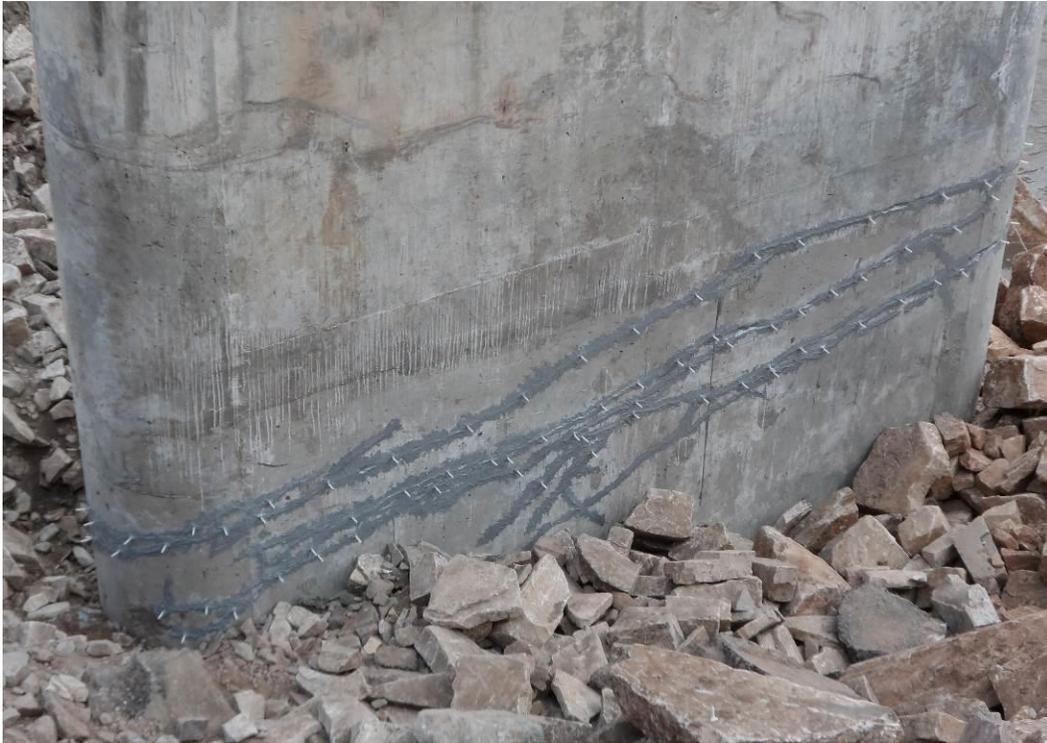
Figure 6.—Injection ports and surface sealing have been applied to the cracks in the pier. Note the cracks without injection ports that have been sealed to prevent possible leakage.

Once the surface is prepared, the next step of the epoxy injection process is to install the injection ports and seal the surface of the cracks. The injection ports used for epoxy injection are typically surface mounted rather than drilled and set packers. Due to the low viscosity of the epoxy material, it is usually not necessary to drill injection holes. The injection ports are affixed to the surface directly above the crack with a fast-setting, high viscosity epoxy. Once the ports are in place, the same epoxy is applied to the surface of the cracks to prevent the low viscosity epoxy from leaking out of the cracks. In some cases, it is necessary to seal the surface of the cracks that do not appear to connect to the crack that is to be injected. The cracks may intersect somewhere within the concrete and could potentially lead to epoxy leakage. Additionally, due to the low viscosity of the

material, it may even leak from cracks that are not visible to the naked eye. Figure 6 shows the injection ports and surface sealing in place for the cracks in the pier.

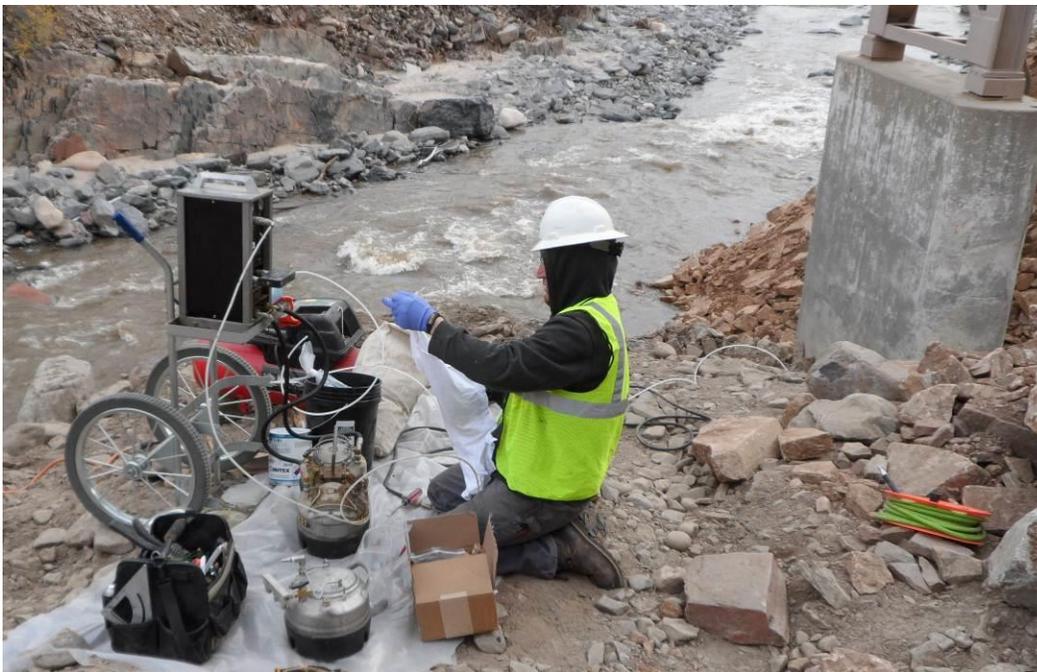
Figure 7.—Pneumatic pump used for epoxy injection. The pier can be seen in the right in the photo.

There are numerous ways to pump the epoxy into the ports, including two-component caulking guns, pneumatic caulking guns, and pneumatic pumps. Due to the low temperatures, the crew used a pneumatic pump. The low temperature caused the viscosity of the epoxy to increase to the point where it would be difficult to pump by hand. Figure 7 shows the pneumatic pump used for injection. Also seen in this figure are the reservoirs for the A and B components of the epoxy resin system. The third reservoir contains acetone for flushing the system after the work is completed.

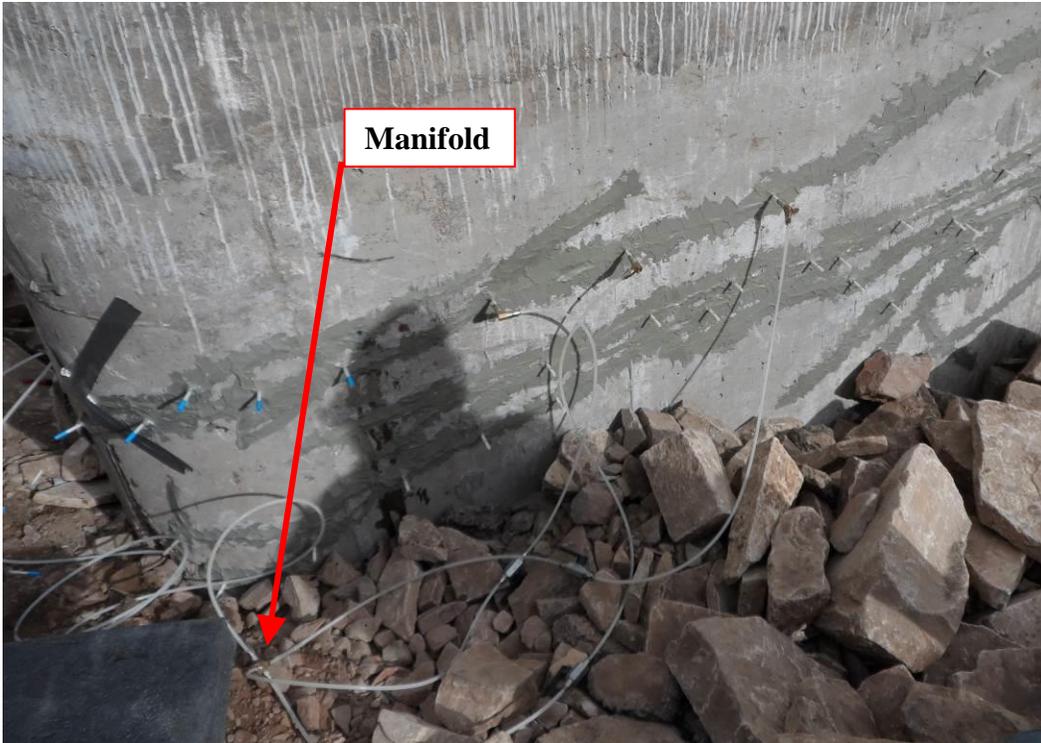
Figure 8.—Injection lines and manifold. Note the simultaneous injection of three ports.

The injection began at the lowest point of the cracking. By beginning the injection at the lowest point, air is allowed to escape as cracks are filled, leading to a more complete filling. In this instance, there were three main cracks to be injected, and each crack was injected from the lowest point at the upstream end of the pier, and progressed downstream and upward. To facilitate a quicker injection rate, the crew assembled a manifold and injected three ports simultaneously. The manifold and injection lines can be seen on figure 8.

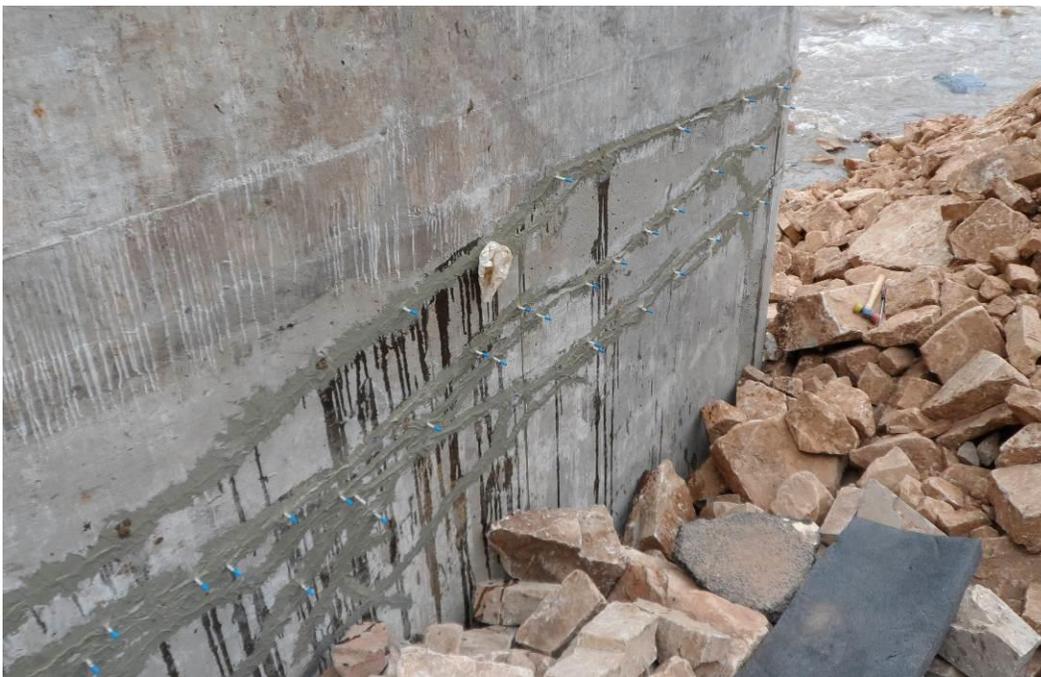
Figure 9.—Epoxy leaking from hairline cracks and through areas of the capping material.

After a port has been injected, a cap is placed over the port to prevent the injected epoxy from leaking out of the crack. The crew pumped just under 2 gallons of epoxy. There was a small amount of leakage around some areas of the capping material and from cracks that we could not see before injection began (figure 9). Additionally, there was material loss associated with removing the injection lines from a port. Accounting for losses, the crew injected approximately 1.6 gallons of epoxy into the cracks. The gel and final cure times of the epoxy vary depending on temperature, and given the concrete temperature of about 42 degrees Fahrenheit, the gel and cure times would be relatively long. After completing the injection work, the crew cleaned up the site and returned a few days later to inspect it. When they returned, the crew removed the injection ports and inspected the exposed portions of the cracks. Figure 10 shows epoxy filling a crack at the site of an injection port.

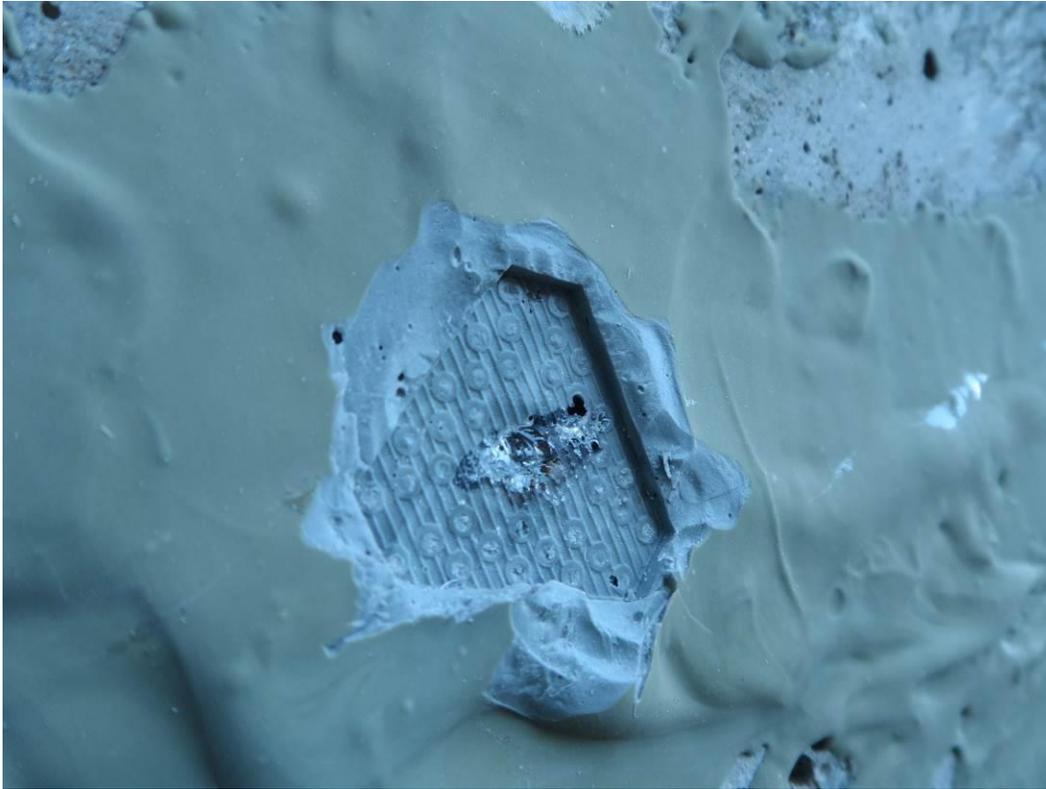
Figure 10.—Epoxy can be seen within the crack after a port was removed.

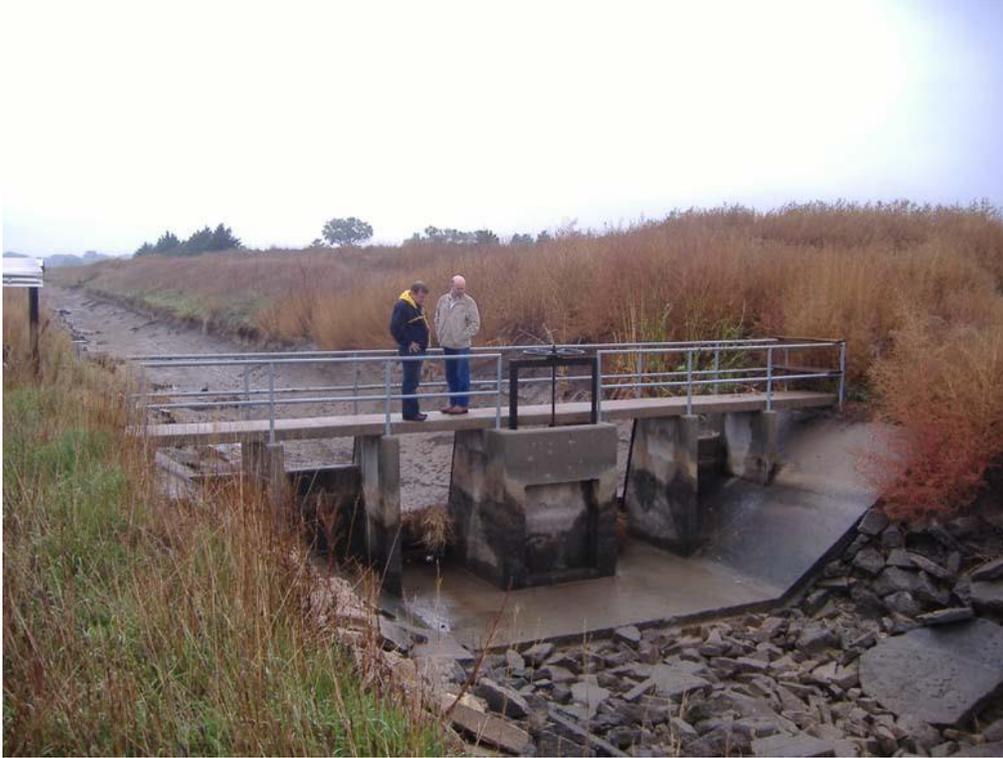
Figure 1.—Reclamation engineer Clinton Powell (left) and Nebraska Bostwick Manager Mike Delka inspect the 5.4 check in February 2009.

The 10 selected checks represented two general design configurations. The upper seven checks were each three-bay structures, the two outer bays were stop-log controlled, and the center bay was a vertical slide gate. None of the gates were motorized. District staff indicated that the vertical slide gates had remained in closed position at all times for as far back as presently employed personnel could remember. The district opted to rebuild existing gates prior to installing the control and communications equipment. Since district staff were tied up on the project of converting open laterals to buried pipe, the district contracted with a local welding shop to construct new gates for the seven upper three-bay structures. Figure 1 shows the three-bay 5.4 check.

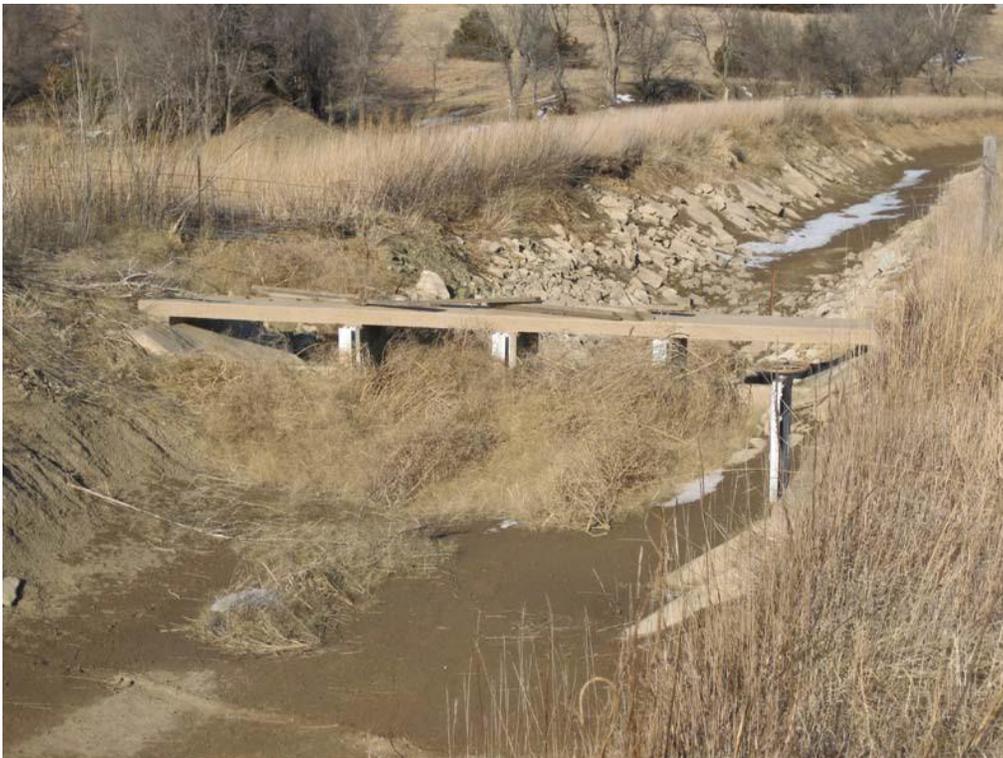
Figure 2.—Nebraska Bostwick 34.2 check in February 2009.

The three checks lower on the canal that the district selected for motorized gate operation initially had no gates installed. Each of these sites was a two-bay structure with stop-log control in each bay. District staff fabricated new vertical slide gates to install in one of the stop-log bays at each of these checks. Figure 2 shows the 34.2 check site.

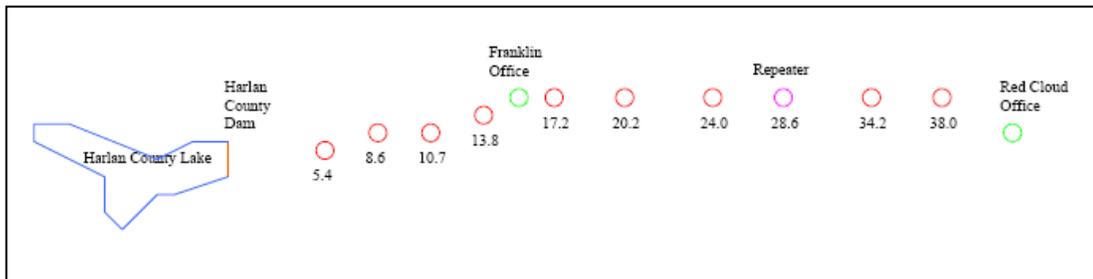
Figure 3.—A layout sketch of approximate locations of the radio/communication sites.

A sense of scale may be derived from figure 3 from check identifier names. The identification number for the Franklin Canal checks represent the number of canal miles they are located from the gate house below Harlan County Dam. It should be noted in the context of the discussions on radio transmission paths that the landscape throughout the project area can be characterized as rolling hills. Much of the radio pathway being utilized is not line of sight.

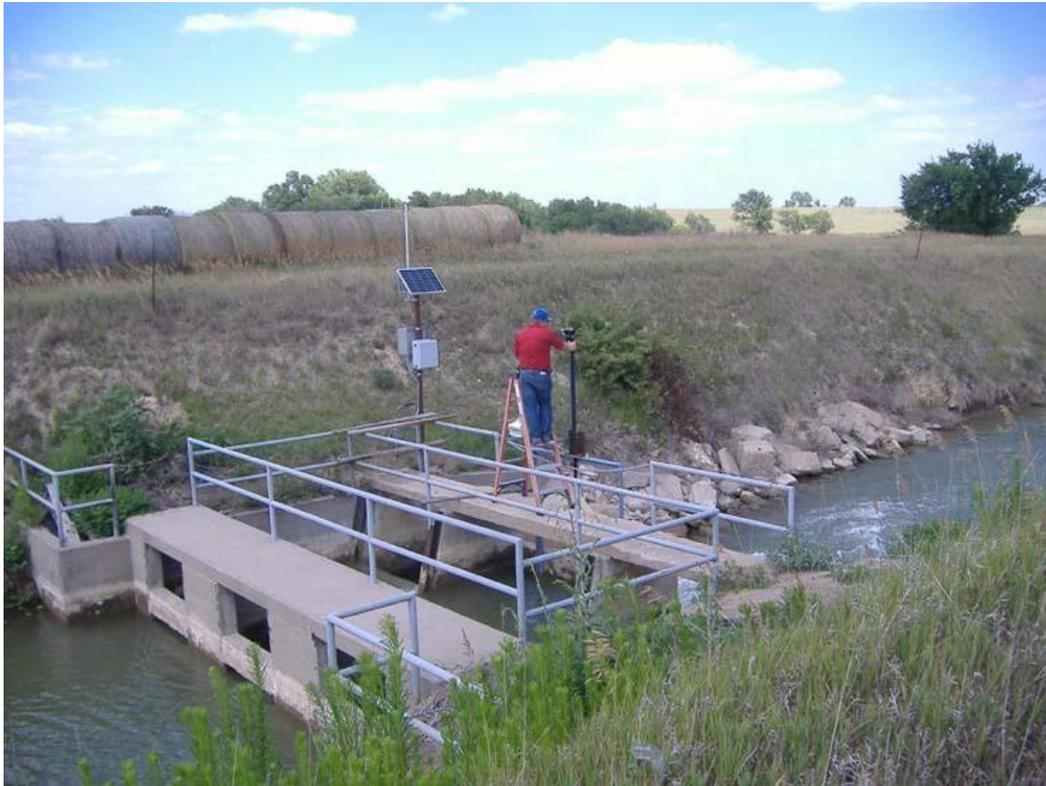
Figure 4.—Reclamation engineer Clinton Powell makes wiring connections on the linear actuator at the Nebraska Bostwick 20.2 check.

throughout much of the irrigation season. Limitations on the time commitments of Reclamation staff proved to be a bottleneck in completion of this task. Reclamation's staff was primarily responsible for calibration and testing of the electrical and electronic components. At sites where gate motorization was not yet functional, canal stage adjustments were made by adjusting stop logs in bays adjacent to the gated bays in the same manner the system had been operated in previous years. Figure 4 shows the final stages of hardware installation at the 20.2 check, and figure 5 shows the same site from a different angle.

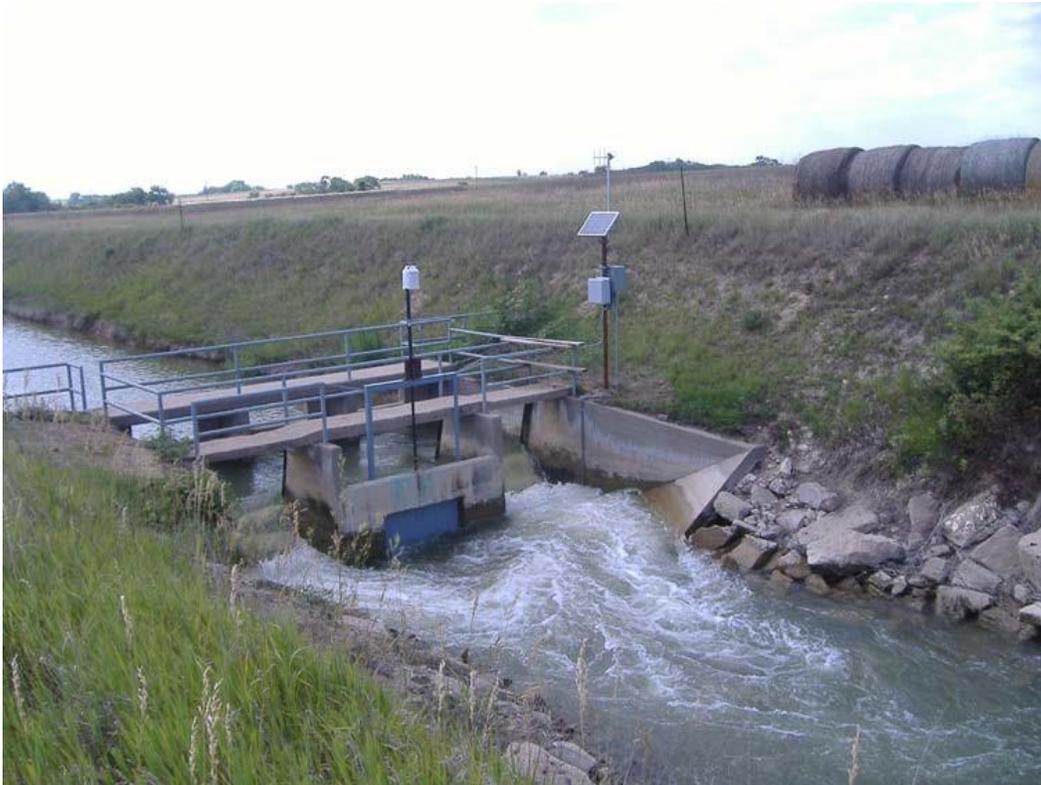
Figure 5.—Completed hardware installation at the Nebraska Bostwick 20.2 check.

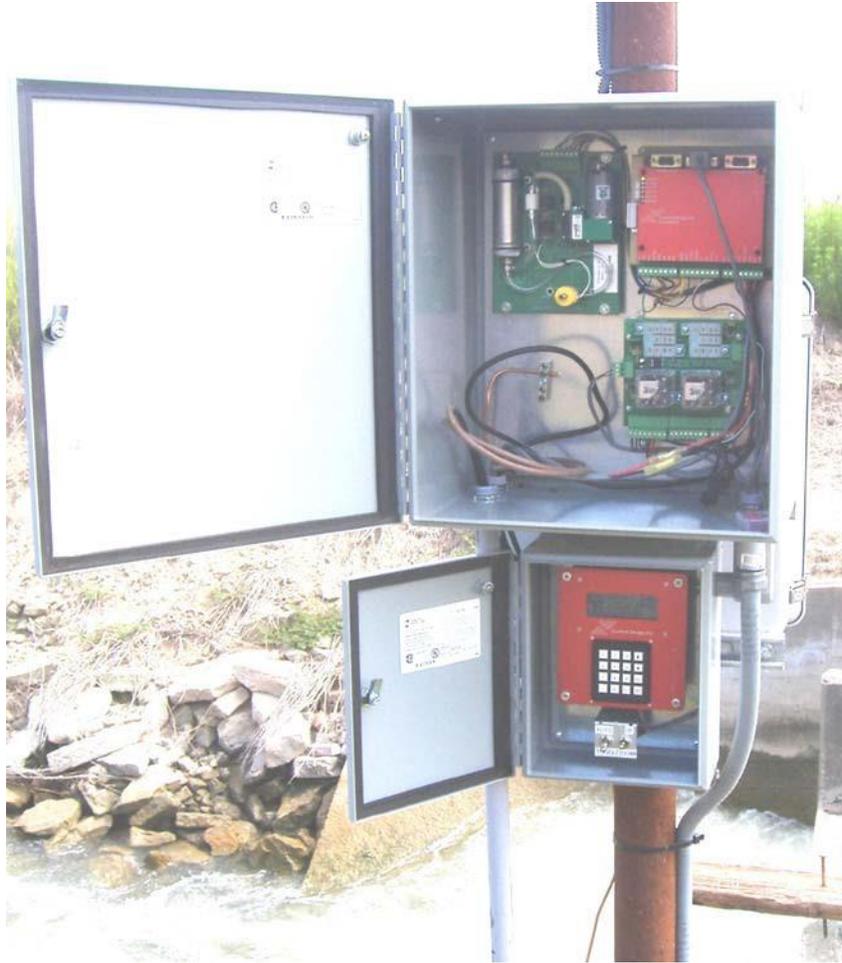
Figure 6.—Control components (upper enclosure) and user-interface components (lower enclosure).

insects disrupting the function of electronic components. For the Nebraska Bostwick project, external display and keypad components are located in a separate enclosure to reduce the potential for exposure of sensitive electronic components to the elements. To further isolate sensitive components from potentially corrosive agents, the battery is housed in a separate enclosure on the opposite side of the pole from the control equipment.

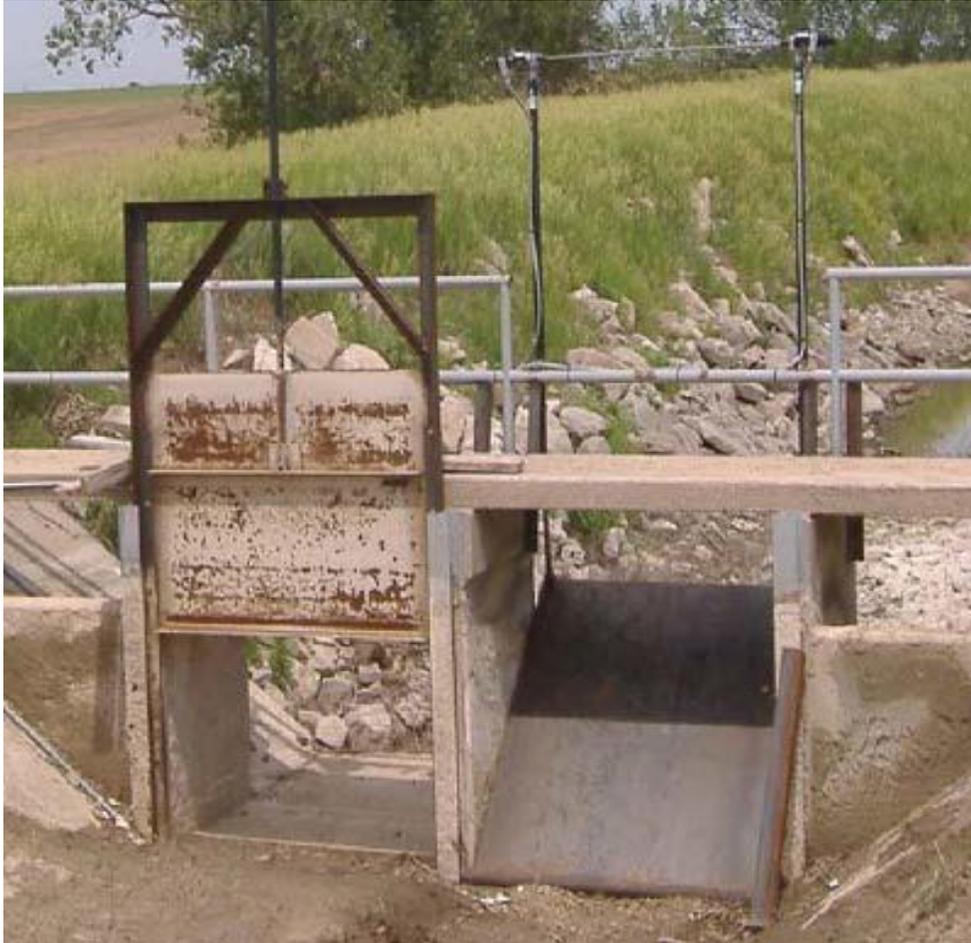
Figure 7.—Vertical slide and overshot gates at the 28.6 check both motorized using DC linear actuators.

expanding this modernization effort at an affordable rate until ultimately all main canal checks have similar automated or remote operating capability. Figure 7 shows the district's 28.6 check where motorized gates have been installed in previously stop-log controlled bays prior to the beginning of the 2010 irrigation season.
