Landslides

Best Practices in Dam and Levee Safety Risk Analysis

Chapter H-2 Landslides

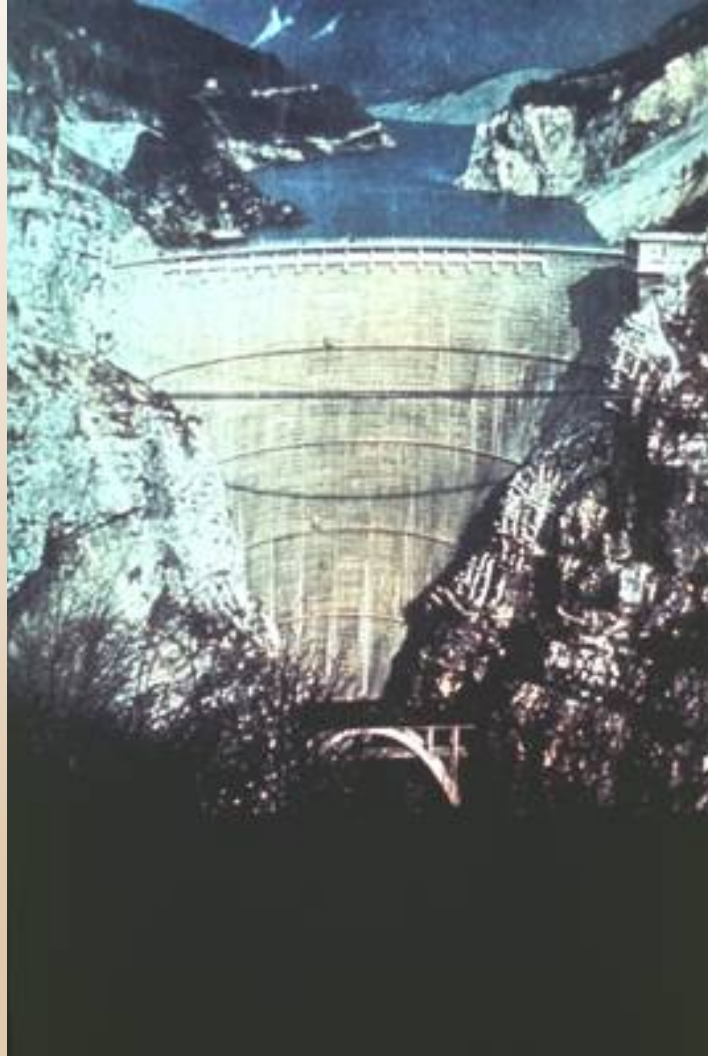
Vaiont Dam, Italy

- 870' high arch dam on Vaiont River near Longarone, Italy
- Completed in 1960
- The foundation and reservoir slopes composed of bedded limestone
- Left bank slide mass from post-glacial period

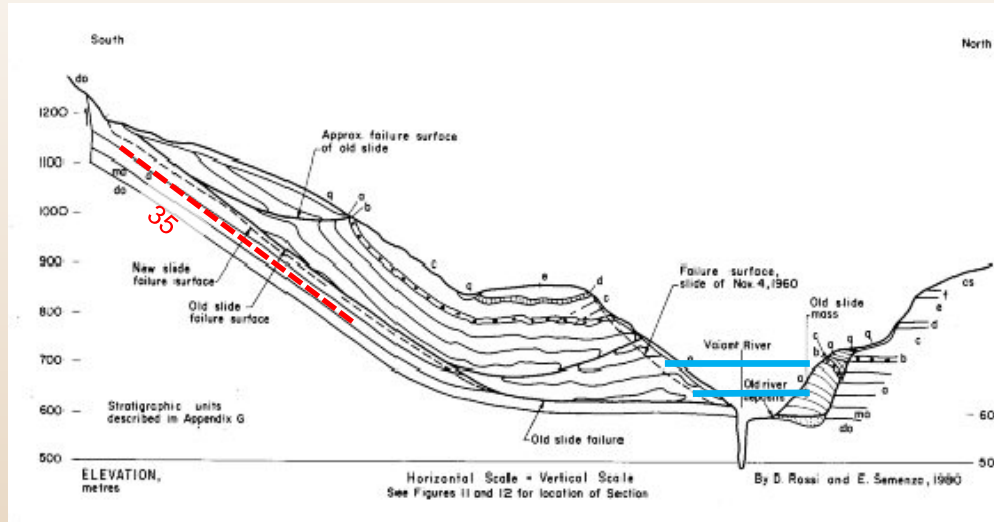
Vaiont Dam (Overtopping Wave)

- A part of the mountain side slid into the reservoir on Oct. 9, 1963
- Filled the entire reservoir for a mile upstream of the dam creating huge wave
- Sliding occurred on clay-filled bedding planes with $\phi = 10$ to 12° with dip of $35^\circ \pm$ to 0°
- Approx. 250 million yd^3

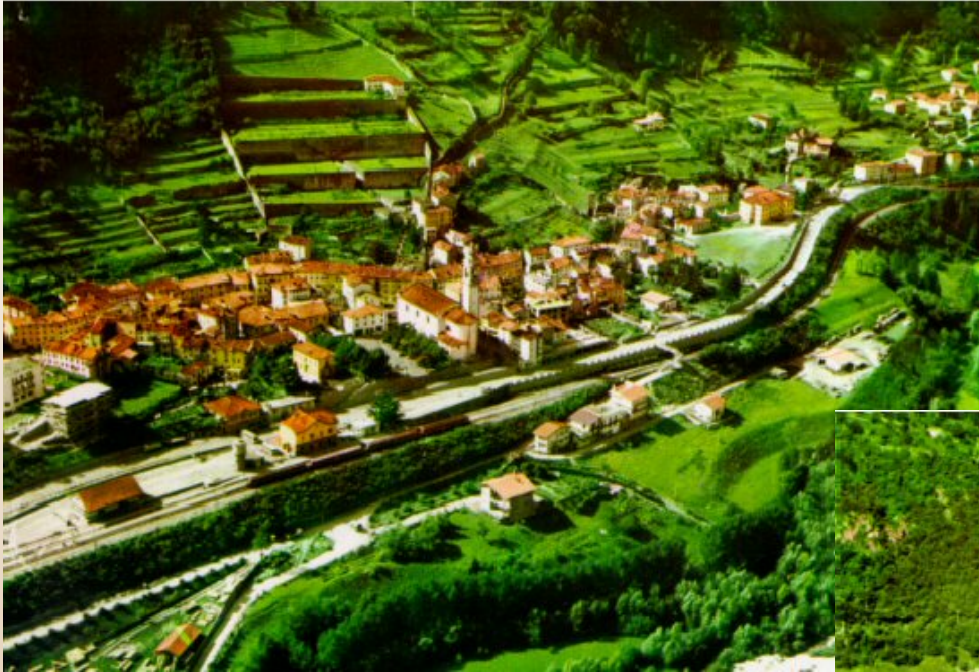
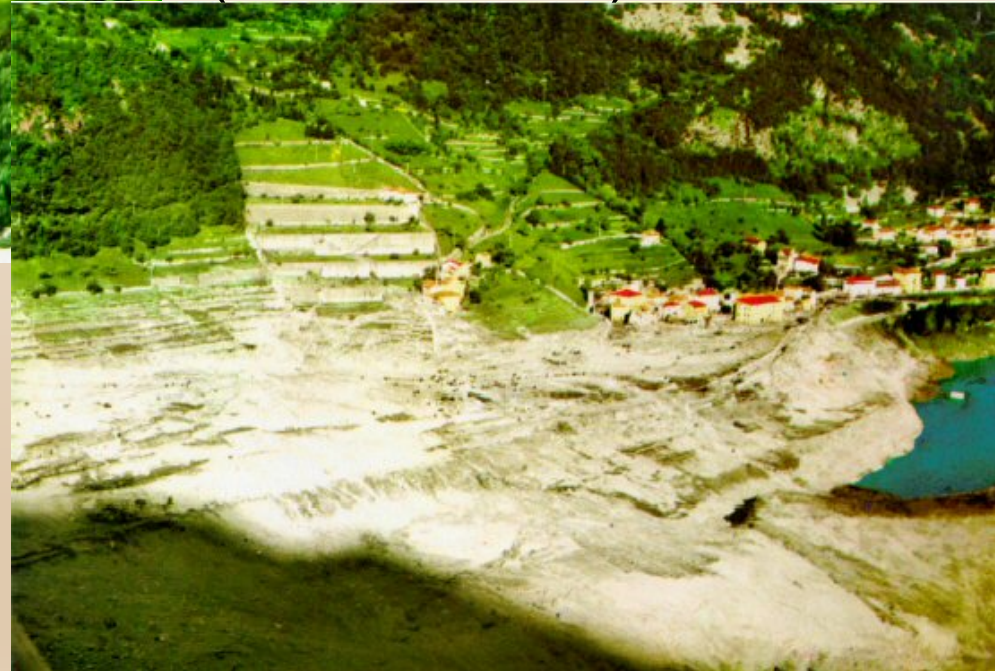
Vaiont Dam

Slide sent wall of water
330' high over the top of
the dam downstream
(dam survived)

2600 fatalities in the
village of Longarone
downstream

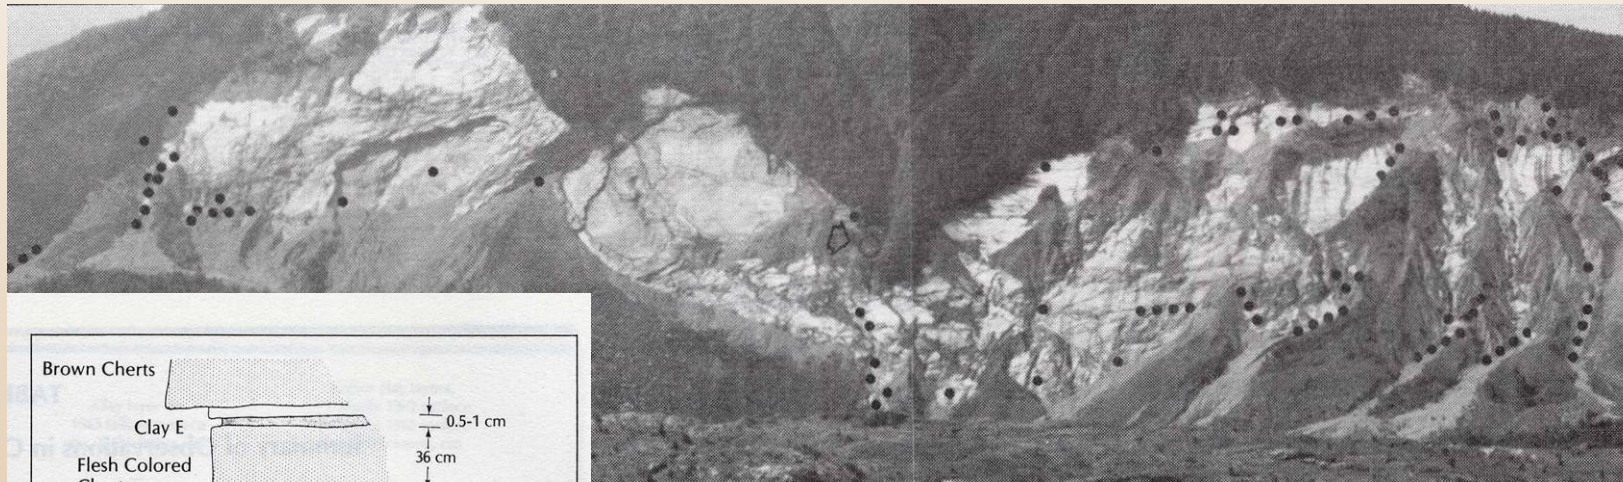
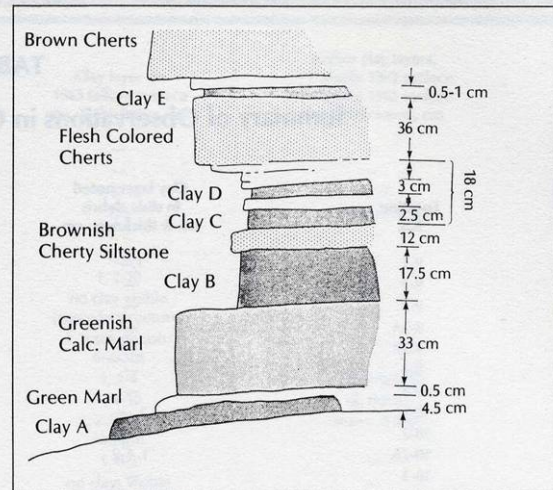
FIGURE 19. A sketch of the outcrop of Malm rocks southwest of Casso. This outcrop lies in the same stratigraphic sequence as those at the base of the Vaiont Slide.

Similar
sequence
outside slide
area

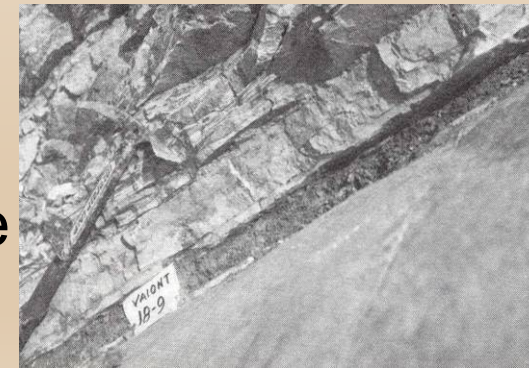
Clay layer at slide plane

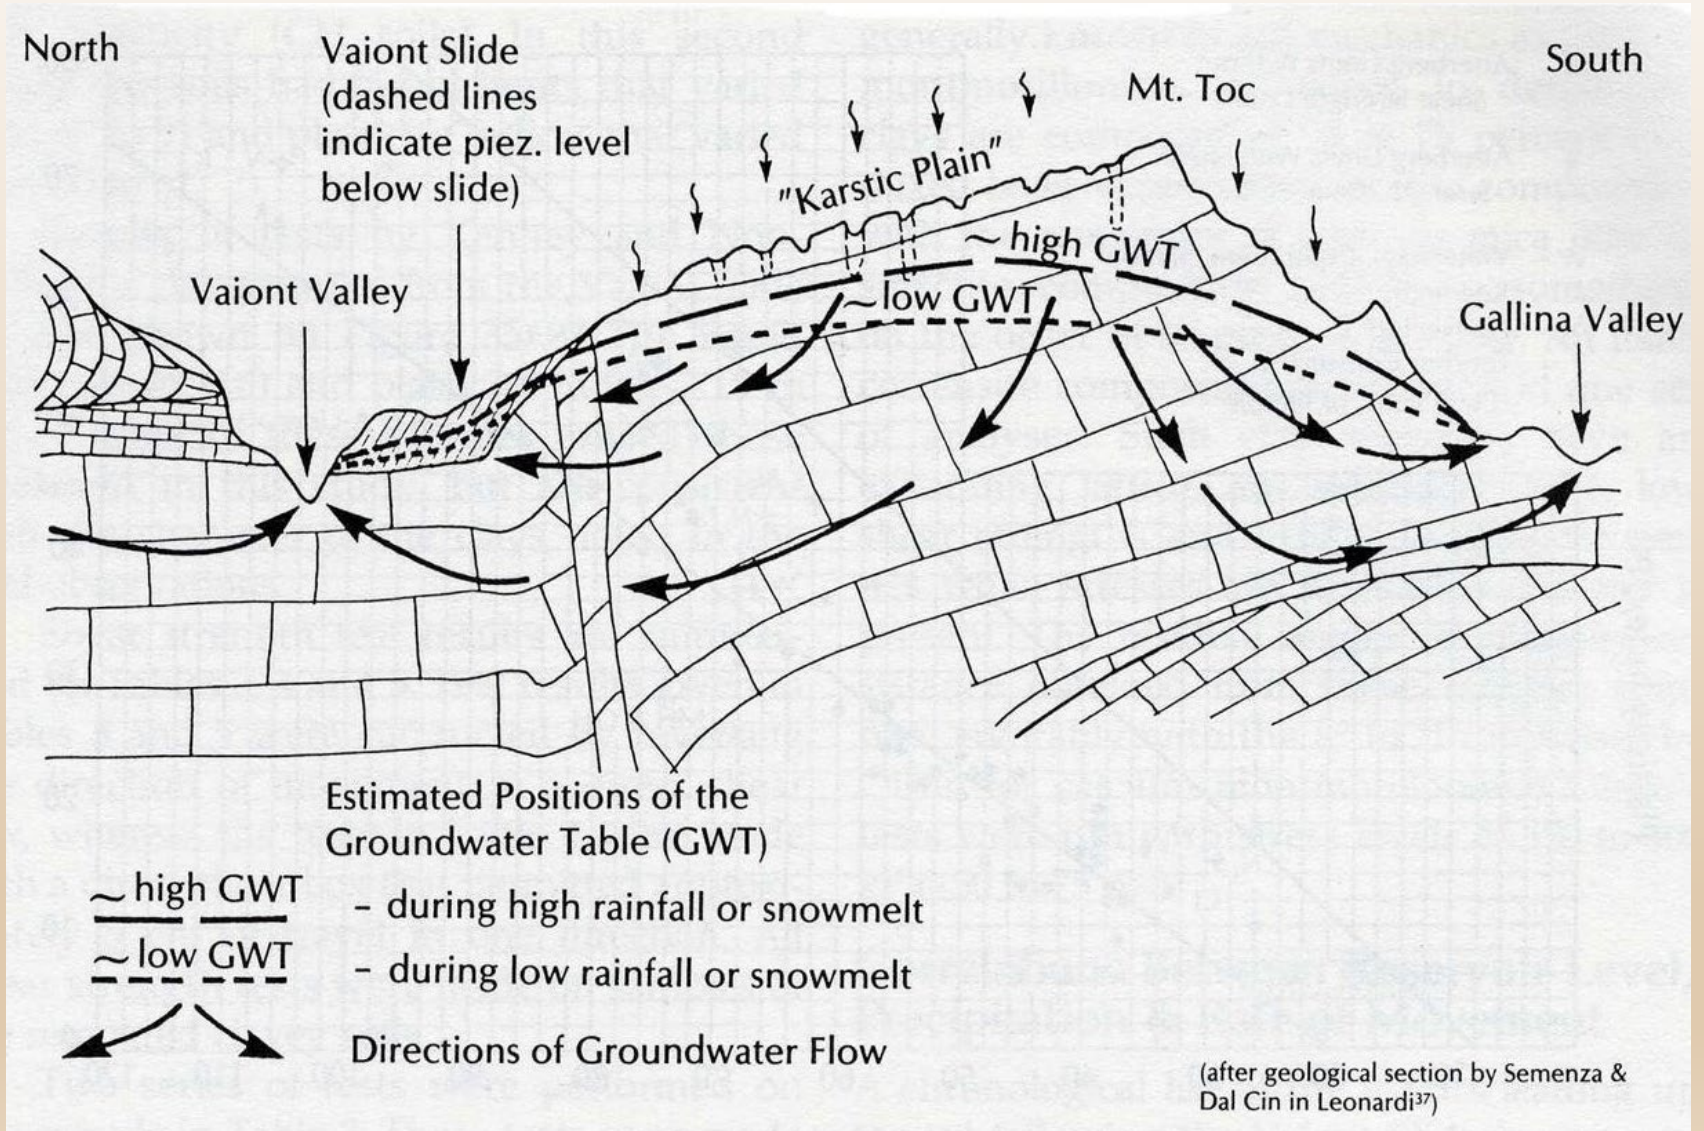
- Karstic terrain groundwater system
- **What effect does this have on the landslide mass?**

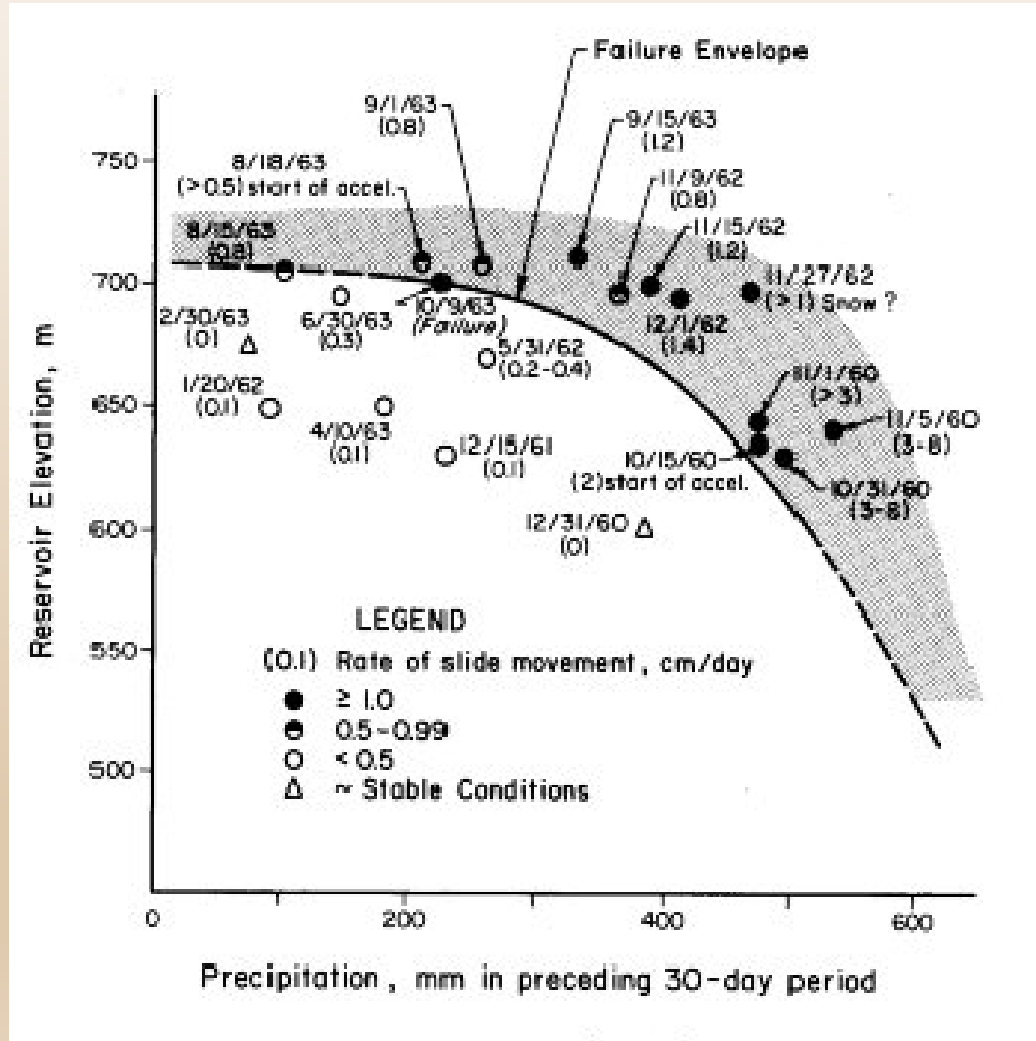
Vaiont Dam Landslide

Combination high reservoir and high rainfall caused slide

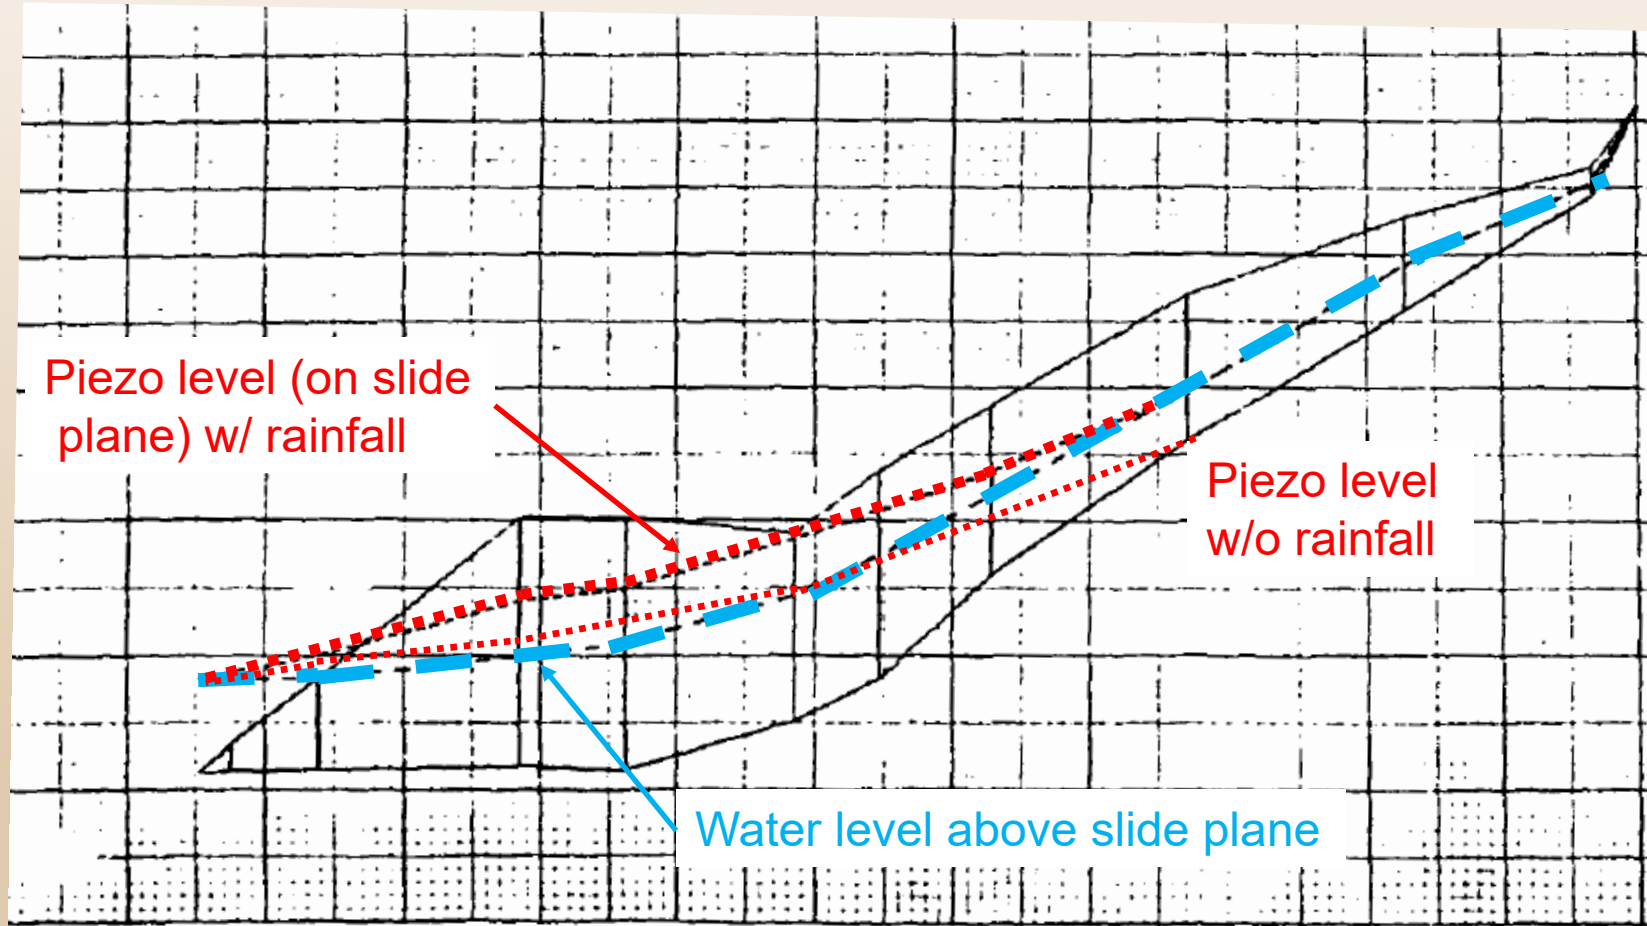
Res (m)	Rain	F.S.
710	High	1.00
710	Low	1.10
650	High	1.08
650	Low	1.18
None	High	1.12
None	Low	1.21

Vaiont Slide - Semenza Section 2, 710 m reservoir, October 1963, with rainfall

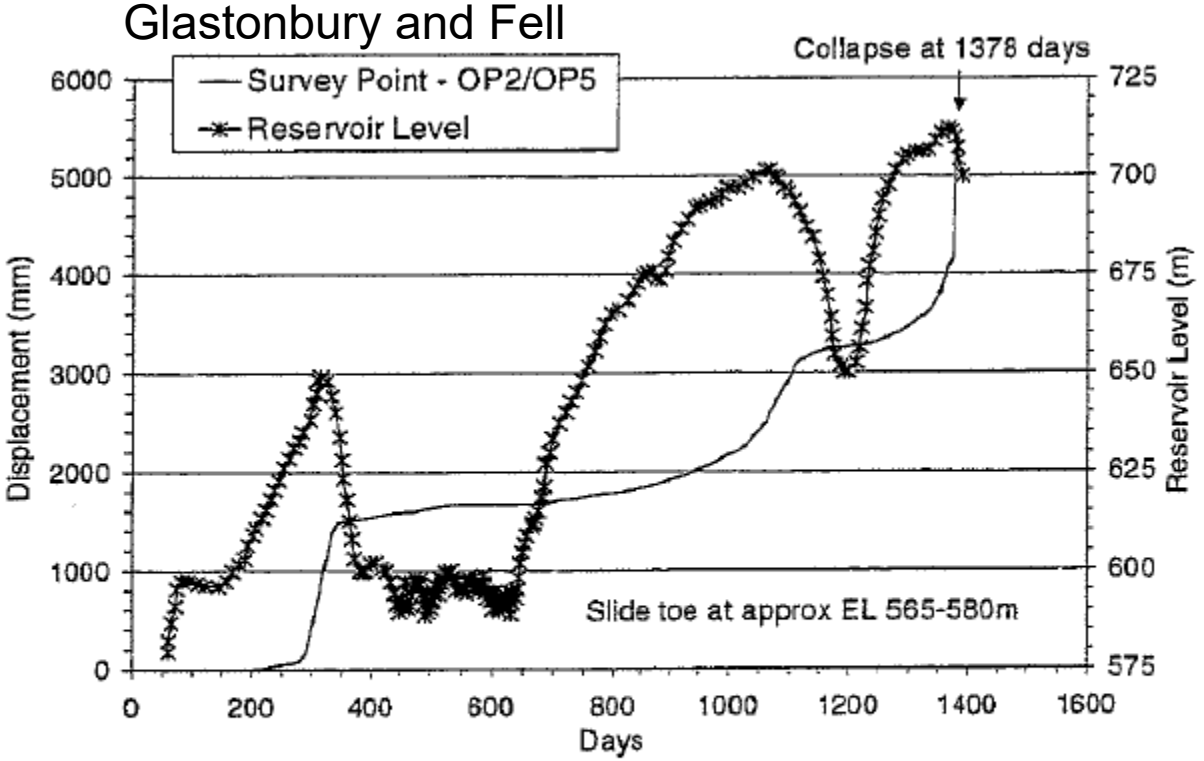
Displacement and Reservoir Level vs Time

Figure Q : Displacement-time data for Vaiont showing relationship with reservoir level (Data modified from Hendron and Patton, 1985).

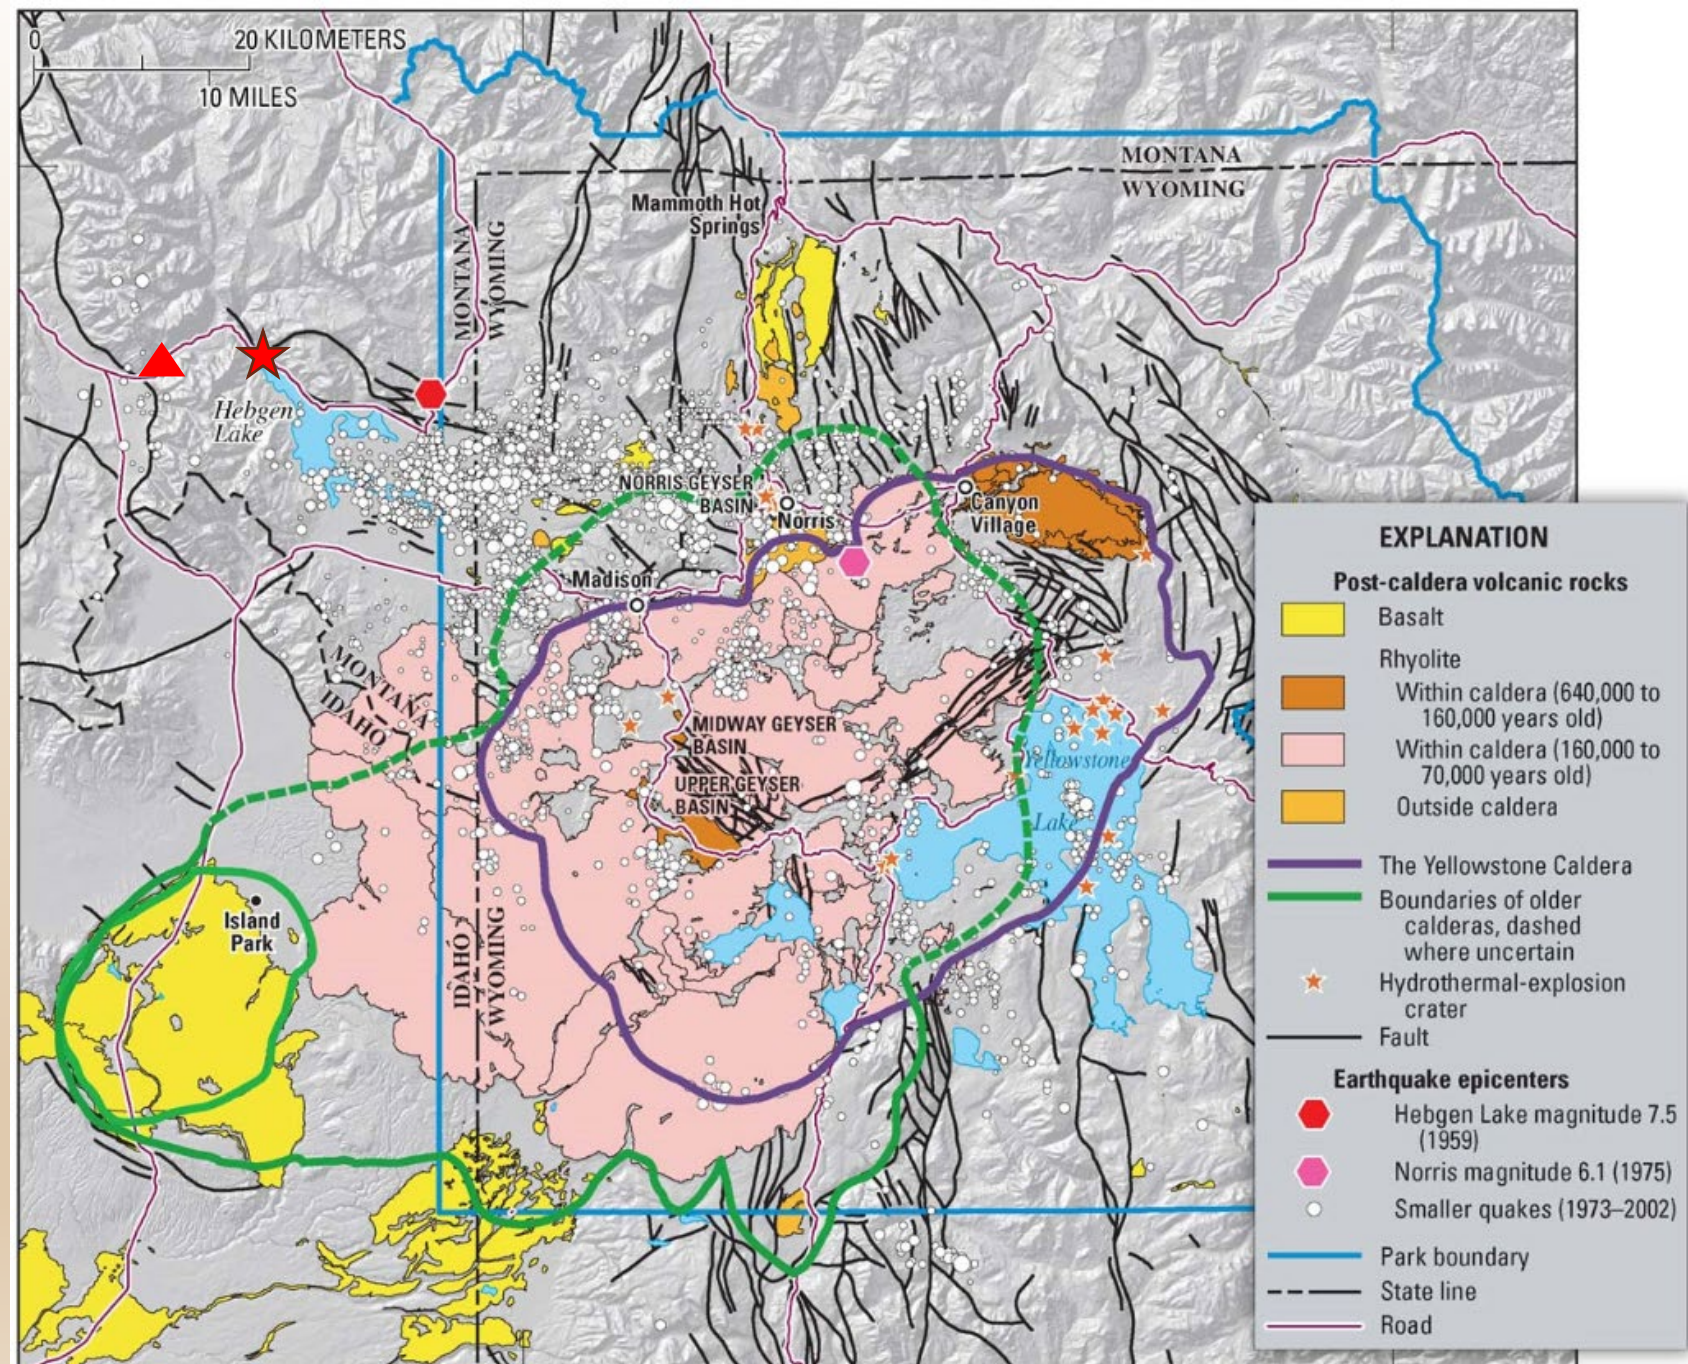
The Quake

- Magnitude 7.5
- Max Intensity X
- Lasted 30-40 secs
- Up to 20 feet vert. offset
- Epicenter ◆
- Dam ★
- Quake Lake ▲

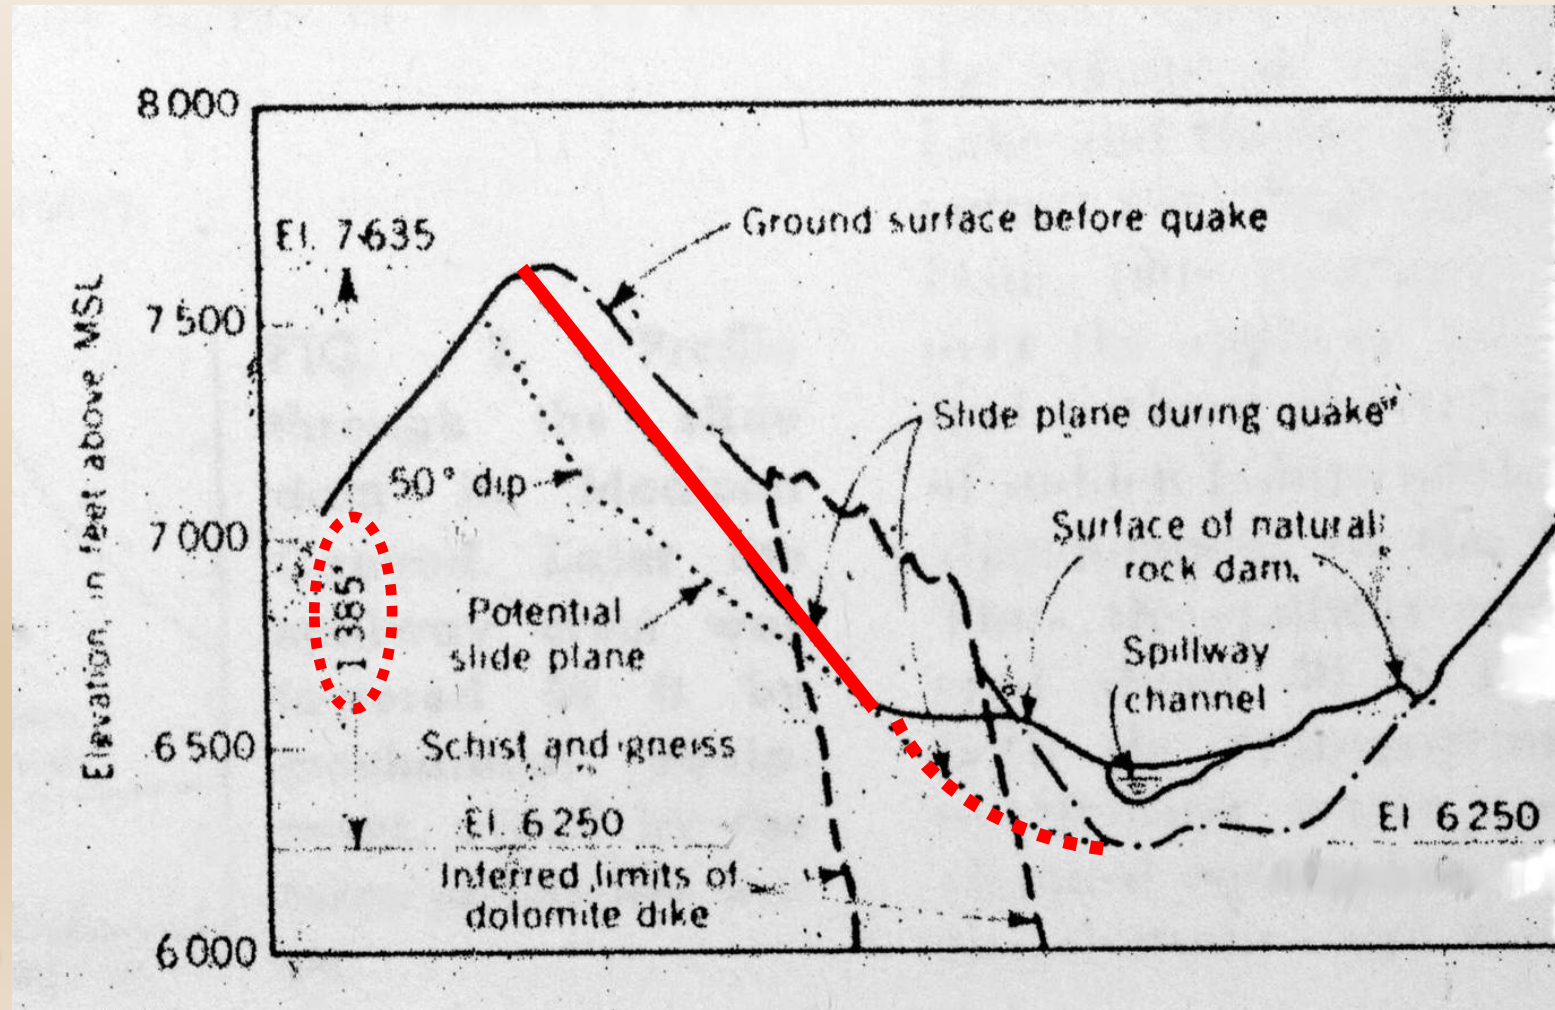
Quake Lake Landslide

- Buttress of jointed dolomite collapsed
- Sliding occurred along 50° foliation toward canyon
