# Bureau of Reclamation

## Tiber Marina Master Plan

May 2026

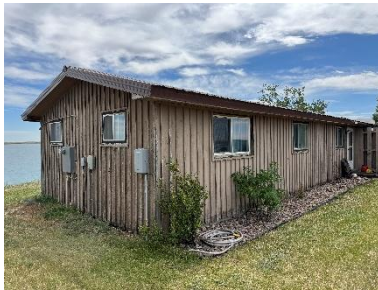
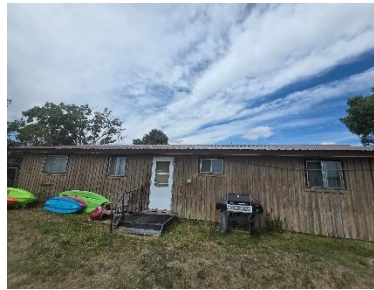
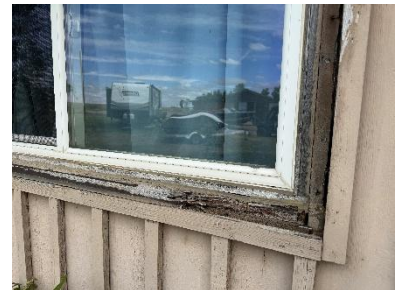
Residence Building - Exterior

The residence building, while at the end of its useful life, is also within thirteen feet (13'-0") of the eroding bank of the lake. The building is in imminent danger of collapsing into the lake and should be demolished. It is recommended that a new residence be constructed in a different location that meets ADA Accessibility requirements to accommodate any and all concessionaires. Although it is a private residence for the concessionaire, it is a government provided building and should allow for ADA Accessibility needs.

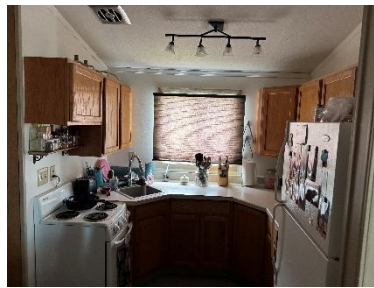
- Interior flooring type is a mix of sheet vinyl or linoleum and carpet. The flooring seemed to be in ok condition but should be replaced.
- Windows types vary between wood, vinyl and aluminum in poor condition. All of the windows need to be replaced.
- Construction type is wood stick framing with interior walls appearing to be 2 1/2" studs. The building is a modular structure that was placed on site.
- The insulation R-value of the exterior walls and roof could not be verified but it is assumed to be inadequate.
- Interior doors types are wood doors and are in good condition.
- The bathroom is linoleum sheet flooring with a shower. It does not meet ADA Accessibility requirements and should be updated.

- There is no designated ADA parking spot for the residence.
- Exterior ingress/egress sidewalk to the residence does not meet ADA Accessibility requirements and should be replaced.
- Exterior siding is of cedar board and batten type at the end of its useful life and should be replaced
- Roofing type is exposed fastener delta rib metal panel. The roof and fascia are in poor condition and should be replaced.
- Overall, the residence building is at the end of its useful life and should be demolished.

Residence Building - Interior

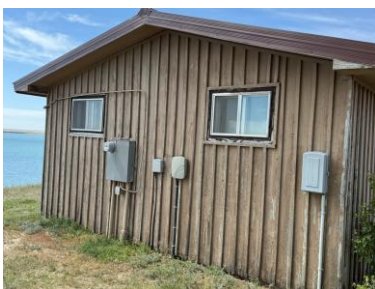
- Overall, the electrical distribution system for the Residence is in poor condition. The service panelboard should be replaced, and circuit breakers upgraded to meet current code requirements. Given the age of the Residence, additional code deficiencies within the electrical system are also likely.

The electrical panelboard should be replaced, and new circuit breakers installed if the building is expected to remain in use for the foreseeable future. Circuit breakers with AFCI, GFCI, or dual-function protection will be required in accordance with

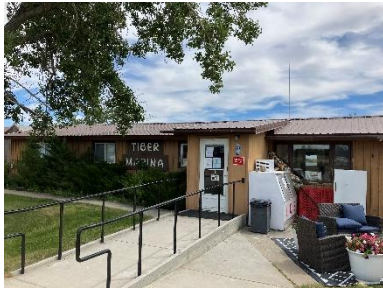
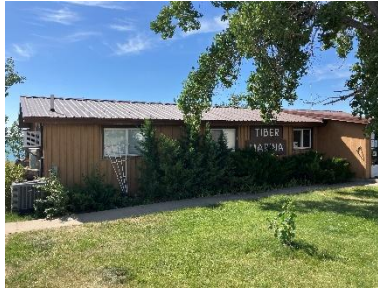
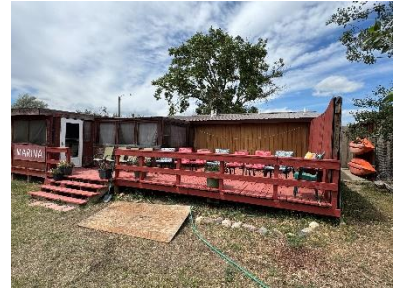
Concession Building - Exterior

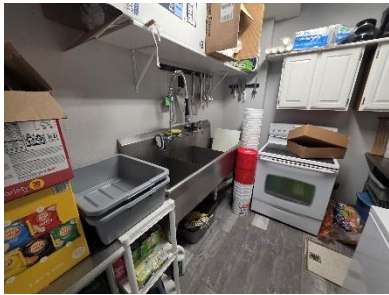
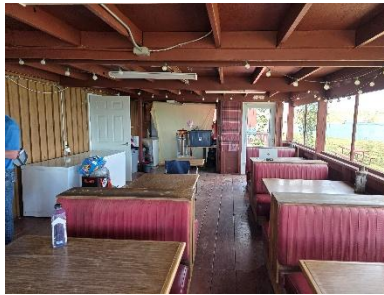
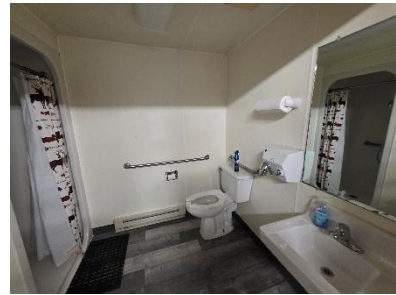
- Interior flooring type is Laminate throughout the building and is in good condition.
- Windows types vary between wood, vinyl and aluminum in poor condition. All of the windows need to be replaced.
- Construction type is wood stick framing with interior walls appearing to be 2 1/2" studs. The building is a modular structure that was placed on site.
- Interior doors types are wood or fiberglass doors and are in good condition.
- There are two separate bathrooms designated as 'Men's' and 'Women's', both with one toilet, sink and shower. The floor area is adequate to meet ADA requirements, but several components are out of compliance.
  - An 18" vertical grab bar needs to be added to both bathrooms at the toilet locations.

- The showers need ADA compliant seats
- The men's sink is set too low and does not meet wheelchair knee clearance.
- The food prep kitchen includes a triple sink but does not have an open floor sink for drainage.
- There is a designated ADA parking spot that allows for an accessible entrance to the building via a ramp.
- Exterior ingress/egress ramp to the concessionaire's building does meet ADA Accessibility requirements.
- Exterior siding is of cedar board and batten type at the end of its useful life and should be replaced
- Roofing type is exposed fastener delta rib metal panel. The roof and fascia are in poor condition and should be replaced.
- Overall, the concessionaire building is at the end of its useful life and should be demolished.

Concession Building - Interior

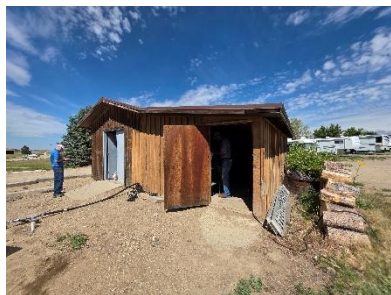
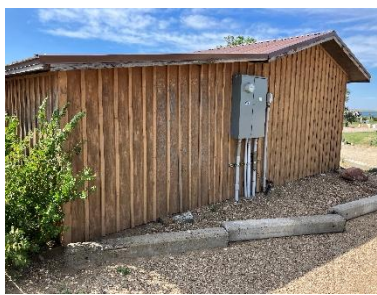
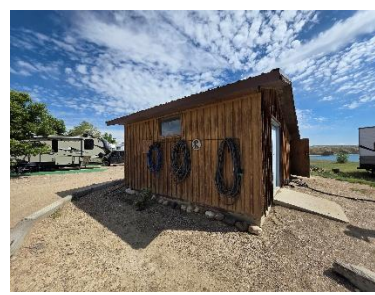
Utility Building - Exterior

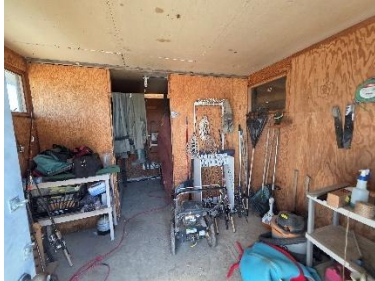
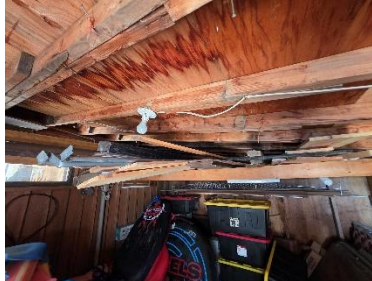
- Interior flooring is unsealed concrete
- Windows types are aluminum frame and are at the end of their useful life and should be replaced.
- The double door into the building is hollow metal with a knock-down hollow metal frame. Both are at the end of useful life and should be replaced.
- Construction type is standard wood framing.
- Access to the Utility Building is not ADA accessible and determined this is acceptable.
- Exterior siding is of cedar board and batten type and condition
- Roofing type is exposed fastener delta rib metal panel. It is at the end of its useful life and be replaced.

- Overall, the Utility Building is being used as a pump house and storage. There are concerns regarding the lean-to roof to the east and it's structural capacity. The building is at the end of its useful life and should be demolished.

Utility Building - Interior

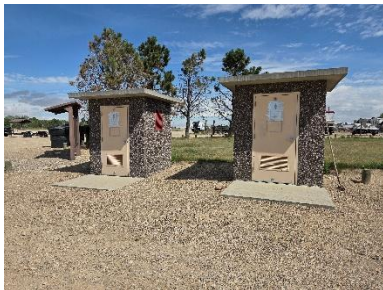
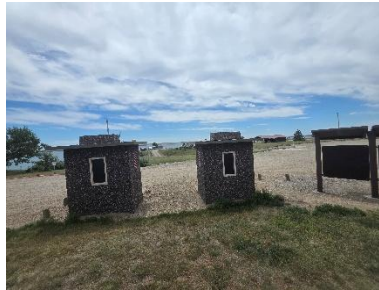
Vault Toilet - Exterior

- Painted concrete
- Precast concrete vault toilets with exposed aggregate exterior finish in fair condition.
- Doors are hollow metal in fair condition.
- Access to the toilets does not meet ADA.
- There is no ADA parking or access sidewalk near the vault toilets.

- Concrete pads at the entrance doors are separated from the vault structure and have a rise of more than one half inch at the threshold taking it out of ADA compliance.
- The roof is precast concrete
- The two vault toilets near the concessionaire building and parking lot are in working condition but lack ADA Accessibility. Due to their age and general wear and tear, they are at the end of their useful life.

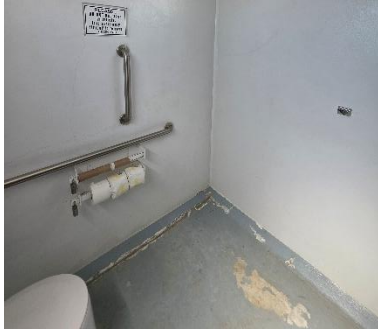
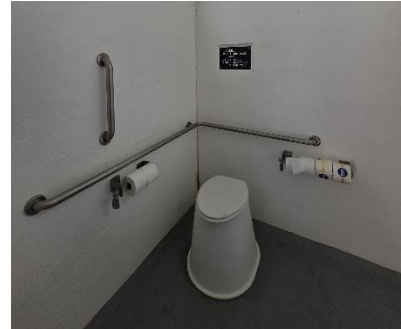
Vault Toilet - Interior

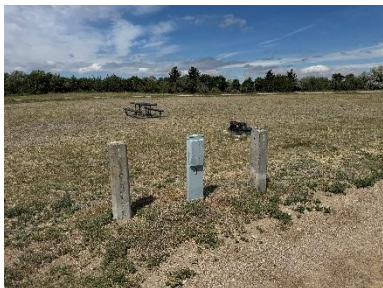
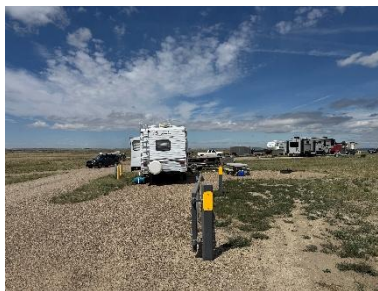
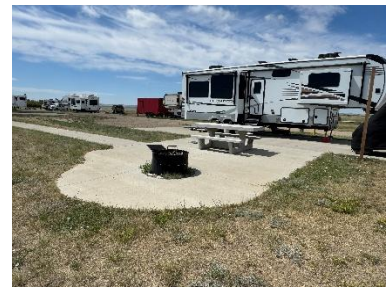
Campsites

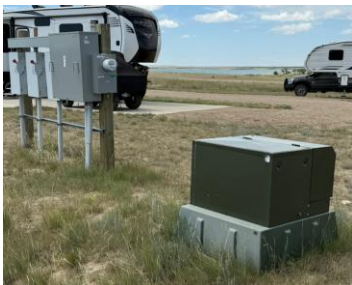
- There are ten (10) RV connection pedestals located on Hilltop Loop, with one additional pedestal providing power to two (2) sleeping cabins. Each pedestal includes a 20A, a 30A, and a 50A circuit breaker protecting a single receptacle of each rating. The pedestals at Hilltop Loop appear to be in good overall condition.

- Liberty Loop also appears to have a dedicated utility transformer with service equipment installed nearby and mounted on a Unistrut support. The service

equipment consists of an electric utility meter, a CT cabinet, and two locked electrical enclosures. The service disconnect was not located during the site visit and may be inside one, or both, of the locked enclosures. The routing of the distribution system downstream of the service equipment is unknown, as existing surveys were conducted prior to the installation of this equipment.

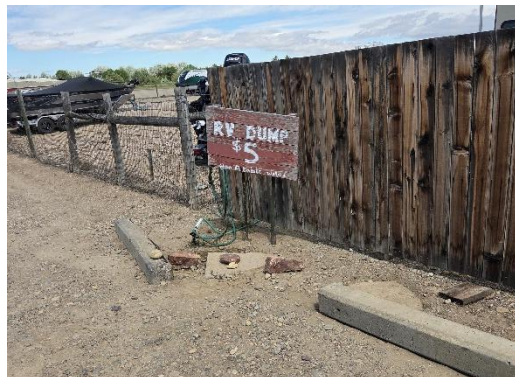
Dump Station

- **Standardize Plumbing Infrastructure:** Conduct a site survey to document existing plumbing and ensure compliance with sanitary codes. Replace the clean-out plug with a purpose-built RV dump inlet featuring a secure, gasketed cap and backflow prevention.
- **Enhanced Rinse Facilities:** Upgrade the rinse station with a dedicated non-potable water supply, hose reel, and signage to prevent cross-contamination.
- **User Guidance and Signage:** Install clear instructional signage for proper use, including rinse procedures, waste disposal etiquette, and emergency contact information.
- **Environmental Safeguards:** Include spill containment measures such as a concrete pad with perimeter curbing and a drain connected to a containment sump.

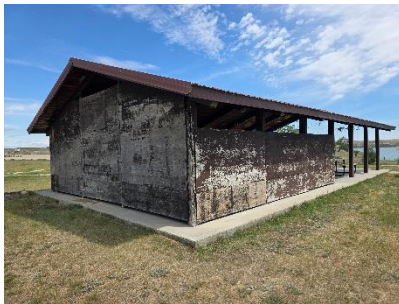
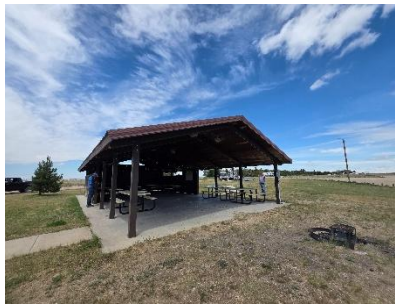
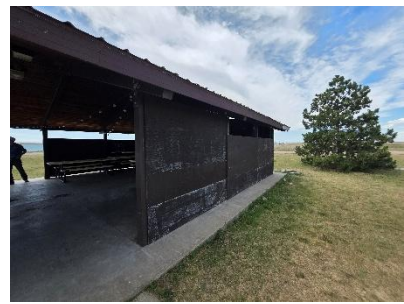
Pavilion - Exterior

- The pavilion is placed on a concrete slab on grade.
- Construction type is steel columns and beams with wood tongue and groove for the roof.
- Part of the pavilion is enclosed with 5/8" sheathing to provide shelter/screening. The sheathing is in poor condition and should be replaced.
- Exposed fastener metal roof panel is in poor condition and should be replaced.
- Fascia metal and flashing is missing.
- The pavilion is generally in good condition and serves its purpose for shelter and a gathering space for campers and lake users.

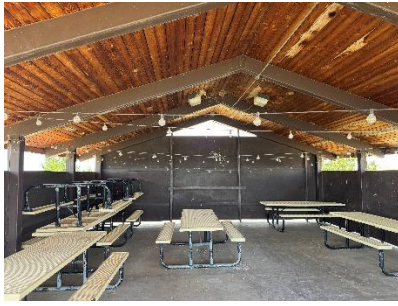
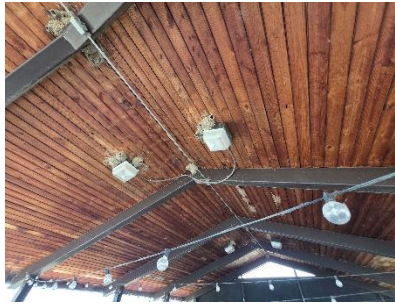
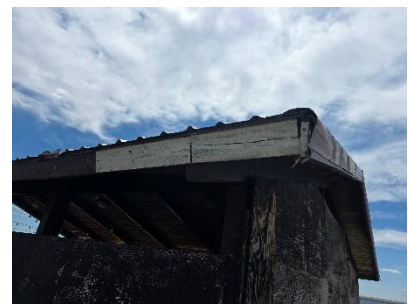
Pavilion - Interior

Pavilion - Fascia

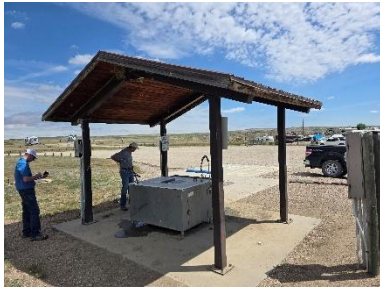
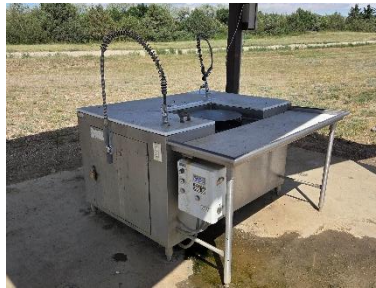
Fish Cleaning Station
