## **Bighorn River Side channel Investigations downstream of Yellowtail Dam and Afterbay *Geomorphic Analysis***

U.S. Department of the Interior  
Bureau of Reclamation

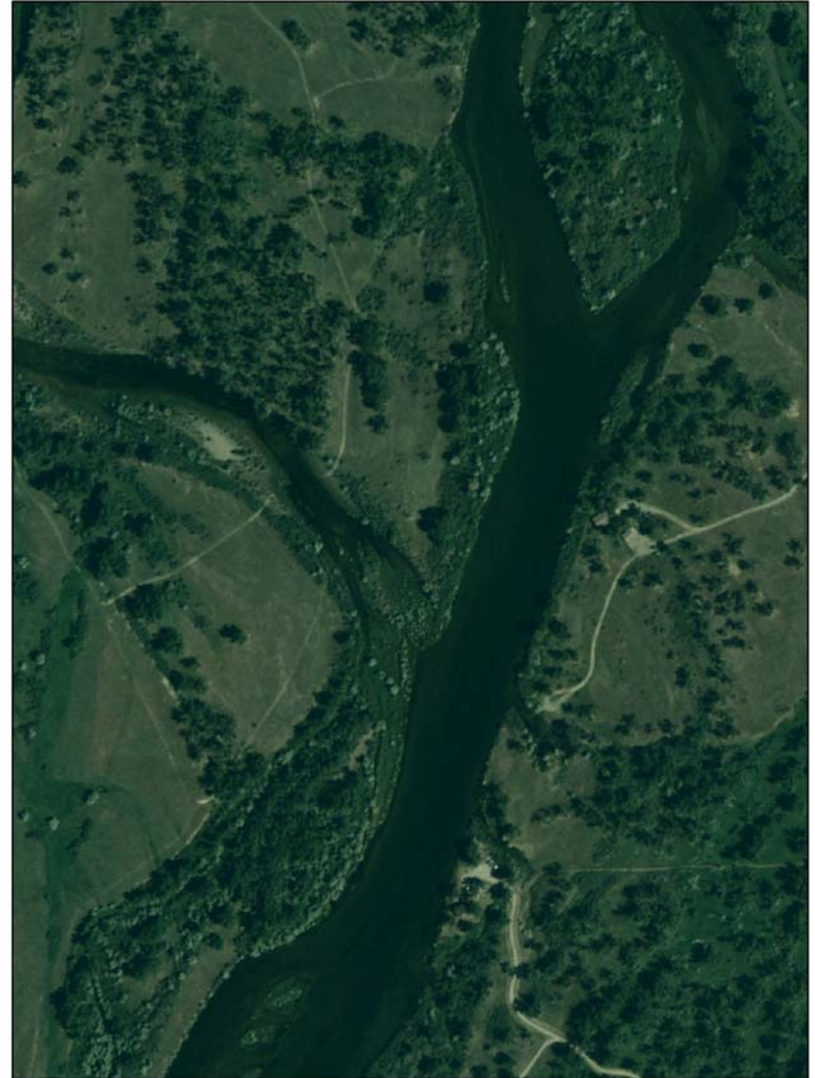
# Channel change: complex 13

1939 ( $Q=1827 \text{ ft}^3/\text{s}$ )

2006 ( $Q=1990 \text{ ft}^3/\text{s}$ )

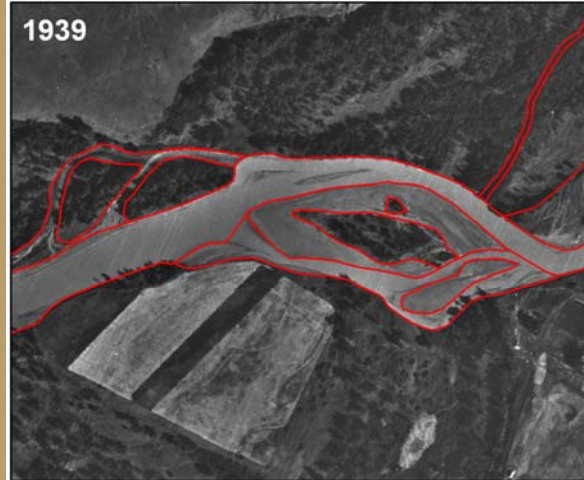
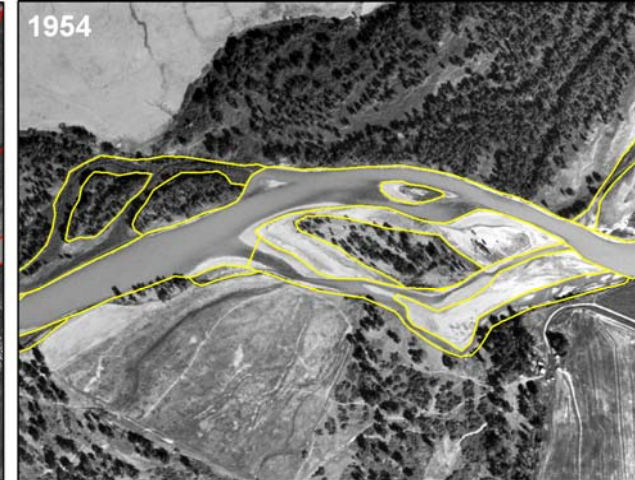
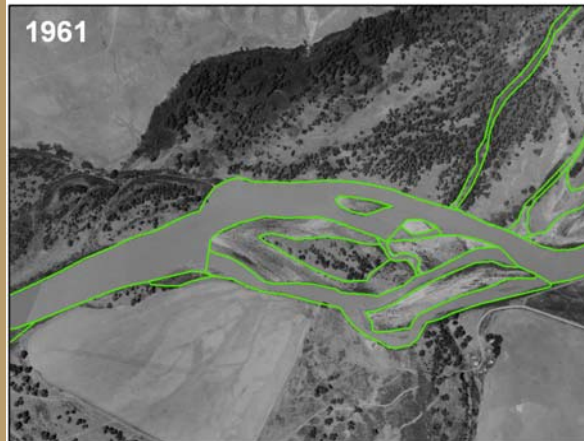
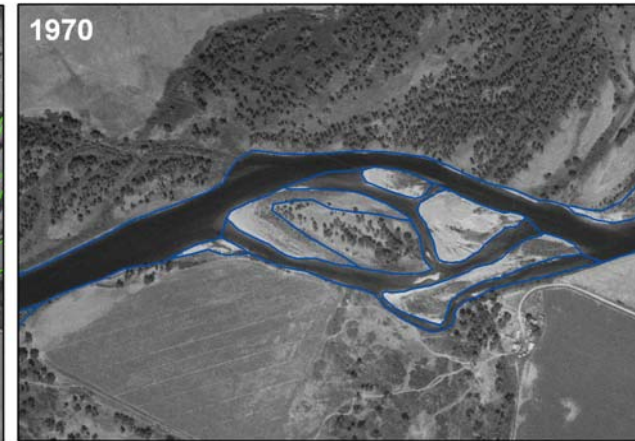
# Complex 6

general configuration  
since 1939

Side channels  
stabilized by 1970

Vegetation growth on  
bars from 1970-2006

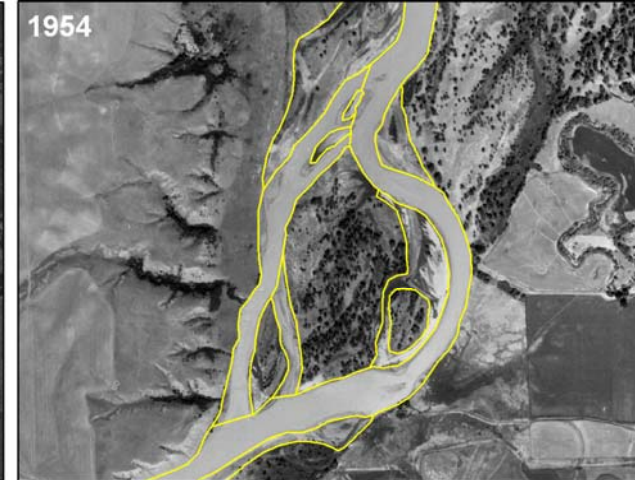
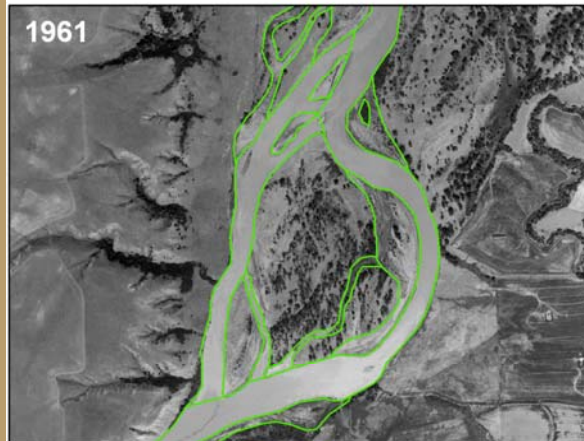
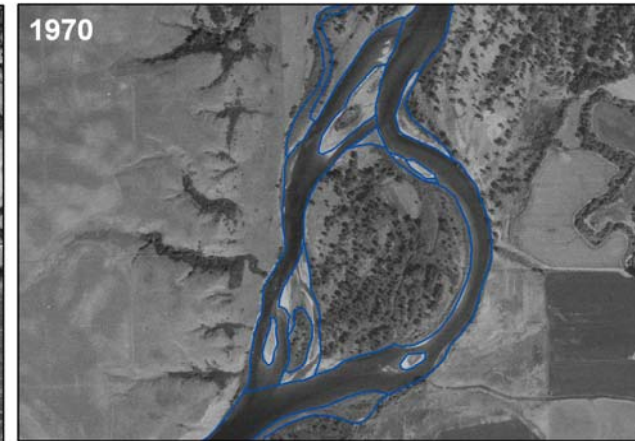
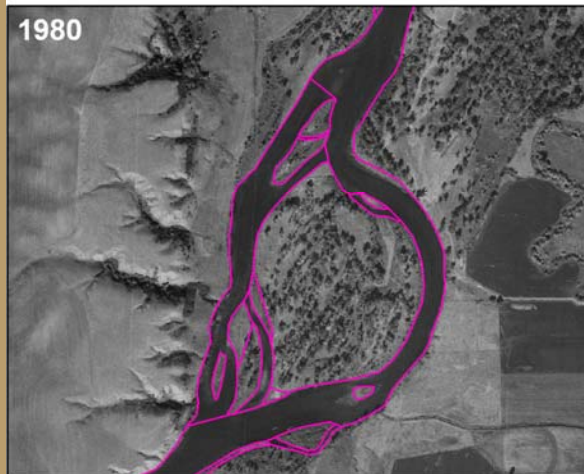
# Complex 12

General channel configuration since 1939

All side channels established by 1980

Vegetation growth on large island and some smaller islands

Formation of new channels between 1980 and 2006 (12J and 12K)

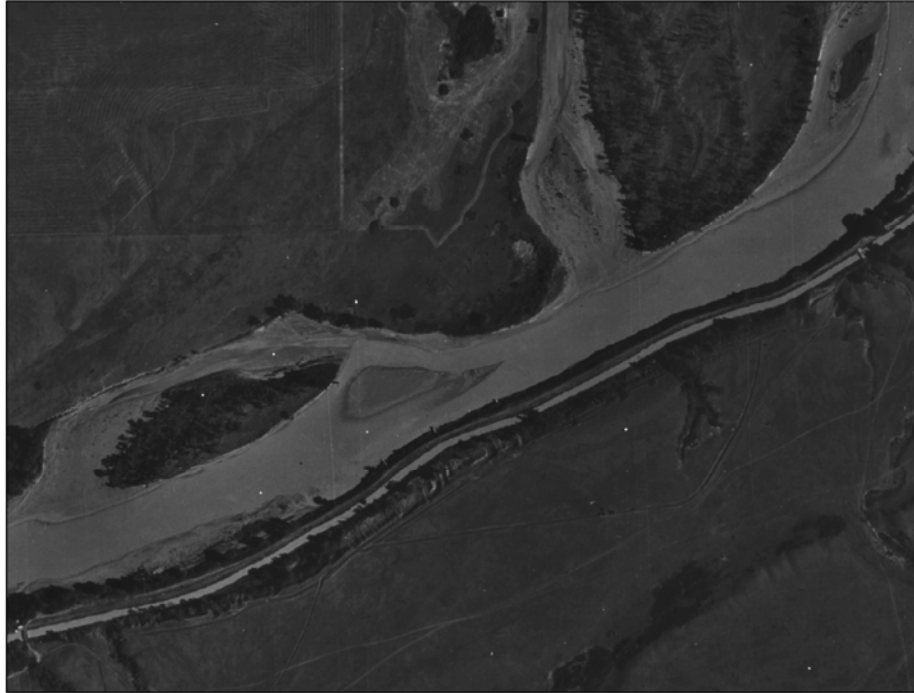
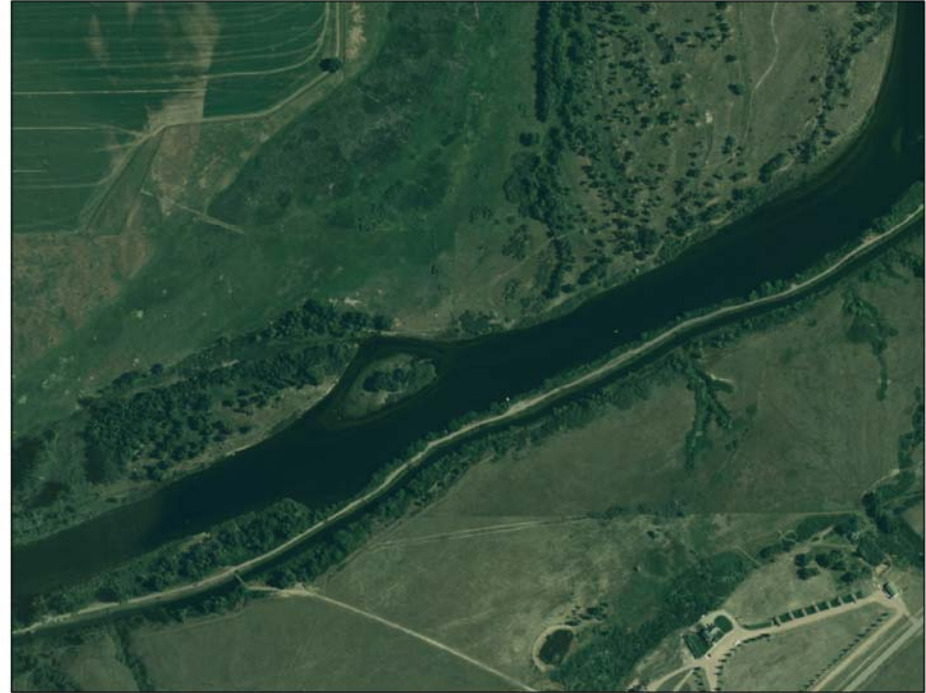
# Side channel 1

1939

2006

- 1939: side channel 1 in 2006 position; several overflow channels
- 2006: overflow channels have filled in; vegetation of mid-channel bar

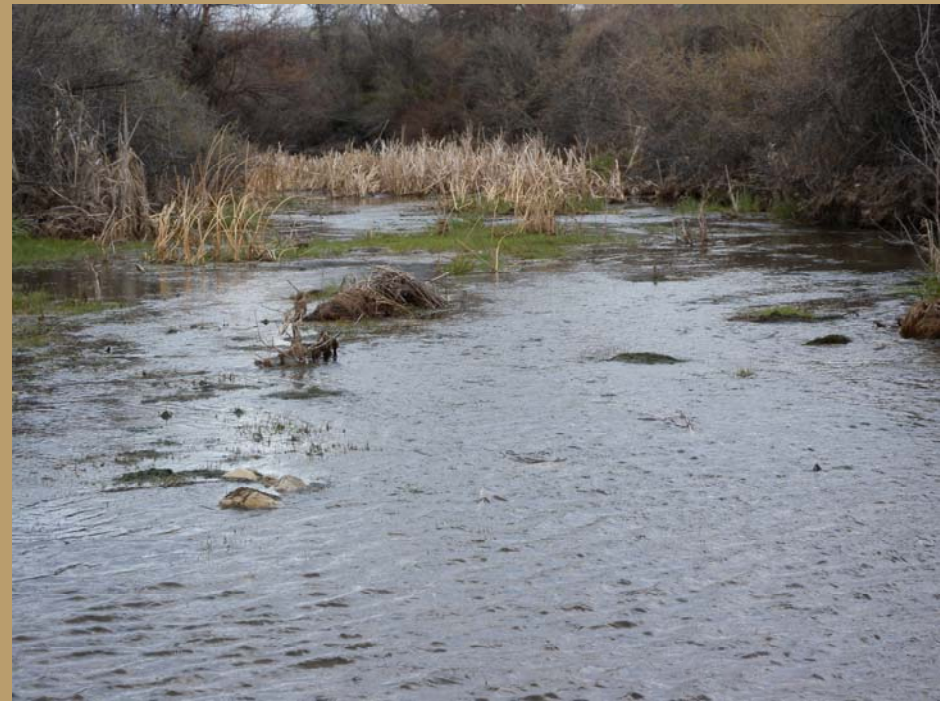
# Side channel loss 1961-2009

- **Abandoned**
  - No flow during 2009 field surveys ( $3,000 < Q < 4,000$  ft<sup>3</sup>/s)
  - Vegetation establishment at side channel entrances
  - Backwater and fine sediment accumulation at mouth
- **At risk of abandonment**
  - Shallow flow at entrance
  - Discontinuous flow
  - Sediment deposits
  - Vegetation establishment

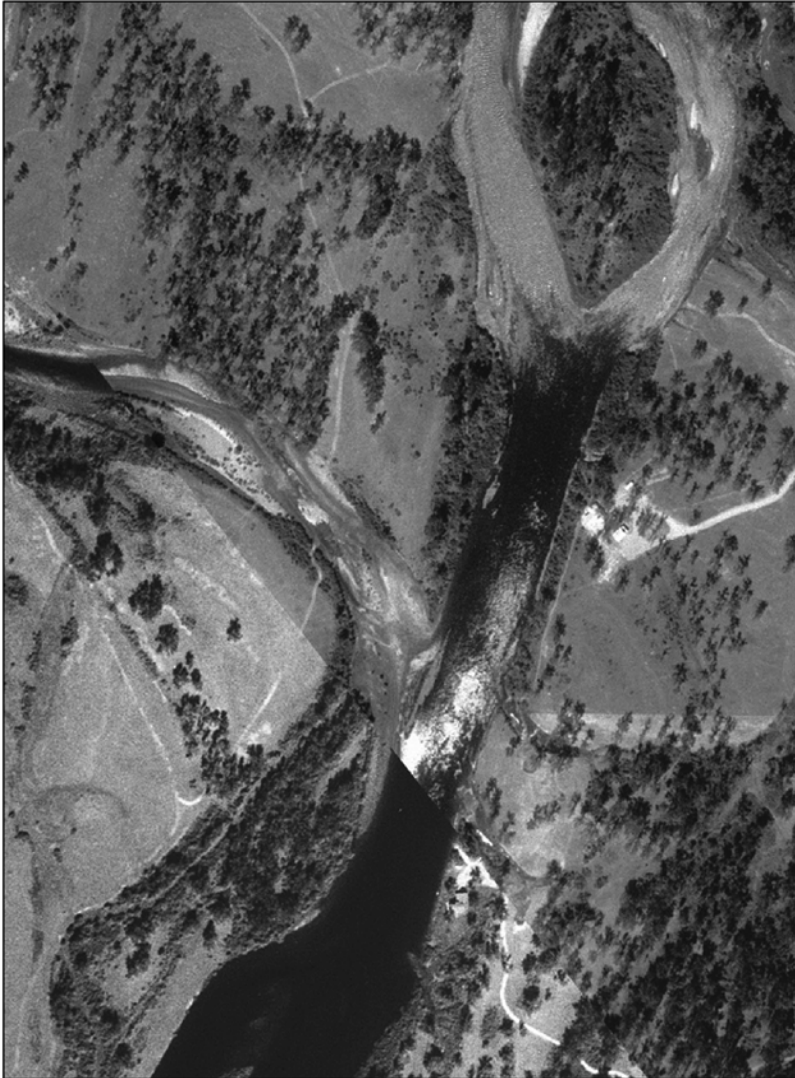
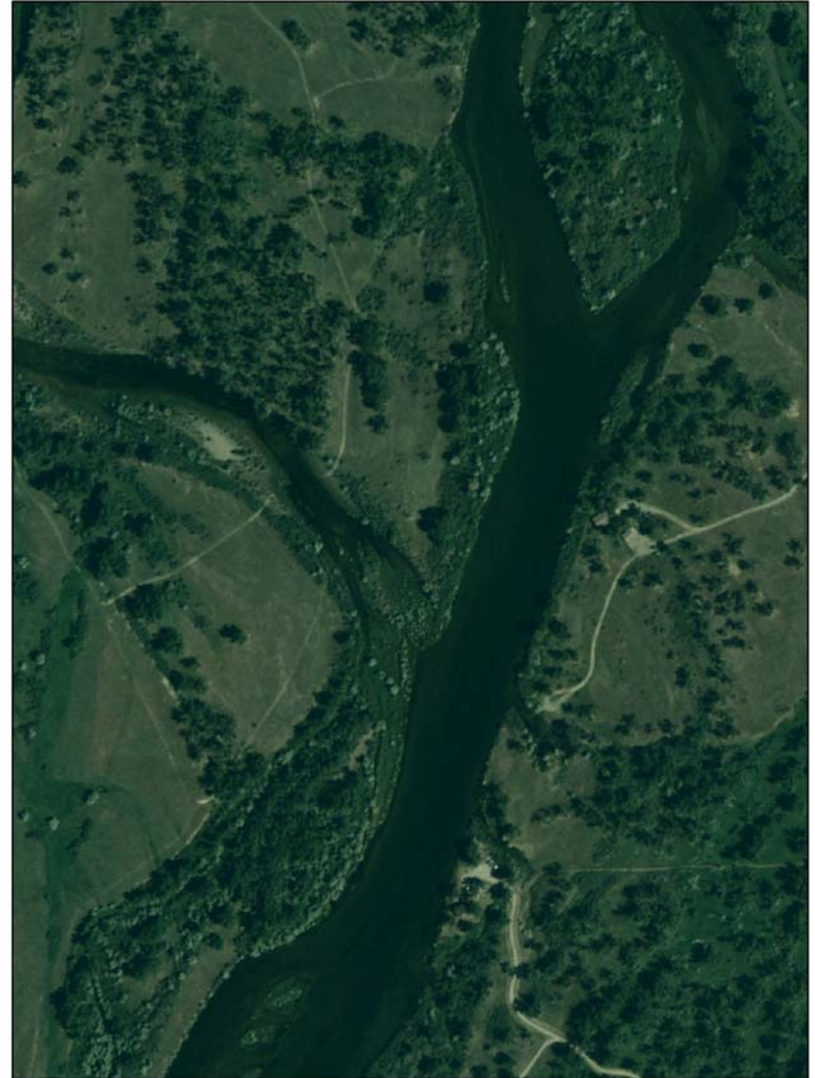
# Channel change: Complex 13

1991 ( $Q=3030 \text{ ft}^3/\text{s}$ )

2006 ( $Q=1990 \text{ ft}^3/\text{s}$ )

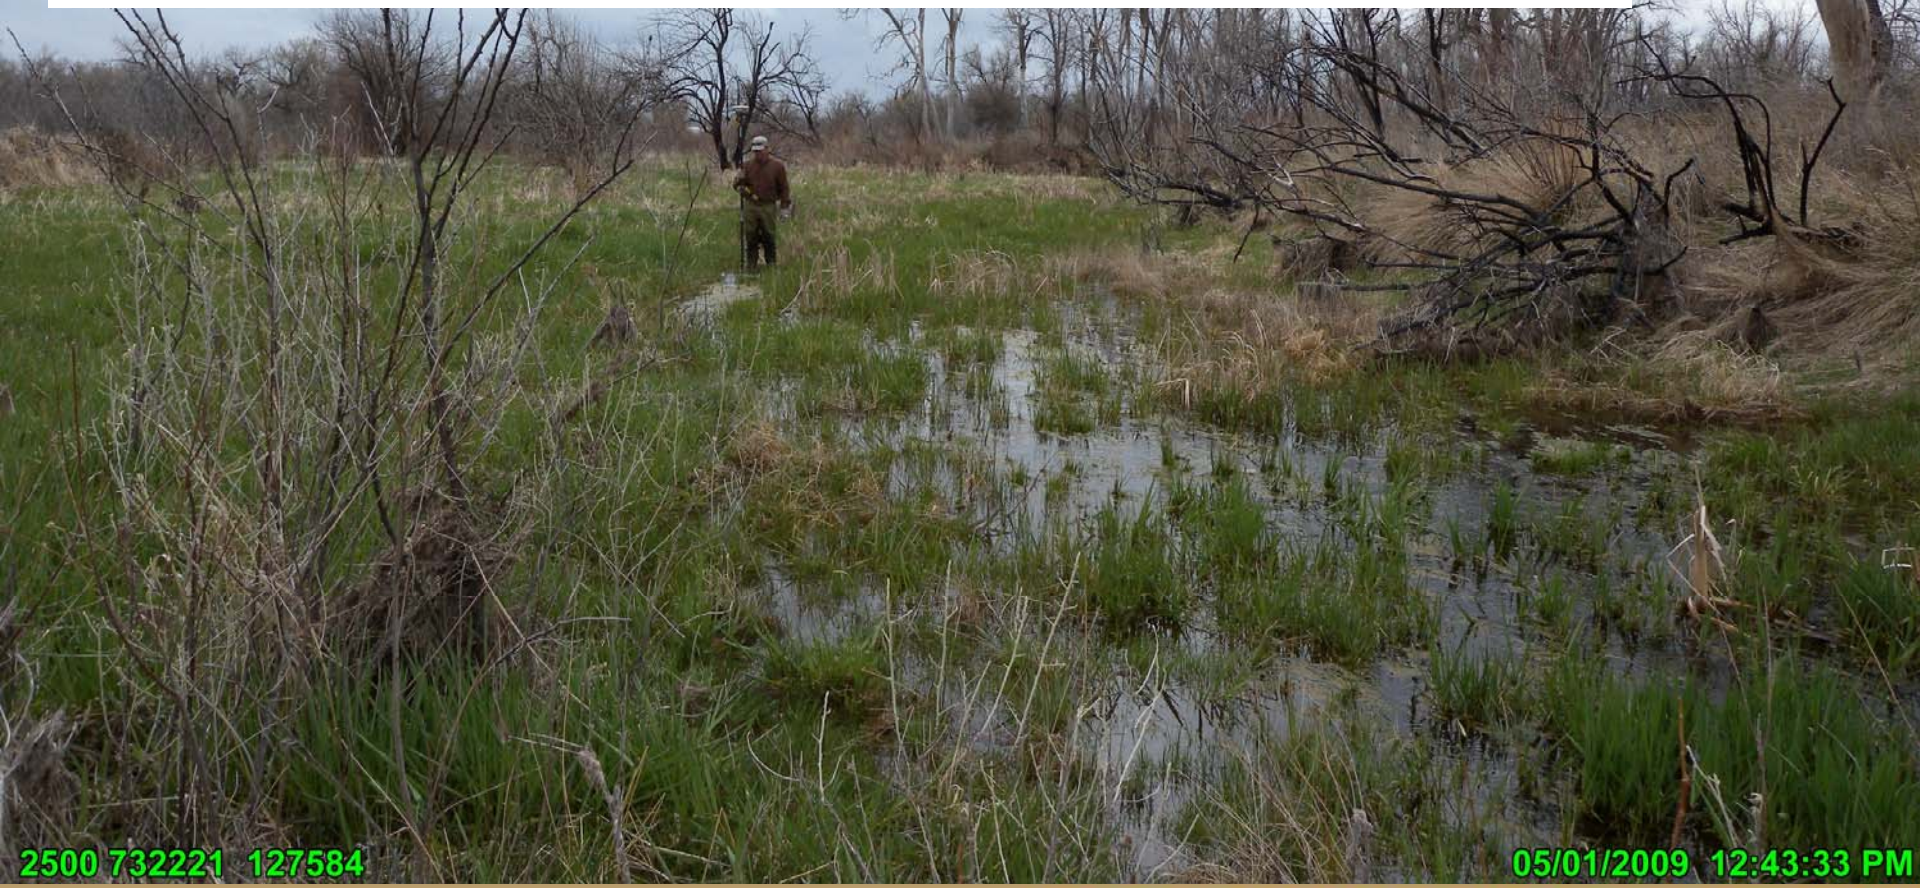
# Bathymetric Survey

- Side channels were surveyed on foot in late April and early May 2009 (over 6,600 points).
- Real Time Kinematic (RTK) Global Positioning Satellite (GPS) surveying equipment was used.

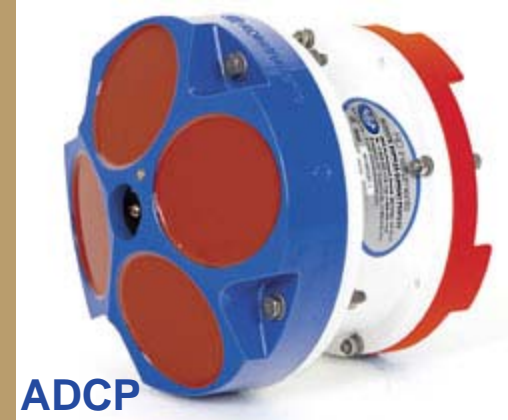
# Bathymetric Survey

- The main river channel was surveyed with SONAR in Apr/May 2009
  - MT Fish Wildlife and Parks provided the boat and driver – thanks to Earl Radonski for great driving
- We used an Acoustic Doppler Current Profiler (ADCP) to obtain depths.
  - Individual depths from four beams were obtained for each ‘ping’ or ‘ensemble’.
- RTK GPS survey equipment was used to obtain position and elevation.
- Discharge was approximately 4500 cfs during this survey

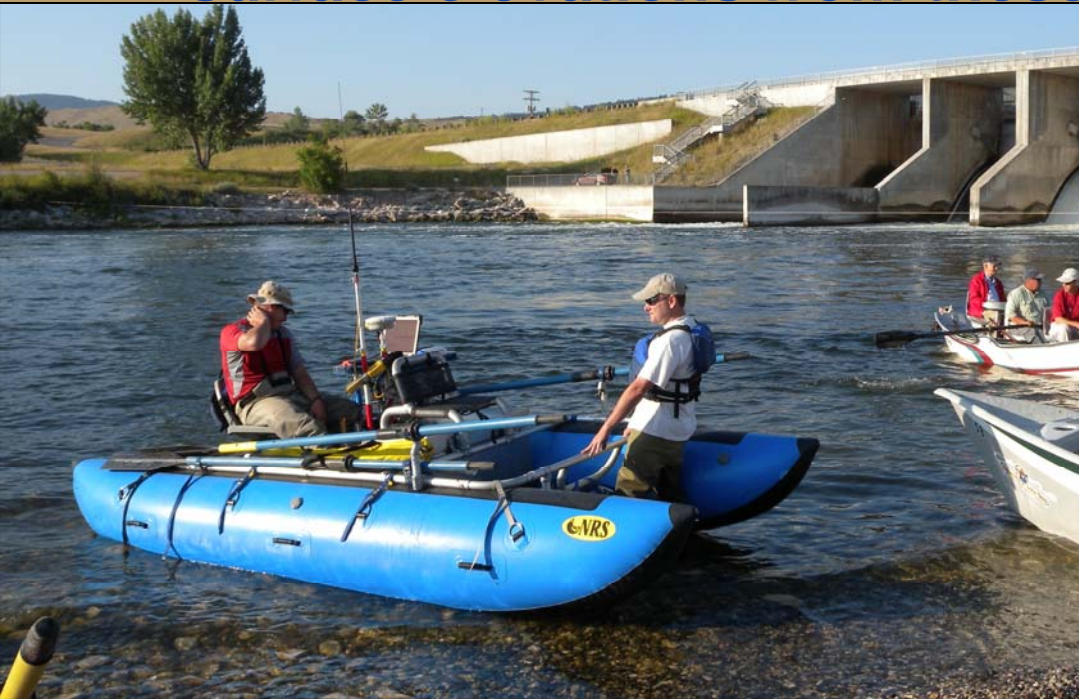
# Bathymetric Survey

- An additional survey was performed in August 2009 to fill in some missing data
- Discharge was approximately 3000 cfs during this survey
- The hydraulic model will be verified with water surface elevations from these two surveys.
