Bighorn Basin Operations and Water Supply Meeting

April 13, 2017

Yellowtail Dam and Bighorn Lake Operations Review

Bighorn Lake Operations 2017

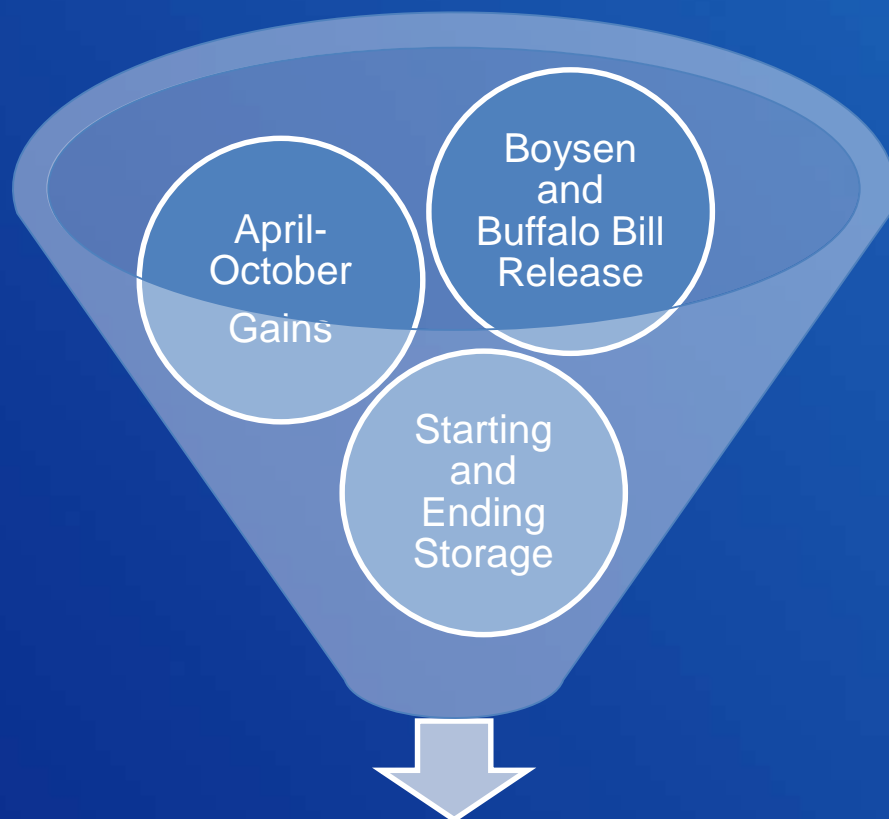
Setting the Winter Release Rate

Winter Release Rate

2,610 cfs

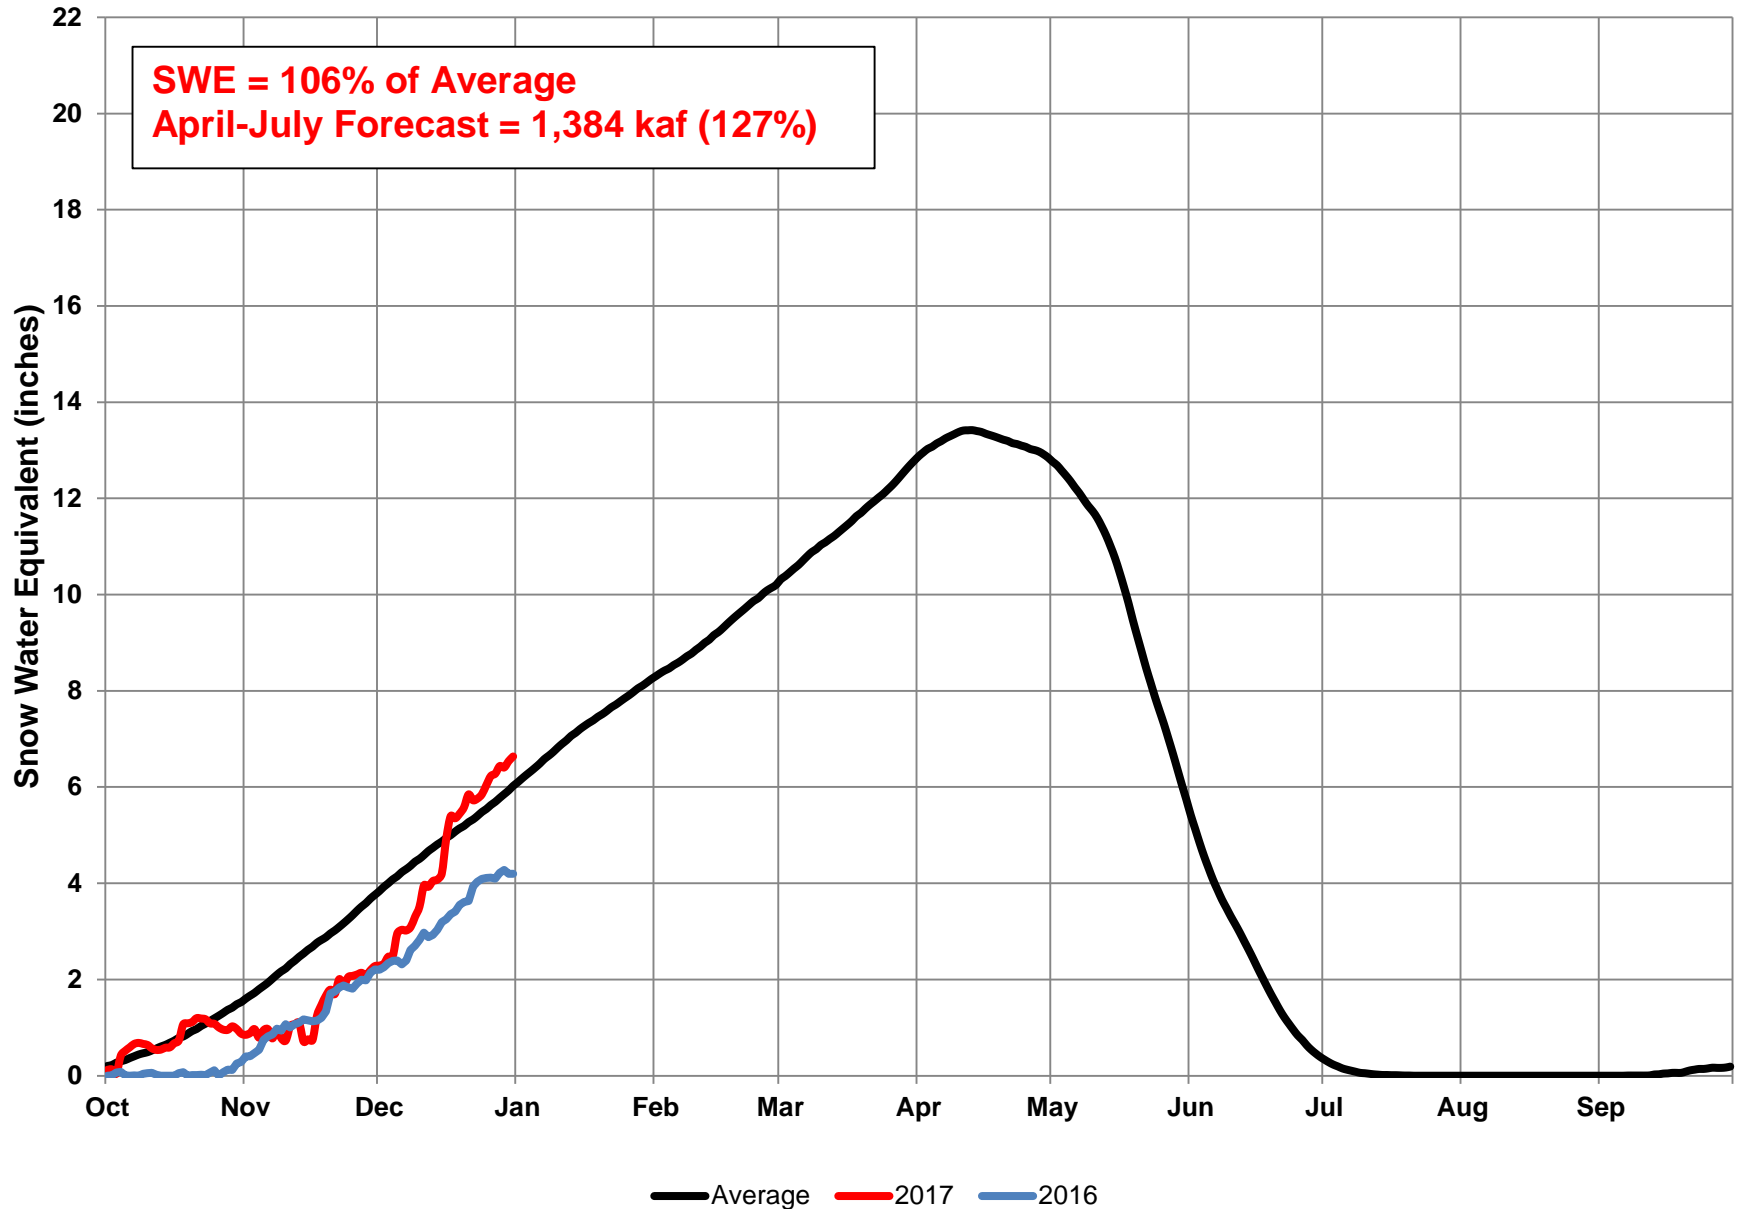
Mountain Snowpack on January 1

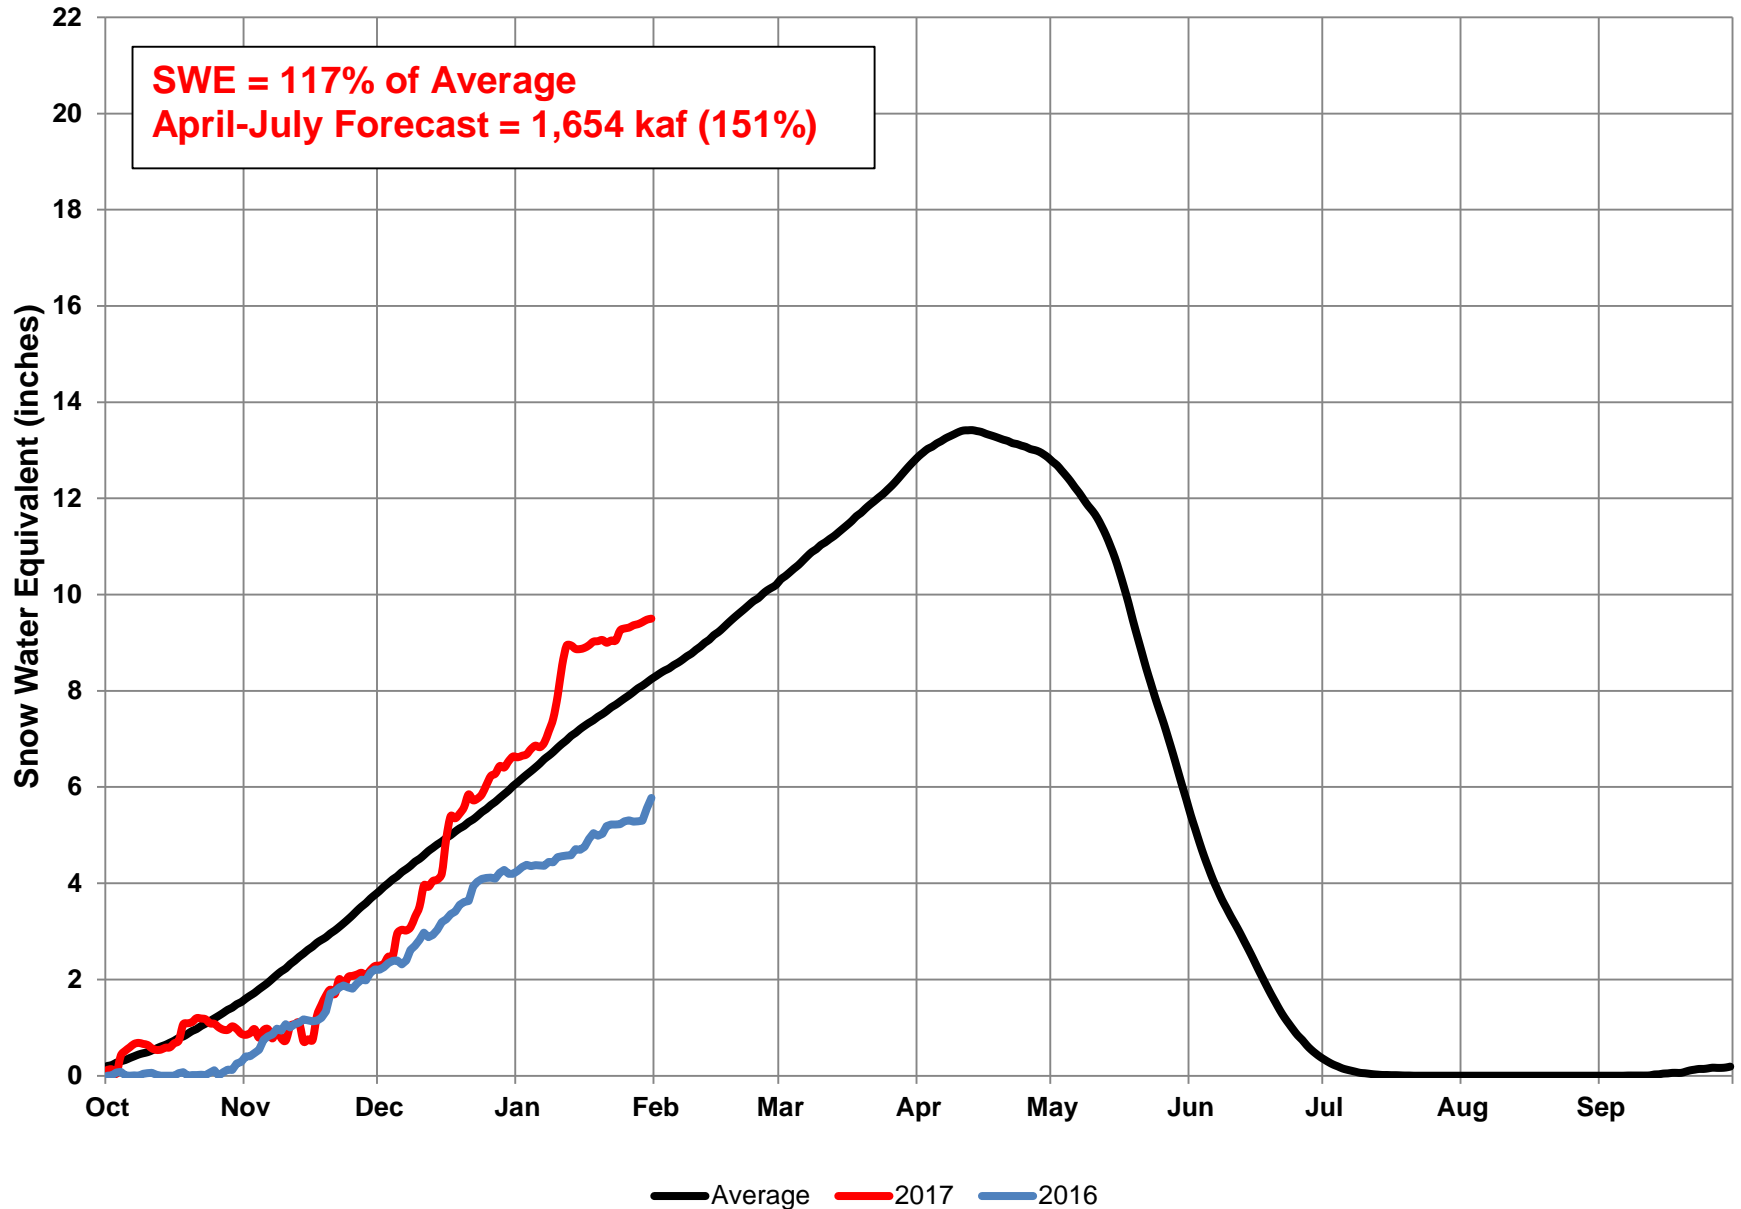
Mountain Snowpack on February 1

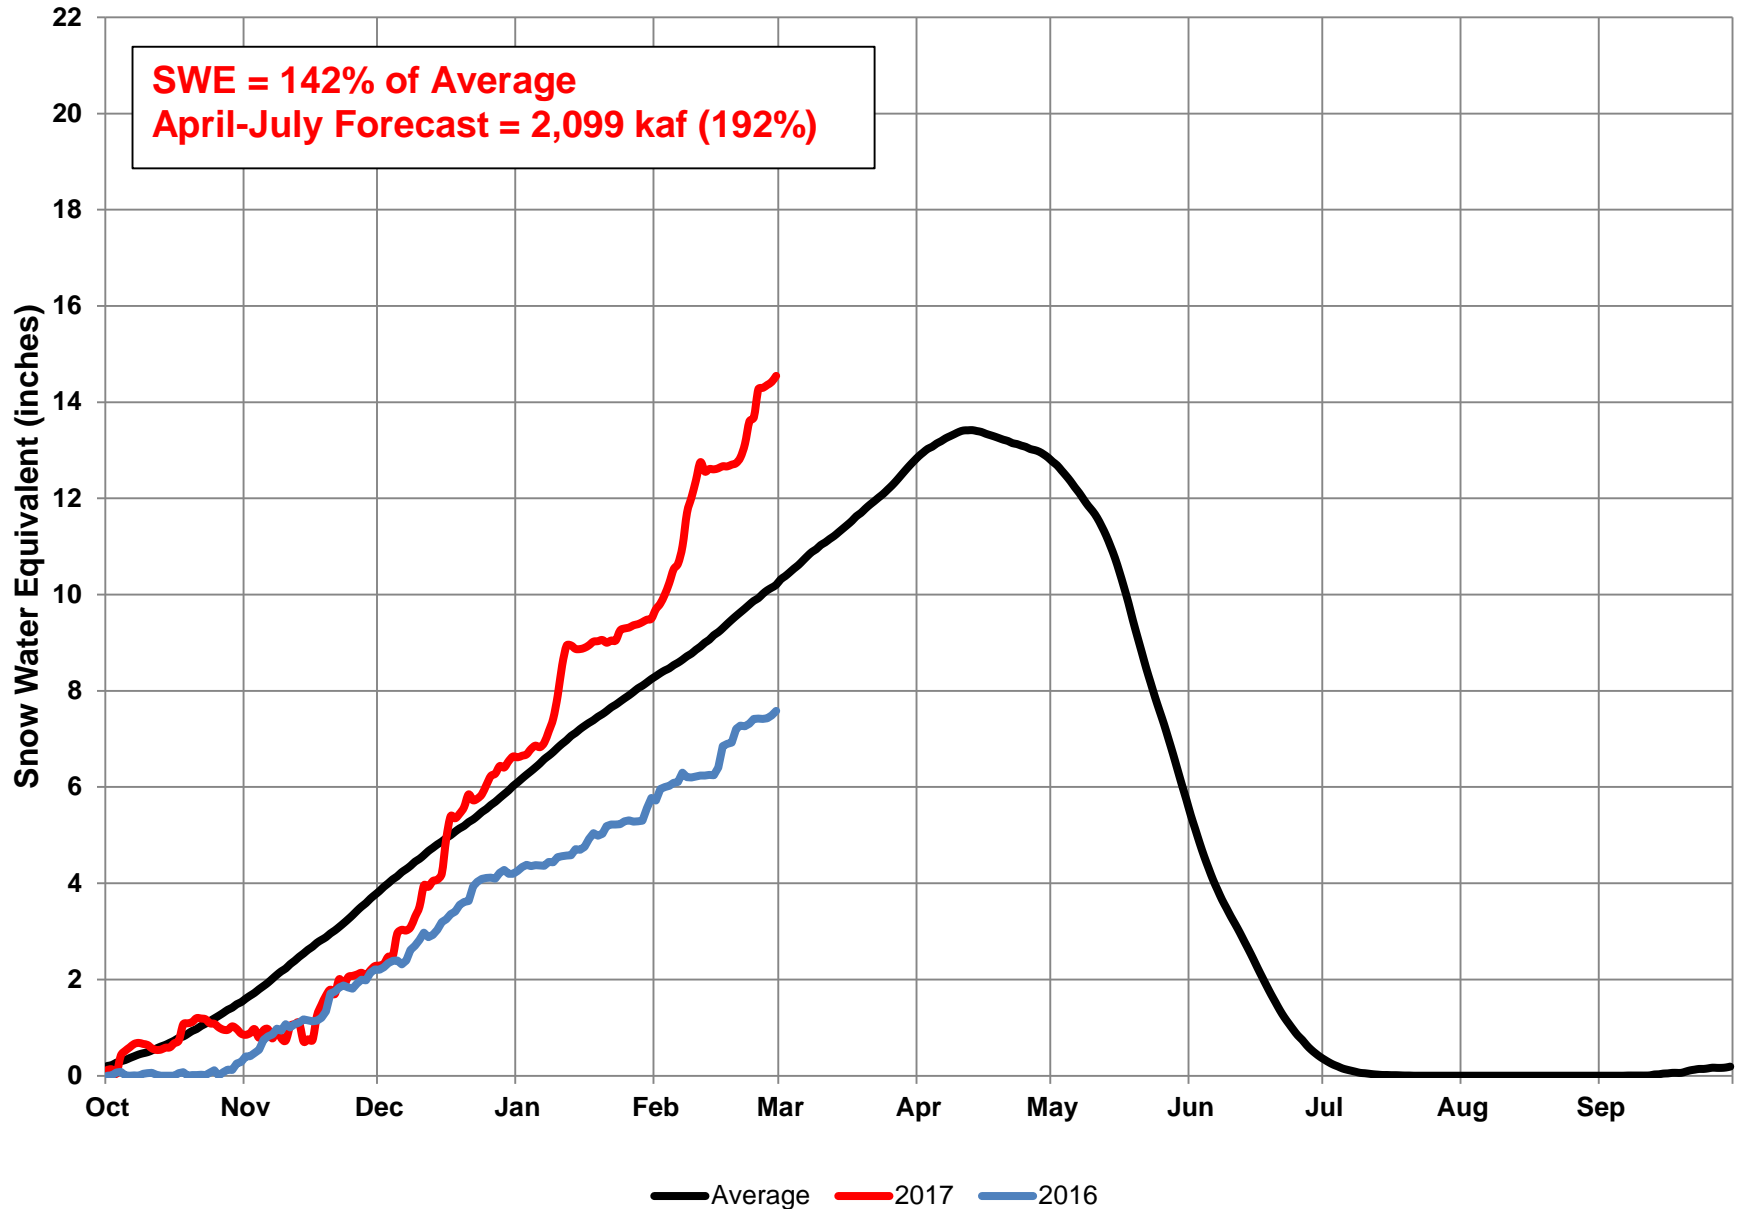
Mountain Snowpack on March 1

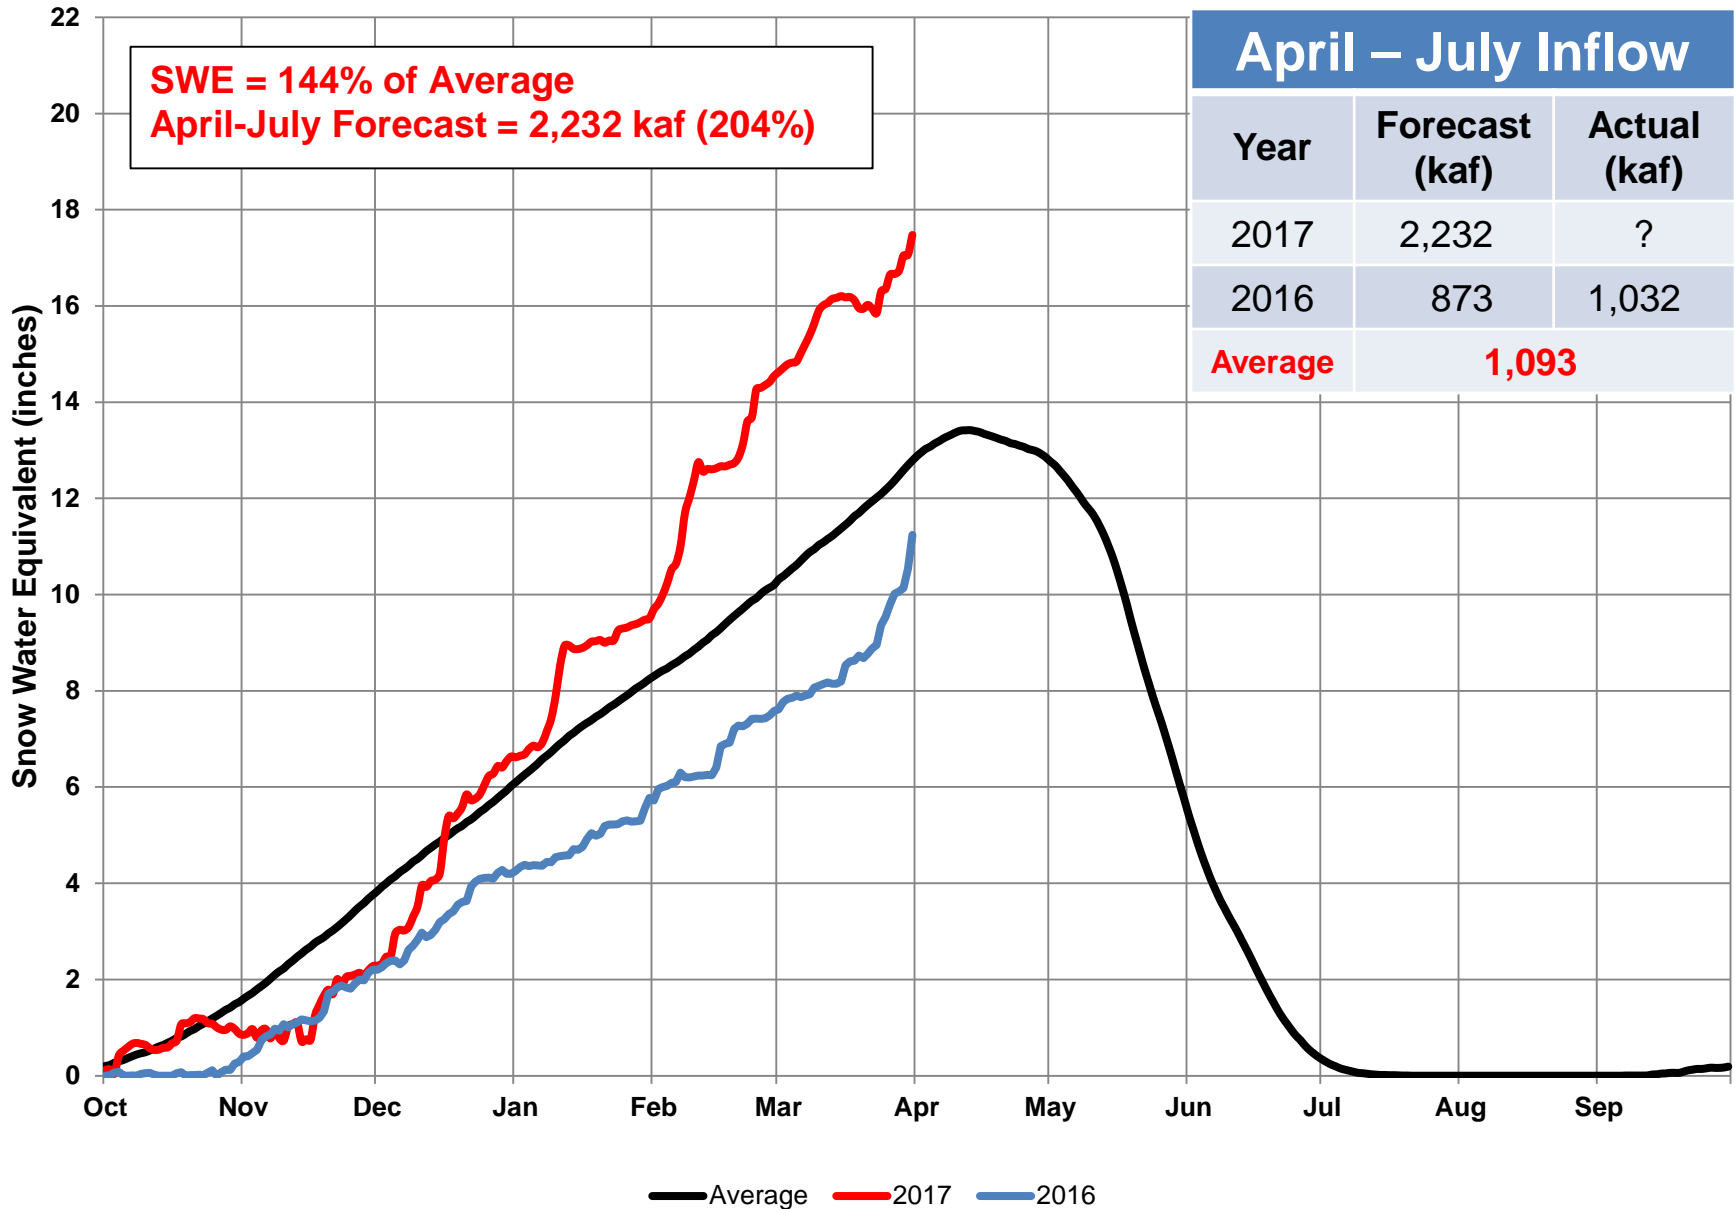
Mountain Snowpack on April 1

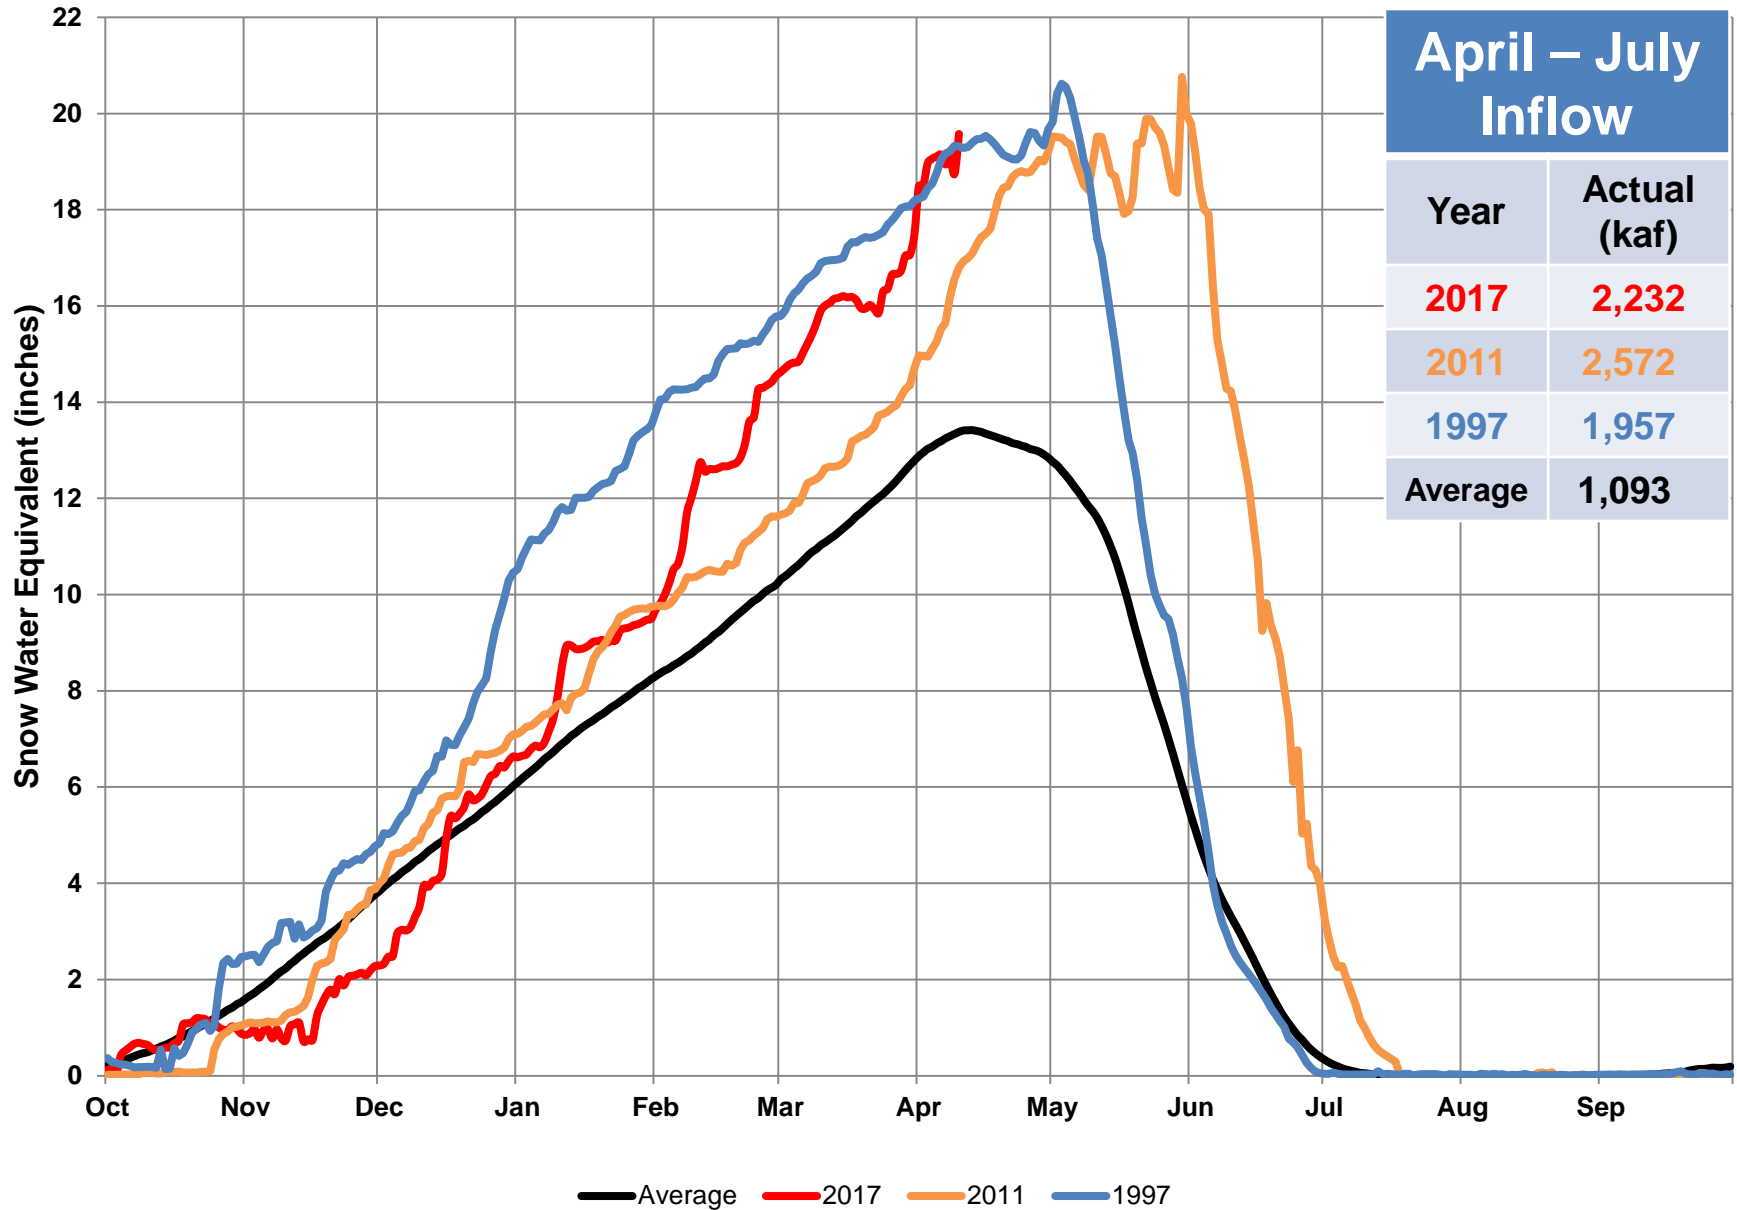
Mountain Snowpack on April 10

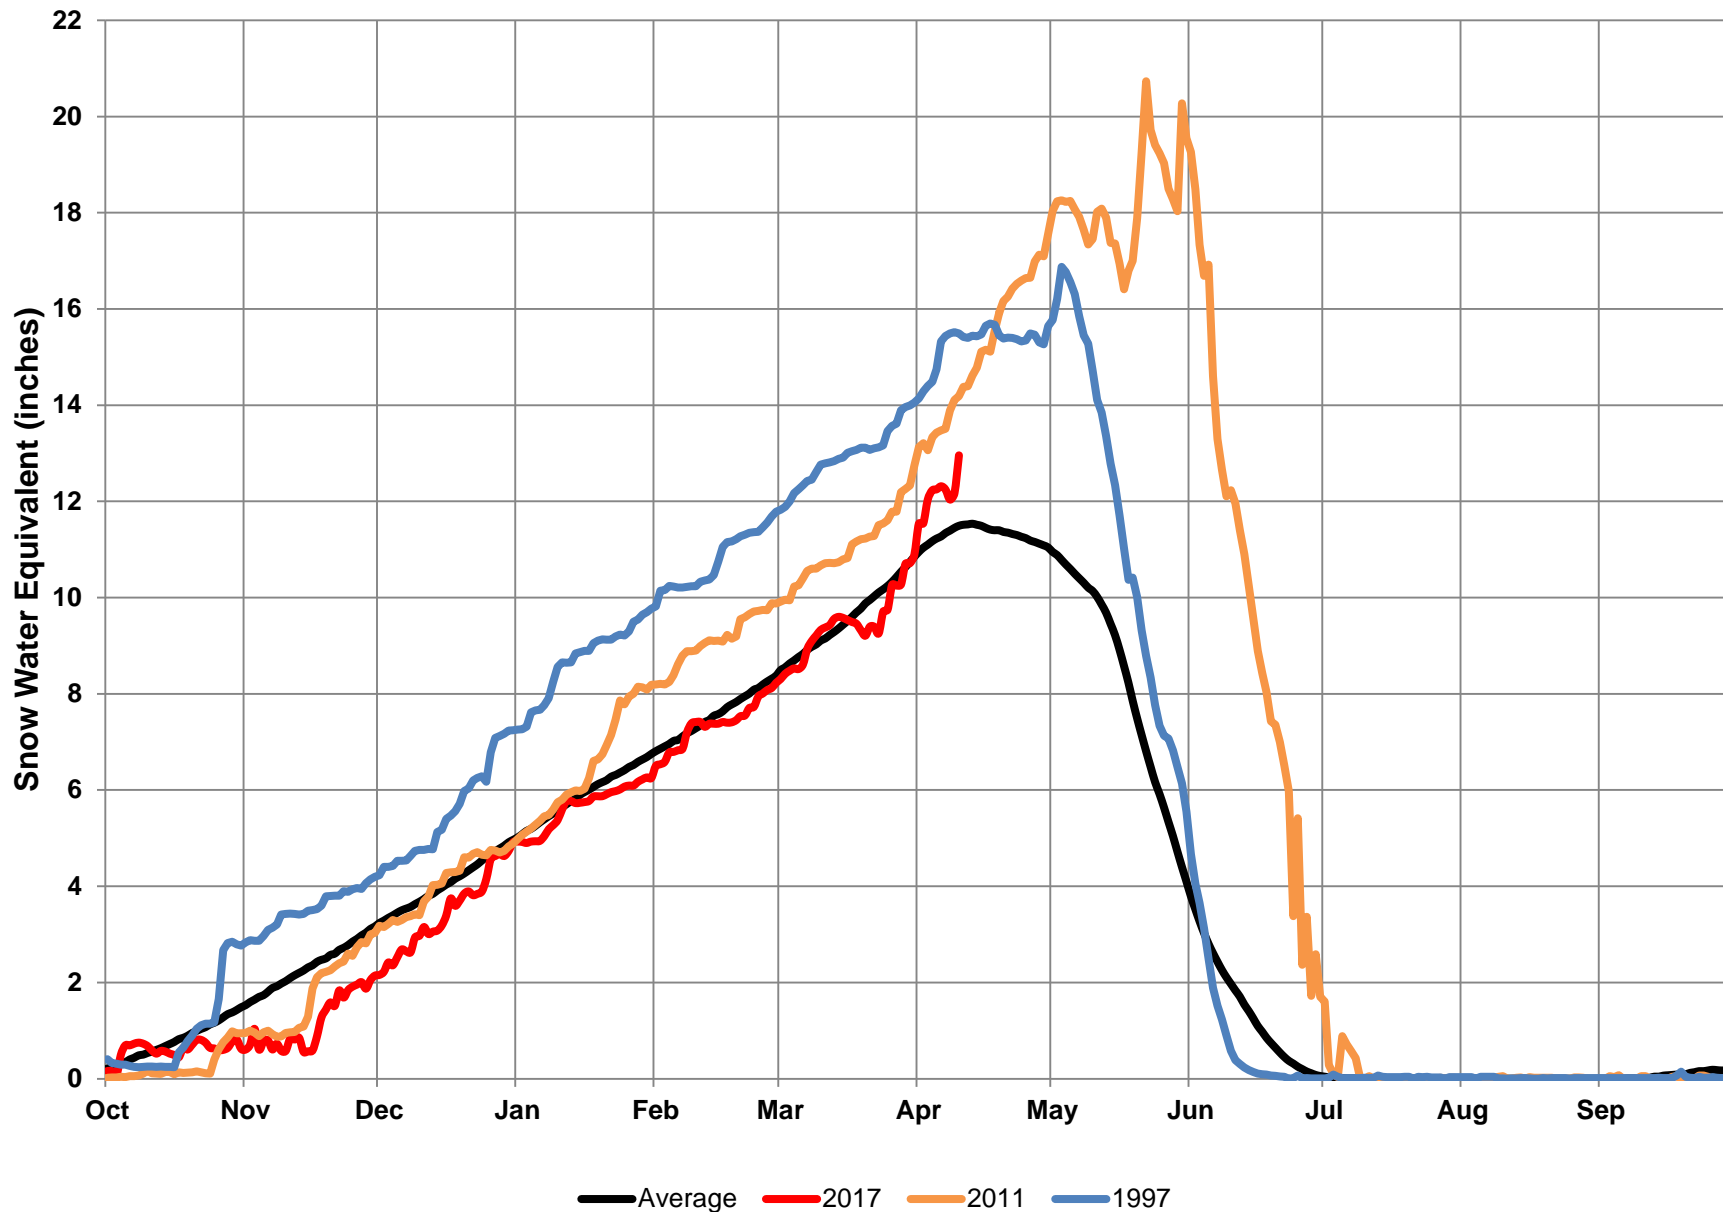
Mountain Snowpack in Bighorn Mountains on April 10

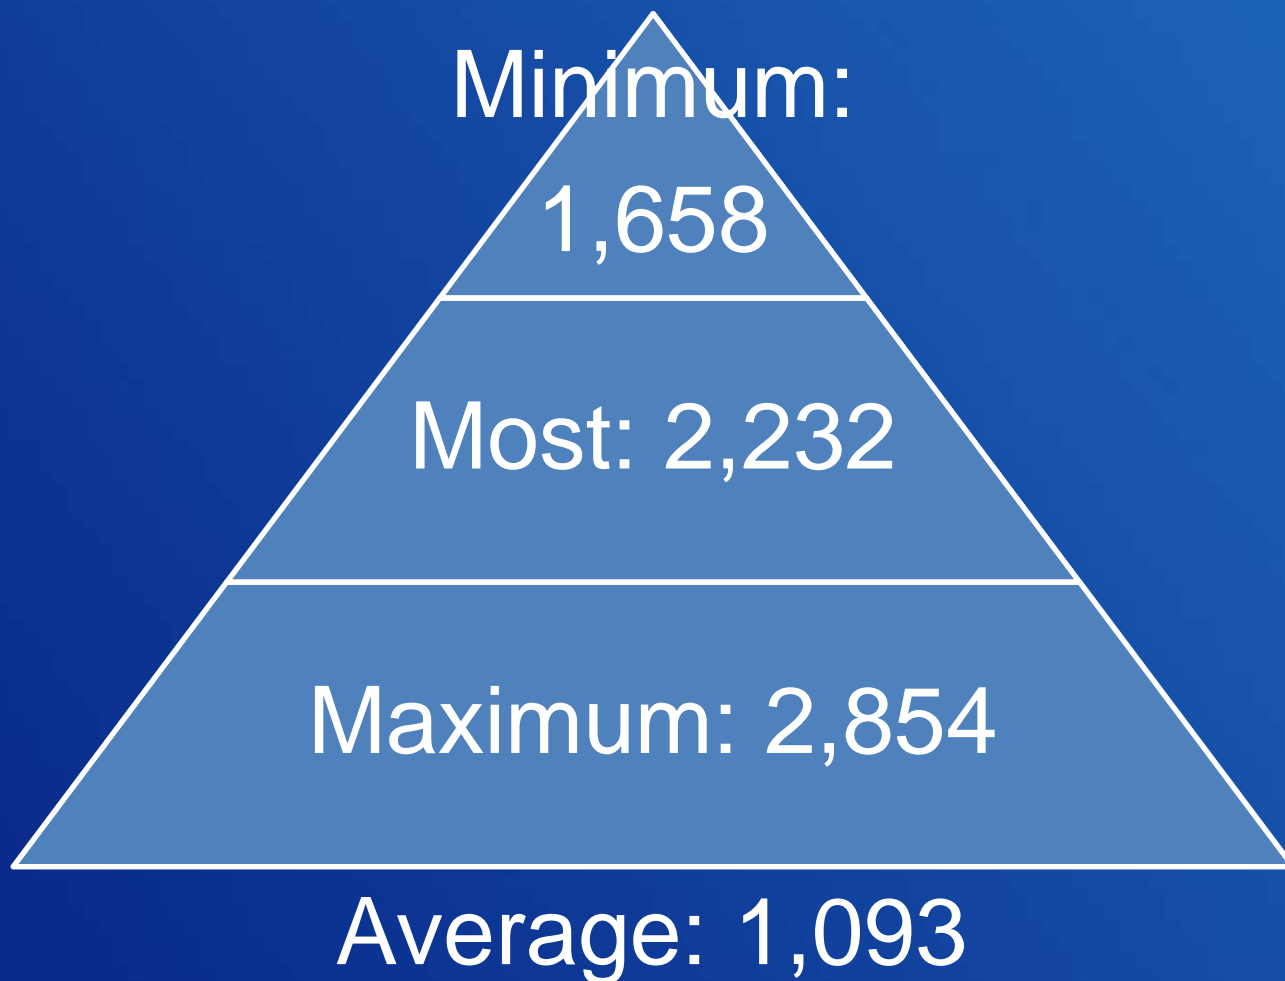
Bighorn Lake April – July Forecast

Thousands of Acre-feet

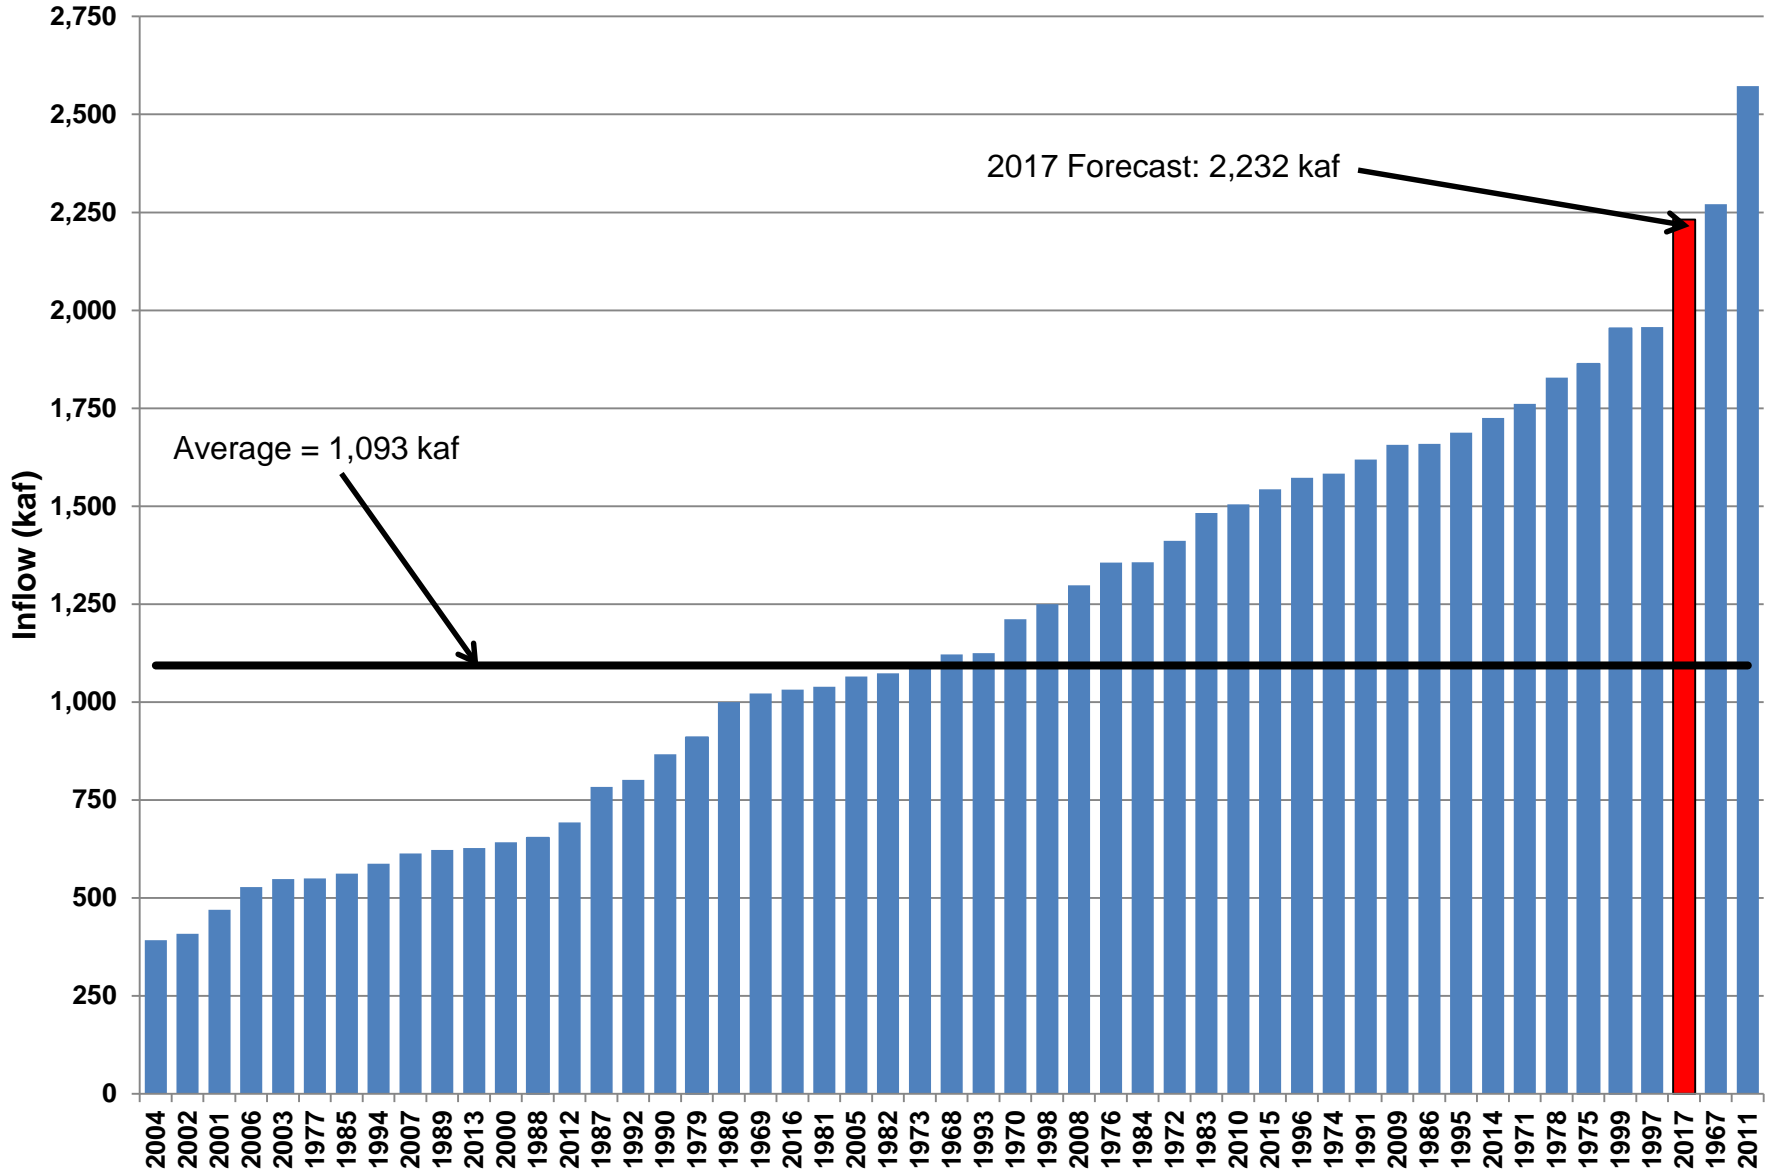
Bighorn Lake April through July Inflow

Period of Record 1967-2016

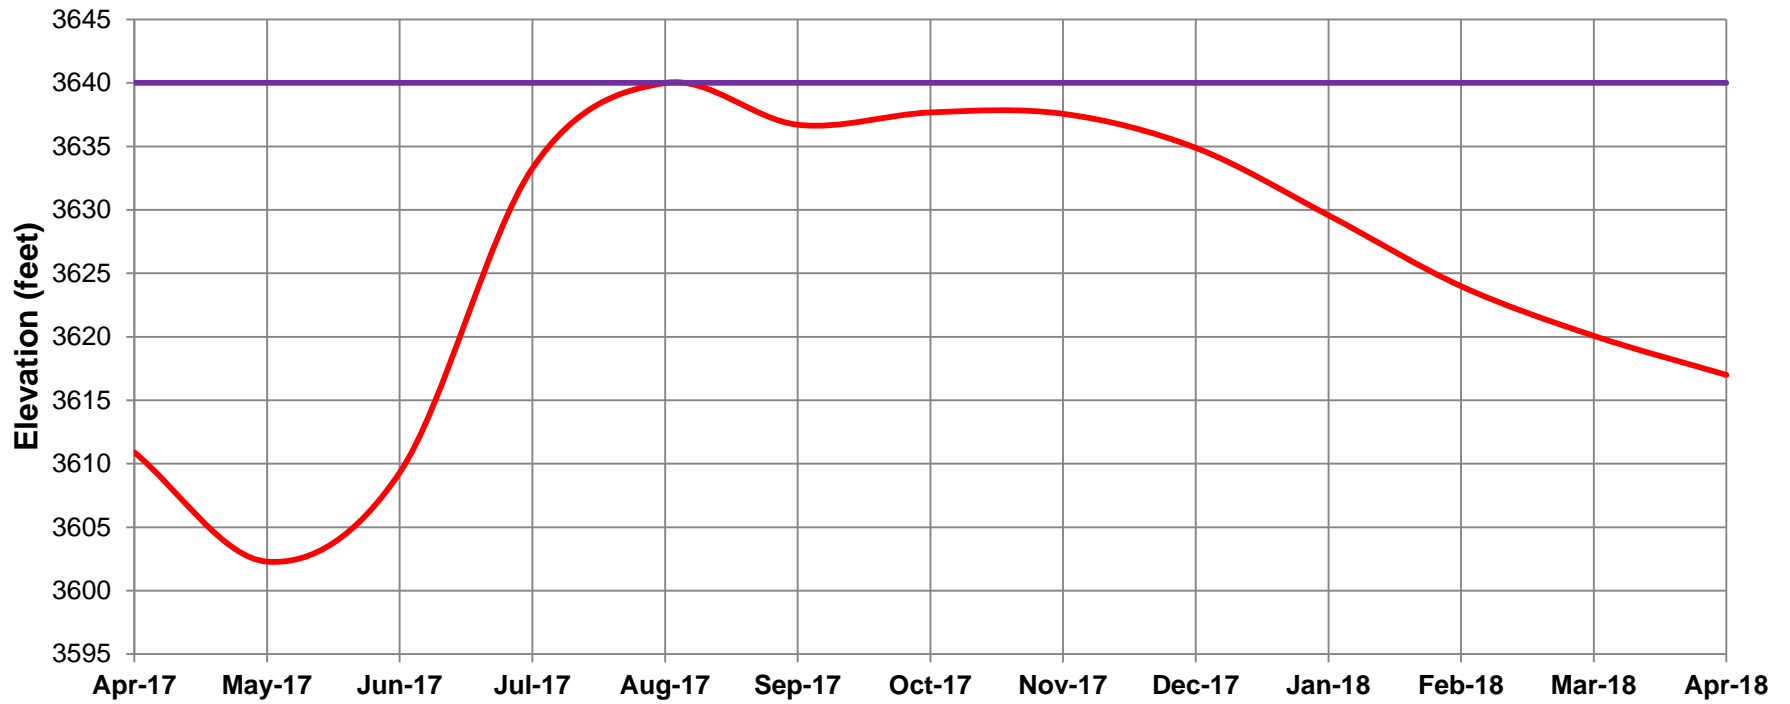
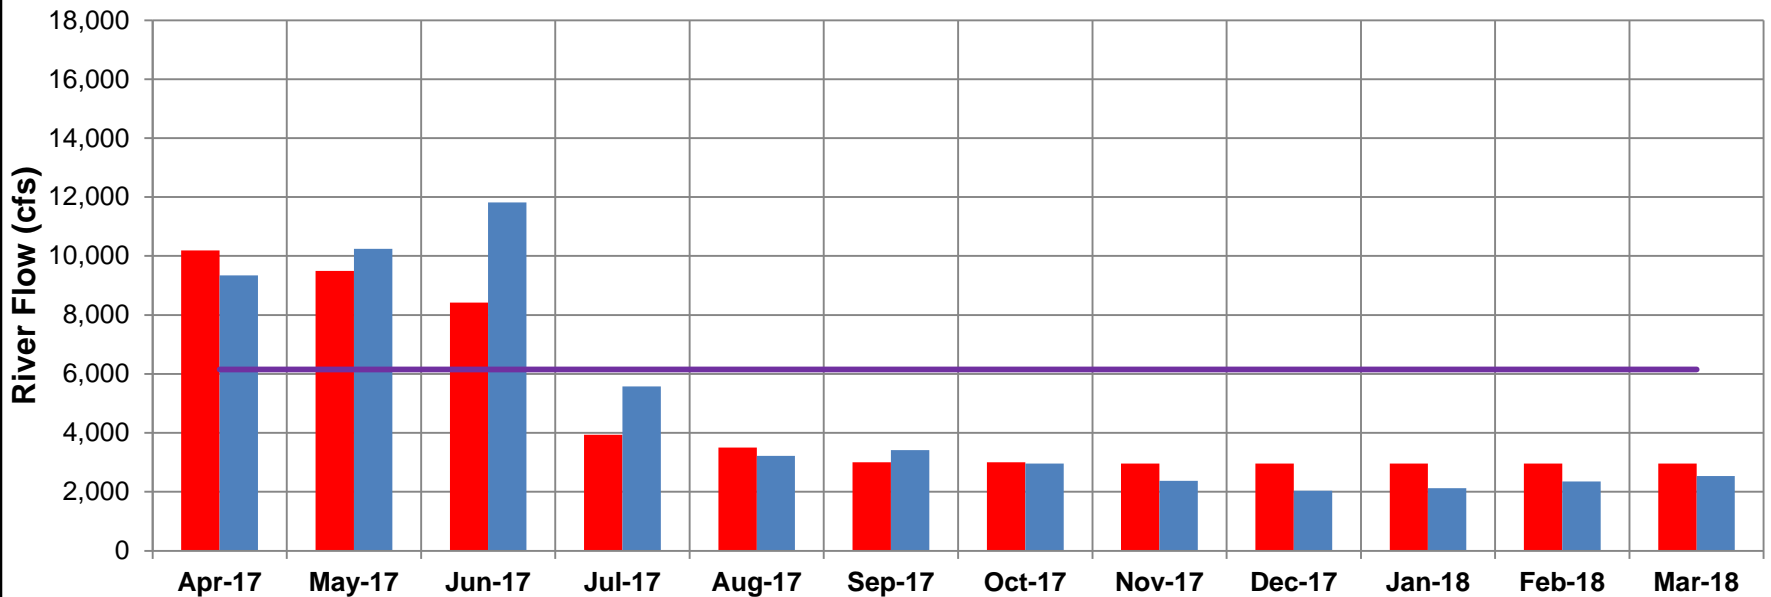
Most Probable Inflow Operations

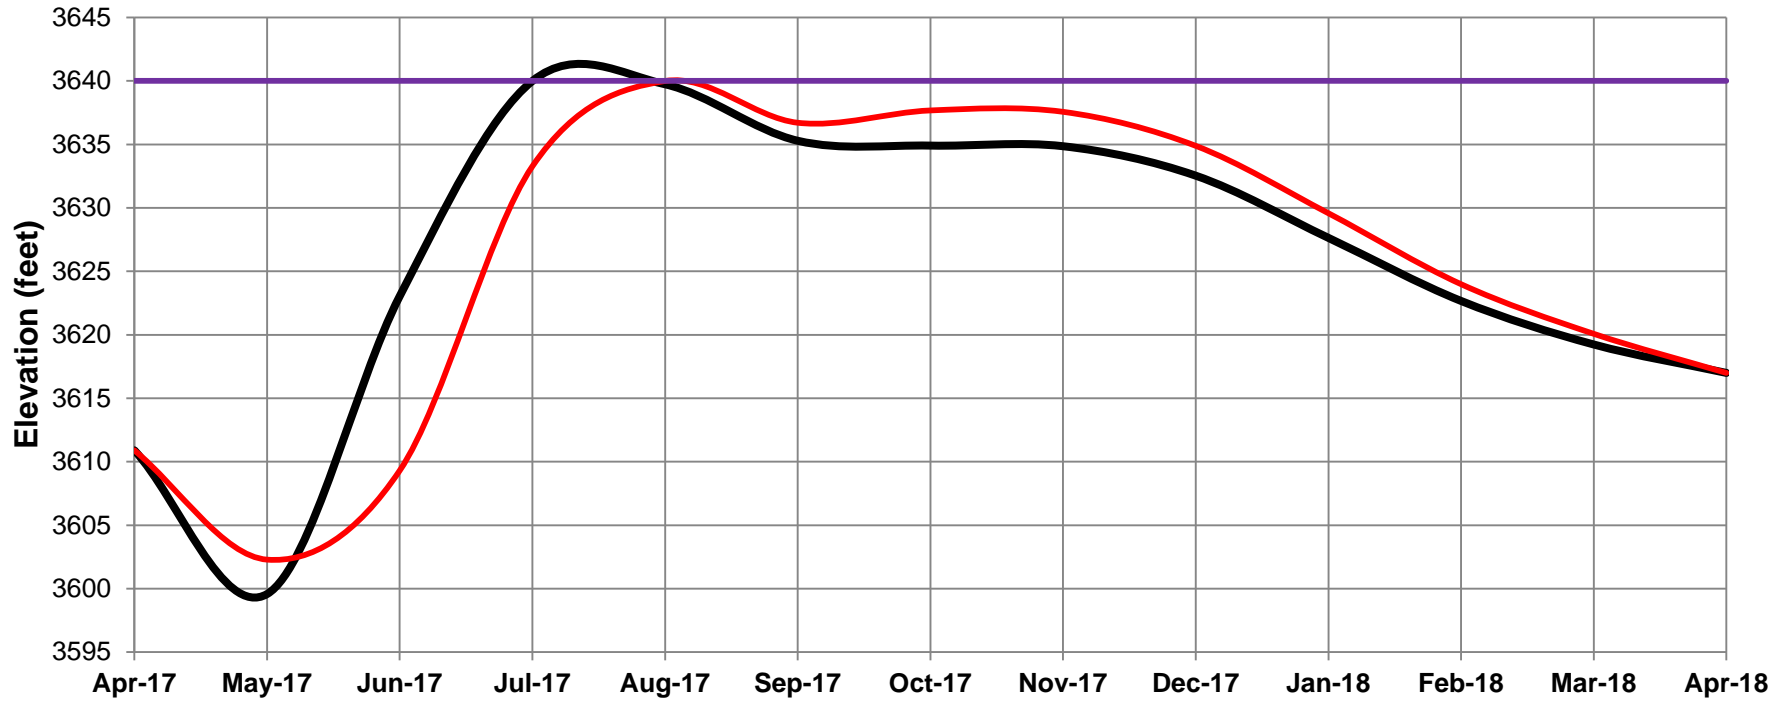
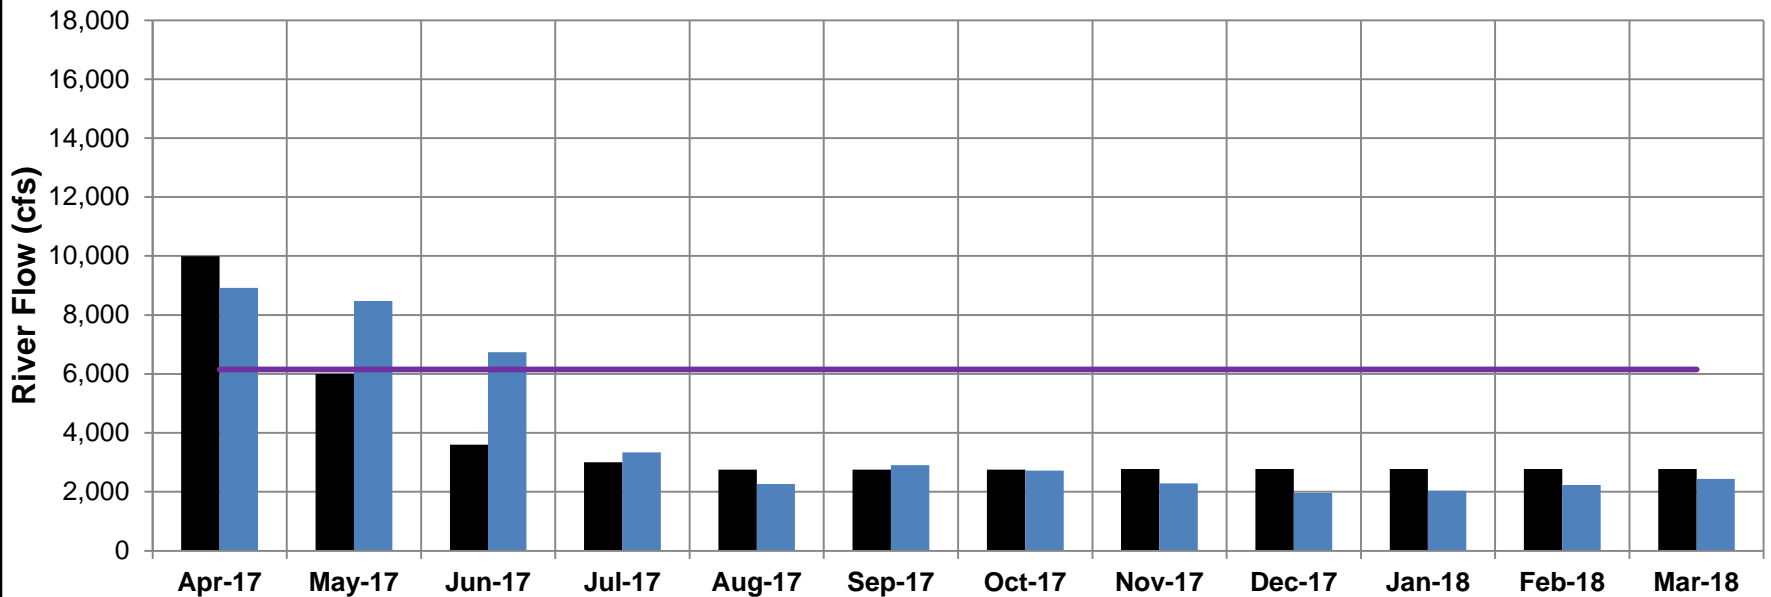
Most and Minimum Probable Inflow Operations
