Bighorn Basin Operations and Water Supply Meeting

April 13, 2017

Yellowtail Dam and Bighorn Lake Operations Review

Bighorn Lake Operations 2017

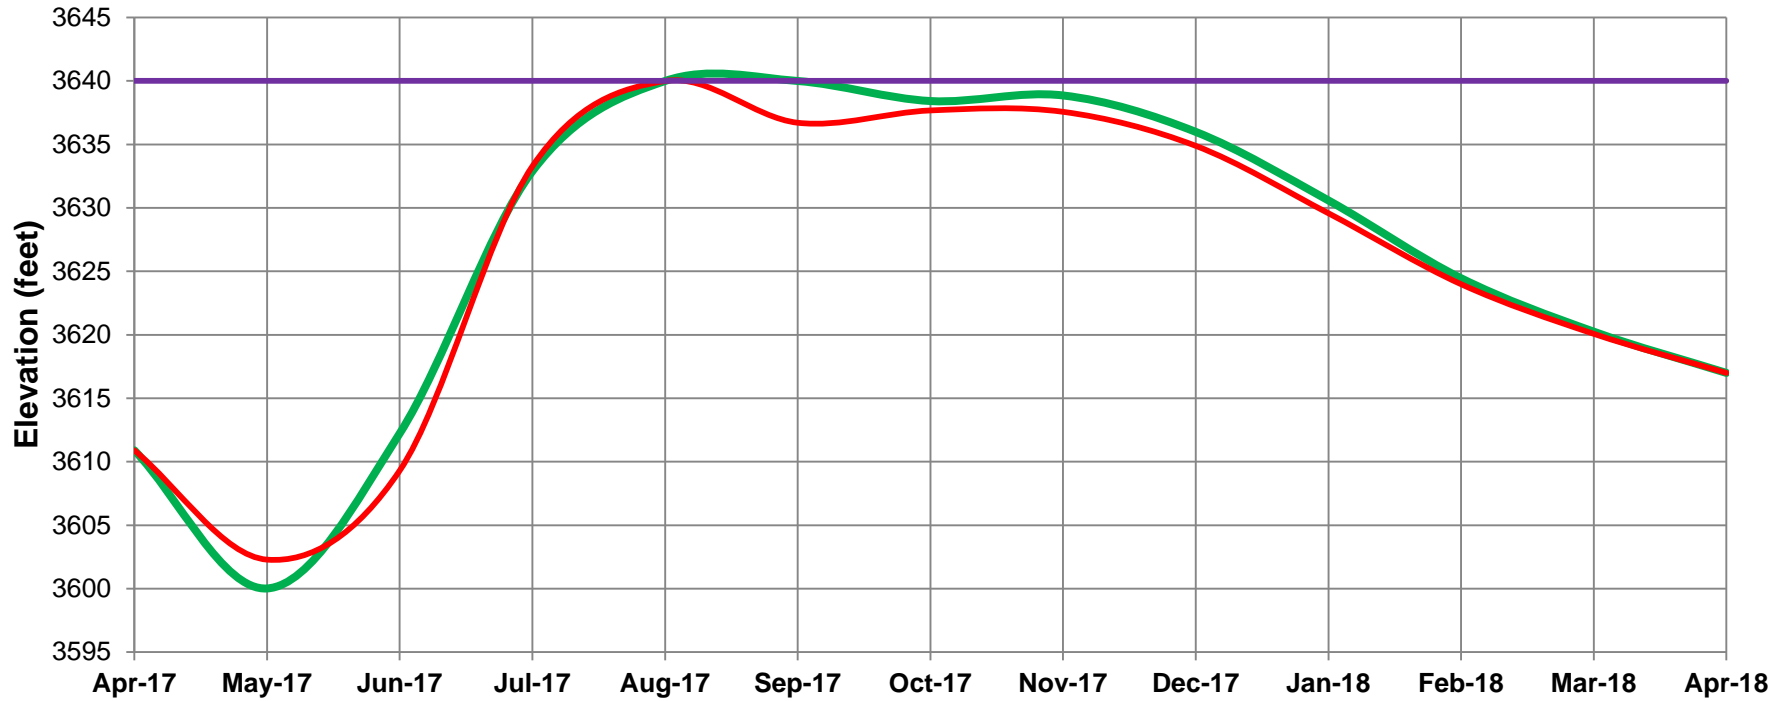
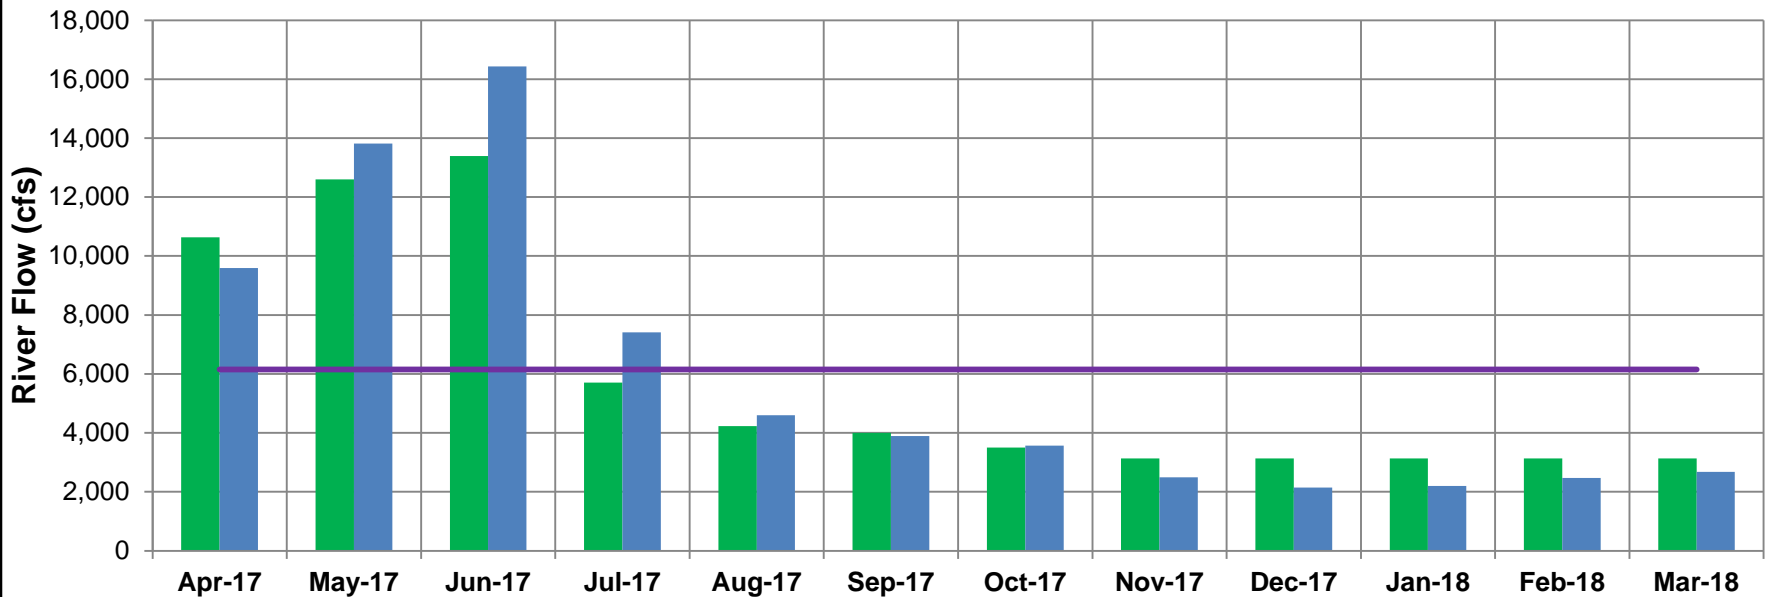
Most and Maximum Probable Inflow Operations

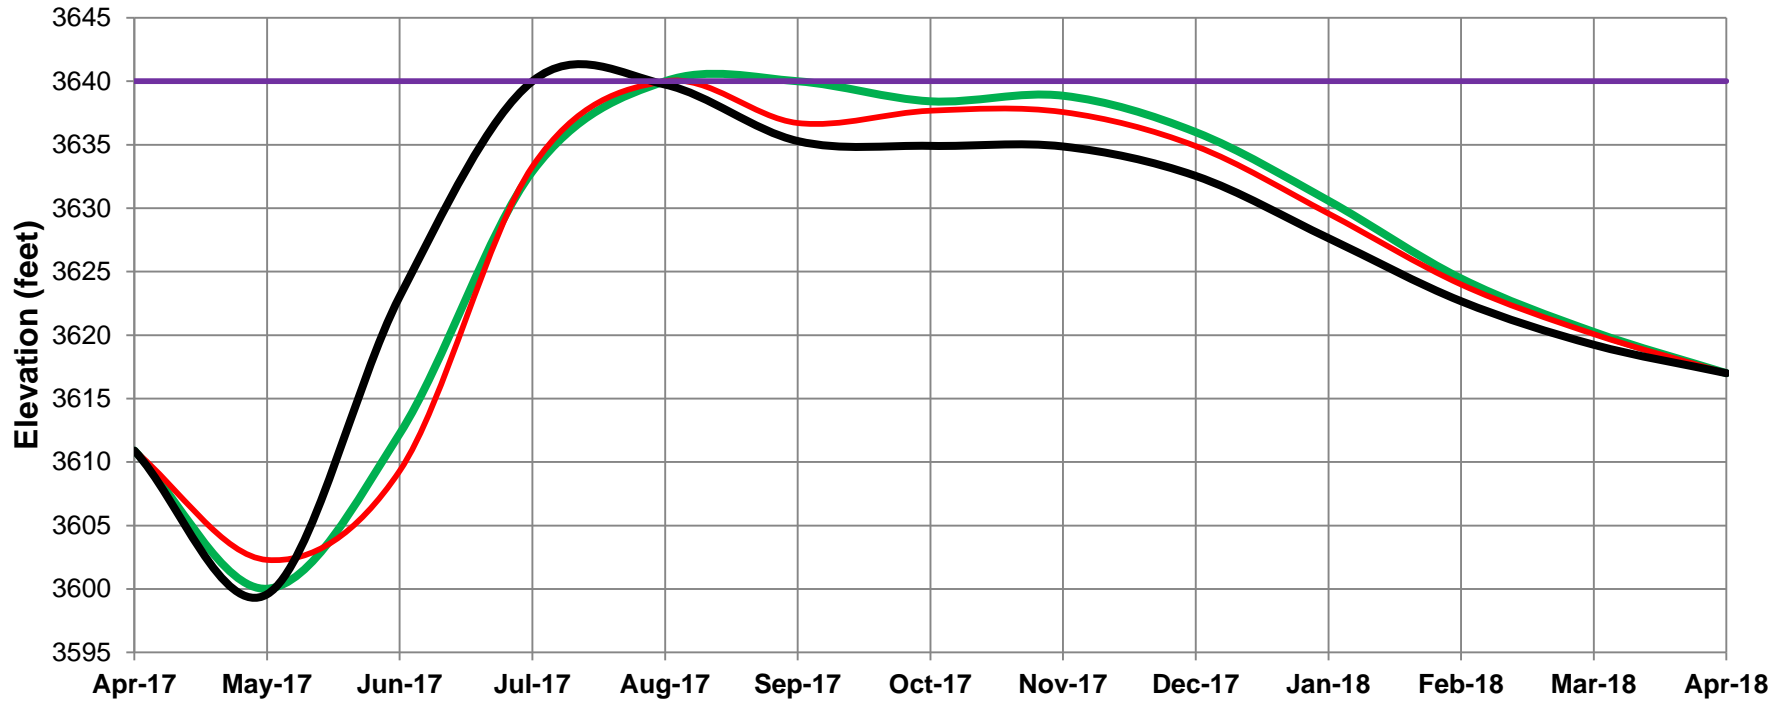
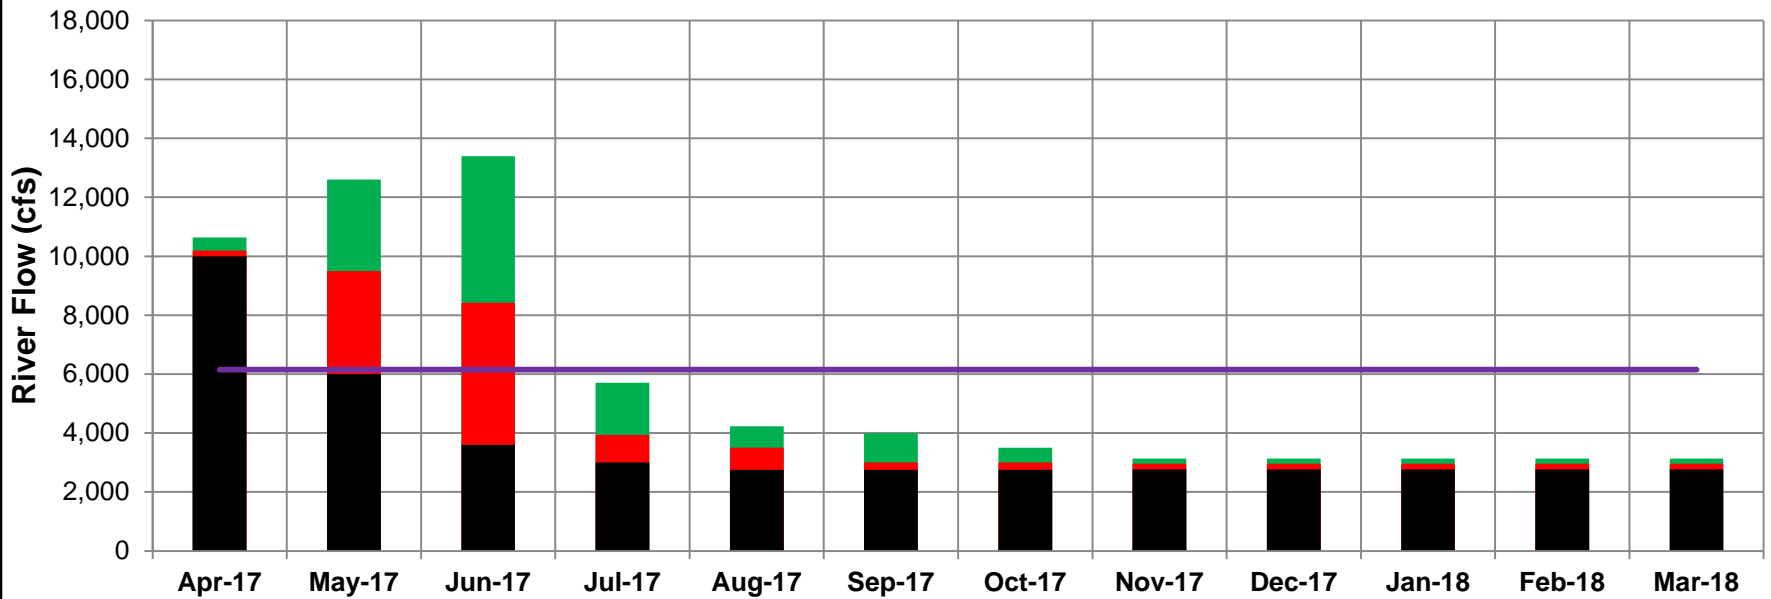
Most, Minimum, and Maximum Probable Inflow Operations
