RECLAMATION
Managing Water in the West

Plains Talk

NEWS FROM THE GREAT PLAINS REGION

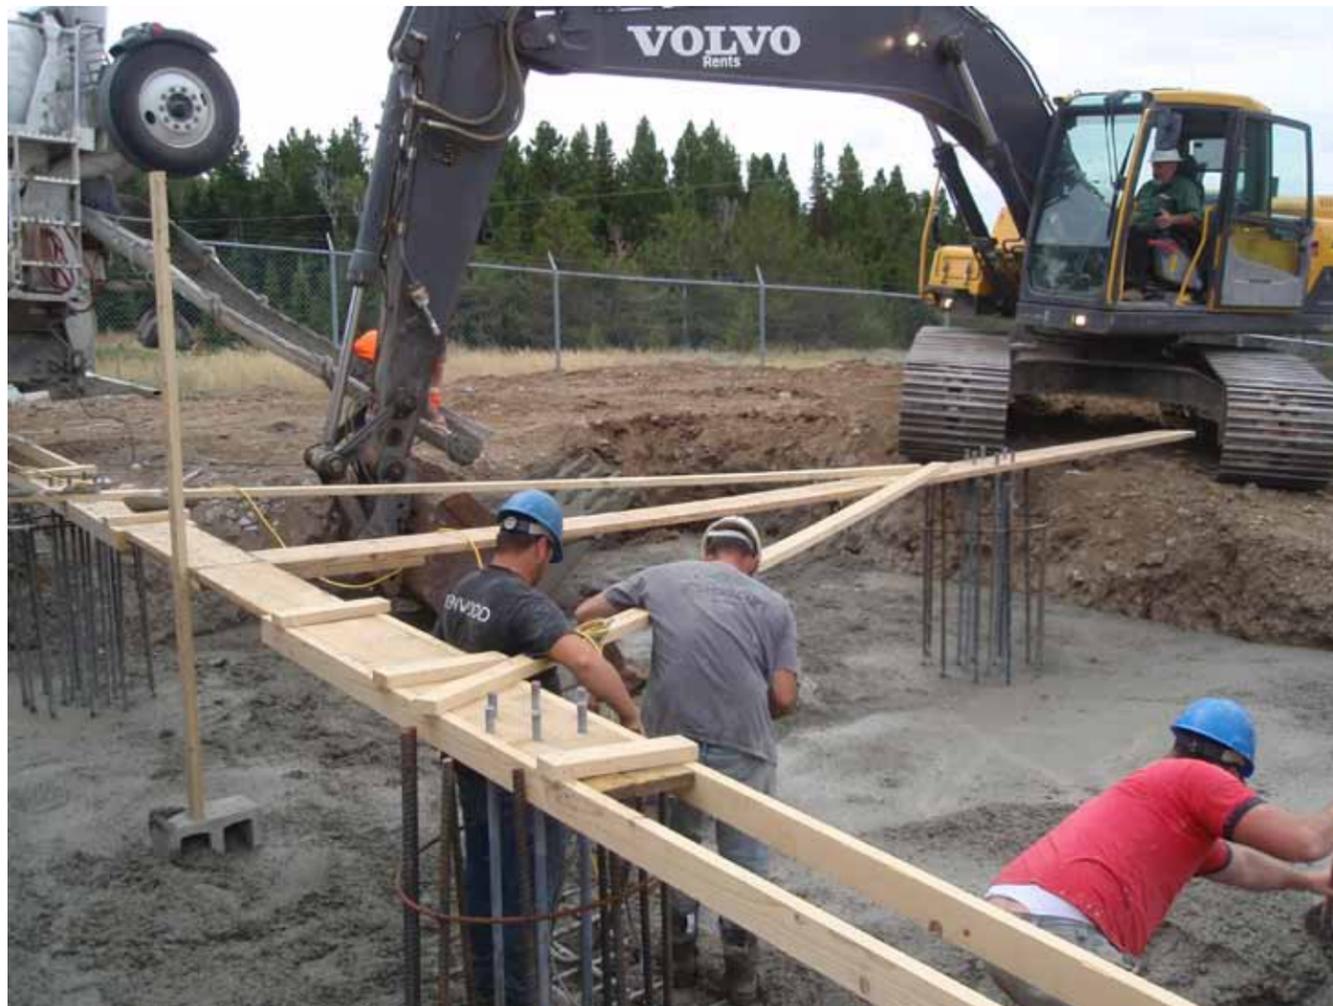
Workers placed concrete to prepare the Casper Mountain West site for a larger communications tower rated to withstand 125 mph winds.

The standard specifically addresses wind and ice loads. Reclamation's old tower was a 130-foot-tall, self-supporting steel structure with a 14-foot base

width and a 90 MPH wind rating. The new tower is a 132-foot-tall, self-supporting steel structure with a 17-foot base width and a 125 mph wind rating.

The larger, stronger tower is designed to better withstand the high winds and heavy winter ice loads

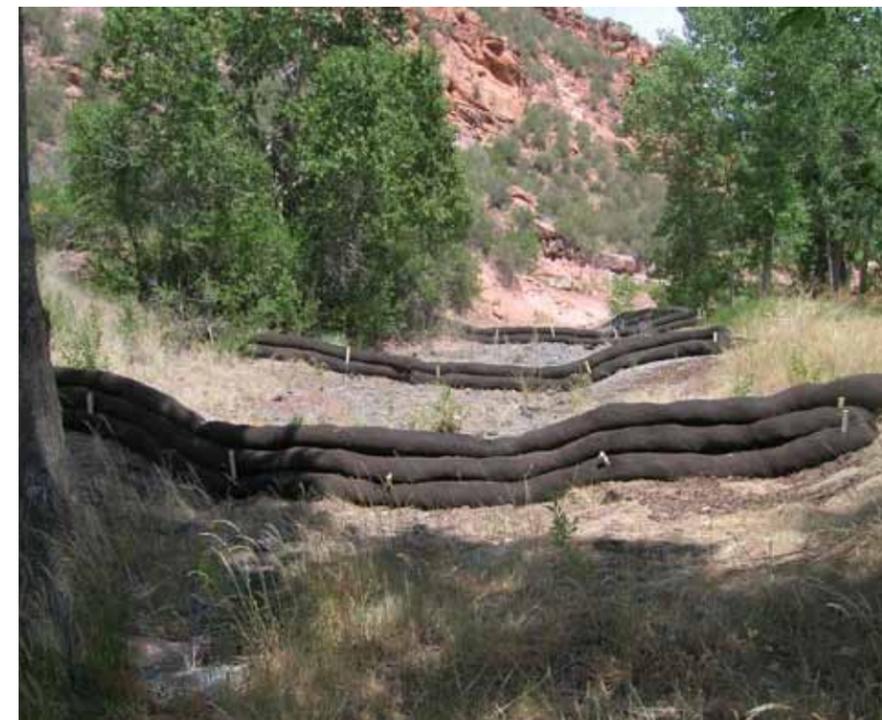
Debris booms in Soldier Creek: After the High Park Fire, debris booms were placed along Soldier Creek, which drains into the north end of Horsetooth Reservoir, to catch ash and other fire sediment that might wash into the waterway during storms and snow melt.

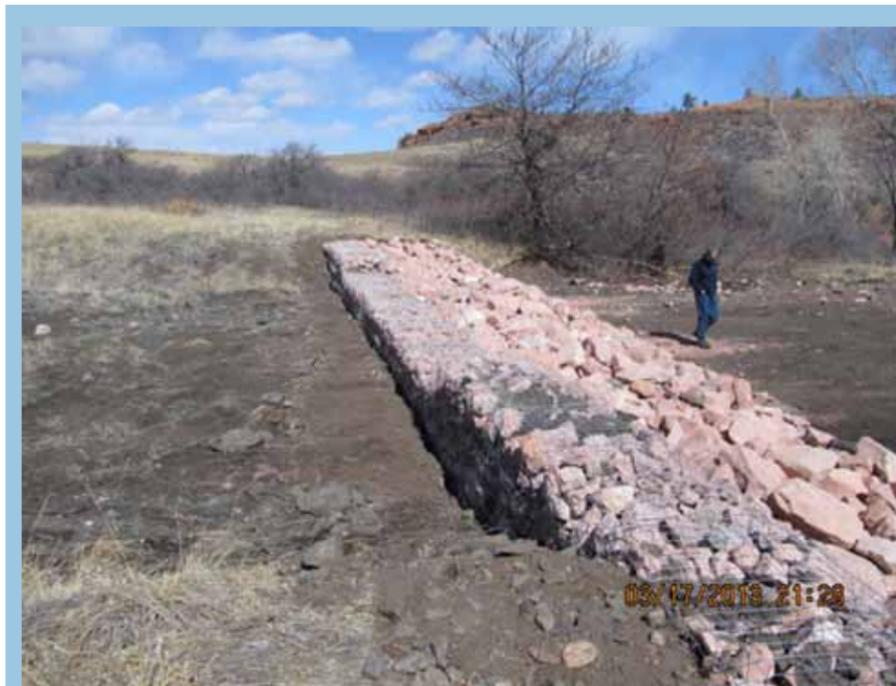
In 2013, sediment dams were placed in Soldier Canyon, upstream of Horsetooth Reservoir.

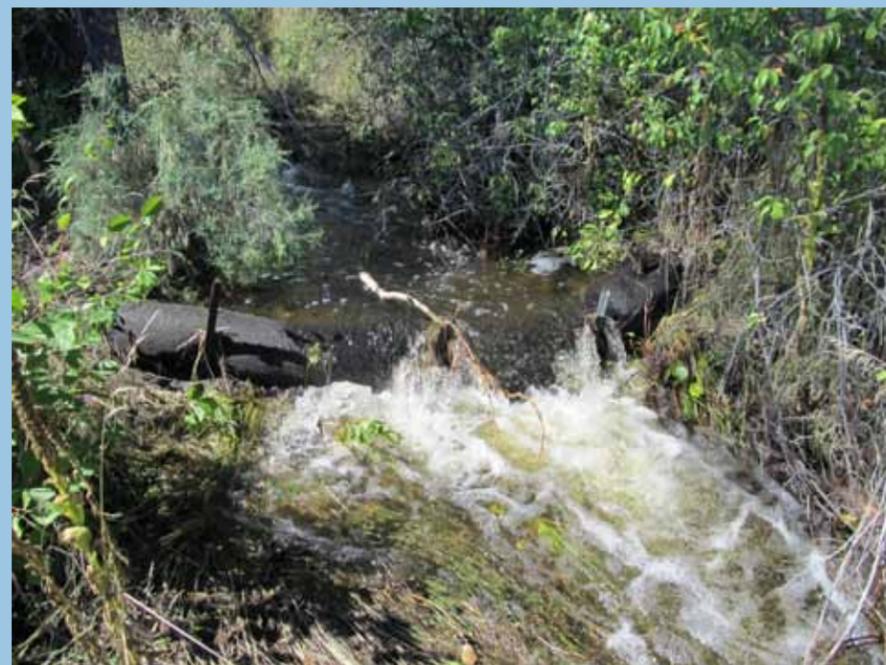
Waddles in action after a rain storm.

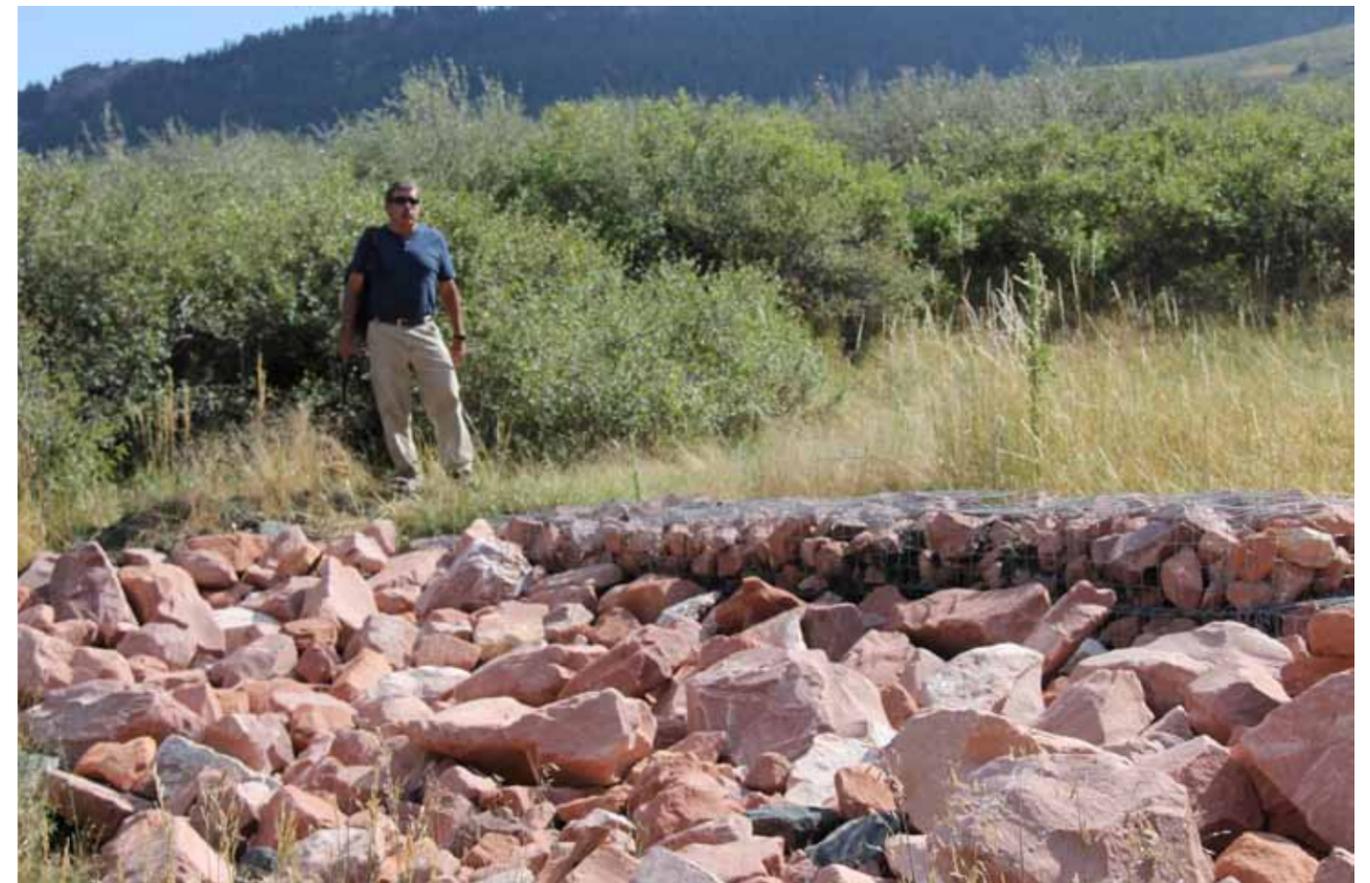
Patrick McCusker, Natural Resource Specialist from ECAO, checks the sediment dam in Soldier Canyon a week before Deputy Secretary Mike Connor’s visit.

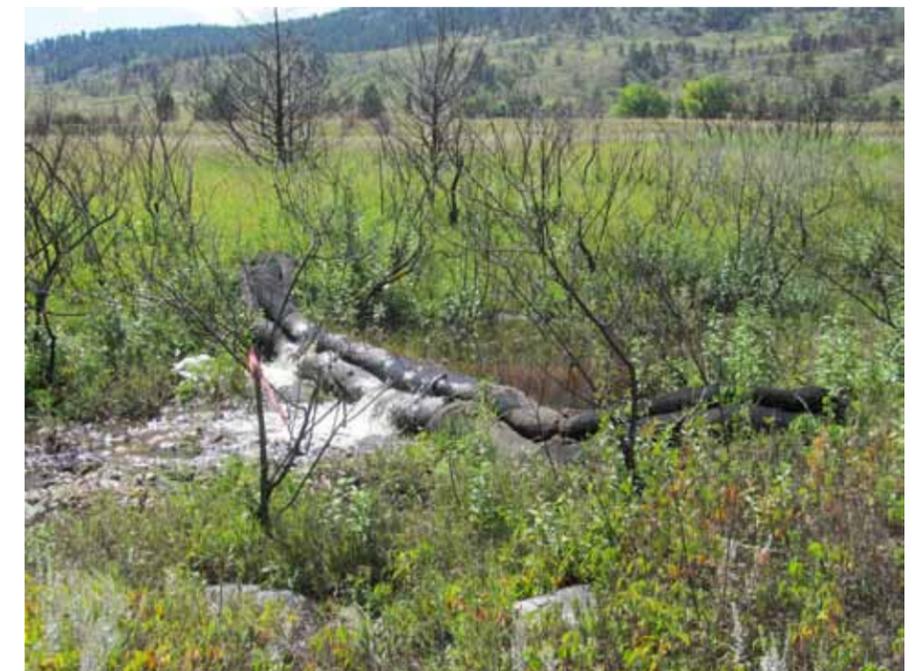
Waddles slowing spring runoff in 2013.

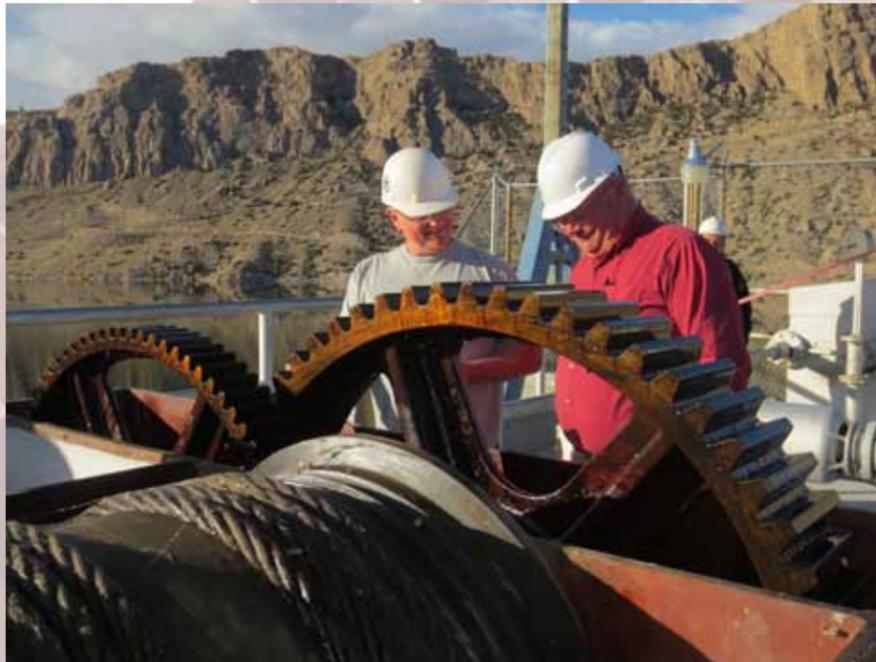
Ron Spangler, WYAO O&M Division Chief, and Mike Bradford, WYAO Safety Officer, observe spillway gate hoist gears in operation.

Reclamation requires that spillway gates associated with continuously high reservoirs, like Boysen, be operated through their full range of travel at least once every six years to ensure the

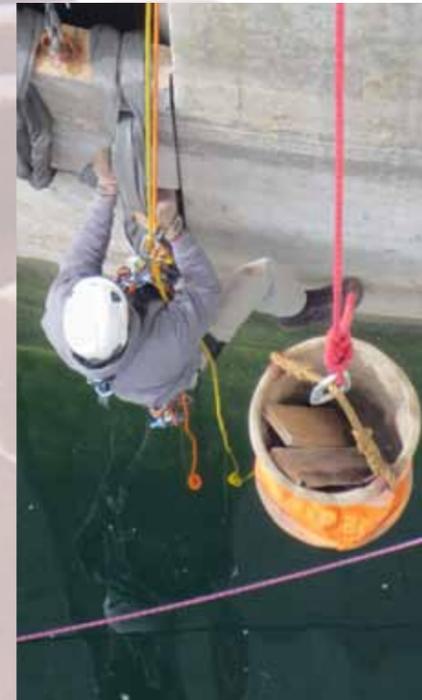
William Newman, WYAO Rope Team Member and Electrical Engineer, rigs a concrete guide slot block for removal at Boysen Dam Spillway.

At Boysen, it was first necessary to remove concrete blocks which protect the guide slots for the bulkheads. The guide slots run about 58 feet from the floor of the spillway to the top of the dam. The blocks are about three feet tall and weigh 700 pounds each. The concrete blocks which were

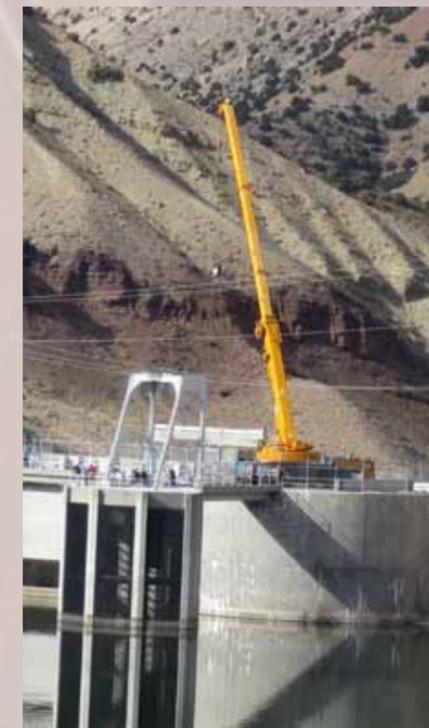
A large mobile crane prepares to set a Stop Log in the Boysen Dam Spillway Gate 1 Bay.

Placement of large spillway gate stop logs is a labor intensive process. Extensive pre-job planning and job hazard analysis was employed, with a focus on safely completing the testing.

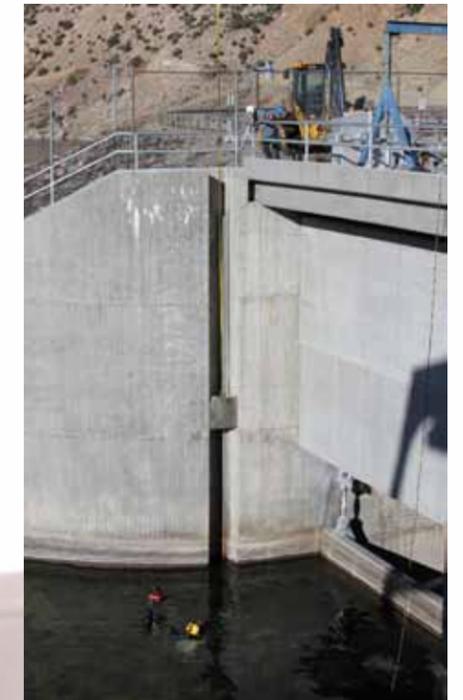
Billy Bright, Chief WYAO Mechanical Engineering Branch (in white hardhat), observes divers assisting with installation of a concrete guide slot block.

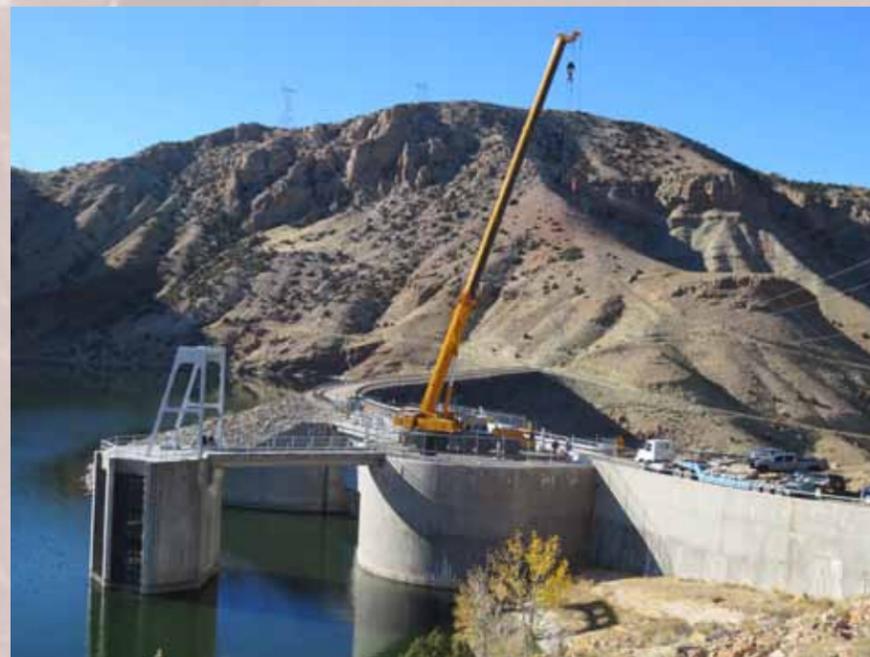
Crew prepares concrete guide slot blocks.

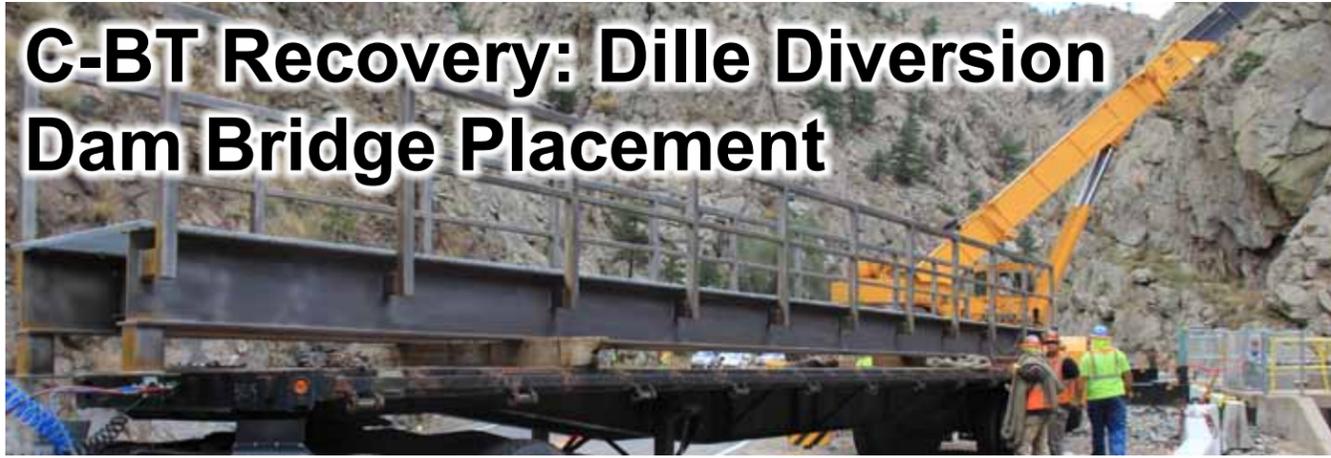
The bridge being delivered to the canyon the morning of October 22.

That milestone was accomplished on October 22, 2014. The new bridge, which provides access across the 90-foot long crest of the dam, weighs approximately 9500 lbs, and replaces the temporary bridge that will soon be removed.

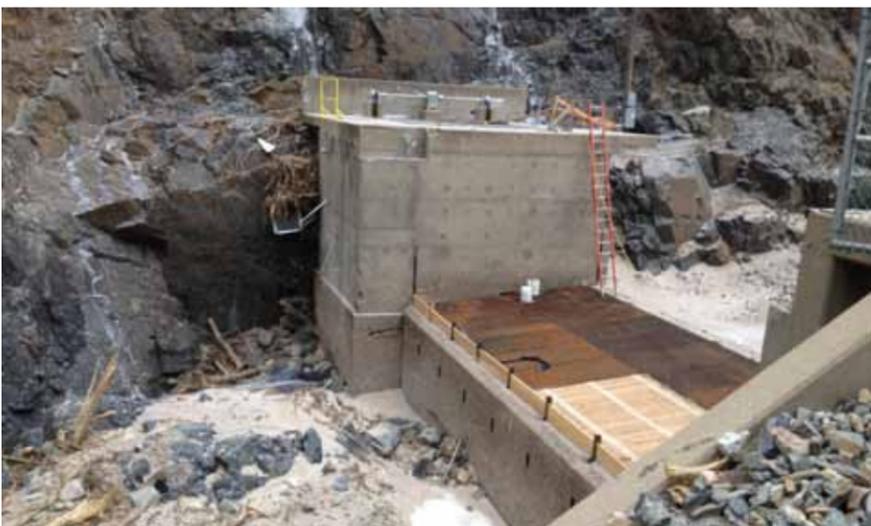
View of Dille Dam before placement of the pedestrian bridge.

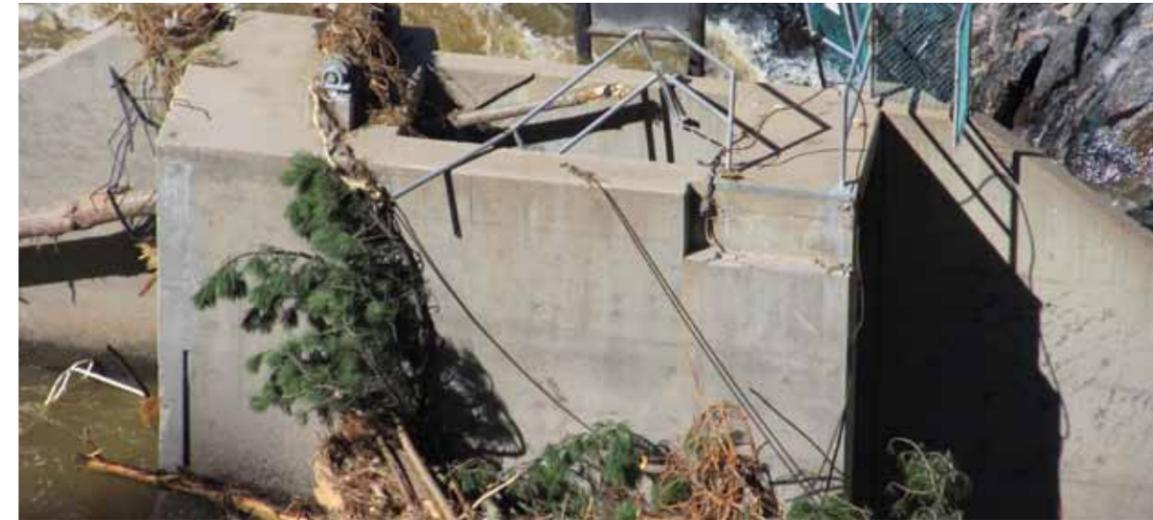
The 2013 Flood washed away the pedestrian bridge the used to span Dille Dam. Colorado Department of Transportation placed a temporary bridge during repairs along the highway.

The small diversion dam, designed to pass up to 1300 cubic-feet-per second over its spillway, withstood a range of flow somewhere between 15,000-24,000 cfs at the flood's peak. Flood waters ripped a small gauging house from the top of the dam, washed away the pedestrian bridge, and tore away the state highway along the dam's left abutment.

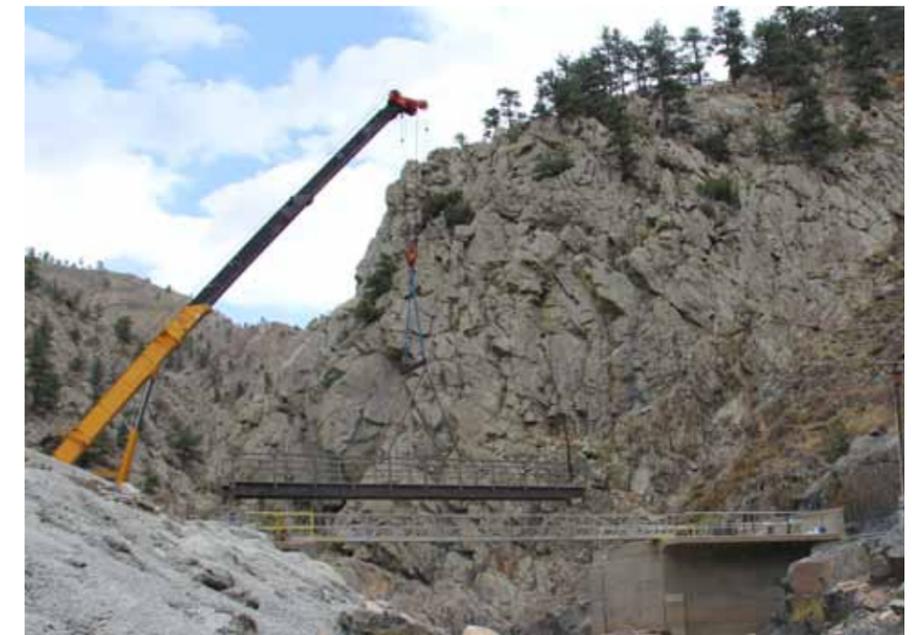
A crane swings the bridge into position.

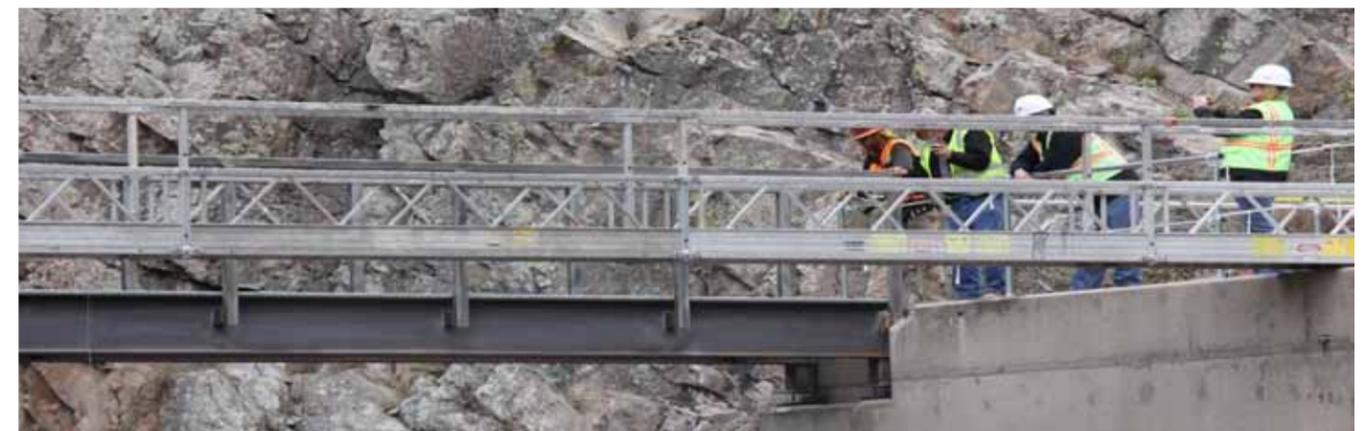
The bridge being carefully aligned before placement across Dille Diversion Dam.

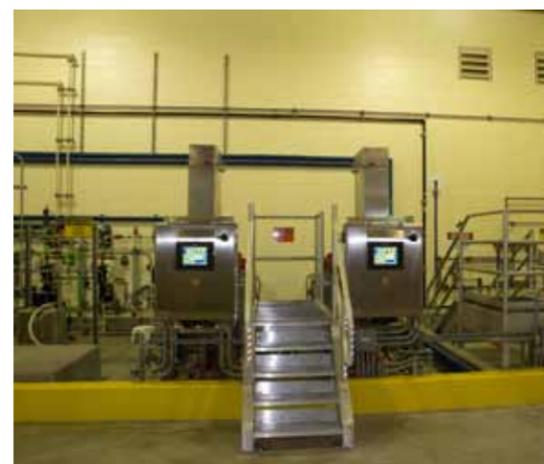
The area of the water treatment plant used to handle chemicals critical to the treatment process.

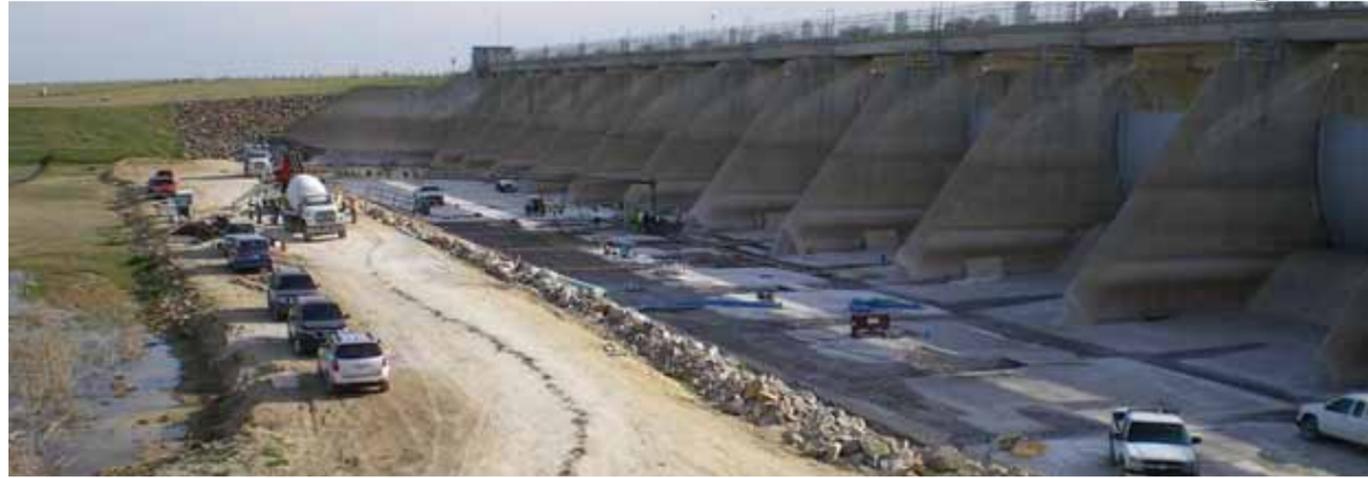
View of repair work for the inlet apron slabs on the upstream side of Glen Elder Dam spillway. There is no water in contact with the spillway unless the reservoir is in the flood pool.

At first glance, a complete replacement of the inlet slabs seemed to be the appropriate method for restoring the sliding stability of the structure.

However, after looking into the difficulty of not deforming or damaging the roughly 760 foundation anchors in the demolition process, it was determined that other alternatives should be evaluated. Life cycle costs were developed for several alternatives, including installing new foundation anchors, partial repairs, and full replacement.

The most economical option was to selectively remove deteriorated concrete using hydrodemolition, and place concrete patches back to the original lines and grades.

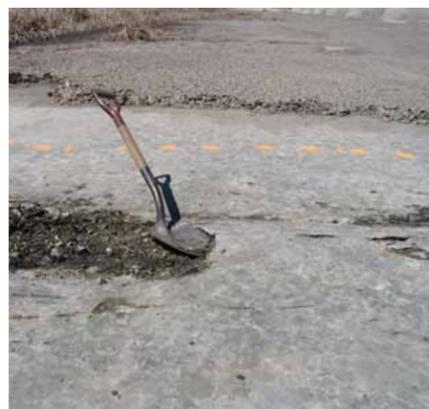
Inlet apron slab concrete in some areas could be excavated with a shovel as seen in this photo taken prior to the repair.

Petrographic evaluations of concrete cores indicated that cracking induced by cycles of freezing-and-thawing in saturated conditions was the primary source of deterioration. The cracks allowed water to flow more easily through the concrete which led to further damage by alkali-silica reaction. Depths of deterioration ranged from 0-14 in. As the concrete began to deteriorate, especially near contraction joints,

the deteriorated areas were capable of holding water, causing an exponential rate of deterioration during freeze thaw cycles. Some of the deteriorated areas could be excavated with a shovel.

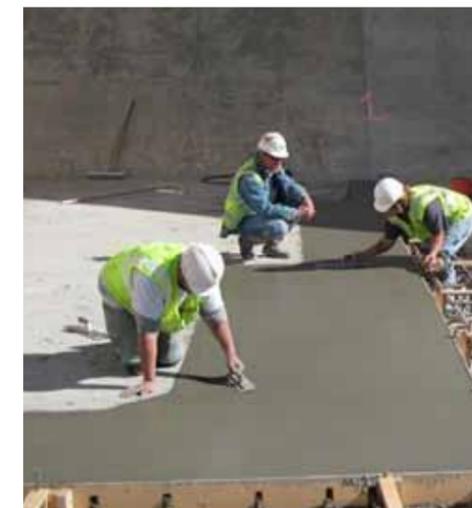
Placing concrete back to the original lines and grades.

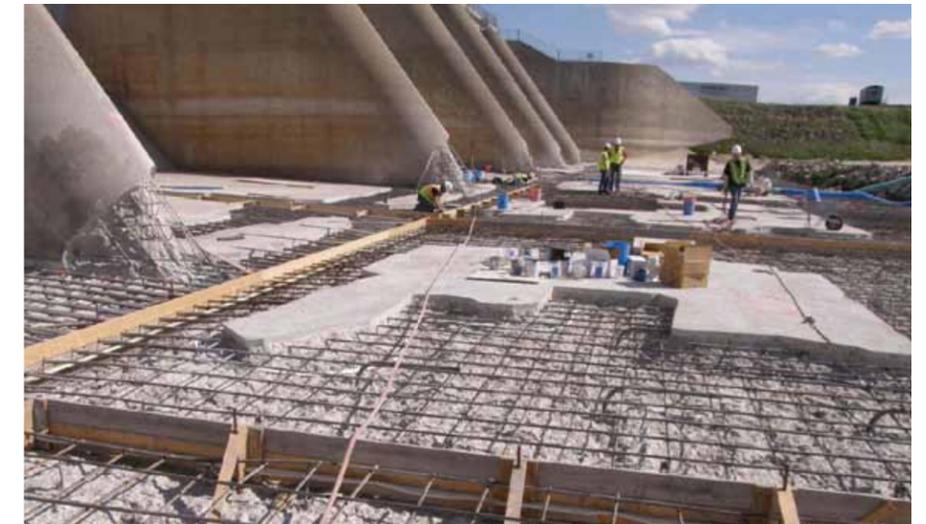
Inlet slabs and spillway structure ready to be placed back with fresh concrete. Foundation anchors are the curved #11 rebars that tie into the top mat of rebar.

The concept behind hydrodemolition is that a high pressure water jet (20,000 psi +/-) will continue to take out deteriorated and cracked concrete until it runs into good quality concrete. The benefits of hydrodemolition include fast removal, a demoed surface is three dimensional and provides maximum potential for bonding, cleans rebar of all rust, eliminates micro-cracking typically associated with jack hammers.

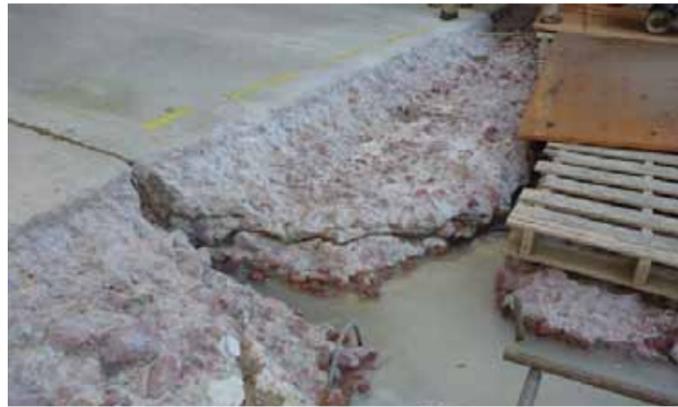
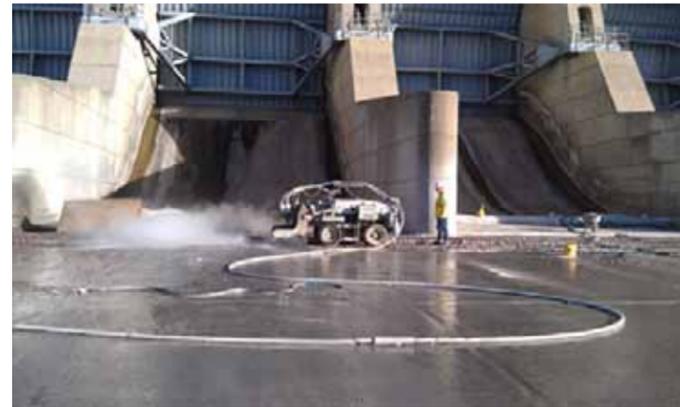
(Left) Delamination at a depth of 6-10 inches of the Fort Randall Dam spillway visible after initial removal (photo, U.S. Army Corps of Engineers, June 16, 2014). (Right) Hydrodemolition of the upper expansion joint at the Fort Randall Dam spillway (photo, U.S. Army Corps of Engineers, Oct. 2013).

During the initial assessment of the spillway damage, ground penetrating radar was used to estimate the required scope of repairs.

While the radar results showed extensive anomalies indicative of delamination along both spillway walls and the expansion joint between the slab and the gate structure, the designers chose to discount a majority of the anomalies as false returns and identified only 40,000 square ft of the in need of repair. This decision was ill founded, however, as nearly 130,000 square ft of delamination repairs were ultimately found to be required.

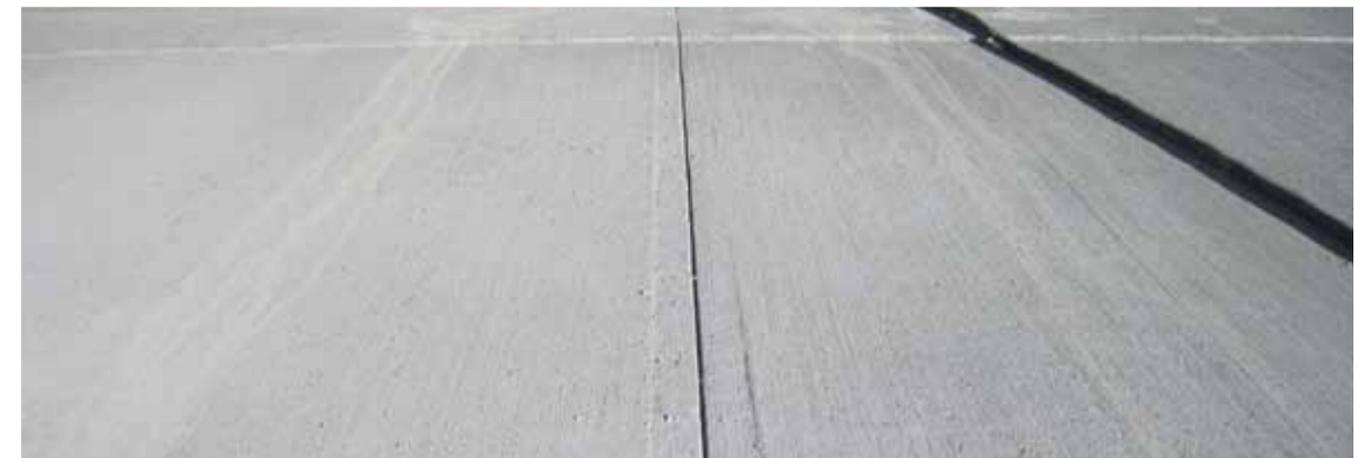
Concrete overlay at 29 days of cure exhibiting no shrinkage cracking on a 25 x 25 ft. monolithic placement (U.S. Army Corps of Engineers, October 11, 2013).

The 18 in. (457 mm) thick spillway slab panels were 25 x 25 ft. (7.62 x 7.62 m) in plan and were constructed with only a single mat of reinforcement at a depth of 9 in. (229 mm). The panels exhibited significant thermal cracking, and some of the cracks extended to mid-depth of the slabs. Because the panels were highly restrained by the spillway wall and gate structures, the repair mixture was designed to have mini-
