# PlainsTalk

Winter 2020

# Reclamation Responds to Fort Laramie Canal Tunnel No. 2 Failure

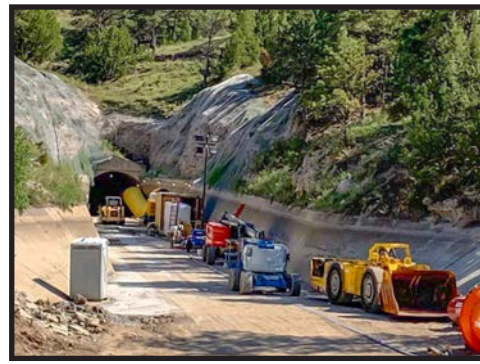
*Heavy equipment was staged at the Tunnel No. 2 entrance.*

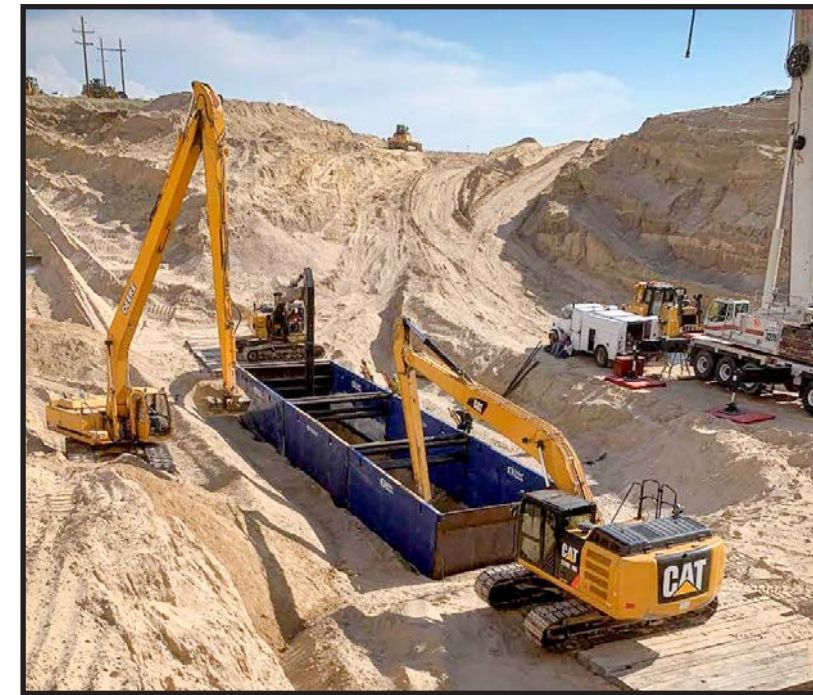
*An excavating trench box was used above the Tunnel No. 2 Ceiling, August 20, 2019. (G.T. Hastings)*

The contractor subsequently mobilized and completed emergency repairs to the tunnel, which included adding internal reinforcement to the tunnel, pumping grout to fill voids behind the tunnel lining, and removing the sinkhole material that had collapsed into the tunnel. The districts and their contractors also excavated and stabilized the sinkhole material on the ground surface above the tunnel in order to prevent additional material from entering the collapsed area. This involved removing massive quantities of soil overburden which covered the collapsed sections of the tunnel.

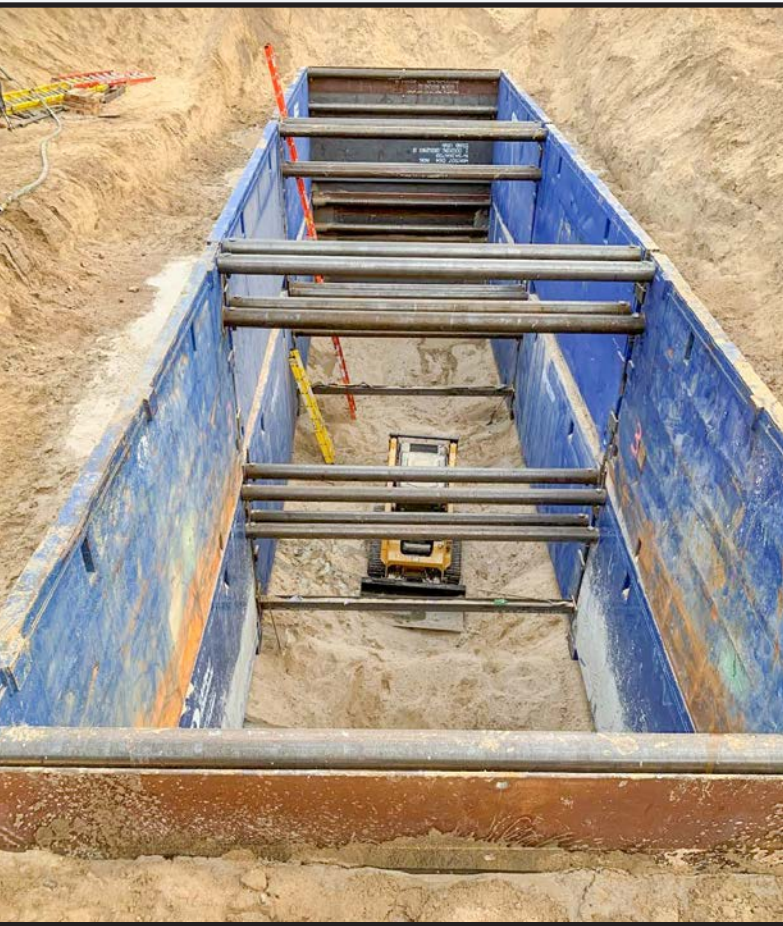
Trench box assembly in use at Fort Laramie Canal Tunnel No. 2, August 23, 2019. (G.T. Hastings)

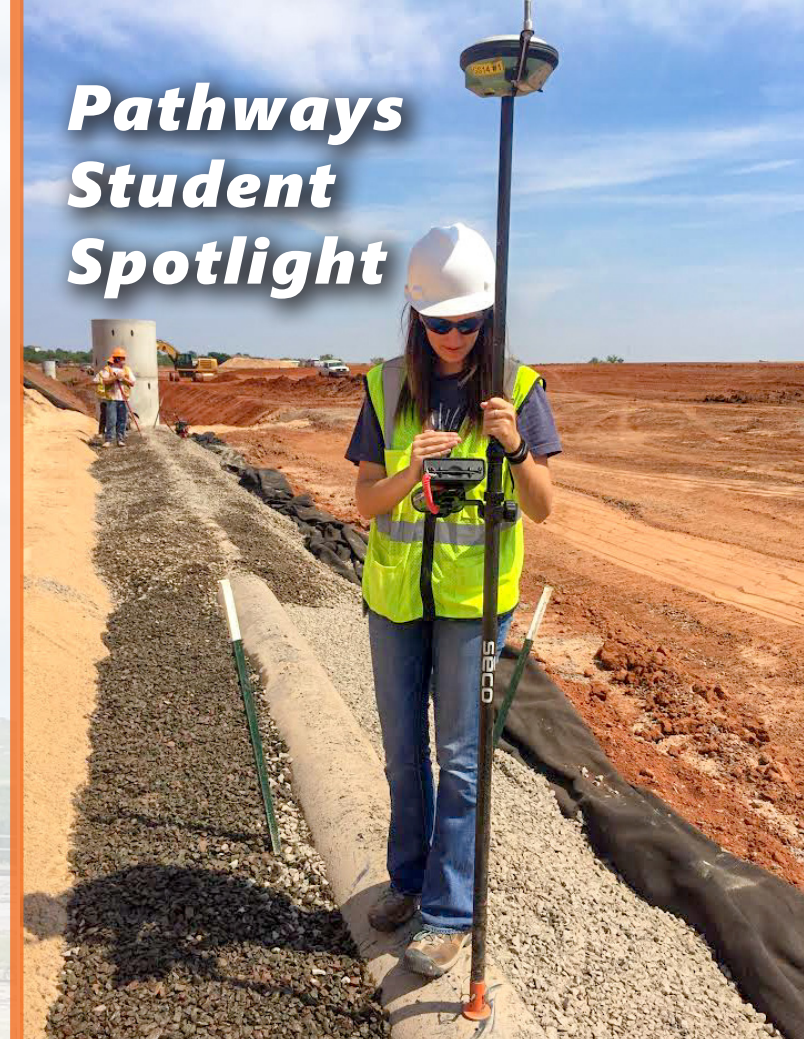
Pathways student Corbyn Coffelt performs Quality Assurance (QA) on the toe drain system at Altus Dam. Corbyn is using a survey grade Global positioning System (GPS) in conjunction with a 3D model to measure the grade of the pipe. The section of pipe is located at the newly excavated Lugert trench. QA is in support of Safety of Dam construction, Altus Dikes modification project, located near Altus, Oklahoma.

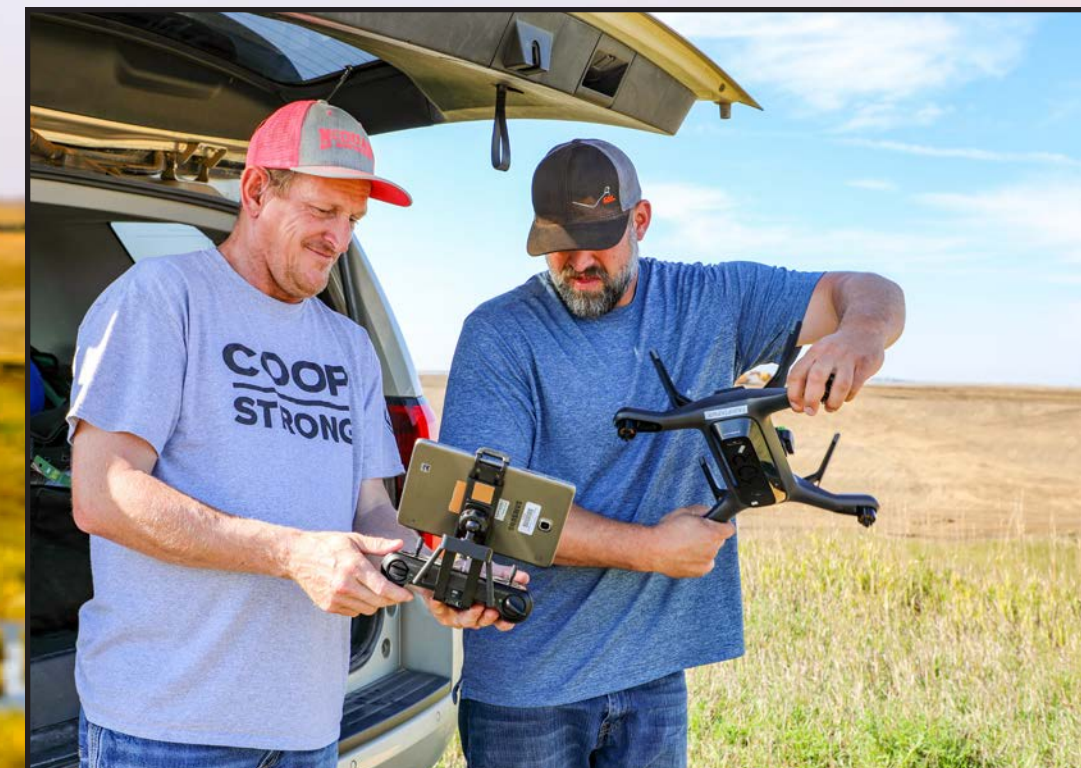
Drone pilots Brian Billman and Adam Madigan calibrate the DKAO drone alongside the Garrison Diversion Unit's McClusky Canal.

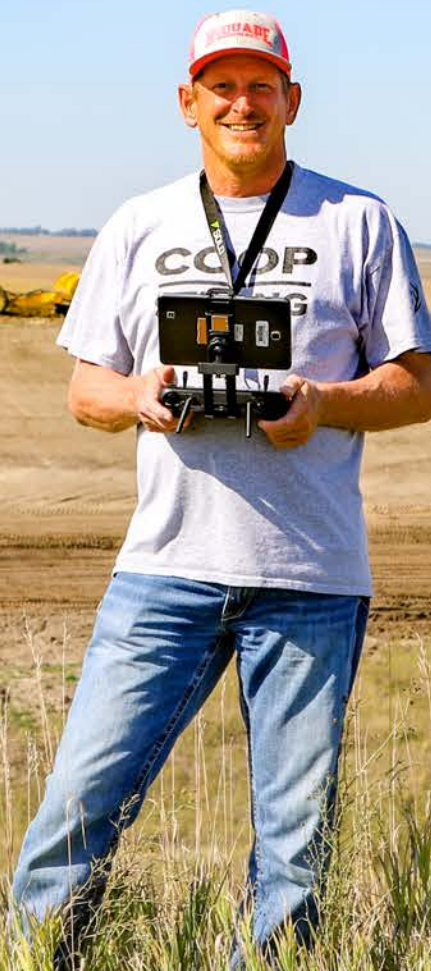
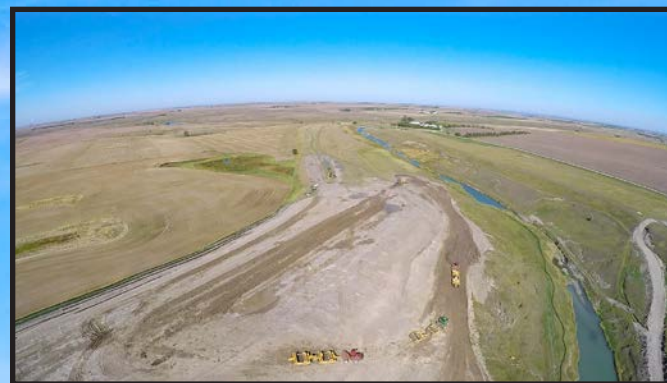
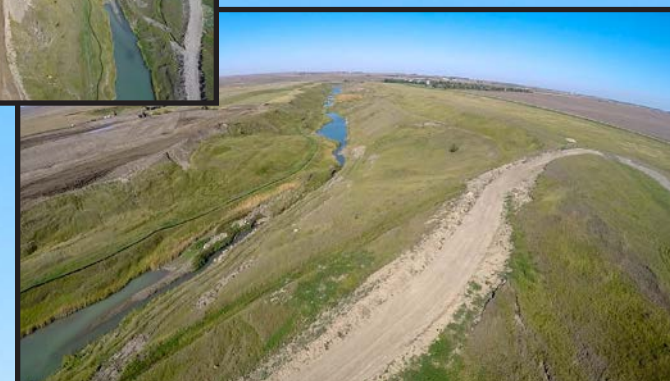
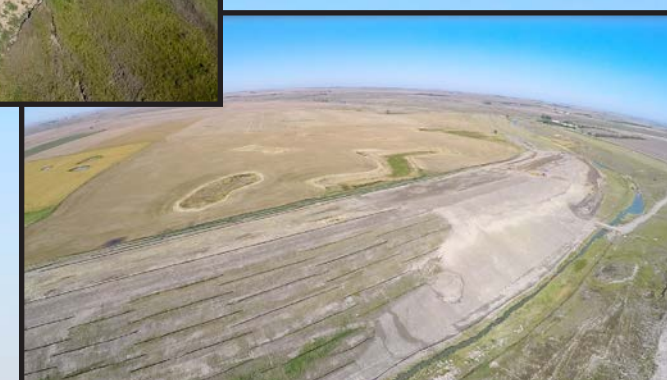
*Drone images show slide repair work and completion at McClusky Canal.*

Drone pilots in the Dakotas, Adam Madigan and Brian Billman demonstrated this “safer, faster, cheaper” awareness by capturing footage of ongoing work on the McClusky Canal. The canal is a feature of the Garrison Diversion Unit and the canal banks are sliding into the canal system. Prior to the use of drones, this level of monitoring the canal slides repair work would have taken several days and presented numerous safety challenges. The drone completed the task in less than one hour.
